# PROPERTY APPRAISER OF MIAMI-DADE COUNTY

PROPERTY INFORMATION	
Folio	03-4117-006-0010
Property Address	2 CORAL WAY CORAL GABLES, FL 33134-0000
Owner	NNN TRS INC
Mailing Address	4440 ROSEWOOD DR PLEASANTON, CA 94588
Primary Zone	5004 MIXED-USE 2
Primary Land Use	1111 STORE : RETAIL OUTLET
Beds / Baths /Half	0 / 0 / 0
Floors	1
Living Units	0
Actual Area	31,977 Sq.Ft
Living Area	31,977 Sq.Ft
Adjusted Area	30,155 Sq.Ft
Lot Size	32,705 Sq.Ft
Year Built	1994

2 Coral Way

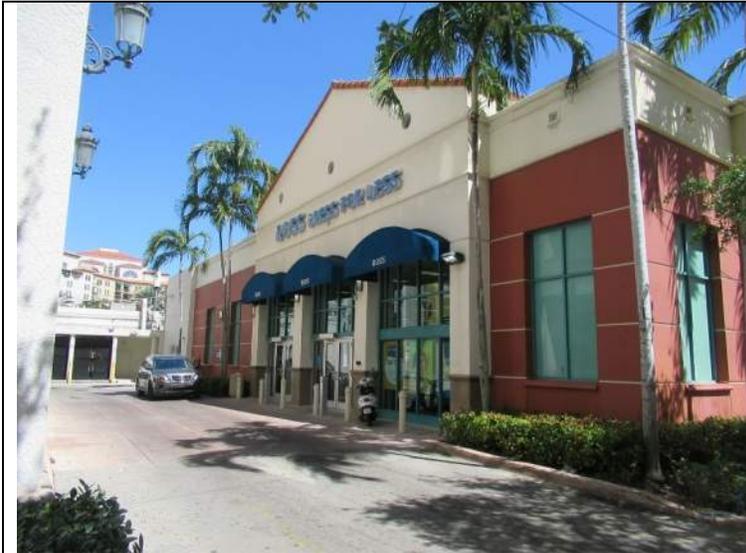
**Photograph No. 1.**

The west elevation of the Ross store showing the back SW entrances.

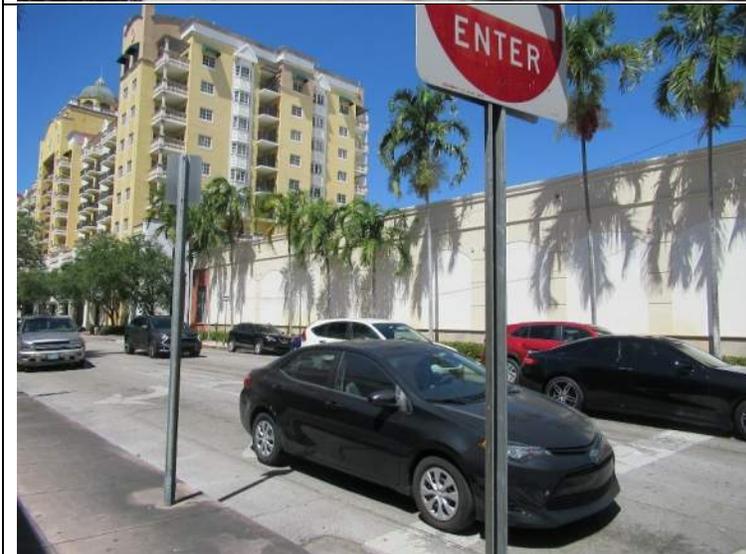
**Photograph No. 2.**

The south elevation of the Ross store along Andalsia Way.

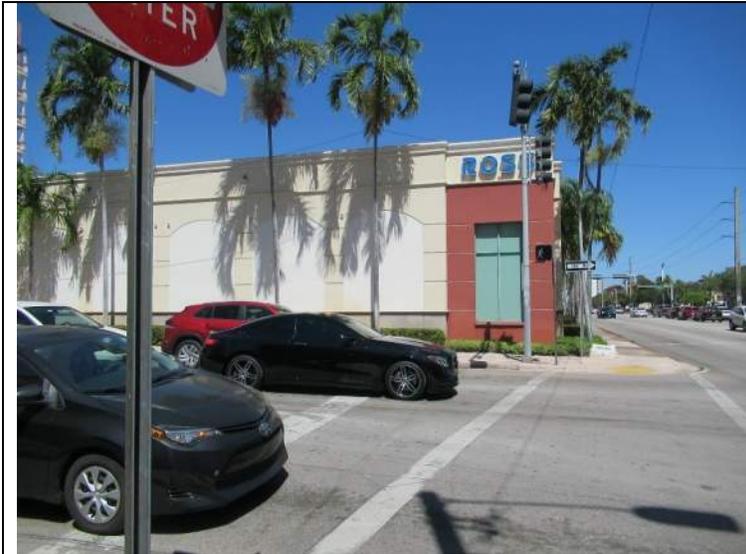
**Photograph No. 3.**

The southeast corner of the store showing an “obscured” storefront window that has a GWB board wall over it in the interior of the store.

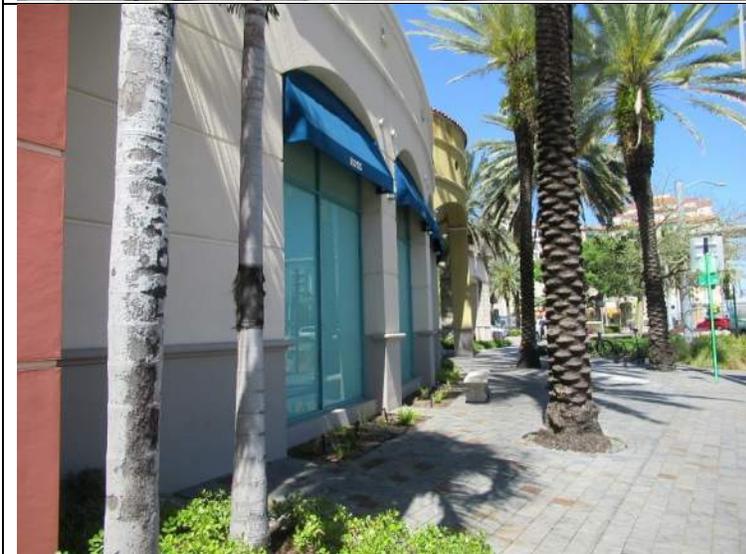
**Photograph No. 4.**

The front main (NE) rounded wall that is next to Coral Way and Douglas Road.

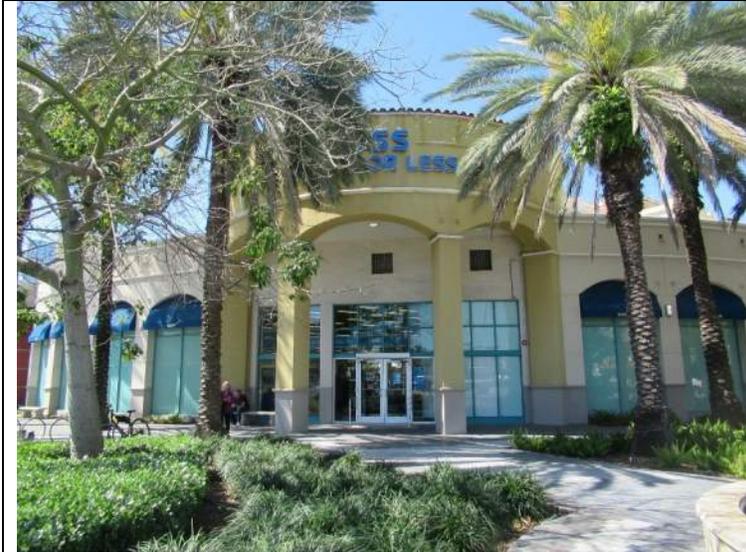
**Photograph No. 5.**

The front main (NE) rounded wall that is next to Coral Way and Douglas Road. The round silo roof feature is better shown in this picture.

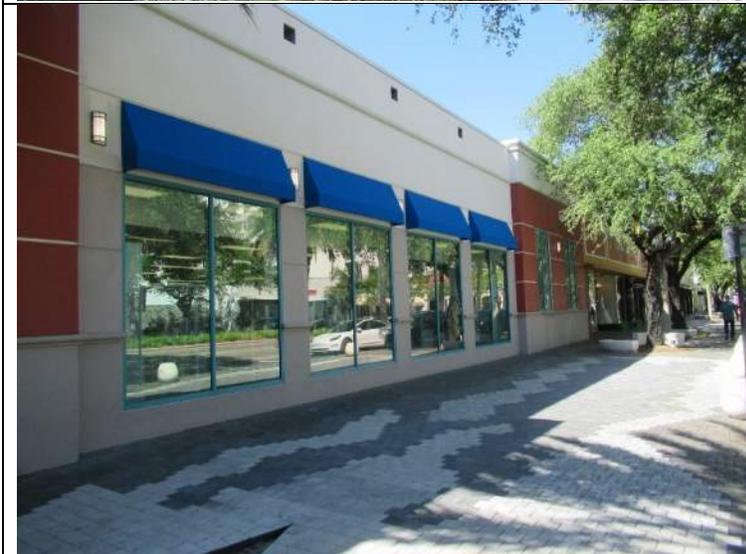
**Photograph No. 6.**

The north elevation looking west along Coral Way.

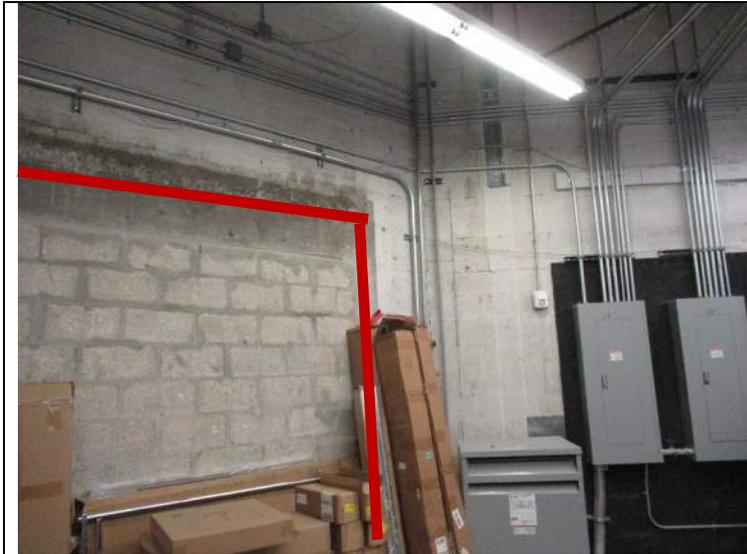
**Photograph No. 9.**

Former garage door opening for the store in the west wall. The other side is now an AT&T and public safety relay equipment locker.

The concrete jamb columns and header was observed. But the interior side exposed wall panels had no signs of concrete tie-columns.

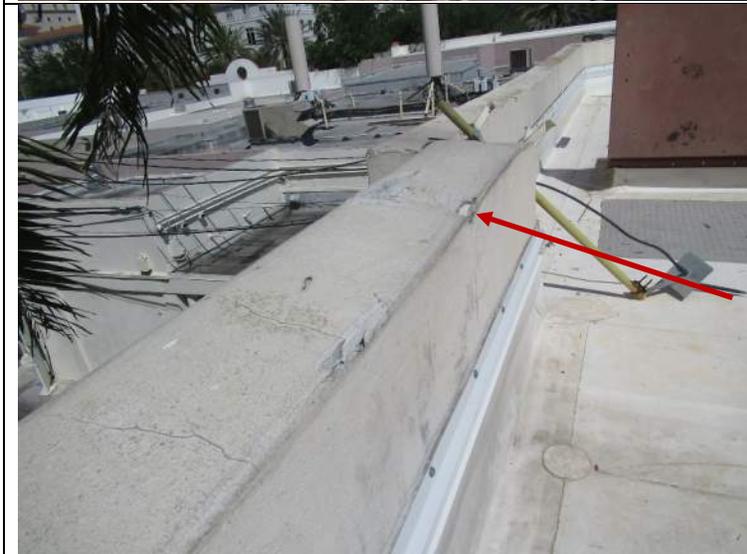
**Photograph No. 10.**

The parapet wall along the west elevation of the building. The top of the wall is a rounded EPS foam/EIFS cap that is adhered to the concrete tie beam. The cap has impact damage from prior storms.

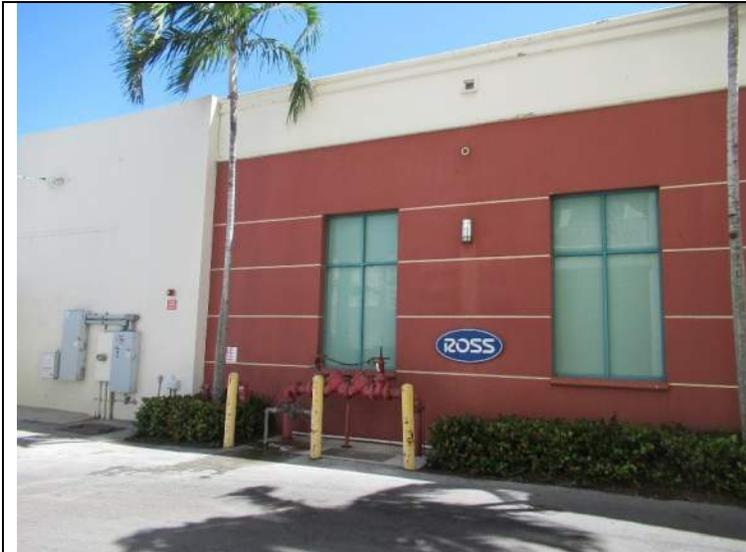
**Photograph No. 15.**

Typical west elevation wall showing the power meter and service disconnect, the obscured storefront windows, and stucco wall surfaces.

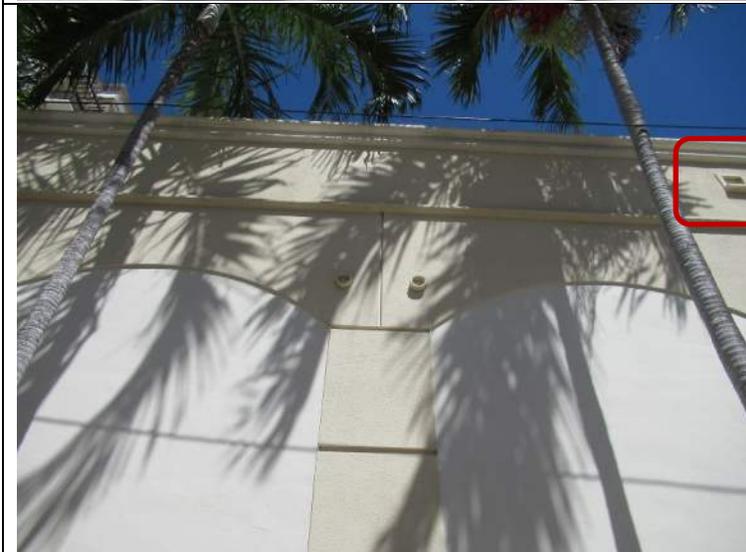
**Photograph No. 16.**

Typical south and east wall surfaces showing banding relief and panel relief. Note the two (2) round scuppers are architectural feature and do not drain. The rectangle overflow feature in some locations are an architectural feature and do not drain while others are part of the roofs overflow drainage system.

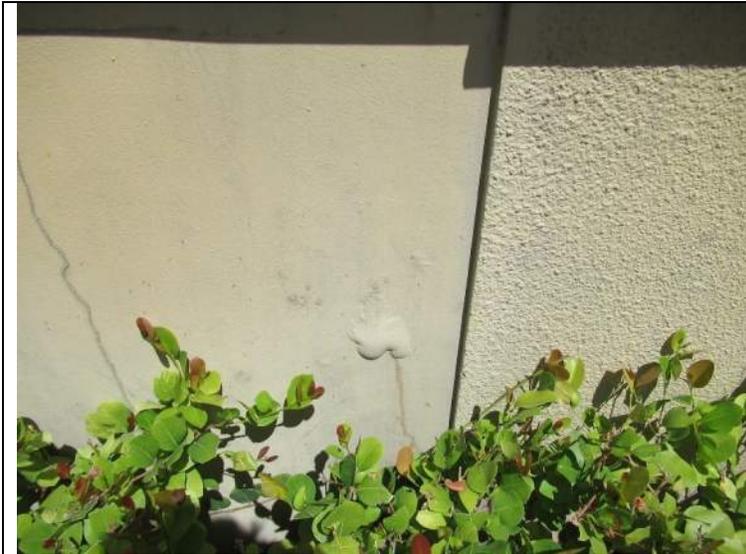
**Photograph No. 17.**

Wall paint bubble filled with water along with a hairline crack to the left in the stucco surface.

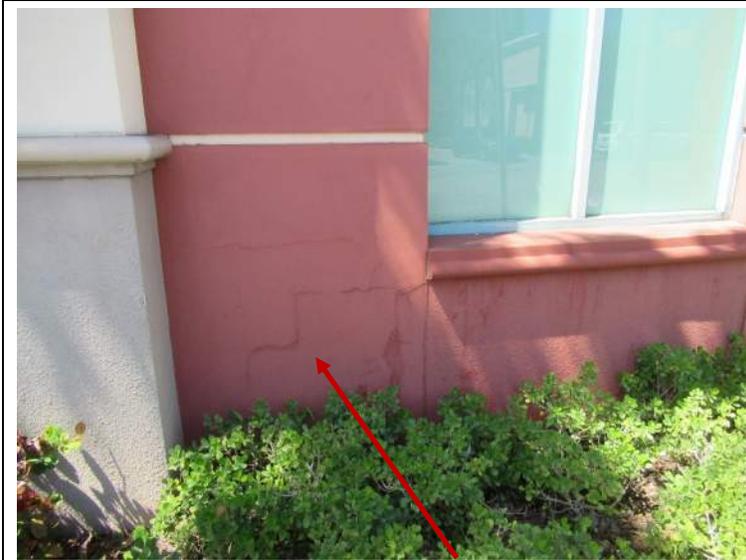
**Photograph No. 19.**

Stairstep mortar joint telegraphing cracks in stucco surface on the east elevation along Douglas Road. The cracks appear to have been present for a significant amount of time based on dirt in cracks. The cracks need to be properly treated and sealed when the building is painted. These are typical storm related movement cracks. The building is structurally sound.

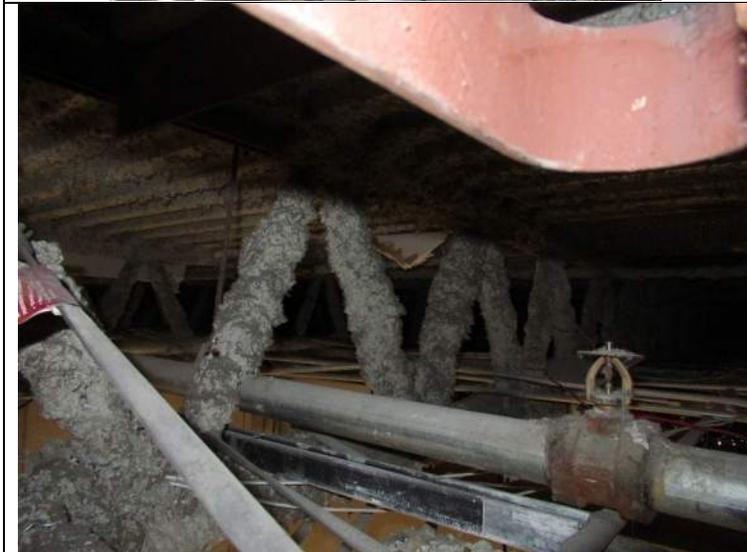
**Photograph No. 22.**

The fireproofed bar joist supporting the metal roof deck pan.

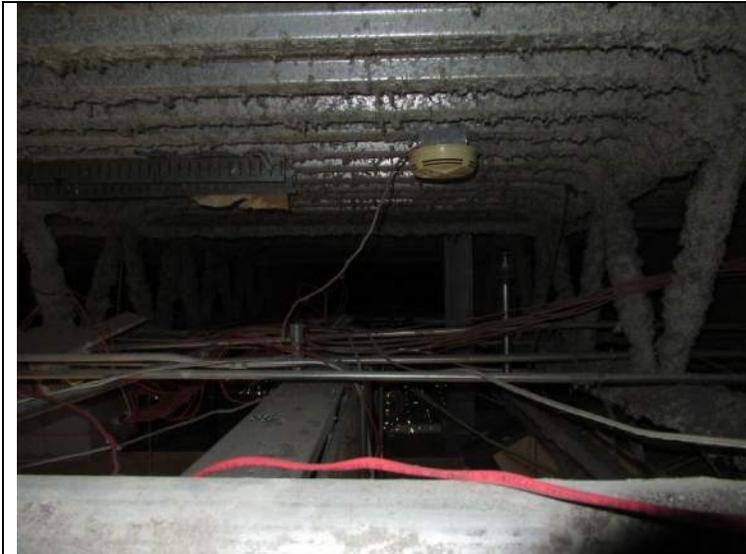
**Photograph No. 23.**

The typical bar joist with fireproofing spray applied.

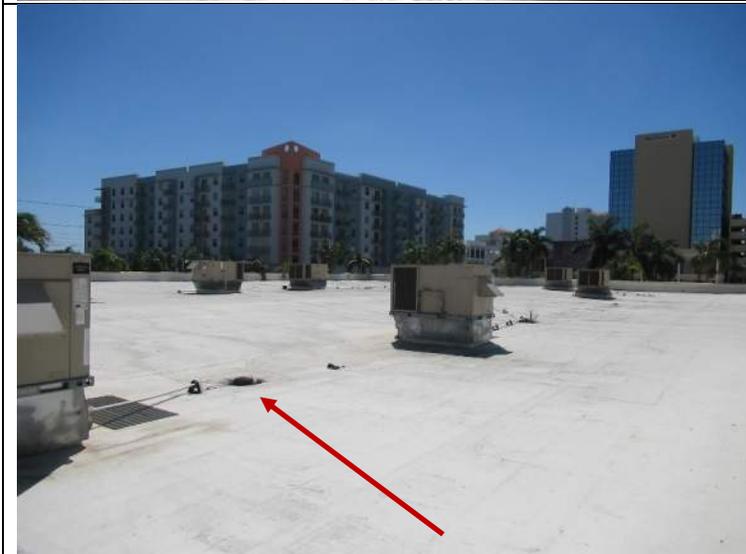
**Photograph No. 24.**

There are six (6) primary roof drains. These drains are beside interior columns. Roof overflow is provided by through parapet wall scuppers.

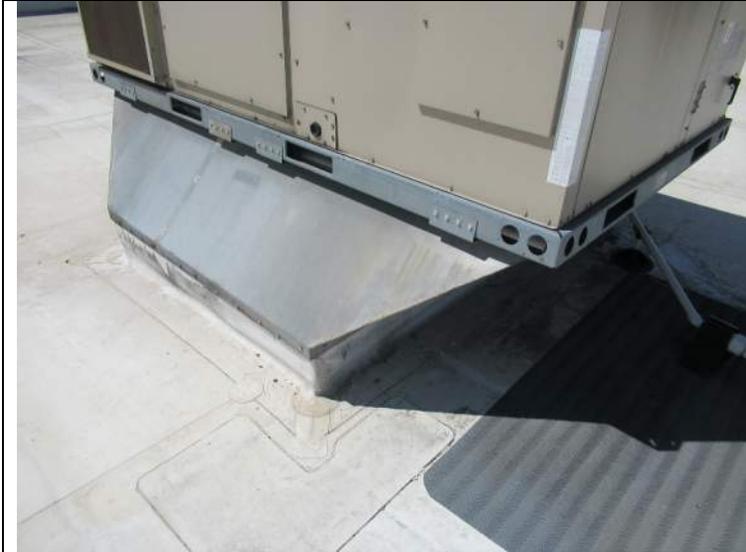
**Photograph No. 25.**

The RTU are relatively new and have welded steel adapters that connect the original roof curb to the new RTUs.

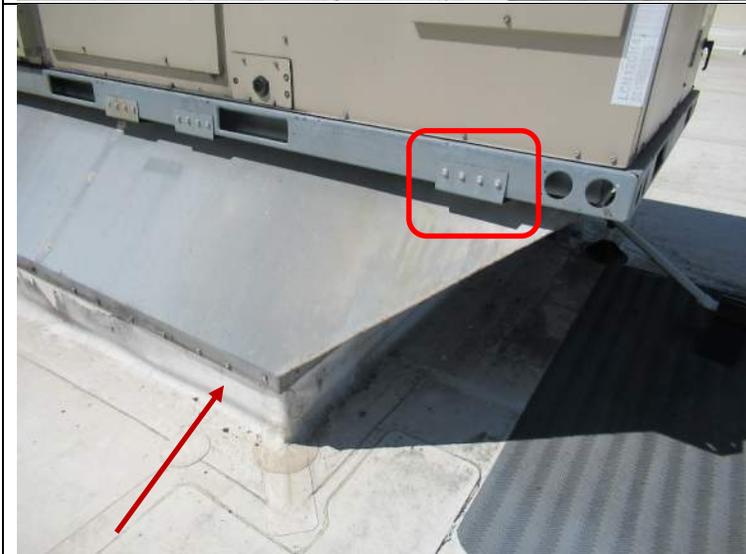
**Photograph No. 26.**

Adequate curb to adapter screws observed. Tie-down clips between adapter and RTU observed.

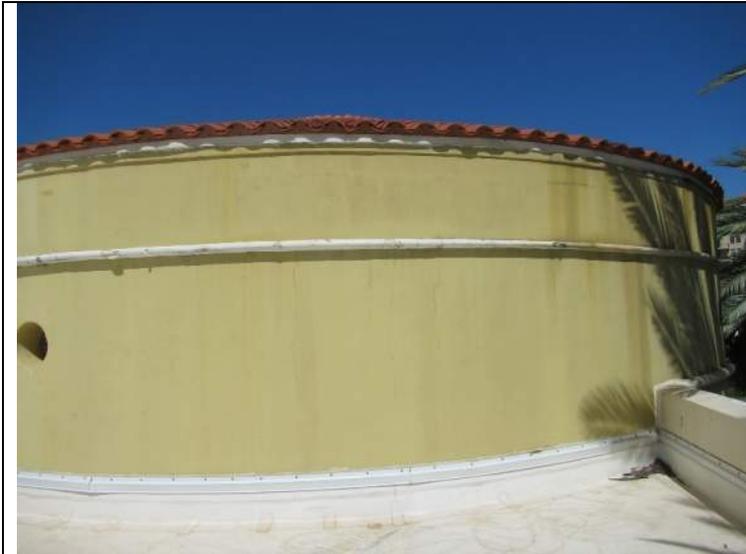
**Photograph No. 27.**

The round silo roof structure over the main (NE) entrance doors. The structure is solid CMU / concrete with no access from the roof to the silo's interior.

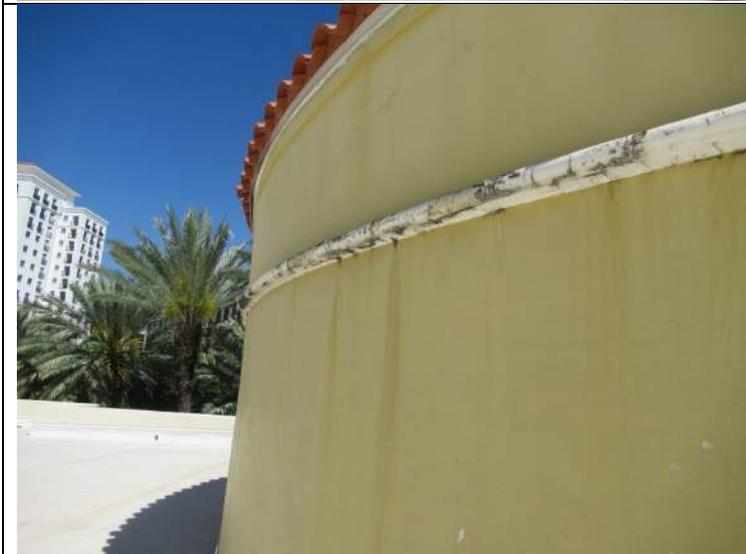
**Photograph No. 28.**

Impact damage to the surface adhered EIFS/EPS trim/band observed. The impact damage needs to be repaired when the building is painted.

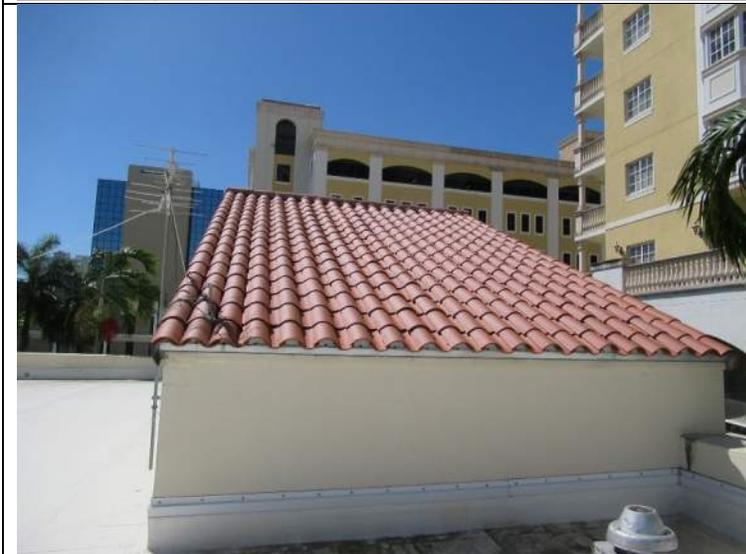
**Photograph No. 30.**

Closer picture of the gable roof structure with red terracotta barrel tile roof.

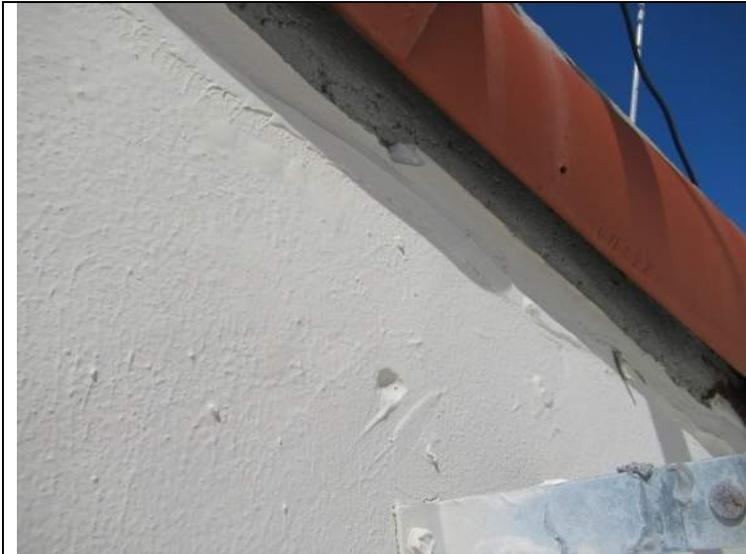
**Photograph No. 31.**

Closeup of the rake showing stucco applied to a concrete rake tie-beam.

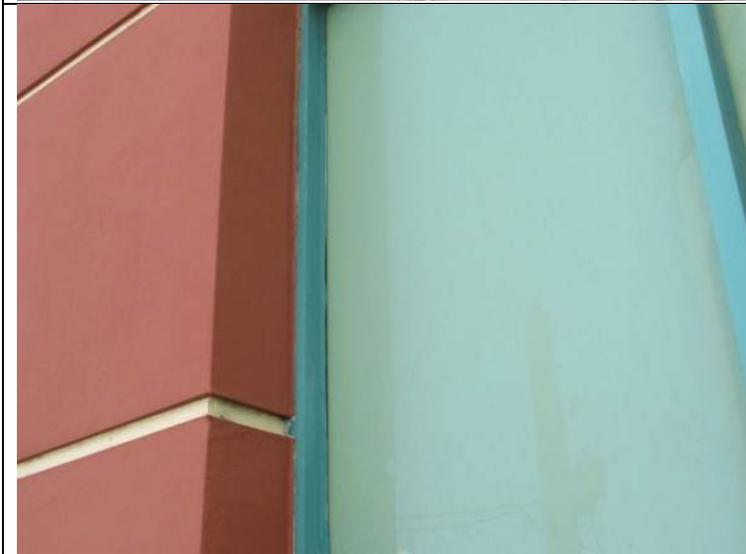
**Photograph No. 32.**

2x2 fixed storefront window showing teal color painted aluminum frames.

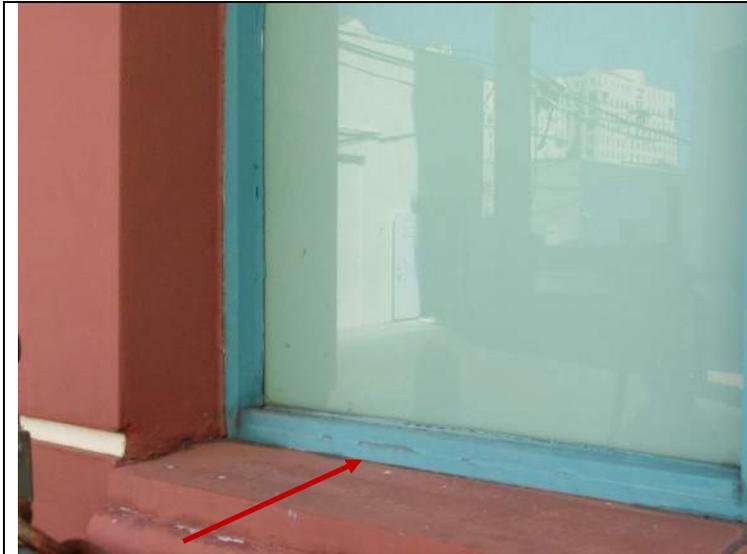
**Photograph No. 33.**

Paint starting to peel off the storefront frames.

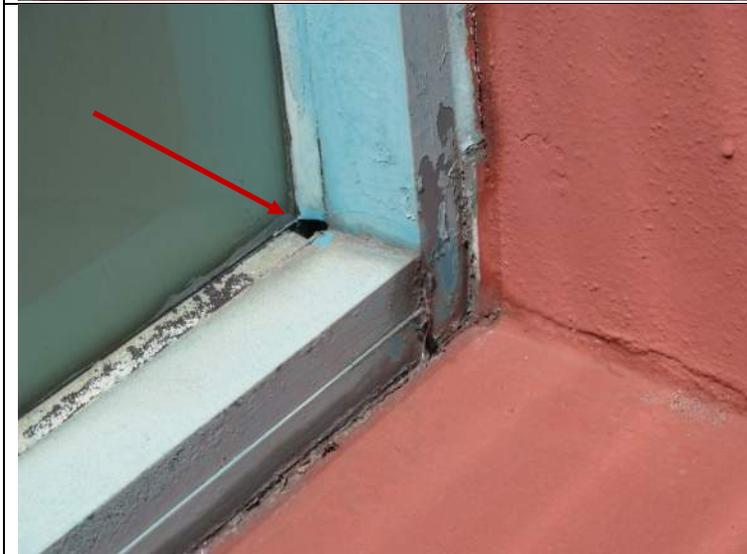
**Photograph No. 34.**

Paint peeling off frame and glass gasket shrinkage observed.

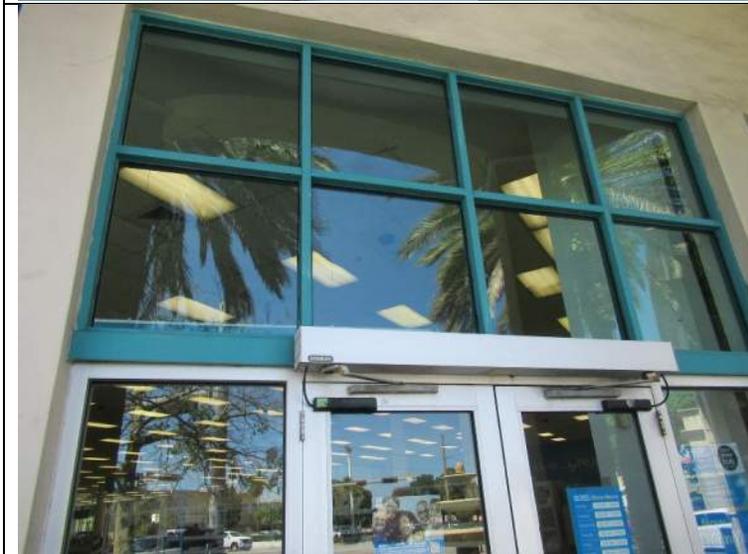
**Photograph No. 36.**

Transom 4x2 storefront over entry door assembly. The door assembly is new compared to the transom assembly.

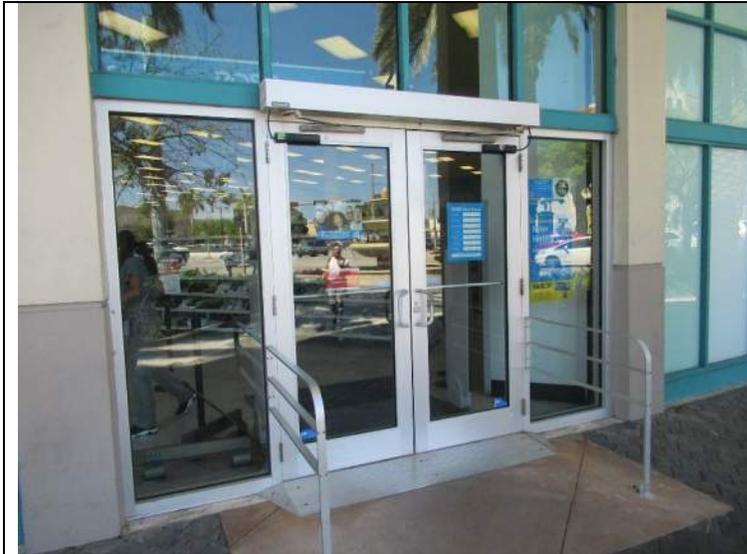
**Photograph No. 37.**

The double door storefront main entry door (NE) with new side lites. The new door leaves and side lites have LMI glass installed.

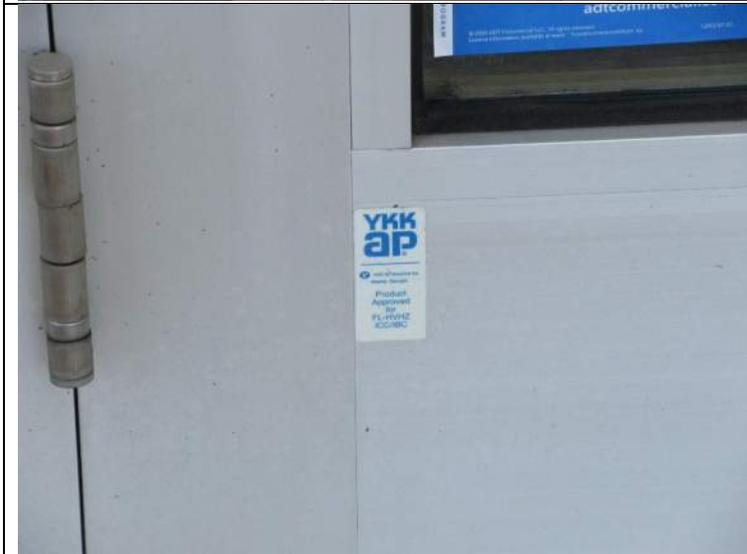
**Photograph No. 38.**

Manufacturer's label on the outside of the door.

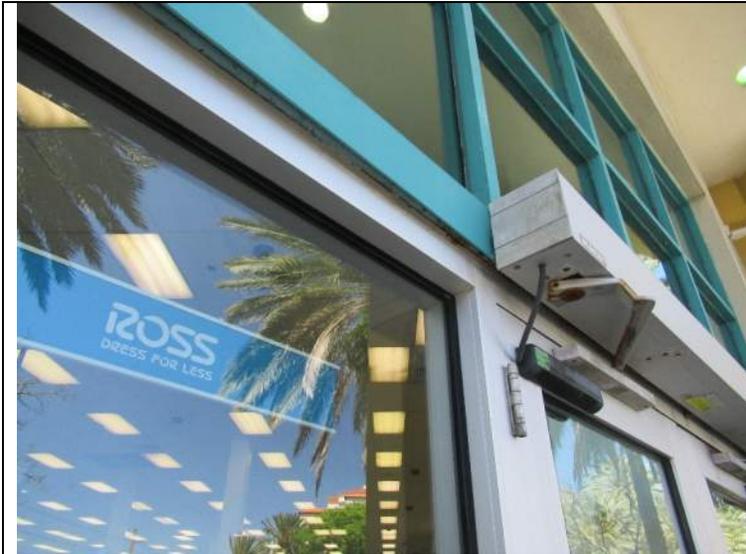
**Photograph No. 39.**

Horizontal steel mullion wrapped with aluminum from original construction.

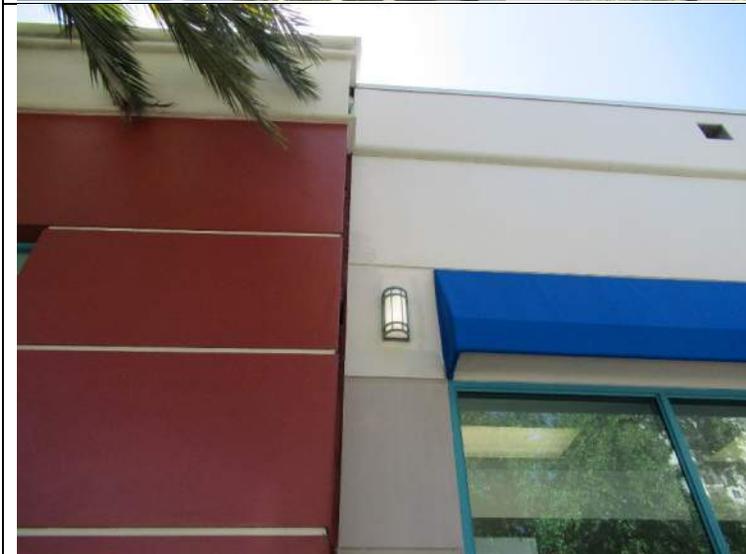
**Photograph No. 40.**

The zero lot line between the Ross store and the adjacent store to the west that Ross expanded into. The gap between the two zero lot line walls needs to be sealed off properly.

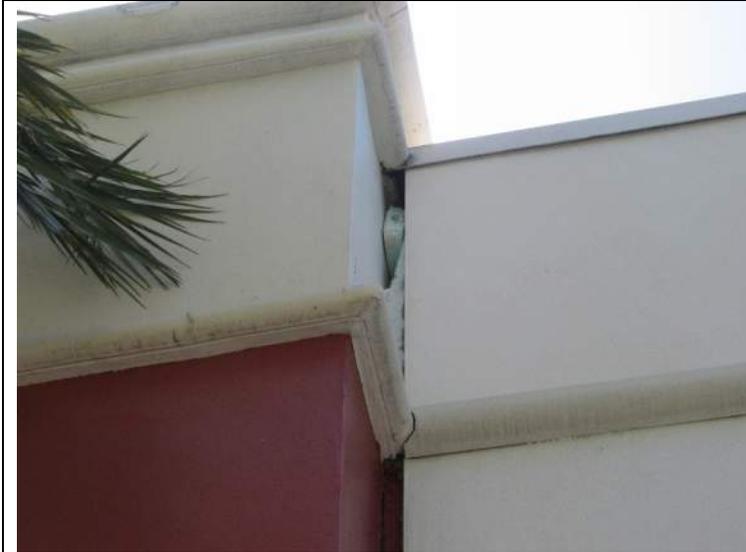
**Photograph No. 41.**

Closeup of zero lot line showing insulation between the two buildings' independent walls. The gap between the two zero lot line walls needs to be sealed off properly.

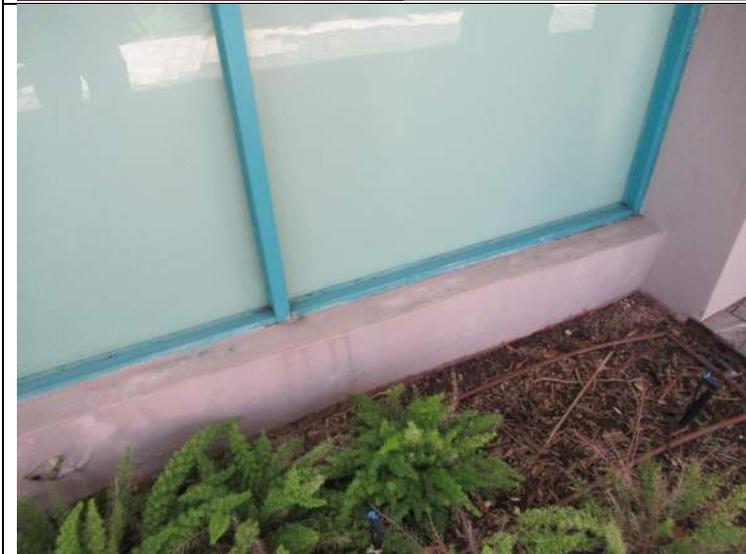
**Photograph No. 42.**

Water stains on exterior wall sill showing trapped water leaking out of frame. This is an indication that the glass gasket is leaking excessive water into the frame. The glass to frame should be wet sealed with sealant.

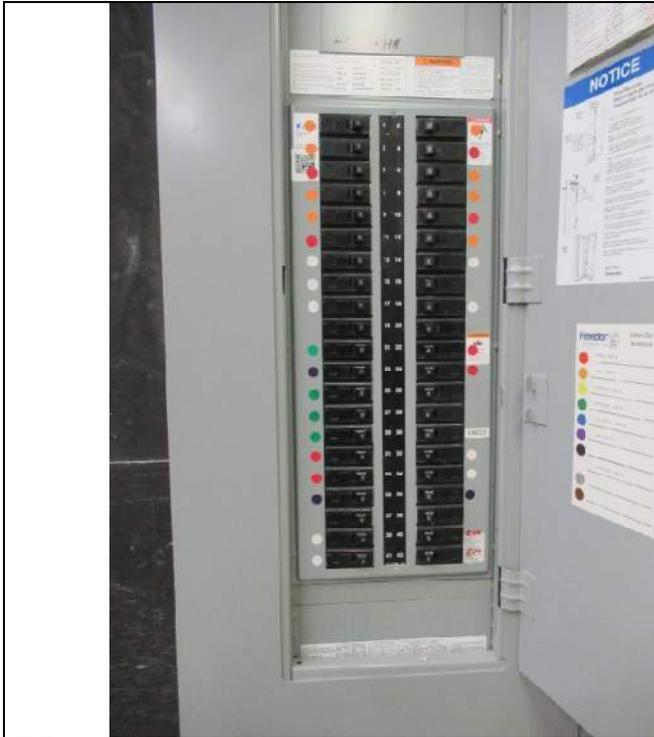
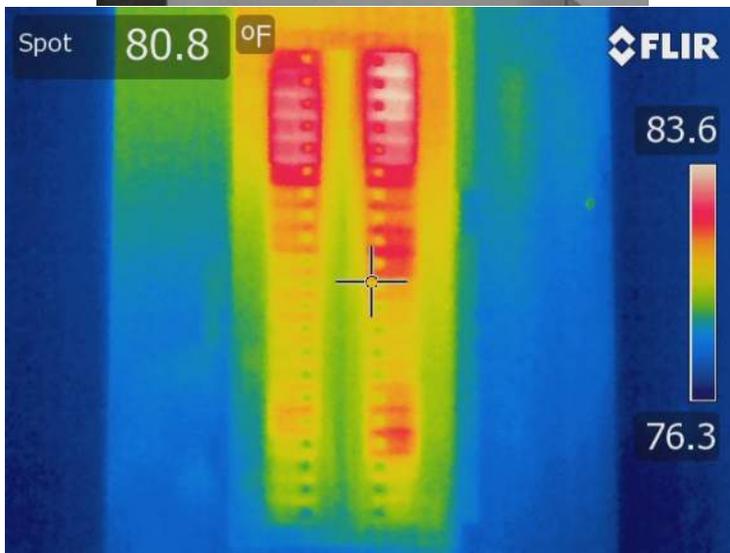
**Photograph No. 46.**

The HA lighting sub-panel with maximum temperature at 83.6 degrees.

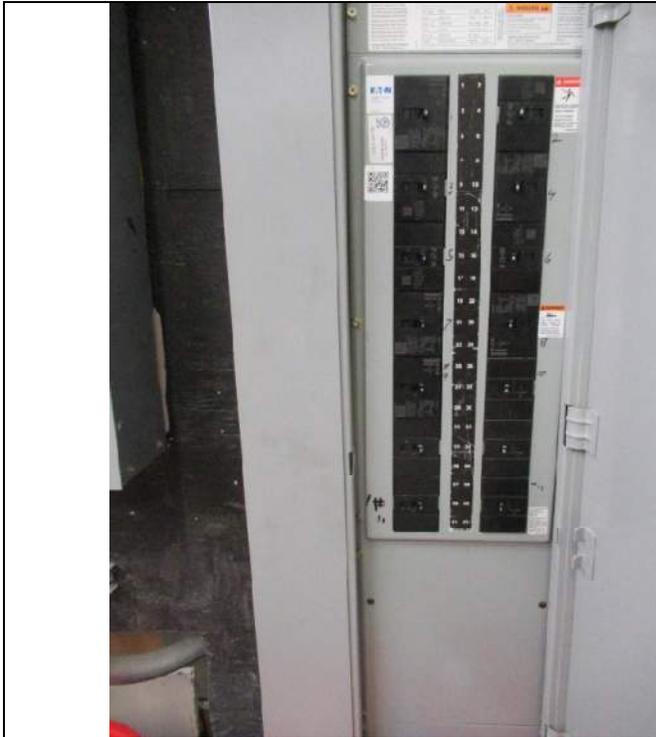
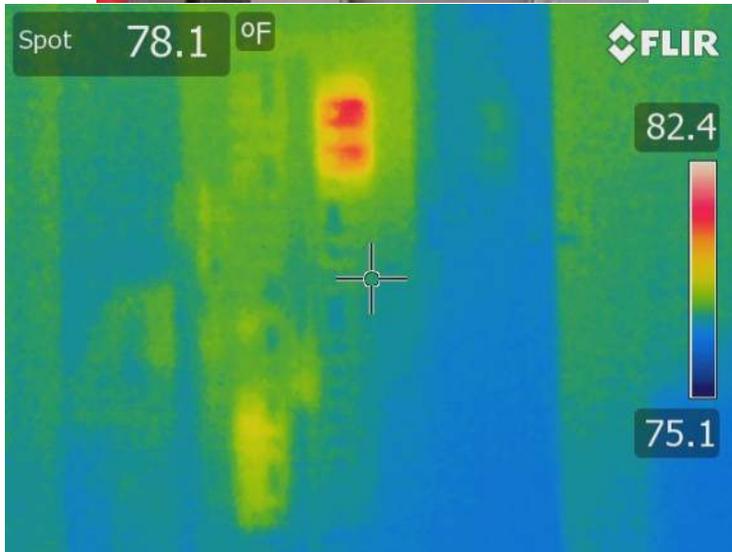
**Photograph No. 47.**

The AC HVAC RTU sub-panel with maximum temperature at 82.4 degrees.

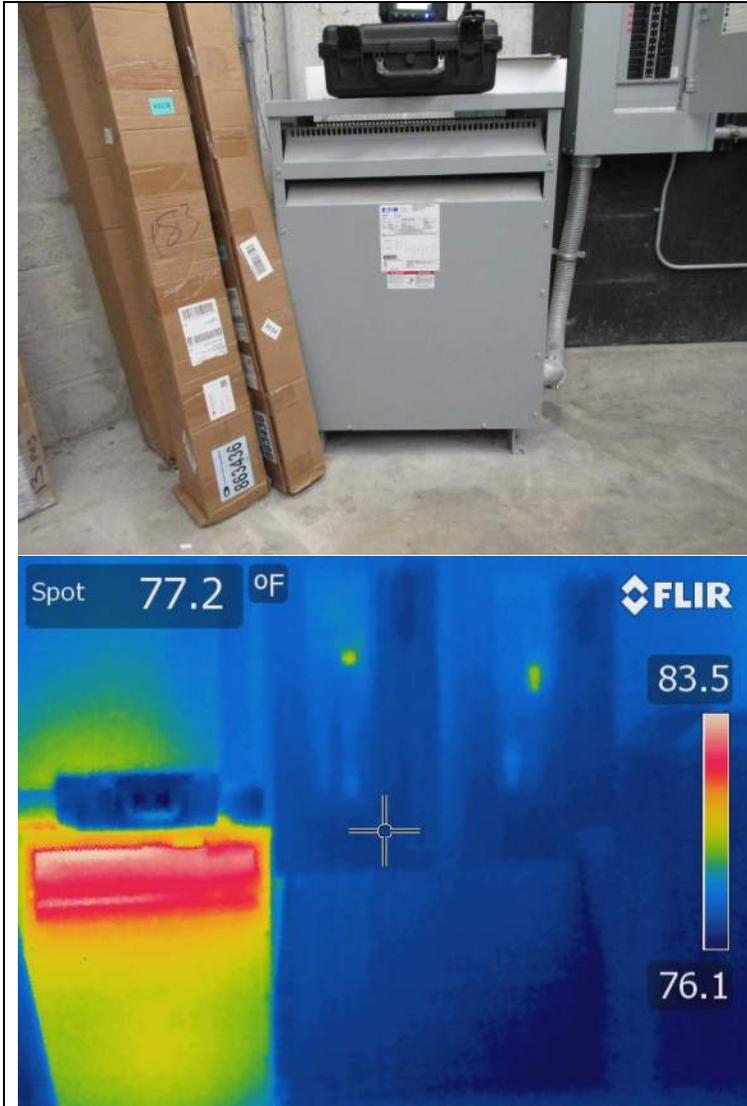
**Photograph No. 48.**

The 75 kva transformer stepping down 480Y277 to 208Y120 volts operating at 83.5 degrees vent temperature.

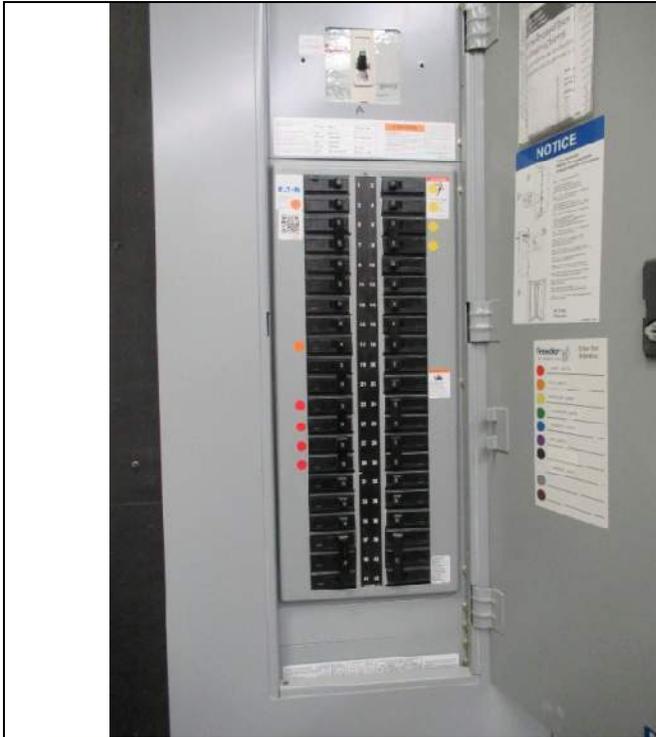
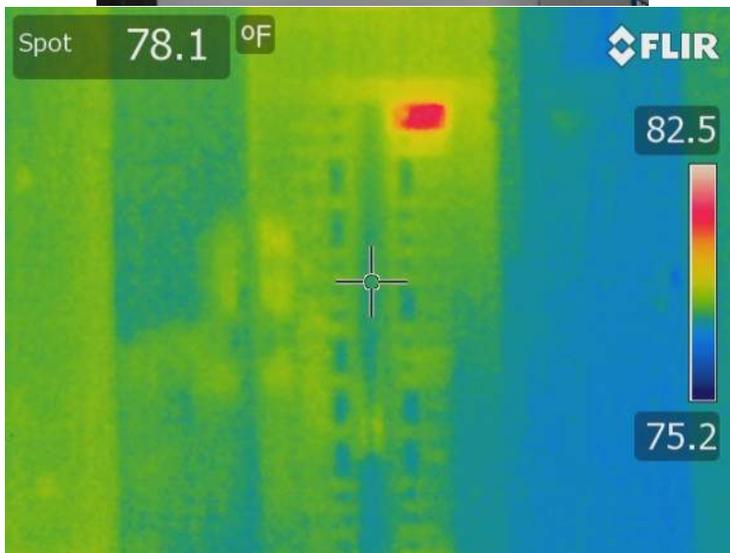
**Photograph No. 49.**

The LA 208Y120 sub-panel with maximum temperature at 82.5 degrees.

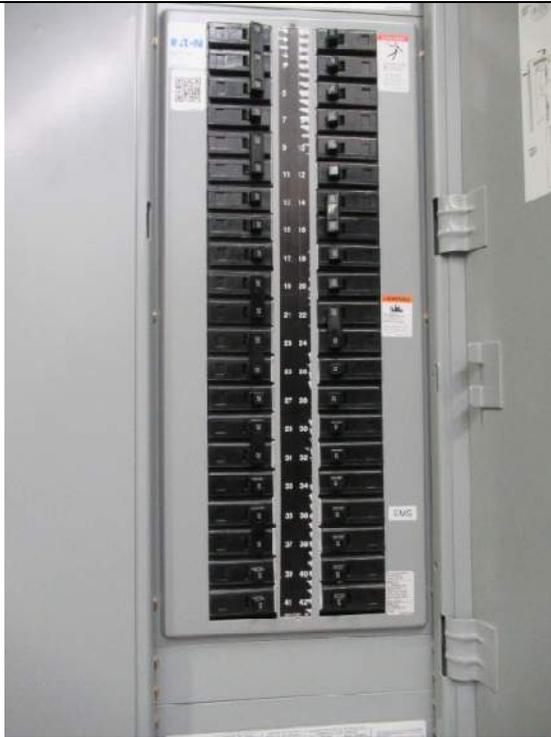
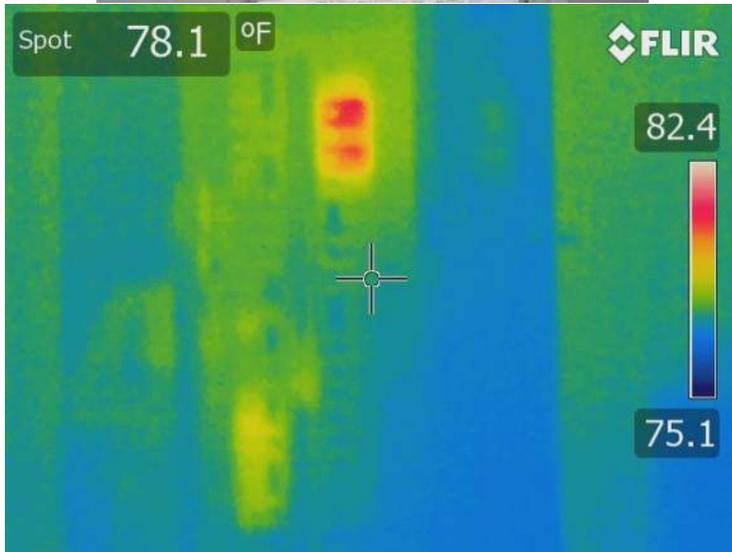
**Photograph No. 50.**

The LB 208Y120 sub-panel with maximum temperature at 82.4 degrees. The LB panel is supplied by the LA panels (CB 38, 40, & 42).

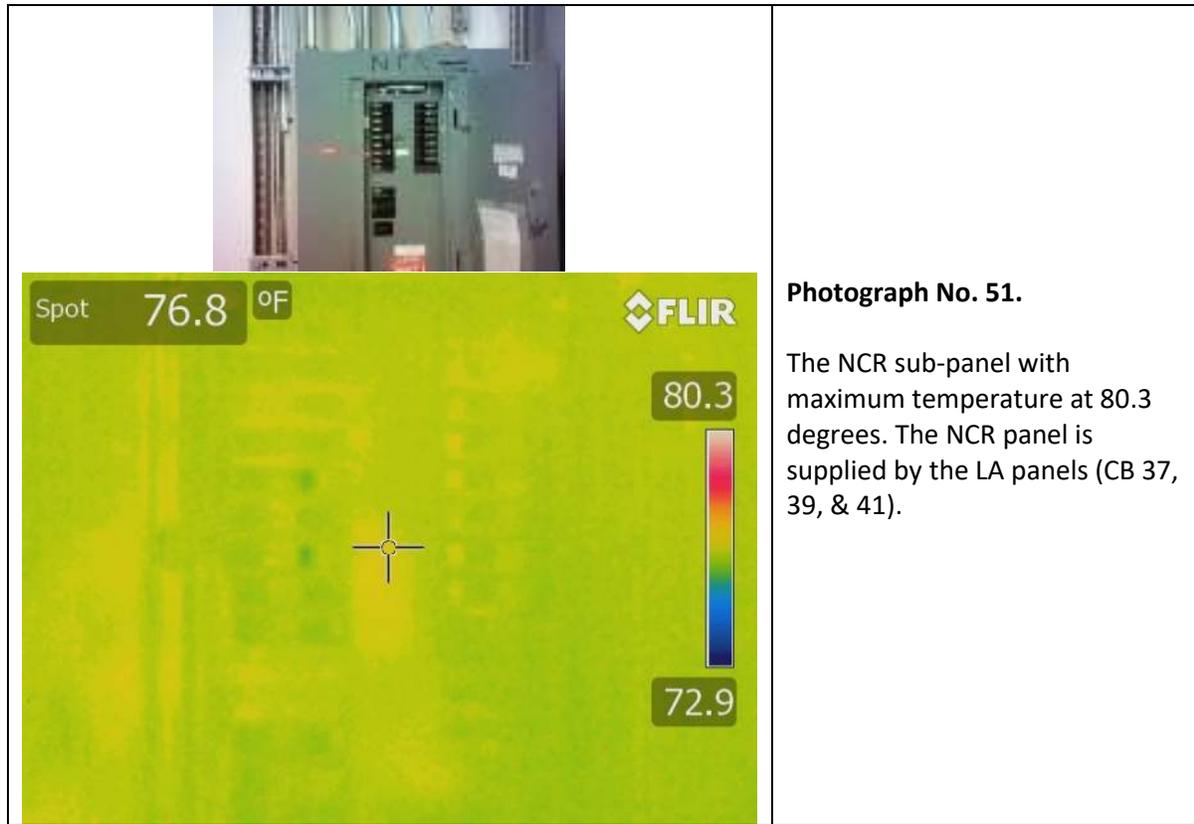
**Photograph No. 51.**

The NCR sub-panel with maximum temperature at 80.3 degrees. The NCR panel is supplied by the LA panels (CB 37, 39, & 41).

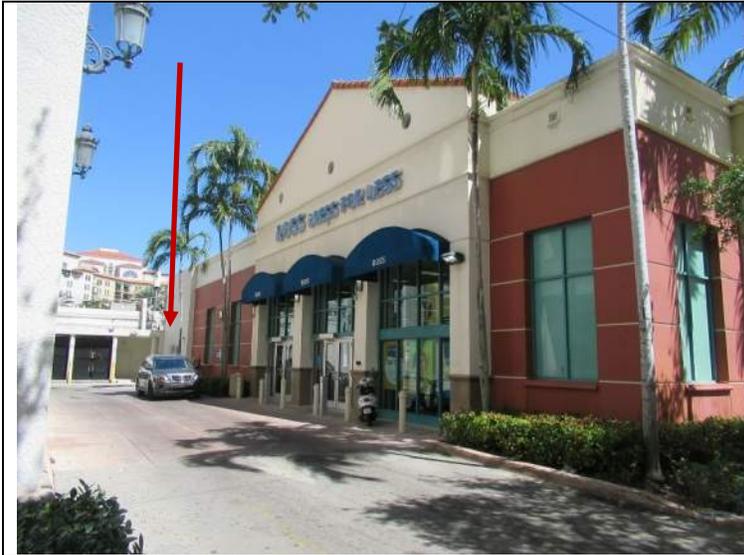
**Photograph No. 1.**

The west elevation of the Ross store showing the back SW entrances. The arrow indicates the electrical service location for the store.

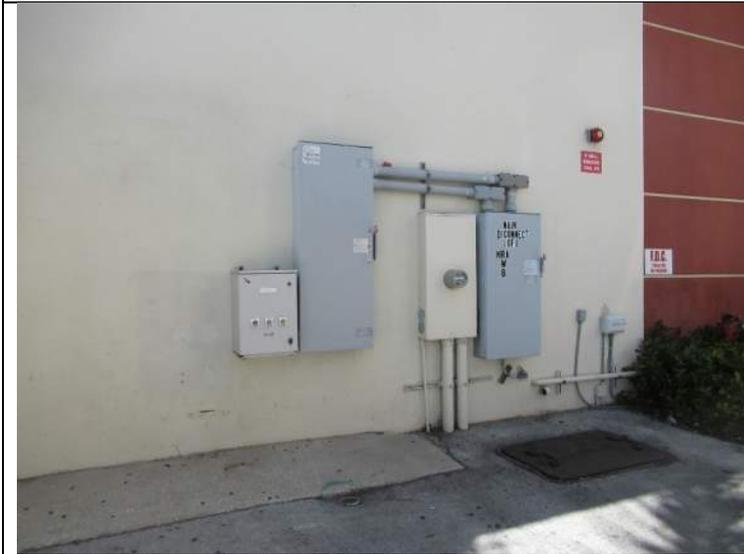
**Photograph No. 2.**

The service entrance to the store with service disconnect.

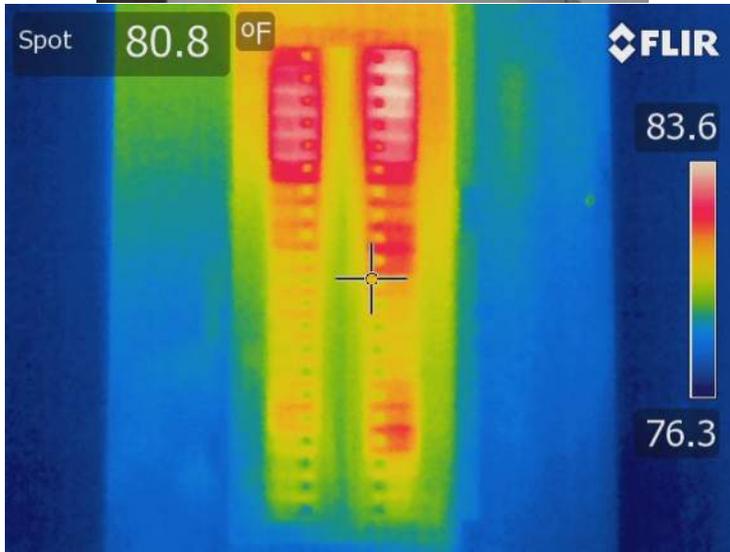
**Photograph No. 4.**

The HA subpanel is powered by the MDP.

The HA lighting sub-panel with maximum temperature at 83.6 degrees.

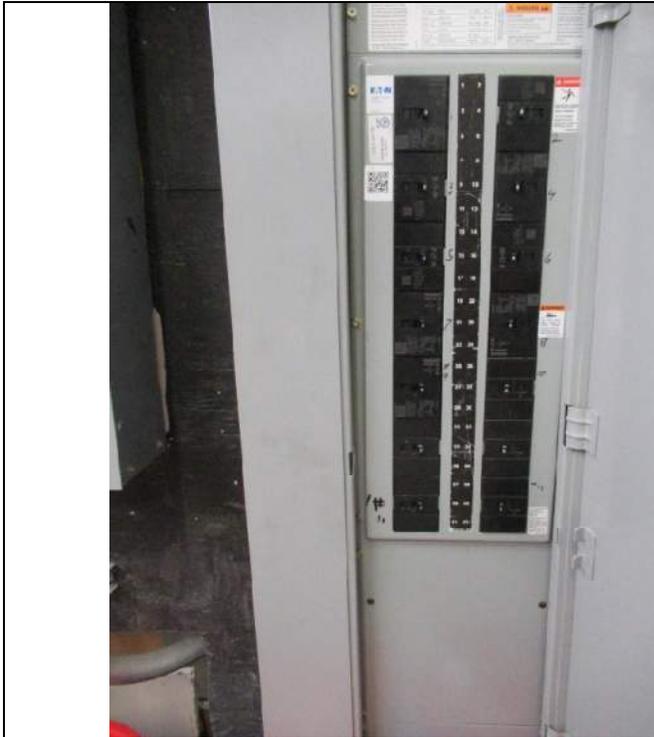
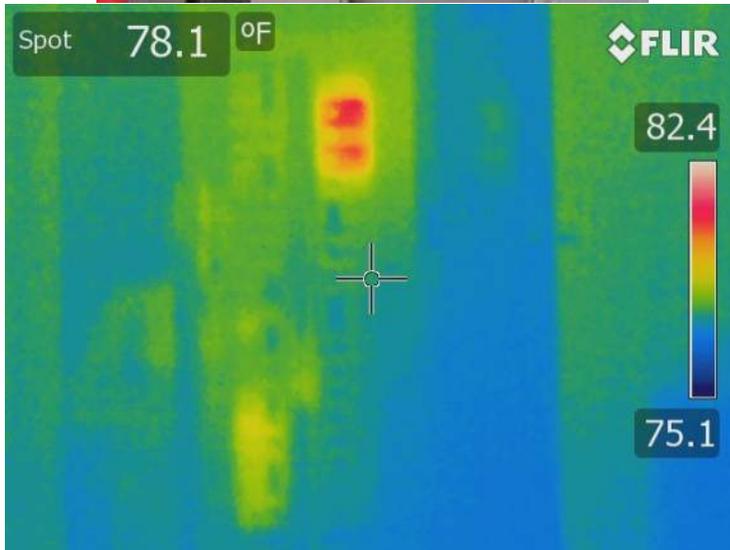
**Photograph No. 5.**

The AC subpanel is powered by the MDP.

The AC HVAC RTU sub-panel with maximum temperature at 82.4 degrees.

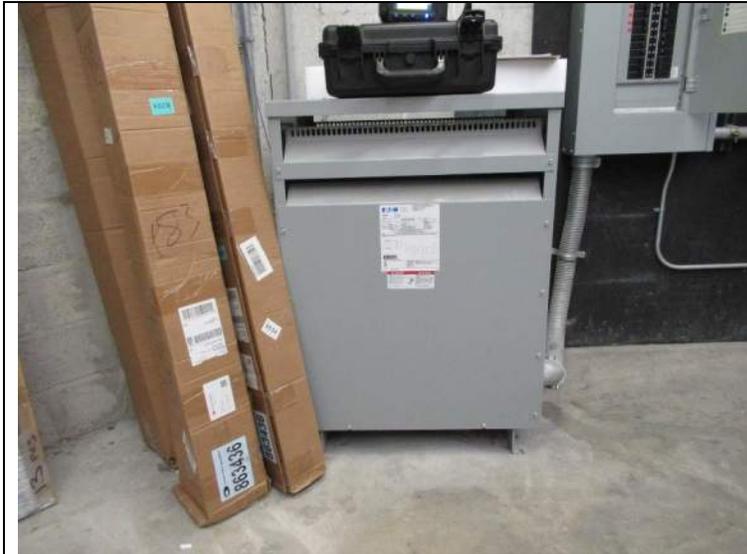
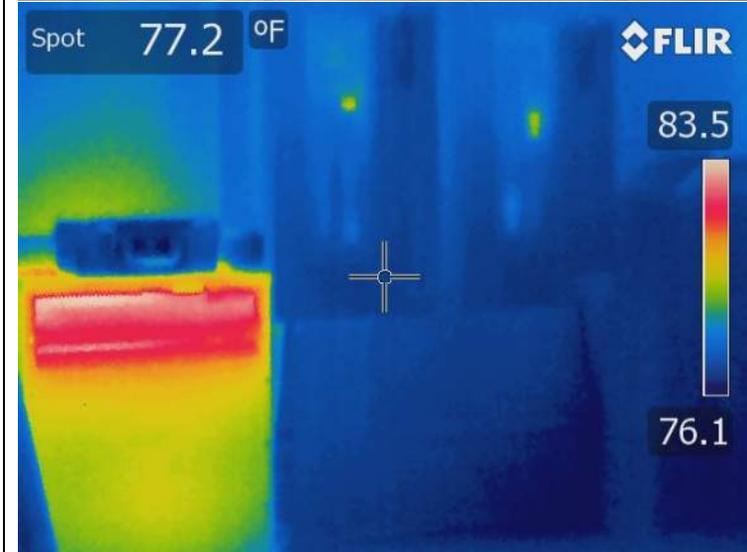
**Photograph No. 6.**

The transformer is powered by the MDP.

The 75 kva transformer stepping down 480Y277 to 208Y120 volts operating at 83.5 degrees vent temperature.
