# PROPERTY APPRAISER OF MIAMI-DADE COUNTY

PROPERTY INFORMATION	
Folio	03-4117-006-0010
Property Address	2 CORAL WAY CORAL GABLES, FL 33134-0000
Owner	NNN TRS INC
Mailing Address	4440 ROSEWOOD DR PLEASANTON, CA 94588
Primary Zone	5004 MIXED-USE 2
Primary Land Use	1111 STORE : RETAIL OUTLET
Beds / Baths /Half	0 / 0 / 0
Floors	1
Living Units	0
Actual Area	31,977 Sq.Ft
Living Area	31,977 Sq.Ft
Adjusted Area	30,155 Sq.Ft
Lot Size	32,705 Sq.Ft
Year Built	1994

2 Coral Way

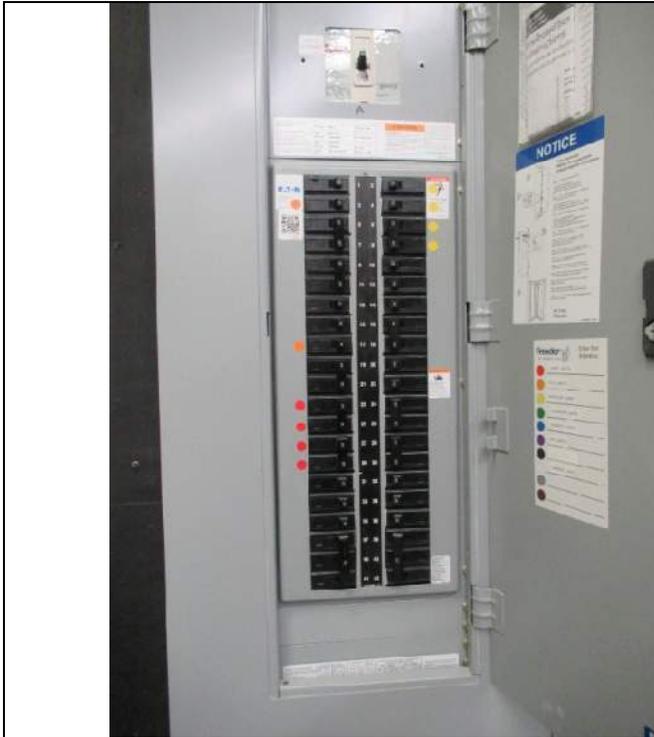
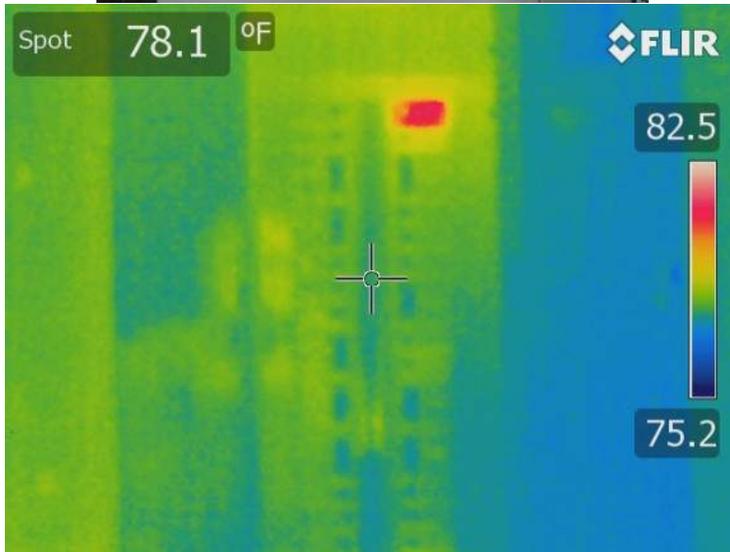
### Photograph No. 7.

The LA subpanel is powered from the MDP to the 75 kva transformer.

The LA 208Y120 sub-panel with maximum temperature at 82.5 degrees.

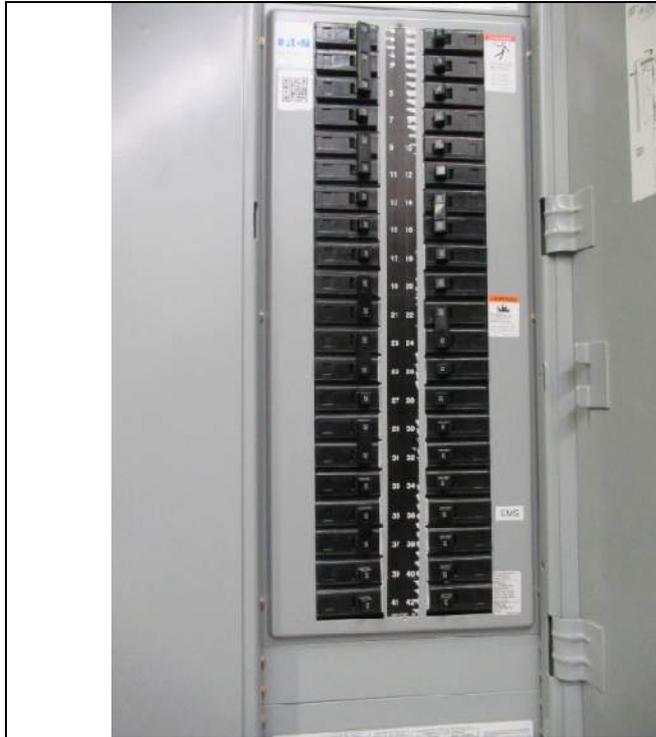
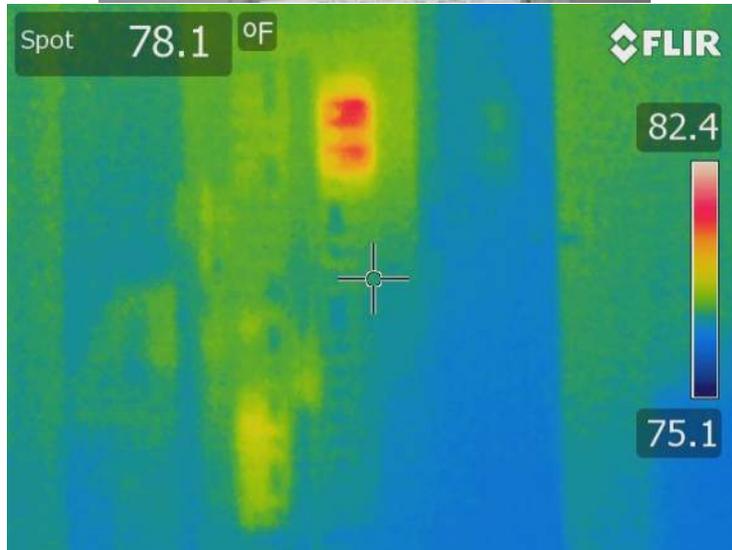
**Photograph No. 8.**

The LB subpanel is powered by the LA subpanel CB 38, 40, 42.

The LB 208Y120 sub-panel with maximum temperature at 82.4 degrees. The LB panel is supplied by the LA panels (CB 38, 40, & 42).

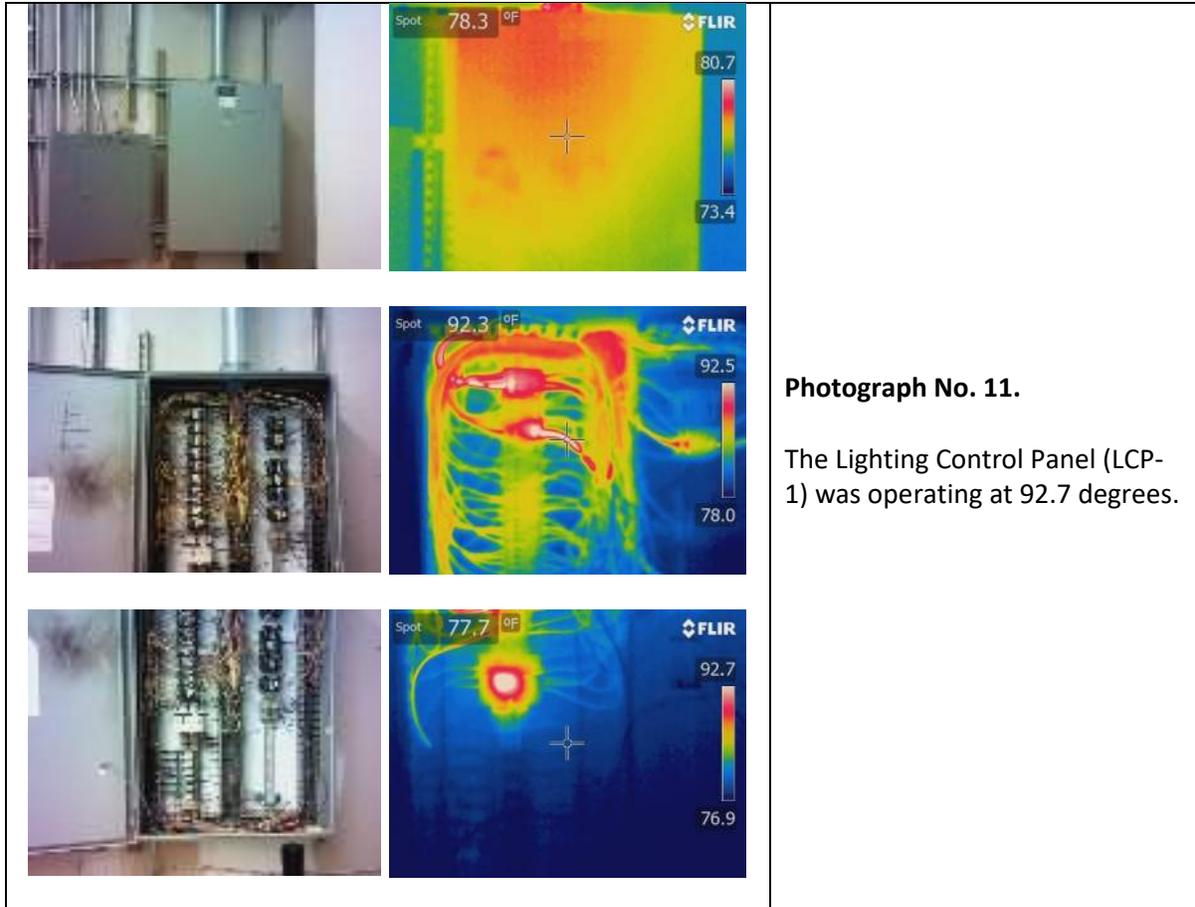
**Photograph No. 11.**

The Lighting Control Panel (LCP-1) was operating at 92.7 degrees.

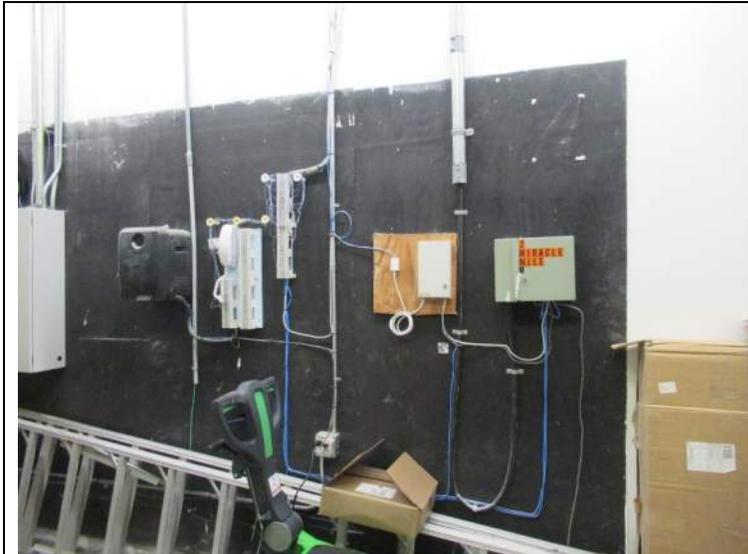
**Photograph No. 13.**

The telecommunication panels on the east wall of the electrical room.

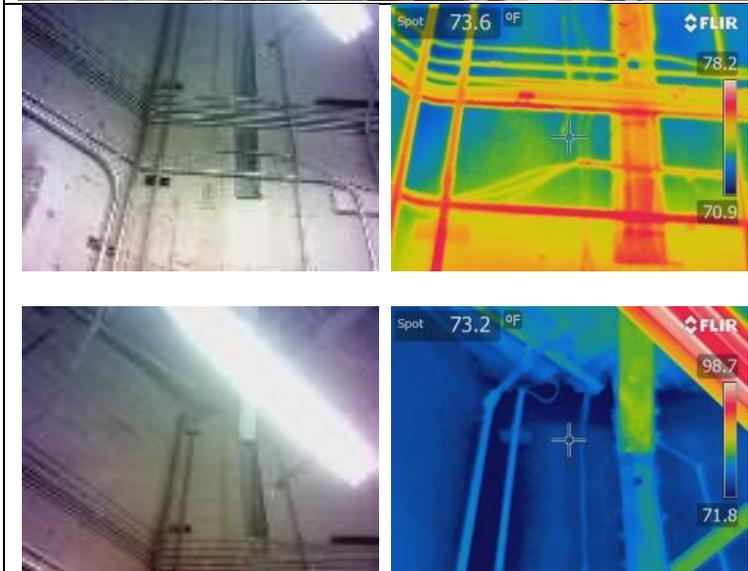
**Photograph No. 14.**

The EMT conduit temperatures agreed with the room's temperature.

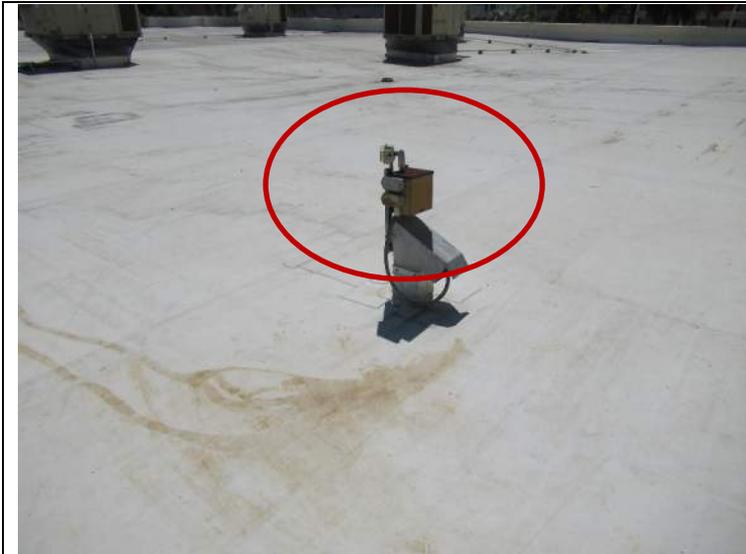
**Photograph No. 15.**

The store's lighting control sensors were located on the roof and observed in good condition.

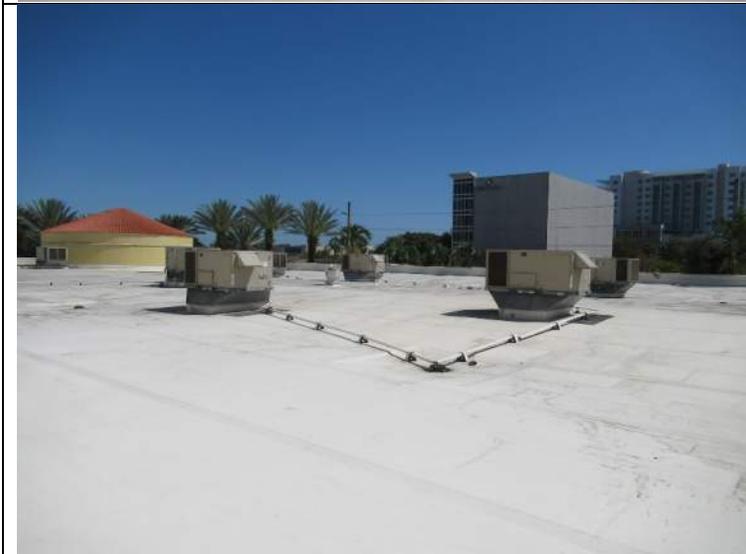
**Photograph No. 16.**

All the roof top HVAC units had internal electrical feed from the MDP or AC subpanel with integral service disconnect manufactured with the RTU.

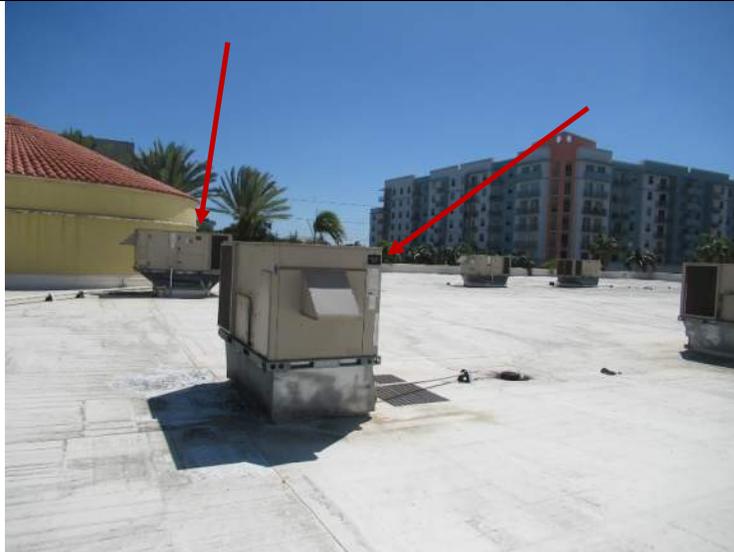
**Photograph No. 17.**

All the roof top HVAC units had proper identification labels on each RTU.

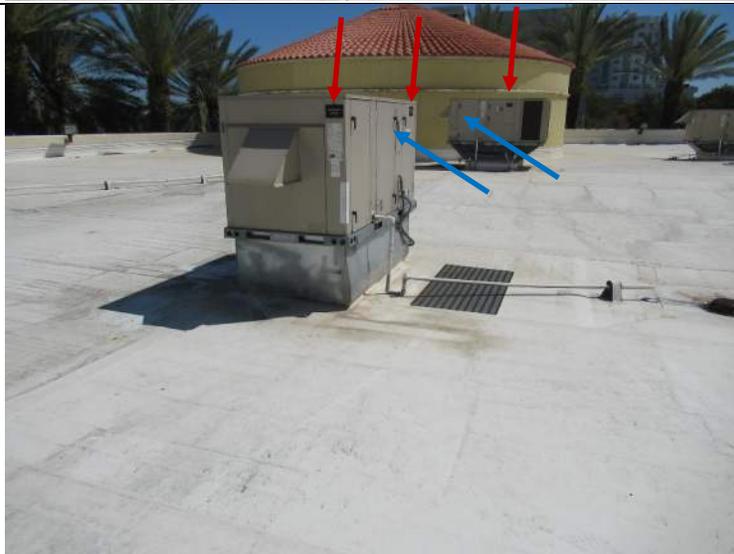
**Photograph No. 18.**

All the roof top HVAC units had proper identification labels on each RTU (red arrows). The HVAC units have integral service disconnect manufactured with the RTUs (blue arrows).

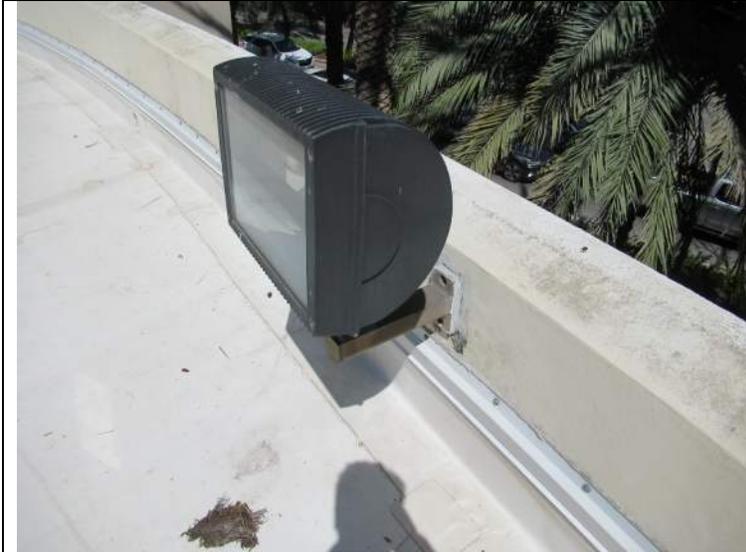
**Photograph No. 19.**

The roof top illumination lights were observed in good condition.

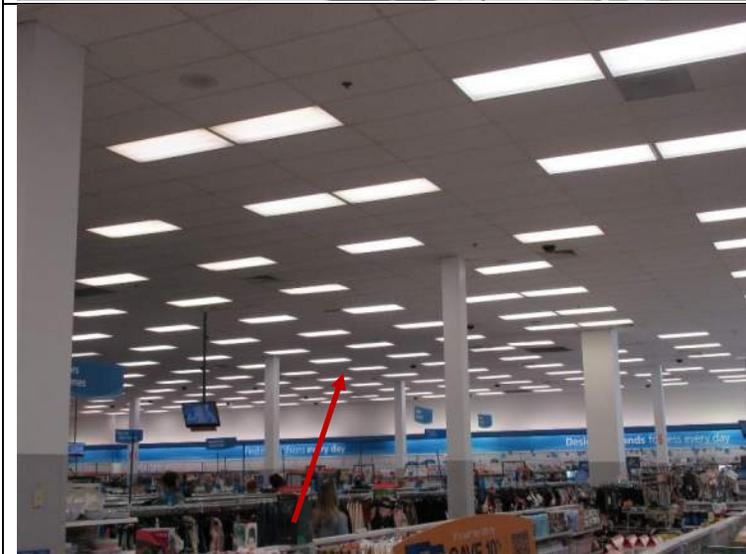
**Photograph No. 20.**

Fire alarm ceiling strobe/annunciator observed in good condition.

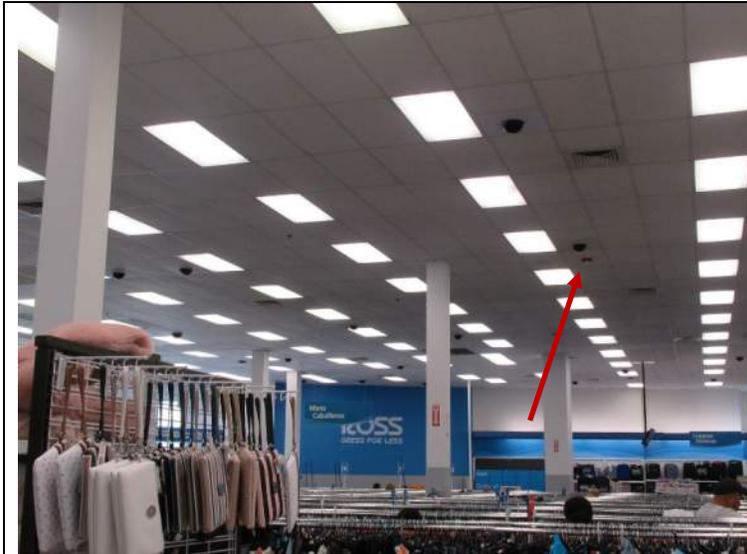
**Photograph No. 21.**

Fire alarm ceiling strobe/annunciator observed in good condition.

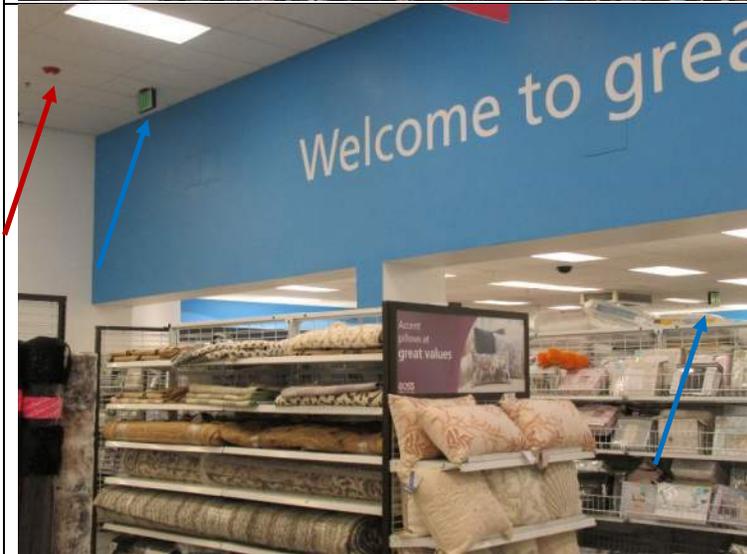
**Photograph No. 22.**

Fire alarm ceiling sensor/strobe/annunciator (red arrow) observed in good condition. Egress lighting (blue arrow) observed in good condition.

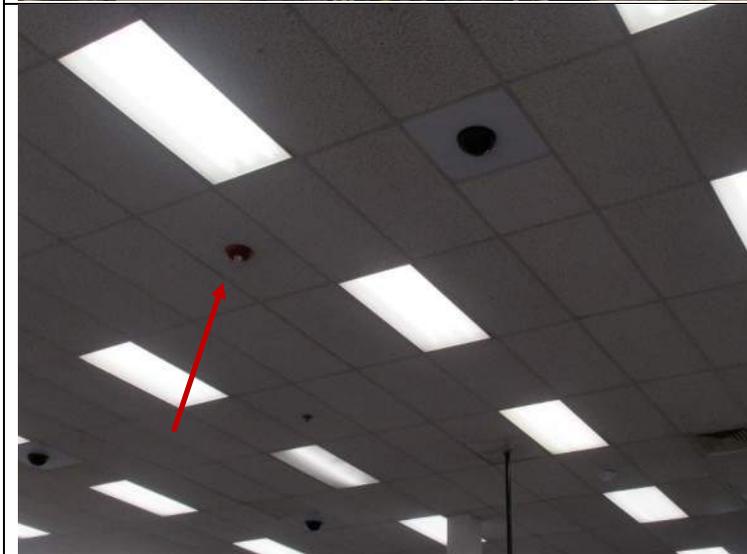
**Photograph No. 23.**

Fire alarm ceiling sensor/strobe/annunciator (red arrow) observed in good condition. Egress lighting (blue arrow) observed in good condition.

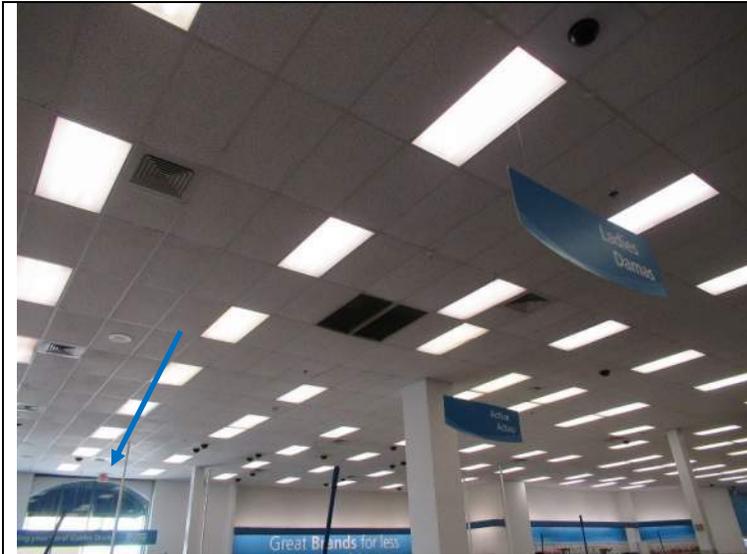
**Photograph No. 26.**

Egress lighting (blue arrow) observed in good condition.

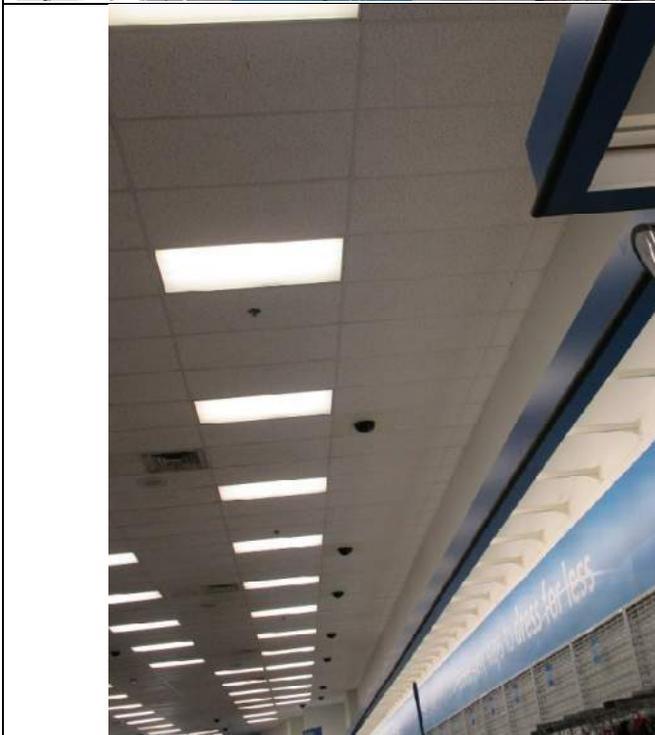
**Photograph No. 27.**

Egress lighting (blue arrow) observed in good condition.

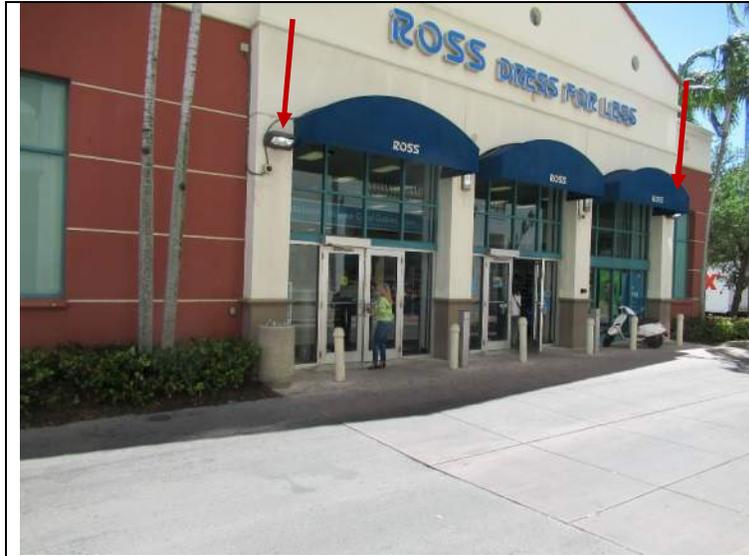
**Photograph No. 29.**

The wall sconce security lighting for public sidewalk along service alley entrance (west) was observed in good condition. No on-site parking provided at this store location.

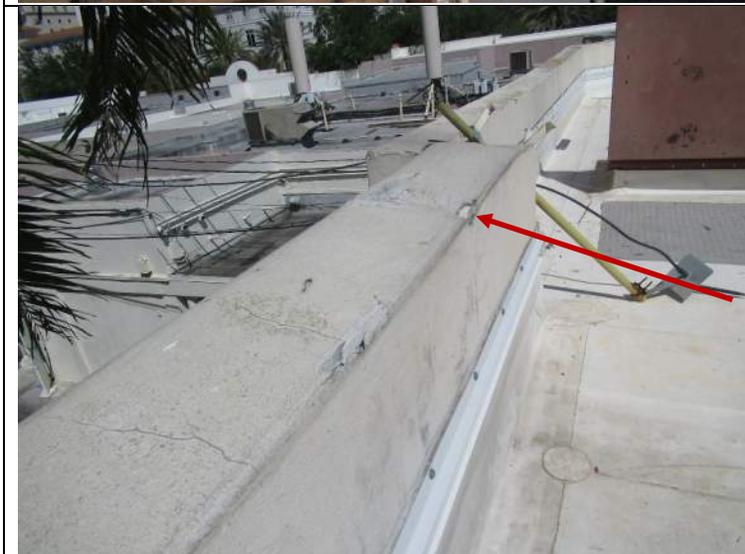
**Photograph No. 10.**

The upper wall surfaces had adhered EIFS/EPS trim decorative features that had impact damage from prior storms. The adhered material was firmly attached to the building with just random locations showing prior storm impact damage. The impact damage will need to be repaired within the next 2-years to protect the EPS from water and exposure damage. This damage is cosmetic in nature and not structural.

The parapet wall along the west elevation of the building. The top of the wall is a rounded EPS foam/EIFS cap that is adhered to the concrete tie beam. The cap has impact damage from prior storms.

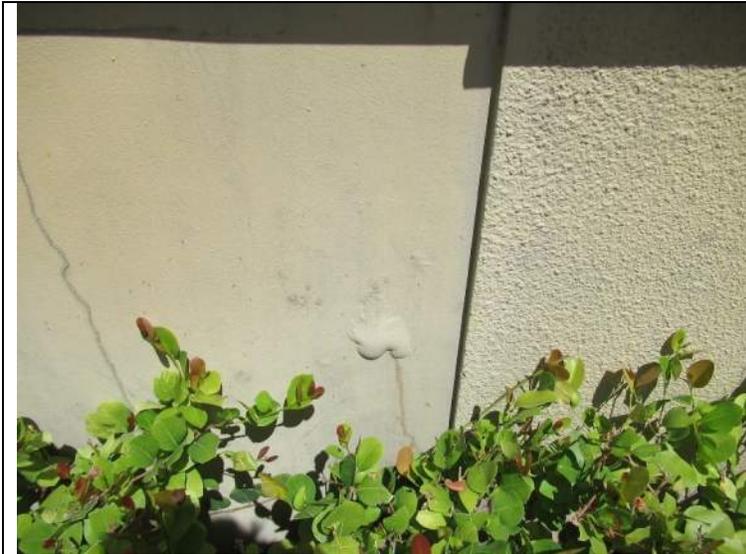
**Photograph No. 17.**

Wall paint bubble filled with water along with a hairline crack to the left in the stucco surface.

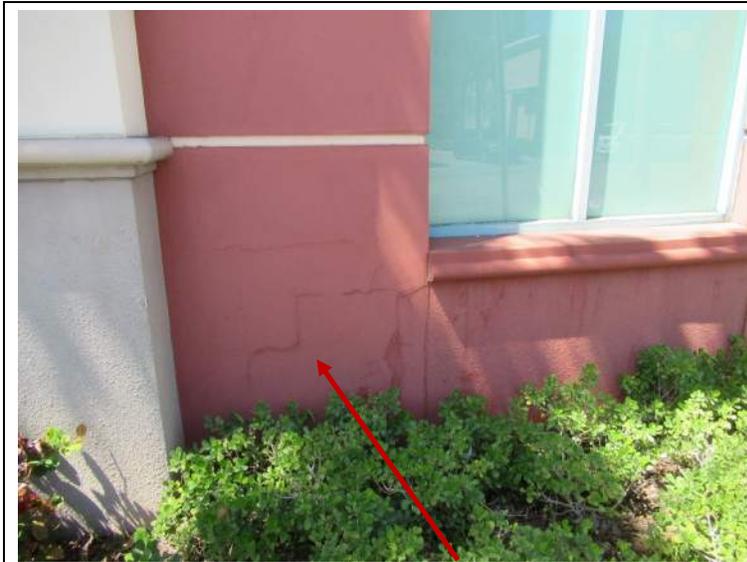
**Photograph No. 19.**

Stairstep mortar joint telegraphing cracks in stucco surface on the east elevation along Douglas Road. The cracks appear to have been present for a significant amount of time based on dirt in cracks. The cracks need to be properly treated and sealed when the building is painted. These are typical storm related movement cracks. The building is structurally sound.

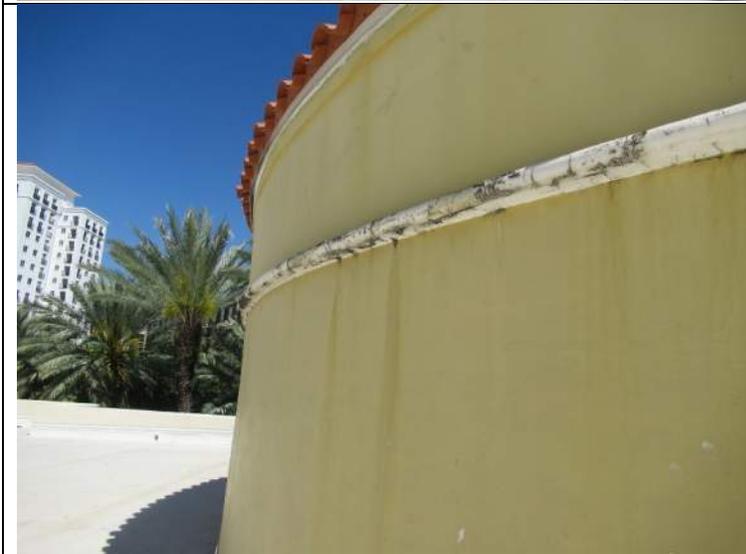
**Photograph No. 28.**

Impact damage to the surface adhered EIFS/eps trim/band observed. The impact damage needs to be repaired when the building is painted.

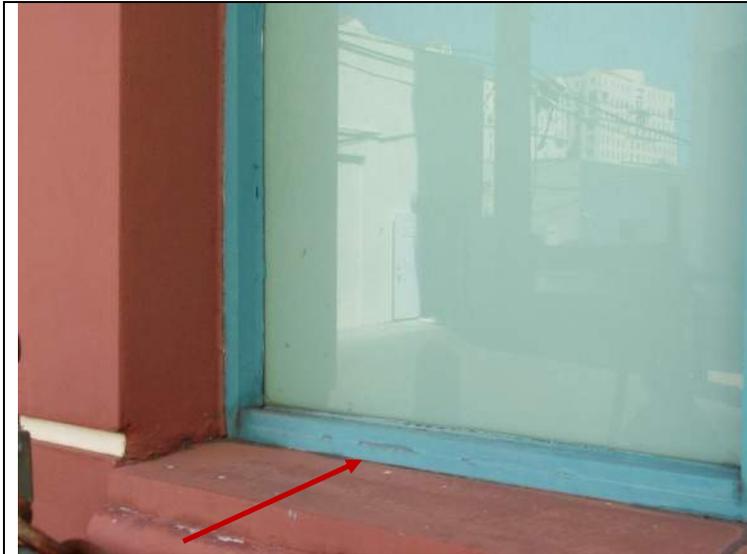
**Photograph No. 33.**

Paint starting to peel off the storefront frames.

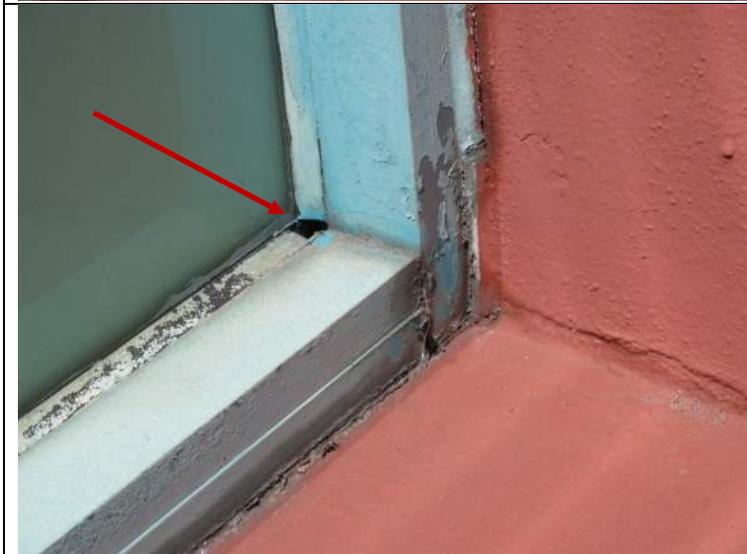
**Photograph No. 34.**

Paint peeling off frame and glass gasket shrinkage observed.

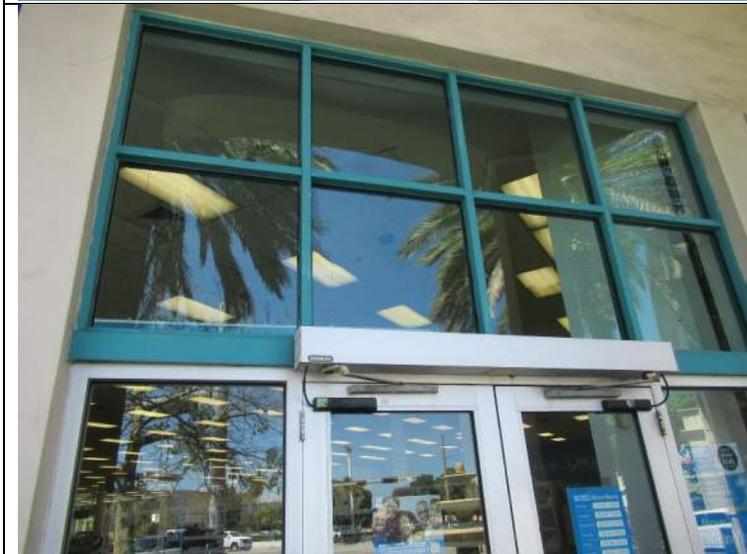
**Photograph No. 36.**

Transom 4x2 storefront over entry door assembly. The door assembly is new compared to the transom assembly.

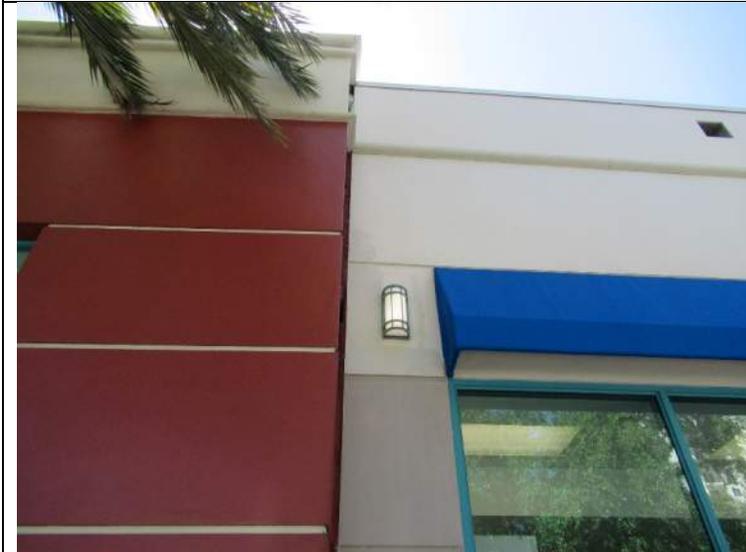
**Photograph No. 39.**

Horizontal steel mullion wrapped with aluminum from original construction.

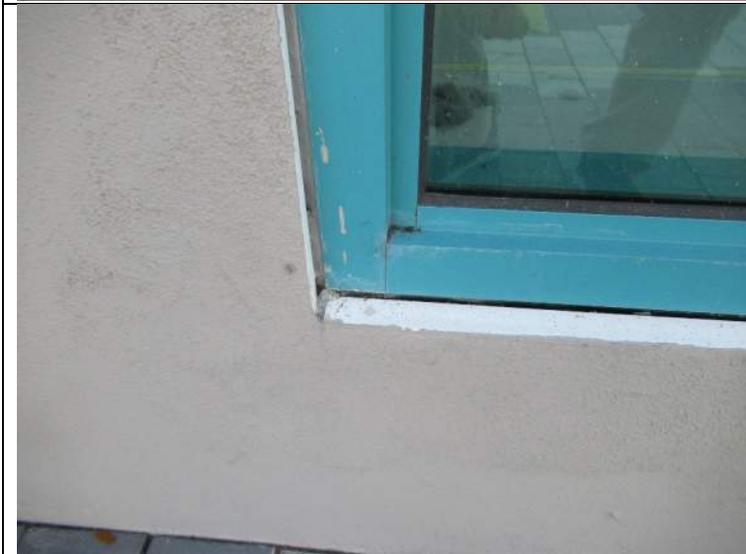
**Photograph No. 43.**

Water stains on exterior wall sill showing trapped water leaking out of frame. This is an indication that the glass gasket is leaking excessive water into the frame. The glass to frame should be wet sealed with sealant.
