ITEMS HANDED OUT TO
HISTORIC PRESERVATION BOARD
BY OWNER'S ATTORNEY
AT 03/15/23 HPB MEETING

Document for:
Inspection Report

Local Historic Designation Number:
LHD 2022-13

Subject Property:
517 Aragon Avenue
Coral Gables, FL

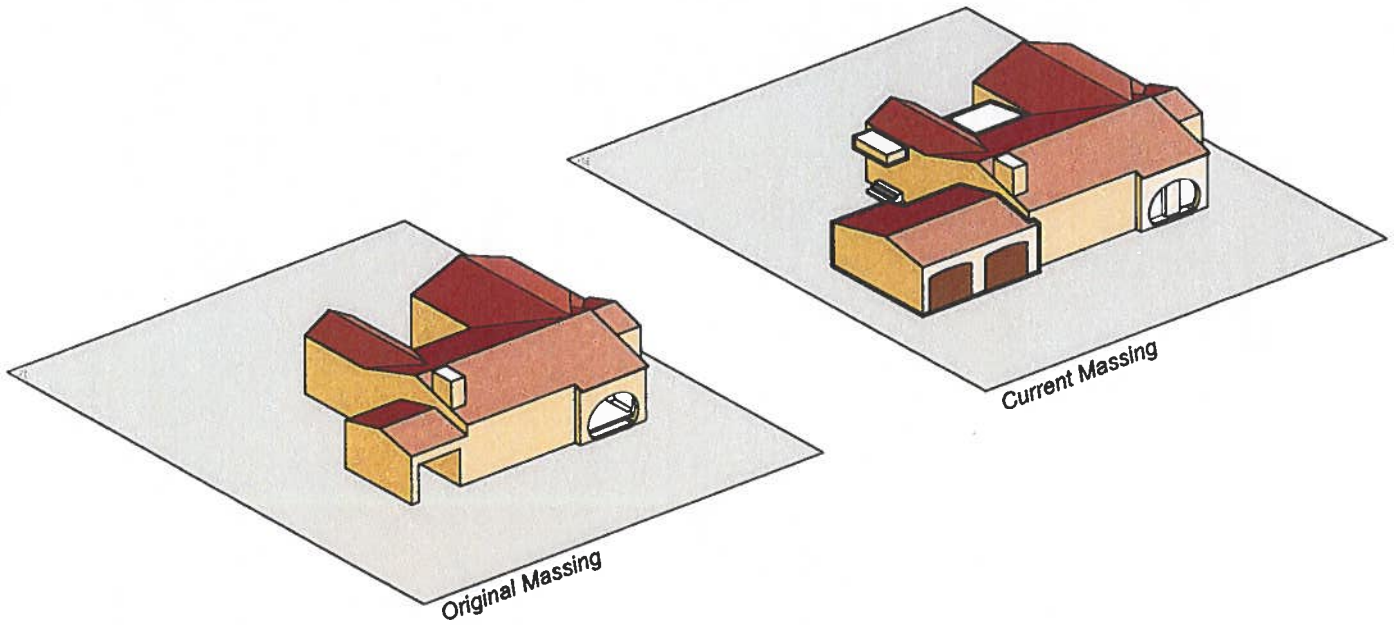
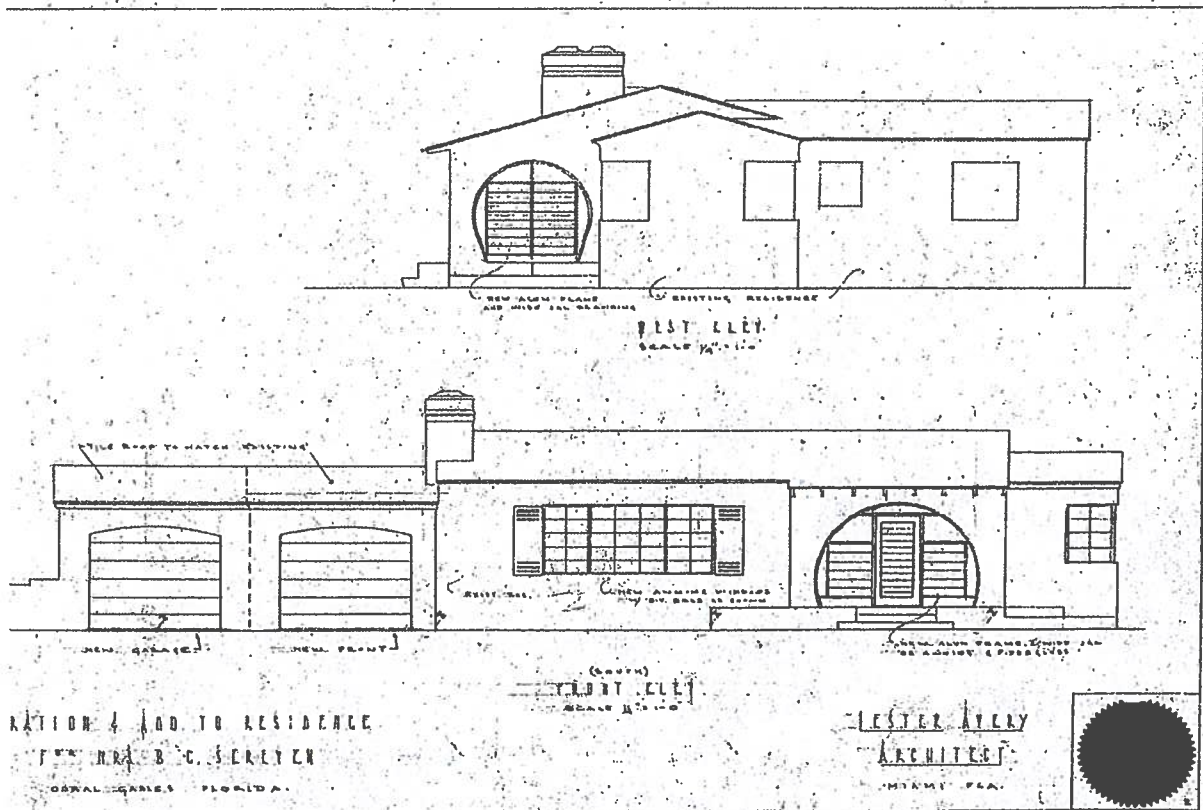
Massing Study

1961 Renovation removes the flat facade into 4 separate masses along the front, giving a push-pull feeling instead of a horizontal, single surface facade as intended.

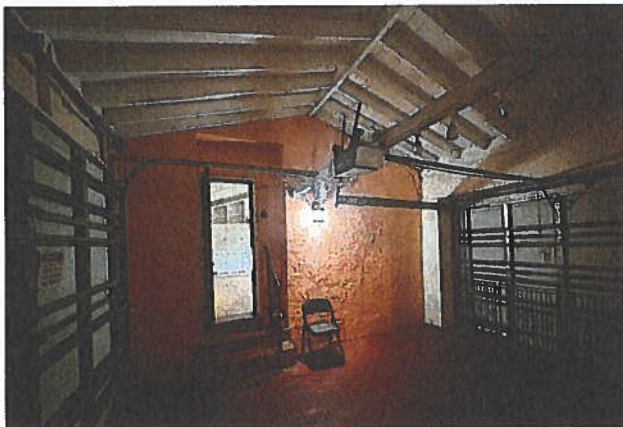
Garage protrudes from original facade

Side entry to home visible, originally accessible from exterior.

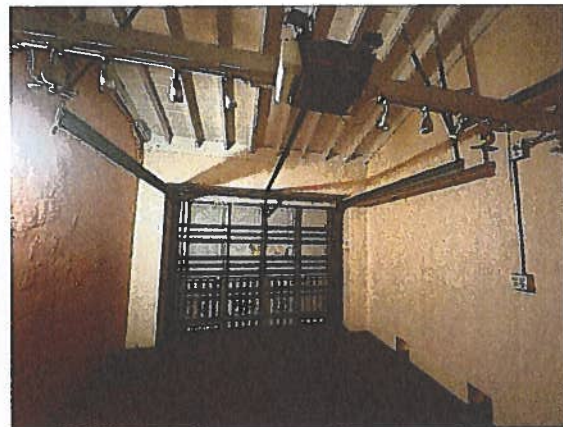
Original opening seen as rectilinear, not eyebrow as original plans intention.

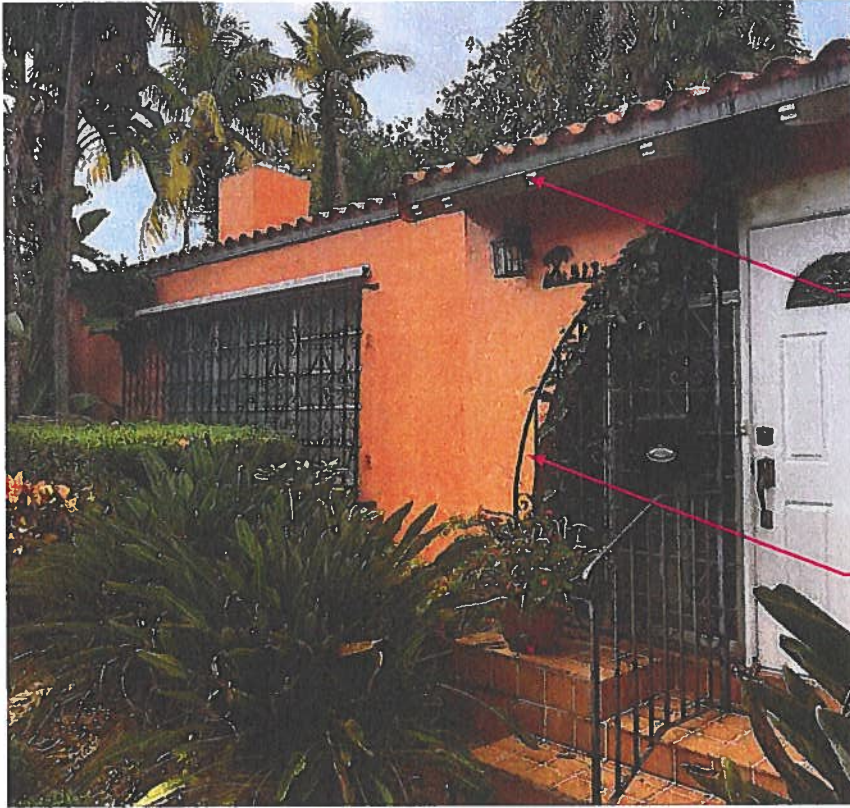
Exposed rafters show intention of ornamentation on home, not minimal traditional modern touches.

Semi-Circular entry difficult and expensive, not cost-effective as per minimal traditional historic trend.

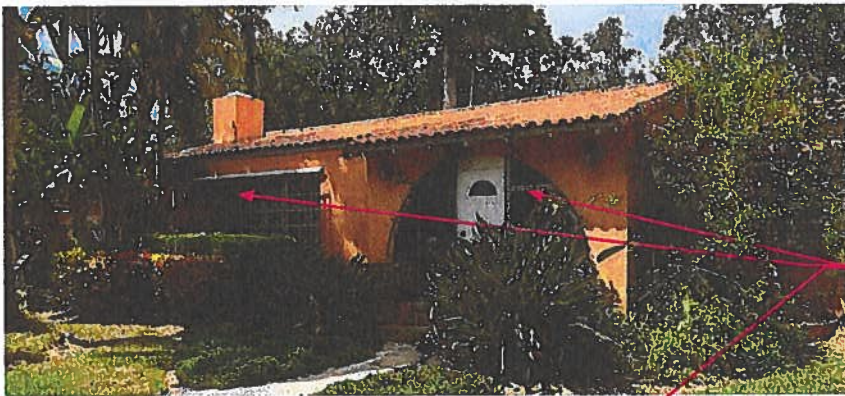
Decorative Security Guards ornament entire home.

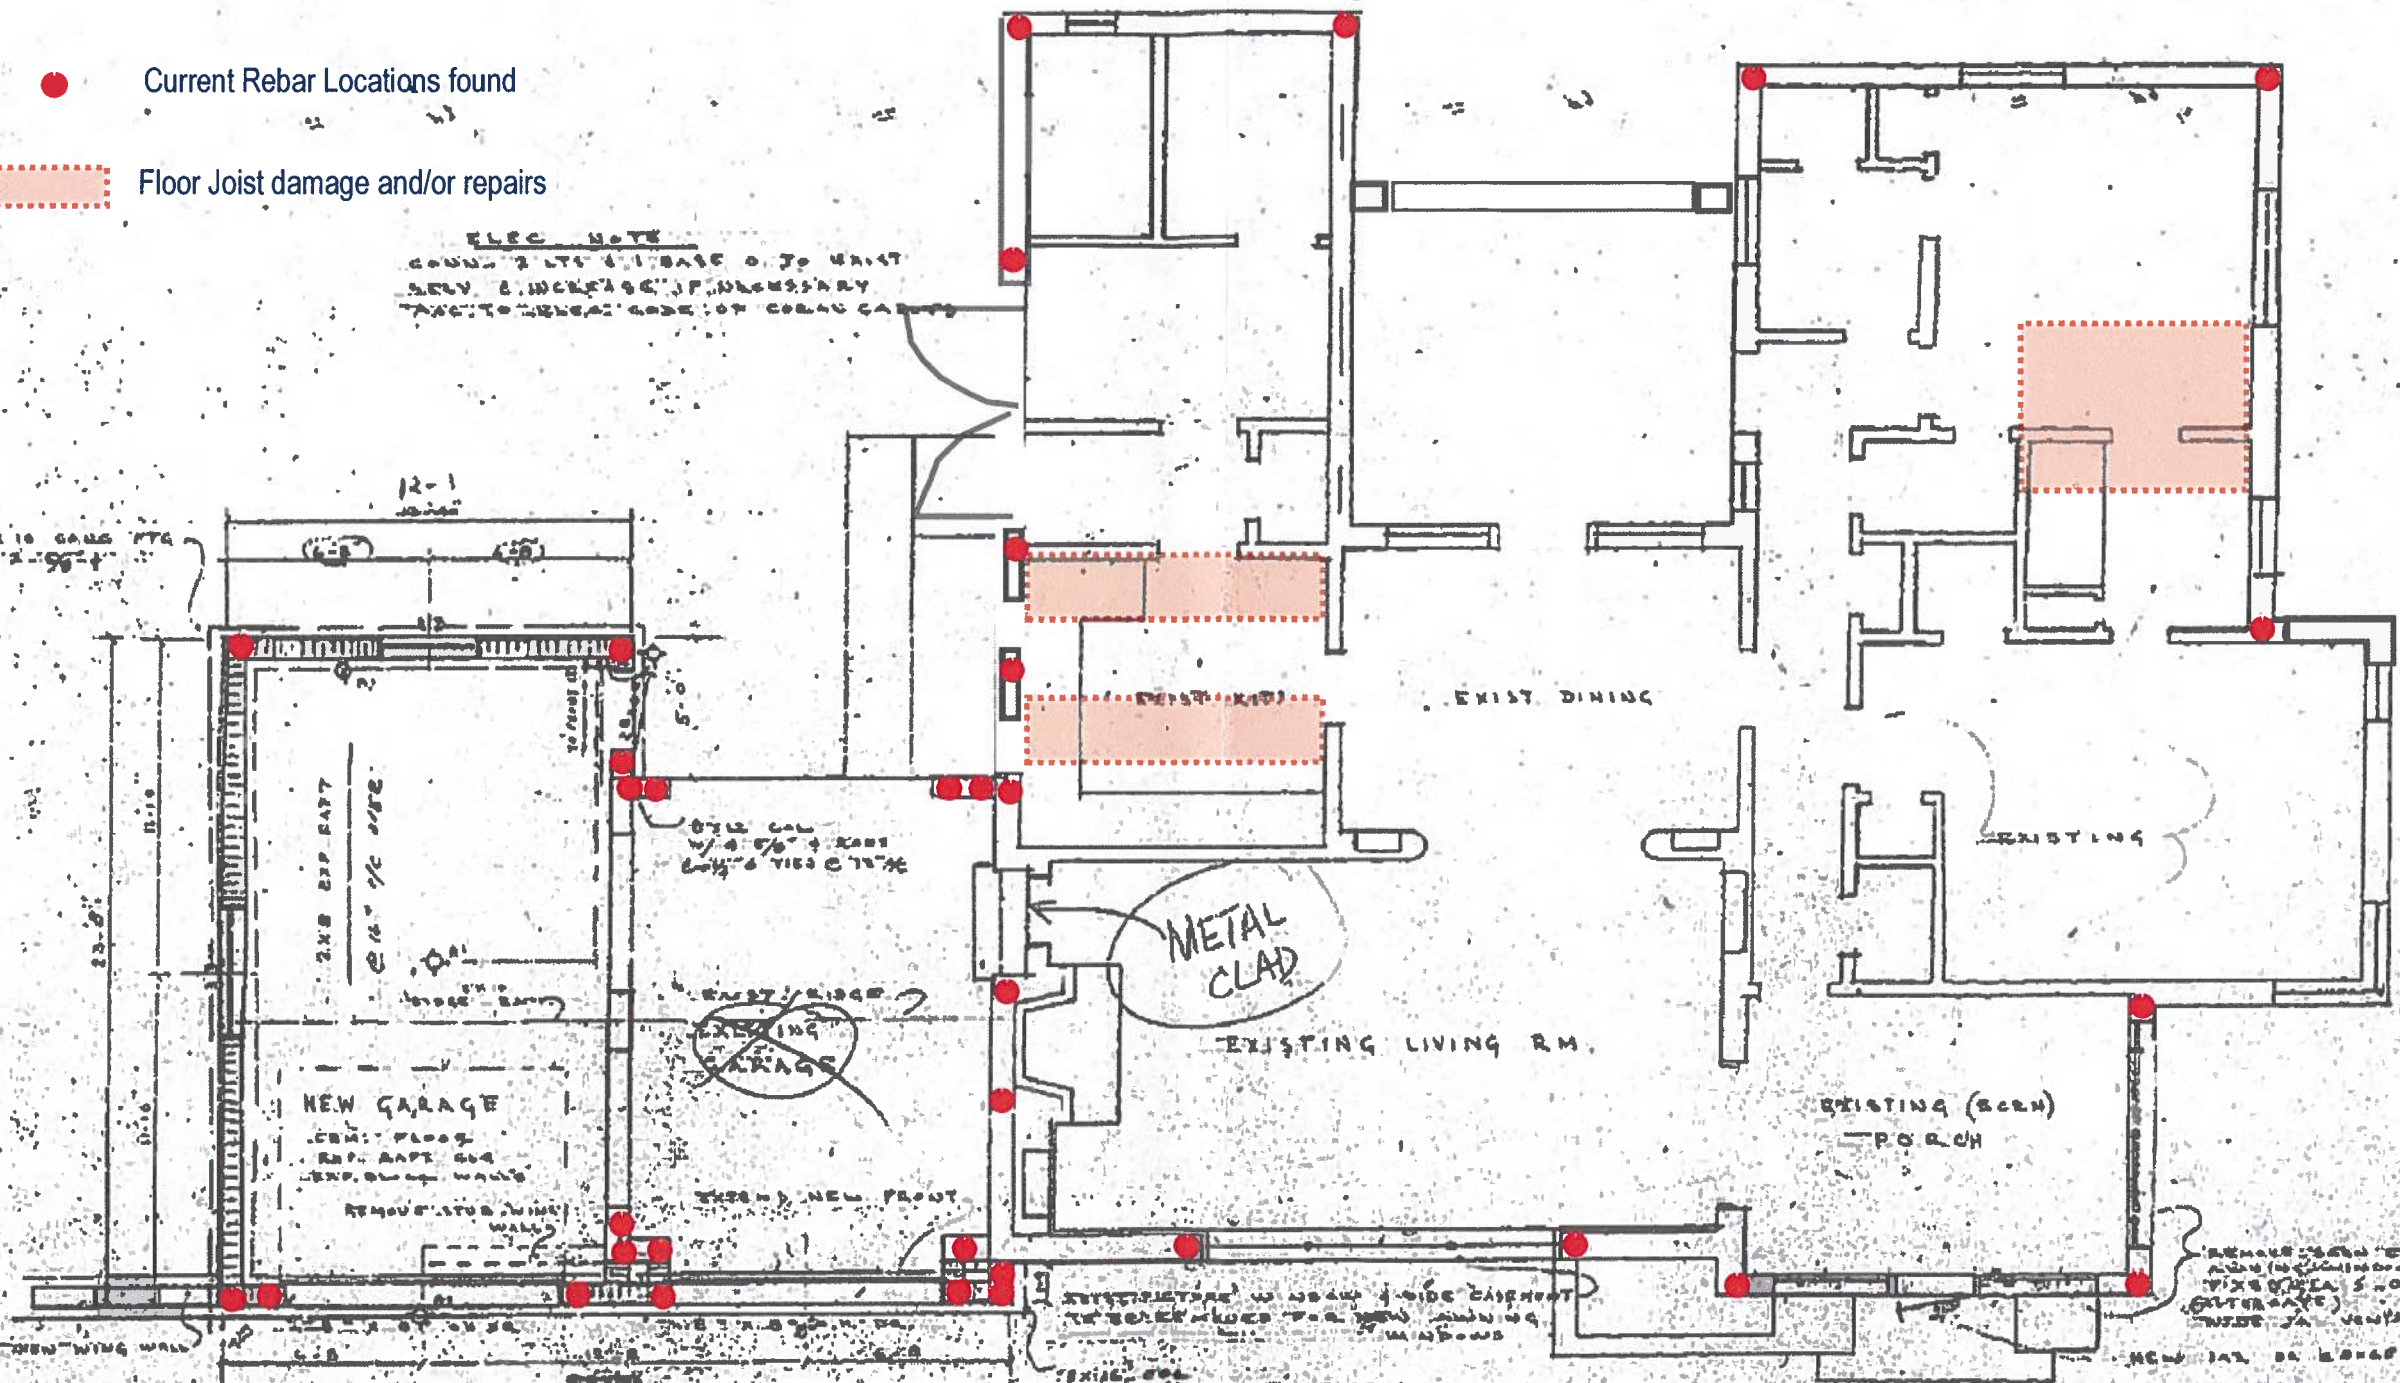
ALTERATION & ADD. TO RESIDENCE
FOR MRS. B. C. SEEVERN
CORAL GABLES, FLORIDA

● Current Rebar Locations found

▭ Floor Joist damage and/or repairs
