OFFICE OF THE PROPERTY APPRAISER

747 PONCE DE LEON BLVD - This is a 46-unit condominium, so the address for service of the initial notice of unsafe structure is the condominium association. However, if the association does not respond, the City will have to serve each individual unit owner and any related interested parties for each unit.

This Department has received the Building Recertification Report ("Report"), prepared by the Professionals listed below, that you submitted for the above property address. Please note the Report indicates <u>remedial repairs must be done to the structure</u> in order for it to meet minimum requirements stipulated for continued occupancy as prescribed in the Miami-Dade County code, Section 8-11.

I, Alexander Rochell, Professional Engineer, have been retained to perform the Structural portion of the Building Recertification for the above-mentioned property. Enclosed you will find the structural report for the required 50-Year Building Recertification by the City of Coral Gables. I hereby attest that to the best of my knowledge, belief and professional judgment, the building is structurally safe for its use and present occupancy, in compliance wit

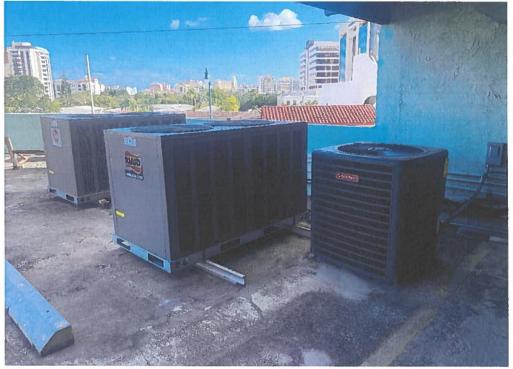
RTUs located at top of the Parking Garage

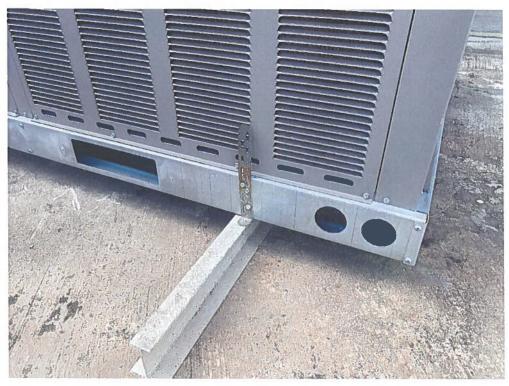
RTU attachment to aluminum frames

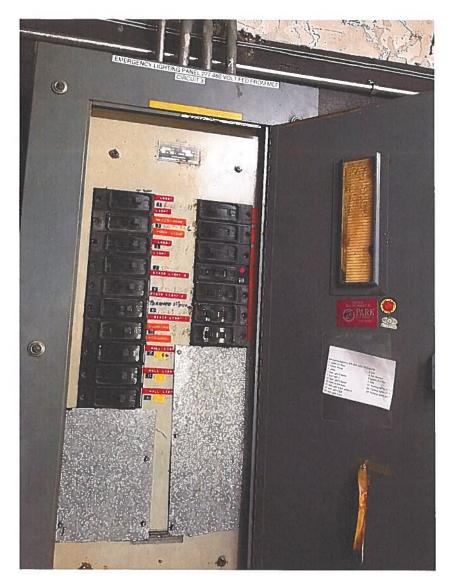
- #3 Panel to be replaced with new, see image 2.
- #4 This panel is located at mechanical mezzanine level accessible through a cutwalk, panel requires replacement, and it is recommended to be relocated for proper access.

Image #1, panel MEP double 3/30A C.B. double tap.

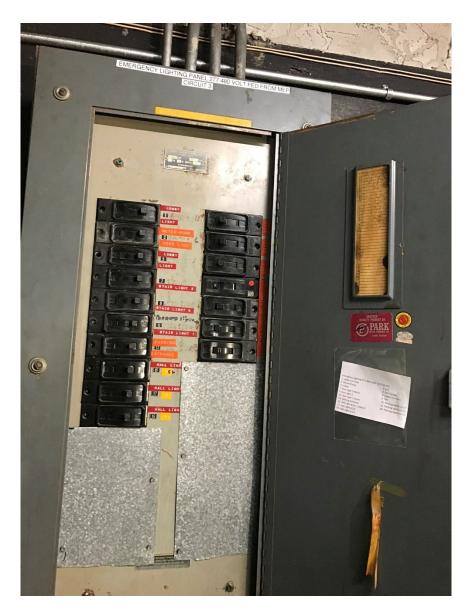
#3 Panel to be replaced with new, see image 2.

Image #1, panel MEP double 3/30A C.B. double tap.

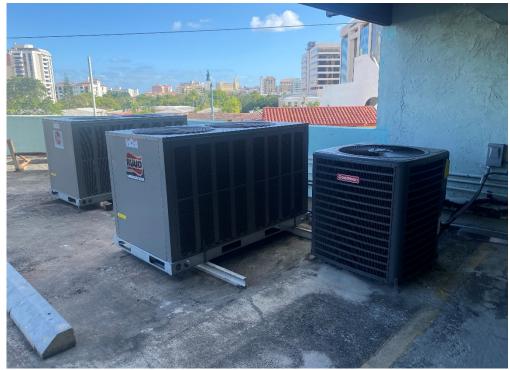
RTUs located at top of the Parking Garage

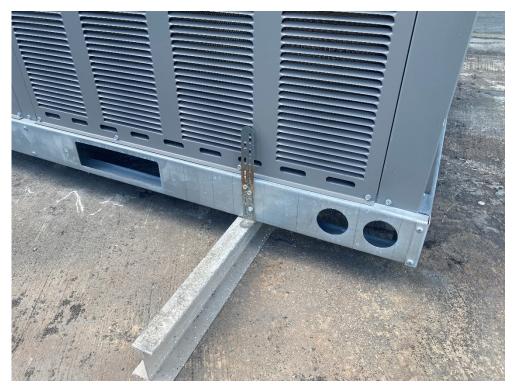
RTU attachment to aluminum frames

- 2. Note water tanks, cooling towers, air conditioning equipment, signs, other heavy equipment and condition of support: Air conditioning equipment (condensing units) on steel framing are present on Parking Garage top level and the roof level of the Main Building. The condition of the supports is GOOD. All condensing units (RTUs) are required to have hurricane straps (Refer to Photographs).

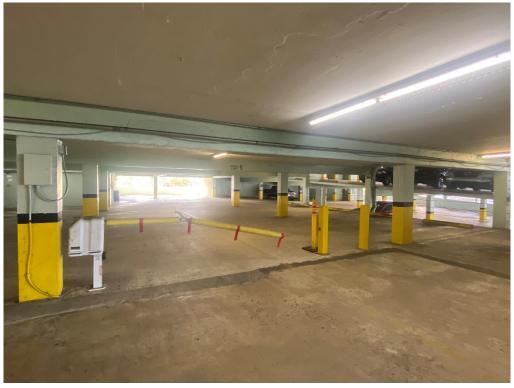
Typical floor of Parking Garage

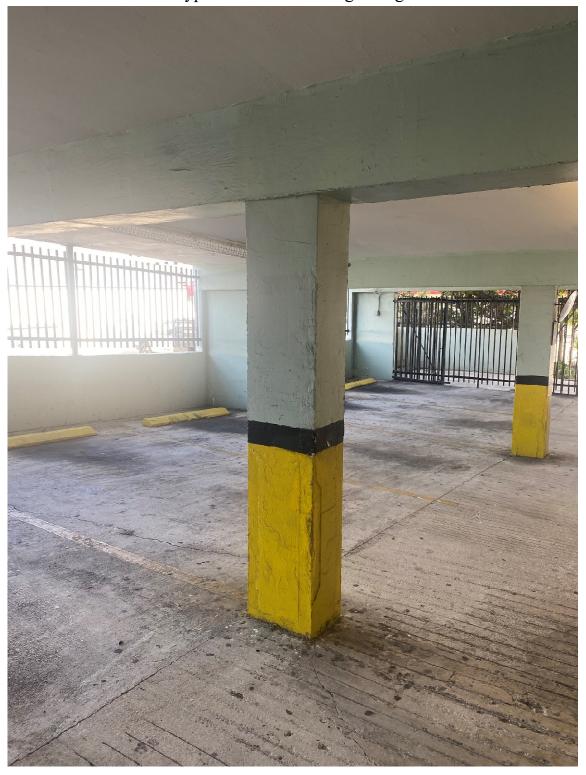
Parking Garage ground level typical column/beam

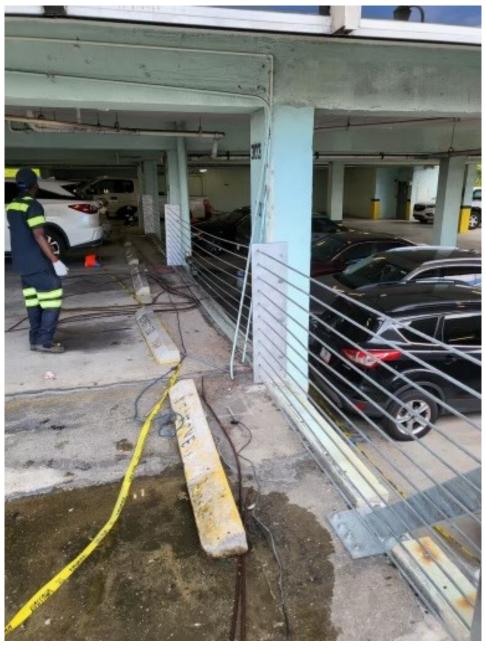
UPDATE 6-7-23: New cable railings installed

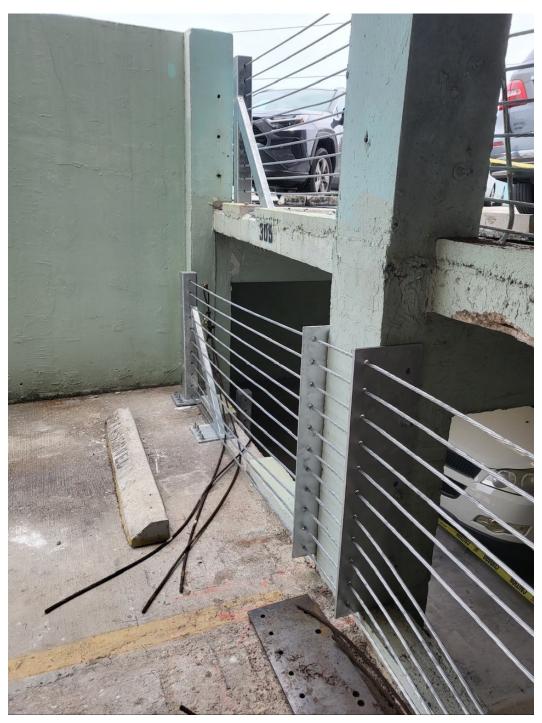
UPDATE 6-7-23: New cable railings installed

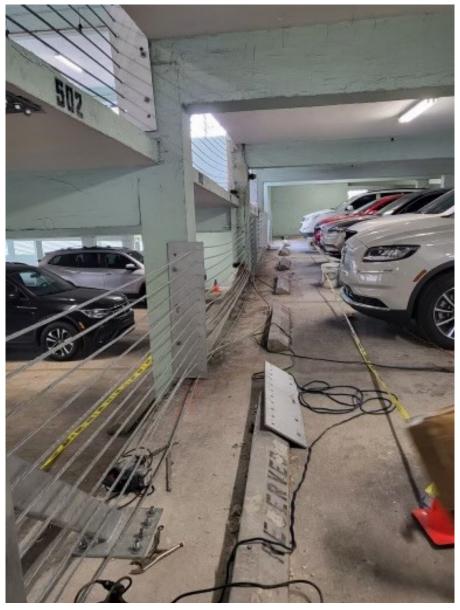
UPDATE 6-7-23: New cable railings installed

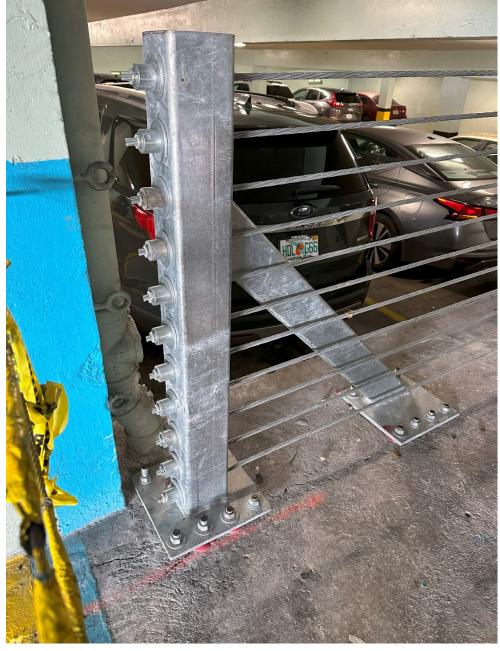
UPDATE 6-7-23: New cable railings installed

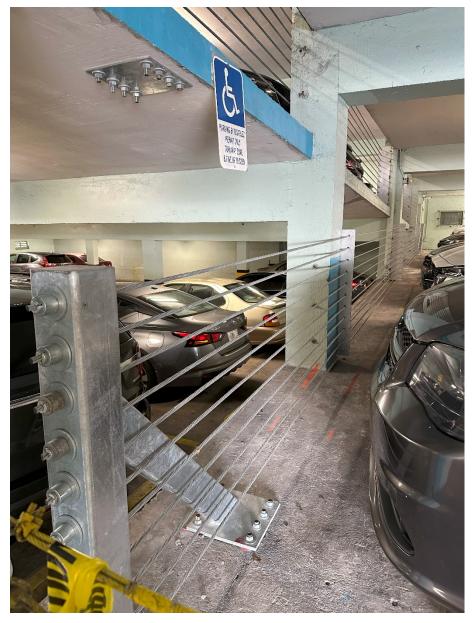
UPDATE 10-27-23: New cable railings final inspection

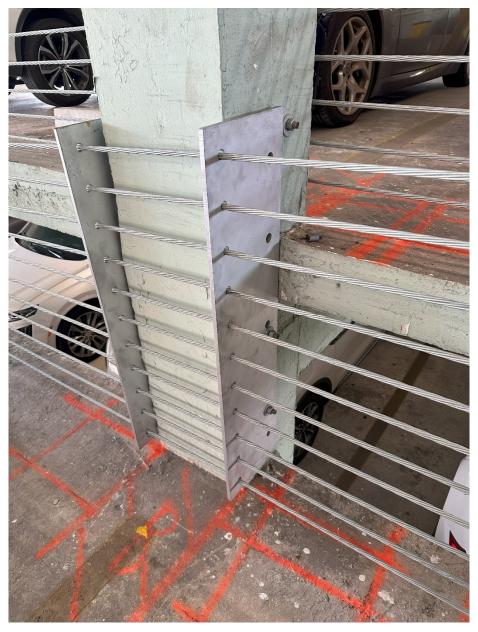
UPDATE 10-27-23: New cable railings final inspection

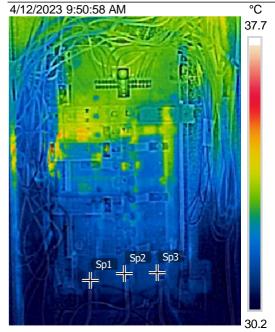
There is double tapping on breaker #5.
Incorrect wire color codes. Wire splices were observed – Possible NEC Violations.

Possible deficiency; warrants investigation.

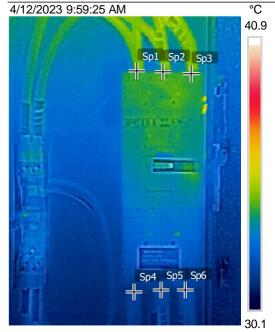
Building 747 Ponce de Leon. Lower floor. Main electrical room. Main breaker 1 of 6

Possible deficiency; warrants investigation.

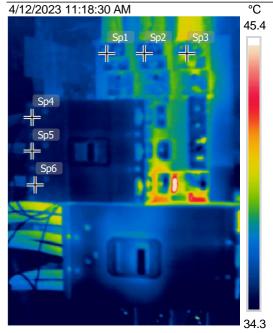
Building 747 Ponce de Leon. Lower floor. Main electrical room. Main panel HV C. CDP main 2. Wires are not color coded. Code violation double tapping on the main logs.

Possible deficiency; warrants investigation.

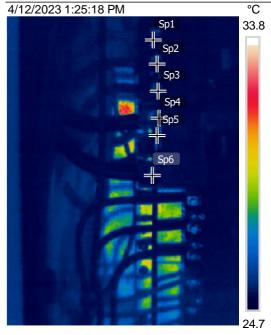
Building 747 Ponce de Leon. 1st floor. Radiation offices. Panel D left top. The panel is in a confined space. Working distance violation as per the NEC.

Possible deficiency; warrants investigation.

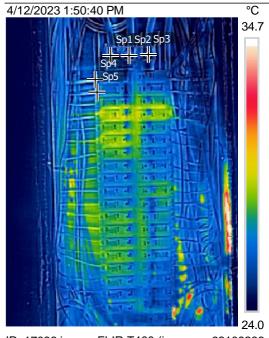
Building 747 Ponce de Leon. 2nd floor. Cafeteria. Distribution panel. Possible deficiency; warrants investigation.

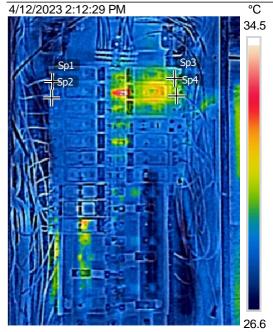
investigation.

Building 747 Ponce de Leon. 2nd floor.
Generator room. Panel emergency lighting.
Wires are not color coded.
Spliced cables and signs of corrosion were observed.
Possible deficiency; warrants

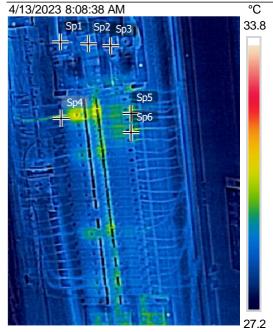
Building 747 Ponce de Leon. 2nd floor. Mechanical room. Panel receptacles 2A. Water was leaking close to the top left corner of the panel.
Visible water damage in the electrical panel.
Incorrect use of wiring color codes.
Possible deficiency; warrants investigation.

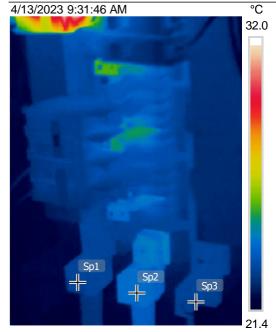
The condition of the electrical panel is critical. The panel is in a confined space. Working distance violation as per the NEC.

Indicates probable deficiency; repair as time permits.

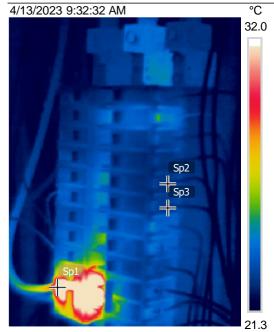
Breakers and busbar are in critical condition.
The condition of the electrical panel is critical.
The panel is in a confined space. Working distance violation as per the NEC.

Breakers 21 and 23 are hot. Indicates probable deficiency; repair as time permits.

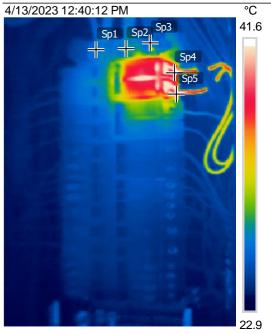
Building 747 Ponce de Leon. 4th floor. Dental clinic office. Panel D. Double pole breakers 2-4 are reading Only 20A each while the size of the breakers is 30A. Monitor until corrective measures can be accomplished.

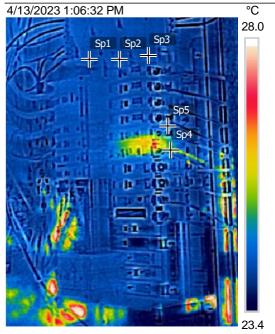
Building 747 Ponce de Leon. 7th floor. Electrical room. Panel A. Spliced cables were observed. Possible deficiency; warrants investigation.

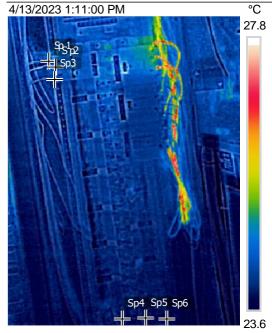
Building 747 Ponce de Leon. 7th floor. Electrical room. Lighting panel. Double tapping. Possible deficiency; warrants investigation.

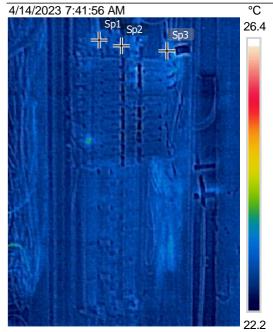
Building 747 Ponce de Leon. 5th floor. Electrical room. Lighting panel. Wires are not color coded.

Mold and severe corrosion were found inside the panel.
The panel is in a bad condition.
Possible deficiency; warrants investigation.

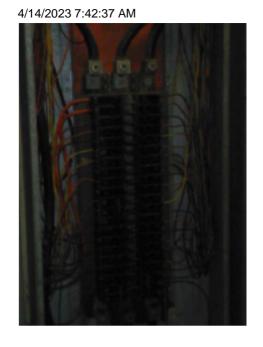
Possible deficiency; warrants investigation.

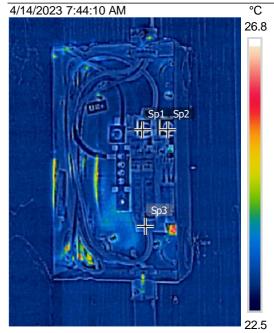
Building 747 Ponce de Leon. 5th floor. Electrical room. Panel circuit 39. Possible deficiency; warrants investigation.

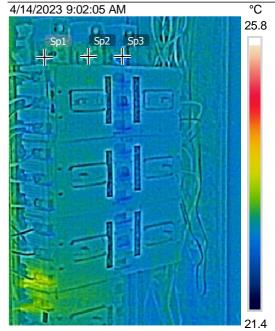
Building 747 Ponce de Leon. 6th floor. Electrical room. HVAC panel. Top. Double tapping. Wires are not color coded. Mold and signs of corrosion inside the panel were found.

Mold and signs of corrosion inside the panel were found. Possible deficiency; warrants investigation.

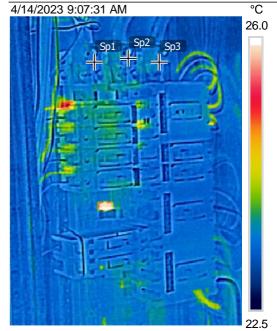
Building 747 Ponce de Leon. 6th floor. Electrical room. Lighting panel. Top. Severe corrosion was observed. Incorrect wire color codes.

Possible deficiency; warrants investigation.

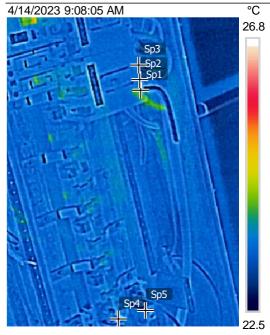
Incorrect wire color codes.

Possible deficiency; warrants investigation.

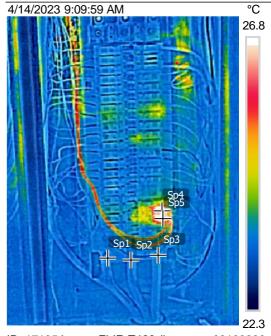
IR_17135.jpg

Building 747 Ponce de Leon. 6th floor. Electrical room. Panel B. Incorrect wire color codes. Exposed wire on the breaker. Mold and severe corrosion were found inside the panel. Breaker 40-42 double pole reads 13.5A each while the size is 20 A. Possible deficiency; warrants investigation.

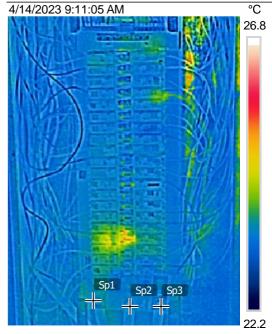
IR_17136.jpg

Building 747 Ponce de Leon. 6th floor. Electrical room. Panel A. Incorrect wire color codes. Exposed wire on the breaker. Severe corrosion was found inside the panel.

Possible deficiency; warrants investigation.

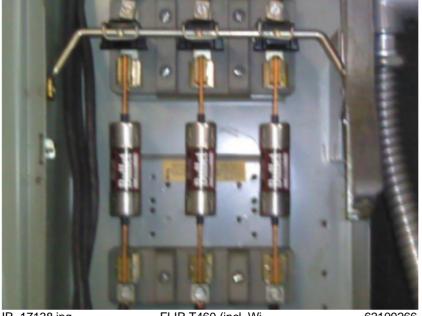
IR_17138.jpg

Building 747 Ponce de Leon. 8th floor. Disconnect left switchin elevator room. Possible deficiency; warrants investigation.

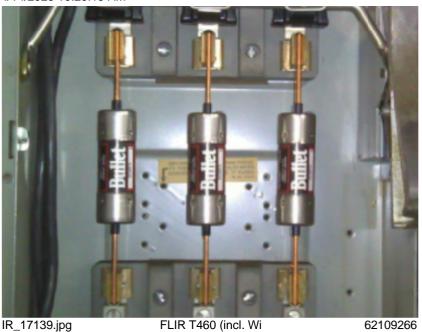
Building 747 Ponce de Leon. 8th floor. Disconnect right switch in elevator room. Possible deficiency; warrants investigation.

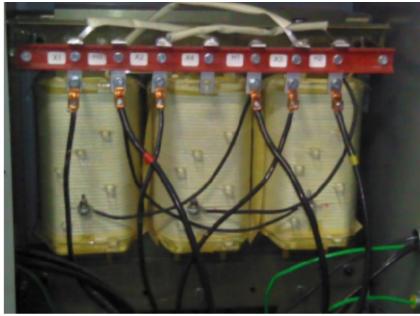
IR_17140.jpg

Building 747 Ponce de Leon. 8th floor. Transformer 1 elevator room. Possible deficiency; warrants investigation.

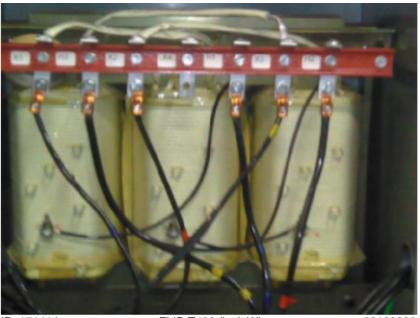
IR_17141.jpg

Building 747 Ponce de Leon. 8th floor. Transformer 2 elevator room. Possible deficiency; warrants investigation.

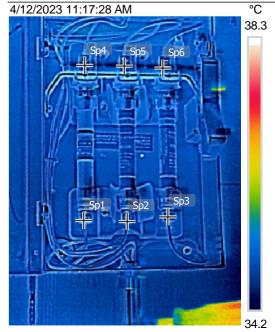
IR_17085.jpg

Building 747 Ponce de Leon. Lower floor. Main electrical room. Disconnect emergency switch. Possible deficiency; warrants investigation.

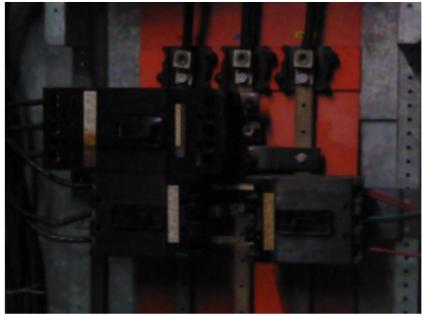
IR_17100.jpg

Wires are not color coded. Signs of some corrosion were observed. Possible deficiency; warrants

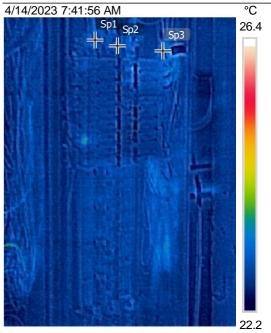
IR_17127.jpg FLIR T460 (i... 62109266

Building 747 Ponce de Leon. 5th floor. Electrical room. Lighting panel. Wires are not color coded.

Mold and severe corrosion were found inside the panel.
The panel is in a bad condition.
Possible deficiency; warrants investigation.

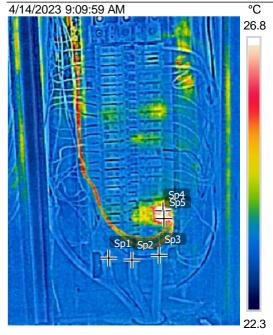
IR_17135.jpg

Building 747 Ponce de Leon. 6th floor. Electrical room. Panel B. Incorrect wire color codes. Exposed wire on the breaker. Mold and severe corrosion were found inside the panel. Breaker 40-42 double pole reads 13.5A each while the size is 20 A. Possible deficiency; warrants investigation.
