Arboriculture Tree Report 1125 Hardee Rd, Coral Gables

To: FXD Construction
Attn: Danny Sanchez

Date: January 30th, 2026
Phone: (786)973-0590
Email: Danny@fxdconstruction.com

Prepared by: Trea Jones
International Society of Arboriculture Certified Arborist

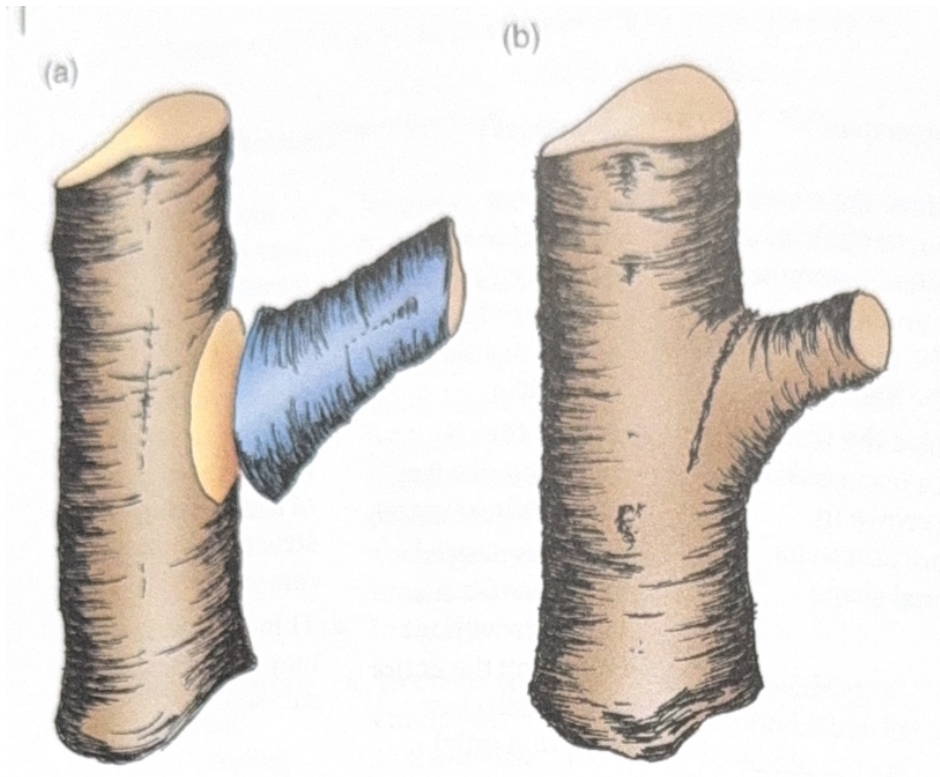
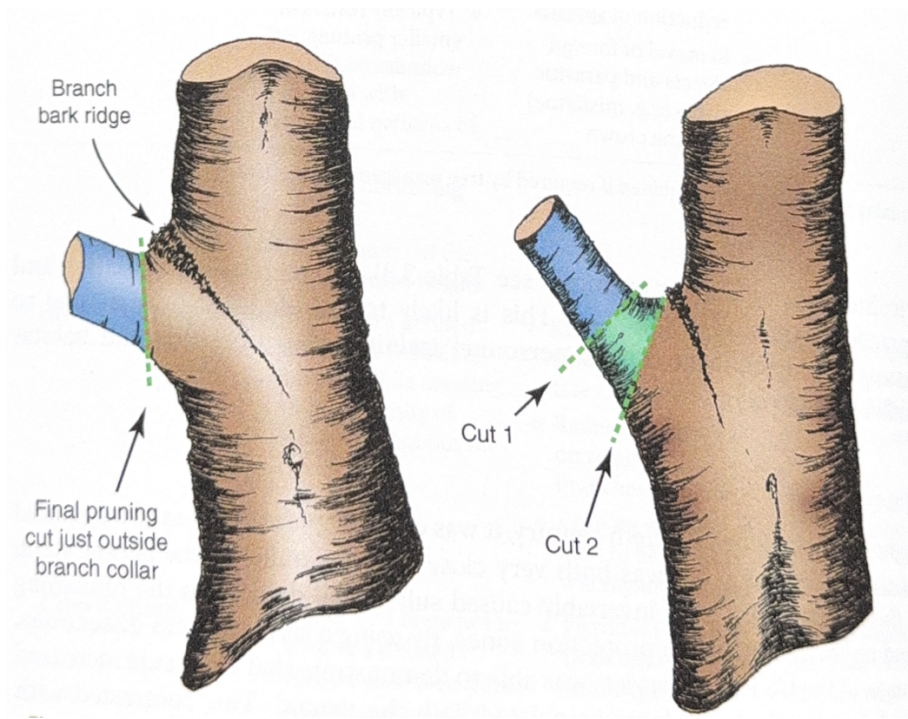
If the torn stub is left as-is, the remaining wood will be nonfunctional and will begin to desiccate. The jagged tear surface dramatically increases exposed area, traps moisture and debris, and creates irregular pockets that are highly favorable for decay fungi to colonize. A retained stub also tends to die back beyond the intended boundary, which often results in a longer period of exposed, non-compartmentalized tissue before the tree can effectively wall it off. Over time, this scenario commonly produces an expanding column of internal discoloration and decay that progresses from the dead stub inward toward the union, because the tree is forced to defend a poorly defined, irregular wound with compromised edges rather than a cleanly positioned pruning cut. In a mature tree, that can translate into avoidable internal defect development at a major union point.

If a flush cut is made, the risk profile shifts from “branch wound management” to “trunk wound creation.” By removing the branch bark collar and cutting into trunk tissues, the tree loses the very structures most responsible for isolating branch-related injuries. The wound becomes larger, deeper, and biologically harder to defend. In that condition, decay organisms are more likely to establish and advance within trunk wood, and closure typically takes longer because the wound edge has been pushed back into tissue that must now both defend and generate woundwood over a larger opening. Over time, flush cuts are strongly associated with increased internal decay at the union, delayed woundwood formation, and an avoidable reduction in long-term structural integrity at that point on the main stem.

The corrective pruning should consist of a single final cut to remove the remaining stub at the proper location just outside the branch bark collar, maintaining the collar intact and avoiding any cut that planes into the trunk. The objective is to create a clean wound margin that the tree can compartmentalize efficiently while preserving the biological “defense zone” that exists at the collar. No wound paint or dressing is recommended; the tree’s defense response is internal and at the wound margin, and wound dressings do not improve compartmentalization and can sometimes create an environment that retains moisture against the wound surface.

Following the corrective cut, the wound should be monitored over time for appropriate woundwood development (even rolling closure from the wound edge), and for any signs of progressive decay or abnormal response such as excessive cracking, persistent wetwood/oozing, or fungal fruiting bodies at or below the wound. With proper cut placement and given the tree’s reported strong vigor and generally good architecture, the prognosis for successful compartmentalization and functional recovery is favorable.
