Public Safety Building Assessment Executive Summary

The Stantec/FGSS Team have performed a basic assessment and programming study of the Public Safety Building. The assessment included investigations by waterproofing specialists Building Enclosure Council, structural engineers Douglas Wood & Associates, MEP engineering consultants EMTec Corporation and the environmental engineering firm of PSI. The cost estimator, Stonehenge Construction, analyzed the cost and duration of construction for each of these options, taking into account the need to maintain building occupancy during construction.

Client/Project: CITY OF CORAL GABLES
 Coral Gables Public Safety Building
 2801 Salzedo Street
 Coral Gables, FL 33134

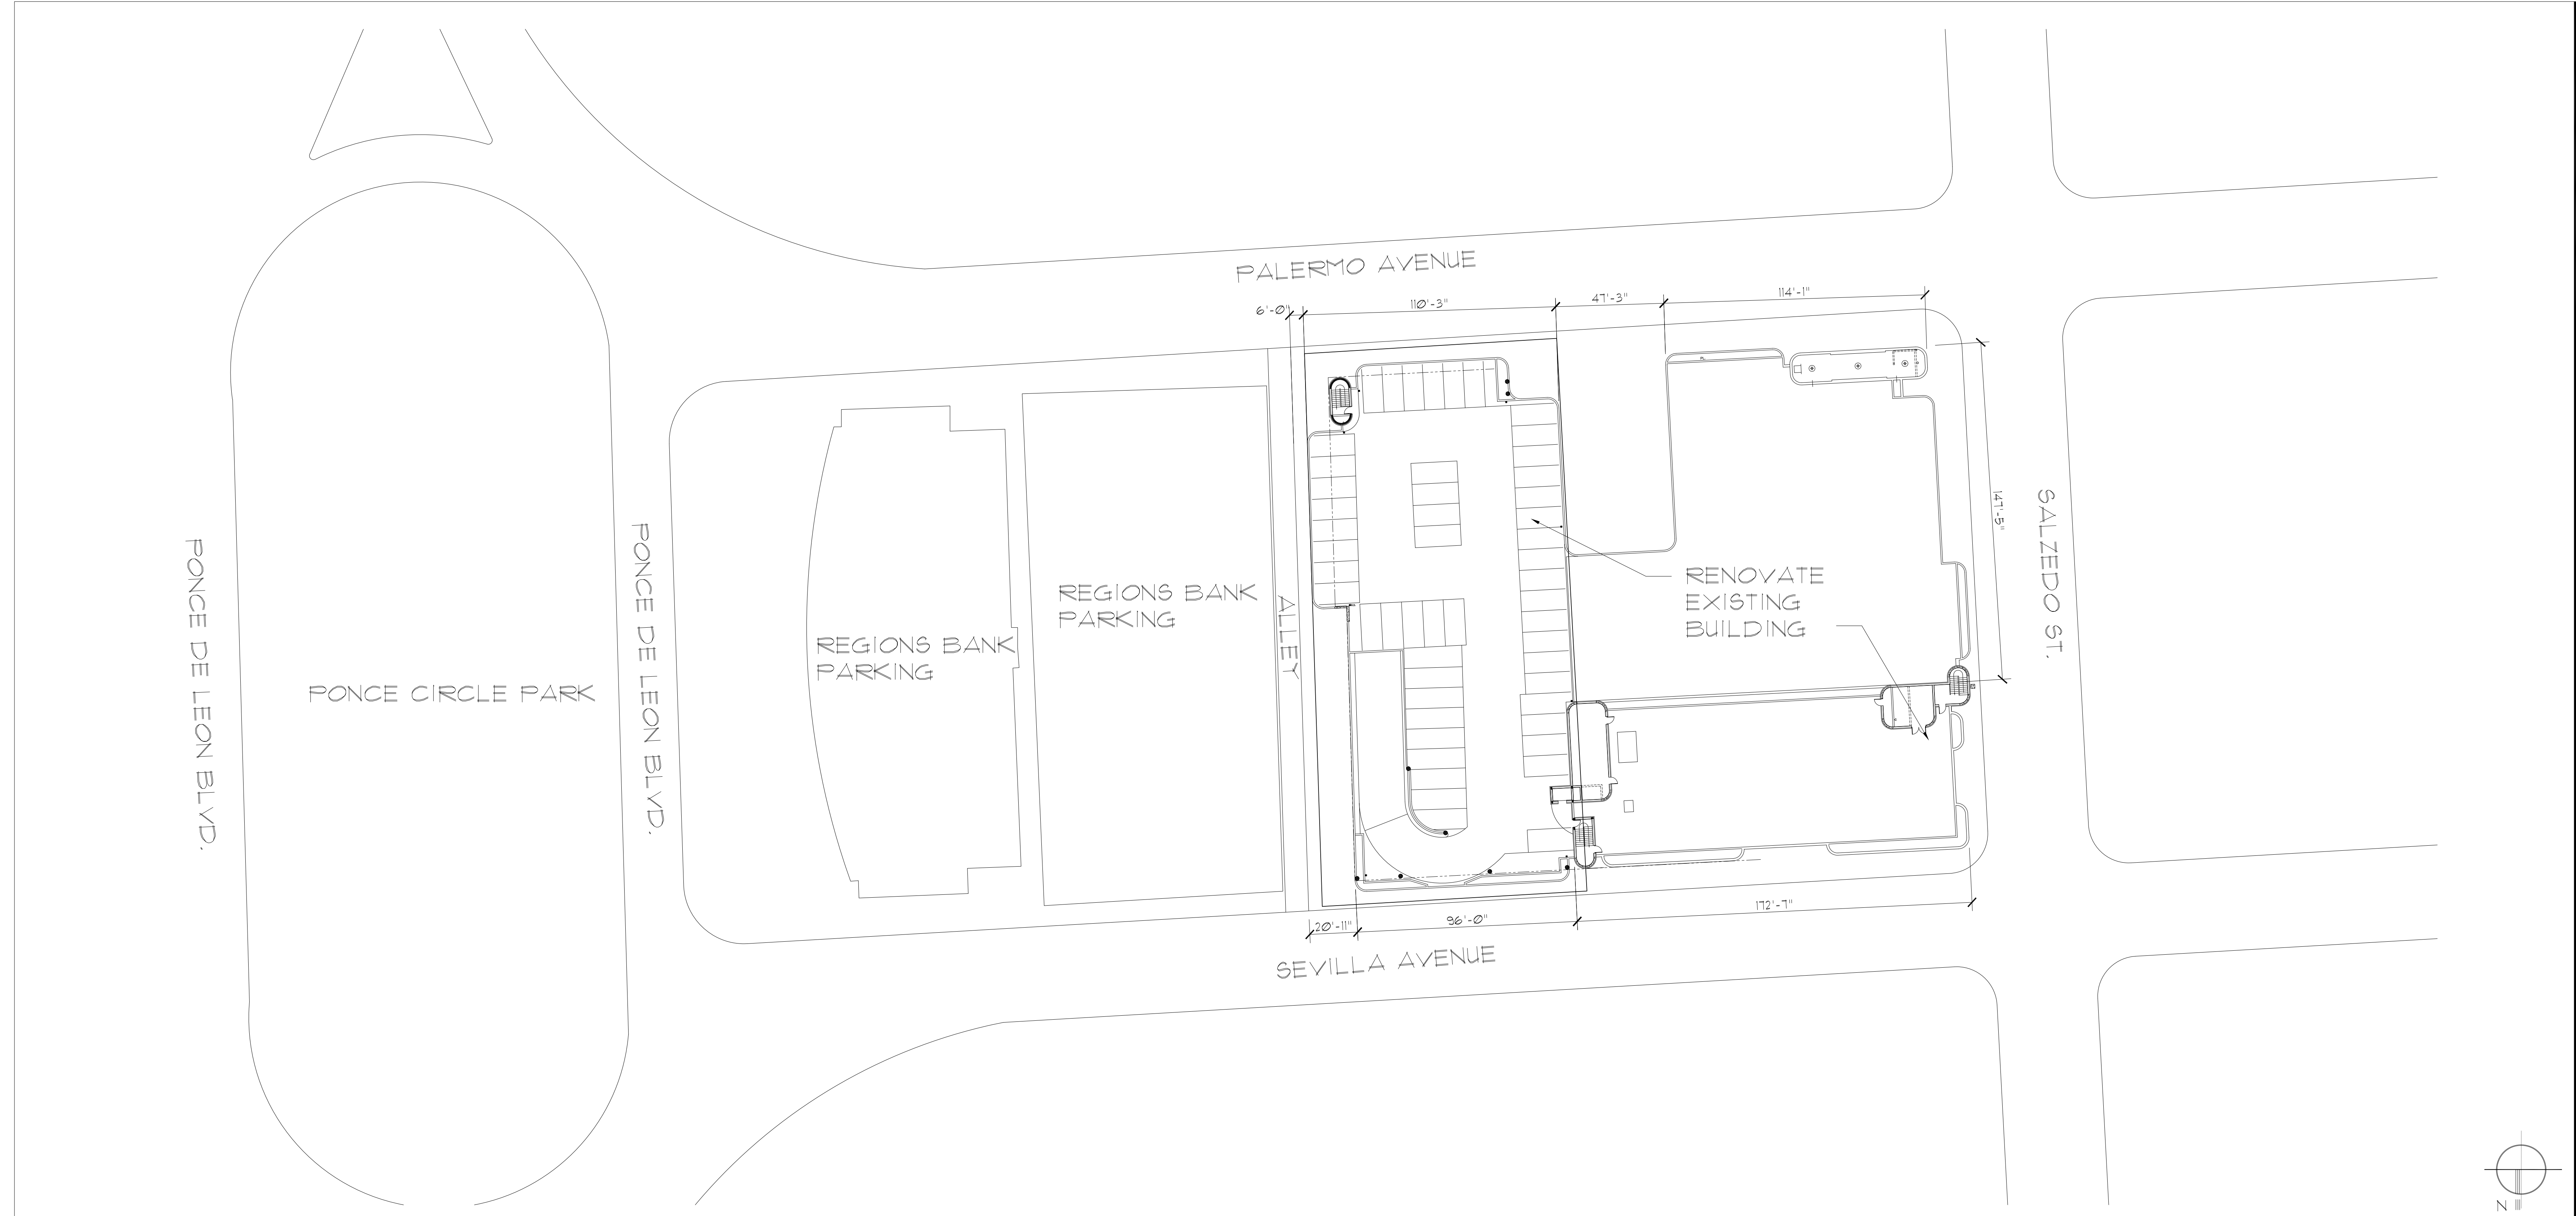
1 Site Plan-Option A
I-100 Scale: 1" = 30'-0"

**OPTION A
TOTAL SF OF PROGRAM AREAS**

PROGRAM	TOTAL GROSS SF
COMMON AREA/SERVICE AREA	12,244
CABLE/TV DEPARTMENT	3,987
POLICE DEPARTMENT	37,384
POLICE-EOC DEPARTMENT	11,219
FIRE DEPARTMENT	30,665
DRIVEWAY	5,291
BUILDING	100,790
PARKING GARAGE # OF CARS - 294	130,778

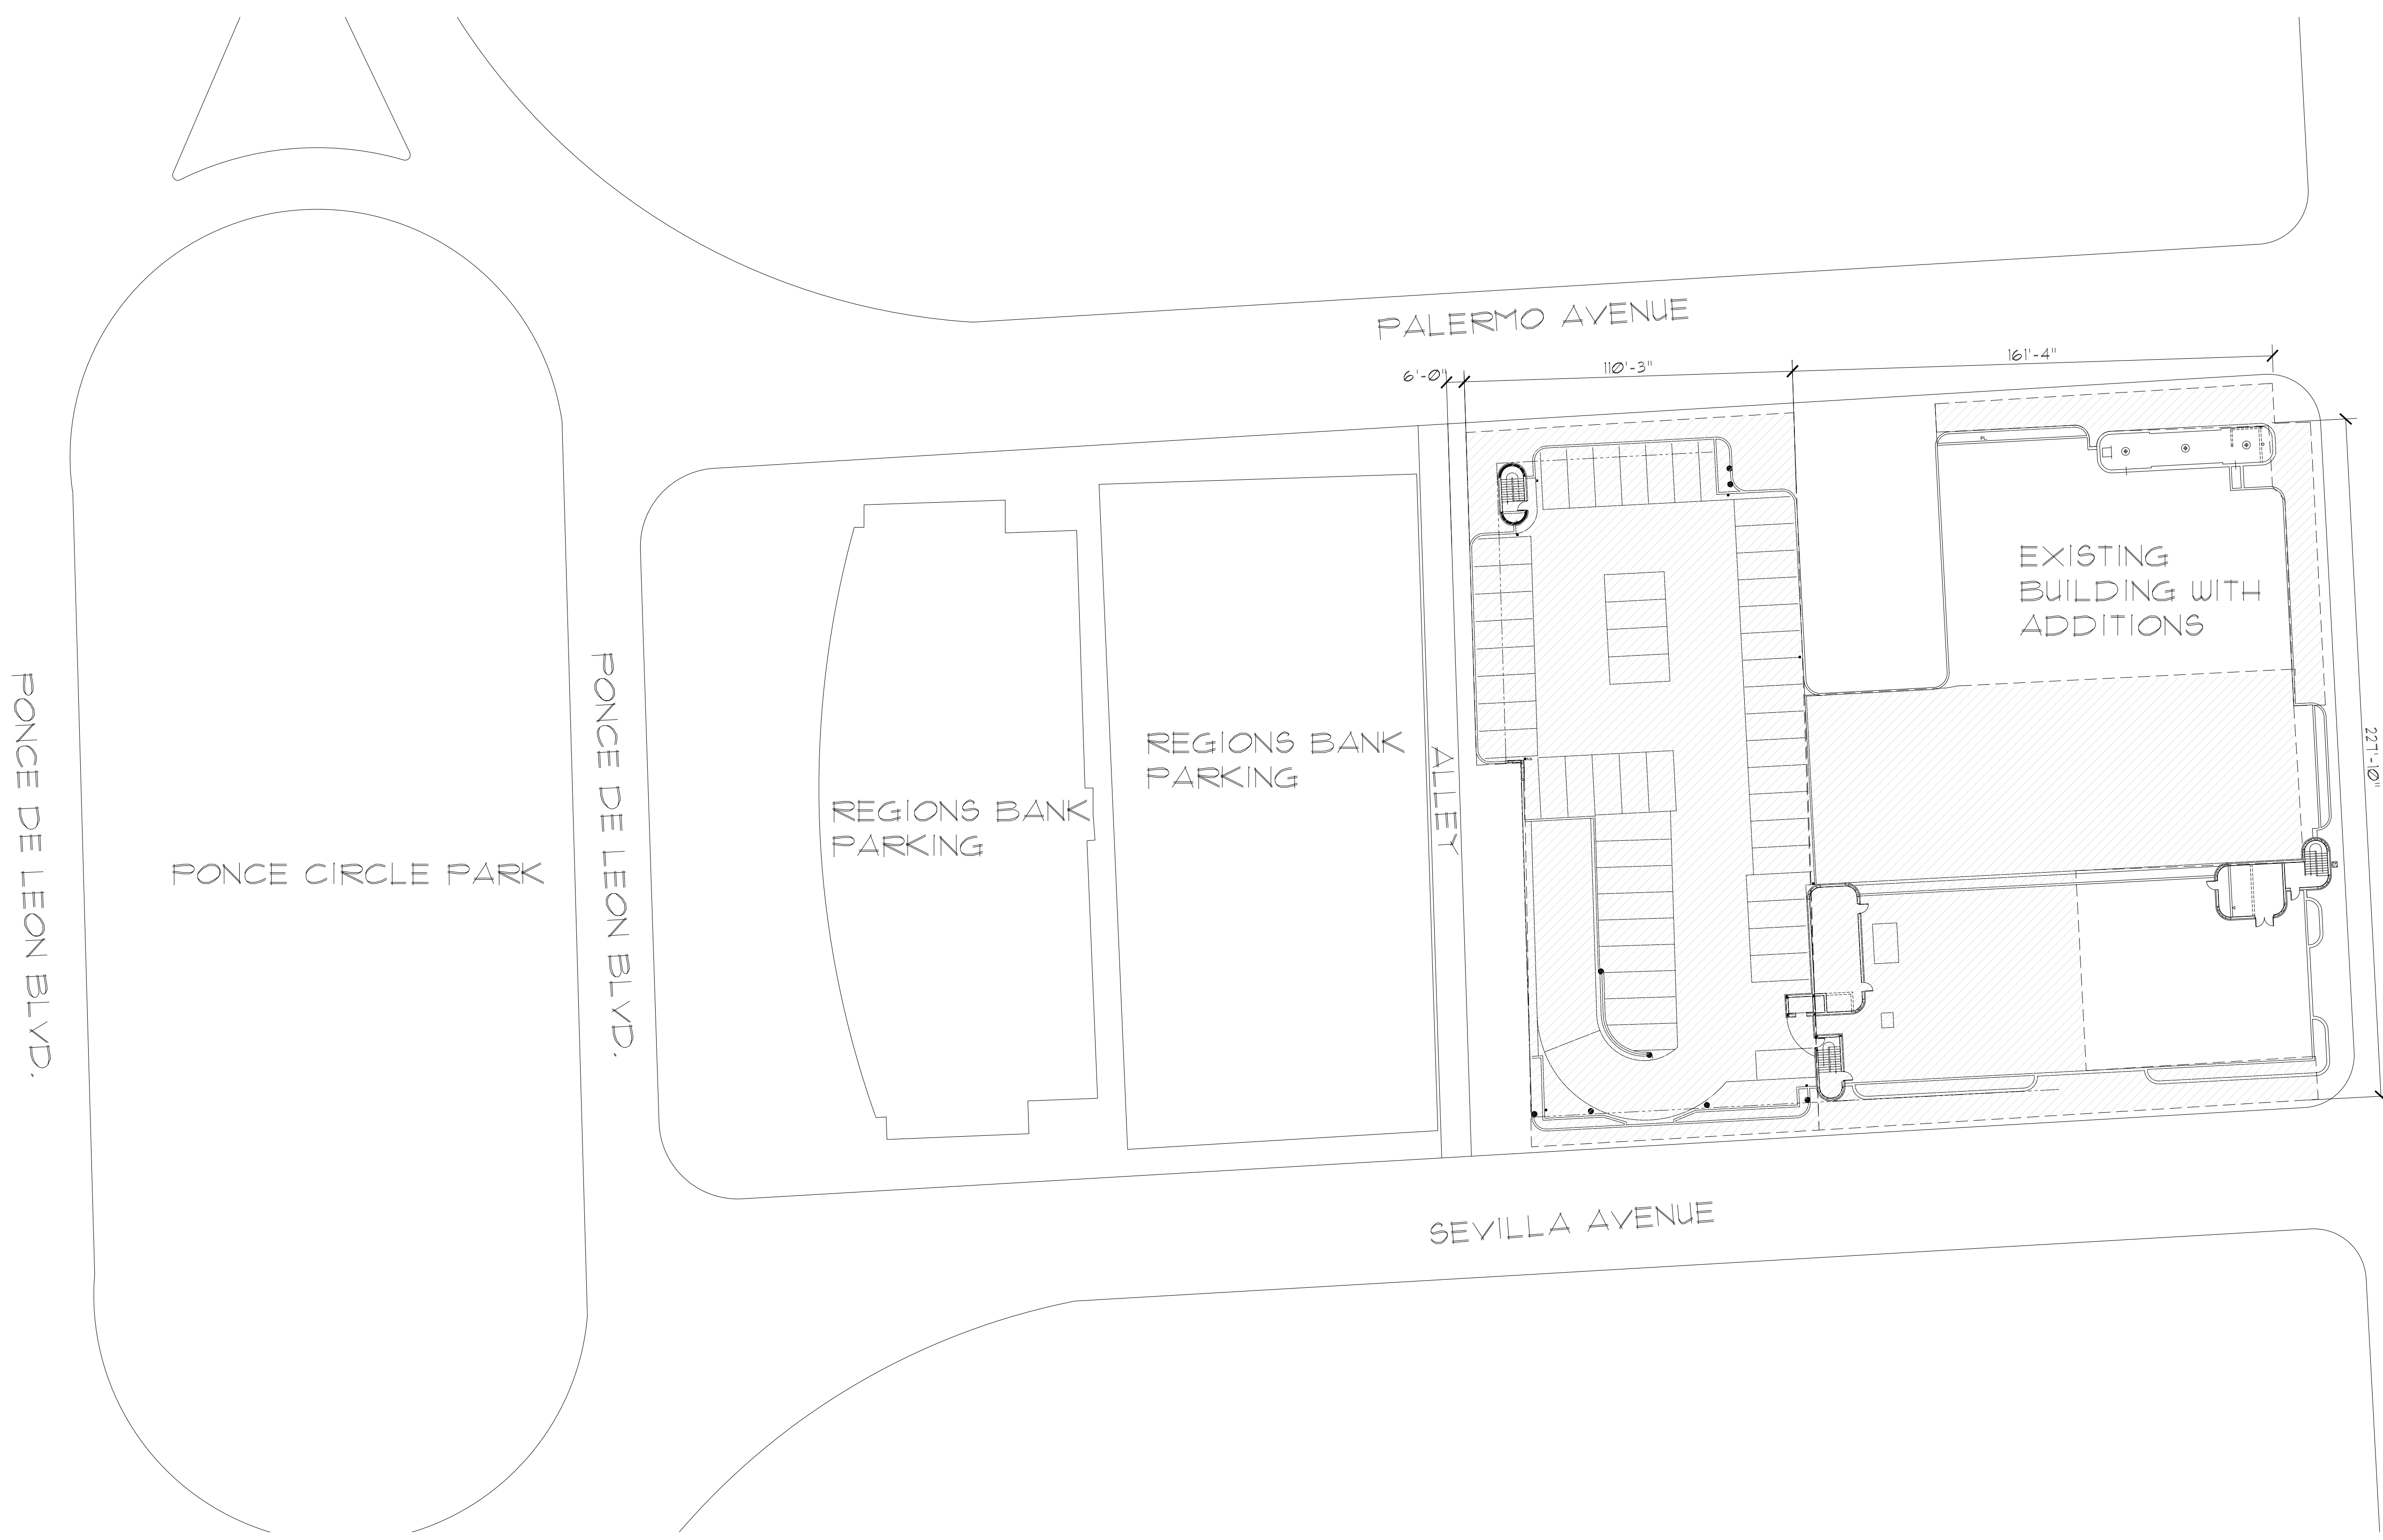
1 Site Plan-Option B
 I-100 Scale: 1" = 30'-0"

**OPTION B
 TOTAL SF OF PROGRAM AREAS**

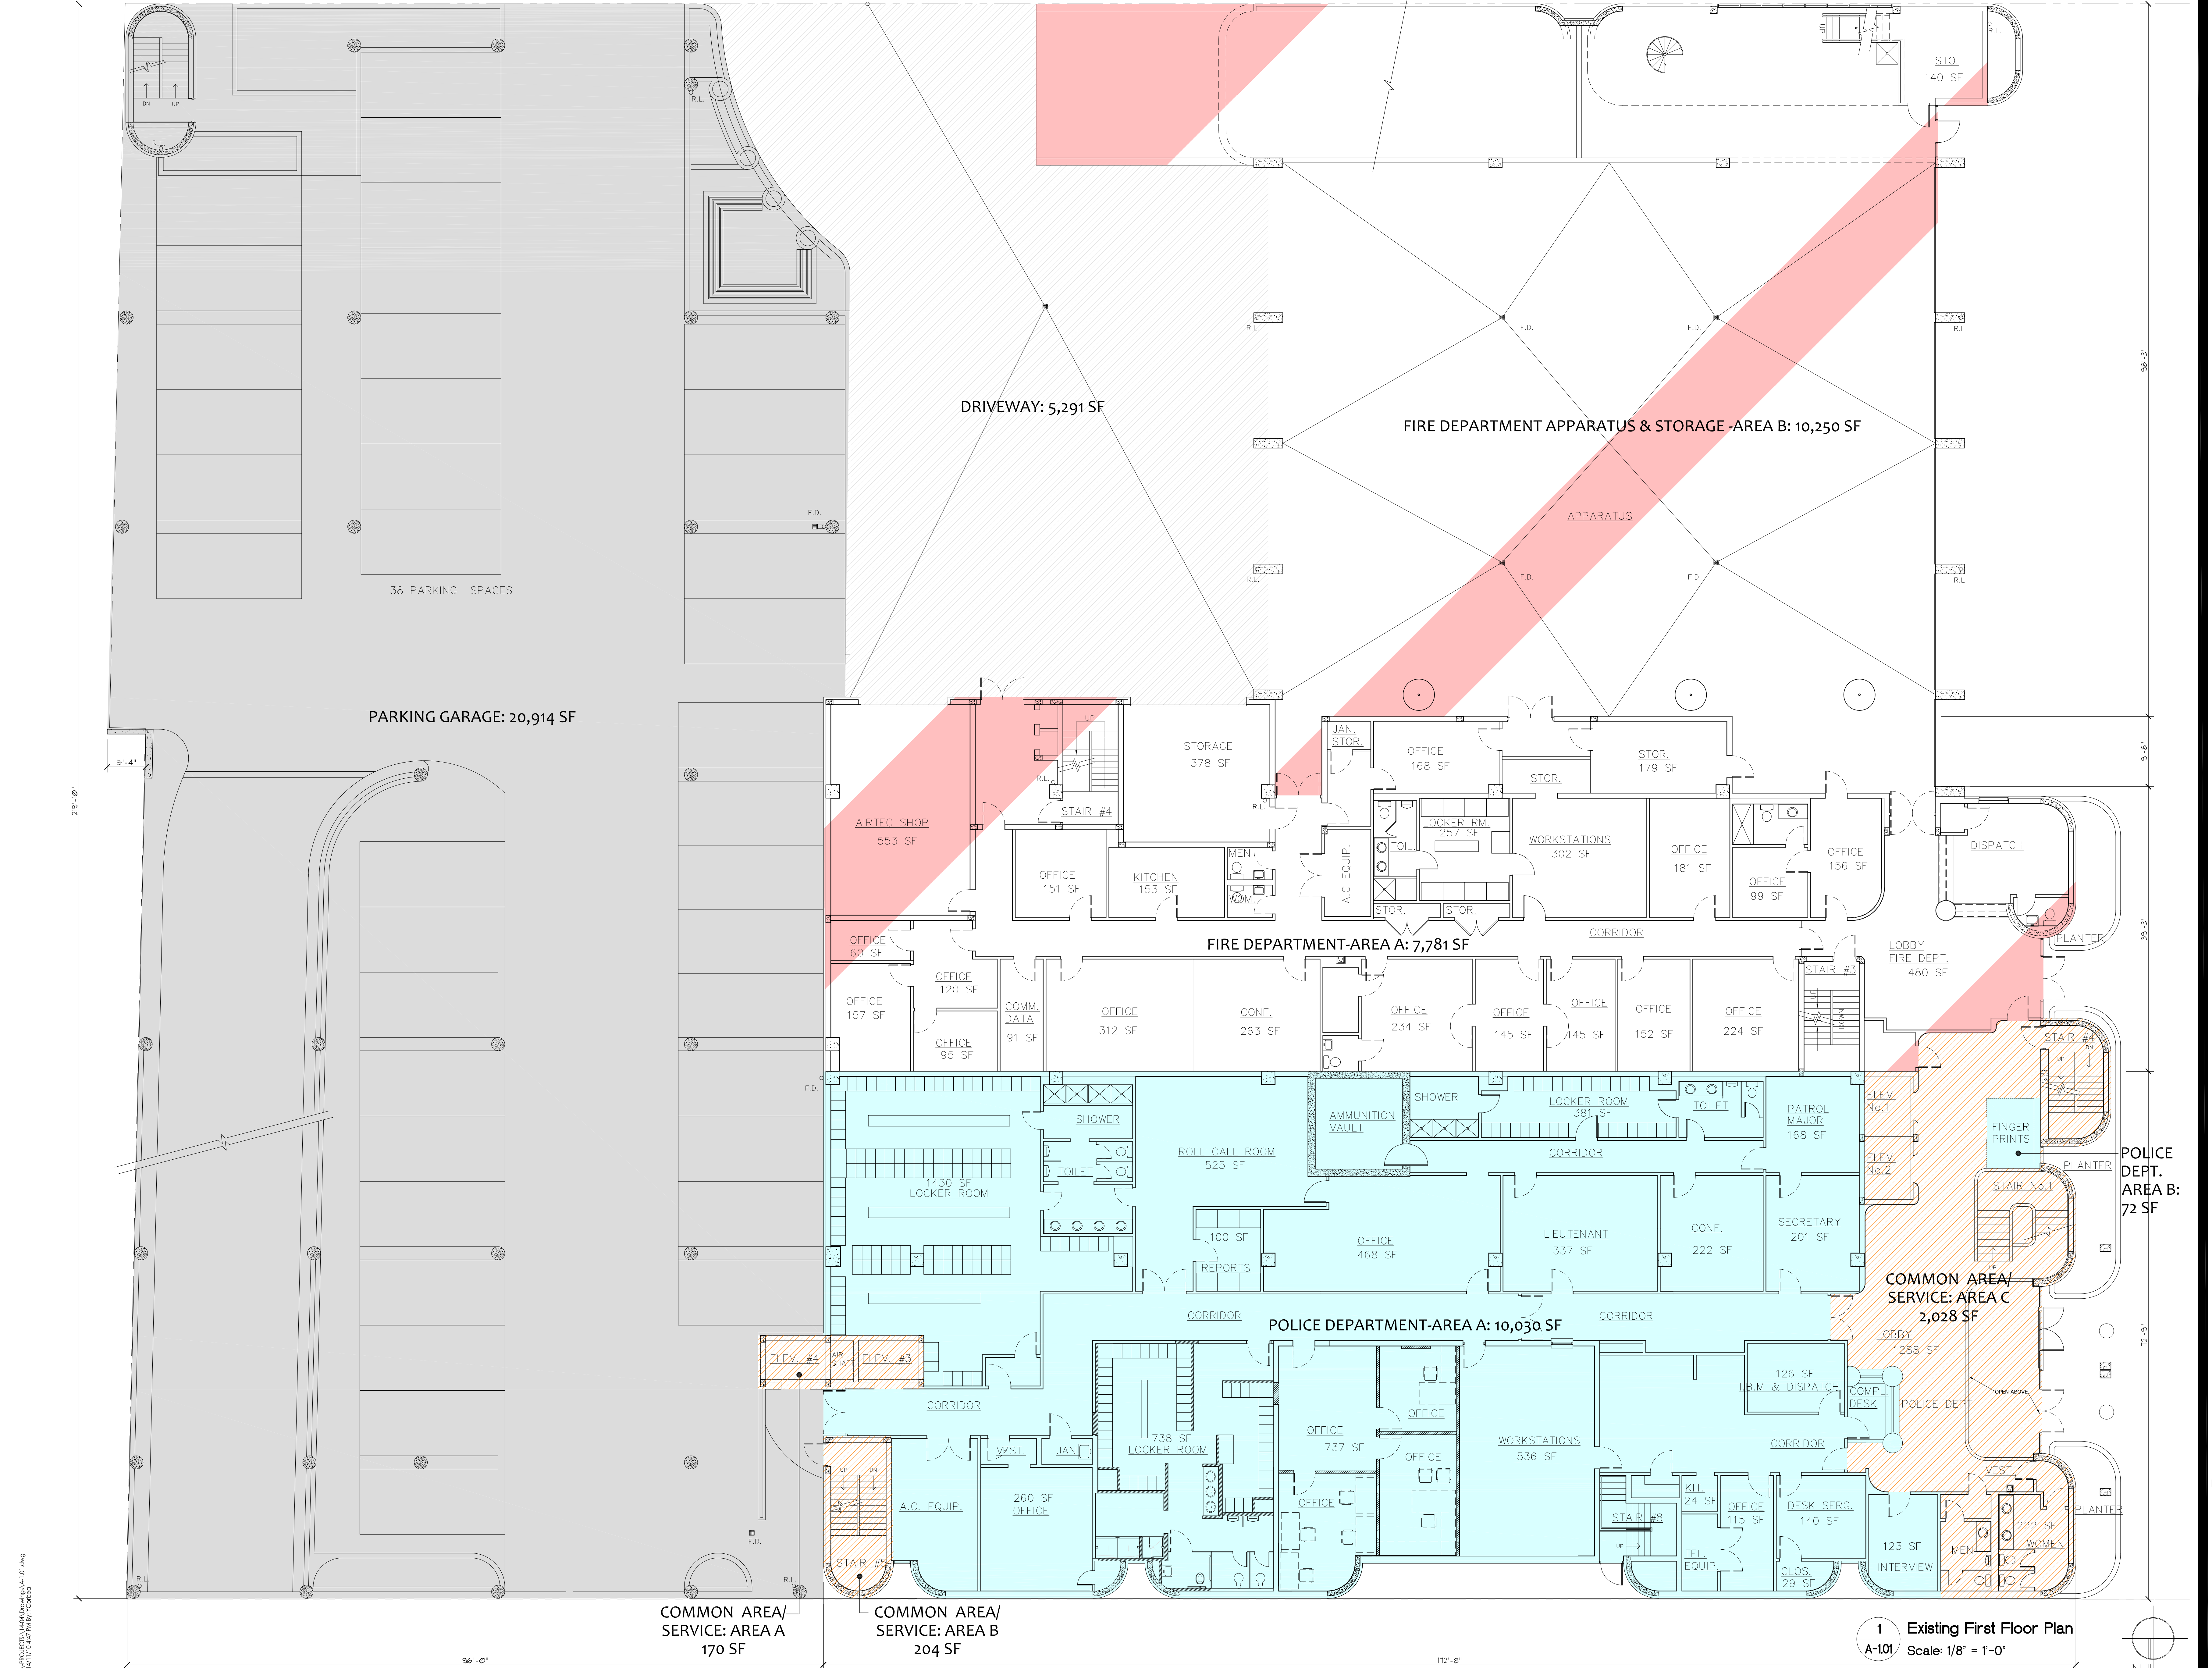
2/19/15
 38 PARKING SPACES
 PARKING GARAGE: 20,914 SF
 DRIVEWAY: 5,291 SF
 FIRE DEPARTMENT APPARATUS & STORAGE - AREA B: 10,250 SF
 FIRE DEPARTMENT - AREA A: 7,781 SF
 POLICE DEPARTMENT - AREA A: 10,030 SF
 COMMON AREA / SERVICE: AREA A: 170 SF
 COMMON AREA / SERVICE: AREA B: 204 SF
 COMMON AREA / SERVICE: AREA C: 2,028 SF
 POLICE DEPT. AREA B: 72 SF
 1 Existing First Floor Plan
 A-101 Scale: 1/8" = 1'-0"
