COA (SP) 2024-004
DECEMBER 19, 2024

**STAFF REPORT
SPECIAL CERTIFICATE OF APPROPRIATENESS
FOR THE PROPERTY AT
3800 GRANADA BOULEVARD
A LOCAL HISTORIC LANDMARK**

*Historical Resources &
Cultural Arts*

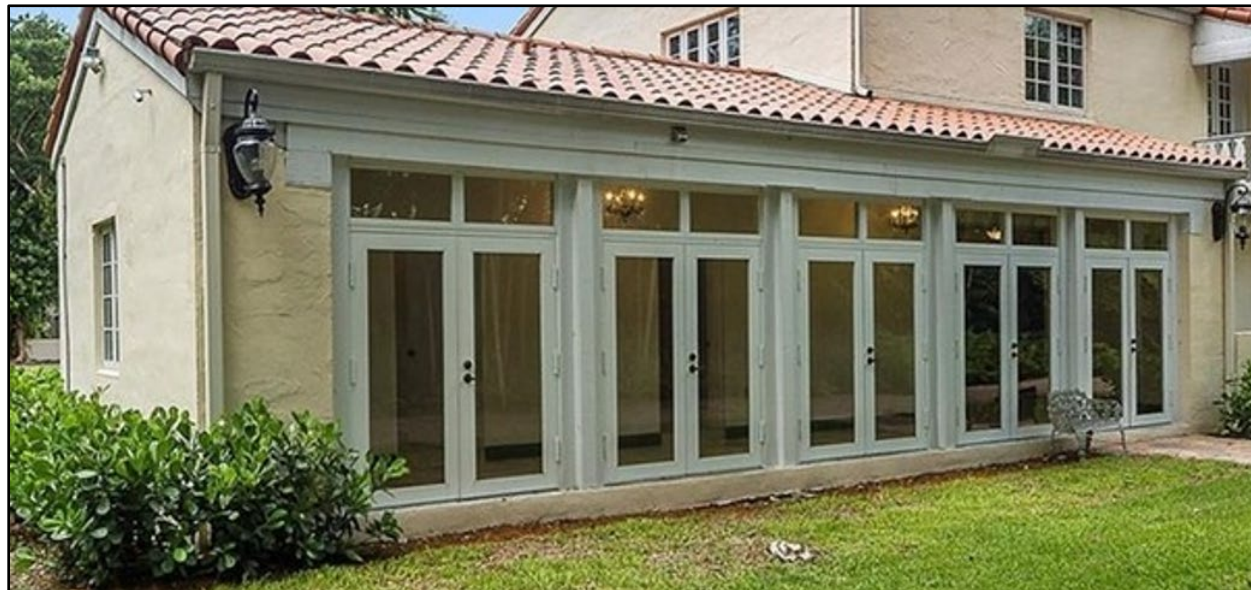
Figure 4: North facade, 2019

The proposed north elevation consists of the existing, historic residence to the east and new construction to the west. The series of doors in the one-story eastern end of this façade was originally a screened service passage with a cypress beam, brackets, and cypress posts. It was enclosed at some point, retaining the cypress beam and the five openings, but inserting new

columns. The existing elevation drawings does not show the existing beam. See Figure 4. The proposal shows brackets, but no details are provided. Note the proportions of this section of the elevation is inconsistent with the extant home.

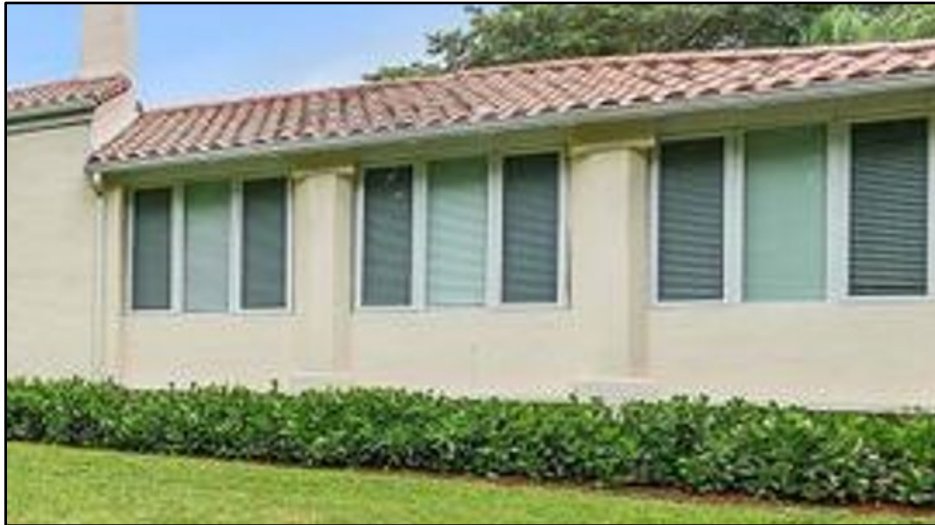
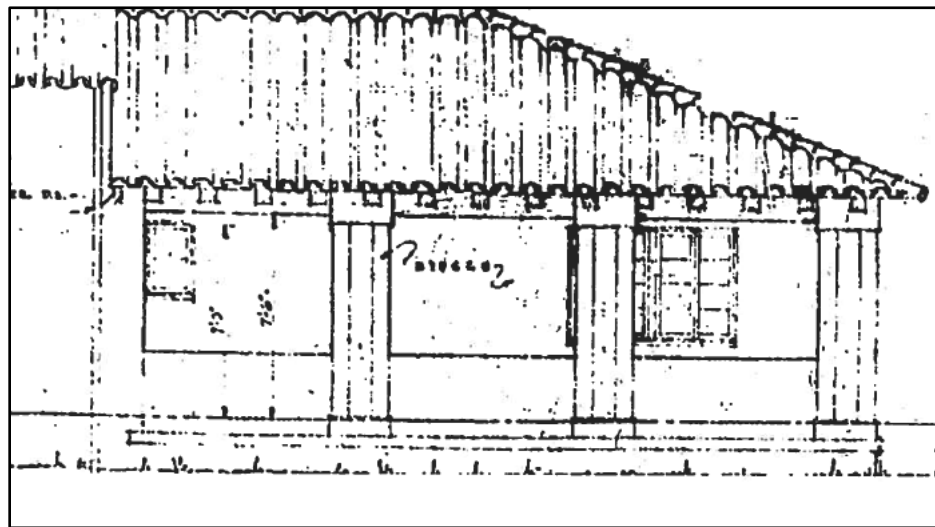
Figures 5: Porch at Southwest corner: Top -Photo, 2019, Bottom – Permit #1341

At the southwest corner of the home, an original porch that was enclosed is being reopened. The original masonry columns, knee wall, and sill are extant. See Figures 5, below. The proposal does not show the knee walls or sill. Staff recommends that the knee walls flanking the center opening

be retained. The window and door within the porch are being reconfigured, although no existing elevation of the space within has been provided for comparison.

On the south elevations the only alteration is the replacement of windows and the reopening of the southwest corner porch. The side of the two-story addition and the covered porch are visible to the west and the stepped up roof of the north wing is visible beyond. A series of three casement windows are placed across the second floor of the addition while French doors below provide access to the covered terrace. A lintel above the French doors mimics one found on the north façade of the south wing (see Sheet A-201).

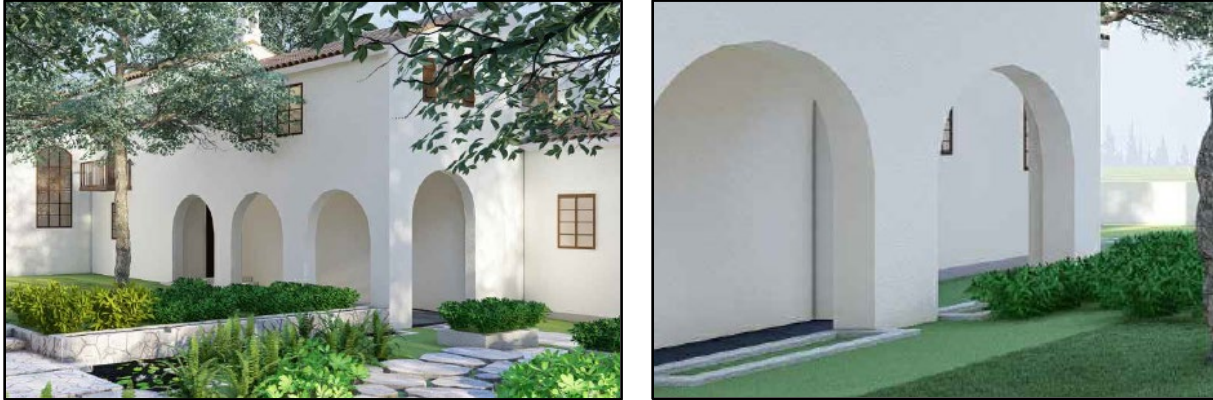
Figures 6: Entry Loggia infill – C & D/Sheet L-1.00

topped with a 3'-0" aluminum picket fence facing the Biltmore Golf Course. Additional regrading takes place to the east of the home within the U created by the two wings of the residence. This center courtyard will be raised by approximately 18" which fills in the base of the original arches of the entryway to the north with planters. (Figures 6)

The proposed grading of the site creates a physical and visual barrier between the property and the golf course to the rear and infills the arches at the entryway. Staff recommends a gradual decrease in the grading toward the rear of the property to mitigate the height of the wall and fencing required. This should be further studied with staff and if necessary, may need further review by the Historic Preservation Board. Staff will require further clarification of the infill proposed at the arched entryway. Modifications to prominent original openings should be avoided. If possible, adjust the location of the retaining wall to the exterior of the columns or study a gradual transition of the proposed grade to the entry.
