Alhambra Circle Sidewalk

October 22, 2024

TOPOGRAPHIC & SPECIFIC SURVEY
3430 ALHAMBRA CIRCLE

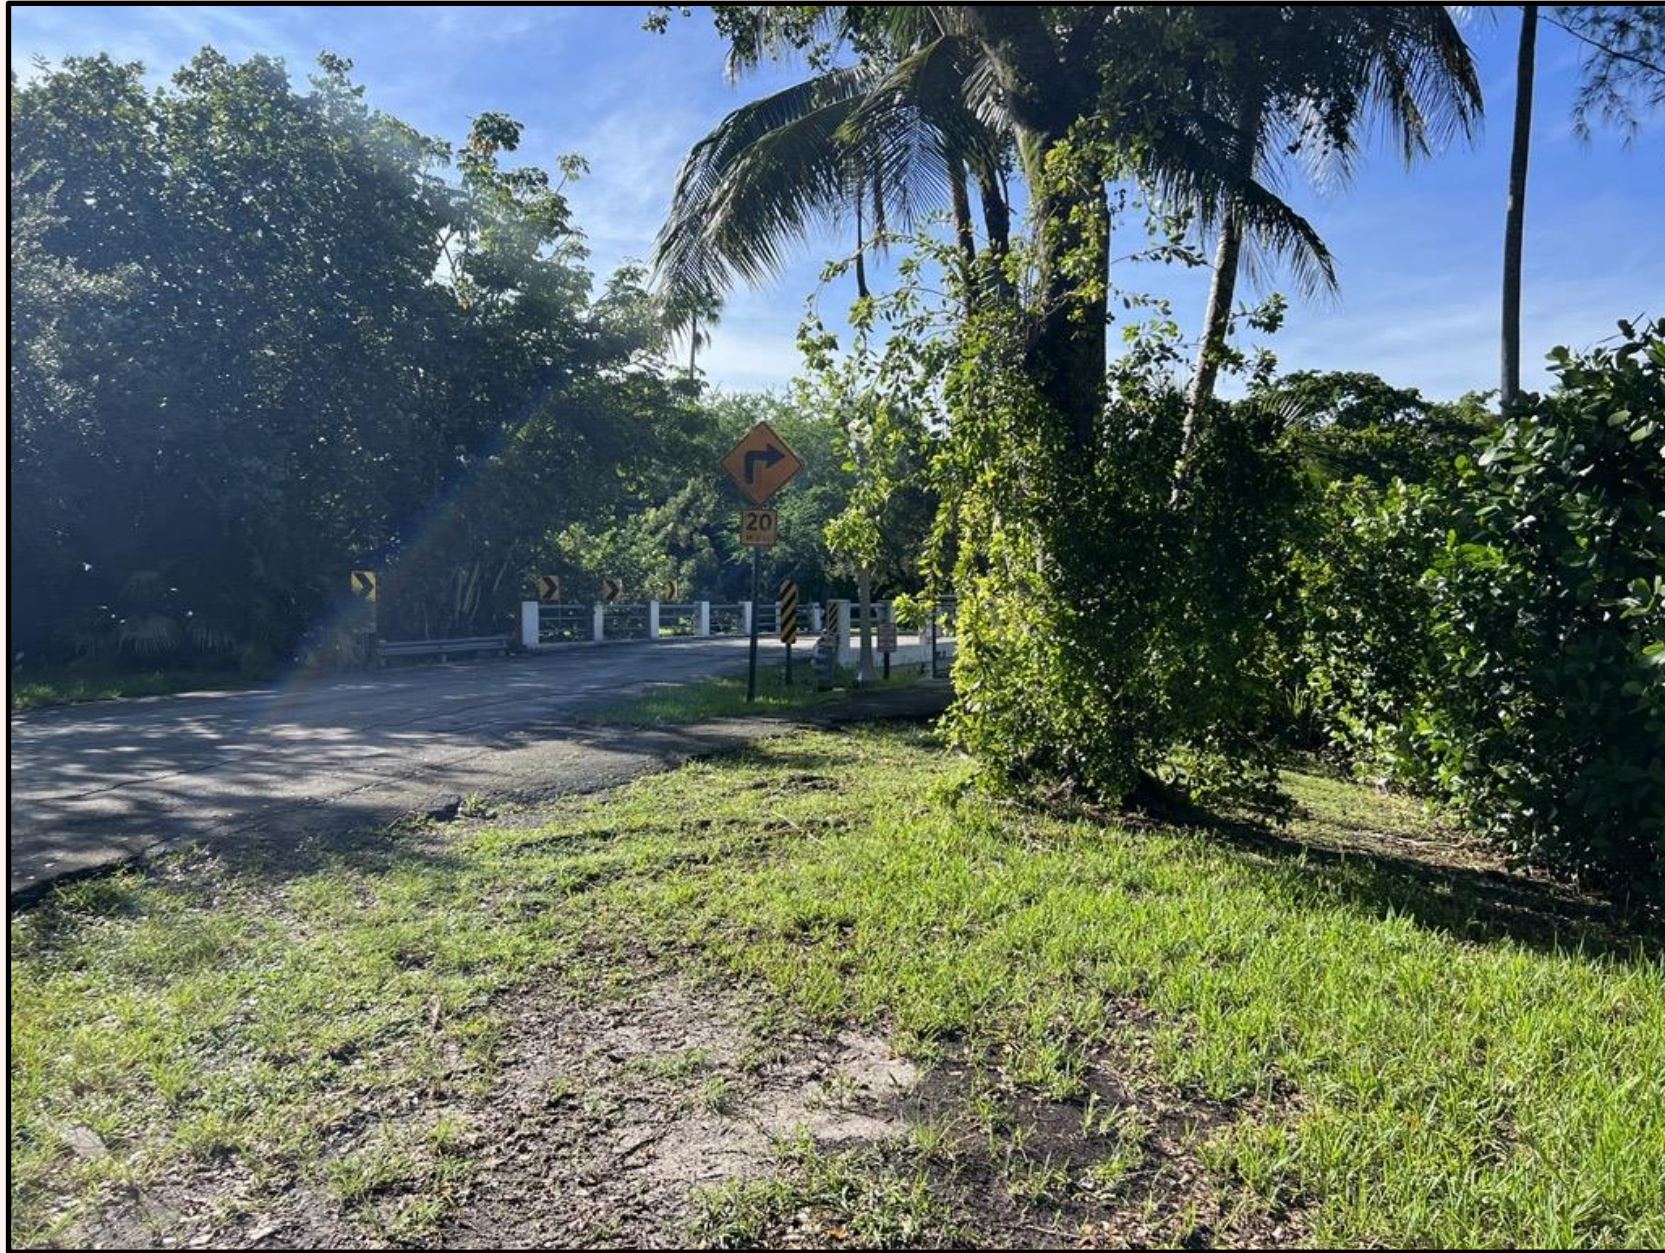
TREE NO. 1

Tree Details:

- Black Olive (Specimen)
- Poor Condition
- 26-inch diameter
- 28-foot RPZ
- 100% sidewalk (6') impact in RPZ

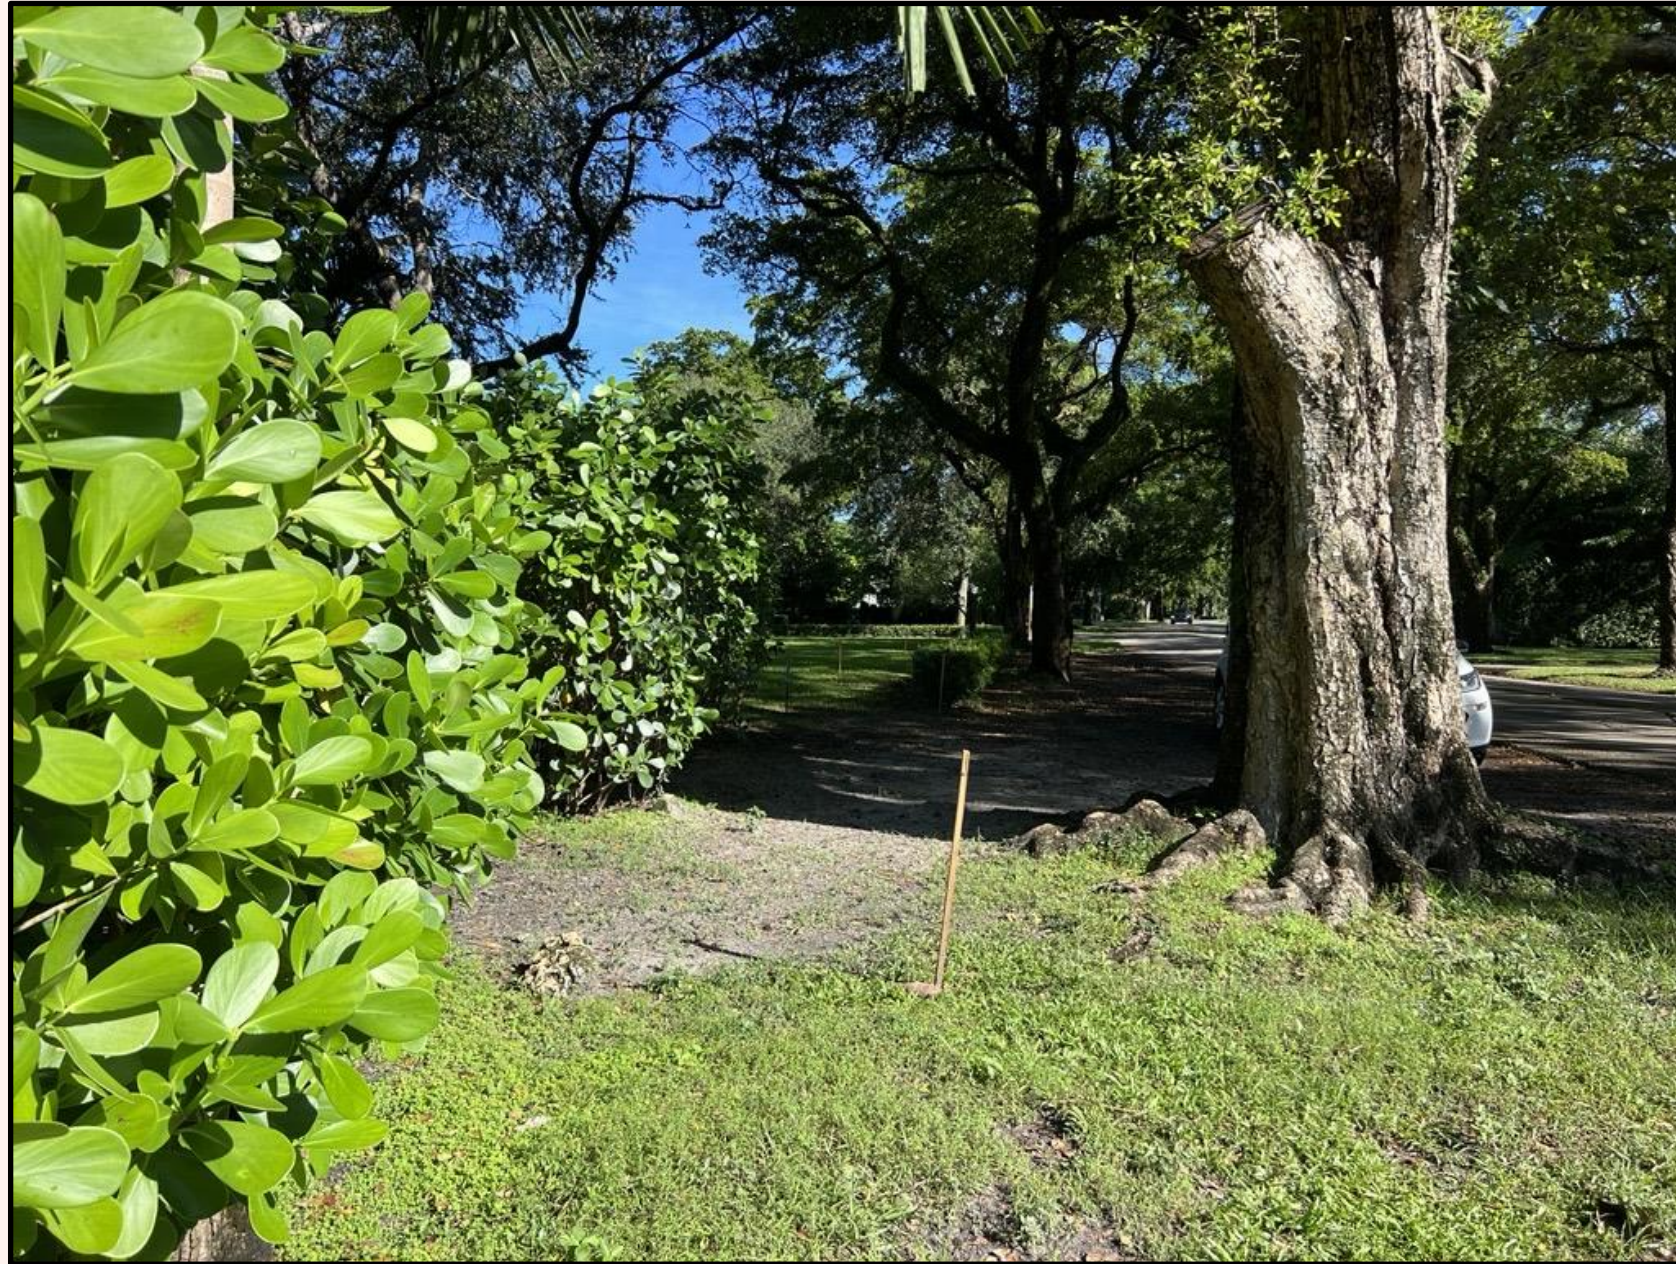
TREE NO. 2

Tree Details:

- Black Olive (Specimen)
- Fair Condition
- 39-inch diameter
- 42-foot RPZ
- 28% sidewalk (6') impact in RPZ
- 26% sidewalk (5') impact in RPZ

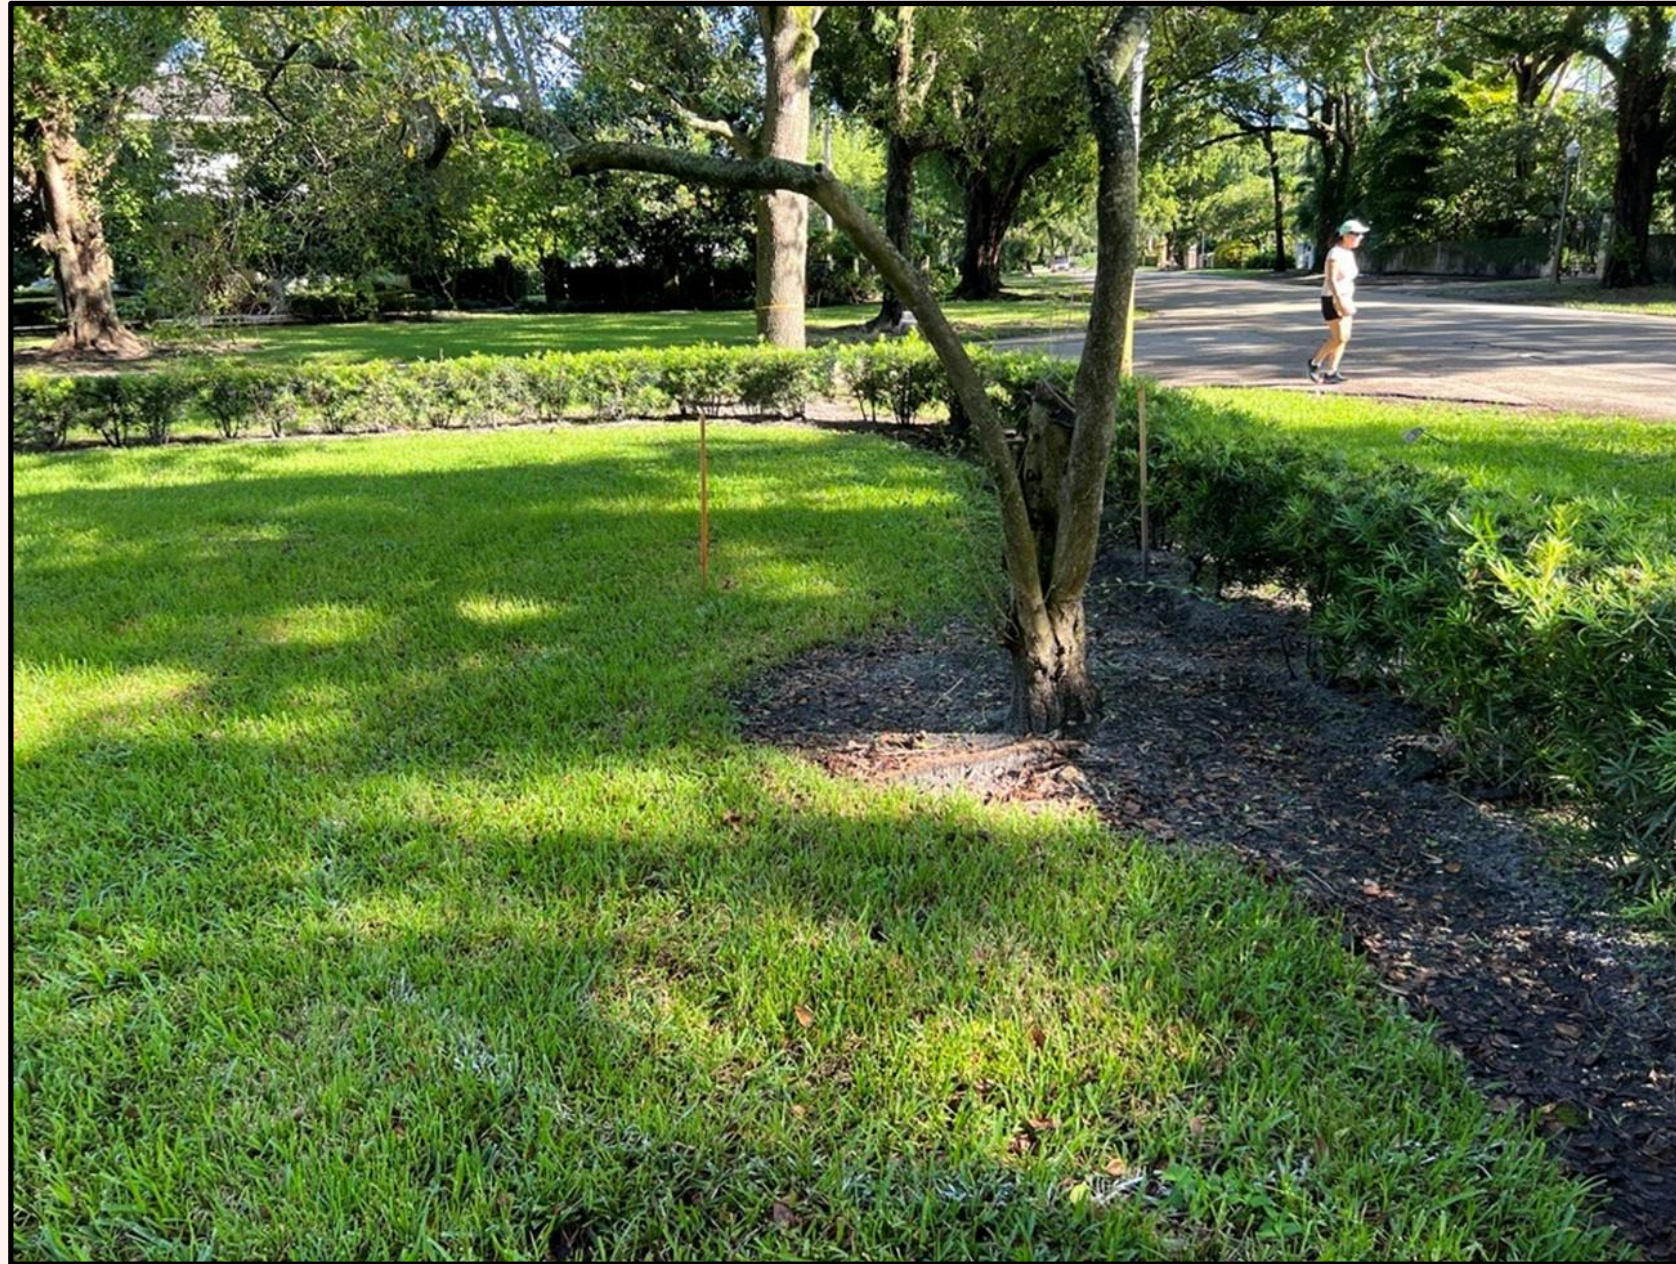
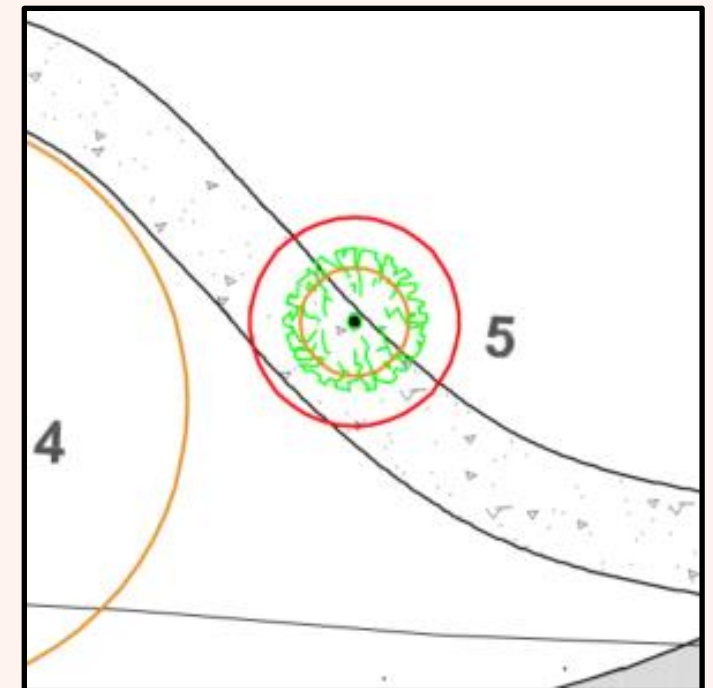
TREE NO. 5

Tree Details:

- Crape Myrtle
- Fair Condition
- 6-inch diameter
- 7-foot RPZ
- 100% sidewalk (6') impact in RPZ

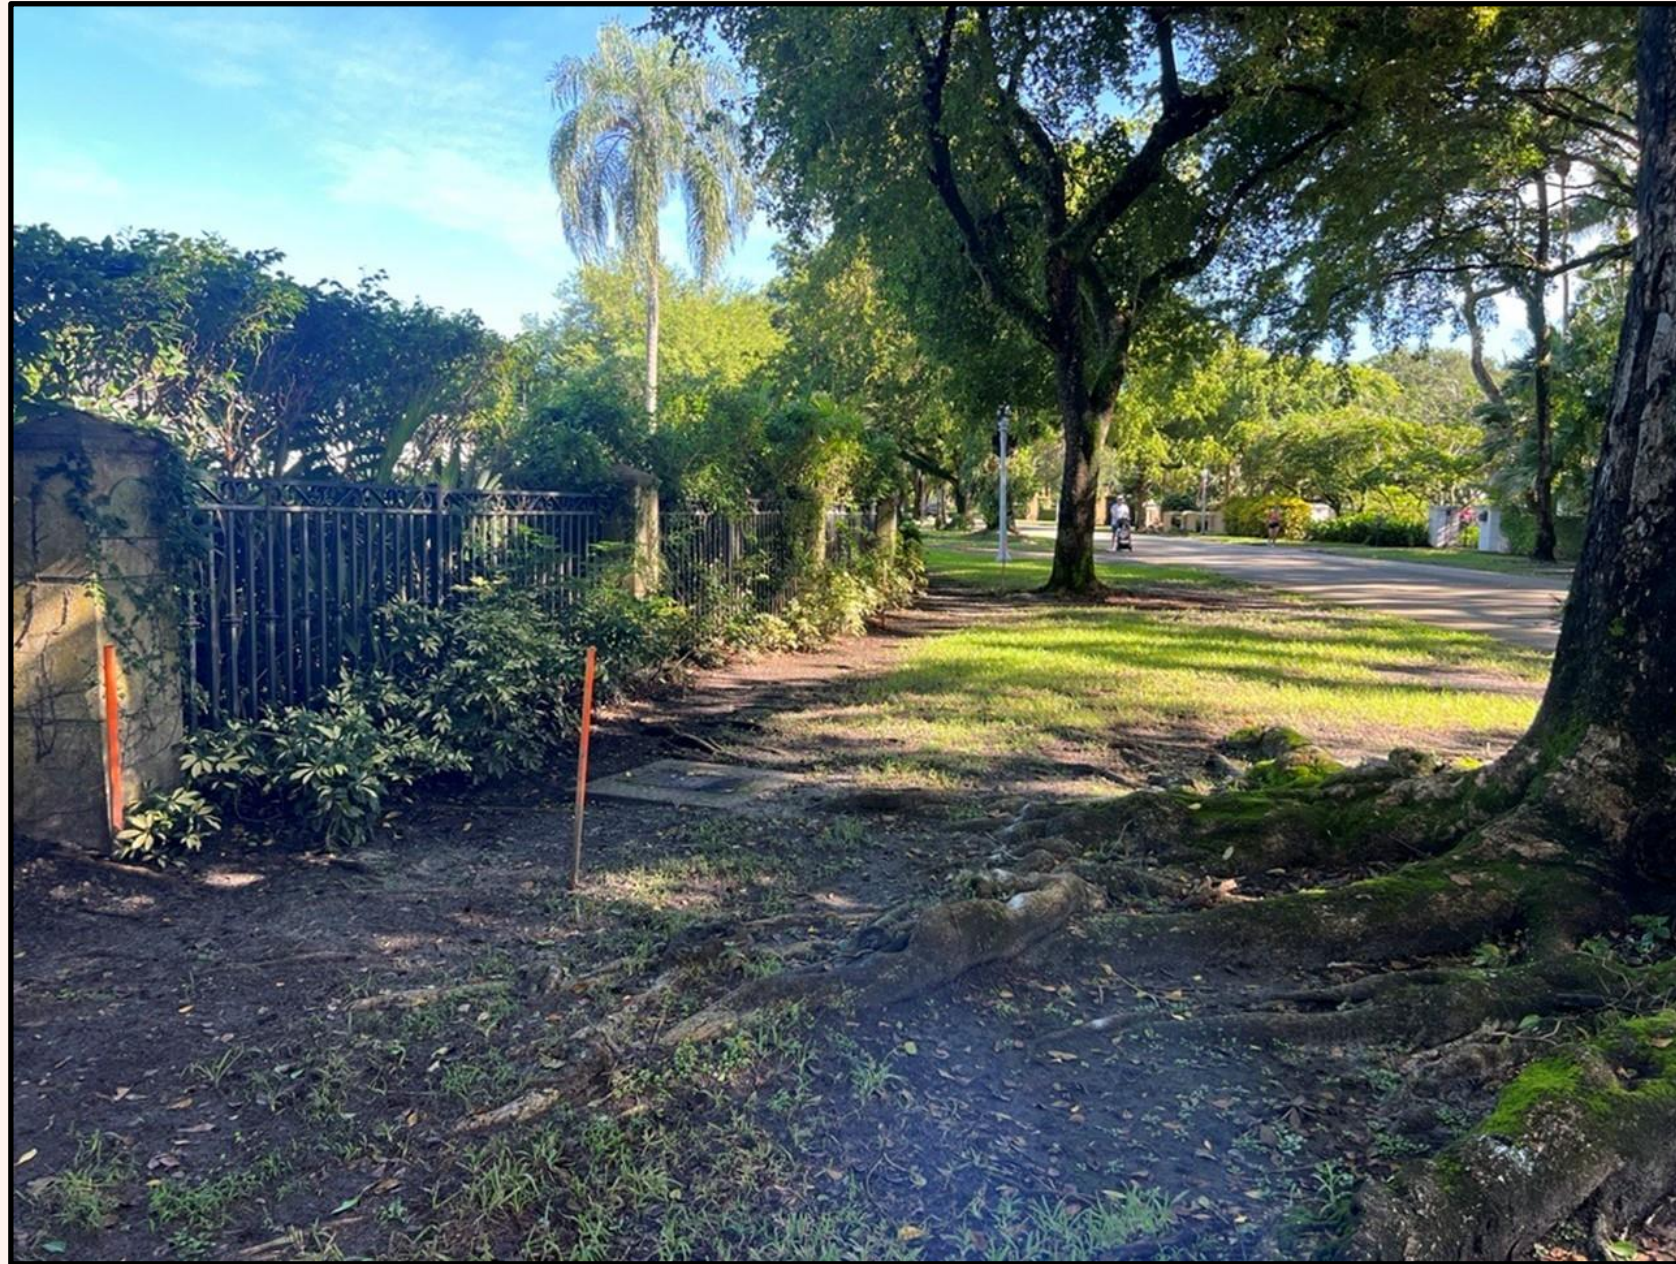
TREE NO. 8

Tree Details:

- Black Olive (Specimen)
- Fair Condition
- 43-inch diameter
- 47-foot RPZ
- 30% sidewalk (6') impact in RPZ
- 27% sidewalk (5') impact in RPZ

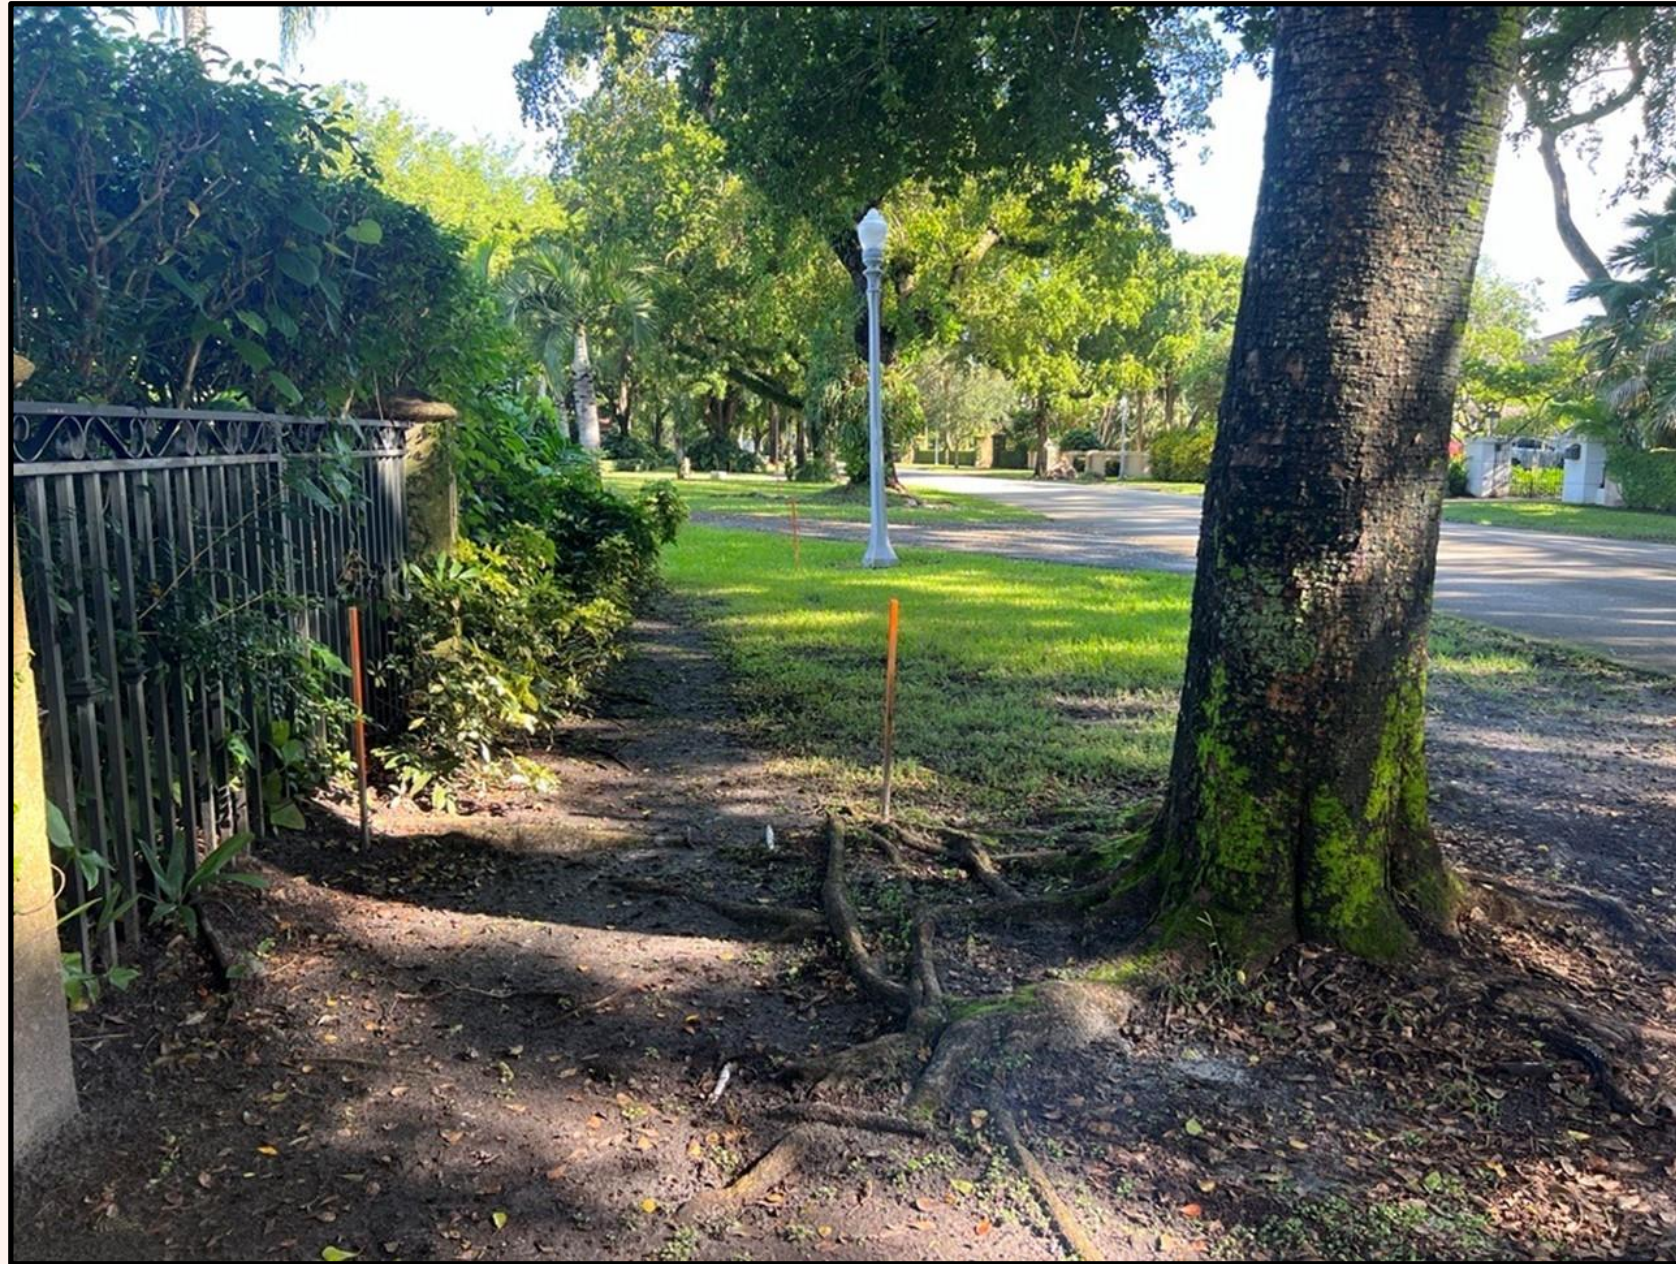
TREE No. 9

Tree Details:

- Black Olive (Specimen)
- Fair Condition
- 21-inch diameter
- 23-foot RPZ
- 38% sidewalk (6') impact in RPZ

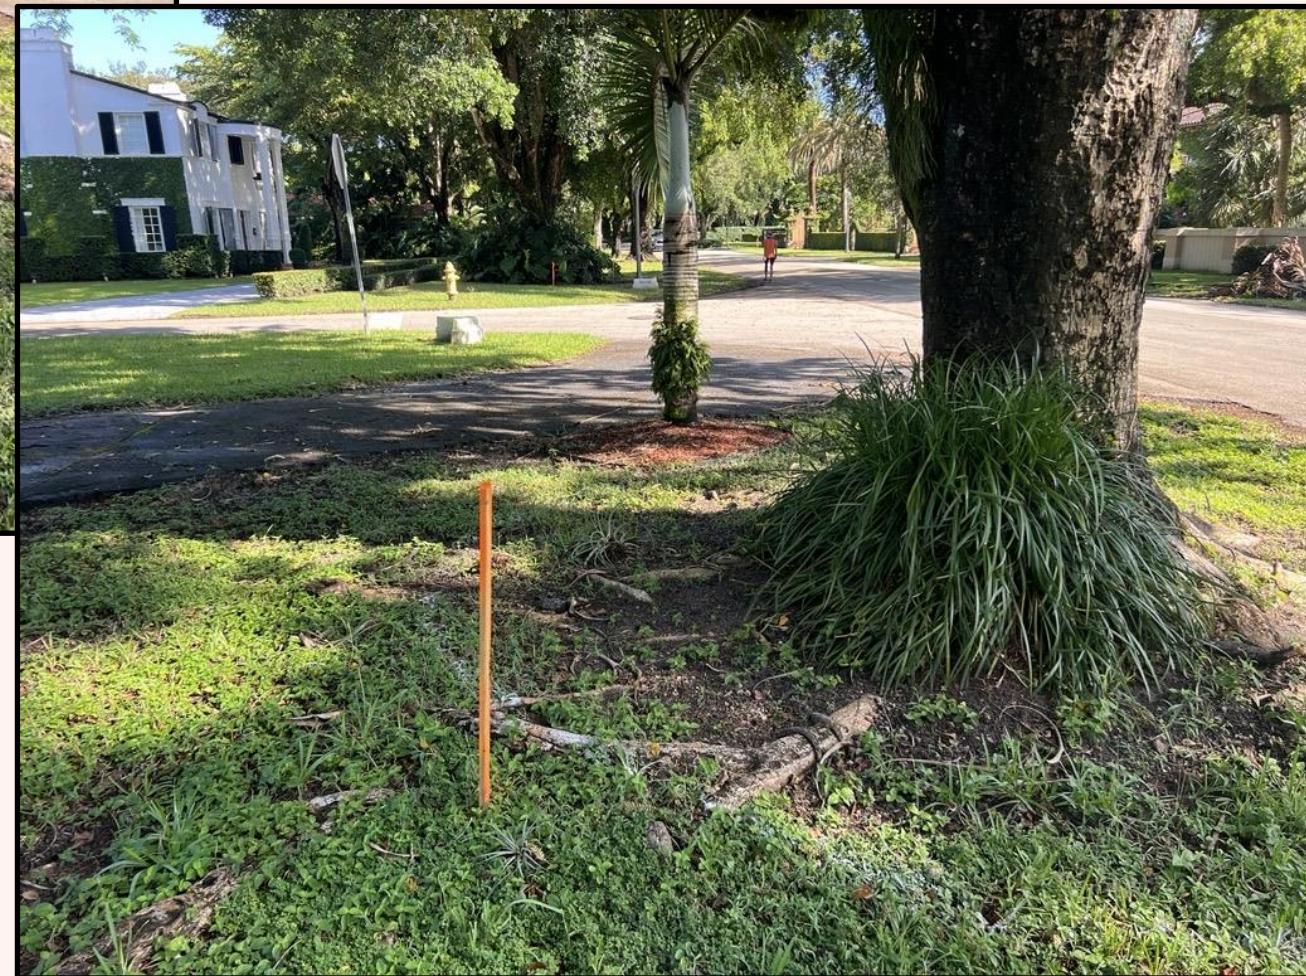
TREE NO. 11

Tree Details:

- Black Olive (Specimen)
- Good Condition
- 33-inch diameter
- 36-foot RPZ
- 43% sidewalk (6') impact in RPZ
- Driveway approach will need to be relocated as part of the project

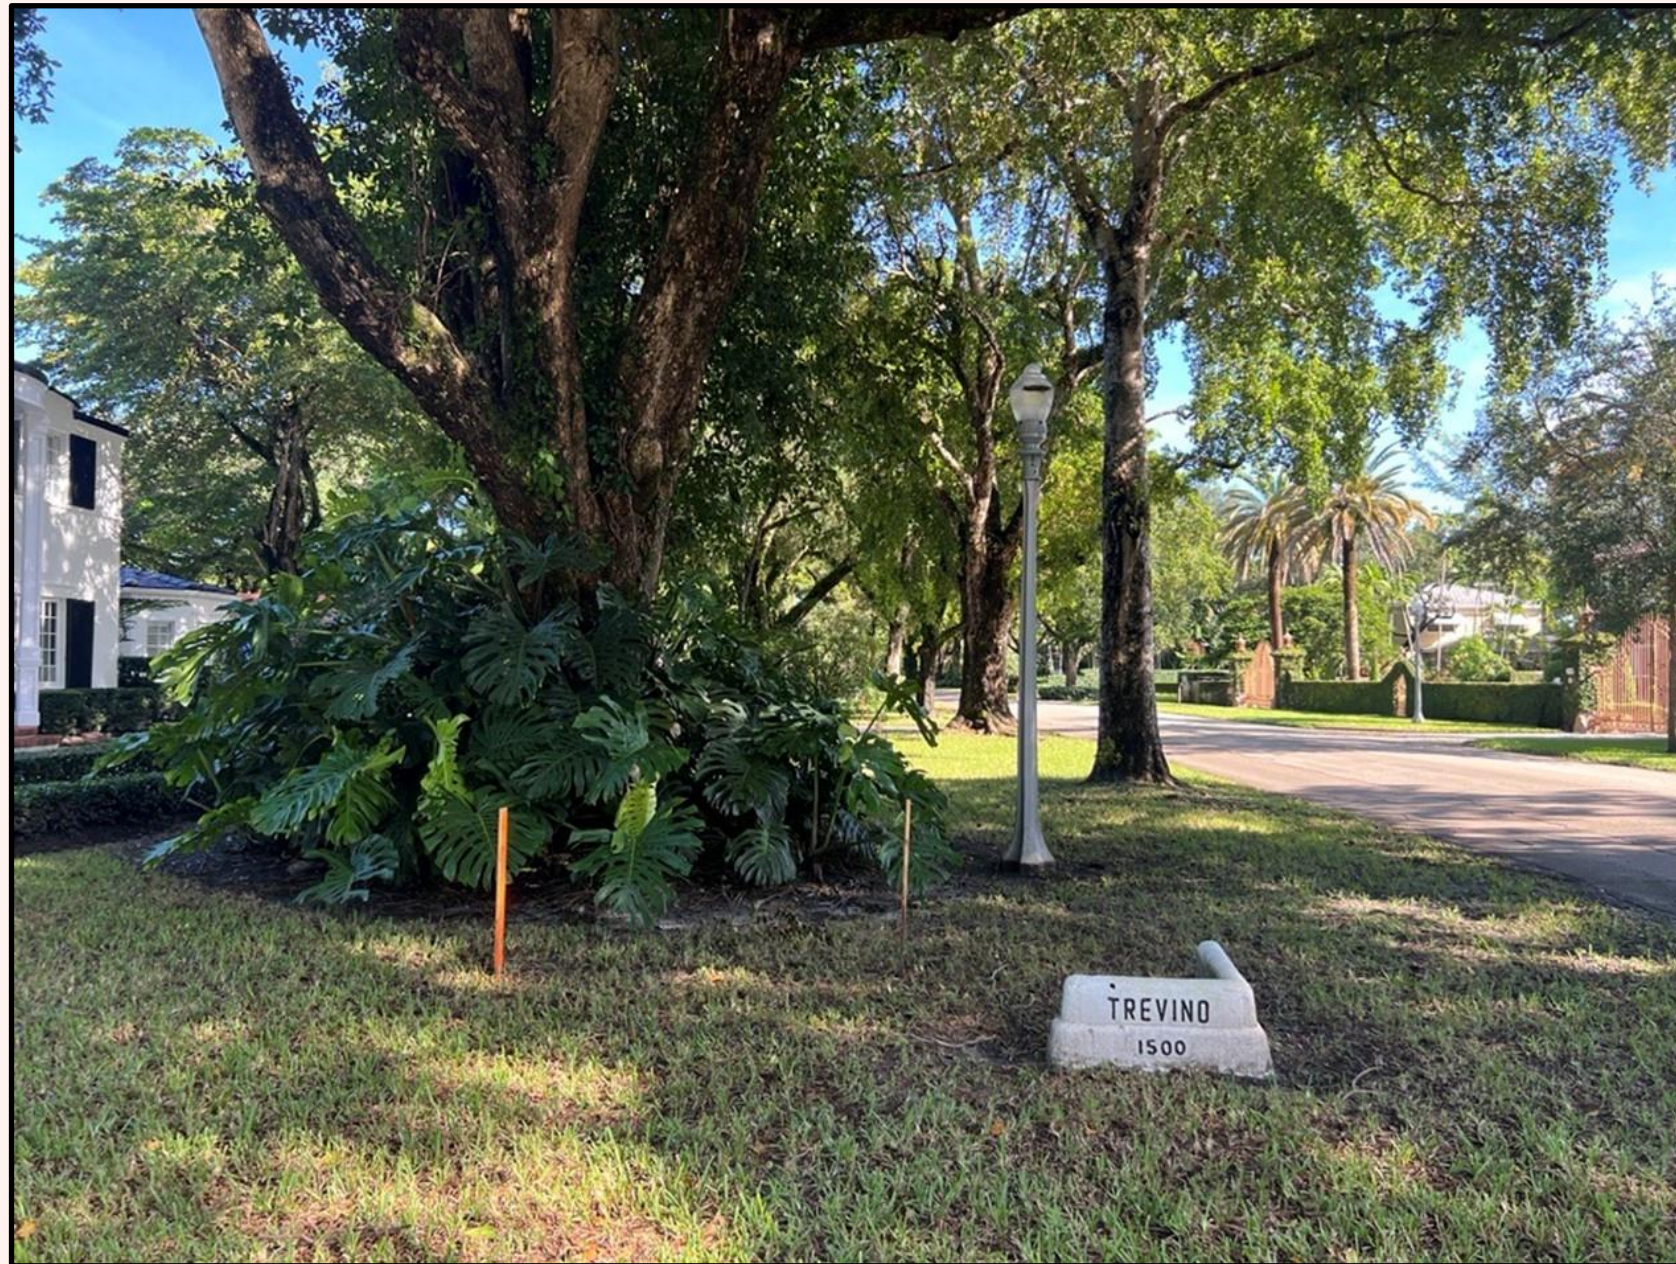
TREE NO. 12

Tree Details:

- Black Olive (Specimen)
- Good Condition
- 40-inch diameter
- 43-foot RPZ
- 26% sidewalk (6') impact in RPZ
- 23% sidewalk (5') impact in RPZ

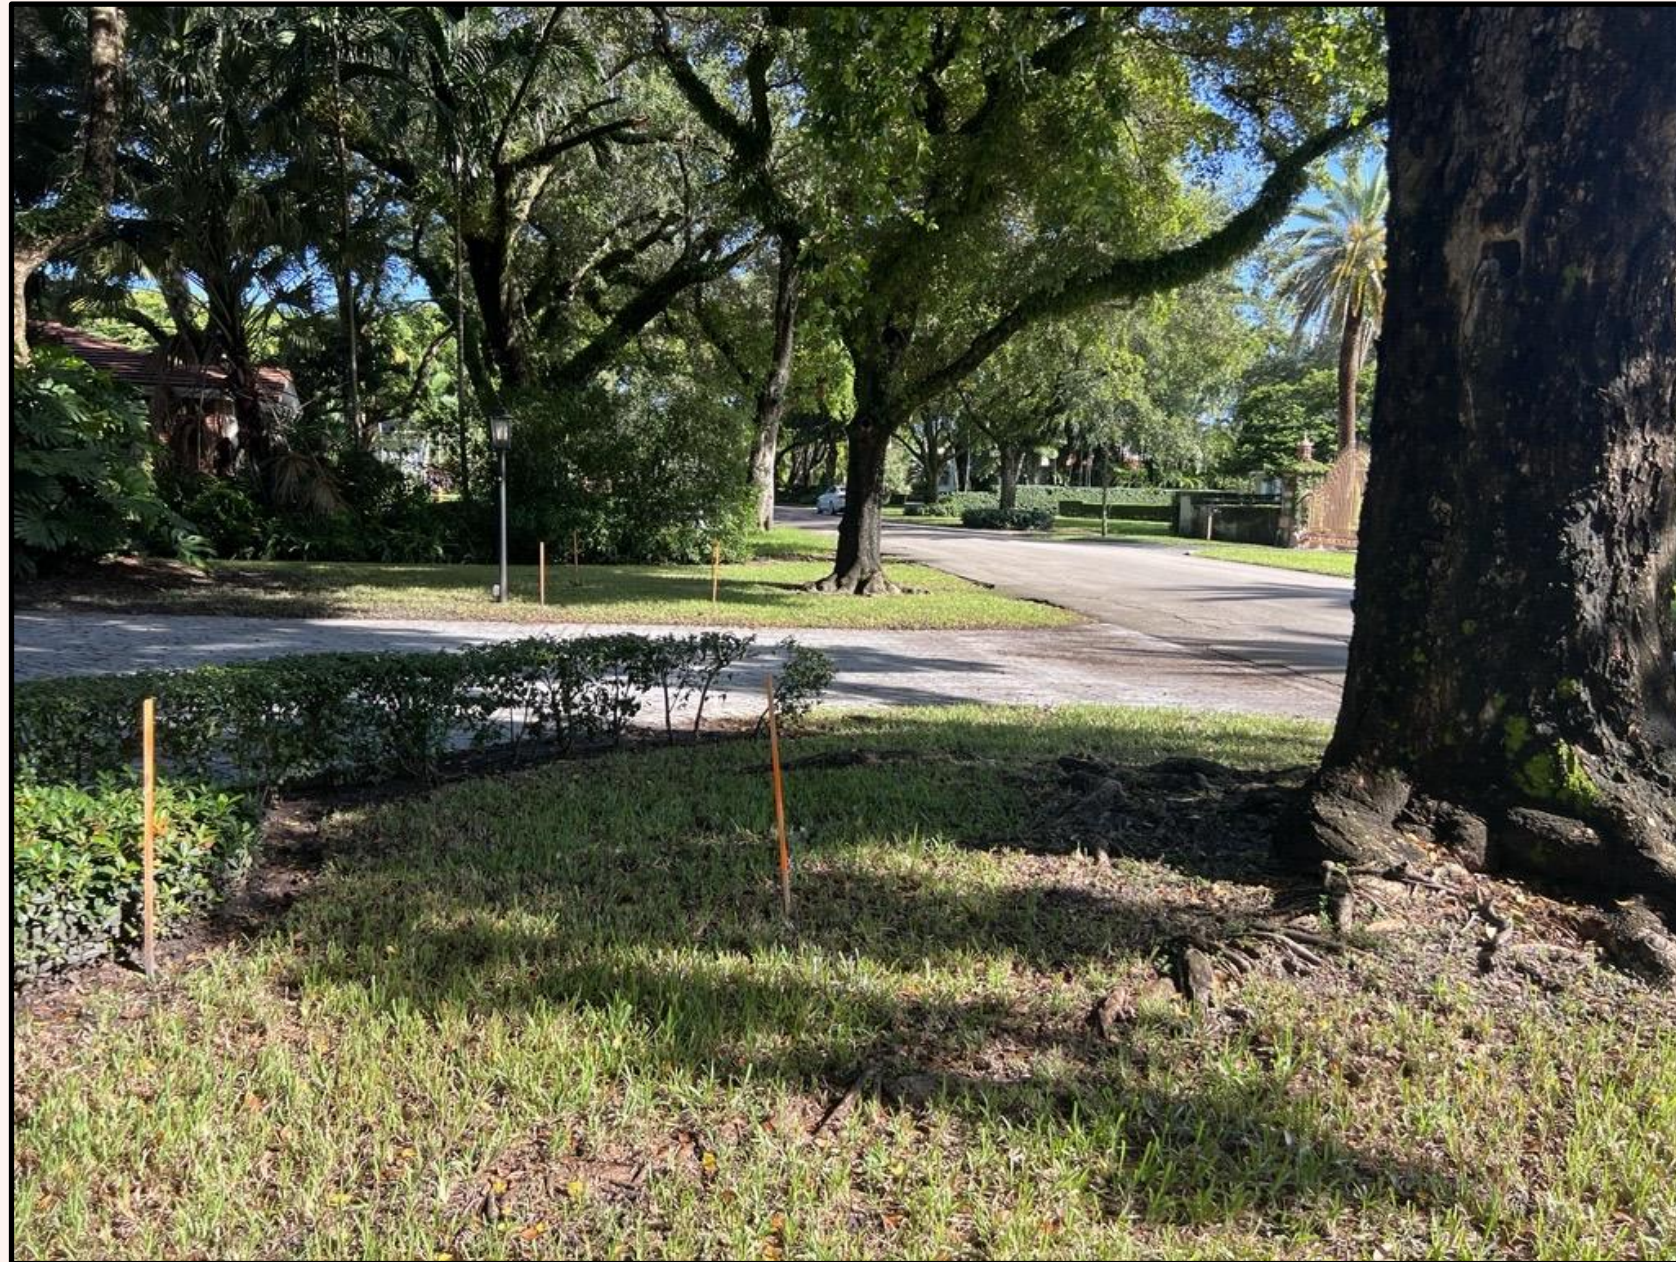
TREE NO. 14

Tree Details:

- Black Olive (Specimen)
- Fair Condition
- 37-inch diameter
- 40-foot RPZ
- 25% sidewalk (6') impact in RPZ
- 22% sidewalk (5') impact in RPZ

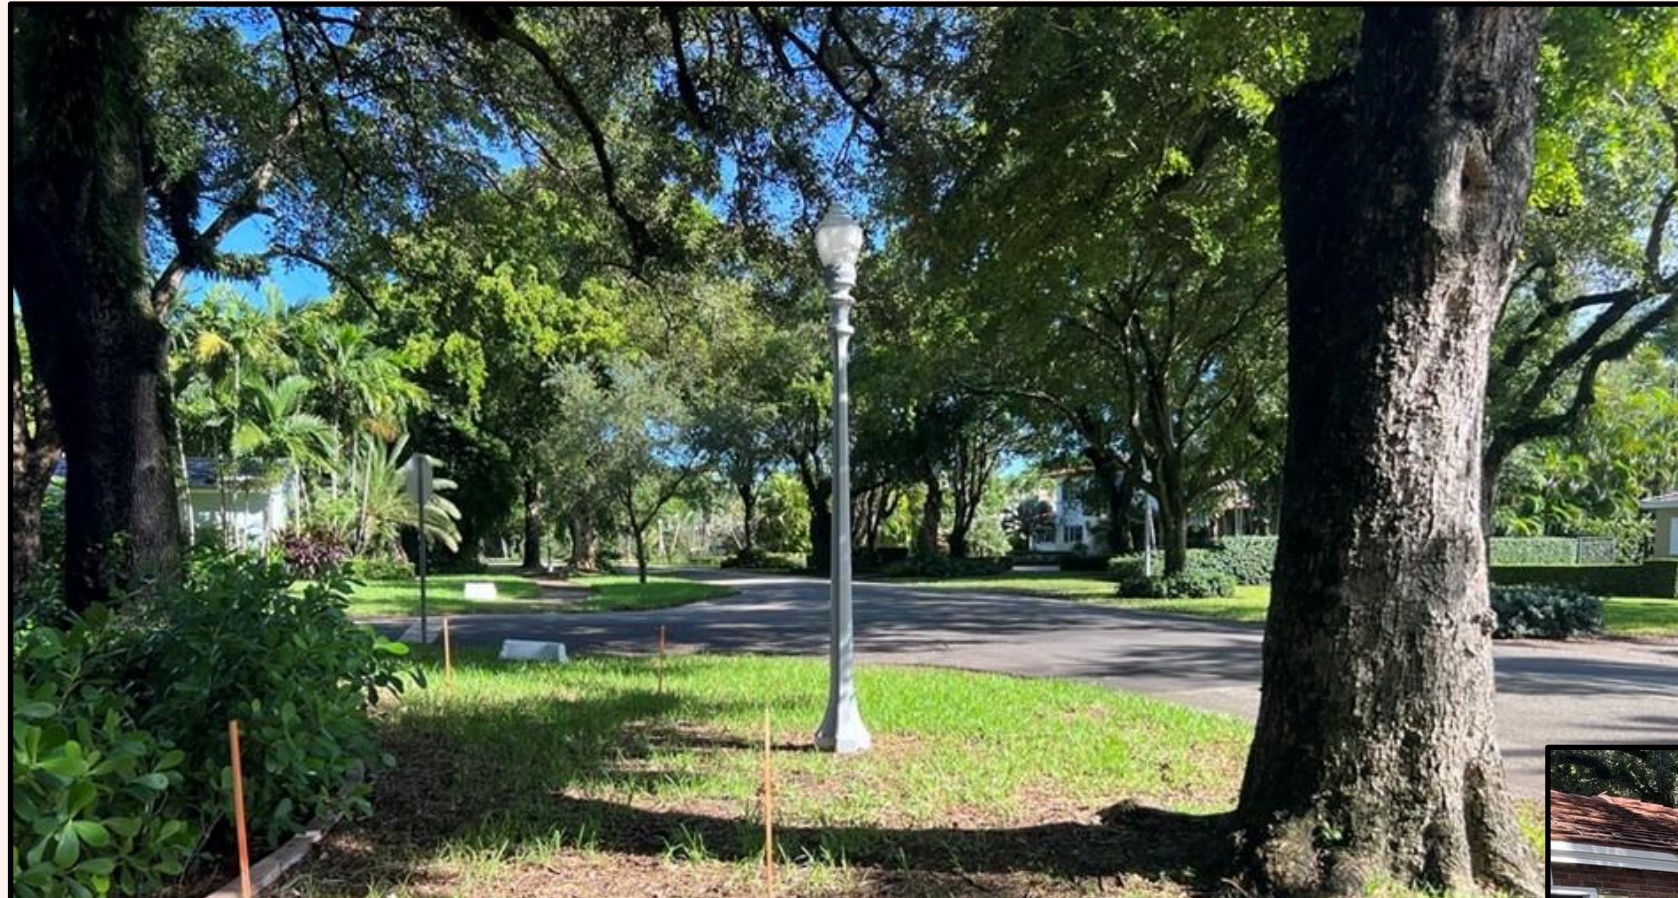
TREE NO. 16

Tree Details:

- Black Olive (Specimen)
- Poor Condition
- 30-inch diameter
- 33-foot RPZ
- 48% sidewalk (6') impact in RPZ
- Recommend removal and offsetting sidewalk
