# GURRIMATUTE

## RE: Certificate of Appropriateness Application

**Project name:** City of Coral gables Gondola Building Reconstruction

**Project Address:** 1200 Anastasia Ave, Coral Gables, FL 33134

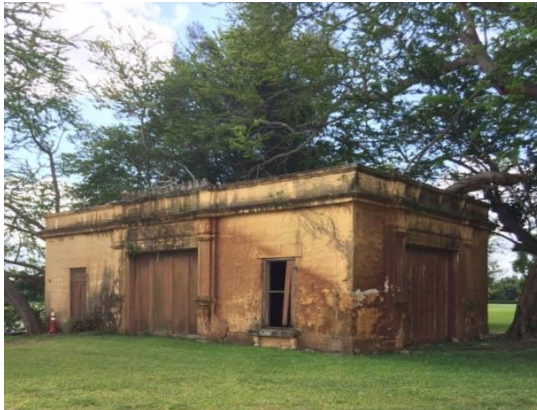
*Gondola Building  
- north facade (2017)*

On the exterior of the Gondola building, all openings will match the original sizes and locations of the now demolished building. Furthermore, the character defining masonry features of the original facades (i.e. decorative parapet, urns, engaged columns, etc.), as well as the wall finish and color will be replicated to match the original structure as closely as possible. The interior of the gondola will also replicate its original interior finish with painted exposed CMU block structure, exterior-graded wood beams, and sealed concrete flooring. All exterior and interior paint colors will be matched to the existing colors after the paint analysis has been completed by the retained conservator.

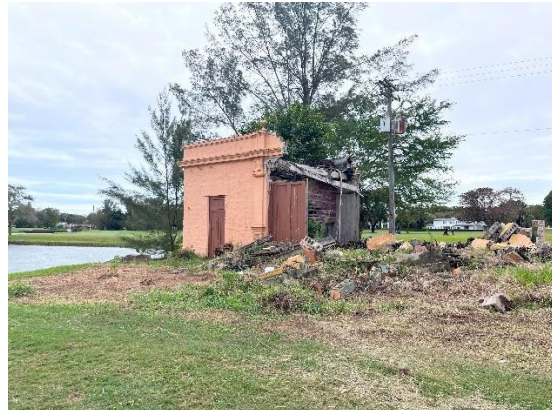
*Current conditions- Gondola Building  
-north facade (2024)*

The original Gondola Building at 1200 Anastasia Avenue is part of the Biltmore Hotel which was designated in 1985 as a historic landmark by the City of Coral Gables Department of Planning. It is believed to have been built approximately in the 1930s. To our knowledge, there are no construction documents or any other legal documents on file with the City of Coral Gables specific to the Gondola Building. The original building was used to store a fleet of gondolas. In 2021, the building collapsed almost entirely and needs a full reconstruction. Therefore, this project seeks to rebuild a replica of the Gondola Building in the same location and with the same design and materials as closely as possible while still meeting the Florida Building Code.
