RE: 343 ALMERIA AVE, CORAL GABLES, FL
FOLIO # 341170052270
Recertification of Building 40 Years or Older

**NOTICE OF UNSAFE STRUCTURE VIOLATION FOR FAILURE TO RECERTIFY
AND NOTICE OF HEARING**

1. DESCRIPTION OF STRUCTURE

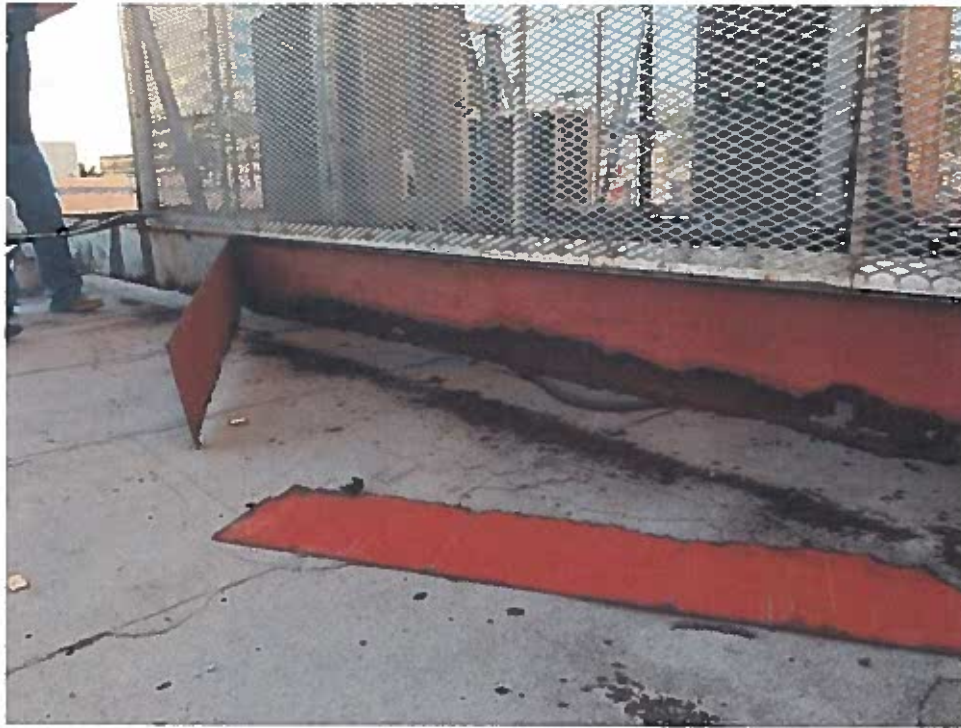
Since the bottom flange of both beams are deteriorated due to corrosion, see attached photographs

e. General extent of deterioration – cracking or spalling of concrete or masonry, oxidation of metals; rot or borer attack in wood.
No concrete or masonry spalls, but main steel beams at roof for A/C units support with sever rusty
f. Previous patching or repairs
Not shown
g. Nature of present loading indicate residential, commercial, other estimate magnitude.
Commercial- Liberal, office

Bottom flange of Steel beam totally corroded

Addition Comments: At roof, main steel beams for support of the A/C units, and enclosure need to be replace

2. Note water tanks, cooling towers, air conditioning equipment, signs, other heavy equipment and condition of support:
No water tanks, no cooling towers, main steel beams that support the A/C units and the aluminum enclosure in bad conditions needs to be replace as per drawings attached, contractor will submit drawings for permit

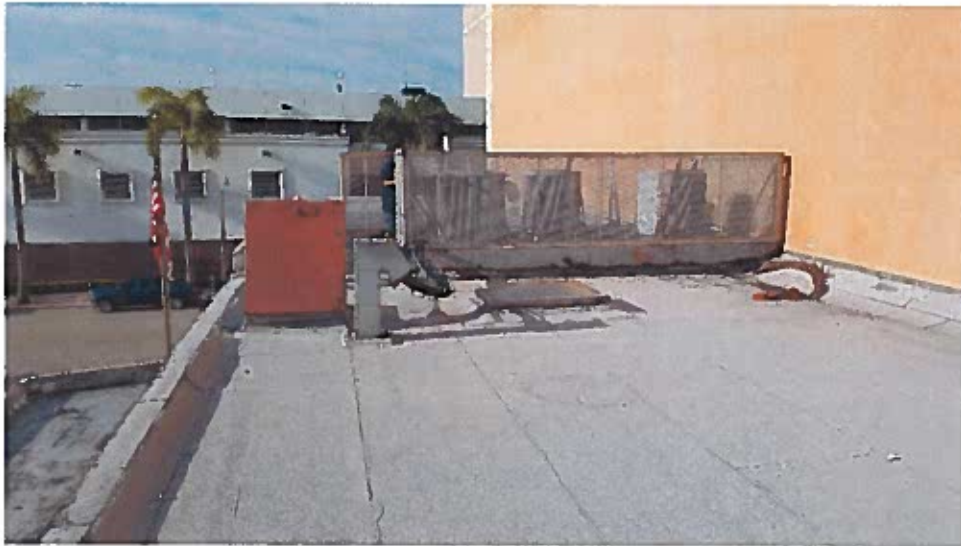
Another view of the rusty steel beam, both beams needs to be replace
