**REPORT OF THE CITY OF CORAL GABLES
HISTORICAL RESOURCES & CULTURAL ARTS DEPARTMENT
TO THE HISTORIC PRESERVATION BOARD
ON THE DESIGNATION OF
THE PROPERTY AT
3701 DURANGO STREET
CORAL GABLES, FLORIDA
AS A LOCAL HISTORIC LANDMARK AND
SPECIAL CERTIFICATE OF APPROPRIATENESS
FOR ALTERATIONS AND ADDITIONS TO THE PROPERTY**

**LOCAL HISTORIC DESIGNATION and
SPECIAL CERTIFICATE OF APPROPRIATENESS FOR ALTERATIONS
to the property at
3701 DURANGO STREET
CORAL GABLES, FLORIDA**

LOCAL HISTORIC DESIGNATION REPORT – LHD 2018-005

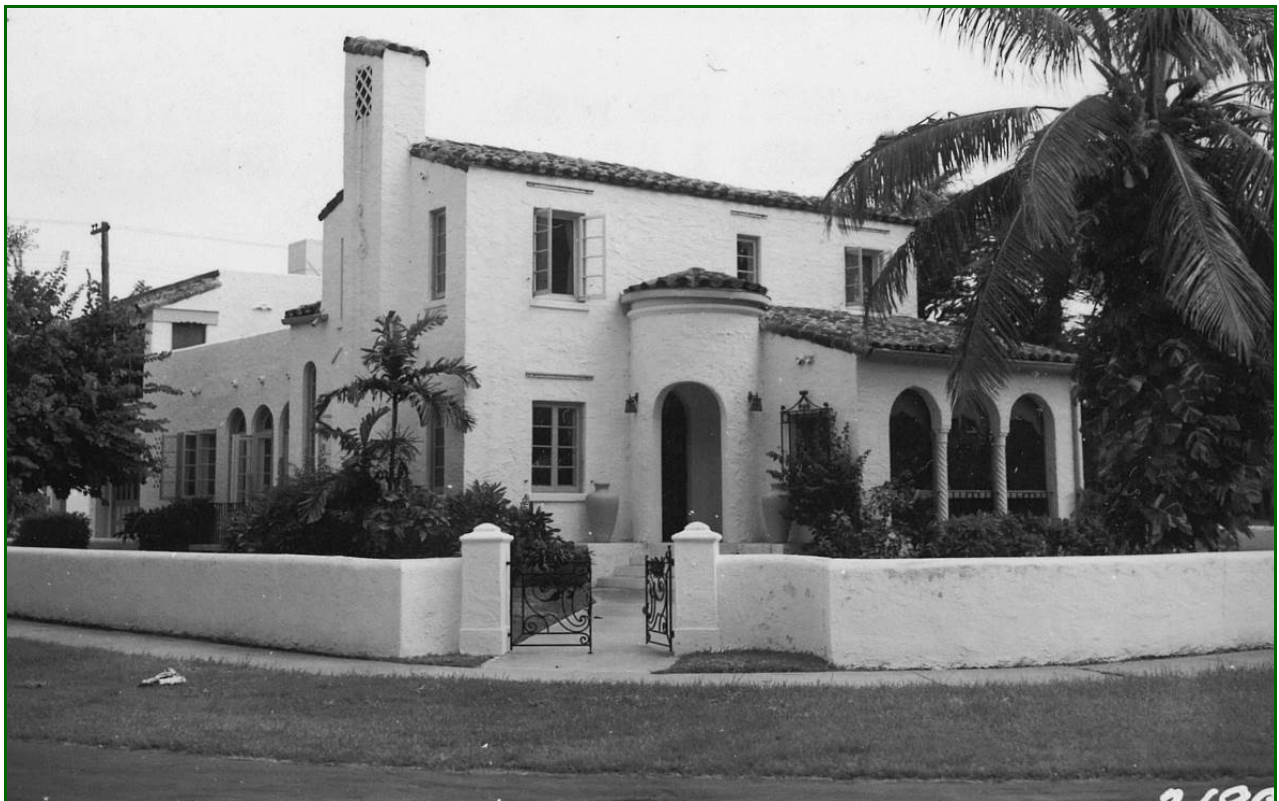
Figure 1: 3701 Durango Street, Front Facades, looking southeast, c. 1940

This two-story, single-family residence was originally designed as three-bedroom home with an attached two-story, two-car garage and apartment. It sits on an approximately 110' x 105' corner lot and is surrounded by a low perimeter wall. The home includes many prominent and defining features of the Mediterranean Revival style such as projecting and recessed planes, rectilinear massing and floor plan, a distinctive round tower entry feature, a projecting screened porch (now enclosed), a series of arched openings, roofs of varying heights and types, two-piece barrel tile, textured stucco, a prominent chimney, decorative masonry screens and vents, as well as deeply recessed casements of various shapes and sizes.

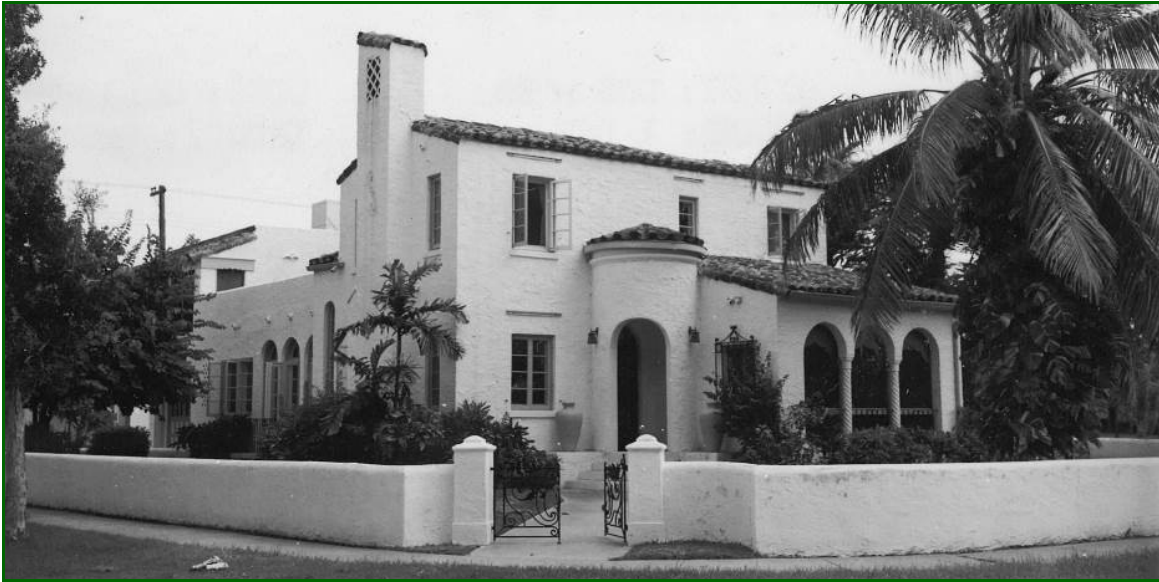
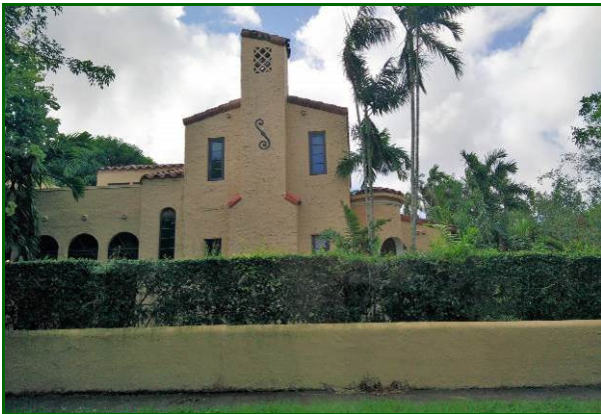
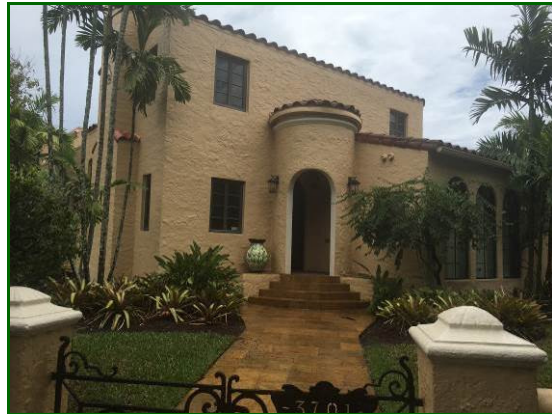
Figures 7: 3701 Durango Street, Street-facing Facades
Historic Photo, looking southeast, c.1940 [top]
North Façade along Roderigo Avenue, 2018 [bottom left]
West Façade along Durango Street, 2018 [bottom right]

Permitted in 1925, the single-family residence at 3701 Durango Street is significant as a classic example of an early single family home in Coral Gables built in the Mediterranean Revival style. It was designed by architect, H. George Fink. He was one of the most well-known and prolific architects in Coral Gables and a prominent member of George Merrick's original design team. Fink was instrumental in creating the fabric of 1920s Mediterranean Revival architecture and his designs aided in the fulfillment of George Merrick's vision for a community designed in the Mediterranean theme. This home retains its integrity and is significant as an example of Fink's work during the City's initial building campaign.

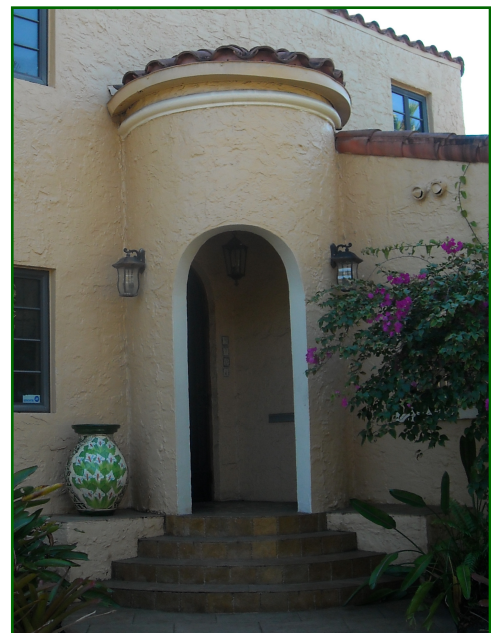
Figure 8: Front Entry Tower, 2018

- ✓ projecting bays which include a one-story round entry tower
- ✓ roofs of varying heights and types
- ✓ rectilinear massing and floor plan
- ✓ distinctive round tower entry feature
- ✓ a projecting screened porch (now enclosed)
- ✓ a small shelf balcony and a second story loggia
- ✓ a series of arched openings
- ✓ two-piece barrel tile
- ✓ textured stucco
- ✓ a prominent chimney
- ✓ decorative masonry screens and vents
- ✓ curved front door
- ✓ applied decorative detailing such as face boards and moldings, grouped round vents, ornamental metalwork
- ✓ deeply recessed casement windows of various shapes and sizes

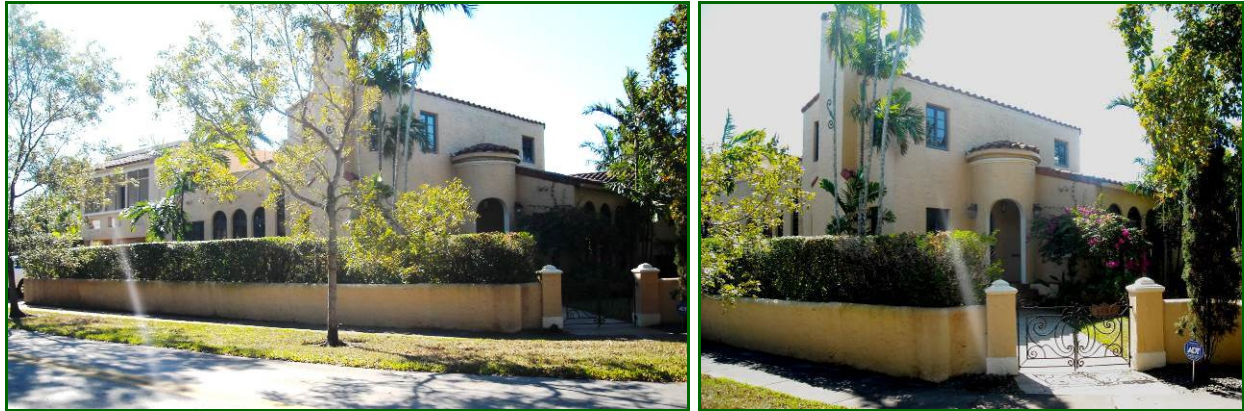
Figures 9: 3701 Durango Street, Durango Street and Roderigo Avenue, Looking Southeast, Front (west) and Side (north) Facades, 2018

The two-story rough-textured stuccoed single-family home sits on the southeast corner of Durango Street and Rodrigo Avenue on an approximately 100' x 105' lot. The front of the home faces onto Durango Street. A low masonry perimeter wall runs along the sidewalk of these two roads. The home and its attached two-car garage and apartment is, in plan, roughly 'C-shaped' with an open terrace feature at the center of the 'C'. (Figure 19) The portion of the home along Rodrigo Street is comprised of one and two story sections that were all constructed in 1925. Along Durango Street, the northern two-story portion dates to 1925 while southern one-story portions that wrap east along the south perimeter of the property are later additions. A rectangular pool with stone deck and walkway lies to the east of the residence.

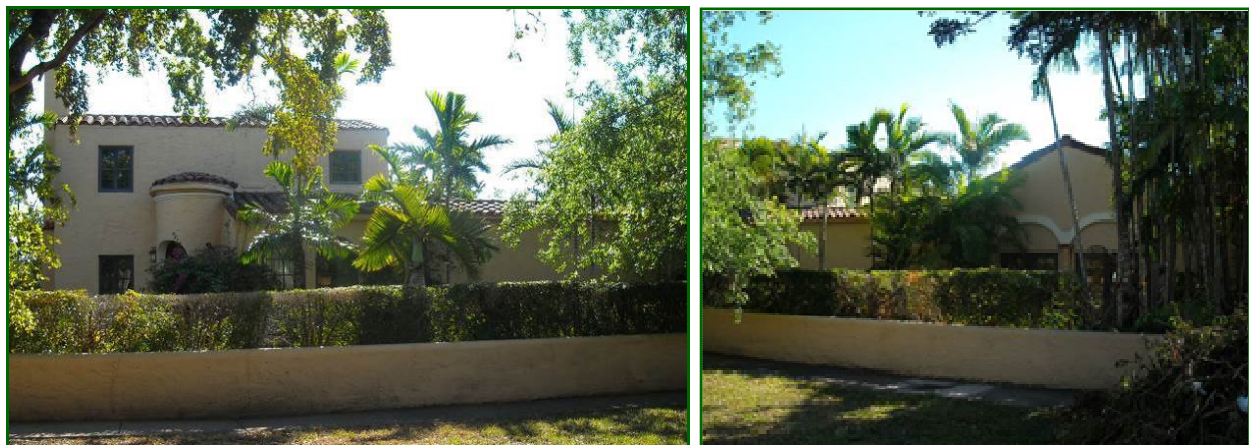
**Figures 10: Front (west) Facade, 2018:
Northern section (1925) [left]; Southern section (1982) [right]**

The front (west) façade is comprised of three distinct sections. The northern 1925 portion is two stories with a side-facing gable and includes a two projecting one-story elements: a round entry tower (described above) and a shed-roofed bay. The entry tower abuts the projecting bay at its northeast corner. Three semi-circular arched full-height openings, matching the arched opening on the entry tower, are centered on the front (west) façade of what was originally a screened porch. Decorative rafter tails are extant but presently obscured by a gutter. On the north (side) façade of the bay is square window with one of the few extant original sills. Above the window is a pair of decorative round vents.

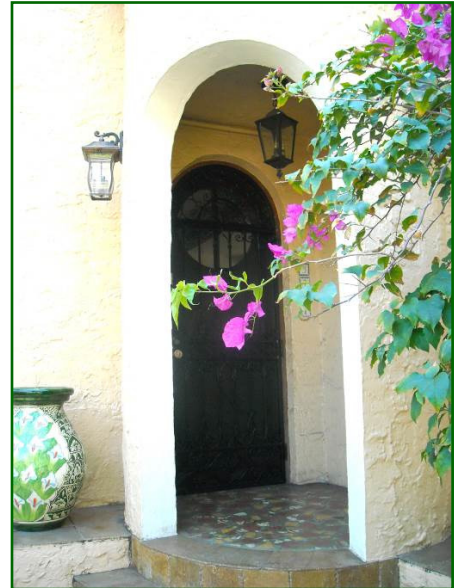
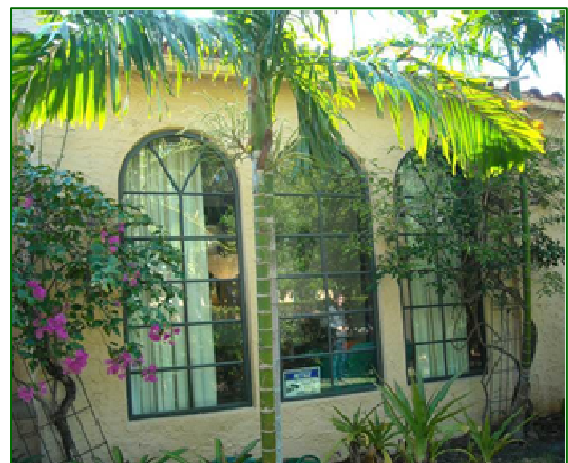
Figures 11: West Façade, 2018
Front entry tower and original door [top]

Entry tower and north wall of projecting porch bay
Note extant sill and decorative rafter tails below
gutter [center]

Porch bay, west wall, arched openings now enclosed
[bottom]

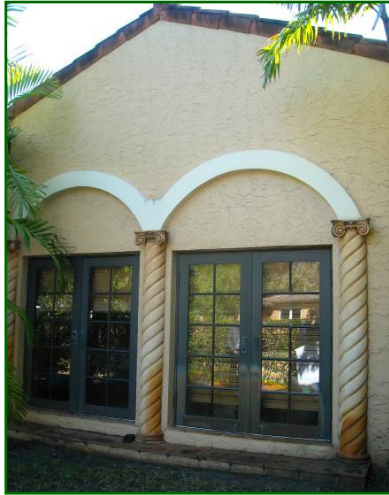
**Figure 12: Front (West) Façade, 2018
Southern Section (1982)**

The central and southern sections of the front (west) façade were added in 1982. Both are rough-stuccoed with two-piece barrel tile roofs. The central section is a one-story gallery that connects the original home to the master bedroom (southern section). It is side-gabled whose roofline seamlessly extends along the same pitch as the shed roof of the adjacent projecting bay described above. This façade, which is flush with the adjacent bay, has no openings. The southern master bedroom section has a broad, front-facing gable roof. Two pairs of French doors are placed between three twisted columns. Two raised-stucco arches spring from the Ionic column capitals.

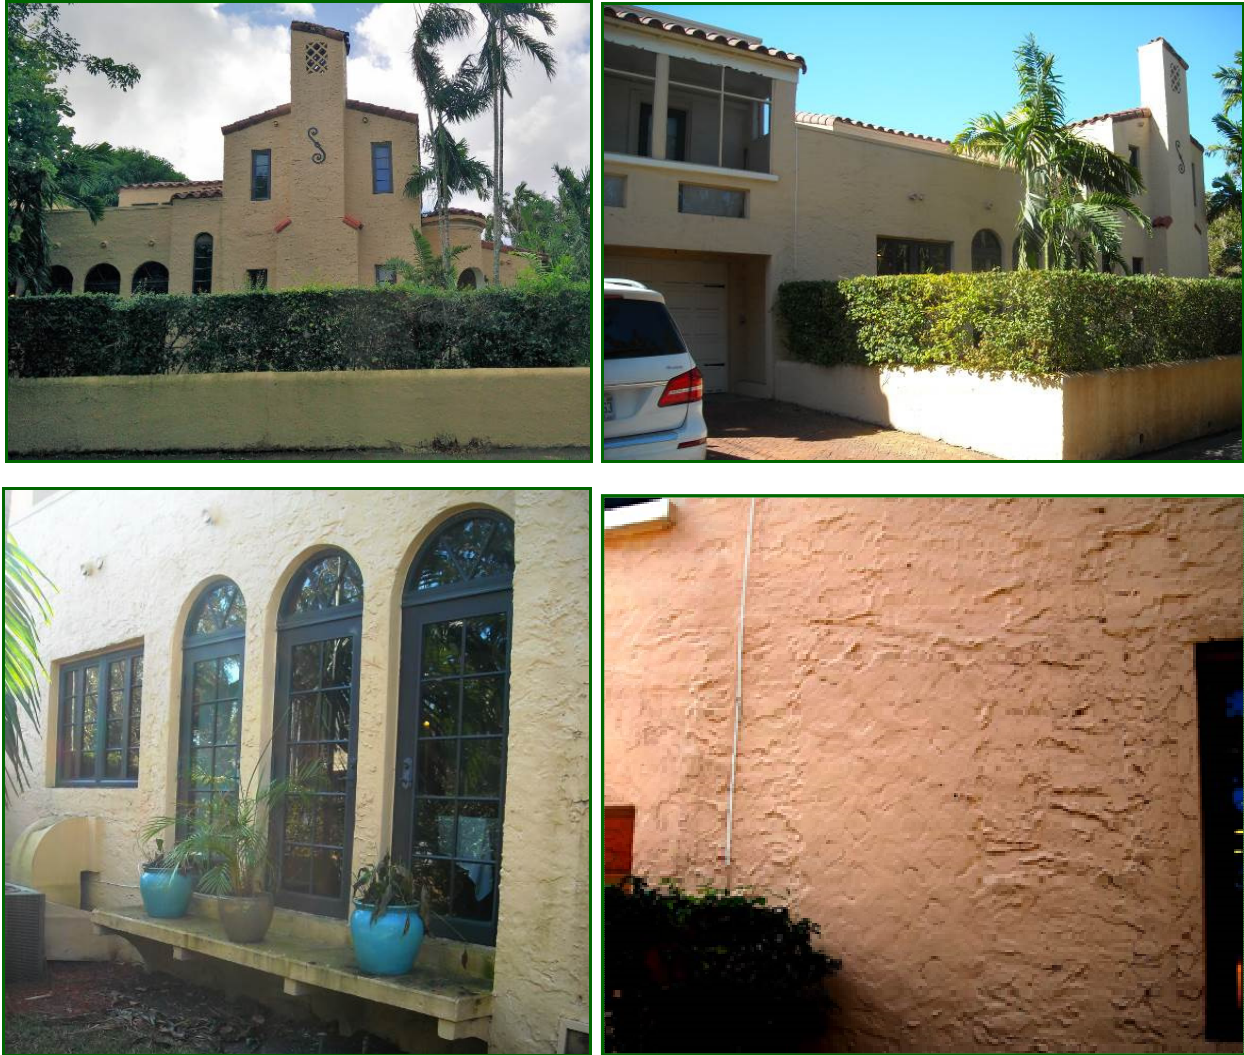
Figures 14: Side (North) Façade, 2018
Western portion [top left]; Looking southwest [top right]
Narrow cantilevered balcony [bottom left]; Filled in masonry grille [bottom right]

The central section of the north façade has a three arched openings each housing a pair of French doors with a fanlight above that lead onto a narrow cantilevered concrete balcony. Centered above each arch is a round vent. Adjacent to this ensemble is a large window formed by two pairs of double casements with a pair of round vents above. The original plans indicate this ensemble looked out from the breakfast room. Between the breakfast room and the attached garage the original plans indicate there was formerly a back porch area. This area has since been enclosed. On the façade the filled-in remnants of a masonry grille opening to the former porch is visible in the stucco. The original plans show a cast masonry grille in a block pattern however the remnant pattern matches the diamond-hatch pattern chimney stack. (Figures 13 & 14)

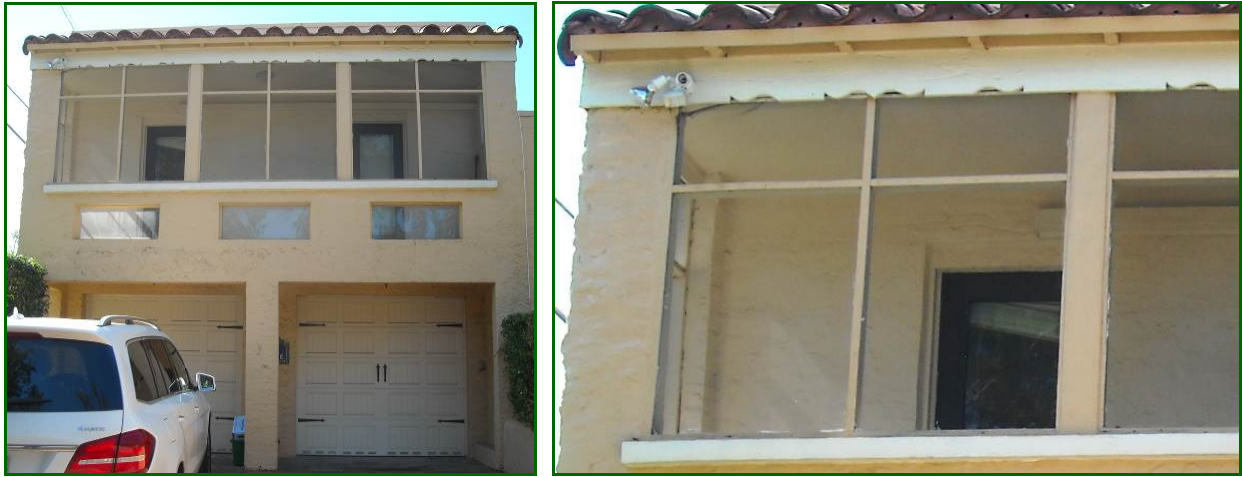
Figure 15: Side (North) Façade, Eastern section, 2018
Two-story Garage and Apartment Loggia
Loggia northeast corner detail

Note: carved rafter tails, decorative face board

The eastern section of the side (north) façade along Rodrigo Avenue is comprised of a two-car garage and a second story apartment under a flat roof. The garage doors have a carriage door appearance and are set back under a projecting loggia on the second story. The loggia is covered by a two-piece barrel tile shed roof. The ends of the loggia's rafters are decoratively carved. Under the rafters is a cypress face board whose bottom edge has repeating carved motif. The face board wraps around the loggia's corner of the east façade. (Figures 15 & 16) The north façade of the loggia encompasses three large square openings (approximately 5'-6"); the three openings read as one unit as they are joined by one long protruding sill. Each square opening is divided into four rectangular sections (2 small on top; 2 large on bottom) by thin flat muntins. Originally screened, they are now enclosed by fixed full-view glass windows. Centered below each of these large square openings is a smaller rectangular opening, now enclosed by Plexiglas, which as per the original permit once held cast masonry screens. (Figures 13 & 15)

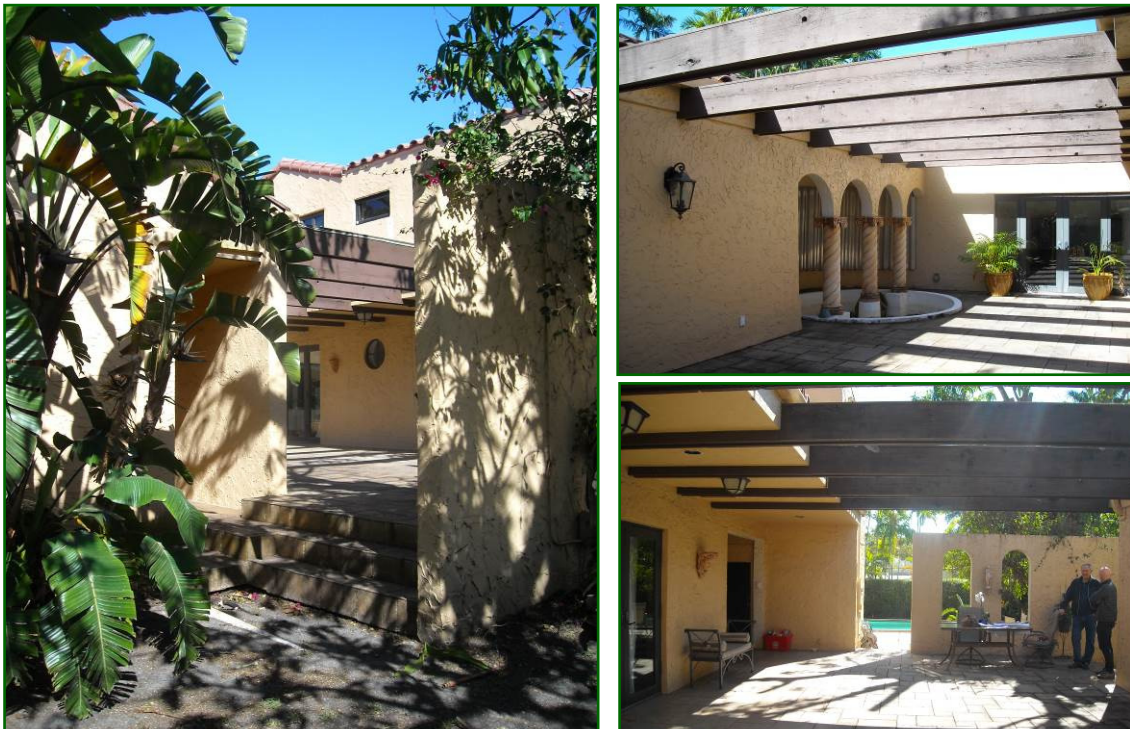
The home is roughly C-shaped in plan with an open terrace feature at the interior of the “C”. The terrace feature is bounded on the north side by the two-story section of the original home and on the west and south by the one-story gallery and master bedroom additions respectively. A free-standing one-story wall with arched openings spans a portion of the east end and gives this terrace feature a courtyard-like feel. Large beaded-edged wooden members form an oversized ‘trellis-like’ feature in this space. The wooden beams run north-south and connecting the two-story original structure to the one-story master bedroom addition. A circular pool feature with three twisted columns supporting arches is at the southwest corner of the terrace feature.

Figures 18: Central Open Terrace, 2018
Looking northwest [left]; Looking southwest [top right]; Looking east [top left]

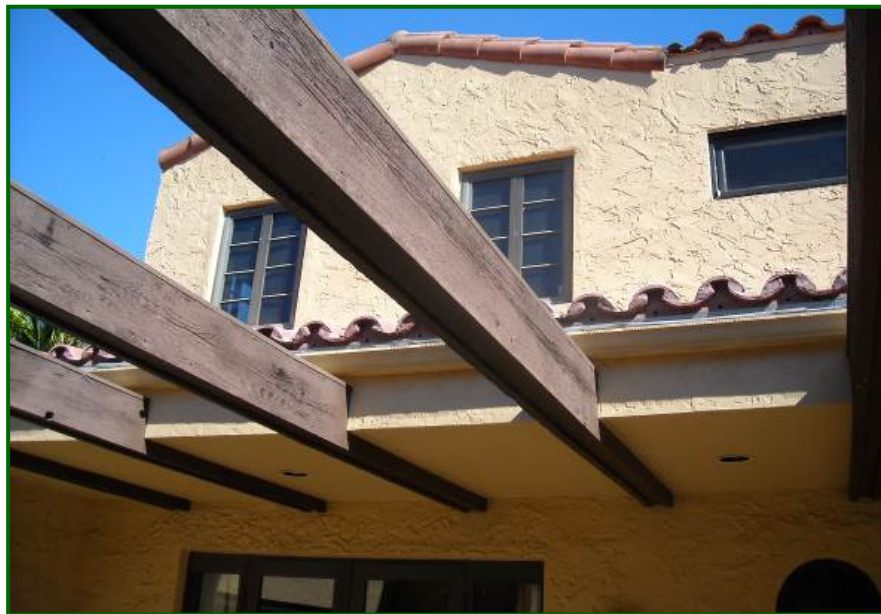
**Figure 20: South Façade,
Roof Ridge and Second Story
Wall Repair
Permit #33127, 1989 [top]
Current Photo, 2018 [bottom]**

*Note: differences in stucco texture – first story, original,
second story, repair
Note: 1977 ‘shed roof’ and terrace timbers in foreground*

In 1989 it was determined that the roof ridge needed to be replaced. (Permit #33127) During the repair the permit was revised to include the reconstruction of portions of the second story wall on the south façade. When rebuilt the three individual windows on the west end of the façade were replaced in-kind and the opening for the three windows on the east end of this façade was blocked up. It is clear from the change in stucco texture where the original wall remains and where the wall was rebuilt. A single casement window on the front (west) façade was also removed. It is not clear if that was also part of this permit or undertaken at another time. This window is present on the 1982 drawings by Arden Green Architect.

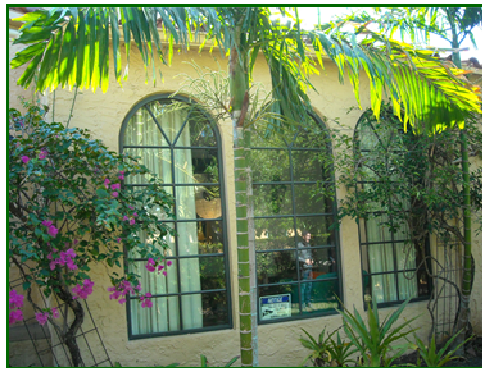
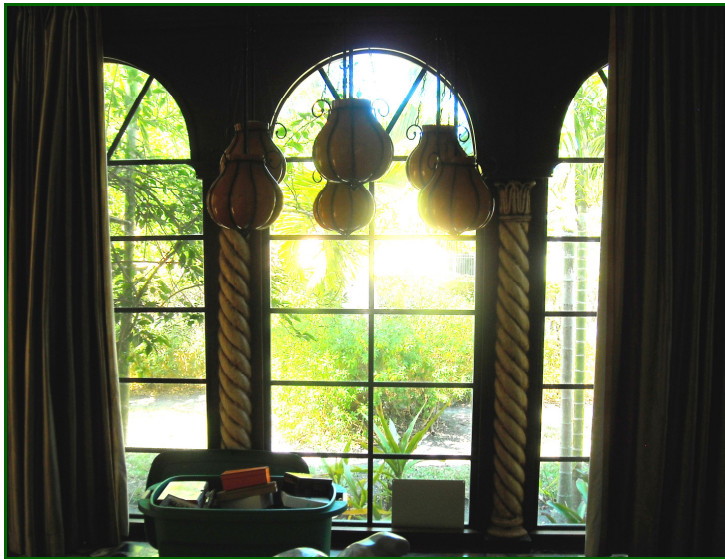
Figures 21: Twisted Columns, Enclosed Porch, Front Façade
Top: Permit #1749 Drawing, 1925 [left]; Current Condition, Exterior, 2018 [right]
Bottom: Current Condition, Interior, 2018: looking west [left]; looking south [left]
Note: Original porch random tile flooring; same flooring as entry tower

In 2004 thirty-one casement windows were replaced in-kind with impact-resistant windows. All of the original window sills are drawn on the plans. With the exception of one window on the original screened porch no sills are extant. The one window where the sill still remains was one of the few windows listed as existing to remain on this permit. It is likely that the sills were removed with the installation of these windows. It is also notable that the north elevation, the balcony railing, which is no longer extant, is drawn in the 1982 permit plans but is not depicted on these window plans. It is also likely that the front porch was first enclosed at this time and the twisted columns removed and/or encapsulated. Although the columns are no longer visible on the exterior of the home they still remain on the interior. (Figures 21) Ten doors, all French doors or sidelights, were also replaced at this time. In the 1982 addition plans it appears that the remaining first story windows on the south façade facing the terrace were still present. In 2004 with this door permit, no first story windows remain on this façade. At the center of this façade is a pair of French doors. It is not clear if this is a new installation with this permit or an existing door. Another pair of French doors is drawn on this permit in the previous location of the back door and its adjacent casement window. This pair of French doors is denoted as existing.

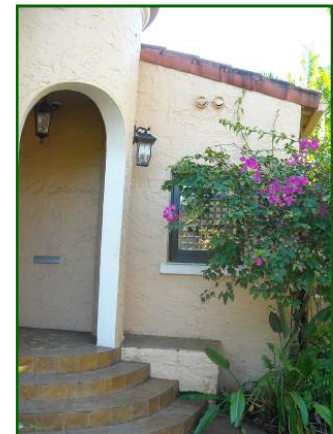
*Note: All re-instated historic sills are to
match this sill in size, shape and
texture*

Many of the original sills were removed from the 1925 portion of the home. This proposal seeks to re-instate these sills. The extant original sill on the west façade (north façade of original screened porch – See Figure 1) will be the model for the re-instated wills. All re-instated sills on the 1925 original facades are to match the size, shape and texture of this sill. Their locations are noted on the plans.
