CITY OF CORAL GABLES  
Historic Preservation Ad-Valorem Tax Exemption Program

**Part I: Preconstruction Application**

Address: 720 Madeira Avenue Coral Gables, FL 33134 (AKA 710 Obispo Avenue formerly)

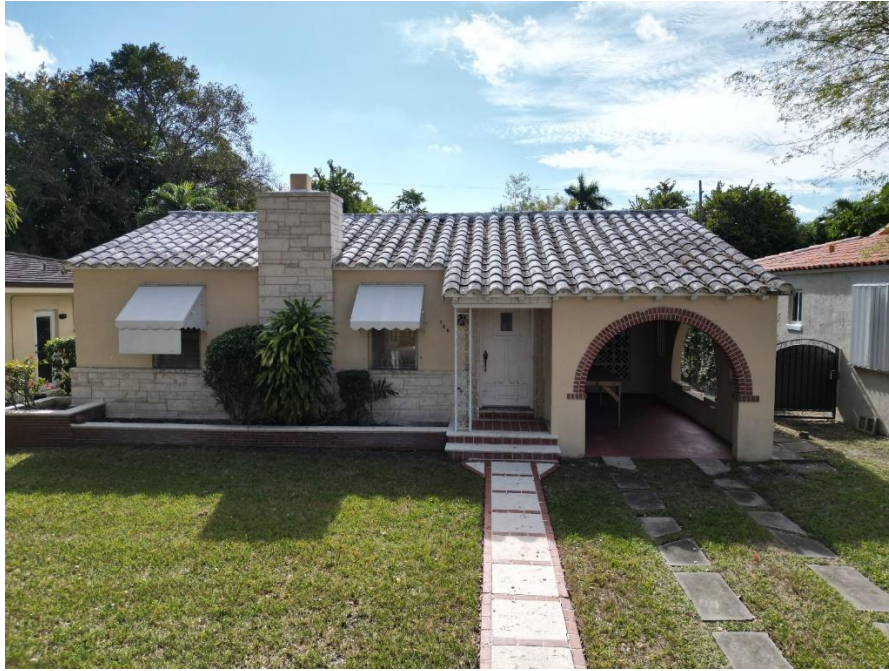
[before] Feature 1: Impact-Resistant Windows & Door Upgrades

Work and Impact on existing feature: The existing front elevation will undergo minimal modifications. New impact-resistant windows will be installed to match the original steel casement configuration. The non-original metal awnings will be removed, and the brick planter (not original) will be stuccoed to blend with the façade. A new wing wall with an aluminum pedestrian gate will be introduced on the east side.

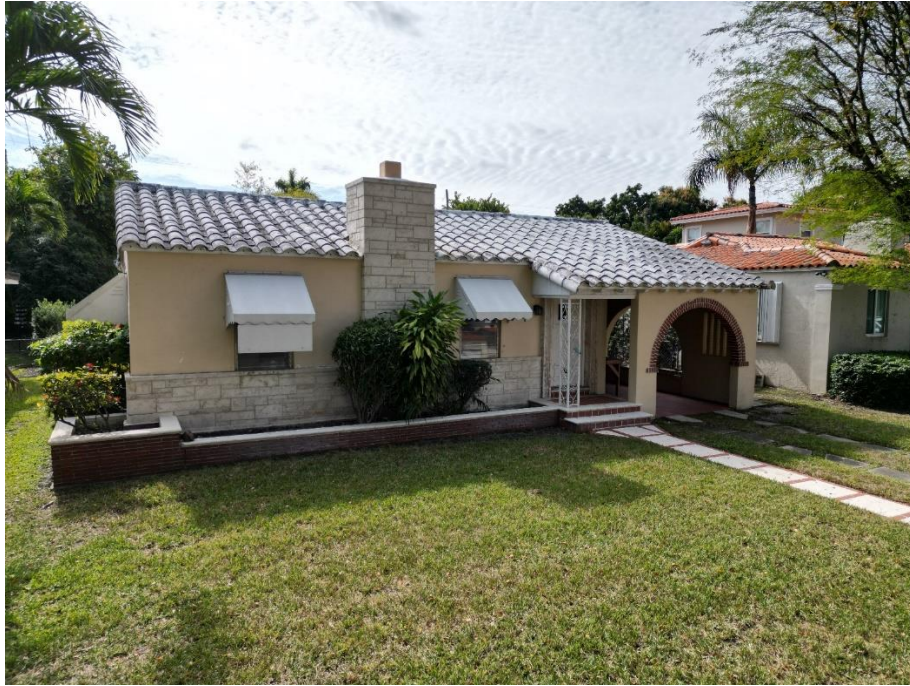
[before] Feature 2: Impact-Resistant Windows & Door Upgrades

Work and Impact on existing feature: The existing front elevation will undergo minimal modifications. New impact-resistant windows will be installed to match the original steel casement configuration. The non-original metal awnings will be removed, and the brick planter (not original) will be stuccoed to blend with the façade. A new wing wall with an aluminum pedestrian gate will be introduced on the east side.

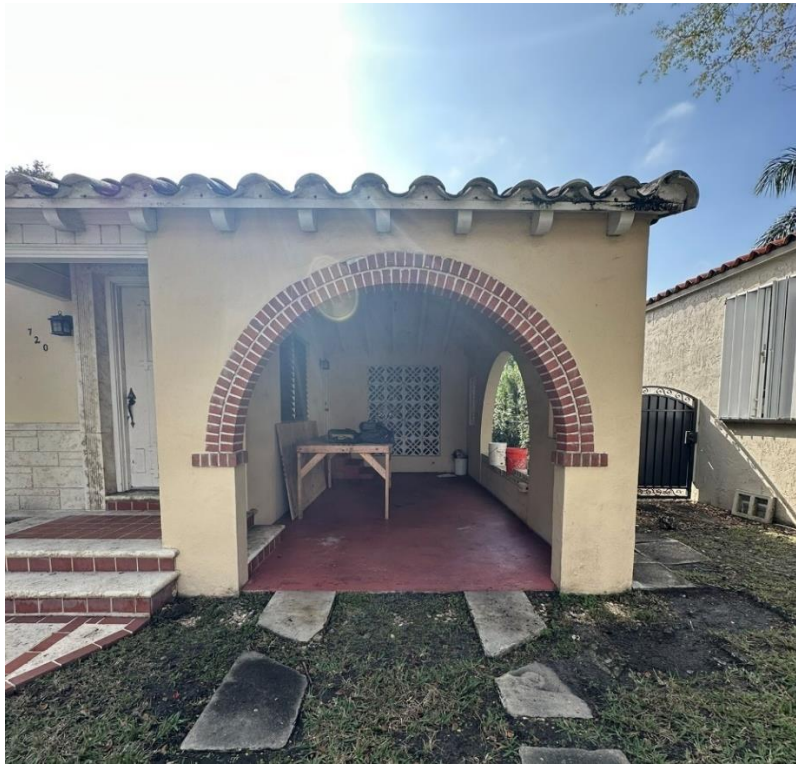
[before] Feature 3: Porte Cochere Restoration

Work and Impact on existing feature: The arched brick-framed porte cochere will be preserved and restored. The roof modifications made in 1963 will remain, maintaining the existing roofline and structural integrity.

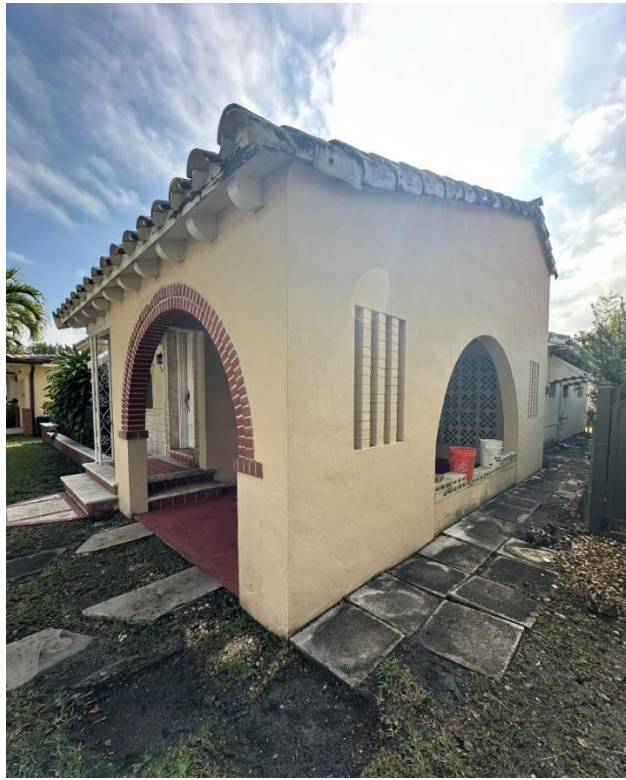
[before] Feature 4: Porte Cochere Restoration

Work and Impact on existing feature: The arched brick-framed porte cochere will be preserved and restored. The roof modifications made in 1963 will remain, maintaining the existing roofline and structural integrity.

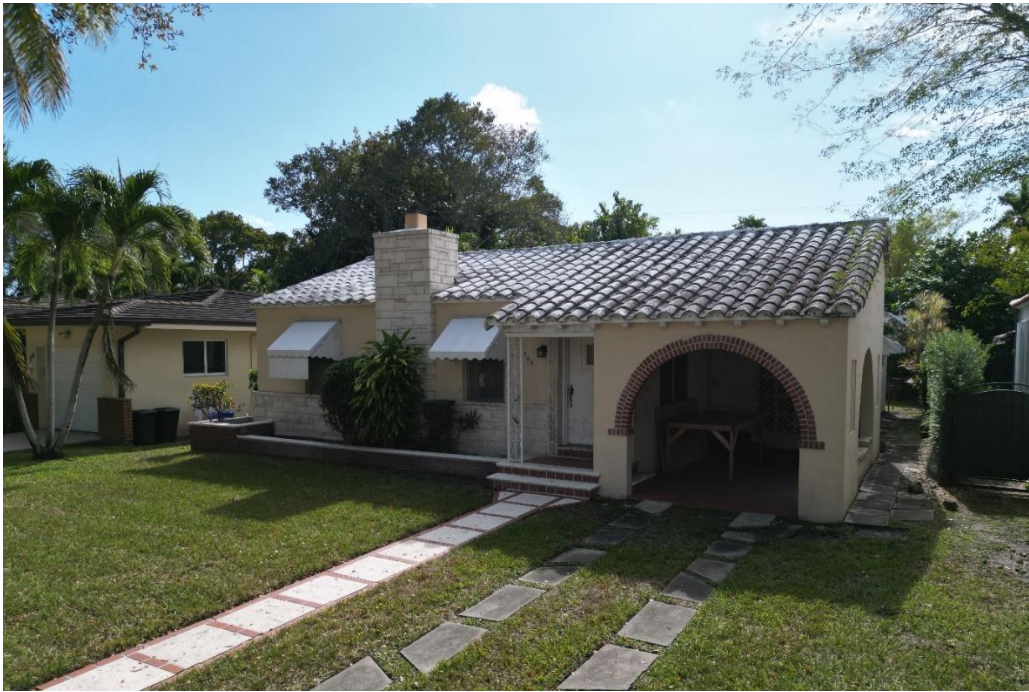
[before] Feature 5: Chimney Restoration

Work and Impact on existing feature: The semi-engaged chimney, a defining architectural feature, will be cleaned and repaired. The stone veneer added in 1957 will remain intact. No structural modifications will be made.

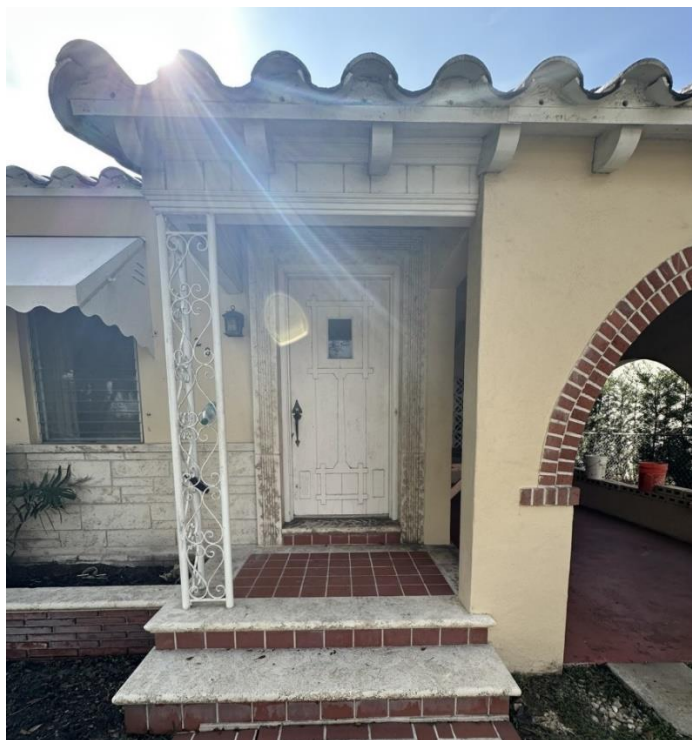
[before] Feature 6: Front Door Preservation

Work and Impact on existing feature: The original wood front door will be preserved and refinished as needed, ensuring retention of this historic feature.

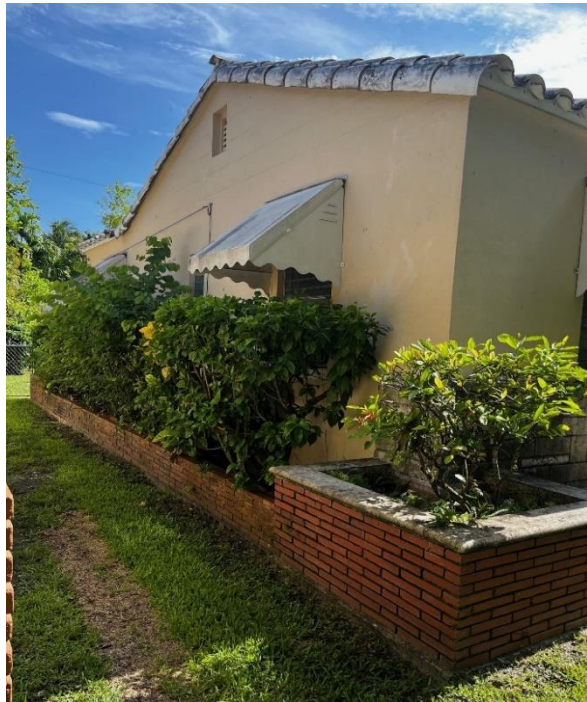
[before] Feature 7: Window Restoration & Planter Removal

Work and Impact on existing feature: All windows on the original residence will be replaced with impact-resistant systems that match the historic configuration, maintaining the existing openings and complying with Historic Preservation Board requirements. The non-original planter will be removed, except for a portion at the northeast corner.

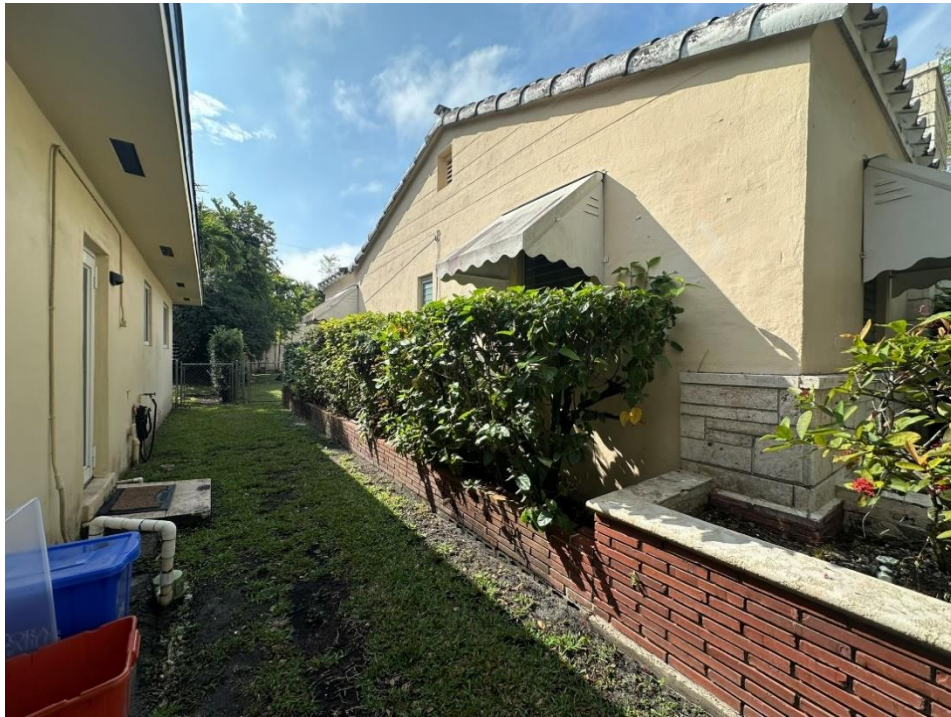
[before] Feature 8: Window Restoration & Planter Removal

Work and Impact on existing feature: All windows on the original residence will be replaced with impact-resistant systems that match the historic configuration, maintaining the existing openings and complying with Historic Preservation Board requirements. The non-original planter will be removed, except for a portion at the northeast corner

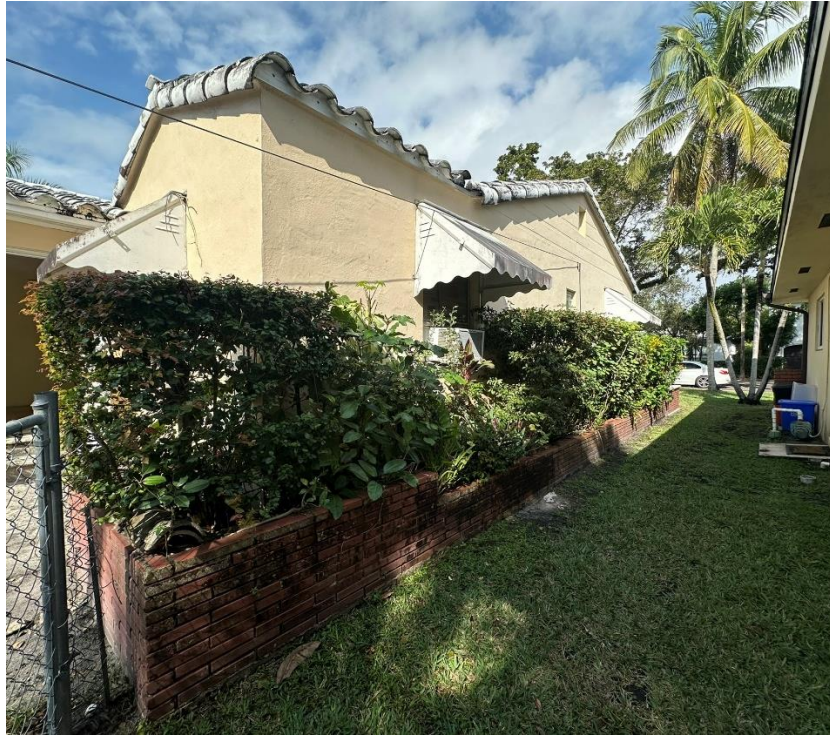
[before] Feature 9: Window Restoration & Planter Removal

Work and Impact on existing feature: All windows on the original residence will be replaced with impact-resistant systems that match the historic configuration, maintaining the existing openings and complying with Historic Preservation Board requirements. The non-original planter will be removed, except for a portion at the northeast corner.

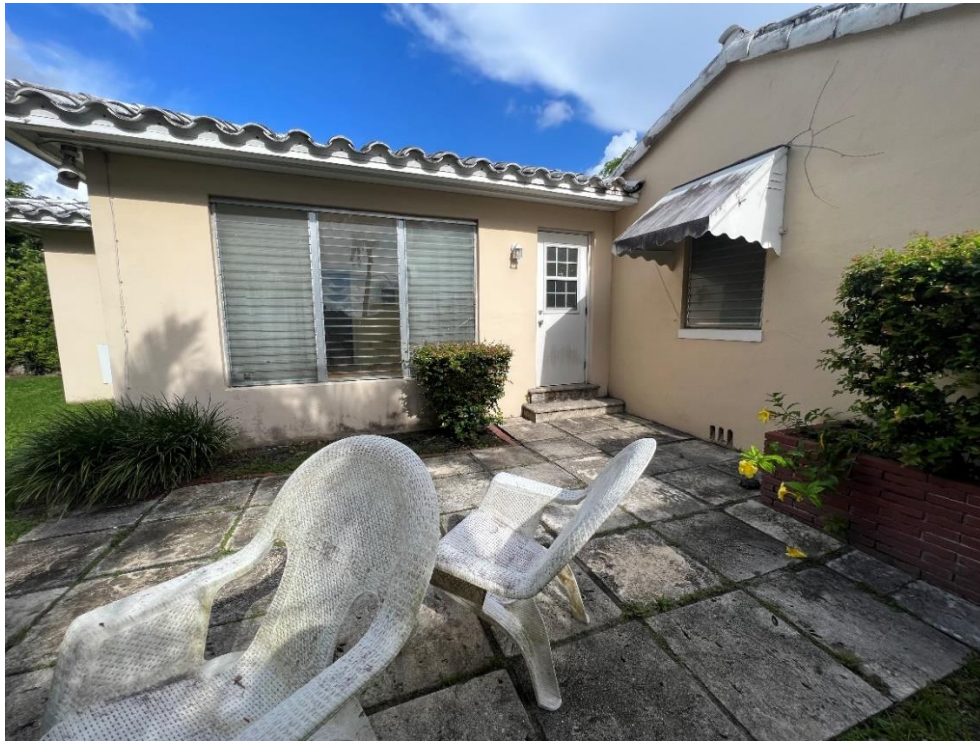
[before] Feature 10: Window Restoration

Work and Impact on existing feature: All windows and doors on the 1963 addition will be replaced, with impact-resistant systems that match the historic configuration, maintaining the existing openings and complying with Historic Preservation Board requirements.

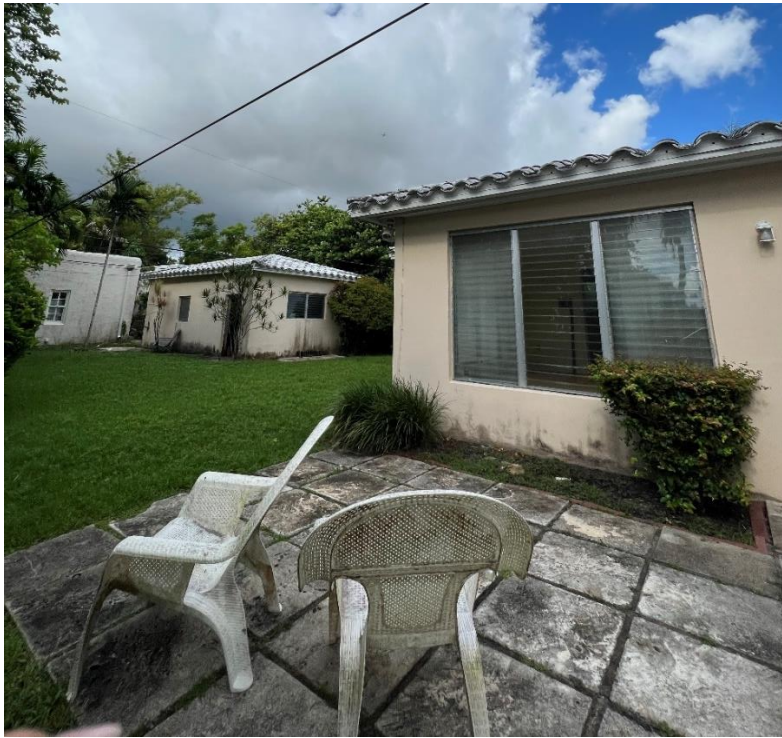
[before] Feature 11: Connector Addition & Auxiliary Structure Alterations

Work and Impact on existing feature: A new one-story connector addition will link the residence and auxiliary structure. It will feature a flat roof with decorative parapets, higher than the main house but not visible from the right-of-way. The auxiliary structure will have its existing door and window infilled, replaced with a large French door with sidelites.

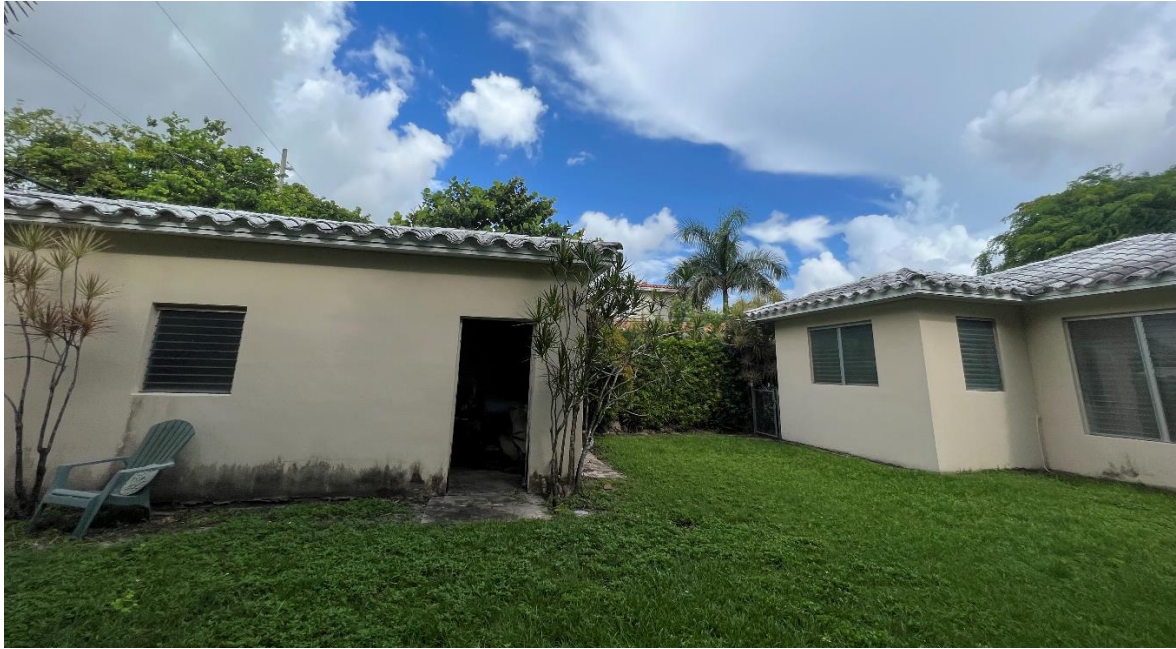
[before] Feature 12: Connector Addition & Auxiliary Structure Alterations

Work and Impact on existing feature: A new one-story connector addition will link the residence and auxiliary structure. It will feature a flat roof with decorative parapets, higher than the main house but not visible from the right-of-way. The auxiliary structure will have its existing door and window infilled, replaced with a large French door with sidelites.

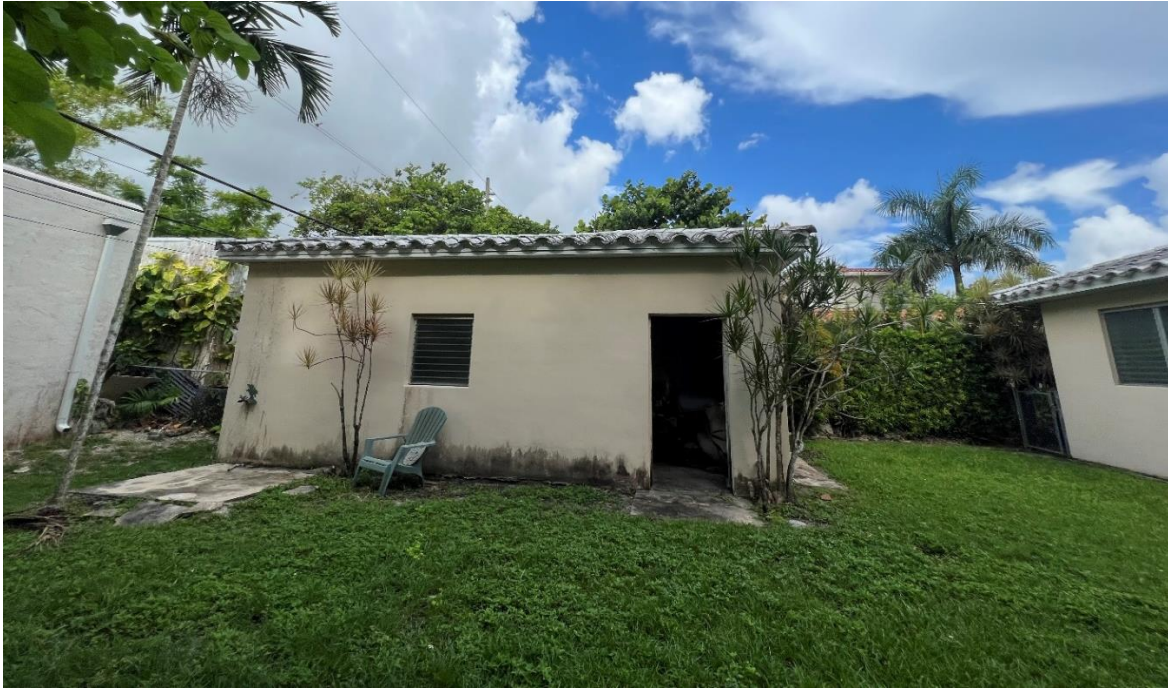
[before] Feature 13: Connector Addition & Auxiliary Structure Alterations

Work and Impact on existing feature: A new one-story connector addition will link the residence and auxiliary structure. It will feature a flat roof with decorative parapets, higher than the main house but not visible from the right-of-way. The auxiliary structure will have its existing door and window infilled, replaced with a large French door with sidelites.

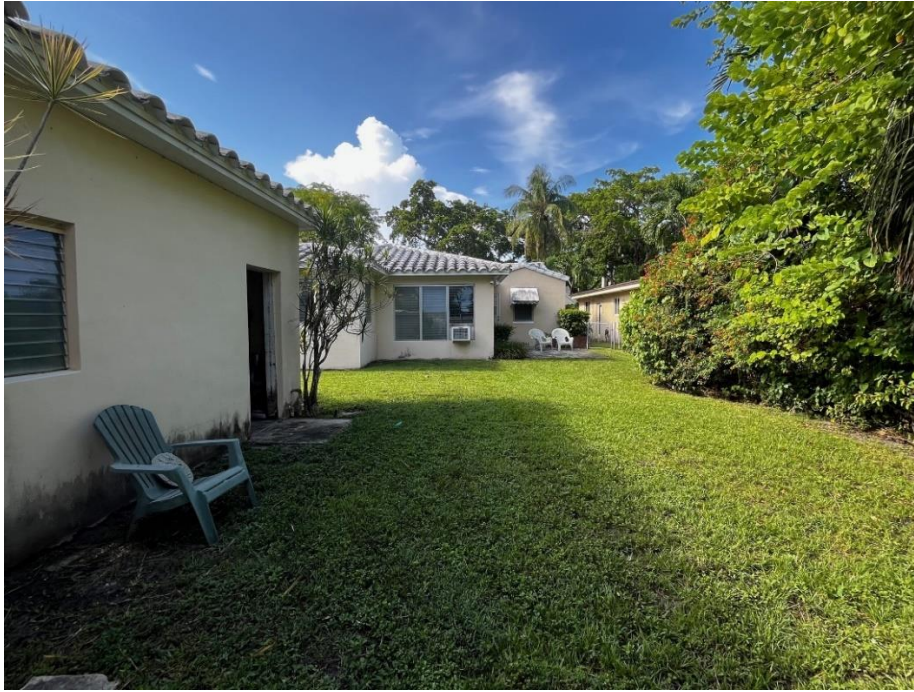
[before] Feature 14: Privacy Wall & Rear Façade Alterations

Work and Impact on existing feature: The rear elevation will be obscured by a new privacy wall, featuring an arched opening leading from the pool area to the rear yard. The center section of the wall will be 8'-6" high, with two lower 7'-10" walls flanking it. A window on the auxiliary structure will be resized to align with the new interior layout and designed to complement the historical elements of the home.

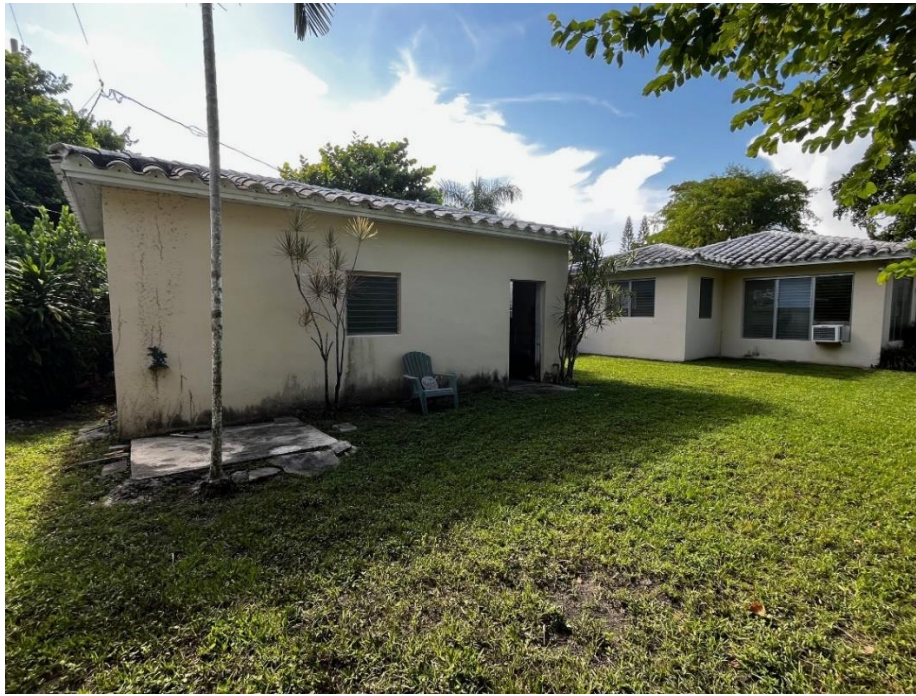
[before] Feature 15: Privacy Wall & Rear Façade Alterations

Work and Impact on existing feature: The rear elevation will be obscured by a new privacy wall, featuring an arched opening leading from the pool area to the rear yard. The center section of the wall will be 8'-6" high, with two lower 7'-10" walls flanking it. A window on the auxiliary structure will be resized to align with the new interior layout and designed to complement the historical elements of the home.

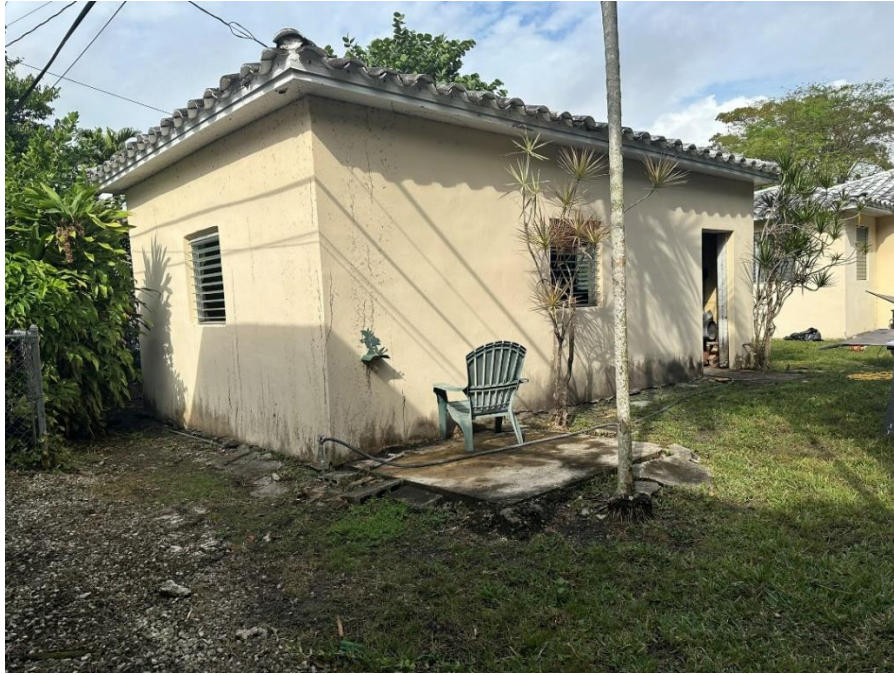
[before] Feature 16: Privacy Wall & Rear Façade Alterations

Work and Impact on existing feature: The rear elevation will be obscured by a new privacy wall, featuring an arched opening leading from the pool area to the rear yard. The center section of the wall will be 8'-6" high, with two lower 7'-10" walls flanking it. A window on the auxiliary structure will be resized to align with the new interior layout and designed to complement the historical elements of the home.

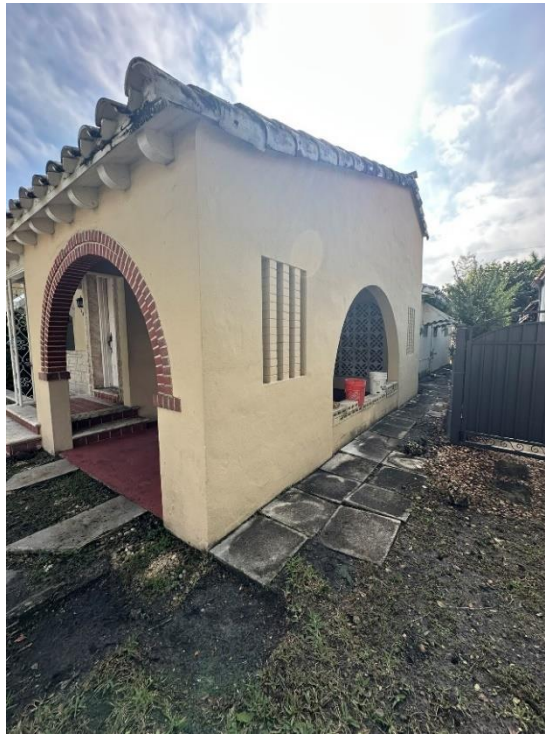
[before] Feature 17: Carport Modifications

Work and Impact on existing feature: The original door opening and steps into the carport will be removed, in alignment with the home's revised layout. A recess will be provided at the infilled door opening, per Historic Preservation Board requirements.

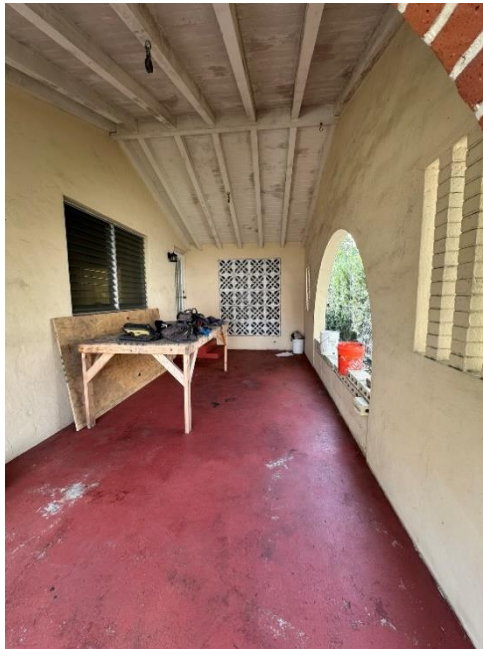
[before] Feature 18: Carport Modifications

Work and Impact on existing feature: The original door opening and steps into the carport will be removed, in alignment with the home's revised layout. A recess will be provided at the infilled door opening, per Historic Preservation Board requirements.

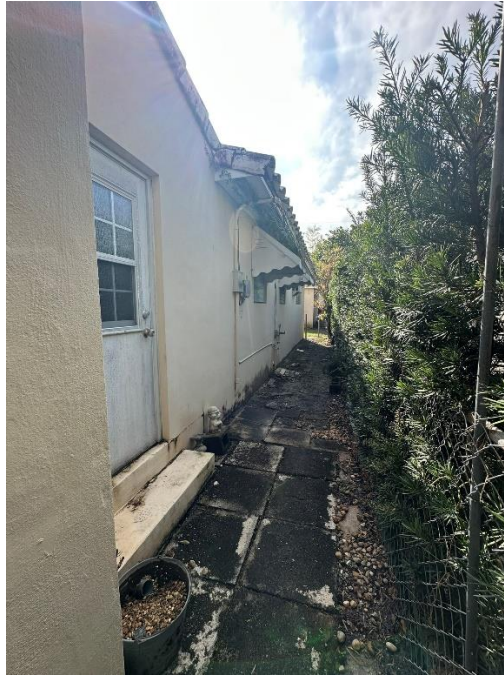
[before] Feature 20: Window & Door Modifications

Work and Impact on existing feature: The existing home's windows will be replaced to match the original historic design. In the 1963 addition, windows and doors will be relocated and resized to align with the new circulation and functionality. The connector addition will mirror the east façade, and the auxiliary structure will receive two new windows, with one center window being resized and relocated. All windows and doors will be high profile impact-resistant systems.

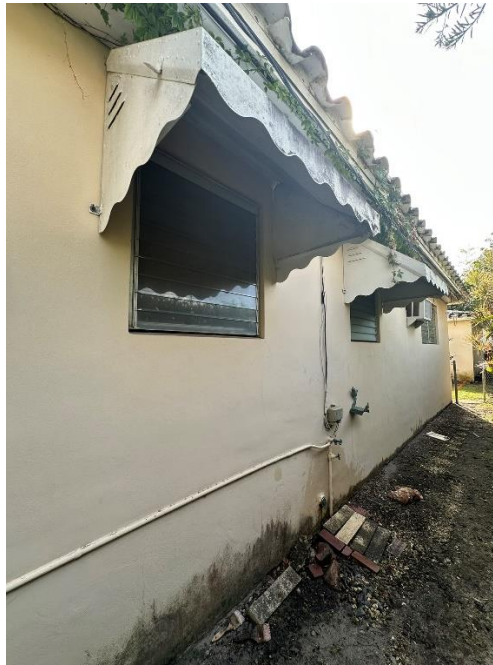
[before] Feature 21: Window & Door Modifications

Work and Impact on existing feature: The existing home's windows will be replaced to match the original historic design. In the 1963 addition, windows and doors will be relocated and resized to align with the new circulation and functionality. The connector addition will mirror the east façade, and the auxiliary structure will receive two new windows, with one center window being resized and relocated. All windows and doors will be high profile impact-resistant systems.

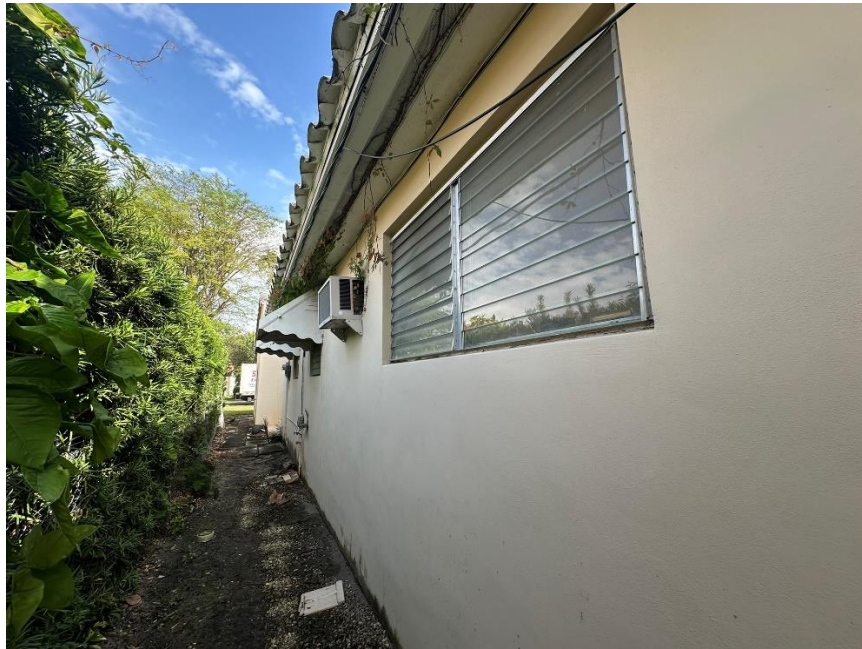
[before] Feature 22: Window & Door Modifications

Work and Impact on existing feature: The existing home's windows will be replaced to match the original historic design. In the 1963 addition, windows and doors will be relocated and resized to align with the new circulation and functionality. The connector addition will mirror the east façade, and the auxiliary structure will receive two new windows, with one center window being resized and relocated. All windows and doors will be high profile impact-resistant systems.

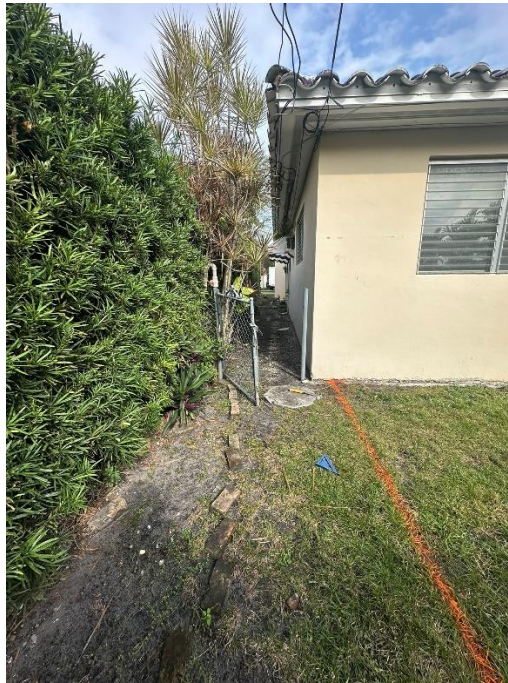
[before] Feature 23: Window & Door Modifications

Work and Impact on existing feature: The existing home's windows will be replaced to match the original historic design. In the 1963 addition, windows and doors will be relocated and resized to align with the new circulation and functionality. The connector addition will mirror the east façade, and the auxiliary structure will receive two new windows, with one center window being resized and relocated. All windows and doors will be high profile impact-resistant systems.

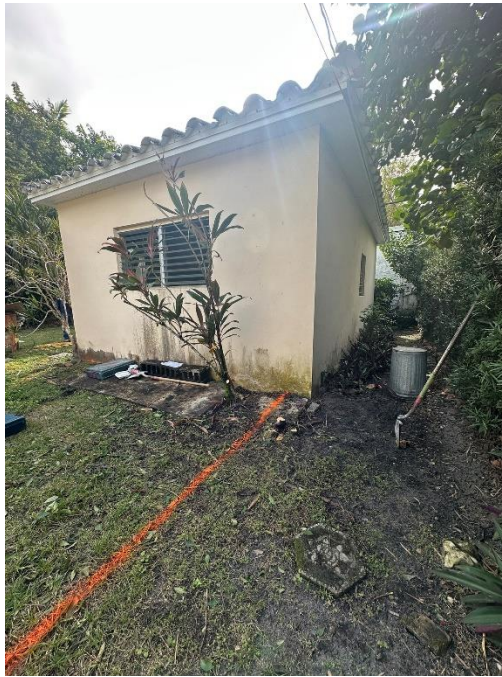
[before] Feature 24: Window & Door Modifications

Work and Impact on existing feature: The existing home's windows will be replaced to match the original historic design. In the 1963 addition, windows and doors will be relocated and resized to align with the new circulation and functionality. The connector addition will mirror the east façade, and the auxiliary structure will receive two new windows, with one center window being resized and relocated. All windows and doors will be high profile impact-resistant systems.

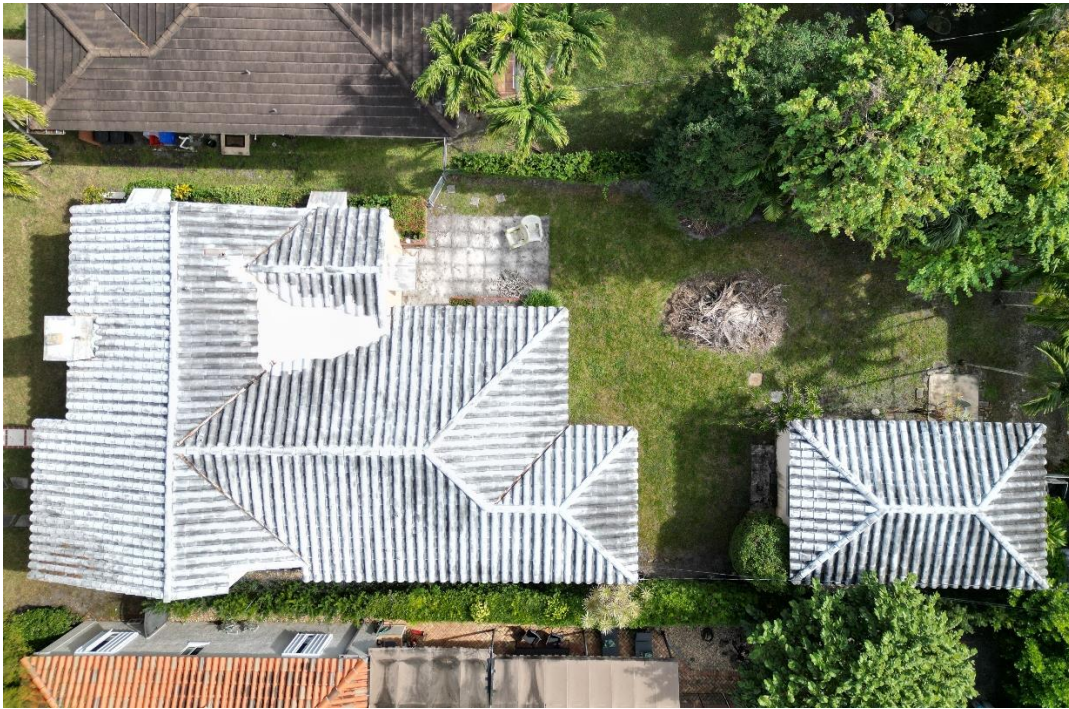
[before] Feature 25: Roof Restoration and New One-Story Connector Addition Roof Plan

Work and Impact on existing feature: The barrel tile roof will be restored and refinished to match the existing barrel tile roof. The roofline will remain unchanged to maintain architectural consistency. The new one-story connector addition that will link the residence and auxiliary structure will feature a flat roof with decorative parapets, higher than the main house but not visible from the right-of-way.

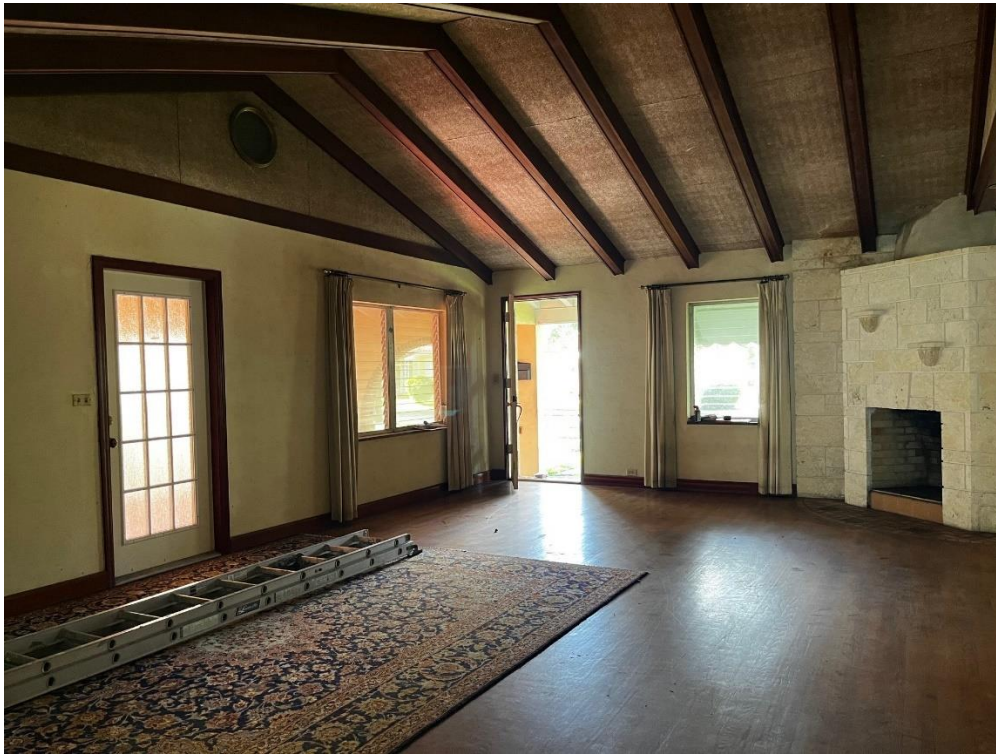
[before] Feature 1: Exposed Rafters (Living Room)

Work and Impact on existing feature: The original exposed rafters will be retained and refinished, preserving a key Mediterranean Revival architectural element of the home. Care will be taken to maintain the craftsmanship of the original beams while addressing any necessary repairs.

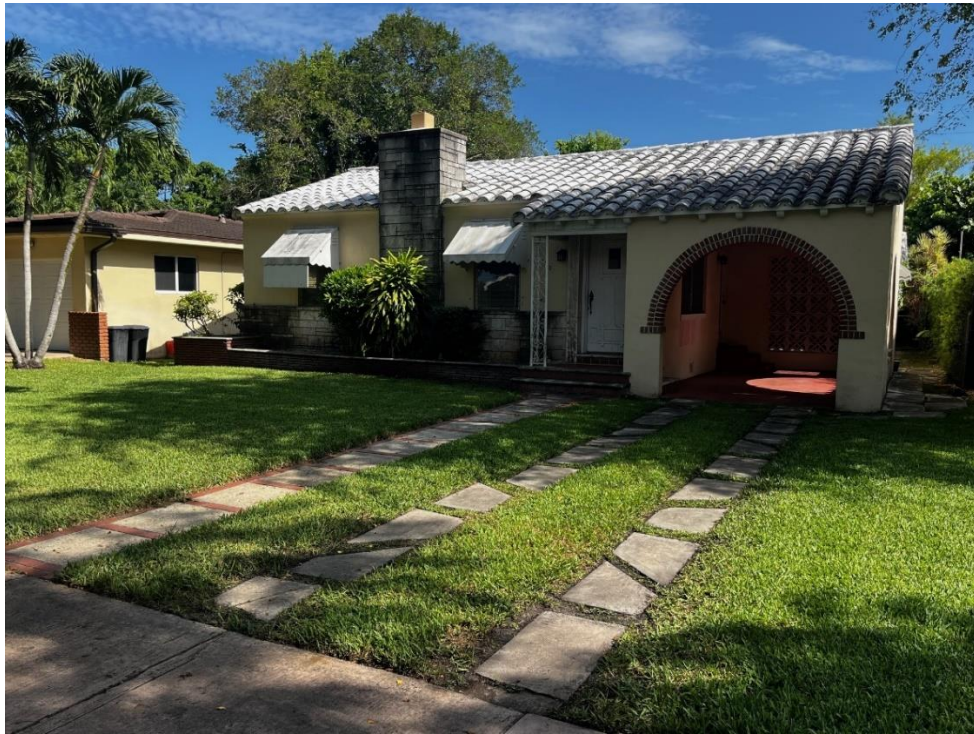
[before] Feature 1: Driveway & Walkway Redesign

Work and Impact on existing feature: The driveway and walkway will be reconfigured, with materials selected for compatibility with the historic context. As required by the Historic Preservation Board, there will be a separation between the new driveway and the new walkway.

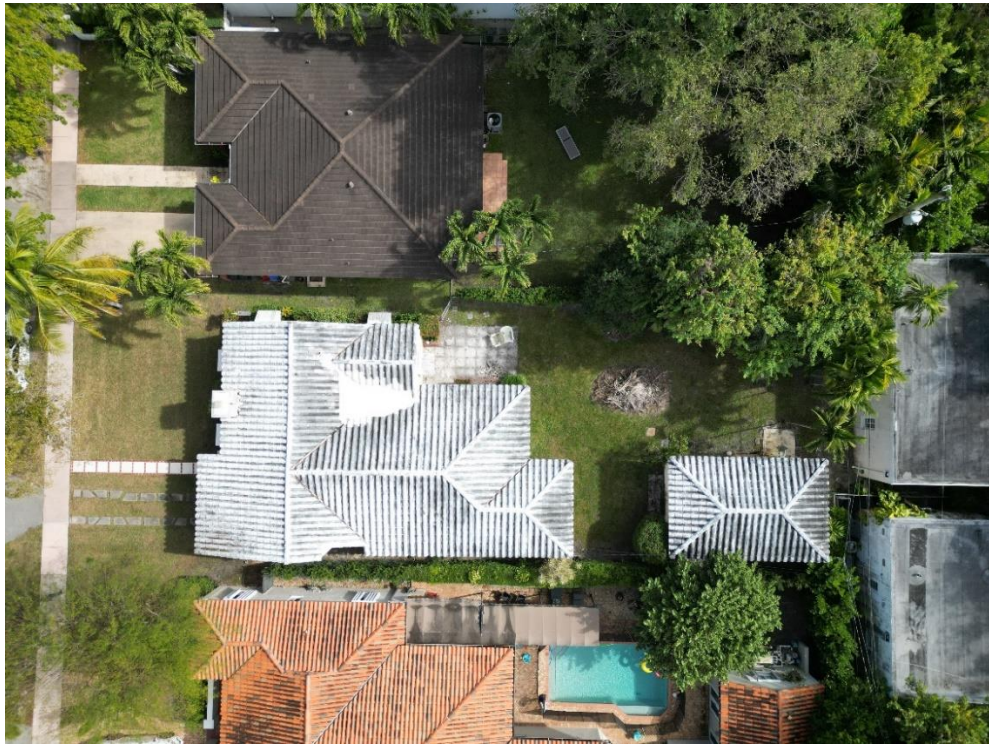
[before] Feature 2: Driveway & Walkway Redesign

Work and Impact on existing feature: The driveway and walkway will be reconfigured, with materials selected for compatibility with the historic context. As required by the Historic Preservation Board, there will be a separation between the new driveway and the new walkway.

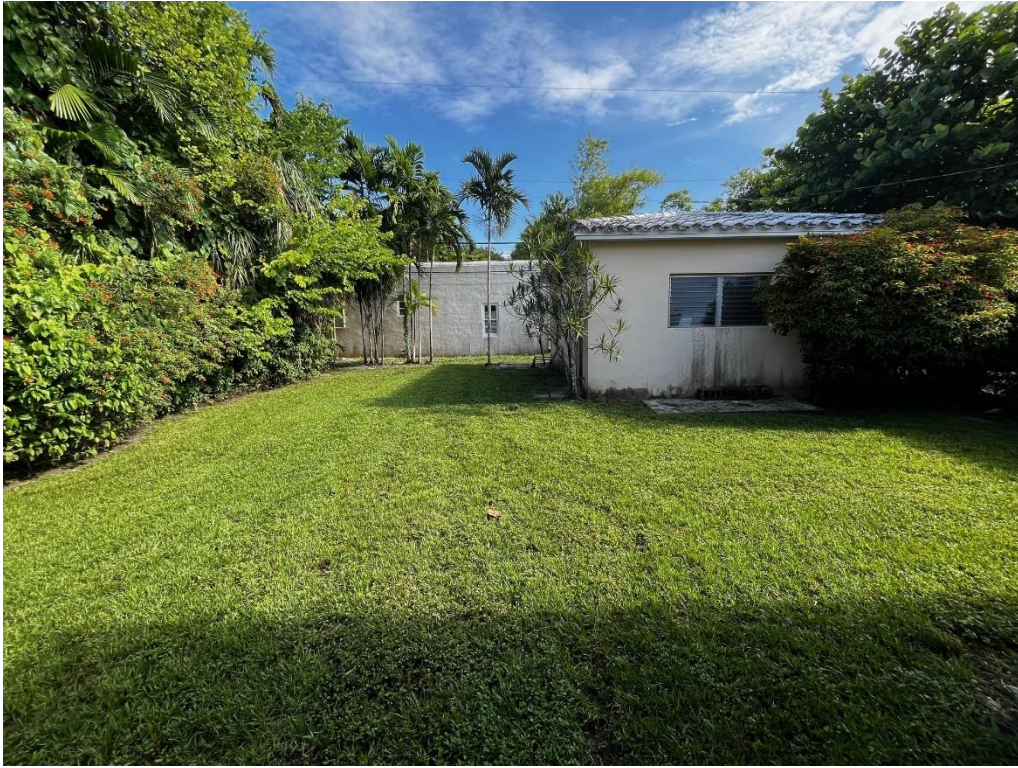
[before] Feature 3: New Privacy Wall Installation

Work and Impact on existing feature: A new privacy wall, ranging from 7'-10" to 8'-6", will be installed constructed, maintaining appropriate setbacks and in compliance with the approved variance, ensuring compatibility with the historic context.

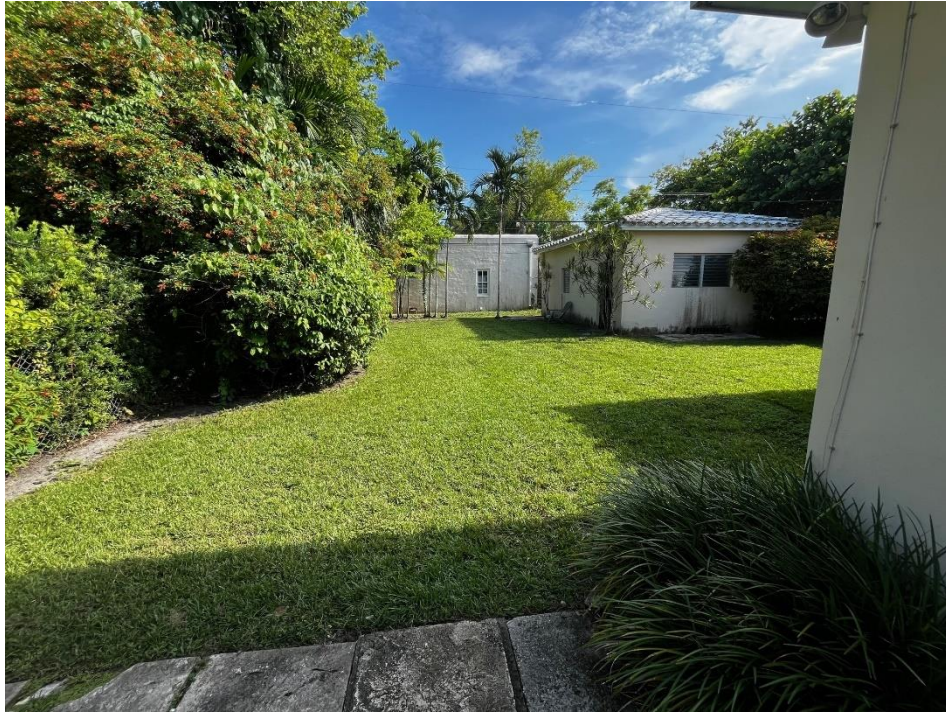
[before] Feature 4: New Swimming Pool & Pool Deck

Work and Impact on existing feature: A new pool and pool deck will be constructed east of the addition, maintaining alignment with the site's historic proportions. The pool deck will be constructed with Coralina Stone to further complement the historical aspects of the home.

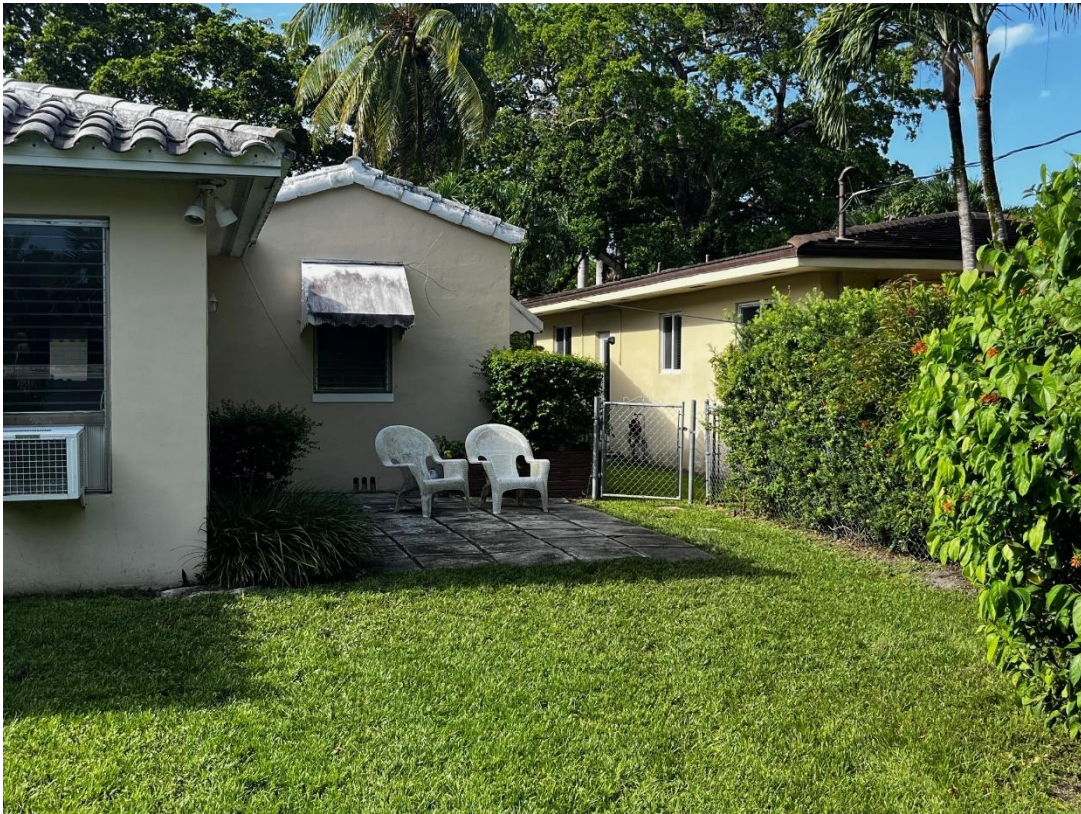
[before] Feature 5: New Swimming Pool & Pool Deck

Work and Impact on existing feature: A new pool and pool deck will be constructed east of the addition, maintaining alignment with the site's historic proportions. The pool deck will be constructed with Coralina Stone to further complement the historical aspects of the home.

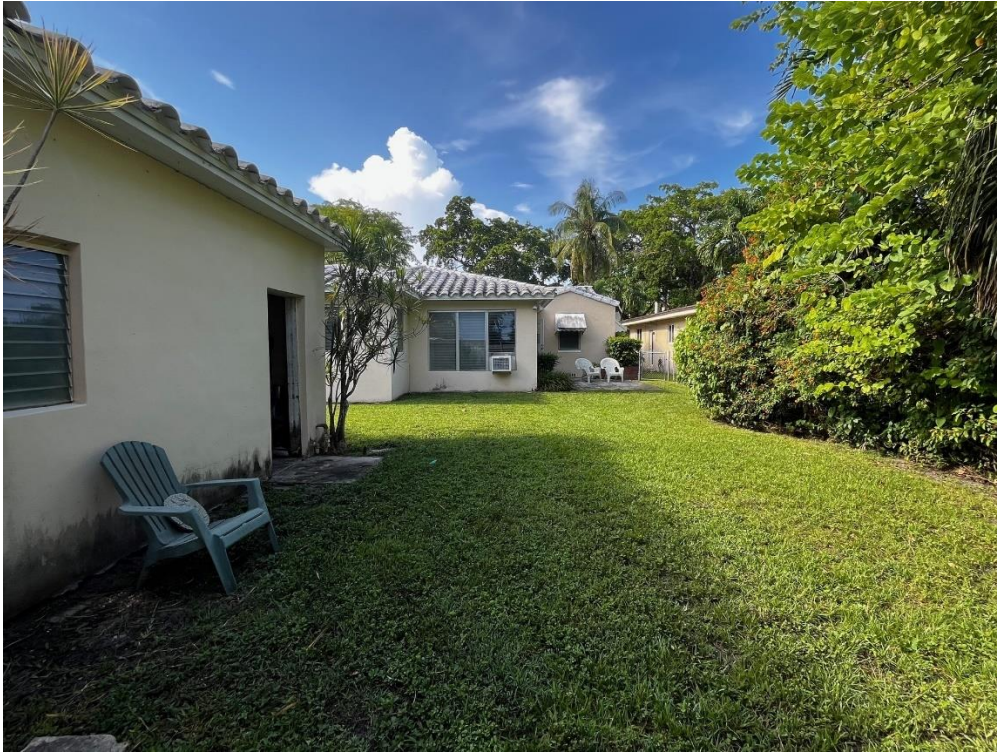
[before] Feature 6: New Swimming Pool & Pool Deck

Work and Impact on existing feature: A new pool and pool deck will be constructed east of the addition, maintaining alignment with the site's historic proportions. The pool deck will be constructed with Coralina Stone to further complement the historical aspects of the home.
