# PROPERTY APPRAISER OF MIAMI-DADE COUNTY

### **LETTER OF BUILDING RECERTIFICATION IN ACCORDANCE WITH SECTION 8-11(f) OF THE CODE OF MIAMI-DADE COUNTY**

Subject: Structural Recertification – Photographs  
Association Name: Royal Caribbean Club Condominium  
Address: 1150 Madruga Avenue, Coral Gables, Florida  
Stone Project Name:

**BUILDING RECERTIFICATION INSPECTION REPORT FORM - STRUCTURAL**

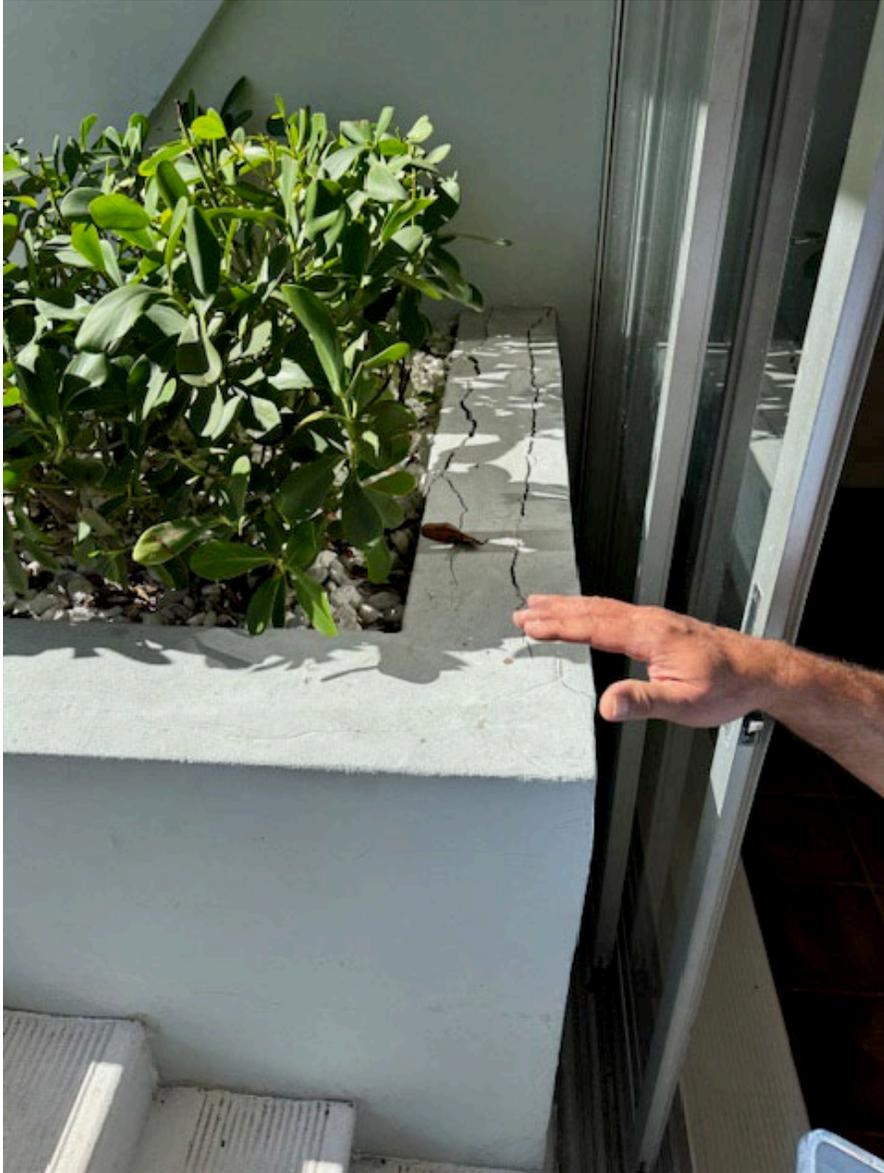
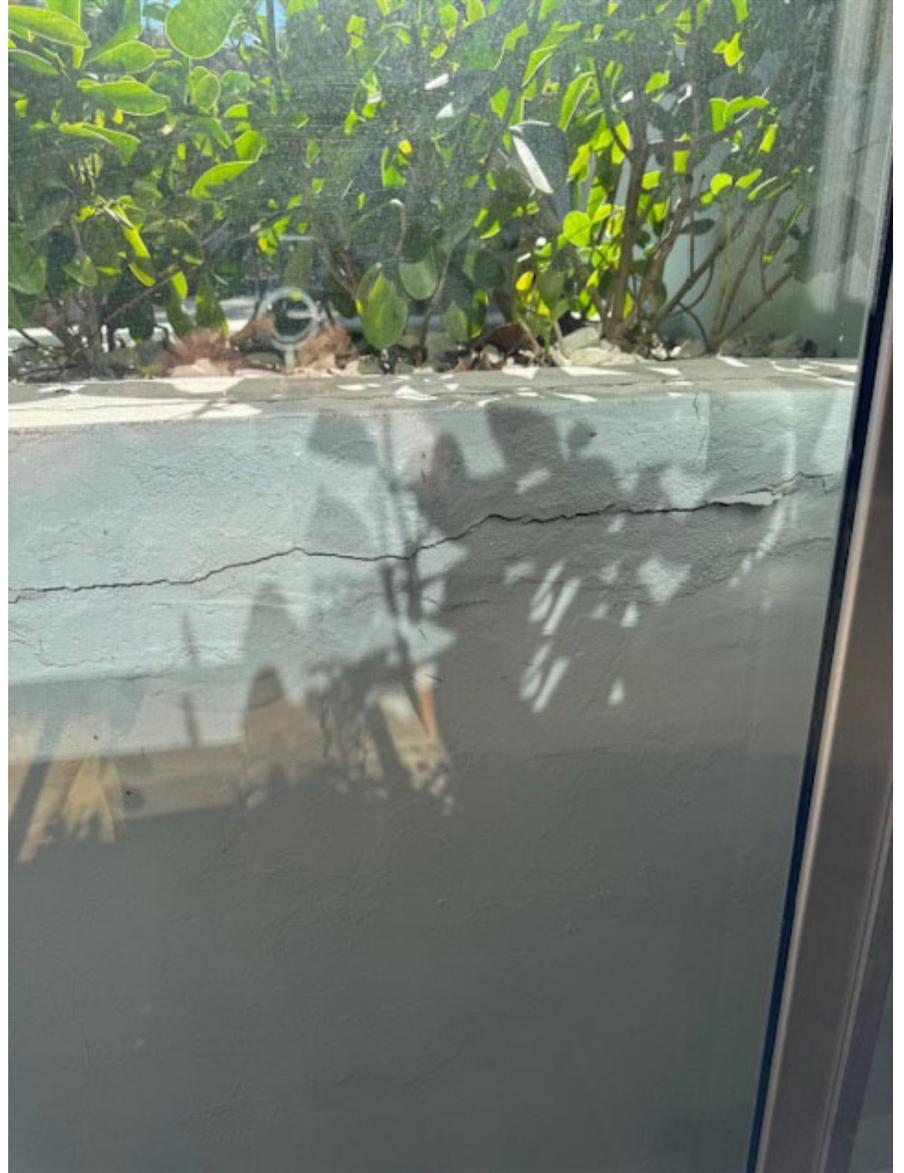
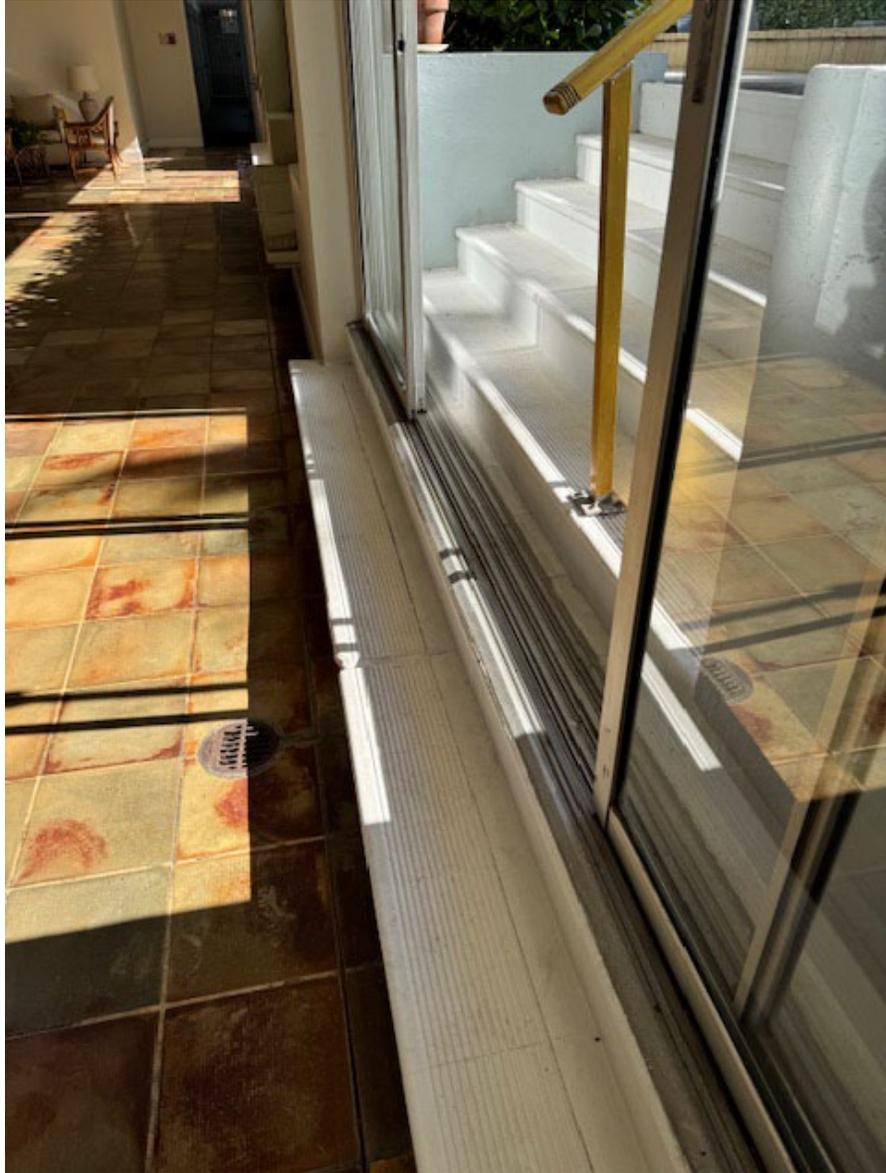
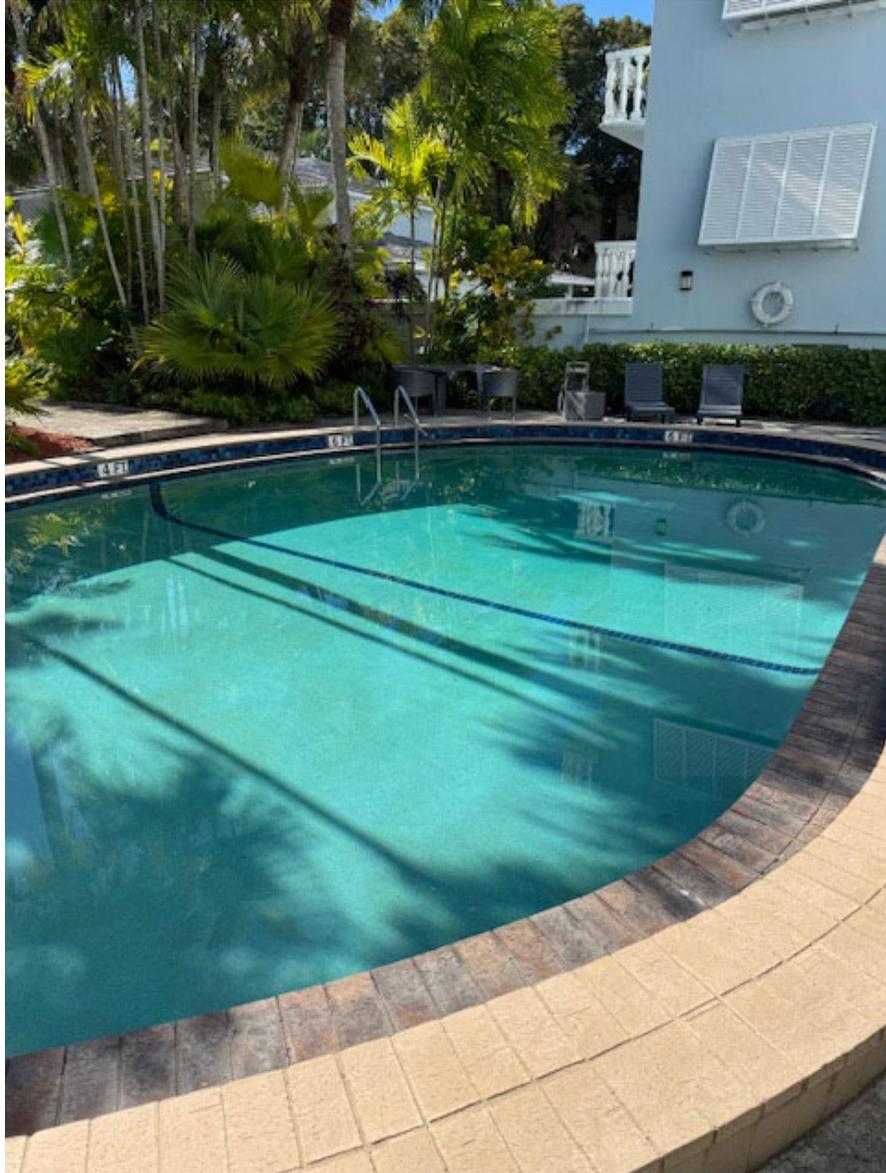
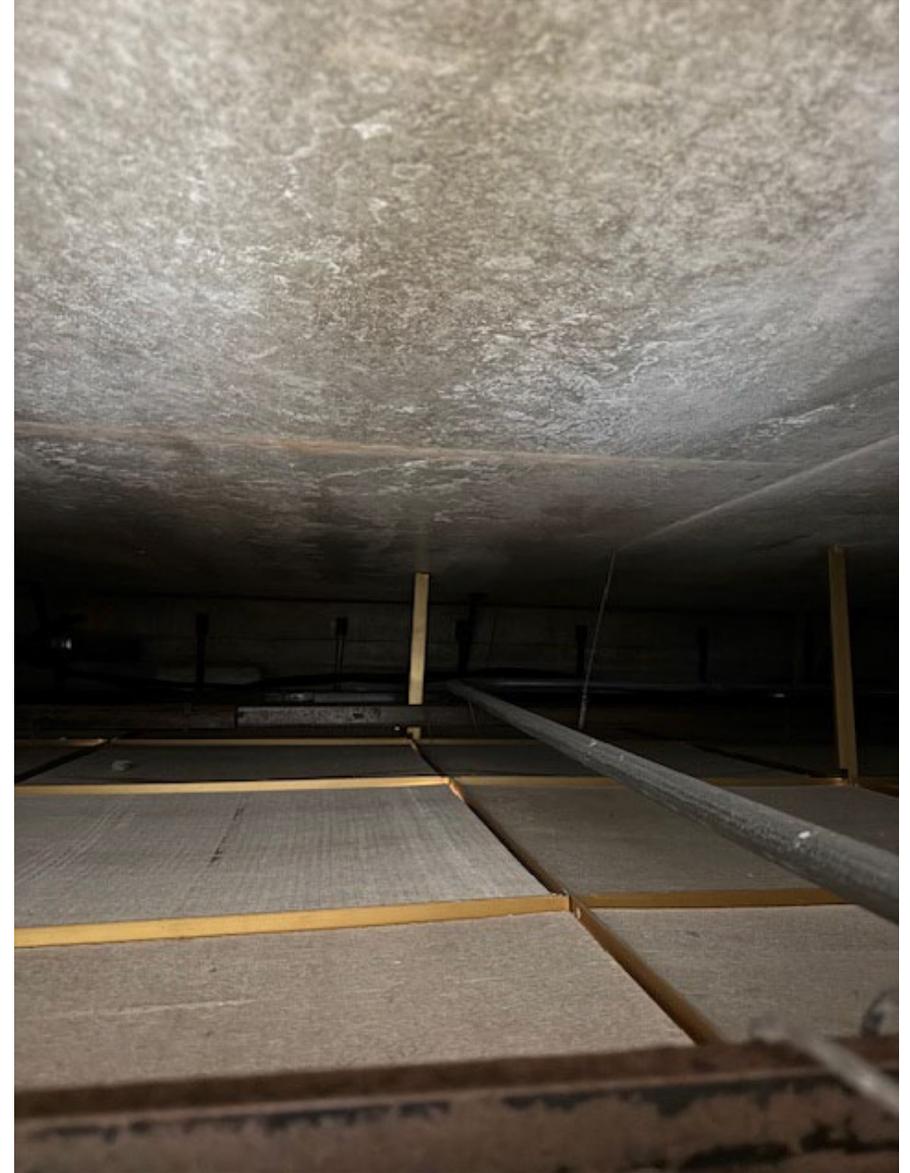
c. Surface conditions: Describe general conditions of finishes, cracking, spalling, peeling, signs of moisture penetration and stains.	PROVIDE PHOTO 5c
The soffit is exhibiting cracking, as well as the concrete cap in the area of the two gardeners.

d. Cracks: Note location in significant members. Identify crack size as <b>HAIRLINE</b> if barely discernible; <b>FINE</b> if less than 1 mm in width; <b>MEDIUM</b> if between 1- and 2-mm width; <b>WIDE</b> if over 2 mm.	PROVIDE PHOTO 5d
Medium (1 - 2 mm) The crack is of moderate size, observed at both the soffit and the gardeners' area.

e. General extent of deterioration: Cracking or spalling of concrete or masonry, oxidation of metals; rot or borer attack in wood.	PROVIDE PHOTO 5e
1) Soffit with 60 feet line of crack

2) Concrete cap along the entire length of both planters.	
f. Previous patching or repairs (Provide description and identify location):	PROVIDE PHOTO 5f

1) Soffit was open to repair sanitary pipes above	
2) The concrete cap of planters is from construction	
g. Nature of present loading: (Indicate residential, commercial, storage, other.)	
Residential

The repair of the soffit in the west parking area needs to be performed on the hanging system of the soffit.

The repair of the soffit and the concrete cap in the gardeners' area is not urgent but should be addressed.
