City of Coral Gables

City Hall

Windows Replacement

December 19, 2024

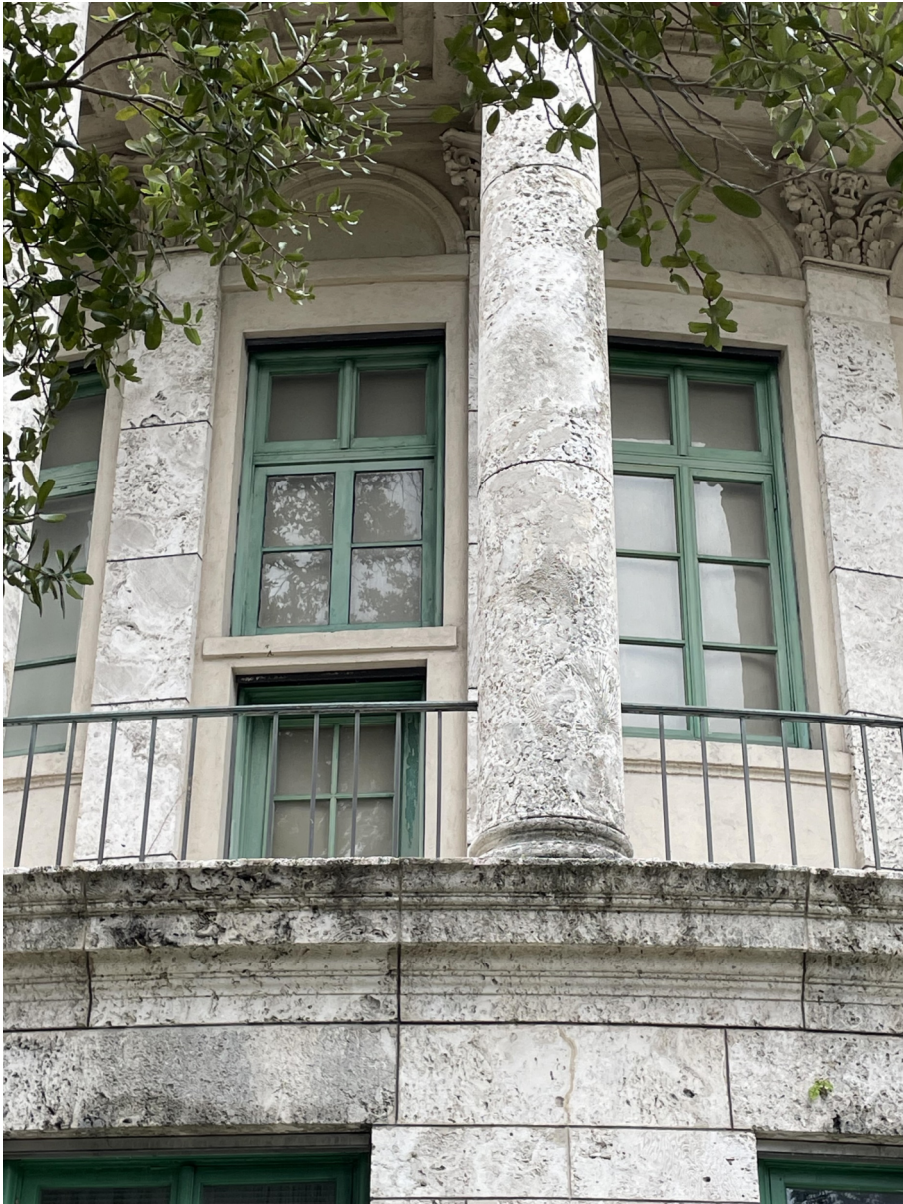
Exterior Windows (East Elevation)

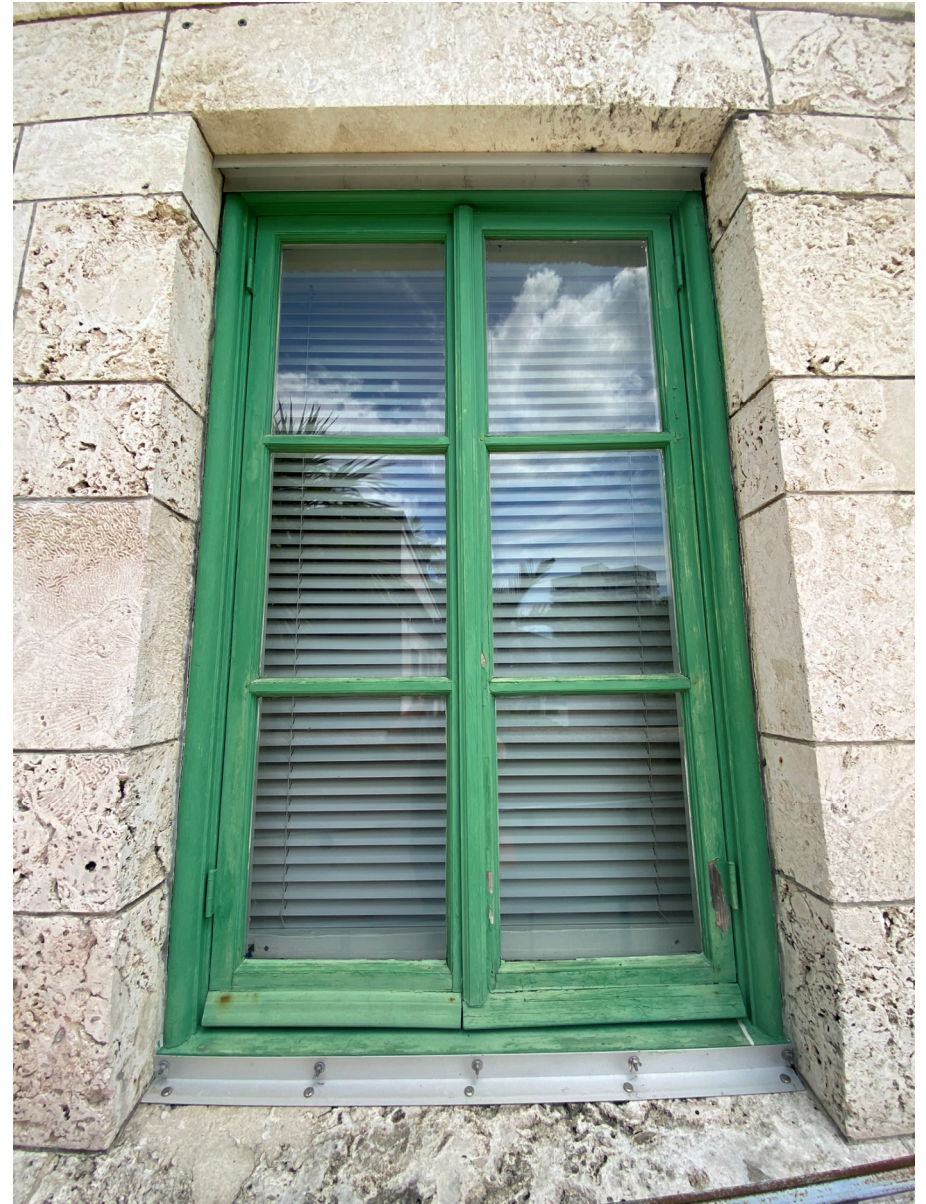
Exterior Window (West Elevation)

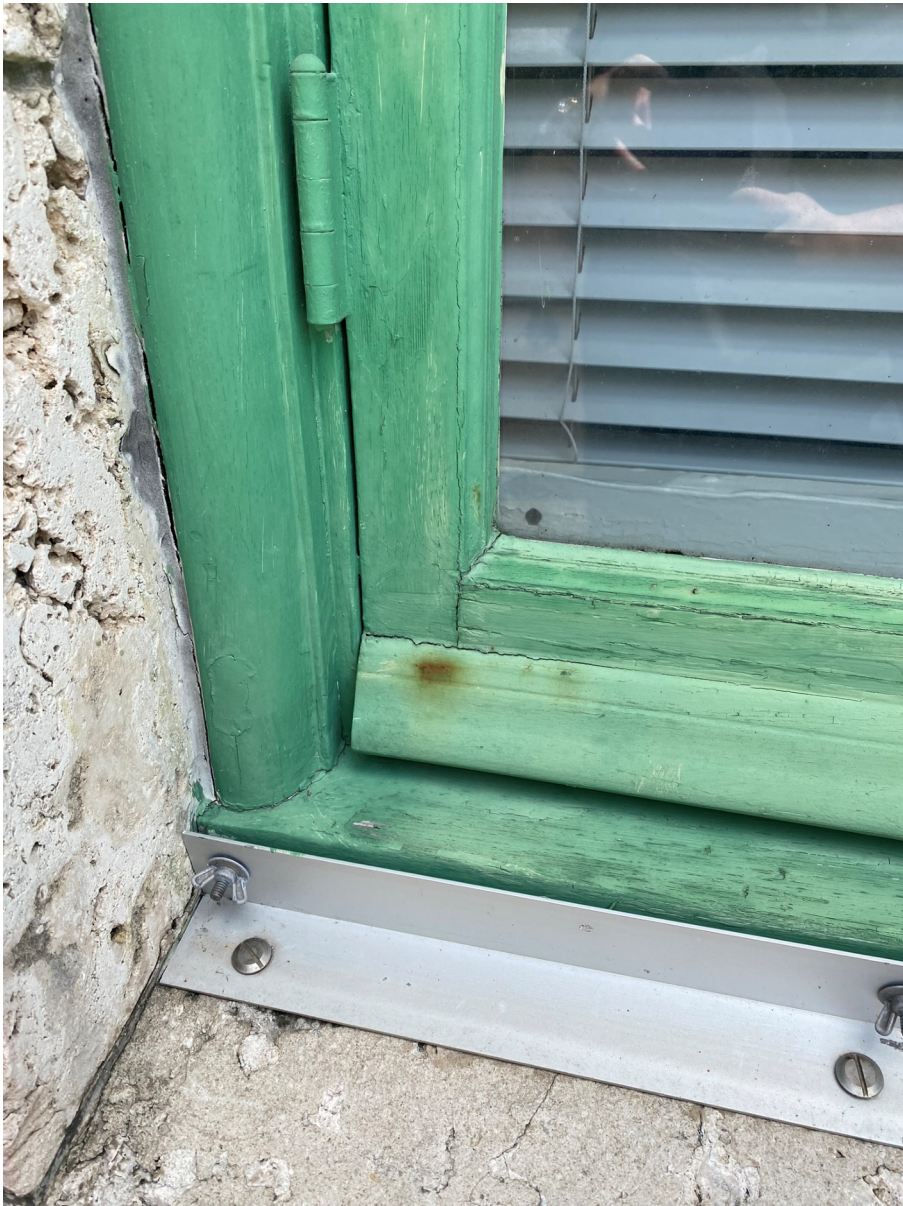
Exterior Window Detail (West Elevation)

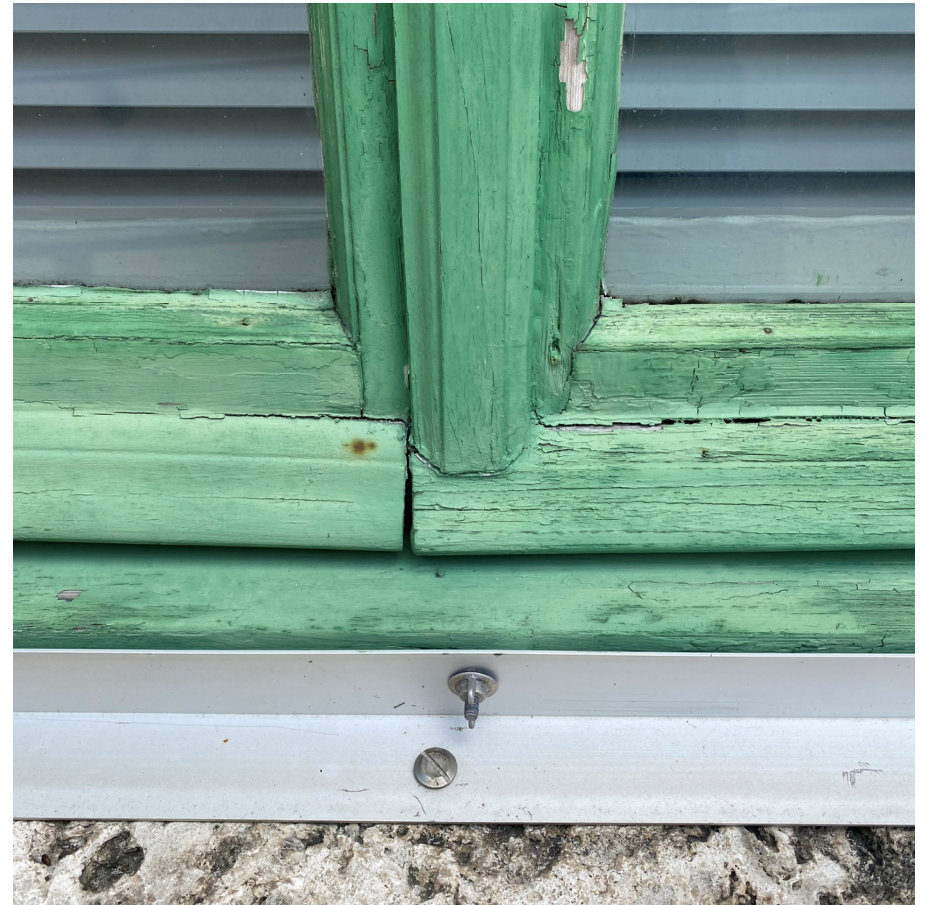
Exterior Window Detail (West Elevation)

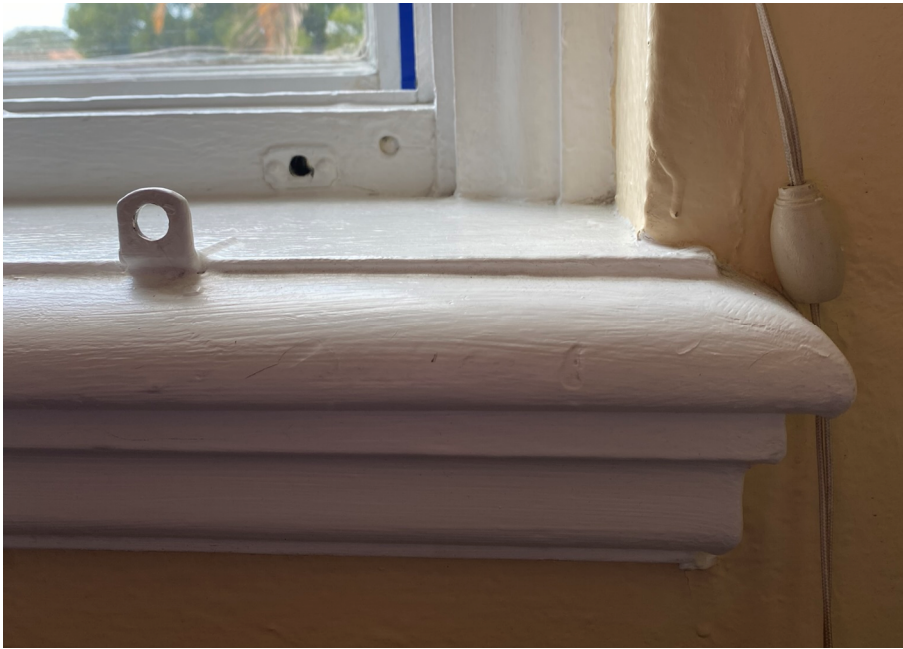
Interior Window Detail (West Elevation)

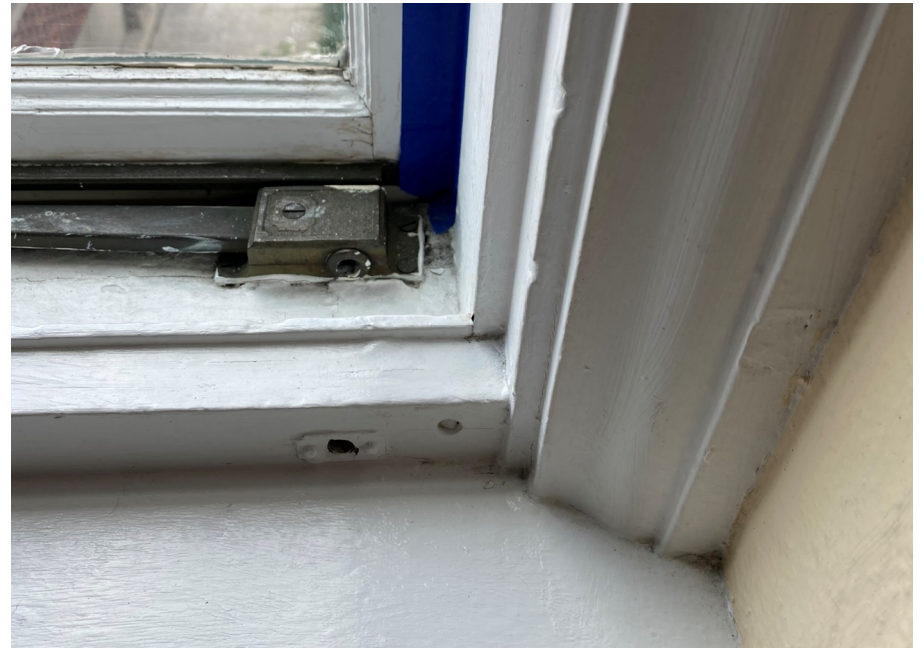
Interior Window Detail (West Elevation)

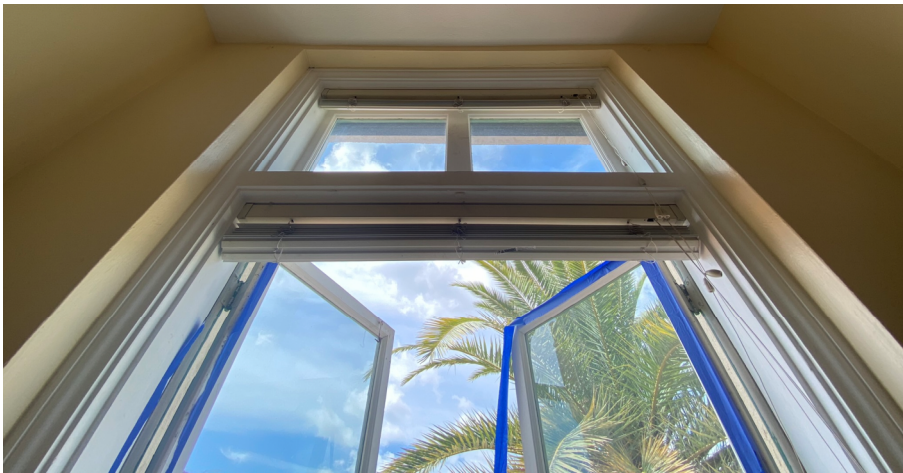
Interior Window (West Elevation)

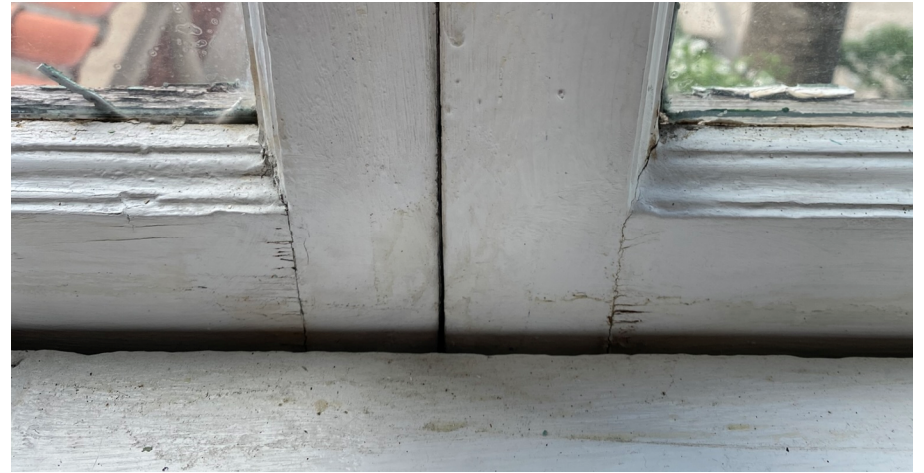
Interior Window Detail (West Elevation)
