#### HISTORIC PRESERVATION AD-VALOREM TAX EXEMPTION

#### PART 2 - REQUEST FOR REVIEW OF COMPLETED WORK

## Nason Residence Photographs 1021 Alhambra Circle, Coral Gables

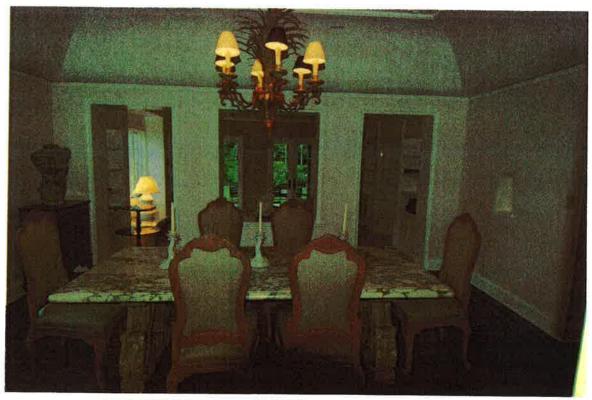
Photo #9

Wood floors at dining room and at master bedroom were restored.

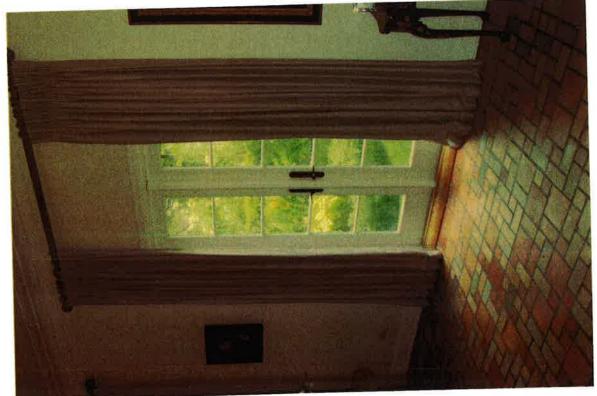
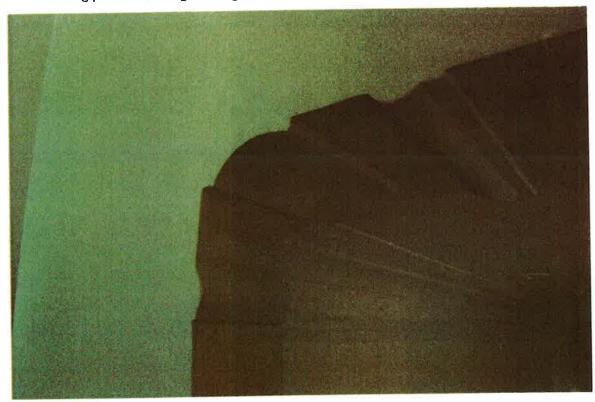
Photo #11

Ceiling plaster molding at living room and at master bedroom was preserved.

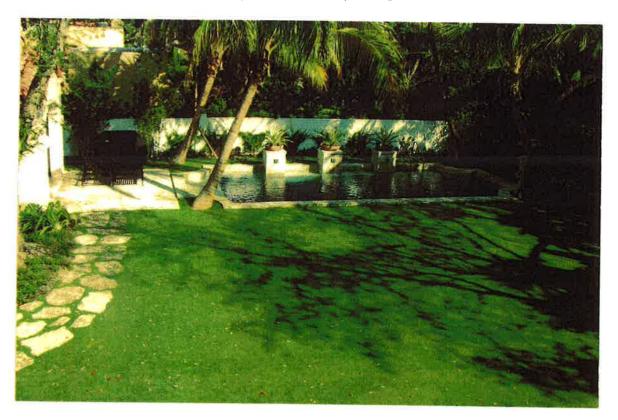
1021 Alhambra Circle, Coral Gables
Photo #27

New pool and landscape design.

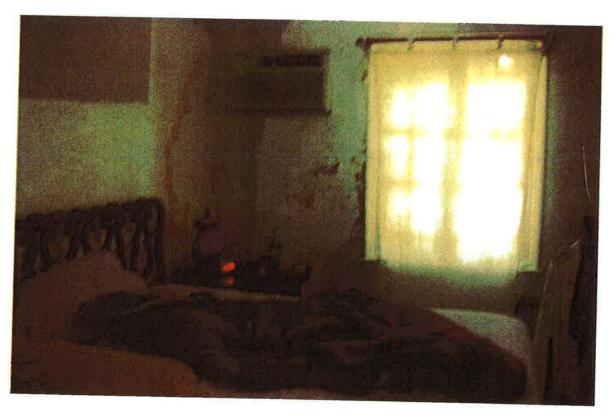
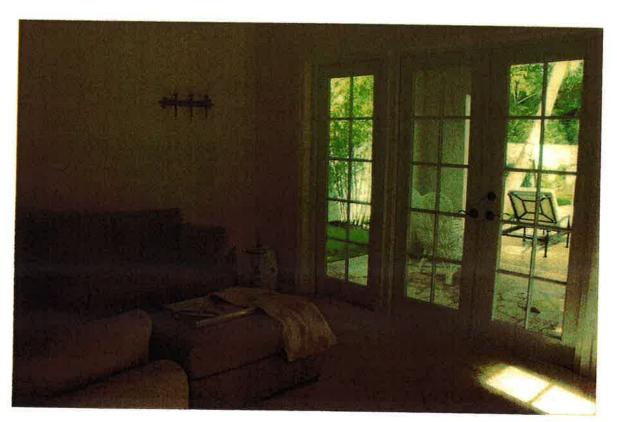
1021 Alhambra Circle, Coral Gables
Photo #29

New Den at Auxiliary Building .

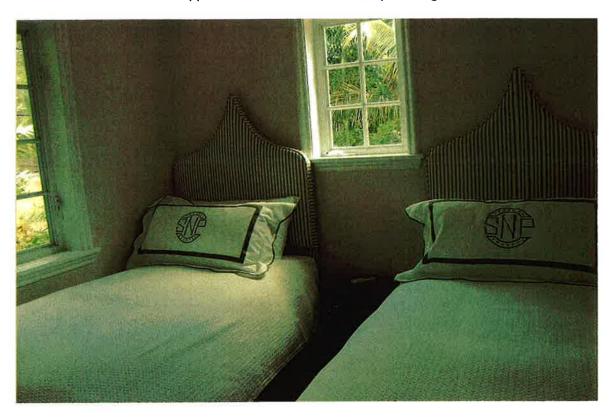
Photo #30

Restored upper level bedrooms at Auxiliary Building .

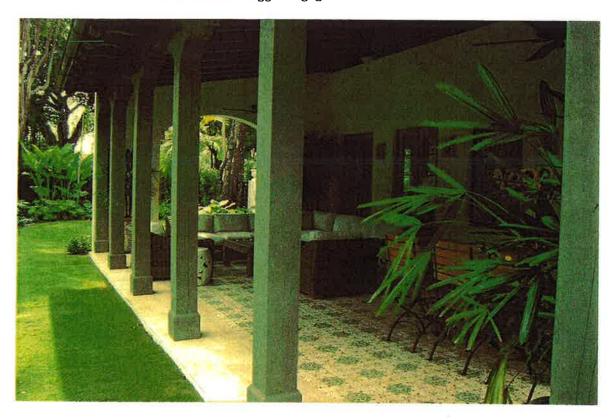
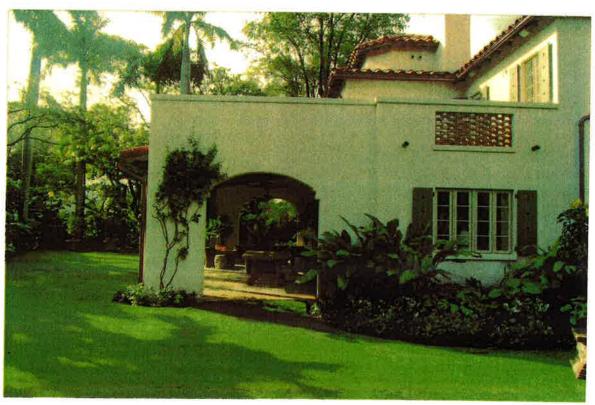
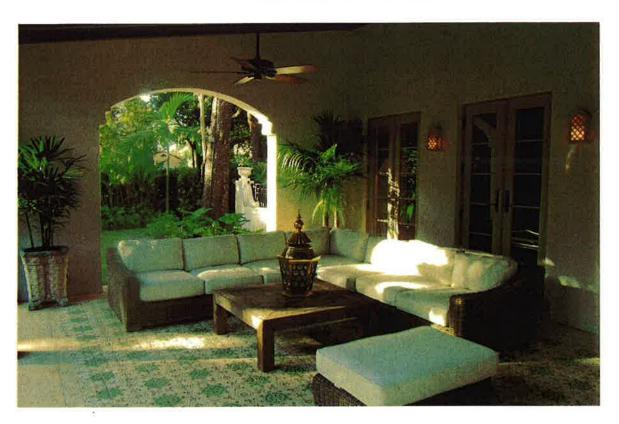
# 1021 Alhambra Circle, Coral Gables Photo #33

New Covered Loggia engaged to the Main House

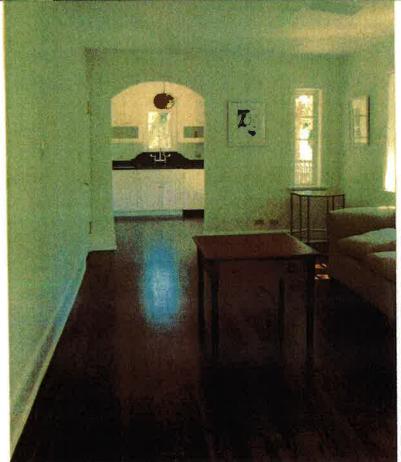
Photo #36

Preserved Sitting room at upper level Auxiliary Building.

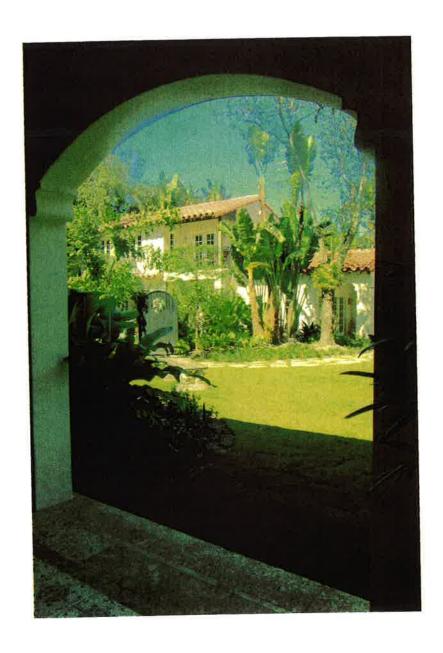
Photo #37

Landscape/Auxiliary building view from new loggia at Main house.

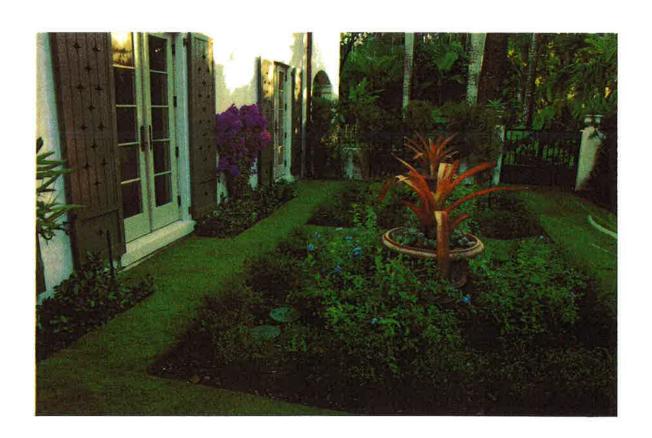
### Photo #38

Landscaping entry garden view.

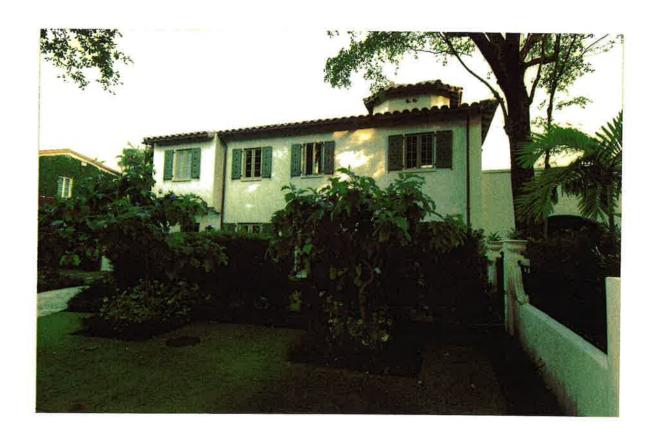
### Photo #39

Garden pedestrian view at the front of the house.

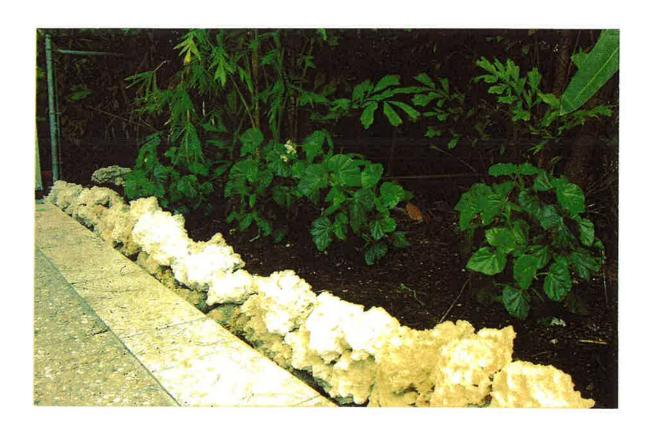
### Photo #40

Landscaping driveway design.

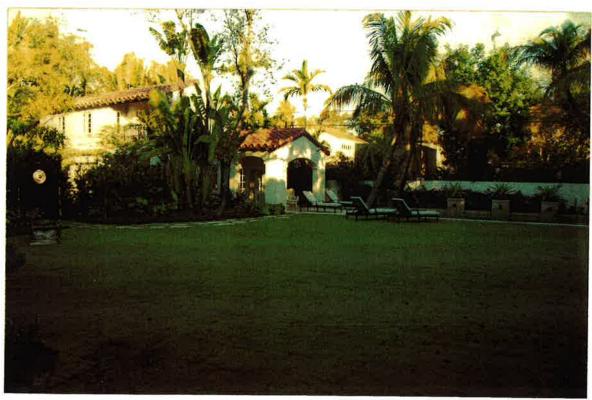
### Photo #41

Landscaping backyard design.

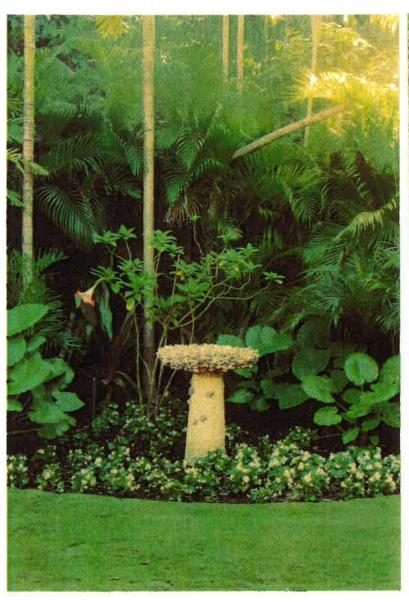
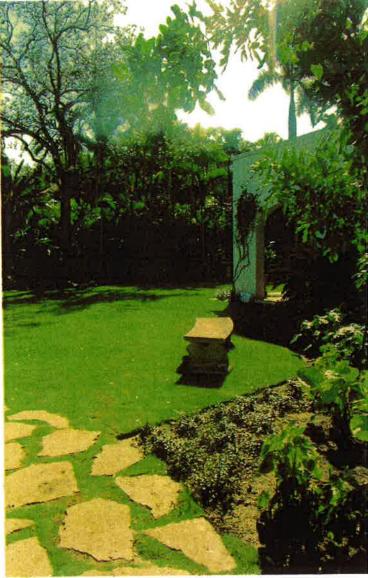
Photo #41

Landscaping backyard design.
