OFFICE OF THE PROPERTY APPRAISER

| Property Information | | | | | |
|---|--|--|--|--|--|
| Property Address: | 250 CATALONIA AVE Coral Gables, FL 33134-6735 | | | | |

RE-INSPECTION OF 250 CATALONIA PASSED INSPECTION, ALL DEFICIENCIES NOTED IN THE

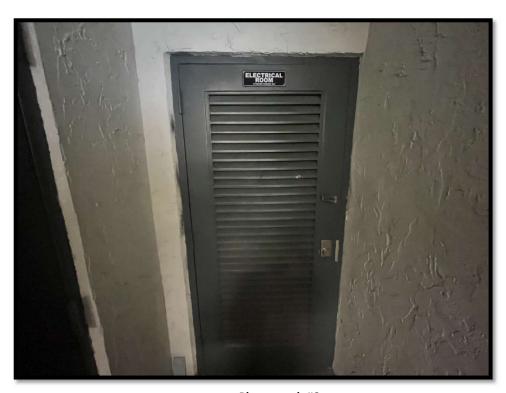
Photograph #2

Electrical Room properly identified.

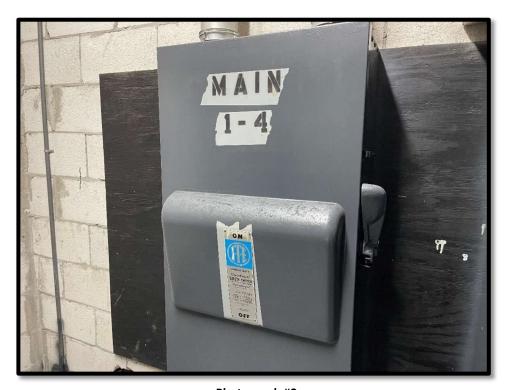
Photograph #3

MAIN DISCONNECT 1-4 (600A) is properly identified.

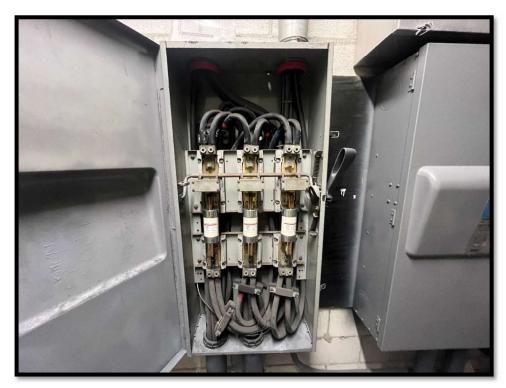
Photograph #4
Phases are properly identified and installed.

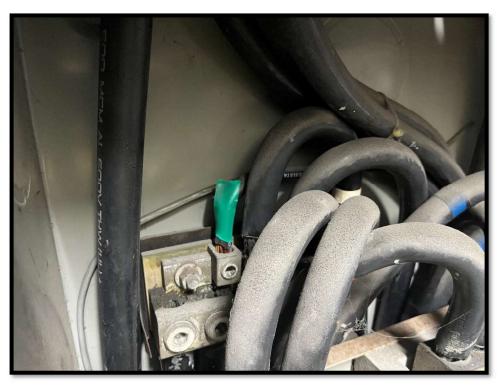
Photograph #5
Ground of the Disconnect is properly installed.

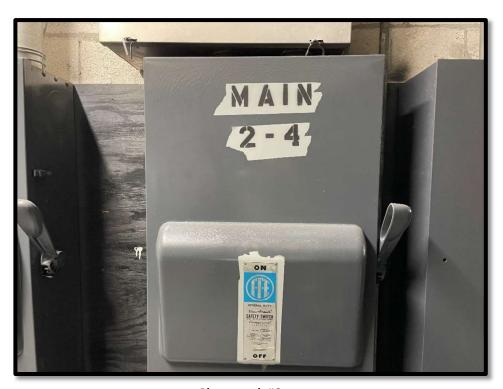
Photograph #6

MAIN DISCONNECT 2-4 (600A) is properly identified.

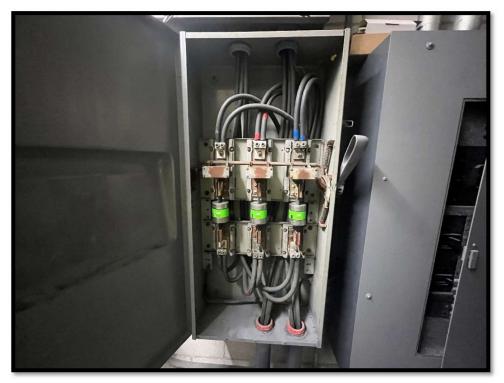
Photograph #7
Phases are properly identified and installed.

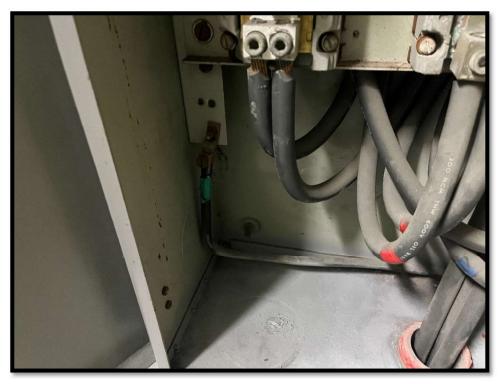
Photograph #8

Ground of the Disconnect is properly installed.

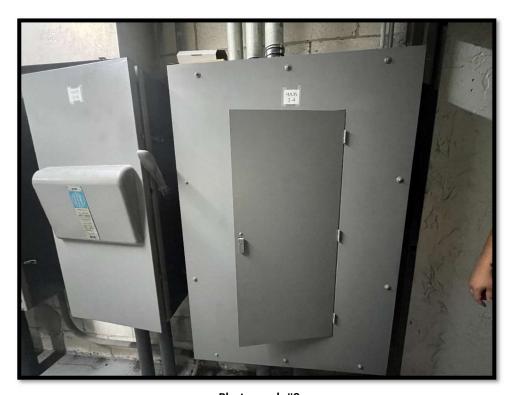
Photograph #9

The Main Panel 3-4 (800A) Branch circuits properly identified.

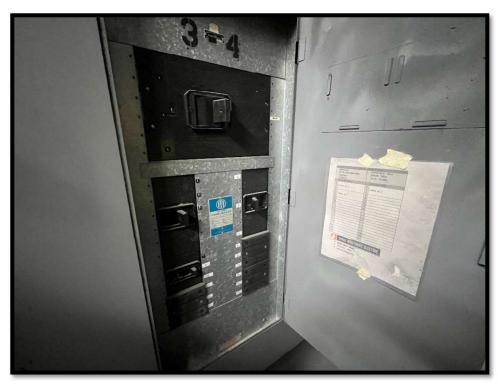
Photograph #10

Re-Inspection 05.20.2024.

Branch circuits breaker and Disconnect in the Main Electrical Room properly identified.

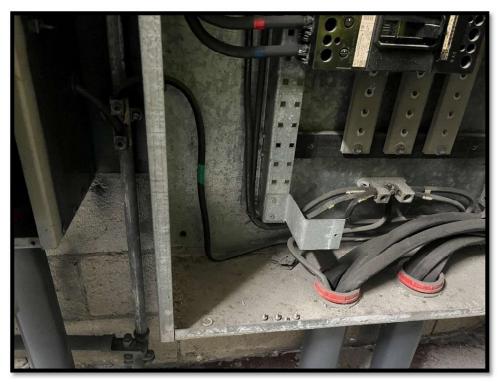
Photograph #12
Ground of the Disconnect is properly installed.

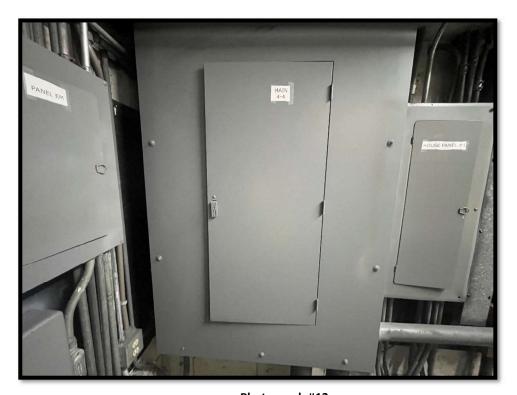
Photograph #13

The Main Panel 4-4 (800A) Branch circuits properly identified.

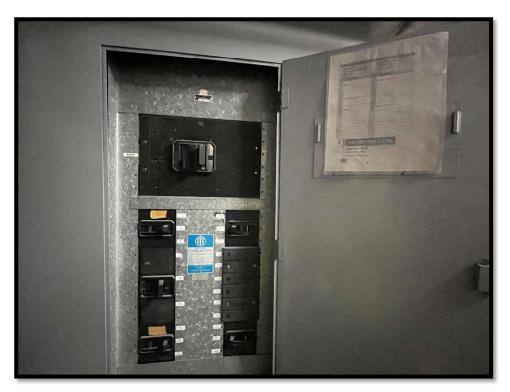
Photograph #14
Re-Inspection 05.26.2023.

The Main Panel 4-4 (800 A). The Sub-Panel Branch circuits breaker and Disconnect in the Main Electrical Room properly identified. NEC 210.5 C (1) (b). In the 2020 NEC°, Section 705.10, Section 11.12.2.1.5 in NFPA 1.

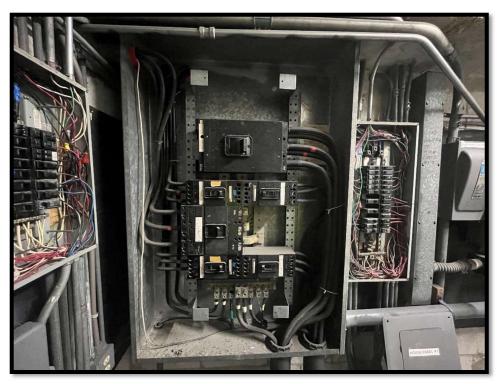
Photograph #15
Phases are properly identified and installed.

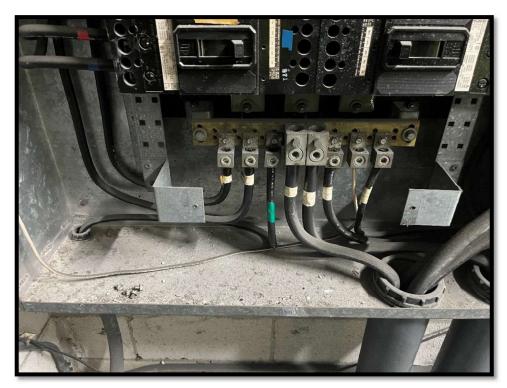
Photograph #16
Ground of the Disconnect is properly installed.

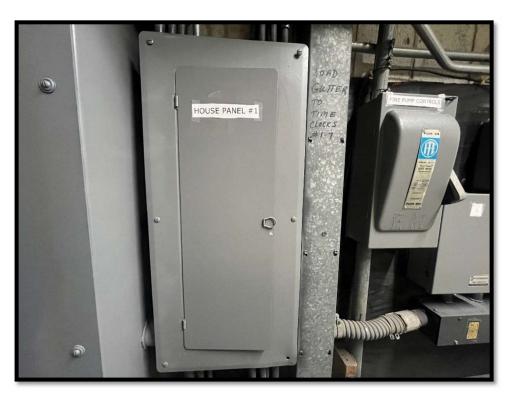
Photograph #17

Re-Inspection 05.20.2024.

The Sub-Panel House #1 Branch circuits properly identified.

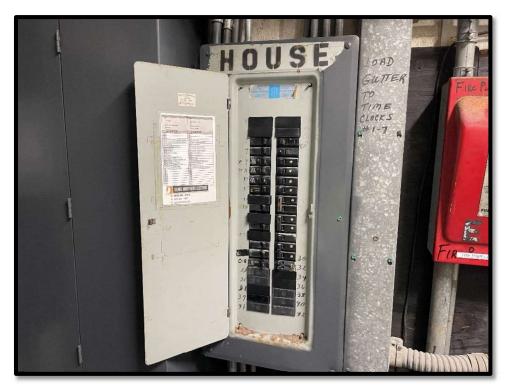
Photograph #17.1 Re-Inspection 05.20.2024.

The Sub-Panel House #1 Branch circuits breaker in the Main Electrical Room properly identified.

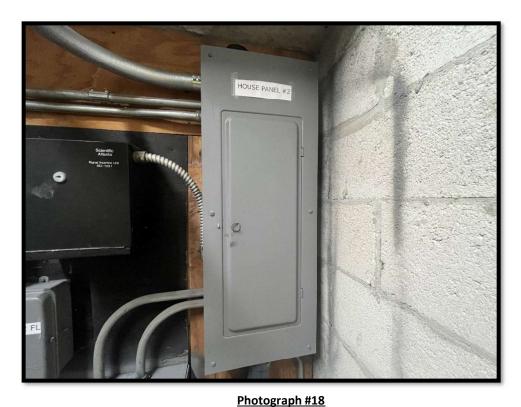
The Sub-Panel House #2 Branch circuits breaker properly identified.

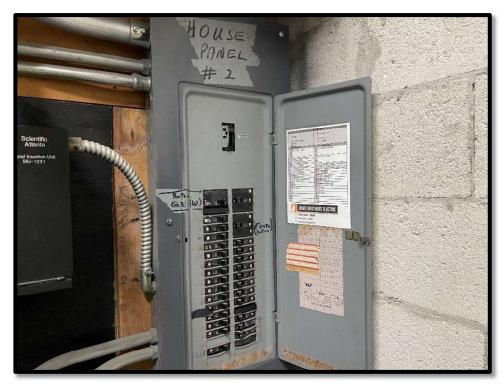
Photograph #18.1 Re-Inspection 05.20.2024.

The Sub-Panel House #2, Branch circuits breaker and Disconnect in the Main Electrical Room properly identified.

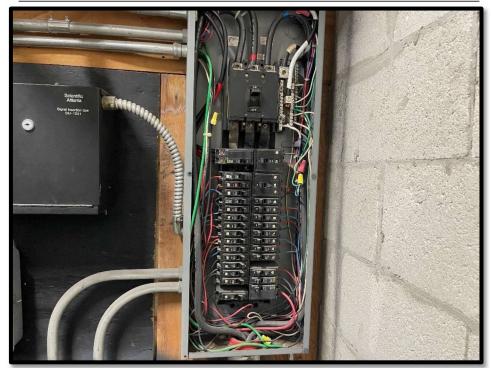
Photograph #19
Phases and Neutral wire are properly identified and installed.

Grounding is properly installed.

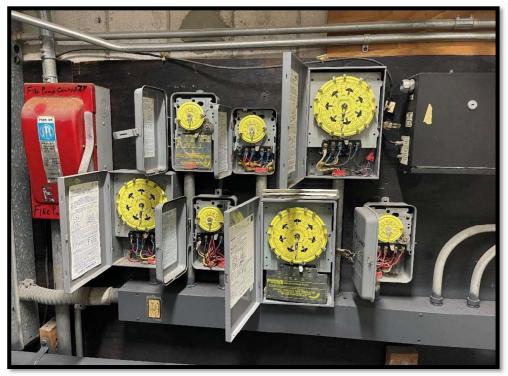
Photograph #21
Re-Inspection 05.20.2024.

The Timer Branch circuits in the Warehouse building properly identified.

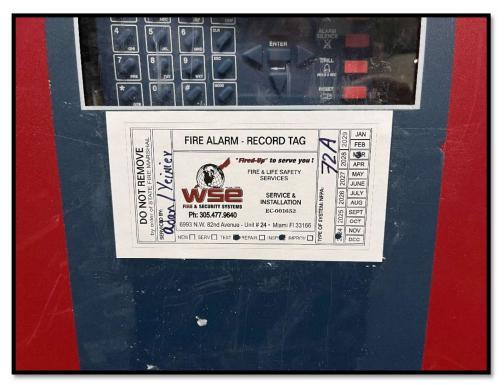
Photograph #23

The Fire Alarm is properly labeled and has the Record Tag March – 2024 required by NFPA 70B.

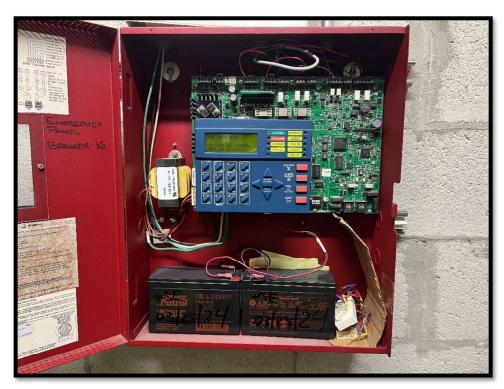
Photograph #24

Fire alarm control panel properly installed.

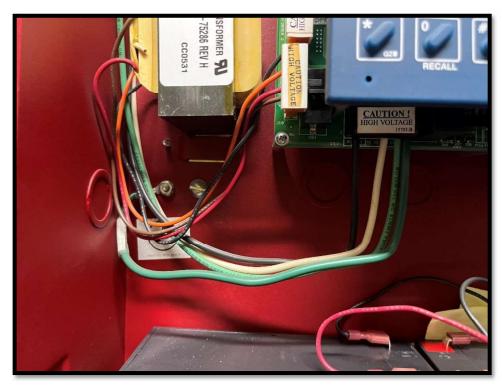
Photograph #25
Grounding is properly installed.

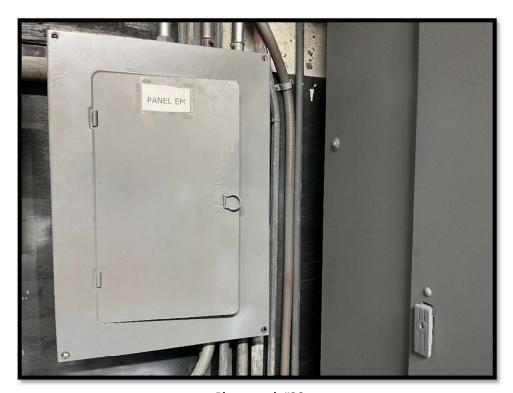
Photograph #26
Circuit Breaker Panel EM properly identified.

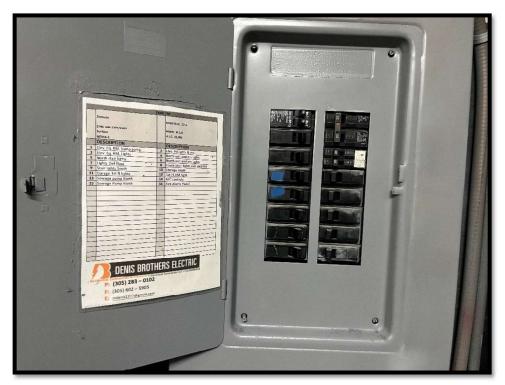
Photograph #27
Circuit Breaker Panel EM is properly labeled.

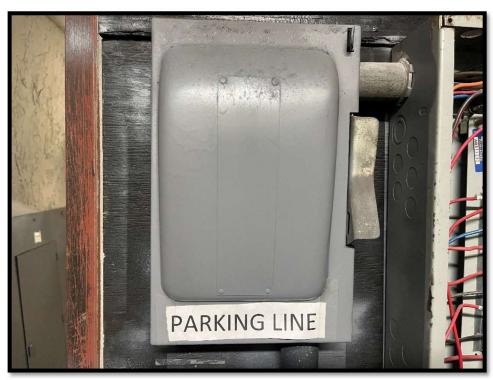
Photograph #29

The Disconnect Parking Line is properly identified.

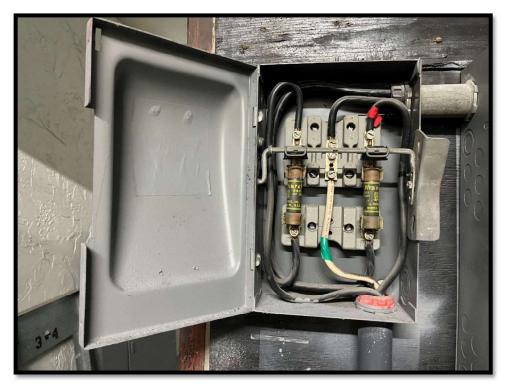
Photograph #30
Fuses are properly identified and installed.
Ground of the Disconnect is properly installed.

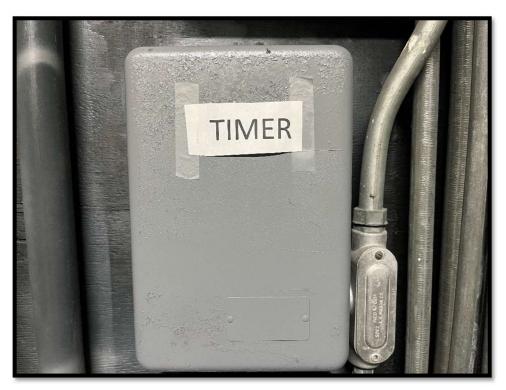
Photograph #31
Timer is properly identified.

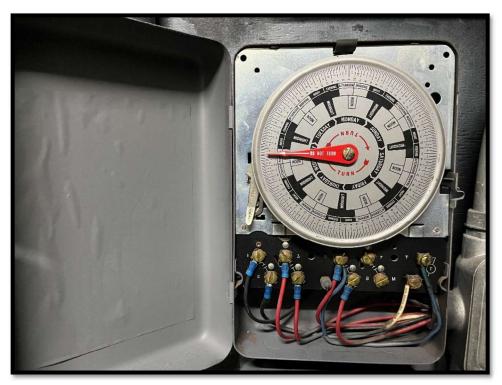
Photograph #32
Timer is properly installed.

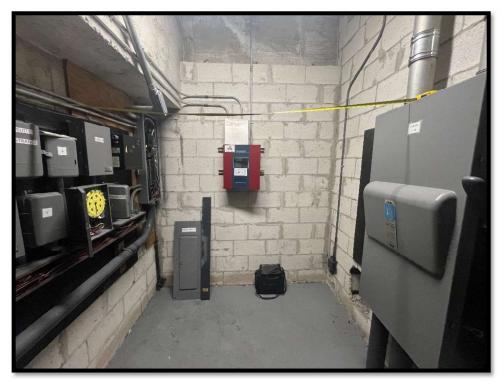
Photograph #33

The National Electrical Code® (NEC)® Section 110.26 requires adequate working space for all electrical equipment.

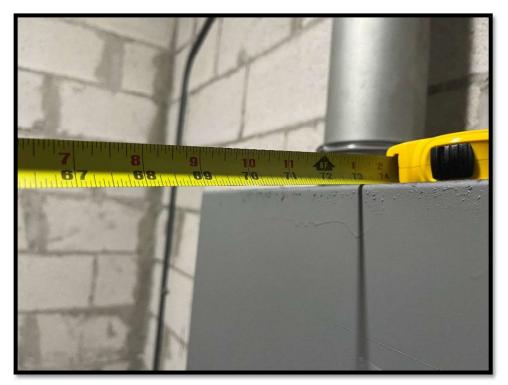
Photograph #34

The National Electrical Code® (NEC)® Section 110.26 requires adequate working space for all electrical equipment.

OSHA, NFPA, and NEC 2020 Section 110.26(A)(1) regulations require that electrical panels are given a 36 inch / 3foot clearance in front to always allow appropriate access, especially in case of an emergency.

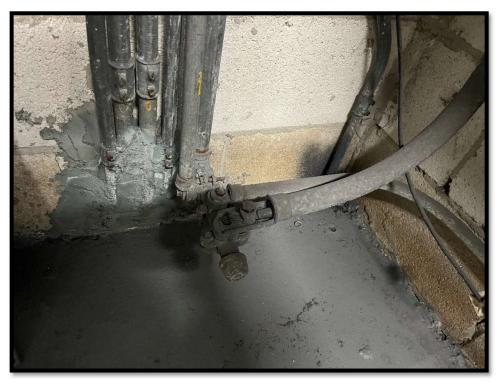
Photograph #35
Ground of the service is properly installed.

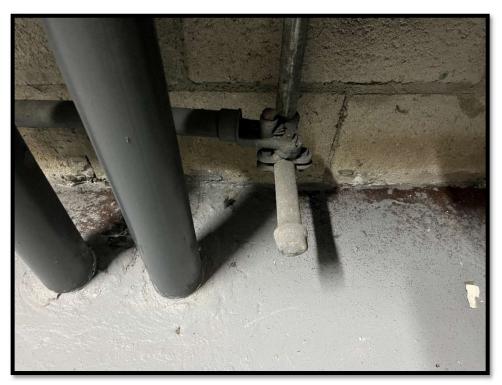
Photograph #36
Ground of the service is properly installed.

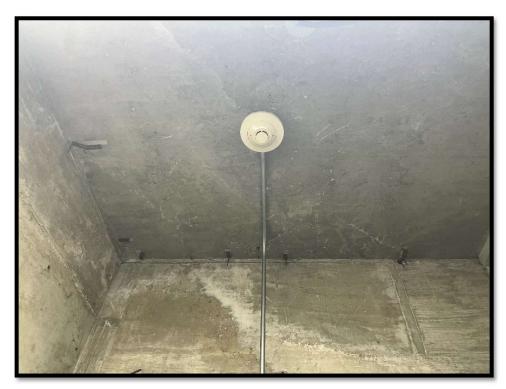
Photograph #37
Smoke detector properly installed.

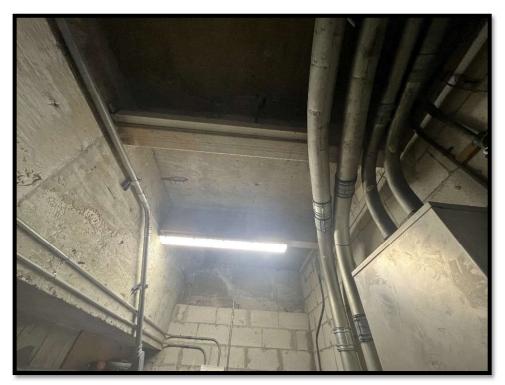
Photograph #38
Electrical room properly lit.

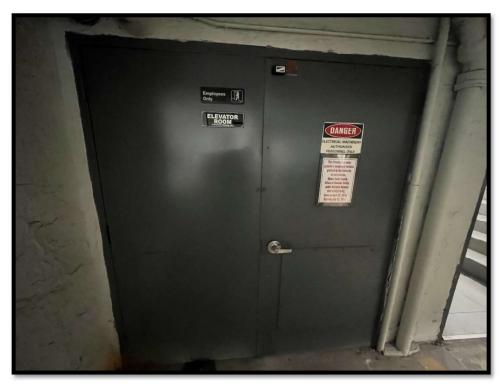
Photograph #39
Elevator Room properly identified.

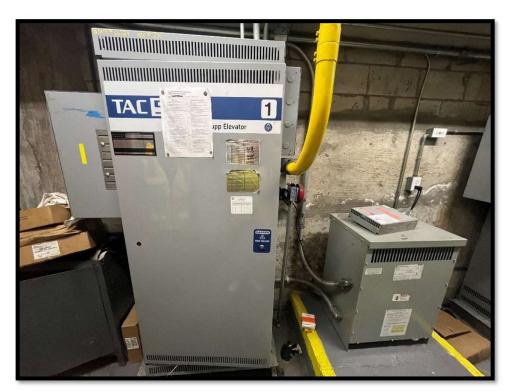
Photograph #40
Elevator Machine 1 properly identified.

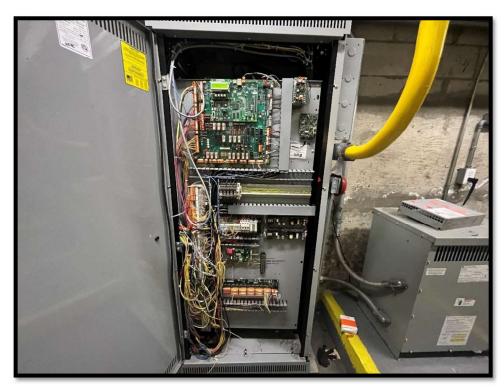
Photograph #41
Elevator Machine 1 properly installed.

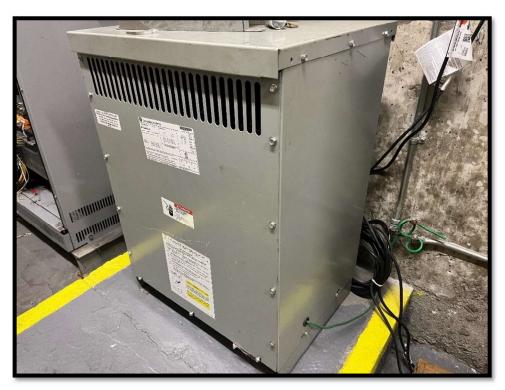
Photograph #43

<u>Transformer 1 properly installed.</u>

Grounding is properly installed.

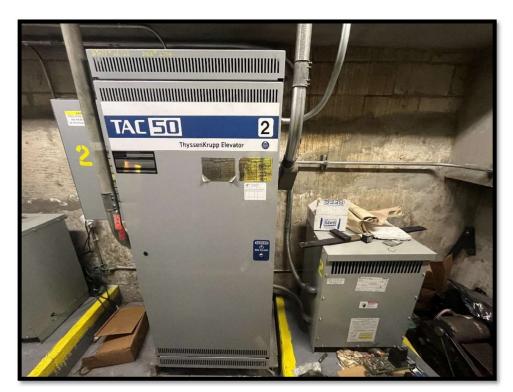
Photograph #44
Elevator Machine 2 properly identified.

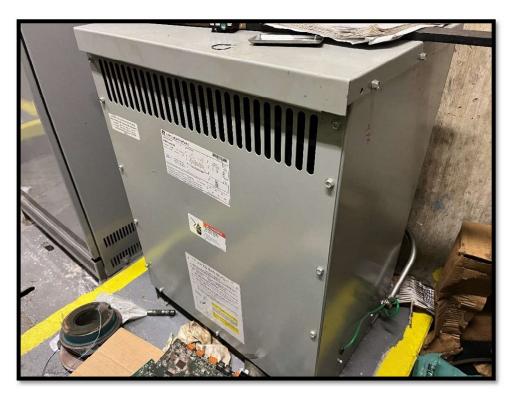
Photograph #47
Transformer 2 properly installed.
Grounding is properly installed.

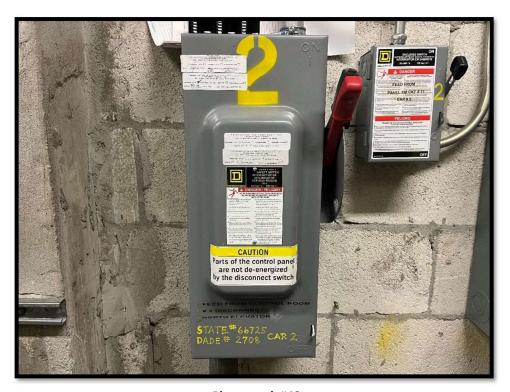
Photograph #48

The Disconnect #2 North Elevator is properly identified.

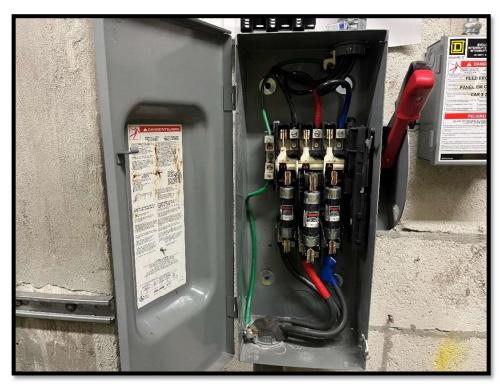
Photograph #49
Phases are properly identified and installed.
Ground of the Disconnect is properly installed.

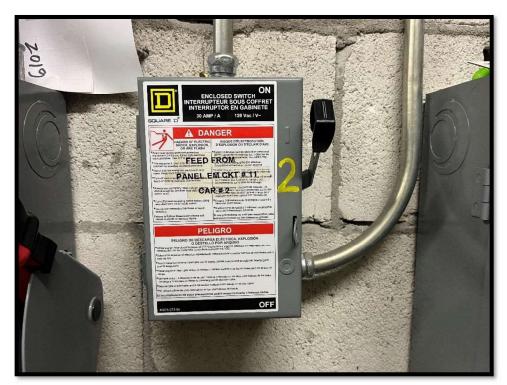
Photograph #50

The Disconnect #2 Feed from Panel EM CKT#11 CAR#2 is properly identified.

The label shall be of sufficient durability to withstand the environment involved and shall not be handwritten. NEC

210.5 C (1) (b). In the 2020 NEC, Section 705.10, Section11.12.2.1.5 in NFPA 1.

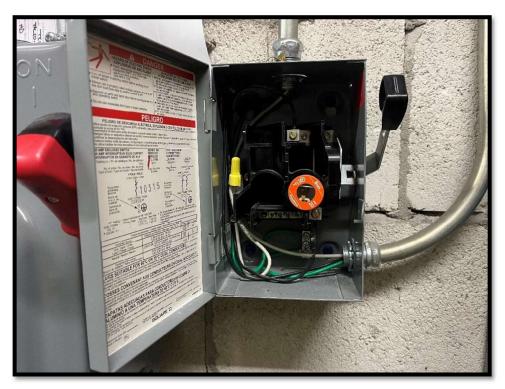
Photograph #51
Ground of the Disconnect is properly installed.

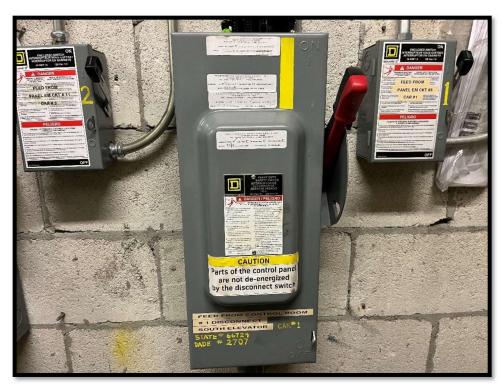
Photograph #52

The Disconnect #1 South Elevator is properly identified.

he label shall be of sufficient durability to withstand the environment involved and shall

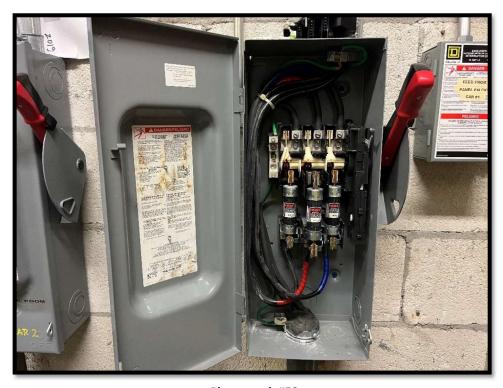
Photograph #53

Phases are properly identified and installed.

Ground of the Disconnect is properly installed.

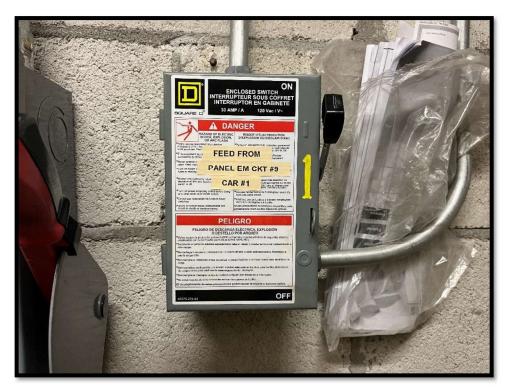
Photograph #54

The Disconnect #1 Feed from Panel EM CKT#9 CAR#1 is properly identified.

The label shall be of sufficient durability to withstand the environment involved and shall not be handwritten. NEC 210.5 C (1) (b). In the 2020 NEC, Section 705.10, Section 11.12.2.1.5 in NFPA 1.

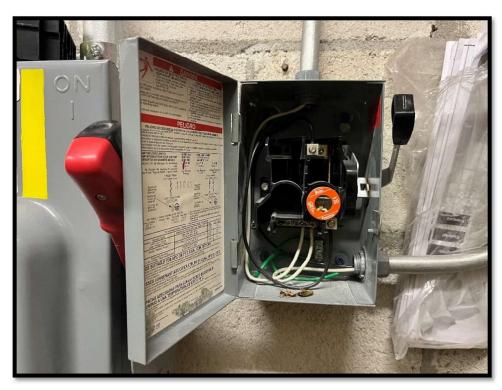
Photograph #55
Ground of the Disconnect is properly installed.

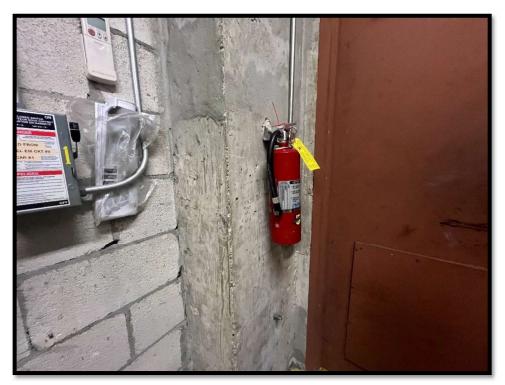
<u>Photograph #56</u> <u>Fire extinguisher properly installed.</u>

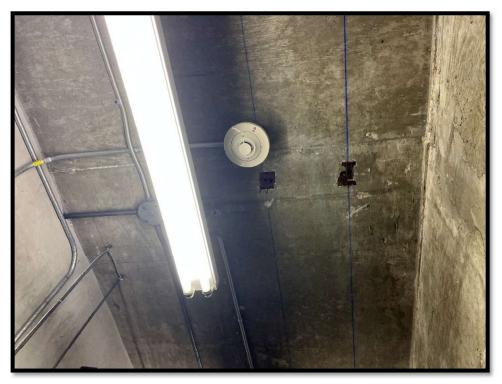
Photograph #57
Smoke detector properly installed.

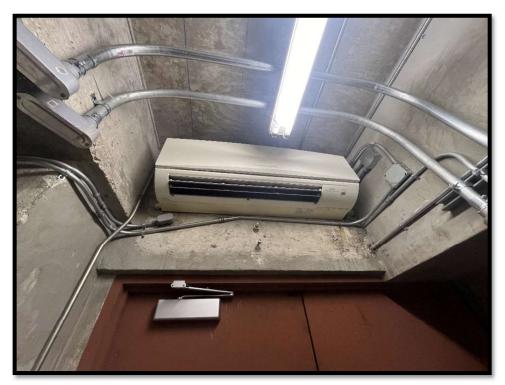
Photograph #58
Mechanical Room properly ventilated.

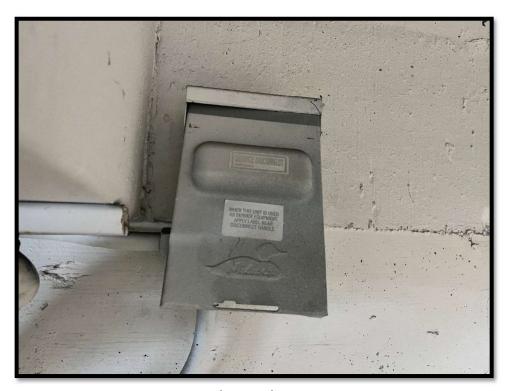
Photograph #60

AC Disconnect properly identified.

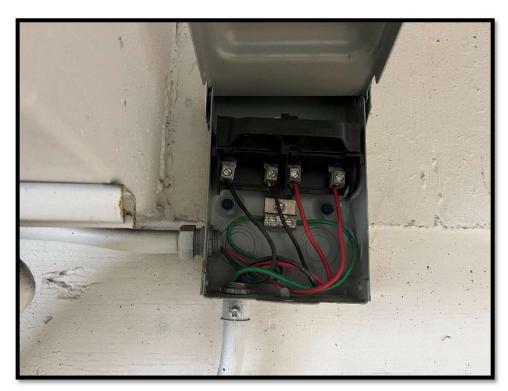
Photograph #61
Ground of the AC Disconnect is properly installed.

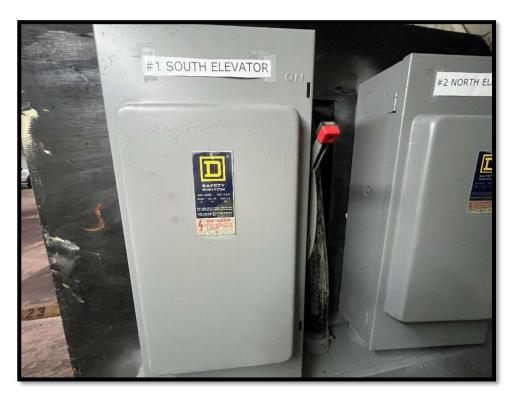
Photograph #64

The Disconnect #1 South Elevator is properly identified.

The label shall be of sufficient durability to withstand the environment involved and shall not be handwritten.

NEC 210.5 C (1) (b). In the 2020 NEC, Section 705.10, Section11.12.2.1.5 in NFPA 1.

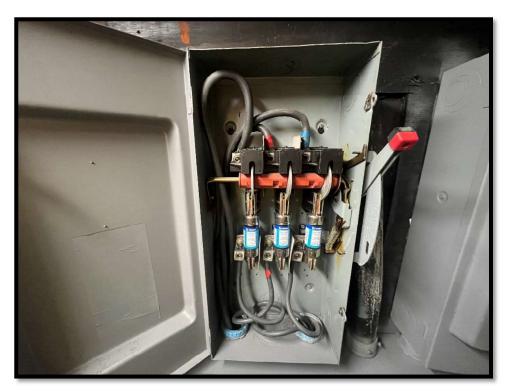
Photograph #65
Phases are properly identified and installed.
Fuses are properly identified and installed.

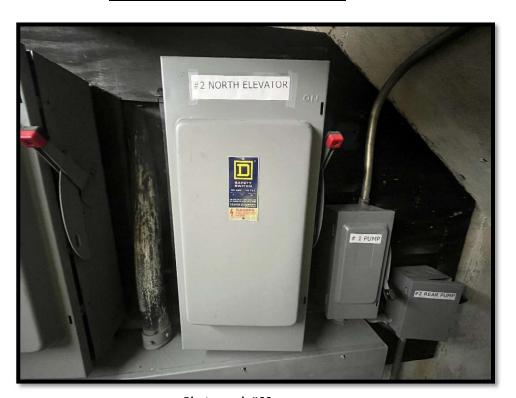
Photograph #66

The Disconnect #2 North Elevator is properly identified.

The label shall be of sufficient durability to withstand the environment involved and shall not be handwritten.

NEC 210.5 C (1) (b). In the 2020 NEC, Section 705.10, Section11.12.2.1.5 in NFPA 1.

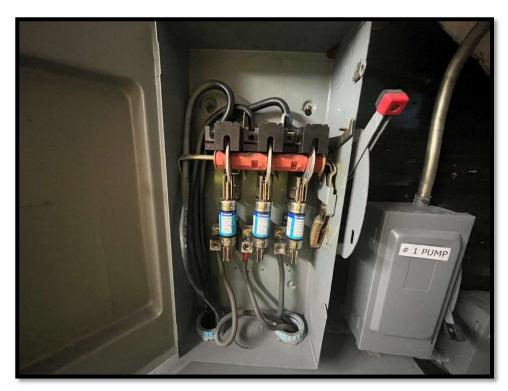
Photograph #67
Phases are properly identified and installed.
Fuses are properly identified and installed.

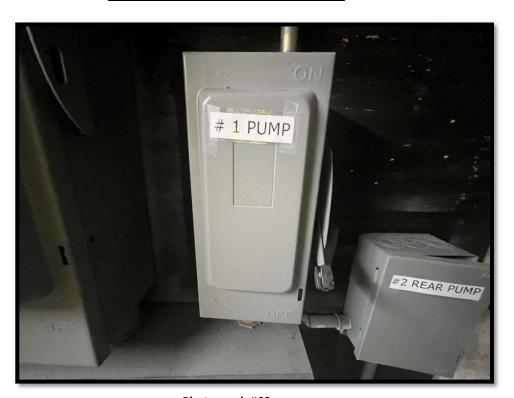
Photograph #68

The Disconnect #1 Pump is properly identified.

The label shall be of sufficient durability to withstand the environment involved and shall not be handwritten.

NEC 210.5 C (1) (b). In the 2020 NEC, Section 705.10, Section11.12.2.1.5 in NFPA 1.

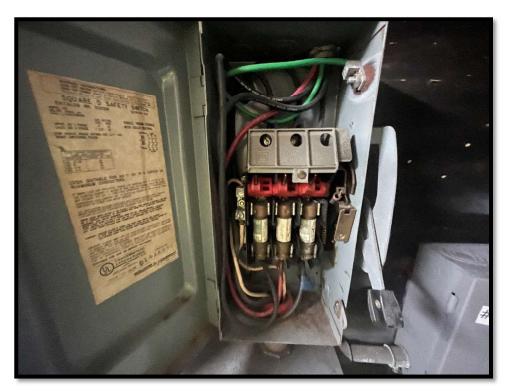
Photograph #69
Phases are properly identified and installed.
Fuses are properly identified and installed.

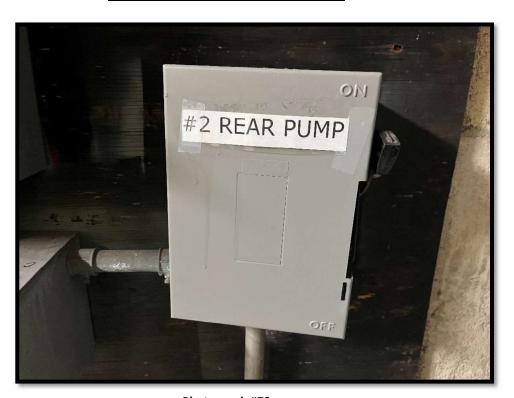
Photograph #70

The Disconnect #2 Rear Pump is properly identified.

The label shall be of sufficient durability to withstand the environment involved and shall not be handwritten.

NEC 210.5 C (1) (b). In the 2020 NEC, Section 705.10, Section11.12.2.1.5 in NFPA 1.

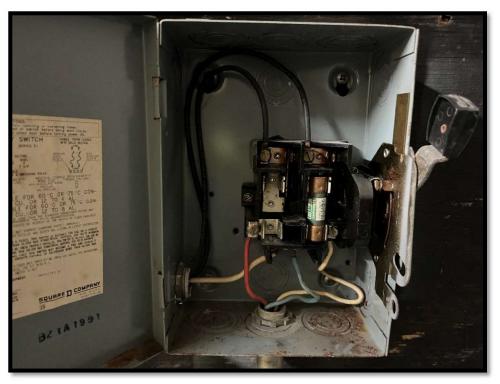
Photograph #71
Phases are properly identified and installed.

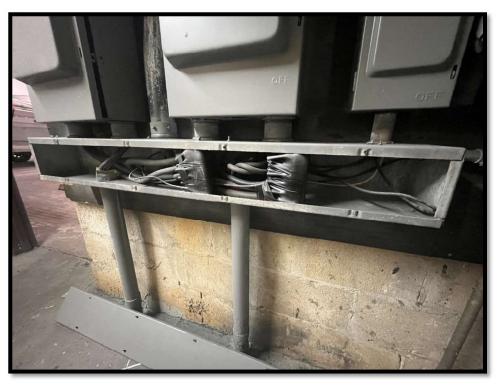
Photograph #73
Gutter properly installed and good standing.

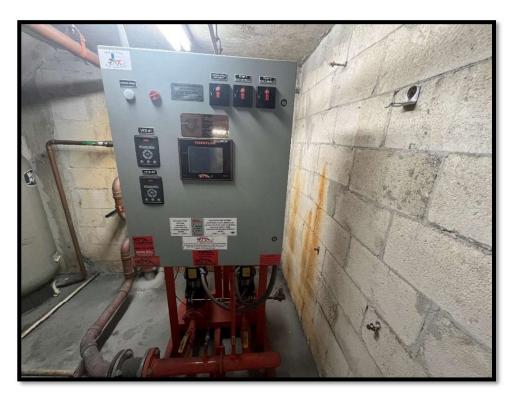
Photograph #74

Fire Pump properly installed and good standing.

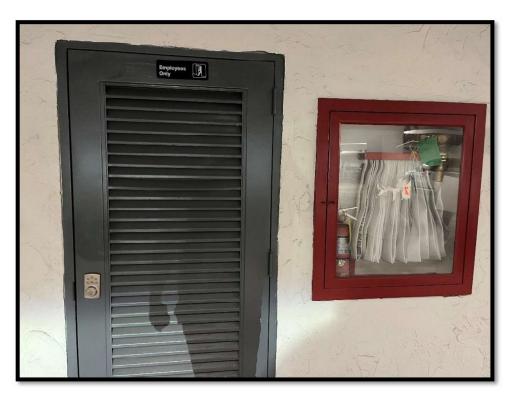
<u>Photograph #75</u> <u>Fire Pump Room 1 properly lit.</u>

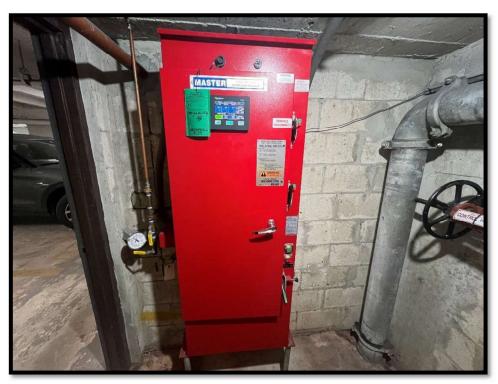
Photograph #76
Electrical Fire Pump Room 2

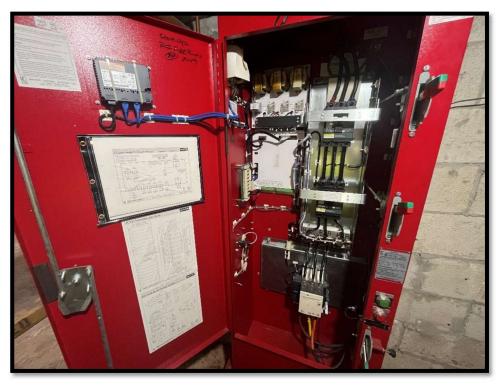
Photograph #77

Disconnect Electrical Fire Pump is properly identified.

The label shall be of sufficient durability to withstand the environment involved and shall not be handwritten.

NEC 210.5 C (1) (b). In the 2020 NEC, Section 705.10, Section11.12.2.1.5 in NFPA 1.

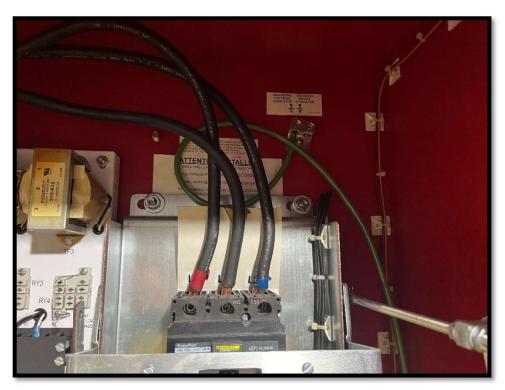
Photograph #78

Disconnect Electrical Fire Pump properly installed and good standing.

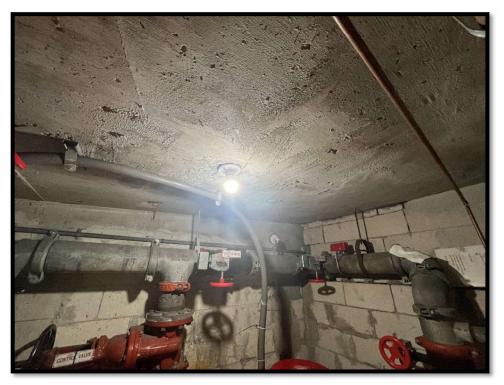
Photograph #79
Grounding is properly installed.

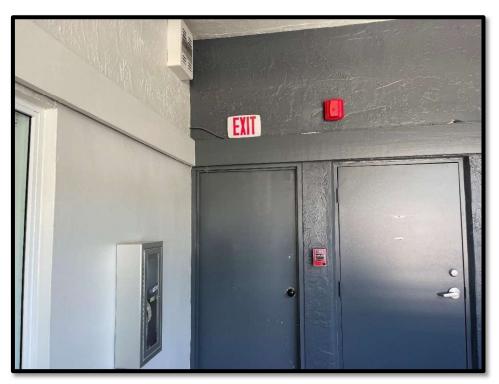
Photograph #81

Exit sign lights outdoor day time at 8 floors in the building in good working condition.

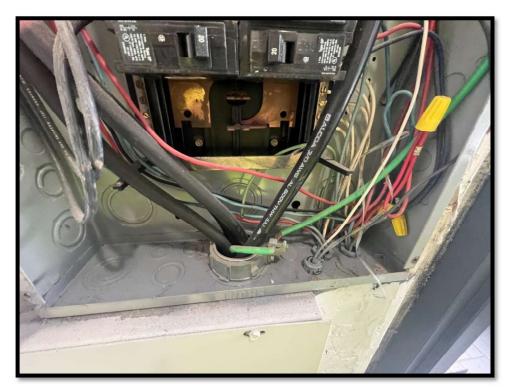
Photograph #86

Phases are properly identified and installed.

Neutral wire properly identified and installed.

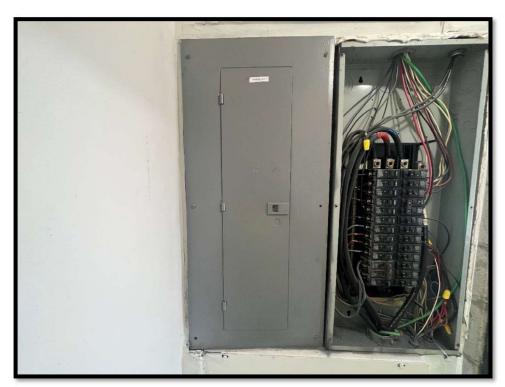
Photograph #87
The ground of the breaker panel is properly installed.

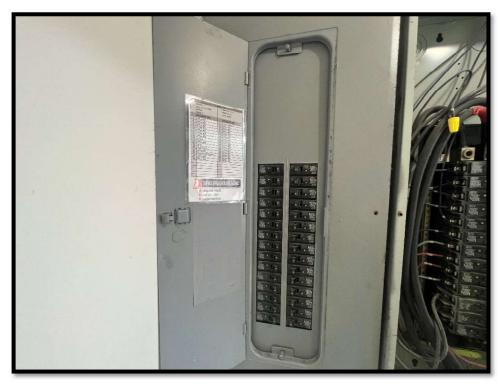
Photograph #88

Circuit Breaker Panel 8 A properly identified.

The label shall be of sufficient durability to withstand the environment involved and shall not be handwritten.

NEC 210.5 C (1) (b). In the 2020 NEC, Section 705.10, Section11.12.2.1.5 in NFPA 1.

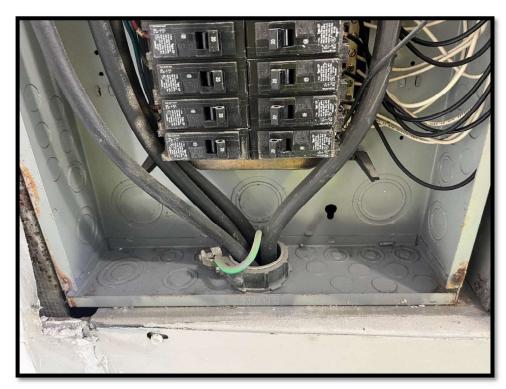
Photograph #90
Phases are properly identified and installed.
Neutral wire properly identified and installed.

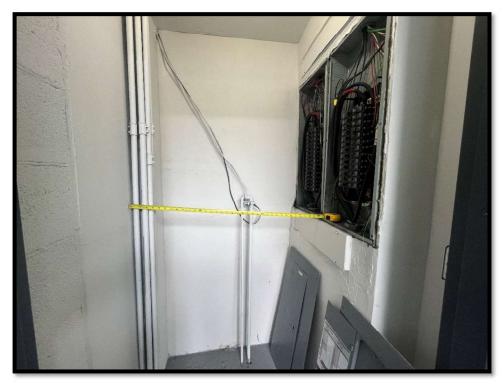
Photograph #91
The ground of the breaker panel is properly installed.

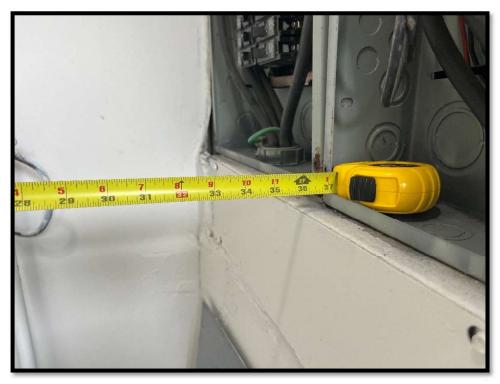
Photograph #92

The National Electrical Code® (NEC)® Section 110.26 requires adequate working space for all electrical equipment.

OSHA, NFPA, and NEC 2020 Section 110.26(A)(1) regulations require that electrical panels are given a 36 inch / 3foot clearance in front to always allow appropriate access, especially in case of an emergency.

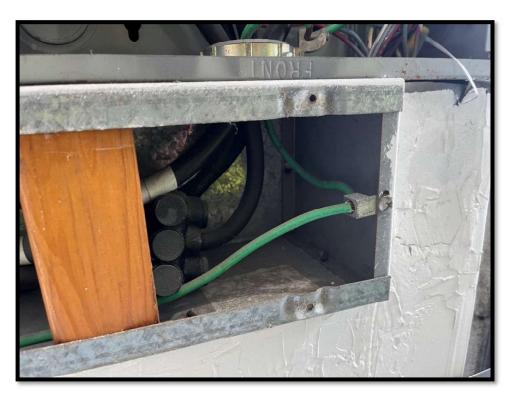
Photograph #95
Gutter properly installed and good standing.

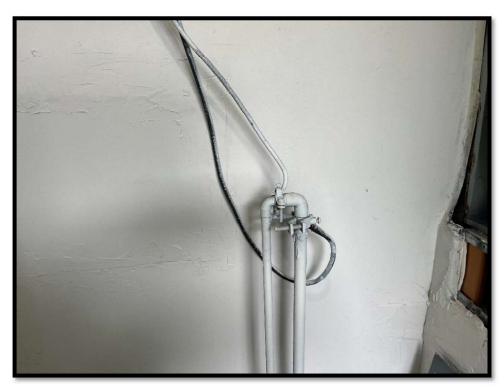
Photograph #96
The ground of the Gutter is properly installed.

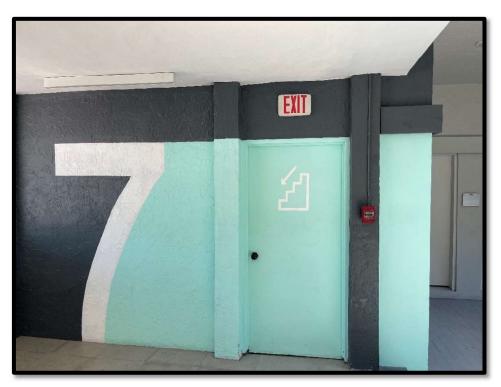
Photograph #98
Electrical room properly lit.

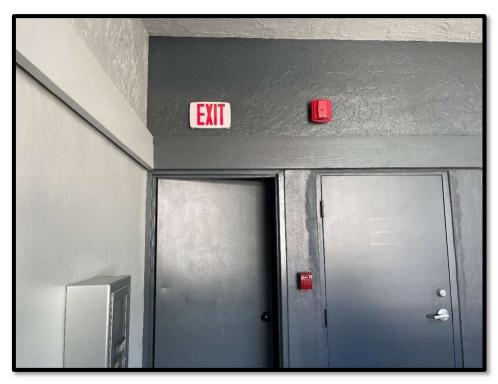
Photograph #99

Exit sign lights outdoor day time at 7 floors in the building in good working condition.

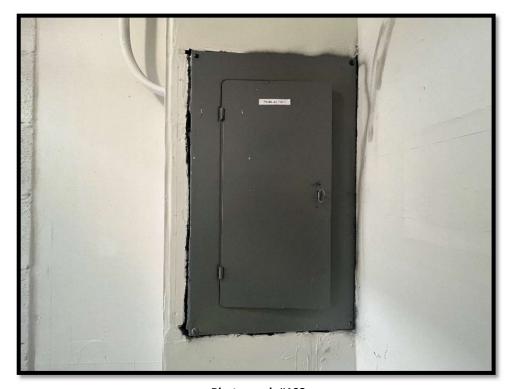
Photograph #101 Electrical Room 7 floor properly identified.

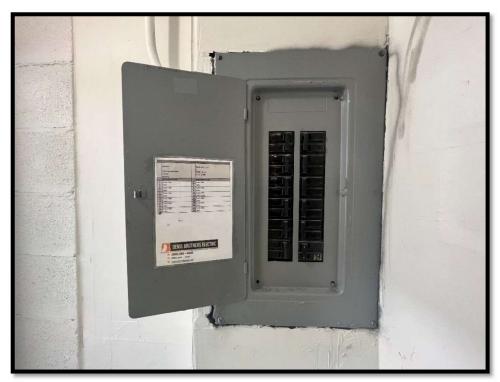
Photograph #102
Circuit Breaker Panel AC 7 th Fl properly identified.

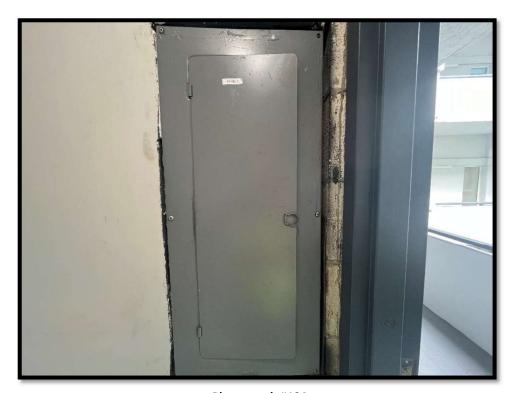
Photograph #104
Phases are properly identified and installed.

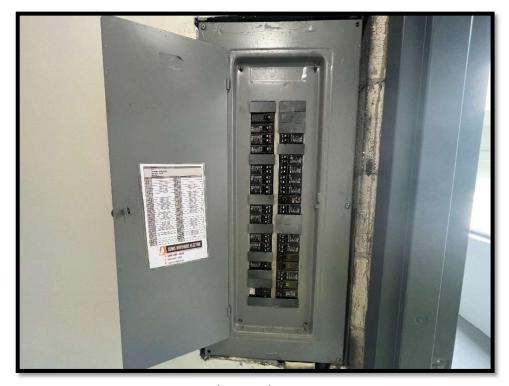
<u>Photograph #104</u> <u>Circuit Breaker Panel 7 properly identified.</u>

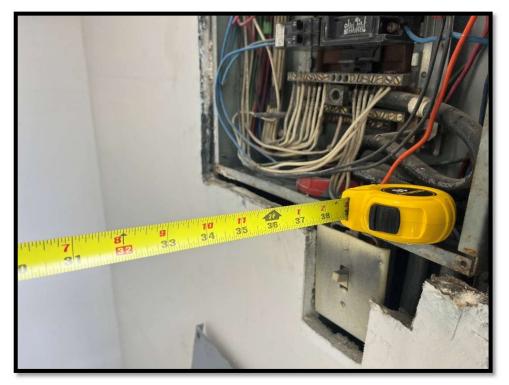
Photograph #108

The National Electrical Code® (NEC)® Section 110.26 requires adequate working space for all electrical equipment.

OSHA, NFPA, and NEC 2020 Section 110.26(A)(1) regulations require that electrical panels are given a 36 inch /

3foot clearance in front to always allow appropriate access, especially in case of an emergency.

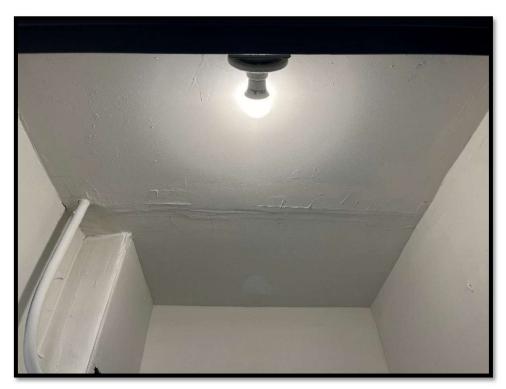
Photograph #109

The National Electrical Code® (NEC)® Section 110.26 requires adequate working space for all electrical equipment.

OSHA, NFPA, and NEC 2020 Section 110.26(A)(1) regulations require that electrical panels are given a 36 inch /

3foot clearance in front to always allow appropriate access, especially in case of an emergency.

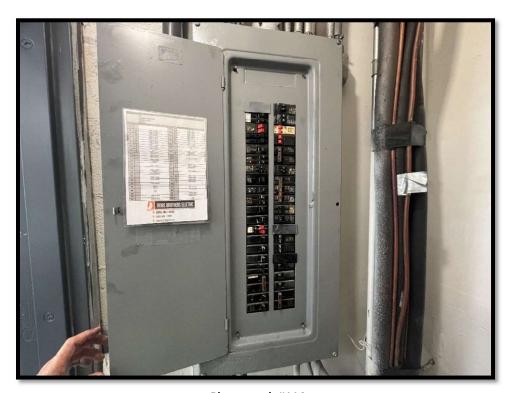
Photograph #113
Circuit Breaker Panel 6 properly identified.

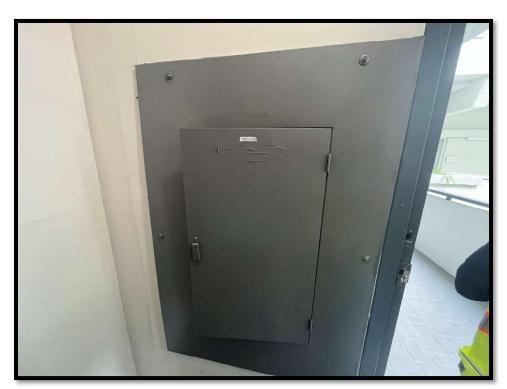
Photograph #116
The ground of the breaker panel is properly installed.

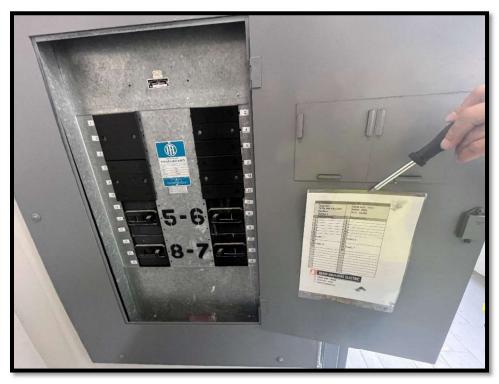
Photograph #117

Circuit Breaker Panel L R properly identified.

The label shall be of sufficient durability to withstand the environment involved and shall not be handwritten.

NEC 210.5 C (1) (b). In the 2020 NEC, Section 705.10, Section11.12.2.1.5 in NFPA 1.

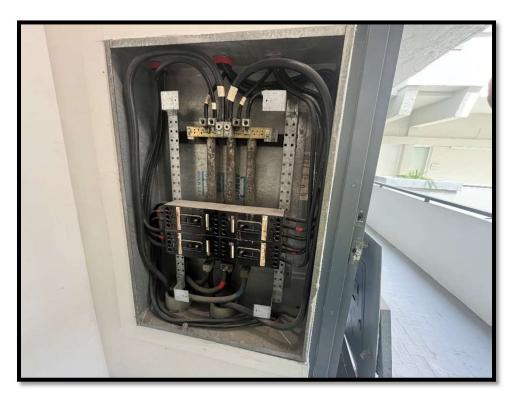
Photograph #118

Circuit Breaker Panel L R properly labeled.

The label shall be of sufficient durability to withstand the environment involved and shall not be handwritten.

NEC 210.5 C (1) (b). In the 2020 NEC, Section 705.10, Section11.12.2.1.5 in NFPA 1.

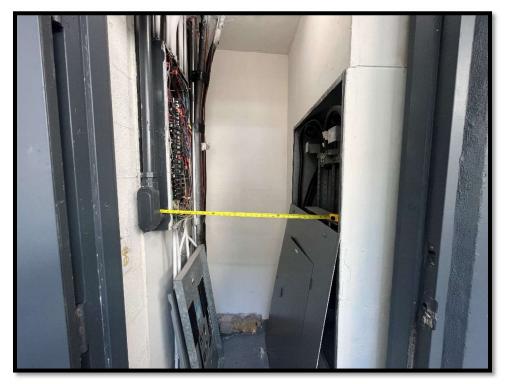
Photograph #120

The National Electrical Code® (NEC)® Section 110.26 requires adequate working space for all electrical equipment.

OSHA, NFPA, and NEC 2020 Section 110.26(A)(1) regulations require that electrical panels are given a 36 inch / 3foot clearance in front to always allow appropriate access, especially in case of an emergency.

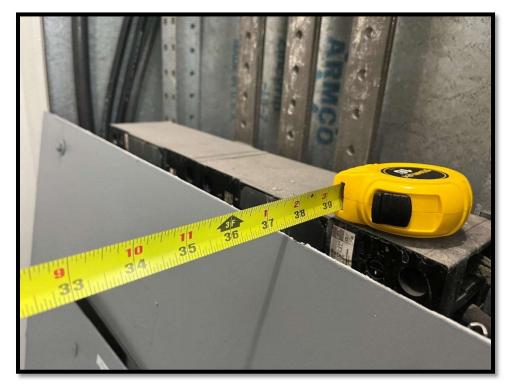
Photograph #121

The National Electrical Code® (NEC)® Section 110.26 requires adequate working space for all electrical equipment.

OSHA, NFPA, and NEC 2020 Section 110.26(A)(1) regulations require that electrical panels are given a 36 inch / 3foot clearance in front to always allow appropriate access, especially in case of an emergency.

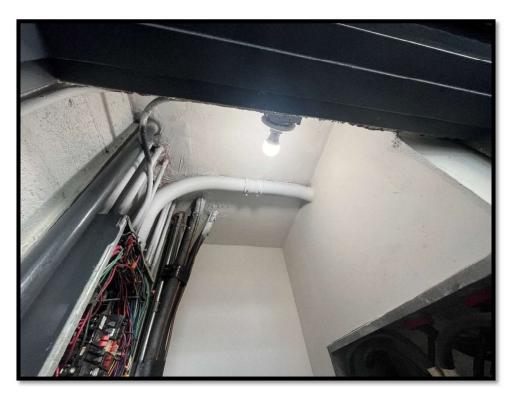
Photograph #122
Electrical room properly lit.

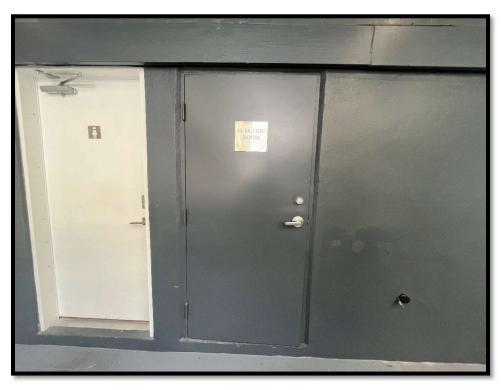
Photograph #124

Electrical Room 5 floor properly identified.

The label shall be of sufficient durability to withstand the environment involved and shall not be handwritten.

NEC 210.5 C (1) (b). In the 2020 NEC, Section 705.10, Section11.12.2.1.5 in NFPA 1.

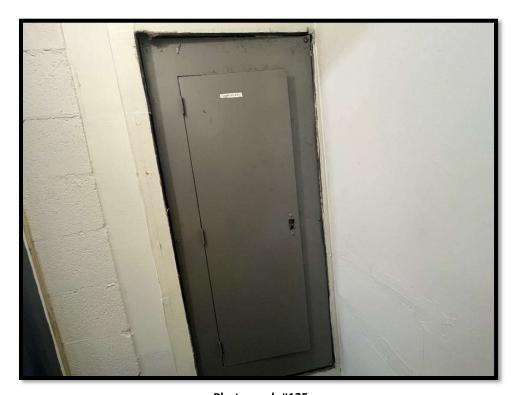
Photograph #125

Circuit Breaker Panel AC th Fl properly identified.

The label shall be of sufficient durability to withstand the environment involved and shall not be handwritten.

NEC 210.5 C (1) (b). In the 2020 NEC, Section 705.10, Section11.12.2.1.5 in NFPA 1.

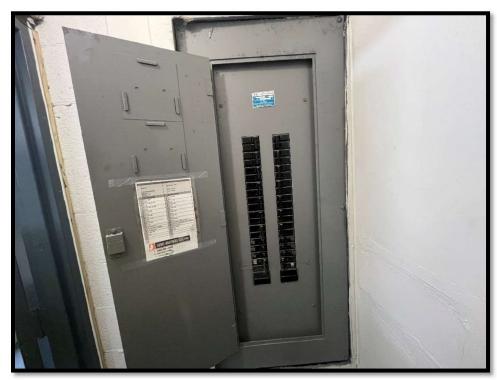
Photograph #126

Circuit Breaker Panel AC th Fl properly labeled.

The label shall be of sufficient durability to withstand the environment involved and shall not be handwritten.

NEC 210.5 C (1) (b). In the 2020 NEC, Section 705.10, Section11.12.2.1.5 in NFPA 1.

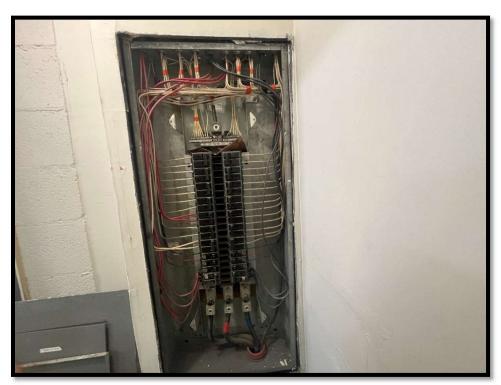
Photograph #127
Phases are properly identified and installed.
Neutral wire properly identified and installed.

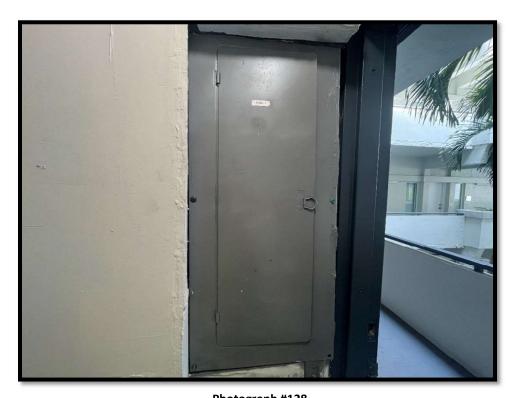
Photograph #128
Circuit Breaker Panel 5 properly identified.
urability to withstand the environment involved and shall not be

The label shall be of sufficient durability to withstand the environment involved and shall not be handwritten.

NEC 210.5 C (1) (b). In the 2020 NEC, Section 705.10, Section11.12.2.1.5 in NFPA 1.

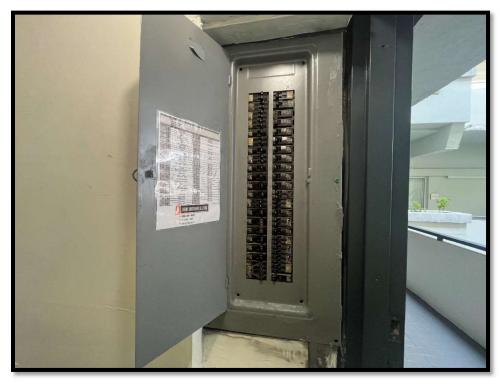
Photograph #129
Circuit Breaker Panel 5 properly labeled.

The label shall be of sufficient durability to withstand the environment involved and shall not be handwritten.

NEC 210.5 C (1) (b). In the 2020 NEC, Section 705.10, Section11.12.2.1.5 in NFPA 1.
