OFFICE OF THE PROPERTY APPRAISER

| Property Information | | | | | |
|---|--|--|--|--|--|
| Property Address: | 250 CATALONIA AVE Coral Gables, FL 33134-6735 | | | | |

RE-INSPECTION OF 250 CATALONIA PASSED INSPECTION, ALL DEFICIENCIES NOTED IN THE

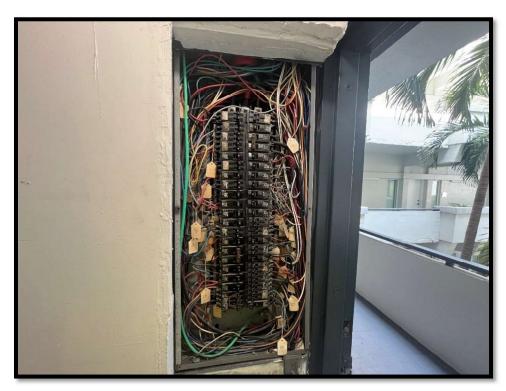
Photograph #130
Phases are properly identified and installed.
Neutral wire properly identified and installed.

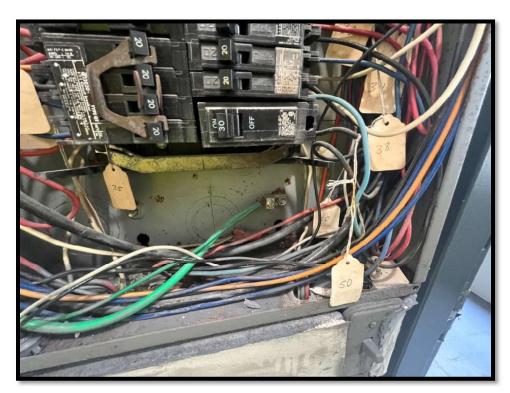
Photograph #131
The ground of the breaker panel is properly installed.

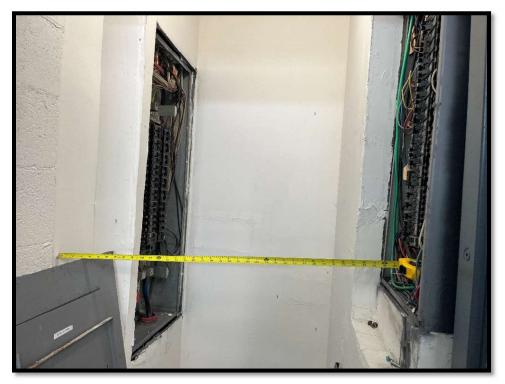
Photograph #132

The National Electrical Code® (NEC)® Section 110.26 requires adequate working space for all electrical equipment.

OSHA, NFPA, and NEC 2020 Section 110.26(A)(1) regulations require that electrical panels are given a 36 inch / 3foot clearance in front to always allow appropriate access, especially in case of an emergency.

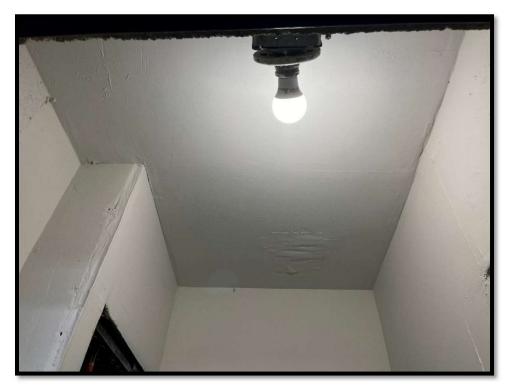
Photograph #134
Electrical room properly lit.

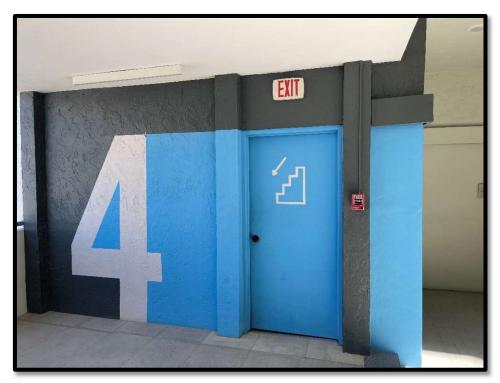
Photograph #135

Exit sign lights outdoor day time at 4th floors in the building in good working condition.

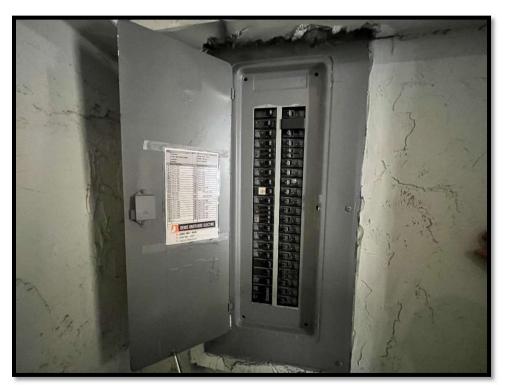
Photograph #137

<u>Circuit Breaker Panel 4 properly labeled.</u>

The label shall be of sufficient durability to withstand the environment involved and shall not be handwritten.

NEC 210.5 C (1) (b). In the 2020 NEC, Section 705.10, Section11.12.2.1.5 in NFPA 1.

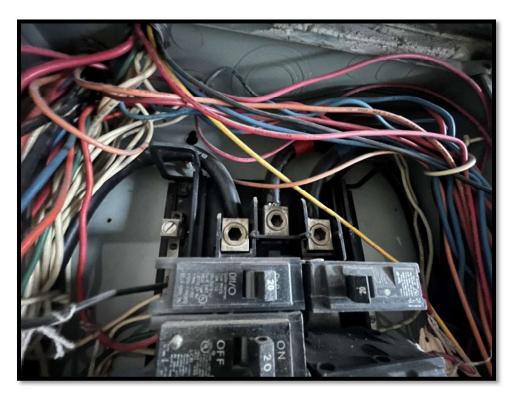
Photograph #139
Phases are properly identified and installed.

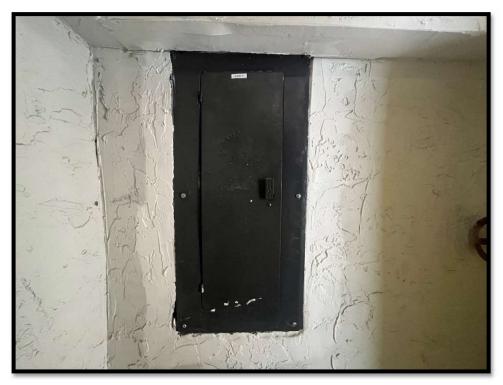
Photograph #141

Circuit Breaker Panel 3 properly identified.

The label shall be of sufficient durability to withstand the environment involved and shall not be handwritten.

NEC 210.5 C (1) (b). In the 2020 NEC, Section 705.10, Section11.12.2.1.5 in NFPA 1.

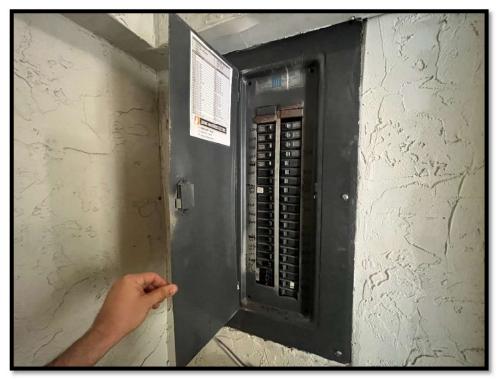
Photograph #142

<u>Circuit Breaker Panel 3 properly labeled.</u>

The label shall be of sufficient durability to withstand the environment involved and shall not be handwritten.

NEC 210.5 C (1) (b). In the 2020 NEC, Section 705.10, Section11.12.2.1.5 in NFPA 1.

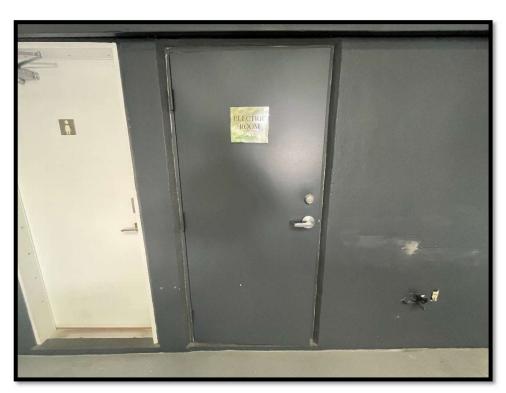
Photograph #145

Electrical Room 3 floor properly identified.

The label shall be of sufficient durability to withstand the environment involved and shall not be handwritten.

NEC 210.5 C (1) (b). In the 2020 NEC, Section 705.10, Section11.12.2.1.5 in NFPA 1.

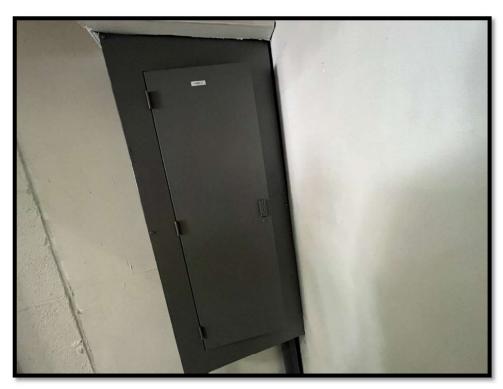
Photograph #146

Circuit Breaker Panel 3 properly identified.

The label shall be of sufficient durability to withstand the environment involved and shall not be handwritten.

NEC 210.5 C (1) (b). In the 2020 NEC, Section 705.10, Section11.12.2.1.5 in NFPA 1.

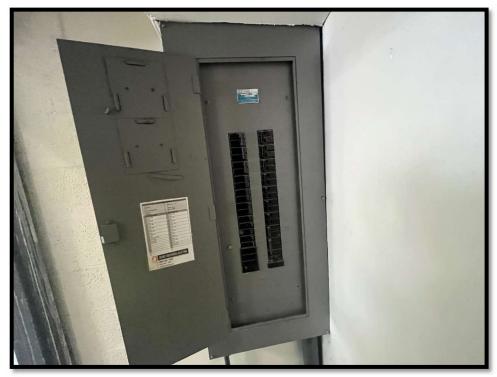
Photograph #147

<u>Circuit Breaker Panel 3 properly labeled.</u>

The label shall be of sufficient durability to withstand the environment involved and shall not be handwritten.

NEC 210.5 C (1) (b). In the 2020 NEC, Section 705.10, Section11.12.2.1.5 in NFPA 1.

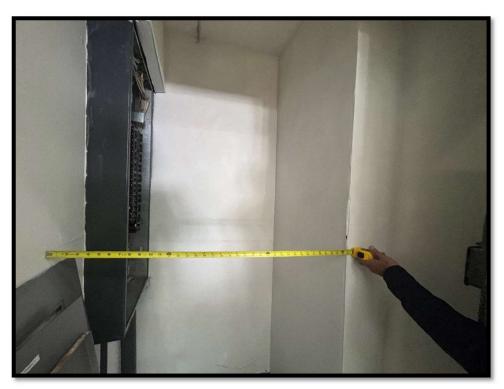
Photograph #150

The National Electrical Code® (NEC)® Section 110.26 requires adequate working space for all electrical equipment.

OSHA, NFPA, and NEC 2020 Section 110.26(A)(1) regulations require that electrical panels are given a 36 inch /

3foot clearance in front to always allow appropriate access, especially in case of an emergency.

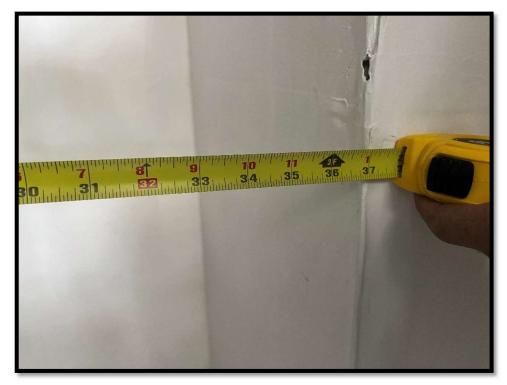
Photograph #151

The National Electrical Code® (NEC)® Section 110.26 requires adequate working space for all electrical equipment.

3foot clearance in front to always allow appropriate access, especially in case of an emergency.

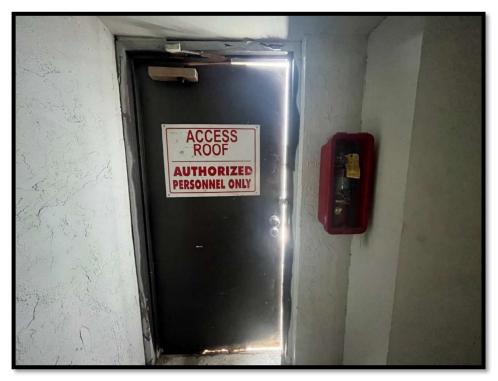
Photograph #153
Roof access is properly identified.
Extinguisier is properly installed.

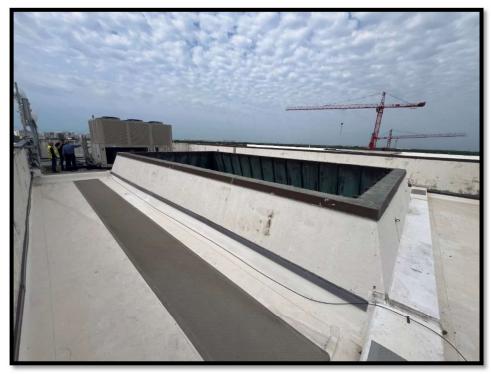
Photograph #154
AC Roof area electrical installation is in good condition.

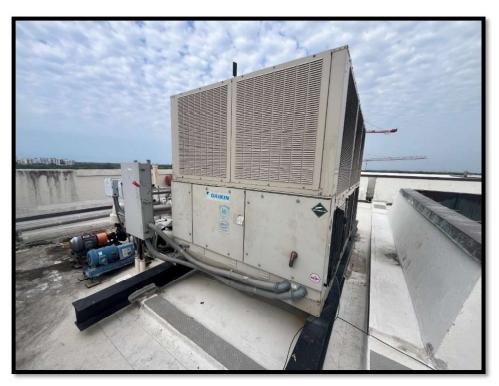
Photograph #155
AC Roof Area properly installed and good standing.

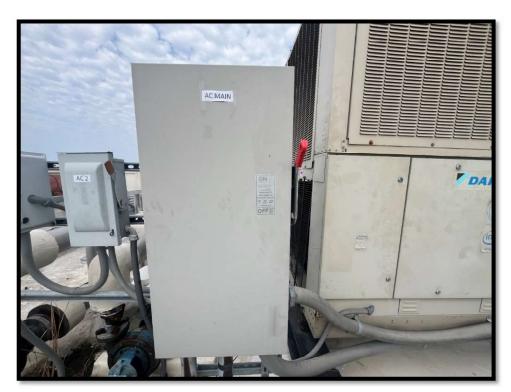
Photograph #156
The Disconnect AC MAIN is properly identified.

The label shall be of sufficient durability to withstand the environment involved and shall not be handwritten. NEC 210.5 C (1) (b). In the 2020 NEC, Section 705.10, Section 11.12.2.1.5 in NFPA 1.

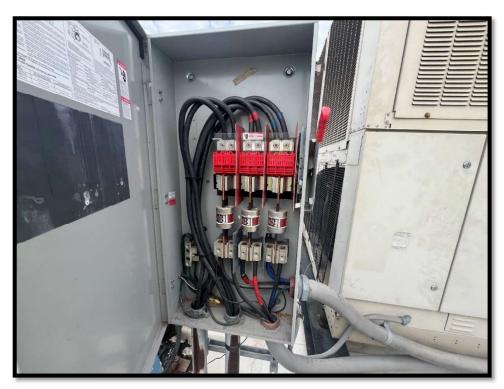
Photograph #157
Phases are properly identified and installed.

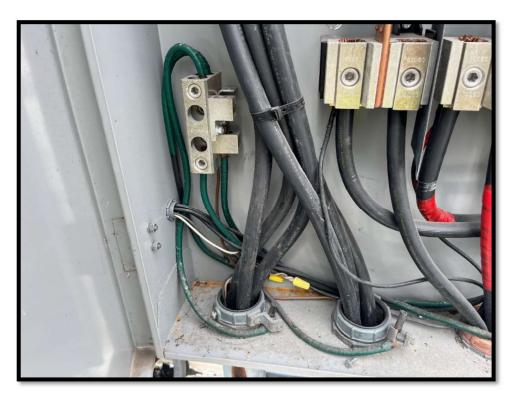
Photograph #158
Ground of the Disconnect is properly installed.

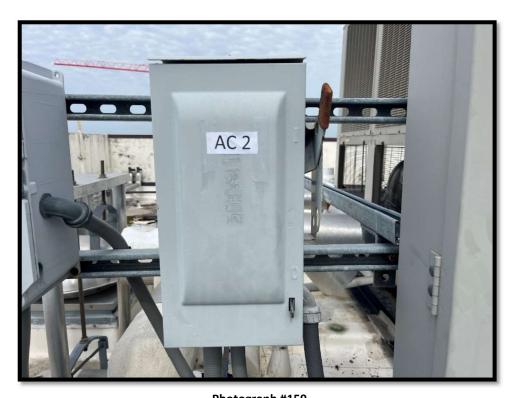
Photograph #159
The Disconnect AC 2 is properly identified.

The label shall be of sufficient durability to withstand the environment involved and shall not be handwritten. NEC 210.5 C (1) (b). In the 2020 NEC, Section 705.10, Section11.12.2.1.5 in NFPA 1.

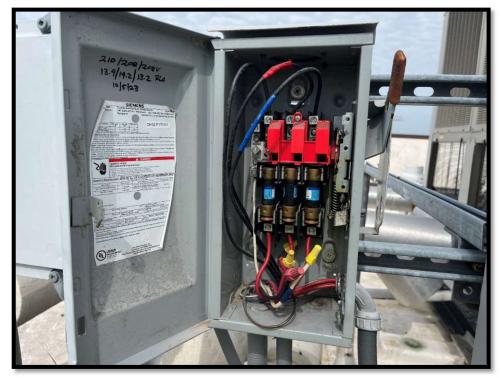
Photograph #160
Phases are properly identified and installed.
Neutral wire properly identified and installed.

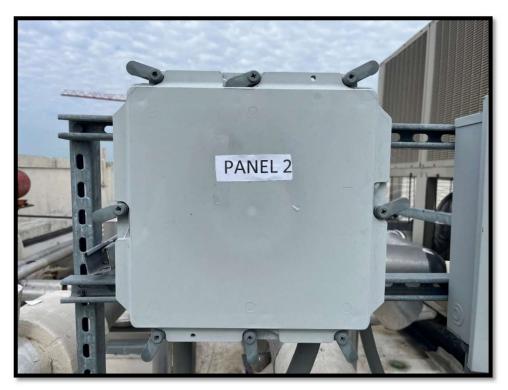
Photograph #161
Panel 2 is properly identified.

The label shall be of sufficient durability to withstand the environment involved and shall not be handwritten. NEC 210.5 C (1) (b). In the 2020 NEC, Section 705.10, Section11.12.2.1.5 in NFPA 1.

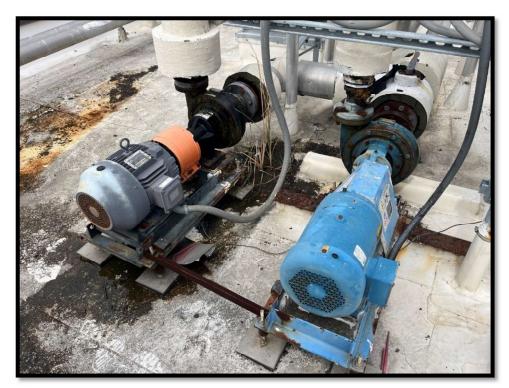
Photograph #163
Ground wire properly connected in the electric motors.

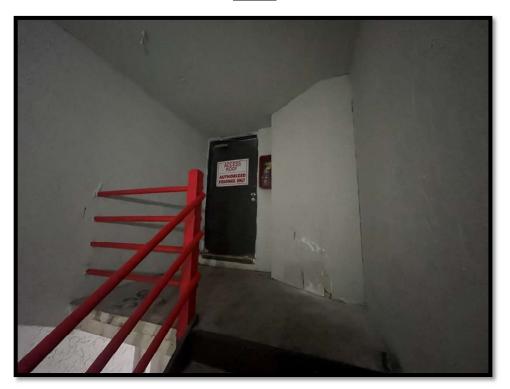
Photograph #164
The stairway landing properly illuminated.

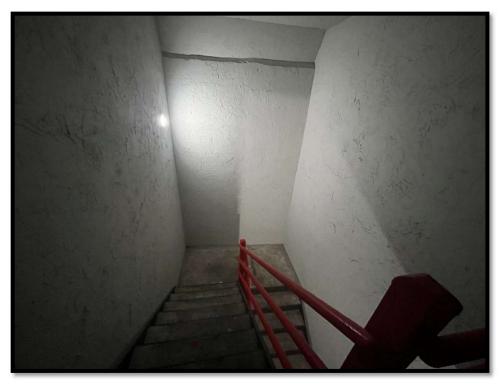
Photograph #165
The stairway landing properly illuminated.

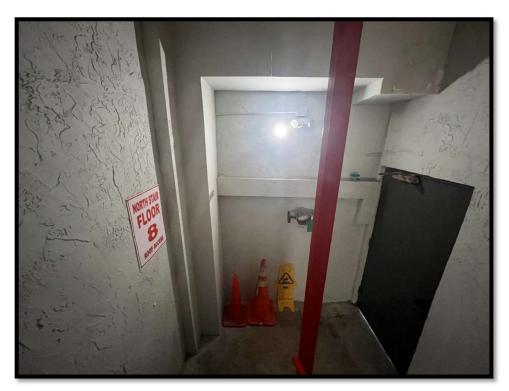
Photograph #166
The stairway landing properly illuminated.
Emergency lights properly installed.

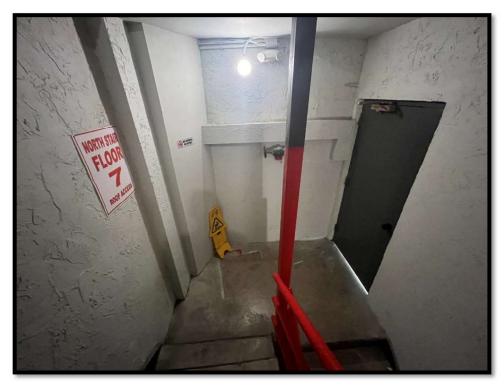
Photograph #169
The stairway landing properly illuminated.
Emergency lights properly installed.

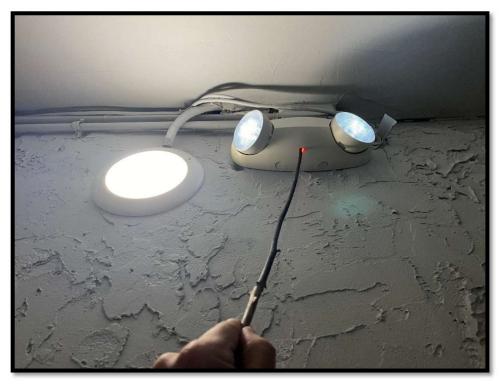
Photograph #170
Emergency lights properly installed and in good working condition.

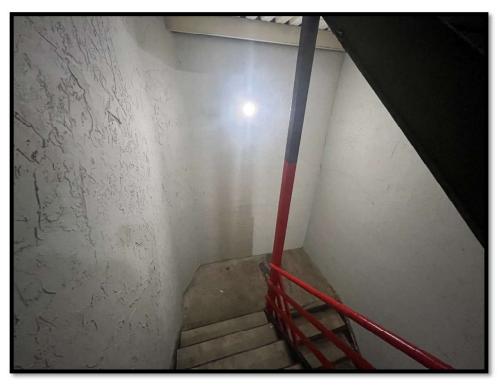
Photograph #171
The stairway landing properly illuminated.

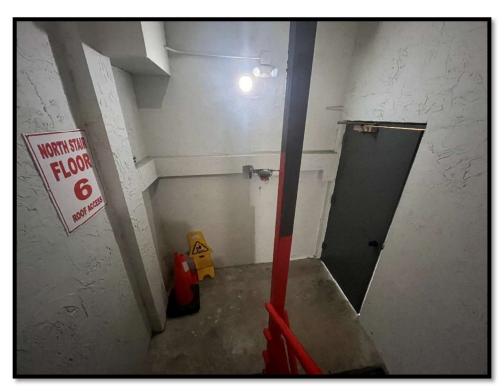
Photograph #172
The stairway landing properly illuminated.
Emergency lights properly installed.

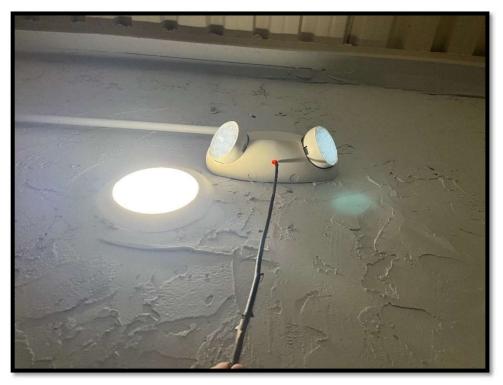
Photograph #173
Emergency lights properly installed and in good working condition.

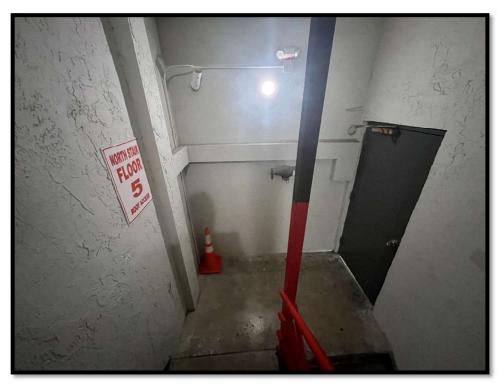
Photograph #175
The stairway landing properly illuminated.
Emergency lights properly installed.

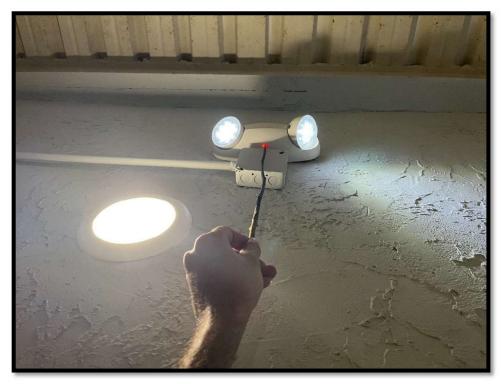
Photograph #176
Emergency lights properly installed and in good working condition.

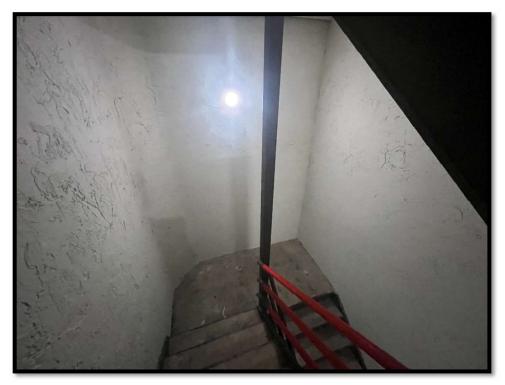
Photograph #177
The stairway landing properly illuminated.

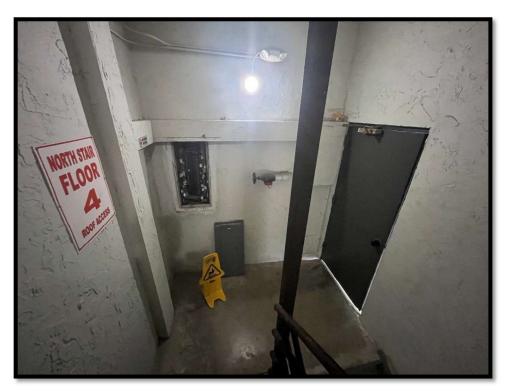
Photograph #178
The stairway landing properly illuminated.
Emergency lights properly installed.

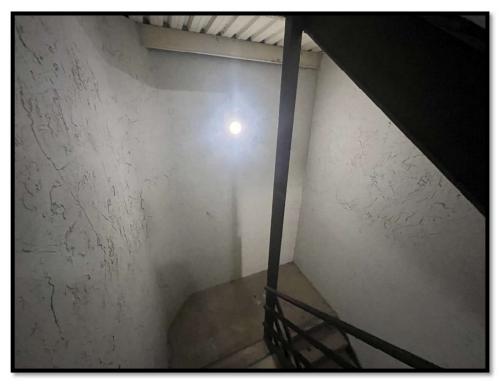
Photograph #179
The stairway landing properly illuminated.

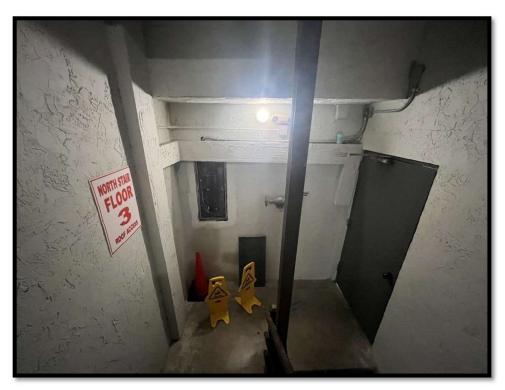
Photograph #180
The stairway landing properly illuminated.
Emergency lights properly installed.

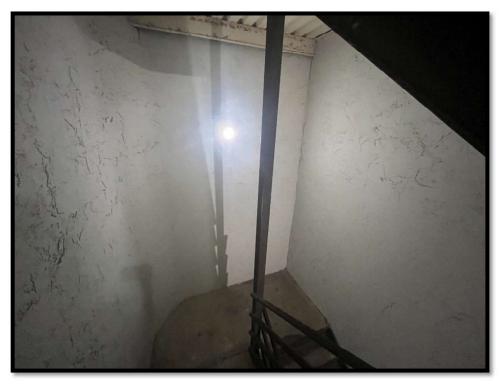
Photograph #181
The stairway landing properly illuminated.

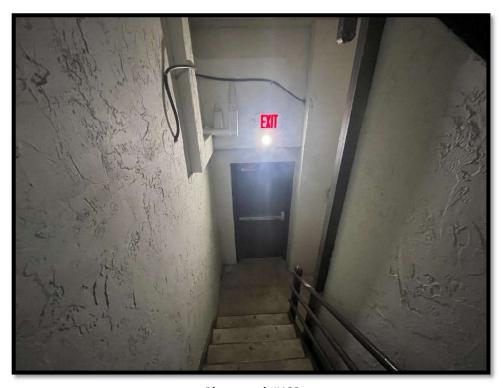
Photograph #182
The stairway landing properly illuminated.
Exit sign light and Emergency Light combo properly installed.

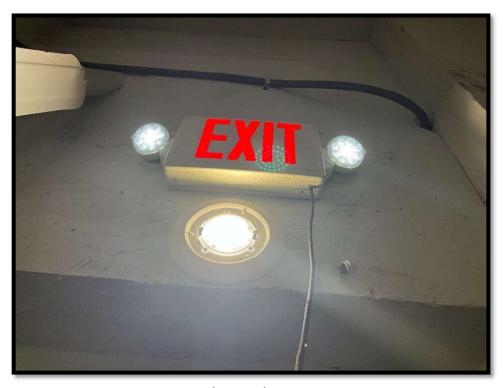
Photograph #183

The stairway landing properly illuminated.

Exit sign light and Emergency Light combo properly installed and in good working condition.

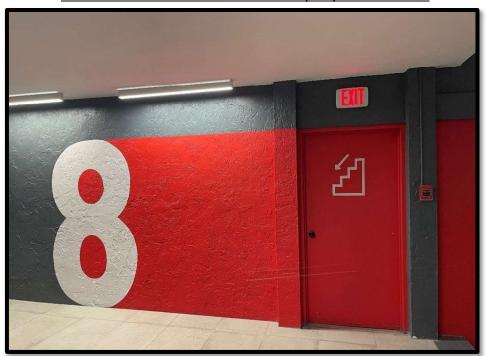
Photograph #184

Exit sign lights outdoor nighttime at 8th floors in the building in good working condition.

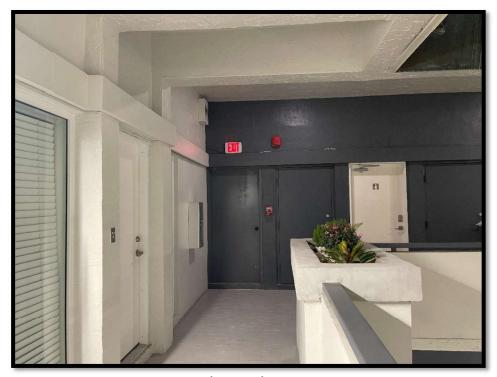
Photograph #185

Exit sign lights outdoor nighttime at 8th floors in the building in good working condition.

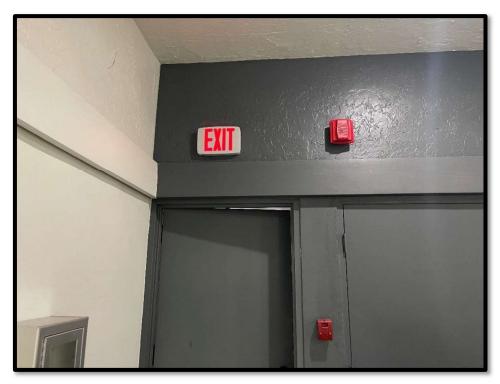
Photograph #187

Exit sign lights outdoor nighttime at 7th floors in the building in good working condition.

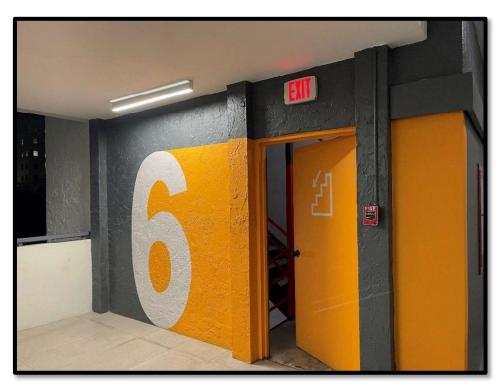
Photograph #188

Exit sign lights outdoor nighttime at 6th floors in the building in good working condition.

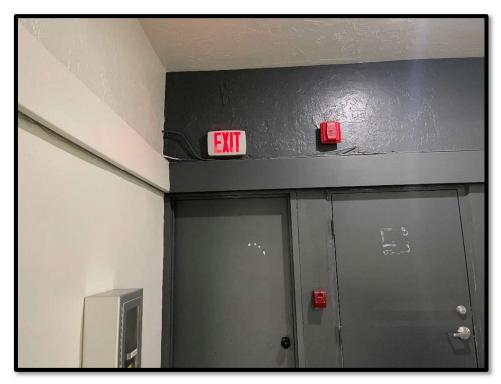
Photograph #191

Exit sign lights outdoor nighttime at 5th floors in the building in good working condition.

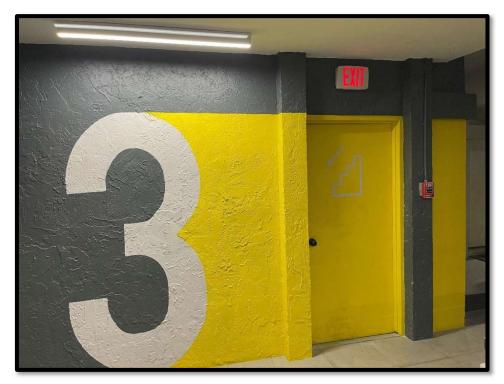
Photograph #193 Exit sign lights outdoor nighttime at 3rd floors in the building in good working condition.

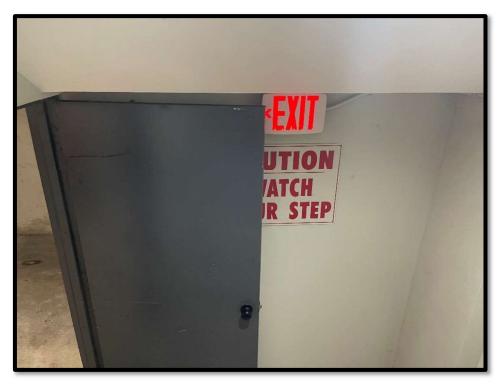
Photograph #197

Exit sign lights outdoor nighttime, access to parking garage in the building in good working condition.

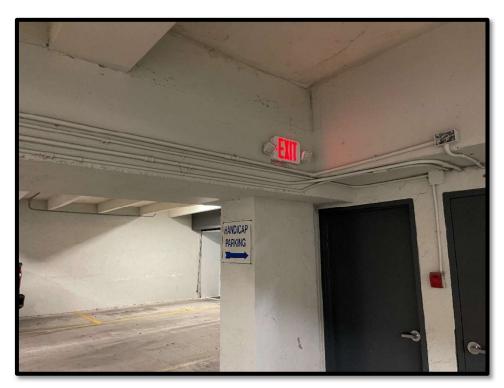
Photograph #198

Exit sign lights outdoor nighttime at parking garage in the building in good working condition.

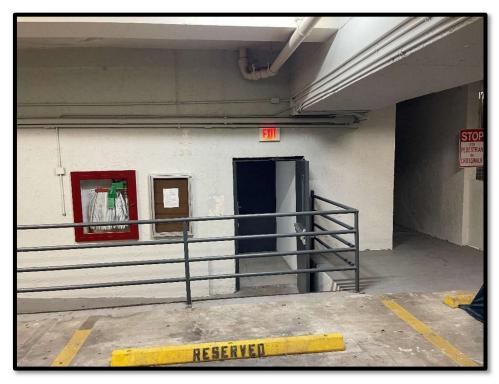
Photograph #199
Exit sign lights outdoor nighttime at parking garage in the building in good working condition.

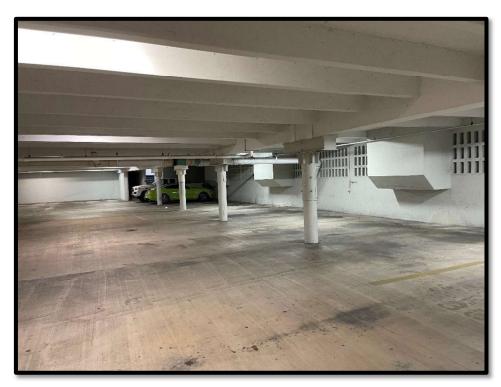
Photograph #200

Building interior parking garage illumination and lights in good working condition.

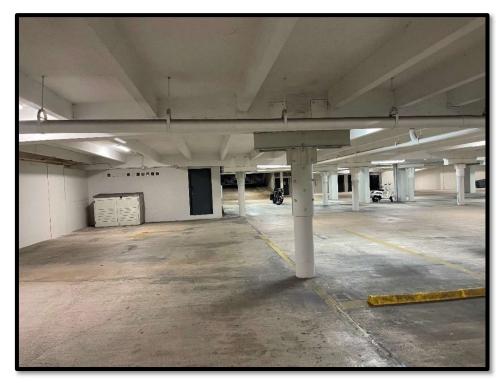
Photograph #203

Building interior parking garage illumination and lights in good working condition.

Is in good standing, in all habitable and non-habitable areas, and deemed necessary.

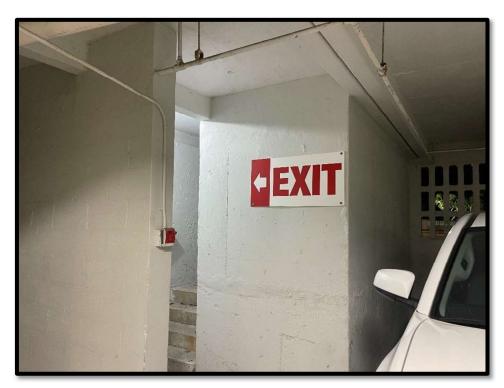
Photograph #204

Exit sign lights outdoor nighttime, access to parking garage in the building in good working condition.

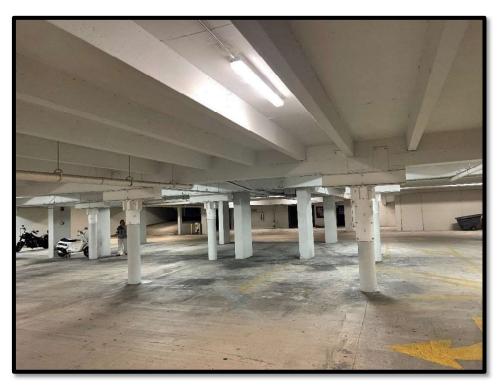
Photograph #206

Building interior parking garage illumination and lights in good working condition.

Is in good standing, in all habitable and non-habitable areas, and deemed necessary.

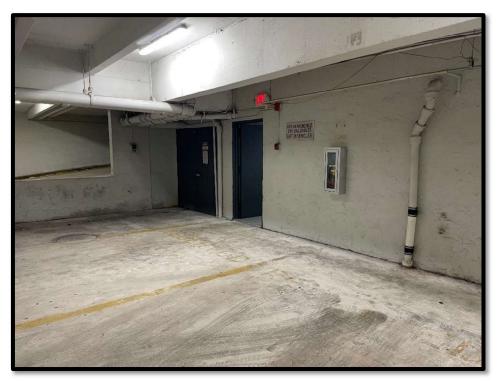
Photograph #207

Exit sign lights outdoor nighttime, access to parking garage in the building in good working condition.

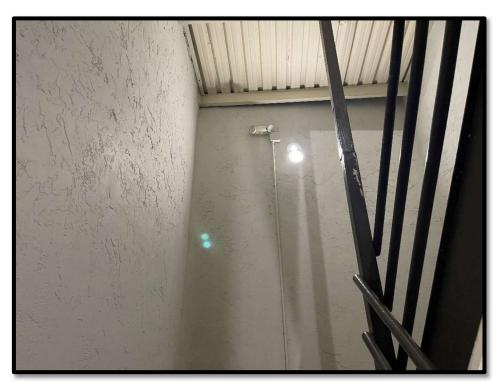
Photograph #209
Emergency light Properly installed and in good condition.

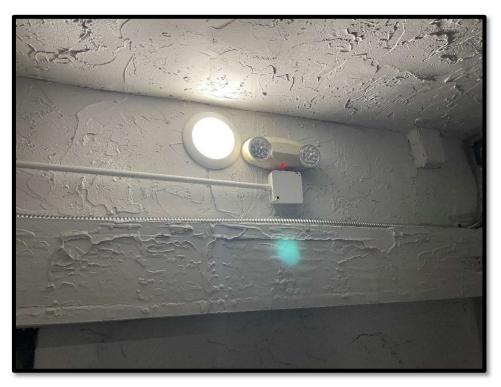
Photograph #210
Emergency light Properly installed and in good condition.

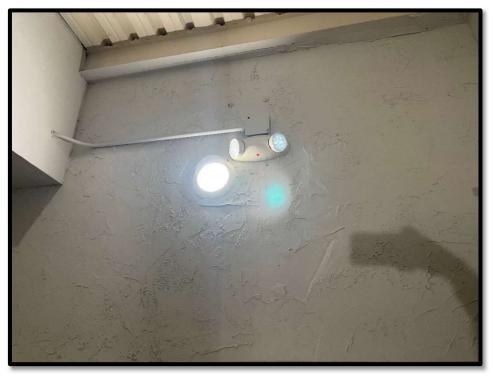
Photograph #211
Emergency light Properly installed and in good condition.

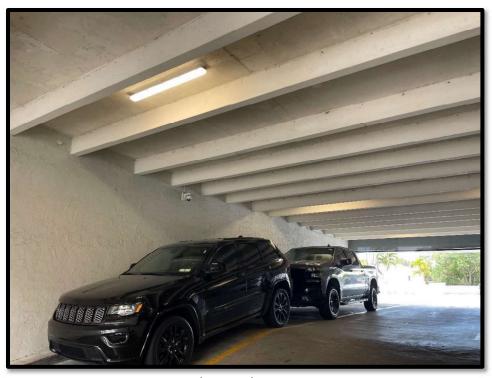
Photograph #212
Re-Inspection 05.20.2024.
Building interior parking garage good illumination and lamps in good working condition.

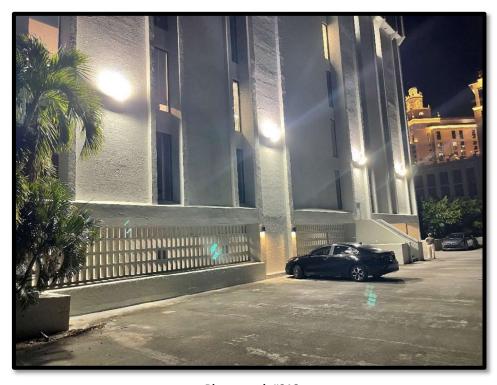
Photograph #218

Parking Garage Exterior Light of the service is in good standing north side area. Parking lot

illumination is according with the foot-candle, (fc, lm/ft2) City required.

This parking area has sufficient illumination.

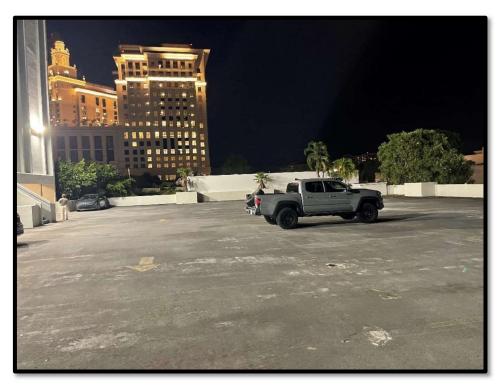
Photograph #219
Re-Inspection 05.26.2023.

Parking Garage Exterior Light of the service good illumination and lamps in good working condition, in good standing at West, South and East side area.

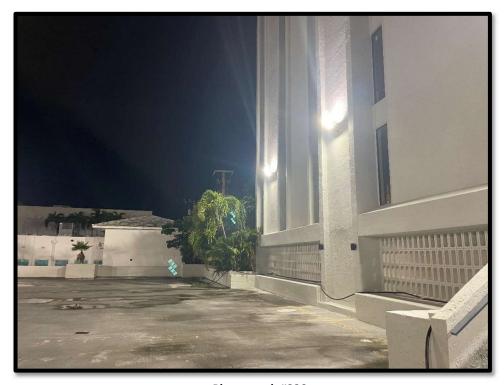
Photograph #220 Re-Inspection 05.26.2023.

Parking Garage Exterior Light of the service good illumination and lamps in good working condition, in good standing at North, West, South and East side area.

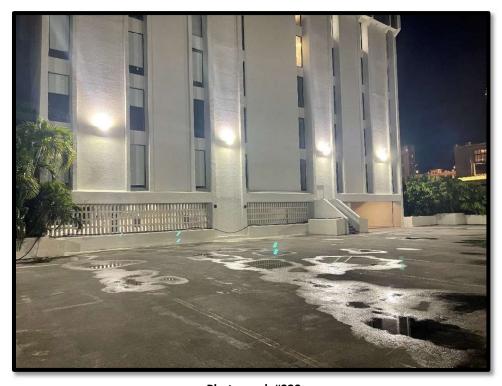
Photograph #221 Re-Inspection 05.26.2023.

<u>Parking Garage Exterior Light of the service good illumination and lamps in good working condition, in good standing at North, West, South and East side area, in all habitable and non-habitable areas.</u>

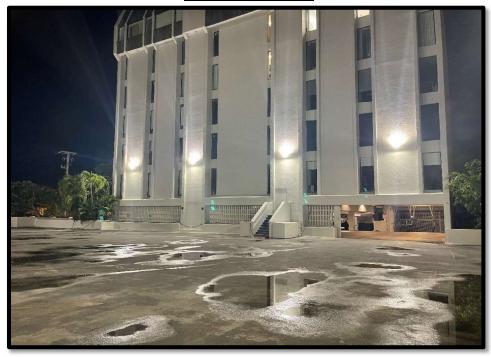
Photograph #222 Re-Inspection 05.26.2023.

Parking Garage Exterior Light of the service good illumination and lamps in good working condition, in good standing at North, West, South and East side area, in all habitable and non-habitable areas, and deemed necessary.

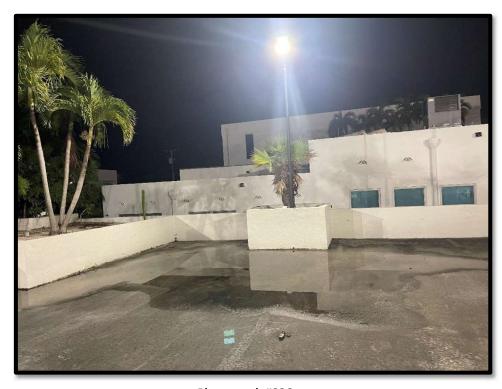
Photograph #225 Re-Inspection 05.26.2023.

<u>Parking Garage Exterior Light of the service good illumination and lamps in good working condition, in good standing at North, West, South and East side area, in all habitable and non-habitable areas.</u>

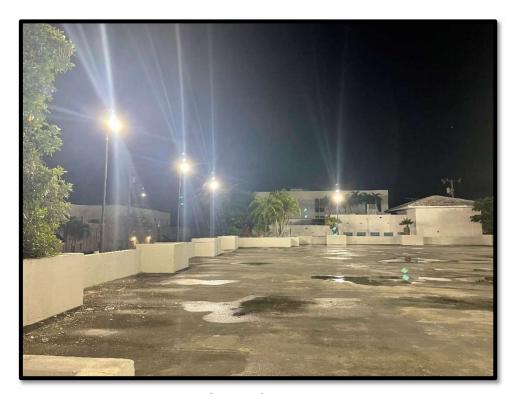
Photograph #228 Re-Inspection 05.26.2023.

<u>Parking Garage Exterior Light of the service good illumination and lamps in good working condition, in good standing at North, West, South and East side area, in all habitable and non-habitable areas.</u>

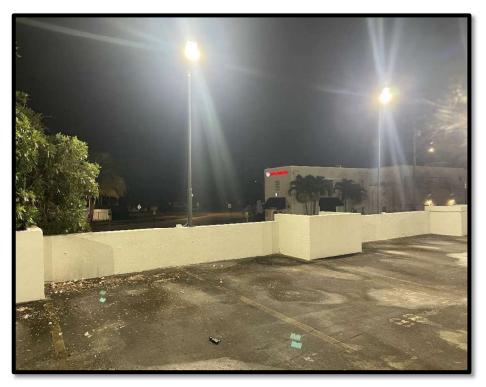
Photograph #229 Re-Inspection 05.26.2023.

Parking Garage Exterior Light of the service good illumination and lamps in good working condition, in good standing at North, West, South and East side area, in all habitable and non-habitable areas.

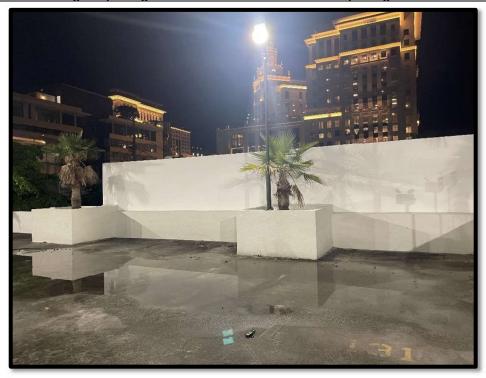
Photograph #230 Re-Inspection 05.26.2023.

<u>Parking and non-enclosed areas under, or within, buildings shall be provided with a maintained minimum of 1.0 foot-candle of light on the walking and parking surfaces from dusk until dawn. This parking area is sufficiently illuminated.</u>

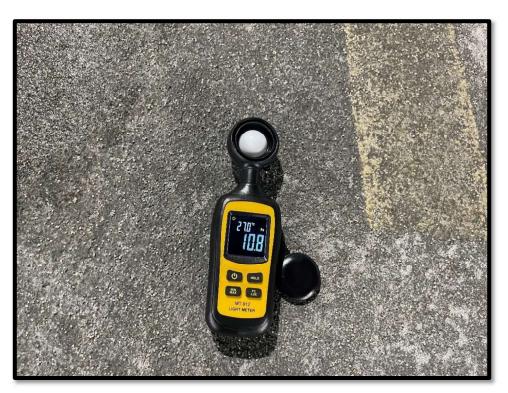
Photograph #231 Re-Inspection 05.26.2023.

Parking and non-enclosed areas under, or within, buildings shall be provided with a maintained minimum of 1.0 foot-candle of light on the walking and parking surfaces from dusk until dawn. This parking area is sufficiently illuminated.

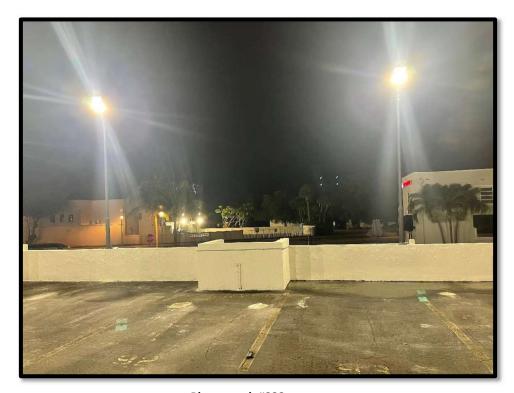
Photograph #232 Re-Inspection 05.26.2023.

Parking and non-enclosed areas under, or within, buildings shall be provided with a maintained minimum of 1.0 foot- candle of light on the walking and parking surfaces from dusk until dawn. This parking area is sufficiently illuminated.

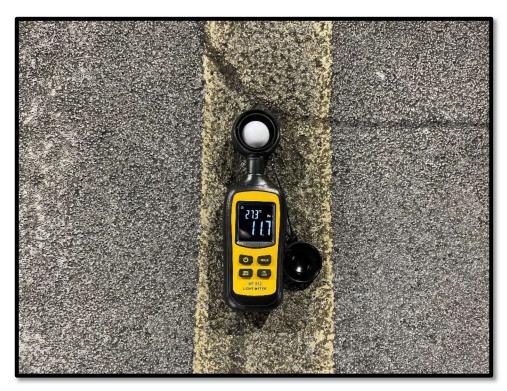
Photograph #233 Re-Inspection 05.26.2023.

Parking and non-enclosed areas under, or within, buildings shall be provided with a maintained minimum of 1.0 foot- candle of light

on the walking and parking surfaces from dusk until dawn. This parking area is sufficiently illuminated.

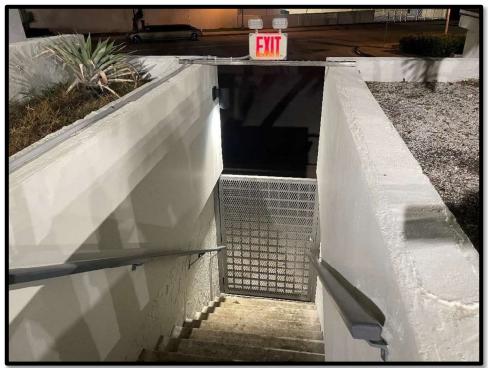
Photograph #234 Re-Inspection 05.26.2023.

Parking and non-enclosed areas under, or within, buildings shall be provided with a maintained minimum of 1.0 foot- candle of light on the walking and parking surfaces from dusk until dawn. This parking area is sufficiently illuminated.

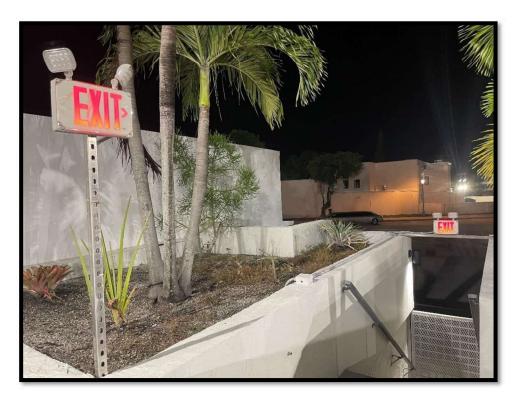
Photograph #235 Re-Inspection 05.26.2023.

Exterior Exit Stair have good illumination and lamps in working condition.

Emergency light and Exit light properly installed in all habitable and non-habitable areas.

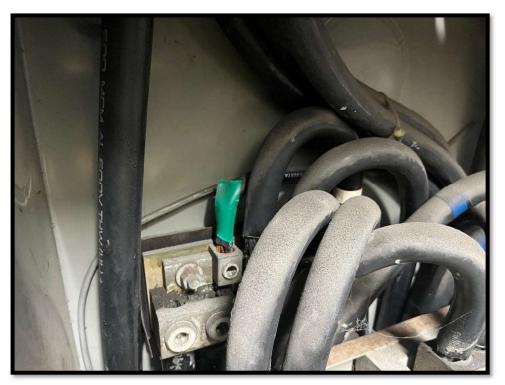
Photograph #4
Phases are properly identified and installed.

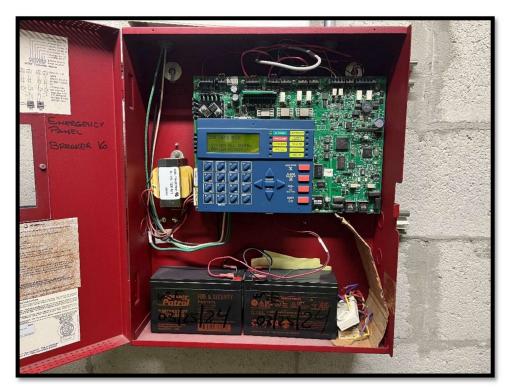
Photograph #24

Fire alarm control panel properly installed.

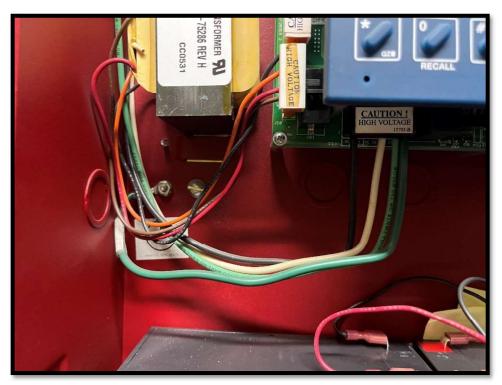
Photograph #25
Grounding is properly installed.

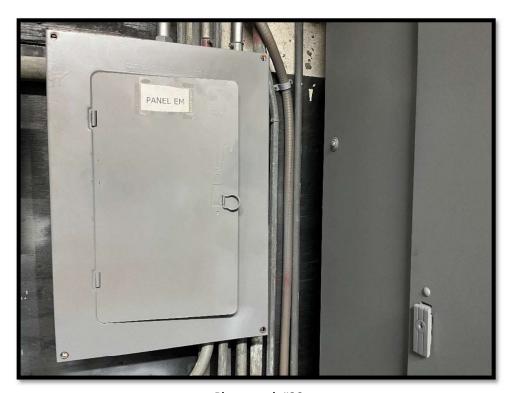
Photograph #26
Circuit Breaker Panel EM properly identified.

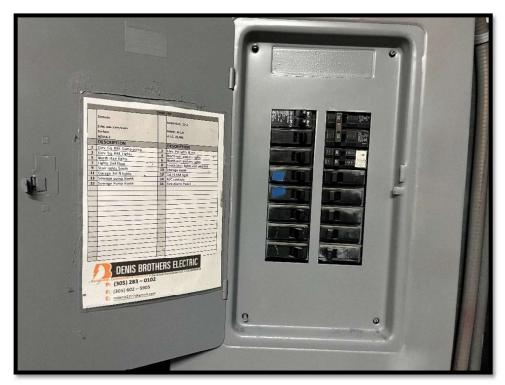
Photograph #27
Circuit Breaker Panel EM is properly labeled.

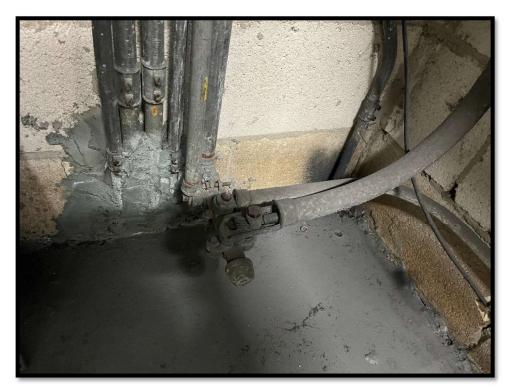
Photograph #35
Ground of the service is properly installed.

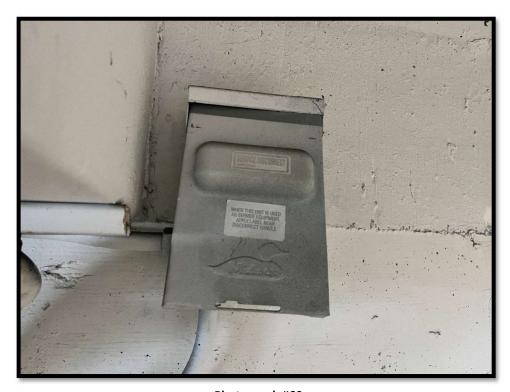
Photograph #60

AC Disconnect properly identified.

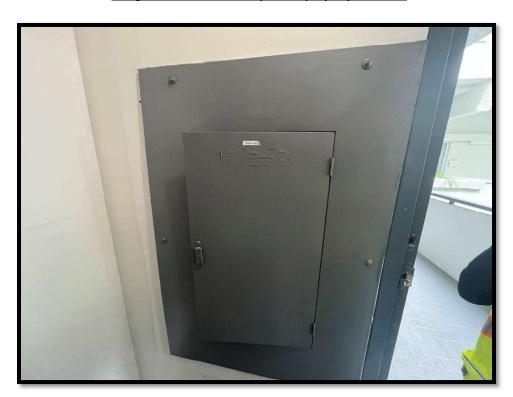
Photograph #117

Circuit Breaker Panel L R properly identified.

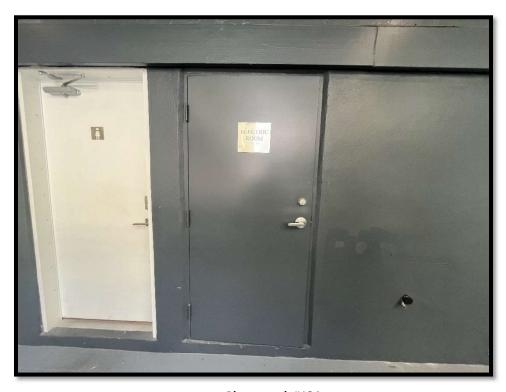
Photograph #124

Electrical Room 5 floor properly identified.

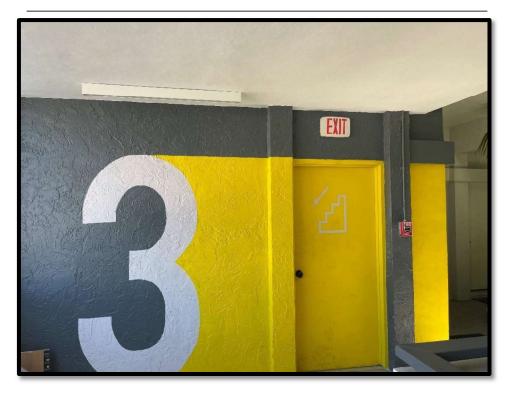
Photograph #140
Exit sign lights outdoor day time at 3rd floors in the building in good working condition.

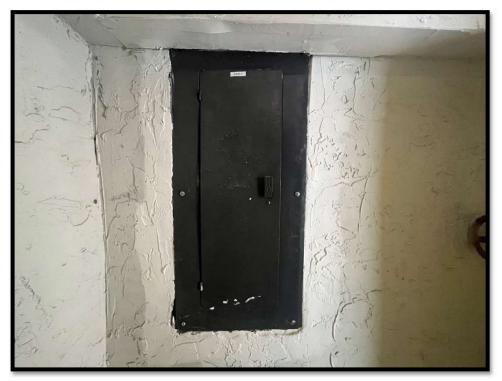
Photograph #141

Circuit Breaker Panel 3 properly identified.

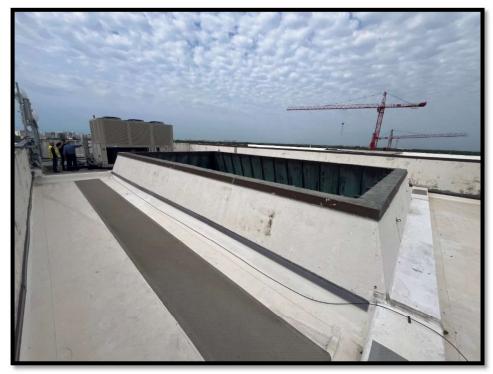
Photograph #154
AC Roof area electrical installation is in good condition.

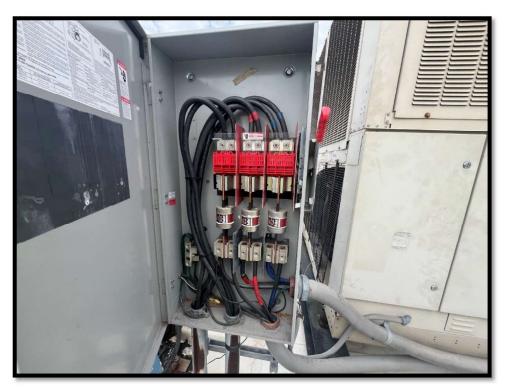
Photograph #157
Phases are properly identified and installed.

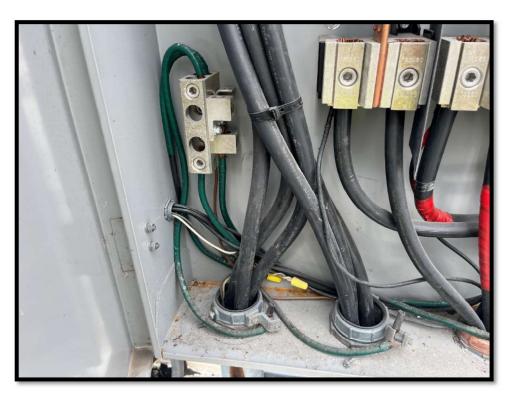
Photograph #158
Ground of the Disconnect is properly installed.

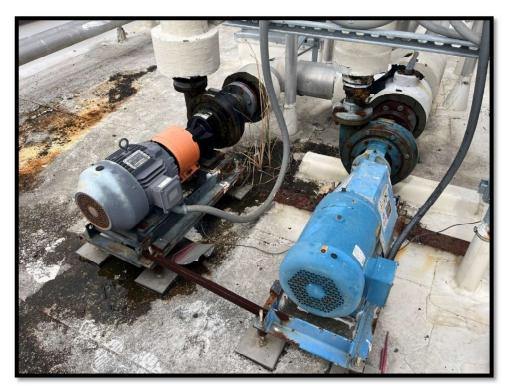
Photograph #163
Ground wire properly connected in the electric motors.

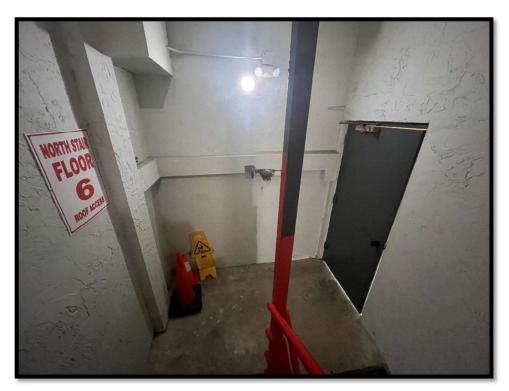
Photograph #172
The stairway landing properly illuminated.
Emergency lights properly installed.

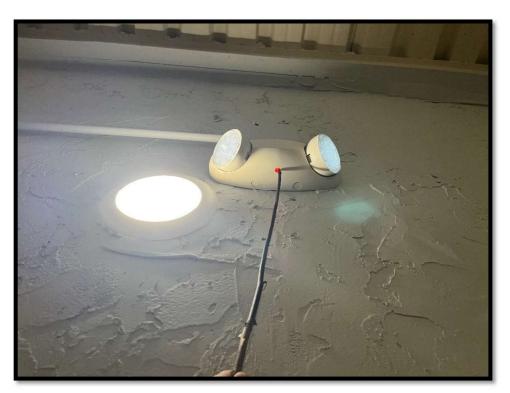
Photograph #173
Emergency lights properly installed and in good working condition.

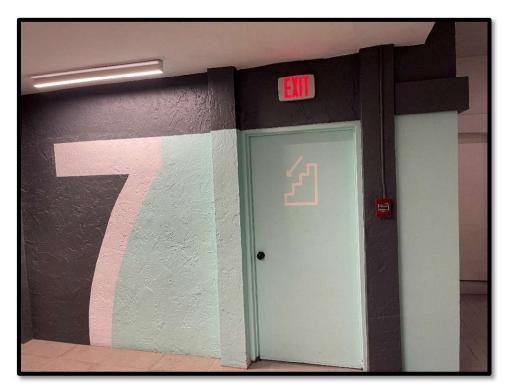
Photograph #186
Exit sign lights outdoor nighttime at 7th floors in the building in good working condition.

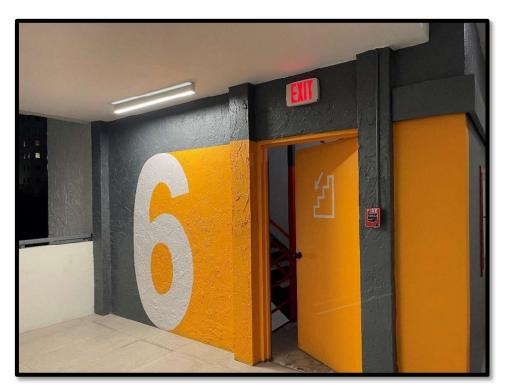
Photograph #188

Exit sign lights outdoor nighttime at 6th floors in the building in good working condition.

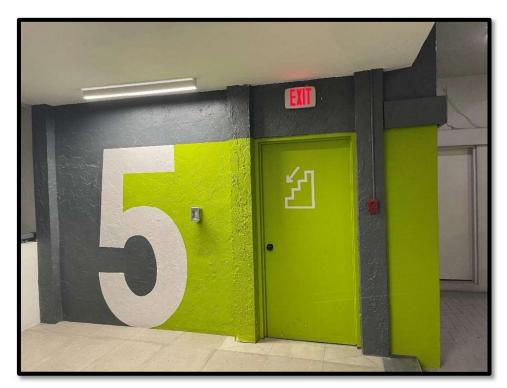
Photograph #190
Exit sign lights outdoor nighttime at 5th floors in the building in good working condition.

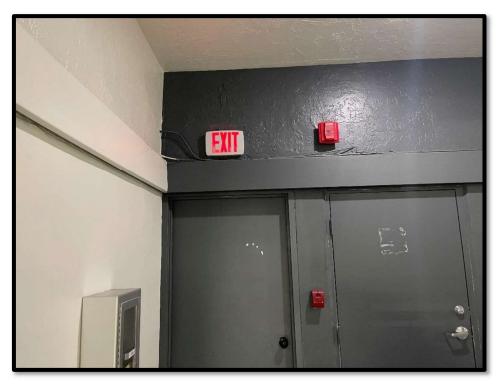
Photograph #191

Exit sign lights outdoor nighttime at 5th floors in the building in good working condition.
