PROPERTY APPRAISER OF MIAMI-DADE COUNTY

PROPERTY INFORMA	TION
Folio	03-4108-006-2040
Property Address	201 ALHAMBRA CIR CORAL GABLES, FL 33134-0000
Owner	EVELYN L GOLDBLOOM TRS & , GOLDBLOOM FAMILY LTD
Mailing Address	201 ALHAMBRA CIRCLE STE 514 CORAL GABLES, FL 33134-5105
Primary Zone	5005 MIXED-USE 3
Primary Land Use	1813 OFFICE BUILDING - MULTISTORY : OFFICE BUILDING
Beds / Baths /Half	0/0/0
Floors	13
Living Units	0
Actual Area	
Living Area	
Adjusted Area	447,478 Sq.Ft
Lot Size	51,762 Sq.Ft
Year Built	1973

The Falcon Group conducted a 50 Year Electrical Recertification of the referenced building in accordance with the requirements of section 8.11(f) of Miami Dade County Code. Please refer to the attached Electrical Recertification Report, the Illumination Letter, and the Thermography Report for this building. In summary, the Electrical Recertification is not approved as electrical repairs are necessary to meet current standards of safety. Please notice that we have not identified any condition that represents an imminent danger to the occupants of the building. Based on our evaluation, the building is electrically safe for its use and present occupancies at the time of our eval

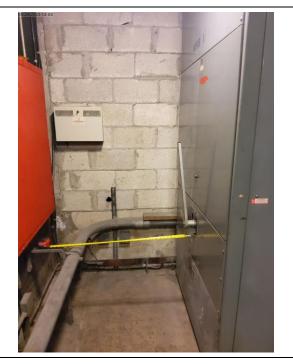
Photo # 1. Item 3.1.a is depicted.

c. Condition: Good () Fair () Needs repair ())
Comments: Location: Main Electrical room
Repairs are required as follows:
a. Working space clearance violation. See Annex "A", photos #1, and 2.b. Main services must be identified as "Main 1 of 6". See Annex "A", photo #3.

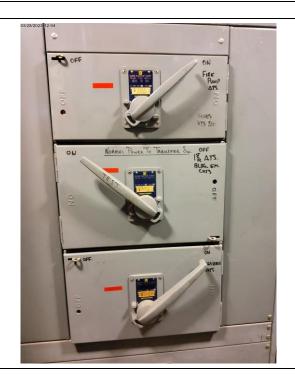
Photo # 4. Items 3.2, 3.3, and 3.4 are depicted.

b. Phase: Three-phase (💿) Single-phase ()
c. Condition: Good () Fair () Needs repair ()
Comments: Location: Main Electrical room
Repairs are required as follows:
Main services must be identified as "Main 2 of 6". See Annex "A", photo #4.

Main services must be identified as "Main 3 of 6". See Annex "A", photo #4

c. Condition:		Good	masc	1)		air				Ne	eds repair	1	•	_
Comments:								ر Nain Elec	trical:	room	110	.cus repair			
Repairs are re	auired	as follows:				_									
Main services			as "Mai	in 4 of 6".	See	Annex "A"	', photo #4.								
							· ·

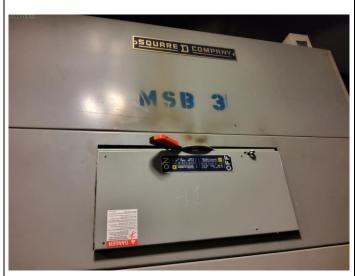
Photo # 5. Item 3.5 is depicted.

c. Condition:		Good		()	F	air	()		Ne	eds repair	(•)
Comments:						L	ocation: N	/lain Elec	trical	room					
Repairs are re	quired	as follows:													
Main services	must k	oe identified a	as "Mai	in 5 of 6".	See	Annex "A"	', photo #5.

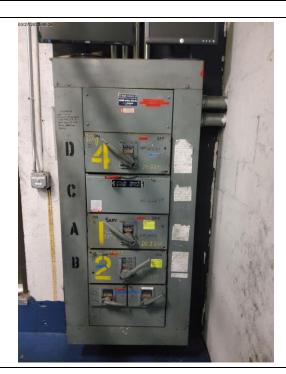
Photo # 11. Items 7.1.a, and 7.1.b are depicted.

a. '		roper panel ID.											
b.		roper circuit iden	tificatio	n (circuit direct	ory).								
See	Annex "A"	', photo #11.											
	Danal #	Nachine veen	DNII		l a sation.	Doof Ele		ر : حام م

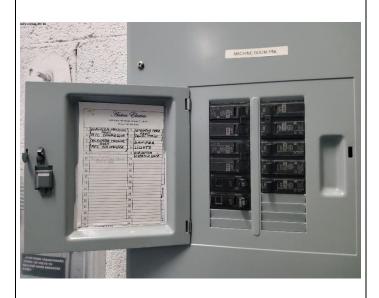
Photo # 12. Item 7.2 is depicted.

3.	Panel #:	No Label			Location:	Roof, Ele	ev M	achir	ne room				
					Good	()			Needs repair	(•)
Cor	nments:		Size:	600 AMPS	Volt:	480/277			Phases:	-	` vpe:	MLO	•
Rep	oairs are re	quired as follows	:			•					, ·		
Mis	ssing prope	r panel ID. See A	nnex "A	", photo #12.

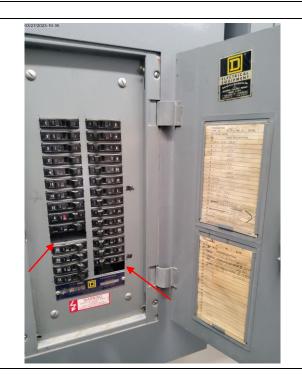
Photo # 16. Item 7.6 is depicted.

b. Openings in circuit spaces. See Annex "A", photo #16.

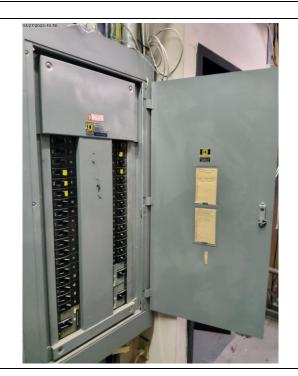
Photo # 20. Item 7.10.a is depicted.

a. ·		oper circuit ident		n (circuit direct	ory). See A	nnex "A", ¡	photo #	20.				
b.	Tapping ir	Main lugs. Repa	ir tappi	ng in panel by u	sing listed	tapping co	nnector	rs. See Ann	ex "A", photo	#21.

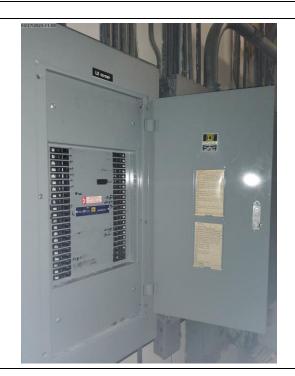
Photo # 23. Item 7.12 is depicted.

•		quired as follows: oper circuit ident		n (circuit direct	oryl							
a. b.	• • •	"A", photo #23.	liiicatio	ii (circuit directi	ory).							
.	00071111107	. , , photo 1123.

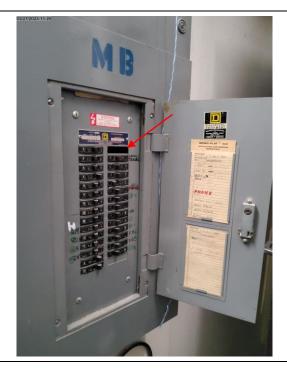
Photo # 26. Items 7.15.a, and 7.15.b are depicted.

a. Missing proper circuit identification (circuit direc	tory)						
b. Openings in circuit spaces.	(O) y /.						
See Annex "A", photo #26.							
ocerument it prioto iizoi

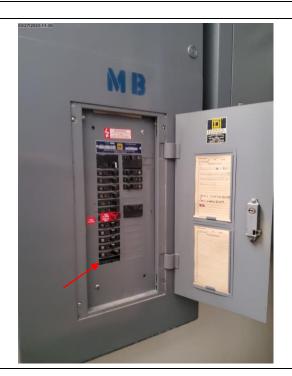
Photo # 27. Items 7.16.a, and 7.16.b are depicted.

b. Openings in circuit spaces.							
See Annex "A", photo #27.							
47.0.14.16			144 1 41	!!			
17. Panel #: LC		Level 12.	. West Air	r Handler			
	Good	()		Needs repa		(a)
Comments: Size: 400 AMPS	Volt:	208/120		Phases:	3	Type:	MLO
Repairs are required as follows:							
Missing proper circuit identification (circuit directory)	. See Anne	κ "A", phot	o #28.

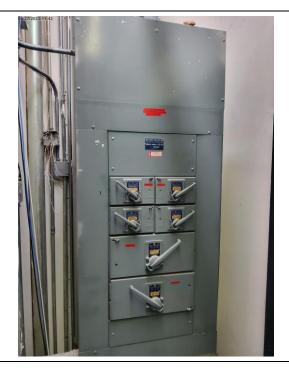
Photo # 29. Item 7.18 is depicted.

18. Panel #: No Label	Location	Level 12.	. West Air	r Handler	-Electrical-te	lephon	e room
	Good	()		Needs repa	ir ()
Comments: Size: 400 AMPS	Volt:	480/277		Phases:	3	Type:	MLO
Repairs are required as follows:							
Missing proper panel ID. See Annex "A", photo #29.

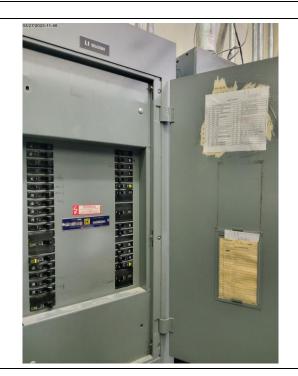
Photo #32. Items 7.20.a, and 7.20.b are depicted.

a. Missing proper circuit identification (circuit direc	tory).						
b. Missing 2 screw(s).							
See Annex "A", photo #32.							
21. Panel #: L2	Location	Level 12.	. West Air	r Handler	-Electrical-te	lephon	e room
	Good	()		Needs repa	ir ()
Comments: Size: 400 AMPS	Volt:	208/120		Phases:	3	Type:	MLO
Repairs are required as follows:							
Missing proper circuit identification (circuit directory)	. See Anne	κ "A", phot	o #33.

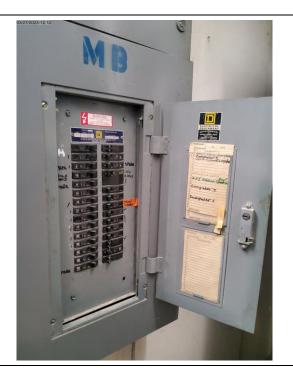
Photo # 34. Item 7.23 is depicted.

23. Panel #: MB	Comments:		Size:	400 AMPS	Volt:	208/120		Phases:	3	Type:	MLO
Good () Needs repair (None.										
Good () Needs repair (
Comments: Size: 60 AMPS Volt: 208/120 Phases: 3 Type: MLO Repairs are required as follows: Missing proper circuit identification (circuit directory). See Annex "A", photo #34. 24. Panel #: 11L-4 Location: Level 11. East Air Handler-Electrical-telephone room Good () Needs repair (23. Panel #:	MB				Level 11	. East A	Air Handler-		-	
Repairs are required as follows: Missing proper circuit identification (circuit directory). See Annex "A", photo #34. 24. Panel #: 11L-4						()		Needs repa		
Missing proper circuit identification (circuit directory). See Annex "A", photo #34. 24. Panel #: 11L-4				60 AMPS	Volt:	208/120		Phases:	3	Type:	MLO

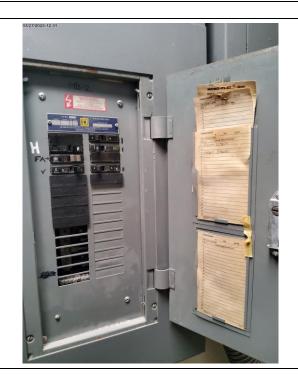
Photo #36. Items 7.27.a, and 7.27.b are depicted.

a. Missing proper circuit identification (circuit directory). b. Openings in circuit spaces. See Annex "A", photo #36. 28. Panel #: LC		auired as fallaus		60 AIVIPS	voit:	208/120		Phases:	3	Type:	MLO

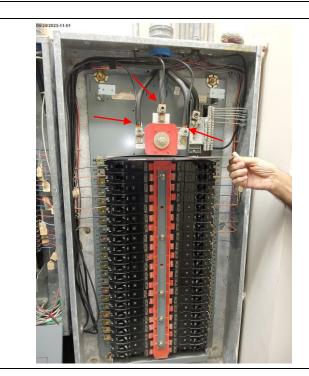
Photo # 58. Item 7.52 is depicted.

52. Panel #: No Label Location: Level 8. West Air Handler-Electrical-telephone room. Good () Needs repair (●) Comments: Size: 400 AMPS Volt: 480/277 Phases: 3 Type: MLO Repairs are required as follows: Missing proper panel ID. See Annex "A", photo #58.

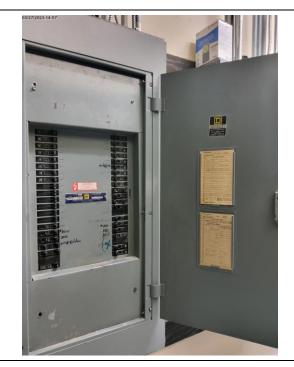
Photo # 60. Items 7.54.a, and 7.54.b are depicted.

a. Missing p	roper circuit id	entificatio	n (circuit direc	tory).						
o. Missing 2	screw(s).									
See Annex "A	", photo #60.									
55. Panel #:	L2			Location:	Level 8	Mast Air	· Handler-	Electrical-te	lenhone	room
JJ. Tallel #.	LZ			Good		\	Tianulei			1
Comments:		C:	400 41400		((((((((((((((((((((,	Dhasas	Needs repa) NALO
		Size:	400 AMPS	Volt:	208/120		Phases:	3	Type:	IVILO
None.

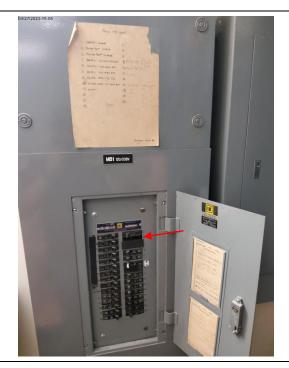
Photo # 64. Item 7.58 is depicted.

•					A ((A)	"lt	U.C. A			
•	er panel ID and		oper circuit di	rectory. See	Annex "A'	", photo	#64.			
Missing prope			oper circuit di					Electrical-te	lephone	e room
Missing prope	er panel ID and		oper circuit di	Location:				Electrical-te		
Missing prope		missing pr		Location: Good	Level 7.		· Handler-	Needs repa	air ()
Missing prope 59. Panel #: Comments:	MB	missing pr	oper circuit di	Location:					air (
Missing prope 59. Panel #: Comments: Repairs are re	MB	missing pr Size: ws:	60 AMPS	Location: Good Volt:	Level 7.		· Handler-	Needs repa	air ()
Missing prope 59. Panel #: Comments: Repairs are re a. Missing p	MB equired as follow	Size: ws: entificatio	60 AMPS	Location: Good Volt:	Level 7.		· Handler-	Needs repa	air ()
Missing prope 59. Panel #: Comments: Repairs are re a. Missing po. Openings	MB equired as followeroper circuit ide	Size: ws: entificatio	60 AMPS	Location: Good Volt:	Level 7.		· Handler-	Needs repa	air ()

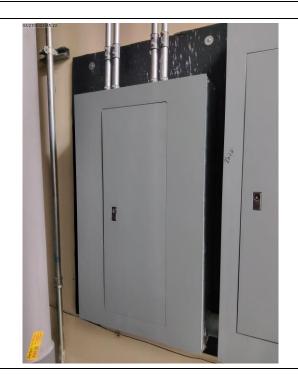
Photo #71. Items 7.65.a, and 7.65.b are depicted.

a. Missing p	quired as follows: roper circuit identi- in circuit spaces. ", photo #71.	ficatio	n (circuit direct								
66. Panel #:	No Label			Location:	Level 7.	West Ai	r Handler-	Electrical-tele	ephone	room	
				Good	()		Needs repai	r (•)

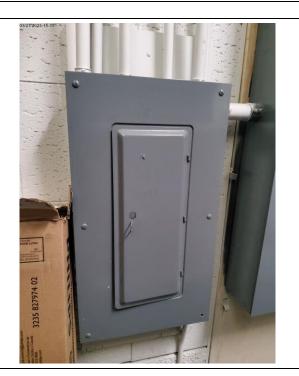
Photo # 75. Items 7.67 is depicted.

Missing proper circuit identification (circuit directory). See Annex "A", photo #75.

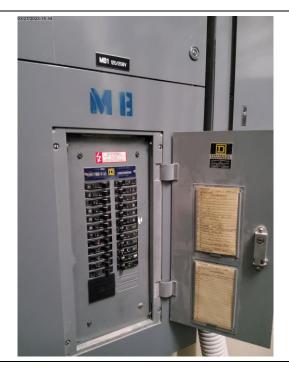
Photo # 77. Item 7.68b is depicted.

b. N	/lissing p	roper circuit idei	<u>ntificatio</u>	n (circuit directo	ory). See Ar	າnex "A", ເ	photo #77.					
60 D	land #ı	MB1			Locations	Lovel	Most Air II	اعمالمما	Electrical-tele		room

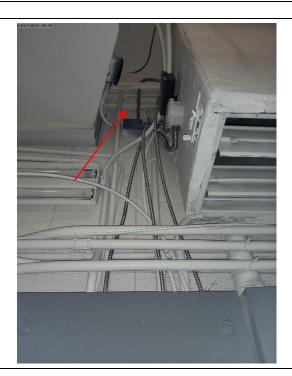
Photo # 78. Item 7.69.a is depicted.

-		roper circuit idei		n (circuit direct	orv) See Ar	nnex "A" i	nhoto #78					
		ing above panel					p11010 11701					
		<u> </u>		,								
70. P	anel #:	LC			Location:	Level 6.	West Air H	andler-	Electrical-tele	ephone	room	
					Good	()		Needs repai	r ()	
Comm	nents:		Size:	400 AMPS	Volt:	208/120	Pl	hases:	3	Type:	MLO	
Repair	rs are re	quired as follows	s:									
		ing above panel		-								
		roper circuit idei		n (circuit directe	ory).							
		in circuit spaces	•									
See Al	nnex A	', photo #81.

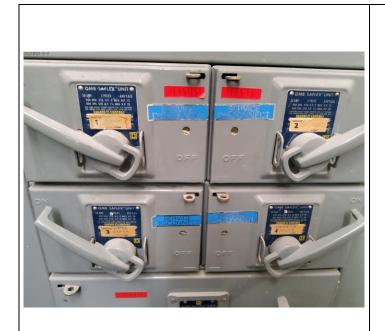
b. N	/lissing p	roper circuit idei	ntificatio	n (circuit direct	ory). See Ar	າnex "A", ເ	photo #83.					
72. P	anel #:	6-H			Location:	Level 6.	West Air H	andler-	Electrical-tele		room	
					Good	()		Needs repai)	
Comm			Size:	225 AMPS	Volt:	480/277	Pl	hases:	3	Type:	MLO

Photo #83. Item 7.71.b is depicted.

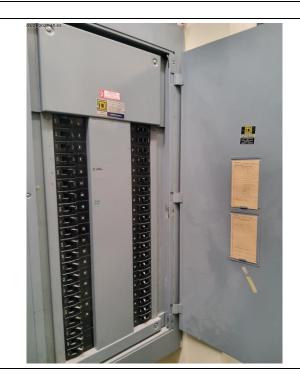
-		quired as follows	: :									
a. Missing proper circuit identification (circuit directory). See Annex "A", photo #84.												
		•		•		-			ov "A" photo	- #OE		
		roper circuit idei 1 Main lugs. Rep		•		-			ex "A", photo	o #85.

Photo #84. Item 7.72.a is depicted.

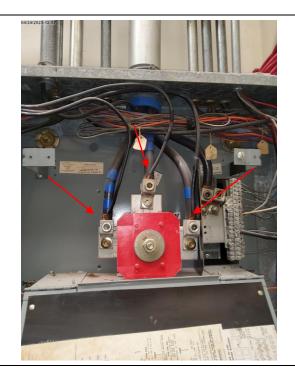
Photo #85. Item 7.72.b is depicted.

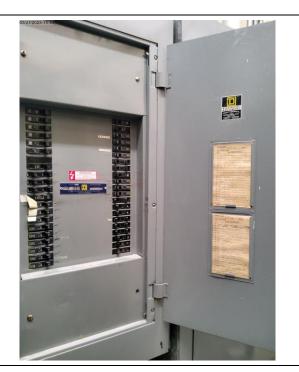
Photo #86. Item 7.73 is depicted.

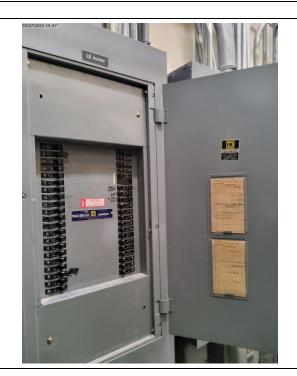
Photo #87. Items 7.74.a and 7.74.b are depicted.

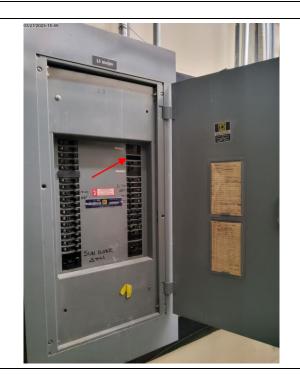
Photo # 88. Items 7.75.a, 7.75.b and 7.75.c are depicted.

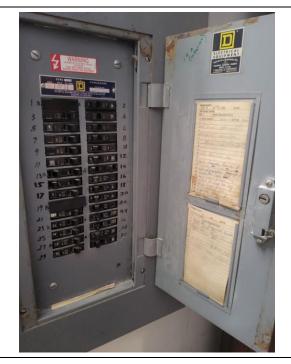
Photo #89. Item 7.76 is depicted.

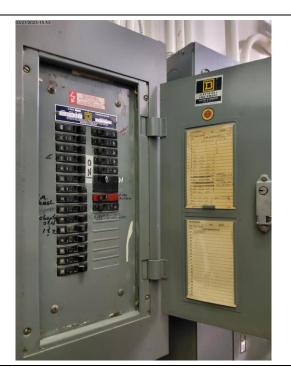
Photo # 90. Item 7.77 is depicted.

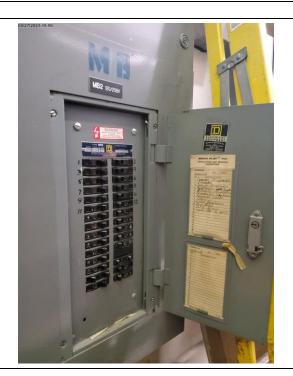
Photo # 91. Items 7.78 is depicted.

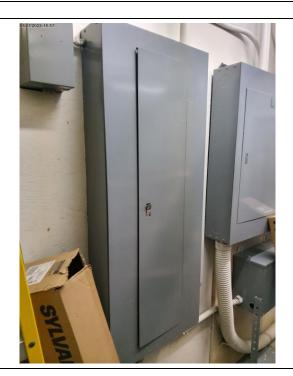
Photo # 92. Item 7.79.a is depicted.

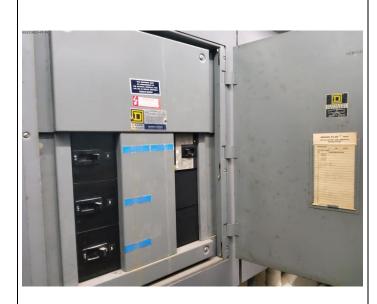
Photo # 93. Item 7.79.b is depicted.

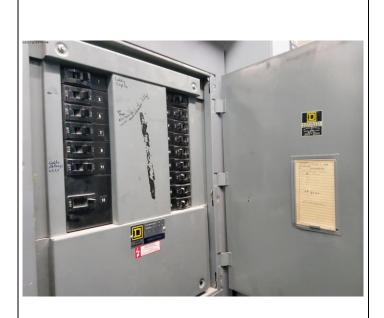
Photo # 94. Item 7.80 is depicted.

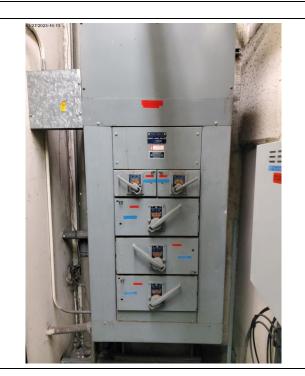
Photo # 95. Items 7.81 is depicted.

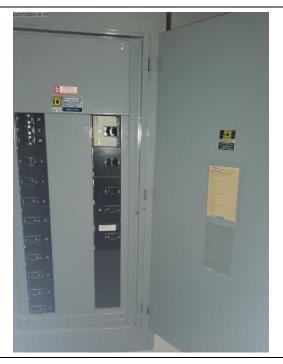
• • • • • • • • • • • • • • • • • • • •	oper panel ID.										
	oper circuit iden	tificatio	n (circuit direct	ory).							
See Annex "A"	, photo #96.										
!!!

Photo # 96. Items 7.82.a, and 7.82.b are depicted.

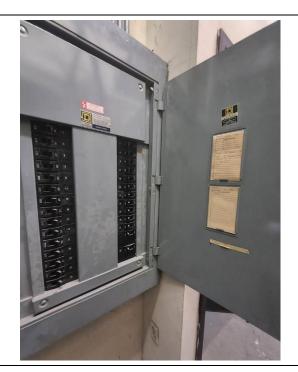
Photo # 97. Item 7.83 is depicted.

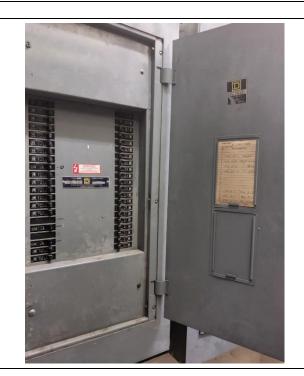
Photo # 98. Item 7.84 is depicted.

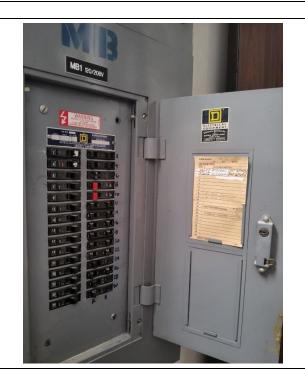
Photo # 99. Item 7.85 is depicted.

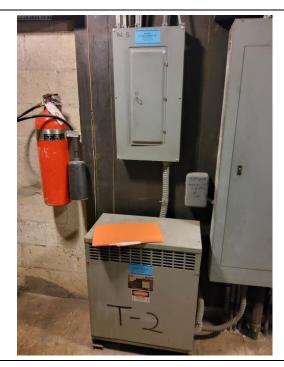
Photo # 100. Item 7.88 is depicted.

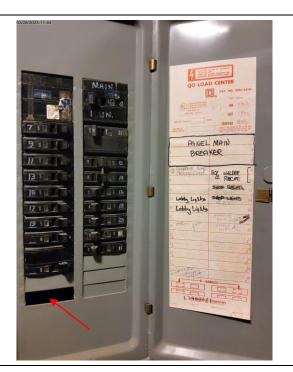
b. Missing 2											
_	space clearance v	iolation	•								
	", photo #101.		/ · · · · · · ·	,							
	roper circuit ider		n (circuit directi	ory).							
	in circuit spaces.										
See Annex "A	", photo #102.

Photo # 101. Items 7.89.a, 7.89.b, and 7.89.c are depicted.

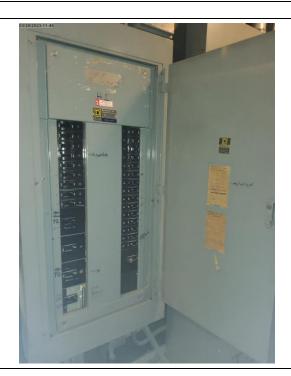
Photo # 102. Items 7.89.d, and 7.89.e are depicted.

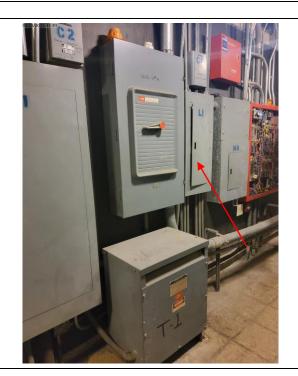
Photo # 103. Item 7.90 is depicted.

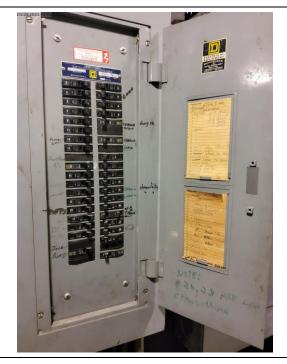
Photo # 104. Item 7.91 is depicted.

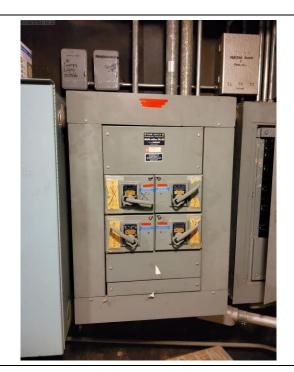
Photo # 105. Item 7.91 is depicted.

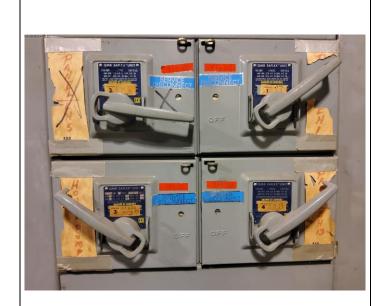
Photo # 106. Item 7.93.a is depicted.

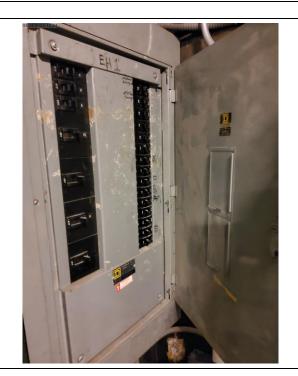
Photo # 107. Item 7.93.b is depicted.

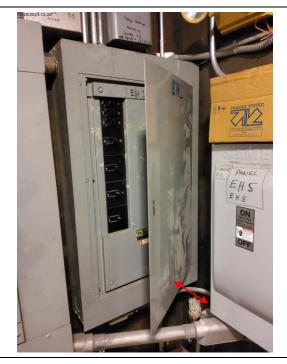
54. Tunern.	2112			Good	1	1	-ctricarroc	Needs repair	. 1	•	1
Comments:		Cizor	100 AMPS		480/277	,	Phases:			•	,
	autional an fallauti	Size:	100 AIVIPS	Volt:	480/277		Priases:	3	Type:		
	quired as follows		n /aireuit direct	om/) Coo A	nnov "A"	nhata #	100				
	roper circuit ider space clearance v		•			photo #	108.

Photo # 108. Item 7.94.a is depicted.

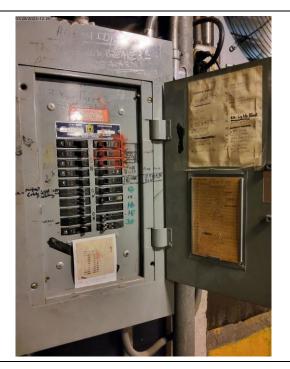
Photo # 109. Item 7.94.b is depicted.

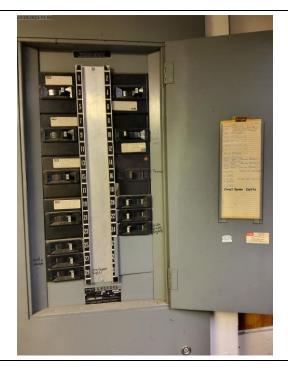
Photo # 110. Item 7.95 is depicted.

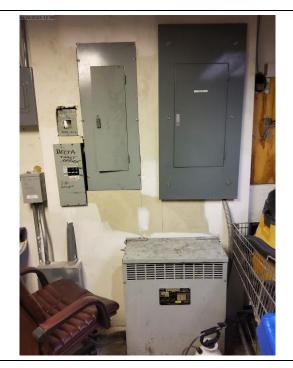
Photo # 111. Item 7.96.a is depicted.

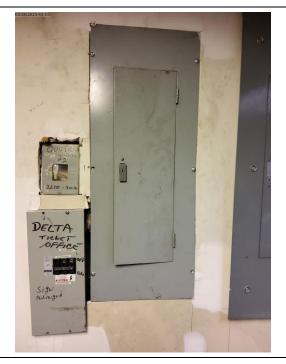
Photo # 112. Items 7.96.b is depicted.

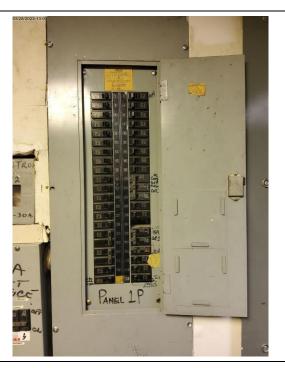
Photo # 113. Items 7.97.a and 7.97.b are depicted.

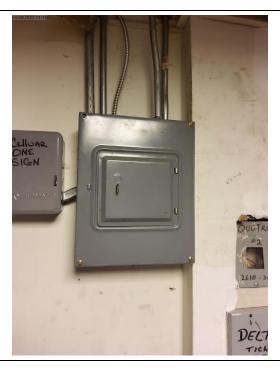
Photo # 114. Items7.97.c, 7.97.d, and 7.97.e are depicted.

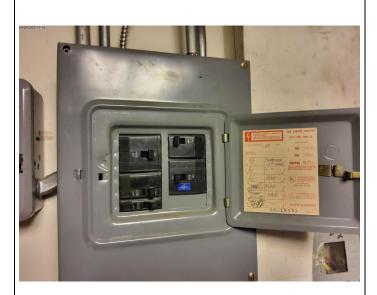
Photo # 115. Item 7.98.a is depicted.

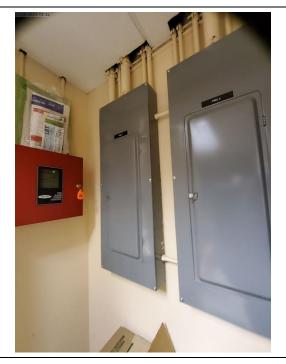
Photo # 116. Item 7.98.b is depicted.

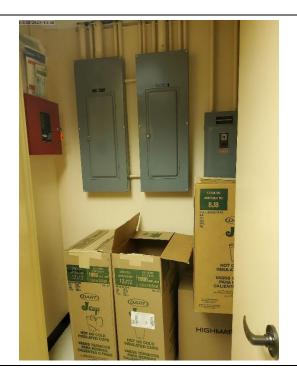
Photo # 117. Items 7.101, and 7.102 are depicted.

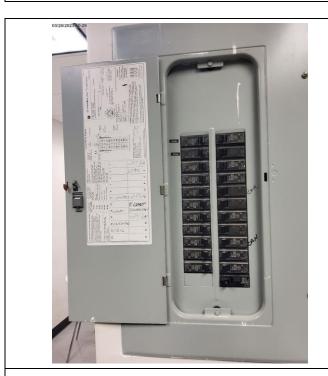
Photo # 118. Items 7.101, and 7.102 are depicted.

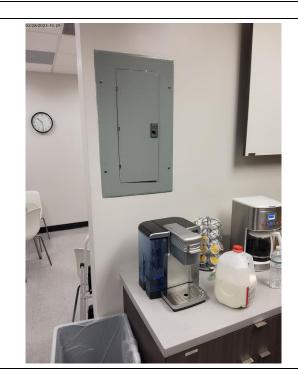
Photo # 119. Item 7.103.a is depicted.

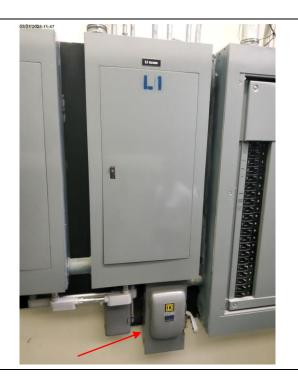
Photo # 121. Item 8.a is depicted.

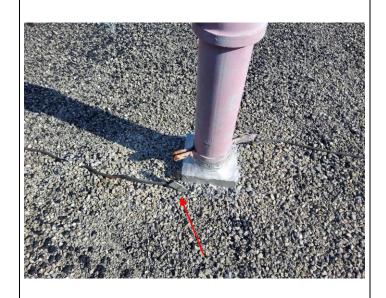
Photo # 144. Item 17.1.p is depicted.

- o. Chiller room. Water heater circulation pump flex conduit detached. See Annex "A", photo #143.
- p. Roof, Grounding wire disconnected. See Annex "A", photo #144.

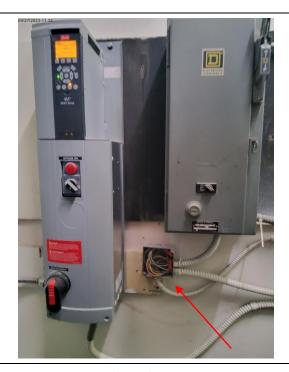
Photo # 145. Item 17.2.a is depicted.

- a. Level 12. East Air Handler. Junction box missing cover. See Annex "A", photo #145.
- b. Level 12. West Air Handler. Junction box missing cover. See Annex "A", photo #146.

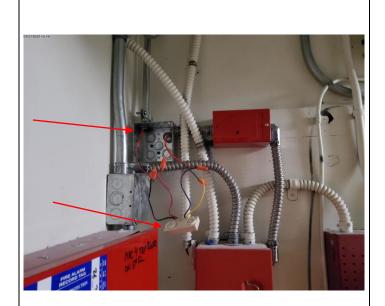
Photo # 147. Item 17.2.c is depicted.

- c. Level 11. West Air Handler Electrical & telephone room. Junction box missing cover, and the Fire alarm device is hanging. See Annex "A", photo #147.

1. Condition	Good			1	Needs Repair			1	N/A	1	١
Comments:	Good	Ι.	•	1	Neeus Repair			,	IN/A		,
None.											
20. FIRE ALARM	SYSTEM										
1. Condition	Good			1	Needs Repair	1	•	1	N/A	1	1
Comments:	3004				Necus Nepuli			,	IVA		,
Repairs are required as	follows:										
Level 11. West Air Hand	dler - Electrical	& t	eleph	one roc	m. Fire alarm device	is ha	angin	g. See Anr	nex "A", photo #:	147.

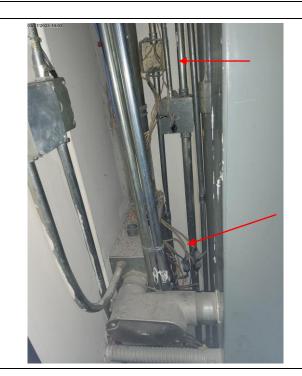
Photo # 148. Item 17.2.d is depicted.

- d. Level 10. West Air Handler Electrical & telephone room. Junction box missing cover. See Annex "A", photo #148.
- e. Level 10. East Air Handler Electrical & telephone room. Transformers 120/24v missing cover. See Annex "A", photo #149.

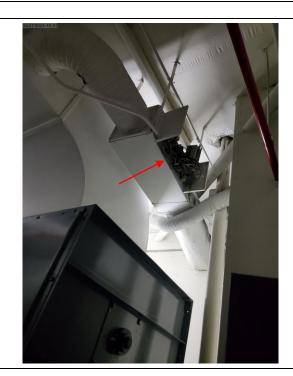
Photo # 152. Item 17.2.h is depicted.

- h. Level 6. West Air Handler Electrical & telephone room. Junction box and control box missing cover. See Annex "A", photo #152.
- i. Level 5. West Air Handler Electrical & telephone room. Opening in 15kva Transformer. See Annex "A", photo #153.

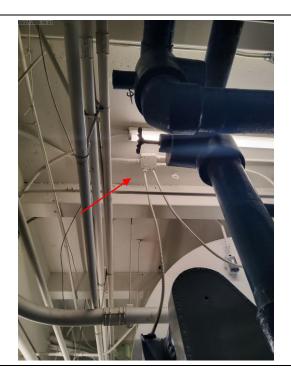
Photo # 154. Item 17.2.j is depicted.

- j. Air Handler Electrical & telephone room. Flex conduit detached. See Annex "A", photo #154.

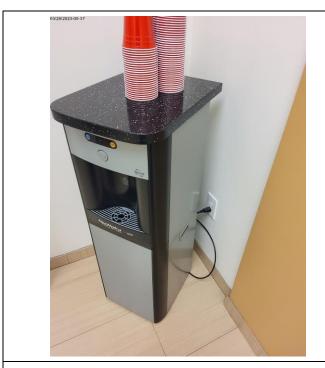
Photo # 136. Item 17.1.h is depicted.

- g. Unit No.703, Kitchen. Receptacle detached. See Annex "A", photo #135.
- h. Unit No.702, Kitchen. Receptacle missing GFCI protection. See Annex "A", photo #136.

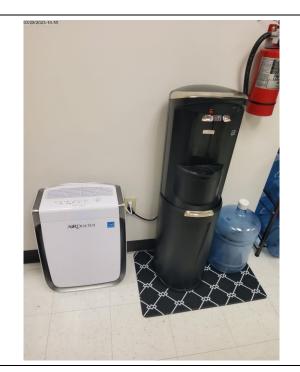
Photo # 137. Item 17.1.i is depicted.

- i. Unit No.1100, Kitchen. Water fountain missing GFCI protection. See Annex "A", photo #137.
- j. Unit No.701-711, Kitchen. Water fountain missing GFCI protection. See Annex "A", photo #138.

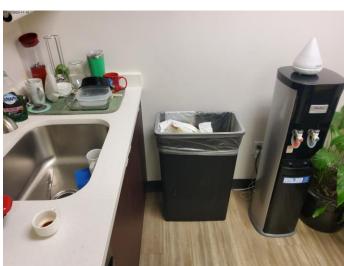
Photo # 139. Item 17.1.l is depicted.

- Unit No.1205, Kichen. Receptacle located less than 6 feet from the sink missing GFCI protection. See Annex "A", photo #139.
- I. Unit No.701-711, Kitchen. Receptacle located less than 6 feet from the sink missing GFCI protection. See Annex "A", photo #140

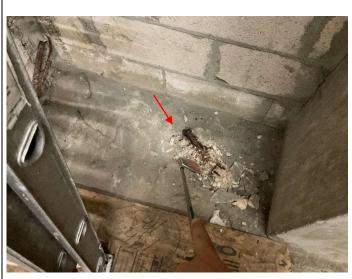
Photo # 5. Concrete spalling and exposed corroded rebar at roof (Generator Room).

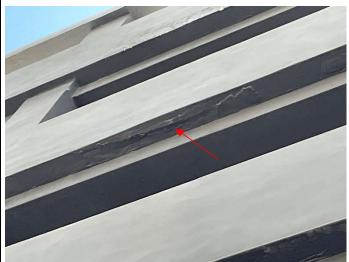
Photo # 16. Concrete spalling at slab edge of parking garage.

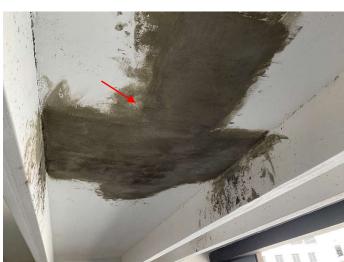
Photo # 28. Previously patched area at parking garage ceiling.

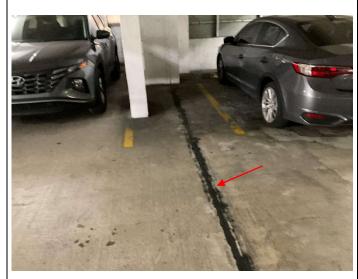
Photo # 40. Expansion joint between tower and parking garage.

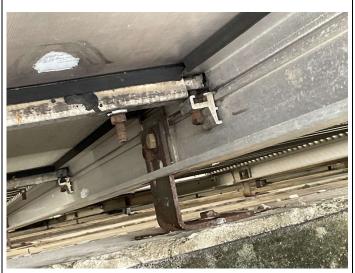
Photo # 49. Overall view of curtain wall anchors.
