# PROPERTY APPRAISER OF MIAMI-DADE COUNTY

### NOTICE OF UNSAFE STRUCTURE VIOLATION FOR FAILURE TO RECERTIFY AND NOTICE OF HEARING

# GABLES LAROC CONDOMINIUM – THERMAL SCANS

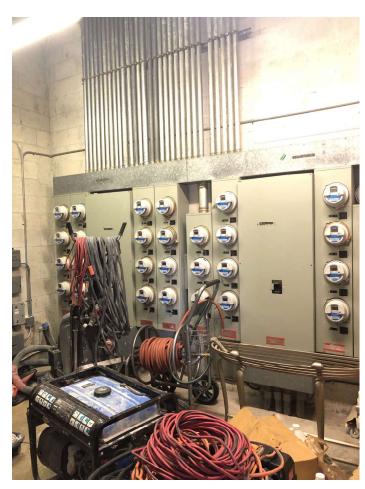
Photo 6 - Meter Equipment

4. METERING EQUIPMENT  PROVIDE PHOTO
1. Clearances: Good ( ) Fair ( ) Needs Correction ( X )
Comments:
Meter centers are in good condition, however the working space around the electrical equipment does not meet the
standard requirements. Refer to the attached Photo 6 and to Supplemental Electrical Report, Item 1.1.

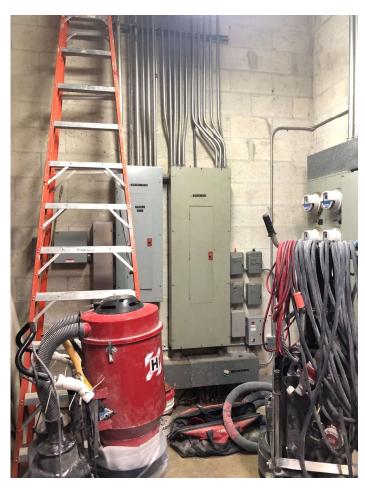
Photo 7 - Electrical Room

1. Clearances: Good (
Electrical equipments inside Electrical Rooms are in good condition, however the working space around the equipment
does not meet the standard requirement. Refer to the attached Photo 7 and to Supplemental Electrical Report, Item 1.
6. GUTTERS PROVIDE PHO
1. Location: Good ( O ) Needs Repair ( X )
2. Taps and Fill: Good ( X ) Needs Repair ( O )
Comments:
Electrical Gutter on the roof was observed with signs of corrosion and deterioration. Refer to the attached Supplementa
Electrical Report, Item 1.2
7. ELECTRICAL PANELS  PROVIDE PHOTO
1. Panel # ( H ) Location:
Good ( C ) Needs Repair ( X ) Uncoordinated circuit directo
2. Panel # ( E ) Location:
Good ( C ) Needs Repair ( X ) Uncoordinated circuit director
3. Panel # ( Pool ) Location:
Good (
4. Panel # ( Unit 1202) Location:
Good ( X ) Needs Repair ( )
5. Panel # ( Unit 203 ) Location:
Good ( X ) Needs Repair ( )

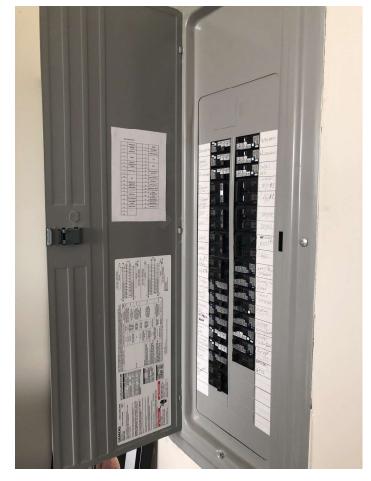
Photo 8 - Electrical Panel

Comments:
Electrical Panels are in good condition overall. Some electrical panels have their circuit directory uncoordinated
with the installed circuit breakers. Additionally, m2e recommend providing GFCI protection for the pool and spa motor
circuit breakers. Refer to the attached Photo 8 and to Supplemental Electrical Report, Items 1.3 and 1.4.

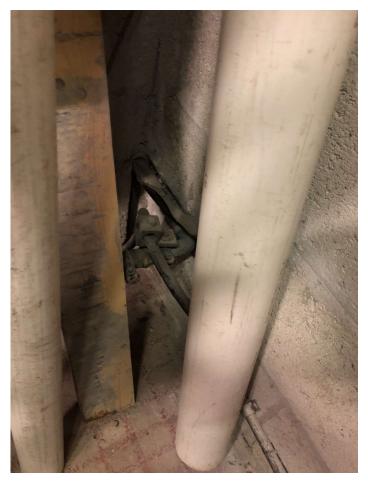
Photo 9 - Grounding of Service

9. GROUNDING OF SERVICE PROVIDE PHOTO
Good ( X ) Needs Repair ( )
Comments:
System grounding was found in good condition. No deficiencies were observed. Refer to the attached Photo 9.

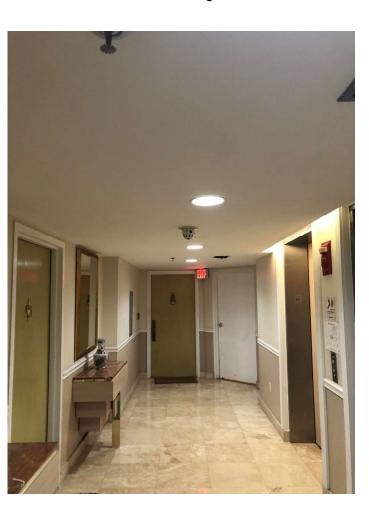
Photo 11 - Emergency Lighting

18.EMERGENCY LIGHT	ΓING		PROVIDE PHOTO			
	Good (X)	Needs Repair ( )	N/A (			
Comments:						
Emergency lighting is provid	ded throughout the building, in co	orridors, electrical rooms, ameni	ty areas and all mean of			
egress. No deficiencies with emergency lighting were observed. Refer to the attached Photo 11.

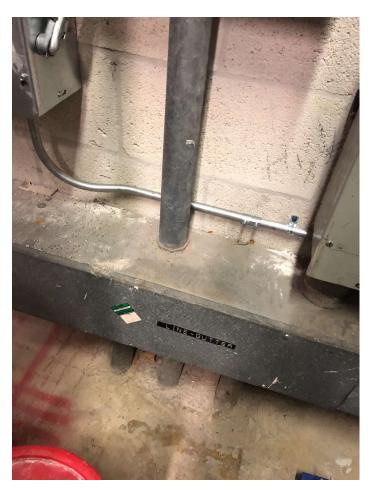
Photo 10 - Service Conduit

11.SERVICE CONDUIT/RACEWAYS	PROVIDE PHOTO
Good ( 💢 ) Needs Repair ( 🔘 )	
Comments:	
Service conduits were found in good condition. No deficiencies observed. Refer to the attached Photo	10.
12.GENERAL CONDUIT/RACEWAYS	PROVIDE PHOTO
Good ( O ) Needs Repair ( X )	
Comments:	
There are some general conduits with sign of corrosion and deterioration. Refer to the attached Suppl	emental Electrical
Report, Item 1.2.	
13.WIRE AND CABLES	PROVIDE PHOTO
Good ( ) Needs Repair ( X )	
Comments:	
Refer to the attached Supplemental Electrical Report, Items 1.5 and 1.9.	
14:00307413	PROVIDE PHOTO
Good ( 🔘 ) Needs Repair ( 🔘 )	
Comments:	
Not Applicable

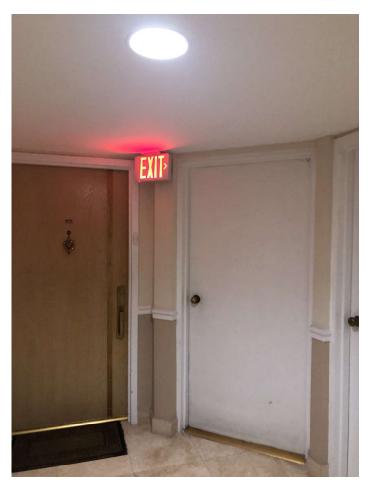
Photo 13 - Exit Lights

22.EXIT LIGHTS								PROVID	Е РНОТО
	Good ( <b>(</b>	X )	Needs	Repair	( (	)	N/A	( (	)
Comments:	`								
Exit signs are provided in a	all exit paths and	d are fully ope	erative. No defi	ciencies	were obs	served.	Refer to	o the atta	iched
Photo 13.

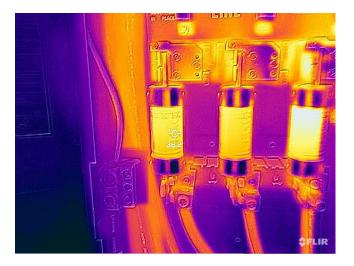
High Priority - PHOTO-05

- 3. The temperature measured on **Elevator #1 and #2 Disconnect** fuses in the rooftop elevator room ranged between 32.4°C and 38.2°C (Delta-T of 10°C to 12°C) while electrically loaded in an acceptable range i.e. below the fuse rating. (See High Priority PHOTO-05 through 10)

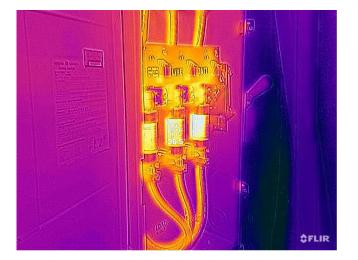
High Priority - PHOTO-11

- 4. The temperature measured on the **Main Elevator Disconnect** fuses in the meter room ranged between 35.9°C and 38.2°C (Delta-T of 9°C to 12°C) while electrically loaded in an acceptable range i.e. below the fuse rating. (See High Priority PHOTO-11 through 16)

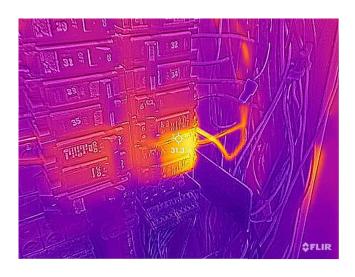
Medium Priority - PHOTO-01

- 5. The temperature measured on two-pole circuit breaker #40/42 on **Panel "H"** was 32.9°C (Delta-T of 6.9°C) at one terminal, while electrically loaded in an acceptable range, indicating a potentially loose contact or wiring termination. (See Medium Priority PHOTO-01 and 02)

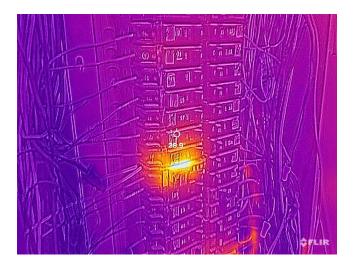
Medium Priority - PHOTO-05

- 7. The temperature measured on single-pole circuit breaker #3 on **Panel "E"** was 33.7°C (Delta-T of 7.7°C) while electrically loaded in an acceptable range, indicating a potentially loose contact or wiring termination. (See Medium Priority PHOTO-05)

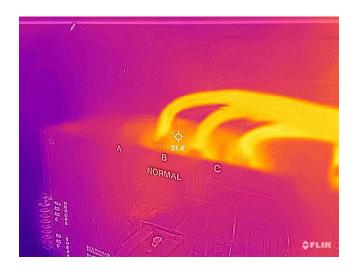
Medium Priority - PHOTO-06

- 8. The temperature measured on three-pole "normal" circuit breaker on **ATS** was 31.4°C (Delta-T of 5.1°C) while electrically loaded in an acceptable range. (See Medium Priority PHOTO-06)

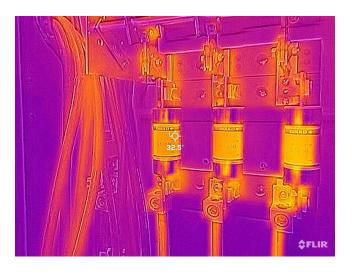
Medium Priority - PHOTO-08

- 9. The temperature measured on **Emergency Disconnect** fuses in the meter room ranged between 32.5°C and 32.8°C (Delta-T of 10°C to 12°C) while electrically loaded in an acceptable range i.e. below the fuse rating. (See Medium Priority PHOTO-08 through 10)

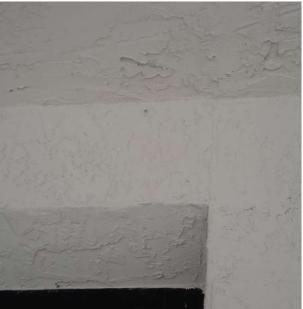
Photo # 1 Stucco crack at pool entrance door Photo # 2 Stucco crack at pool entrance door

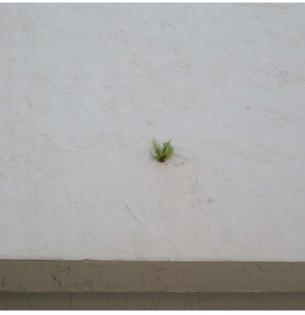
Photo # 6 Closeup of Photo # 5

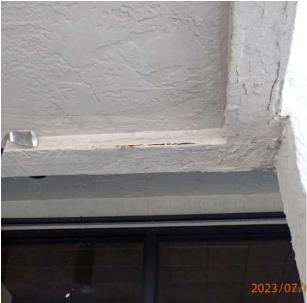
Photo # 7 Cracked stucco at entrance canopy

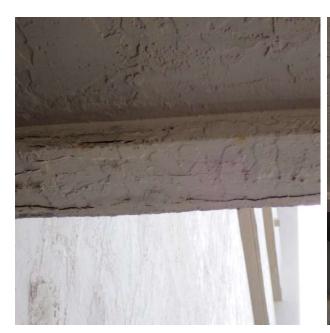
Photo # 8 Closeup of Photo # 7

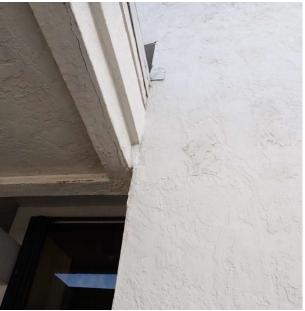
Photo # 10 Closeup of Photo # 7

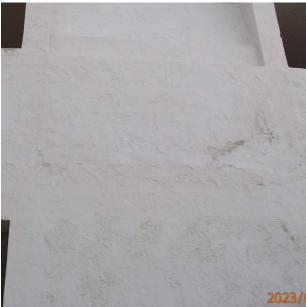
Photo # 14 Closeup of Photo # 13

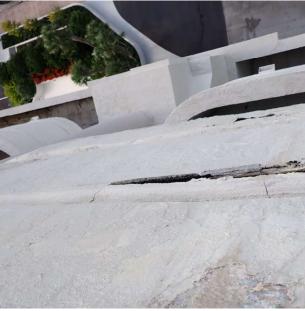
Photo # 18 Closeup of Photo # 17

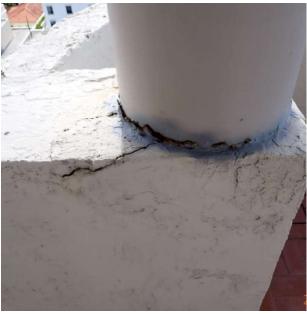
Photo # 24 Closeup of Photo # 23

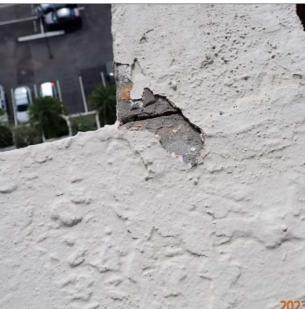
Photo # 26 Closeup of Photo # 25

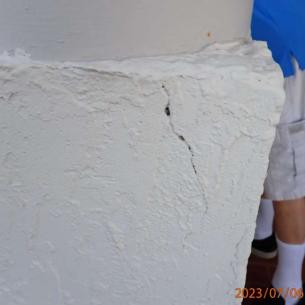
Photo # 27 Cracked stucco at penthouse level railing

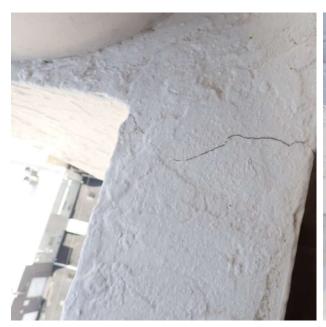
Photo # 28 Crack in stucco at penthouse level

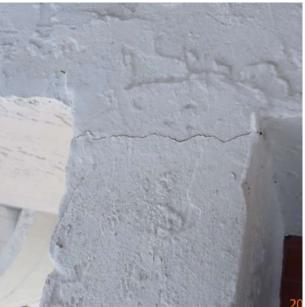
Photo # 30 Closeup of Photo # 29

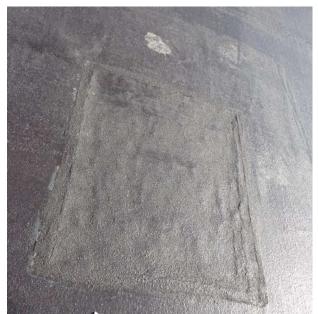
Photo # 32 Driveway cracked and spalled at west ramp

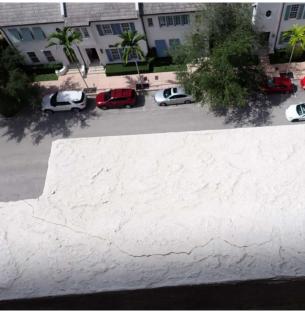
Photo # 48 Cracked stucco on balcony unit 1102

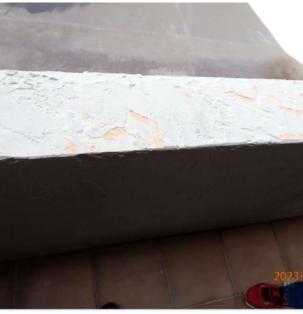
- 3. Pealing chipped paint found on unit balcny railings. (Photo # 52)

Photo # 51 Spalled stucco on balcony unit 201 Photo # 52 Chipped paint on balcony unit 201

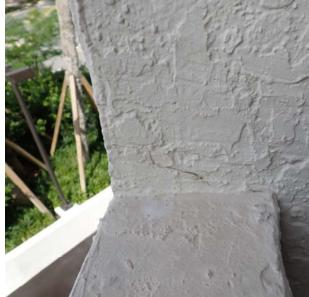
- m2e's inspection revealed the following:
    - 1. Cracks found inside unit walls and in drywall (Photo # 55 through Photo # 58)
    - 2. Cracked and spalling stucco found in unit balconies at multiple locations. (Photo # 45 through Photo # 51, Photo # 53 and Photo # 54)

Photo # 53 Spalled stucco on balcony unit 201

- 2. Cracked and spalling stucco found in unit balconies at multiple locations.
    - a. Since the nature of the cracks listed here are non-structural, perform repairs following engineer protocol and instructions.

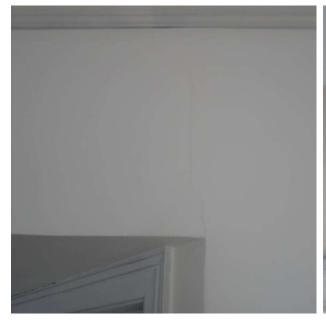
Photo # 54 Cracked stucco on balcony unit 201

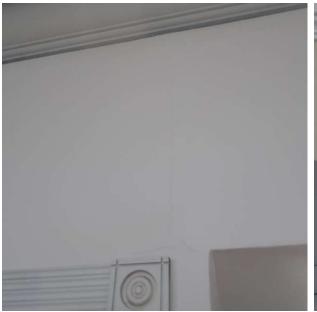
Photo # 56 Wall crack at door in penthouse

- 1. Cracks found inside unit walls and in drywall.
    - a. Visually monitor the cracks in the drywall for 6 months.
    - b. If the cracks widen over time, further investigation is needed to determine the cause. Otherwise perform surface repairs following engineer's repair protocol and recommendations.

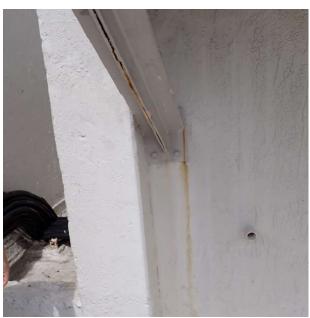
- m2e's inspection revealed the following:
  - 1. Corroded bracing frame members and machine supports (Photo # 60 and Photo # 61)
  - 2. Stucco cracks found multiple locations (Photo # 62 and Photo # 63)
  - 3. Spalling stucco areas (Photo # 64 and Photo # 65)

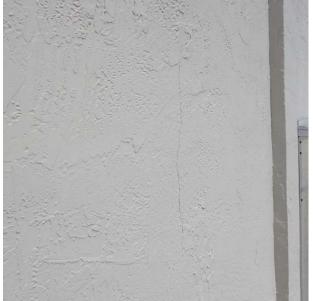
Photo # 62 Stucco crack near entrance door

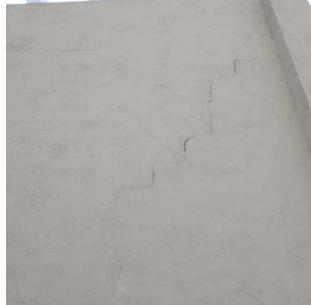
Photo # 63 Stucco crack in wall

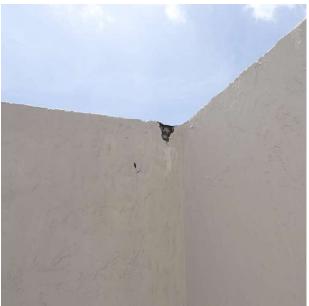
Photo # 64 Spalling stucco

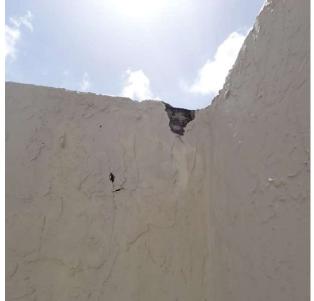
Photo # 65 Closeup of Photo # 64

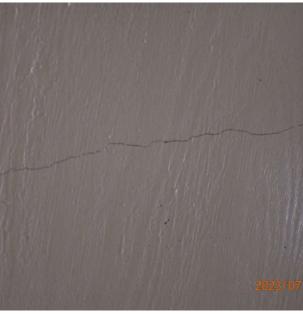
- m2e's inspection revealed the following:
  - 1. Structural cracks in wall, celiling and columns (Photo # 66 through Photo # 75)
  - 2. Spalling concrete areas (Photo # 76 and Photo # 77)
  - 3. Signs of presence of water (Photo # 78 and Photo # 79)
  - 4. Floor cracks throughout the garage (Photo # 80 through Photo # 83)

Photo # 66 Crack in garage ceiling

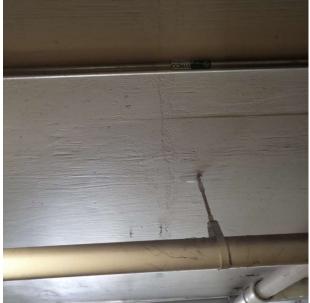
Photo # 68 Crack in garage ceiling

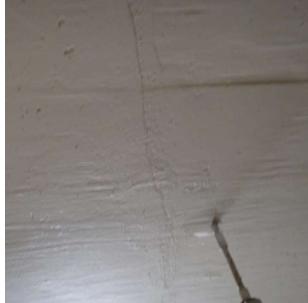
Photo # 69 Closeup of Photo # 68

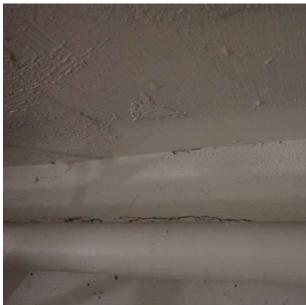
Photo # 71 Wall crack

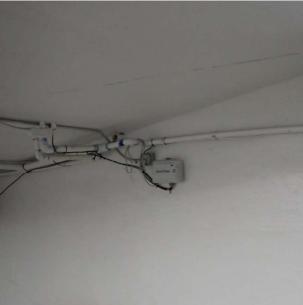
Photo # 72 Crack in garage ceiling

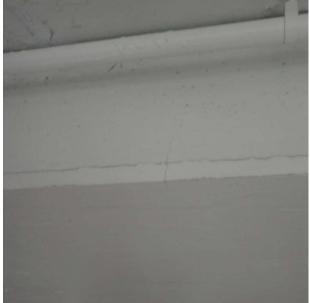
Photo # 75 Crack in garage beam and ceiling

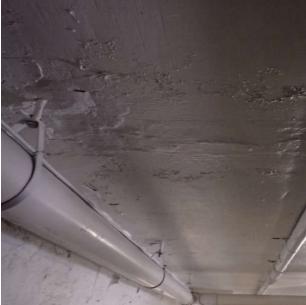
Photo # 79 Sign of water intrusion
