721 Biltmore Way

NOTICE OF UNSAFE STRUCTURE VIOLATION FOR FAILURE TO RECERTIFY AND NOTICE OF HEARING

Aerial of the Property Identifying the Building Being Certified

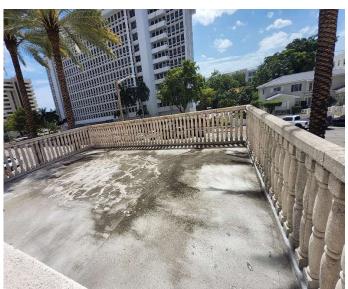
Photo # 6. Lower roof with TPO membrane roofing system.

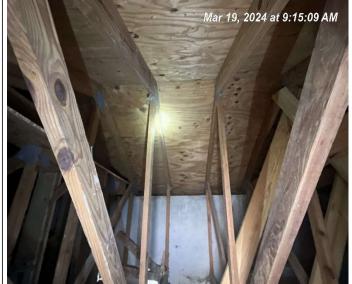
Photo # 7. Porte-cochere roof with bitumen membrane roofing system.

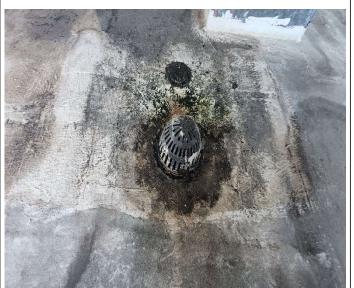
Photo # 13. Primary drain at the lower roof.

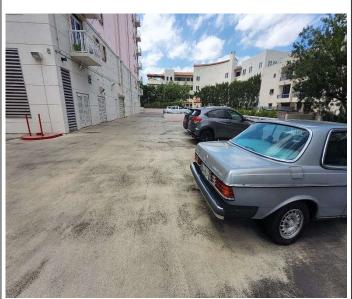
Photo # 17. Garage deck.

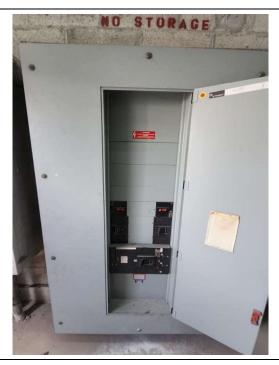
Photo # 2. Item 3.2. Meter Electrical Room. Panelboard. Main 2 of 2. Missing proper circuit identification.

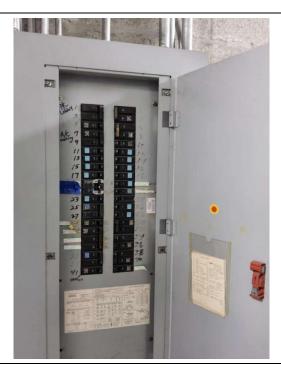
Photo # 10. Item 7.4.a. Meter Electrical Room. Panelboard HOUSE. Missing proper circuit identification.

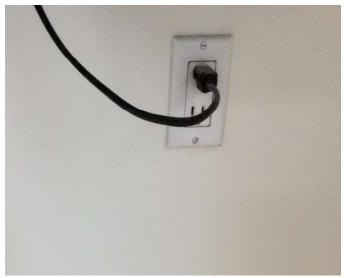
Photo # 16. Item 16.b. Drinking fountain. Missing GFCI protection for receptacles.

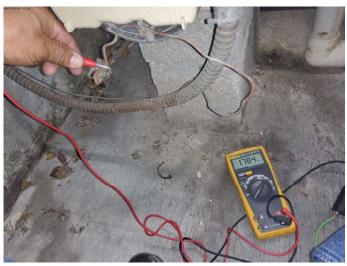
Photo # 24. Item 26.a. Pool equipotential bonding: Failed test between pumps and metal parts.

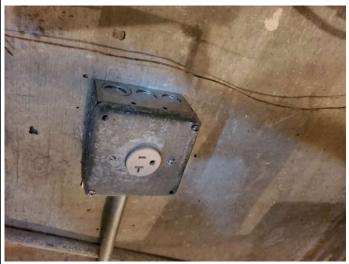
Photo # 28. Item 27.c. Level Bassement. Elevator. Missing GFCI protection for receptacle.

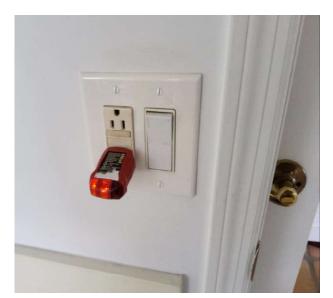
Photo # 32. Item 28.2. Missing GFCI protection for receptacles in the bathroom- test fail.
