PROPERTY APPRAISER OF MIAMI-DADE COUNTY

1960 Douglas Rd

**NOTICE OF UNSAFE STRUCTURE VIOLATION FOR FAILURE TO RECERTIFY
AND NOTICE OF HEARING**

AERIAL IMAGES

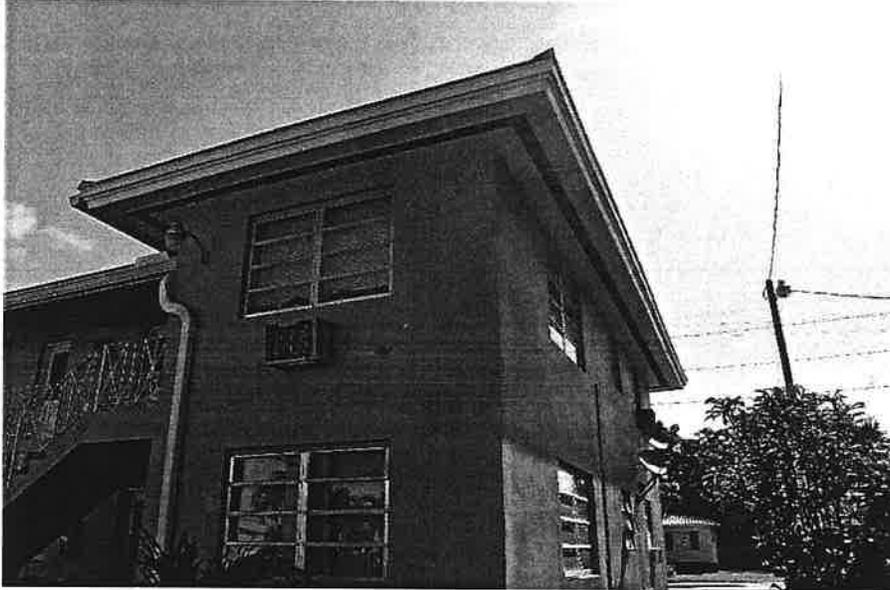
Photo(s) 5a:

Overall fair conditions of the exterior of the structure

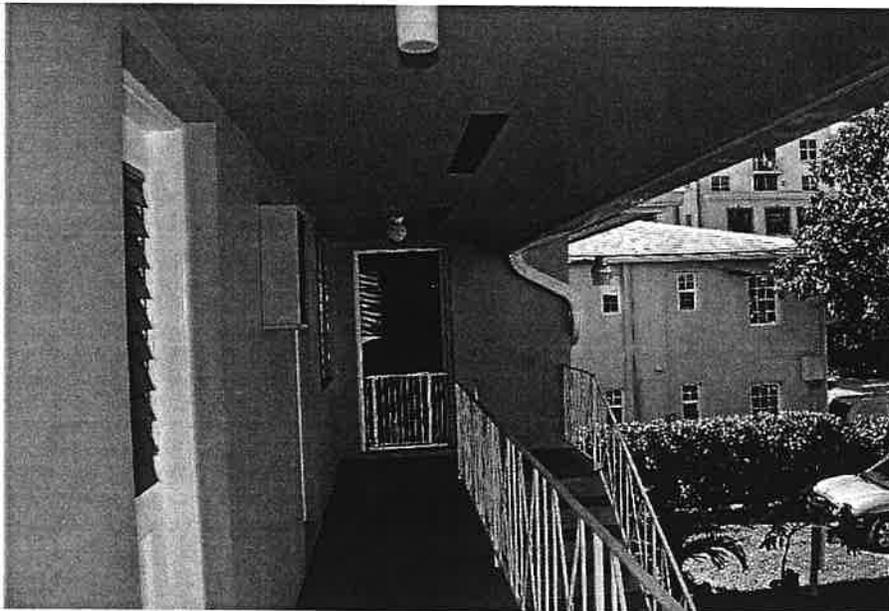
Overall fair conditions of the structure

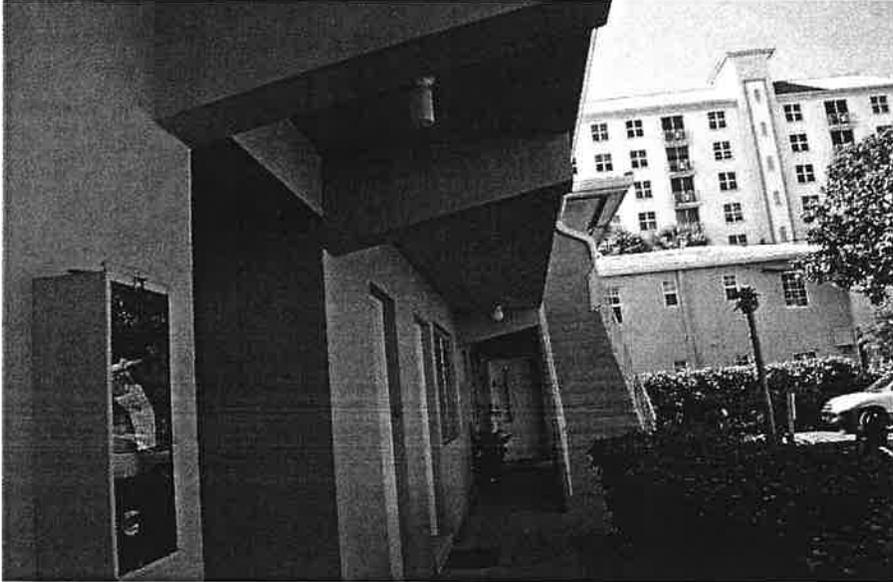
Photo(s) 5b:

Typical concrete frames, 2nd-floor slab, and stairs along the west side of the building. Note no signs of distress

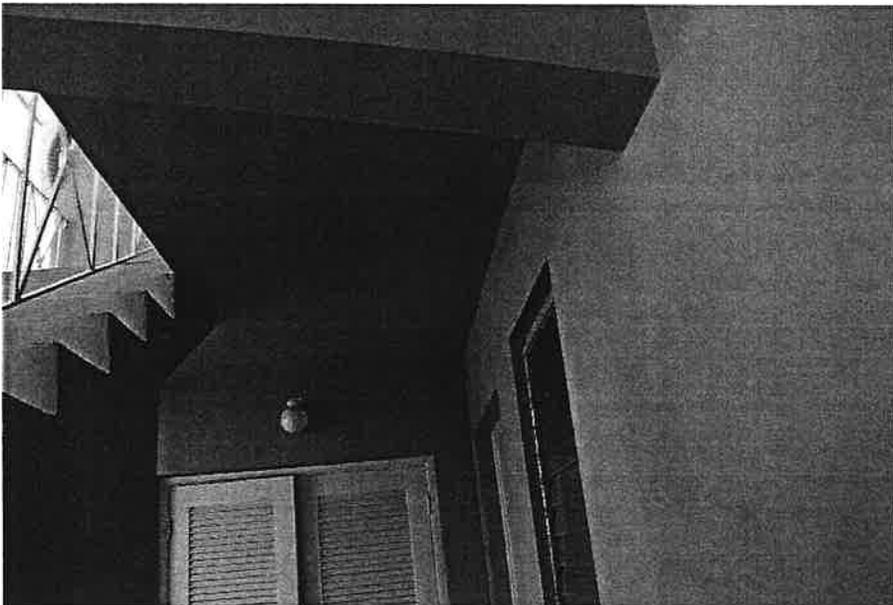
Photo(s) 5c:

Typical exterior finishes of the building

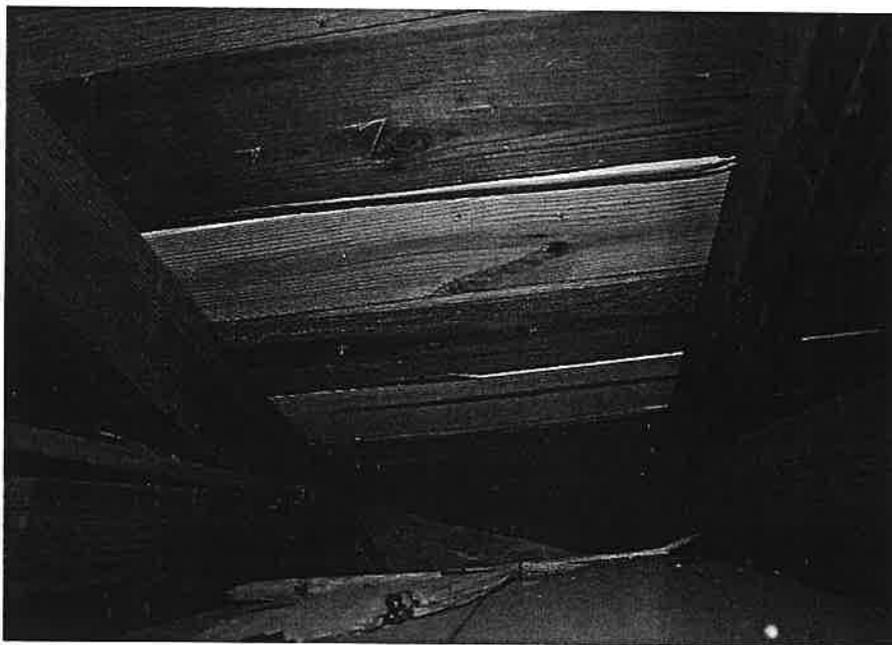
Typical pre-fabricated wood roof trusses and board decking

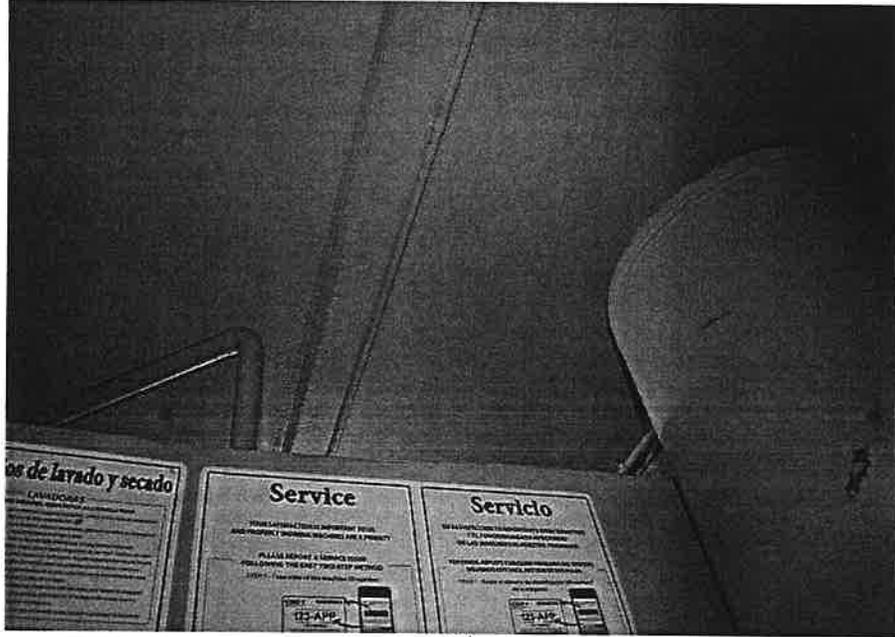
Photo(s) 7b1:

Typical bottom portions of the 2nd-floor pre-cast concrete planks

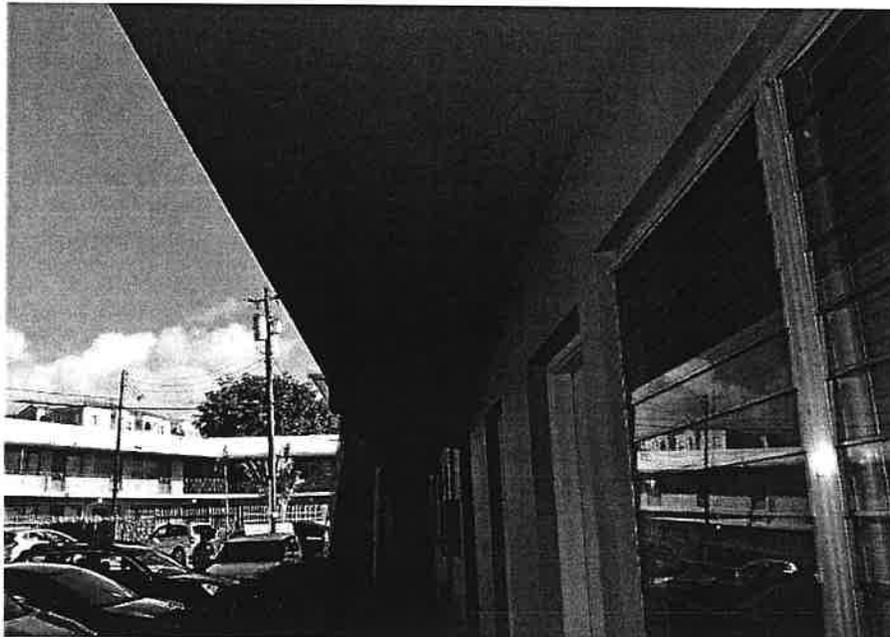
Photo(s) 7b2:

Bottom portion of the continuous balcony along the west side of the building

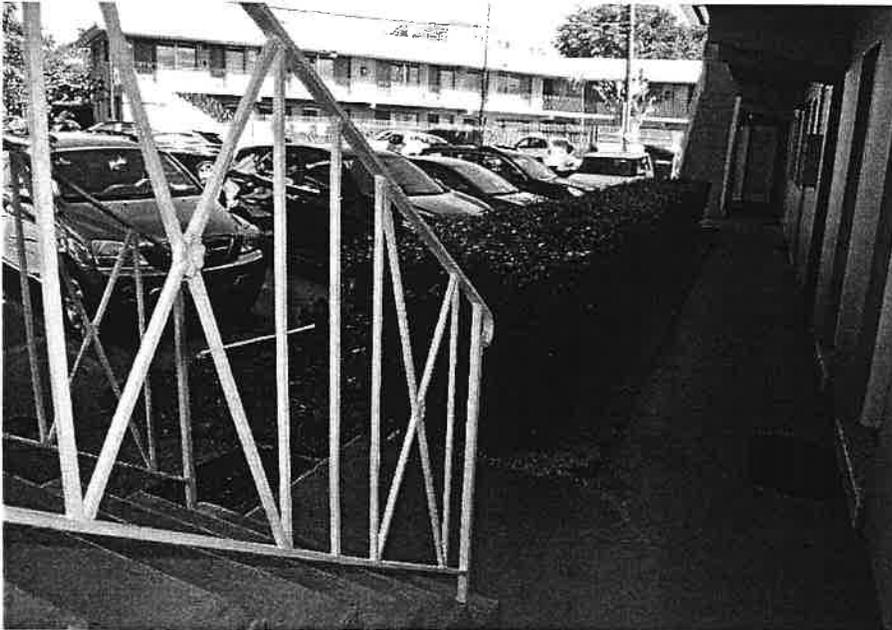
Photo(s) 7b5:

Typical steel guardrails of the stairs and continuous 2nd-floor balcony along the west side of the building

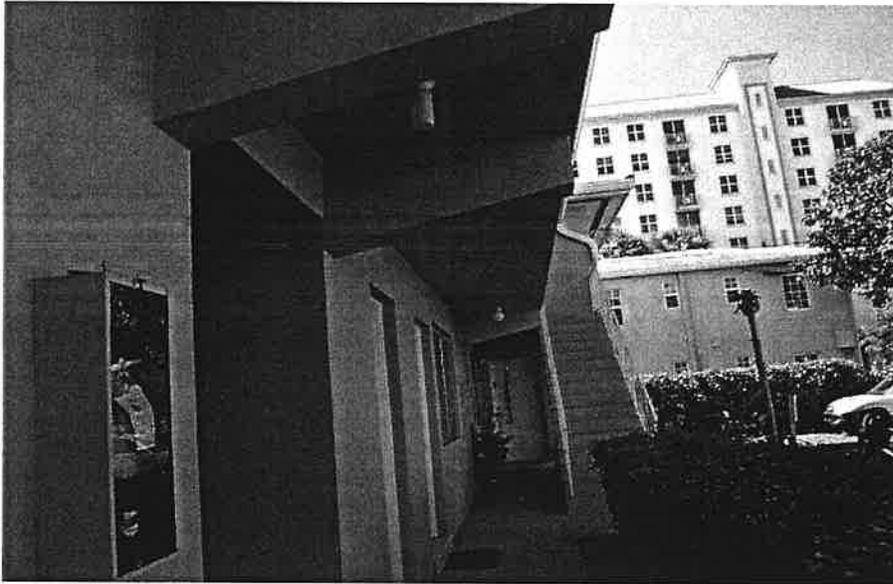
Photo(s) 9a:

Typical concrete frames, 2nd-floor slab, and stairs along the west side of the building

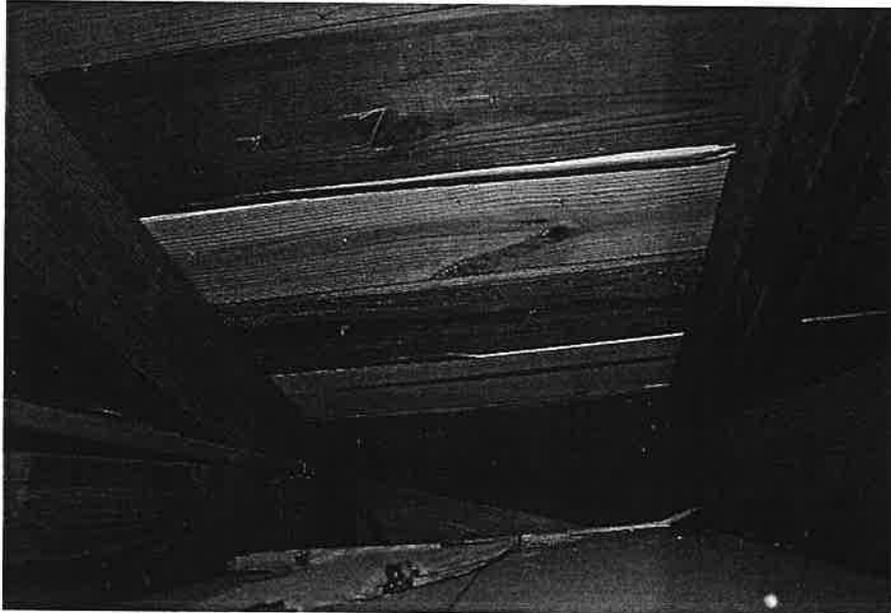
Photo(s) 11a:

Typical pre-fabricated wood roof trusses and board decking

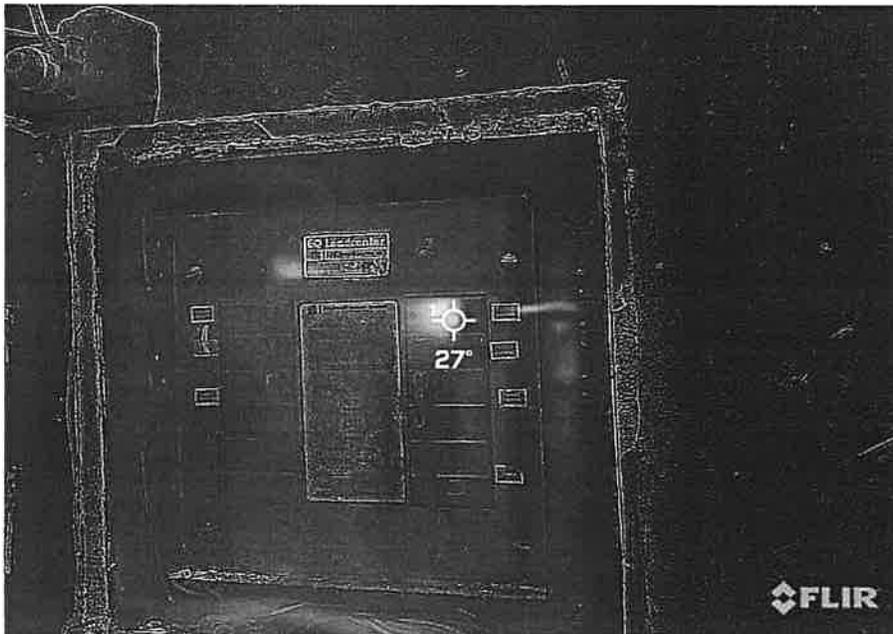
Item 4: Typical Panel at 27.0C (delta 5.0C) -

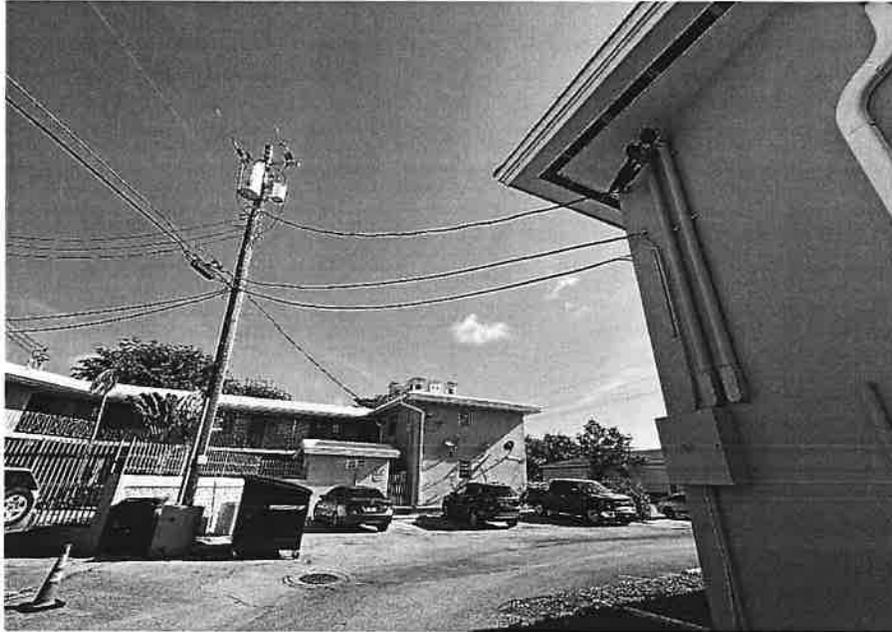
FPL Overhead Service – Single Phase 120/240 Volts, 3 Wire
