# PROPERTY APPRAISER OF MIAMI-DADE COUNTY

| PROPERTY INFORMATION | |
|---|---|
| Property Address | 13637 DEERING BAY DR<br>CORAL GABLES, FL 33158-0000 |

**NOTICE OF UNSAFE STRUCTURE VIOLATION FOR FAILURE TO RECERTIFY  
AND NOTICE OF HEARING**

☒ Initial Inspection Report ☐ Amended Inspection Report after completion of repairs

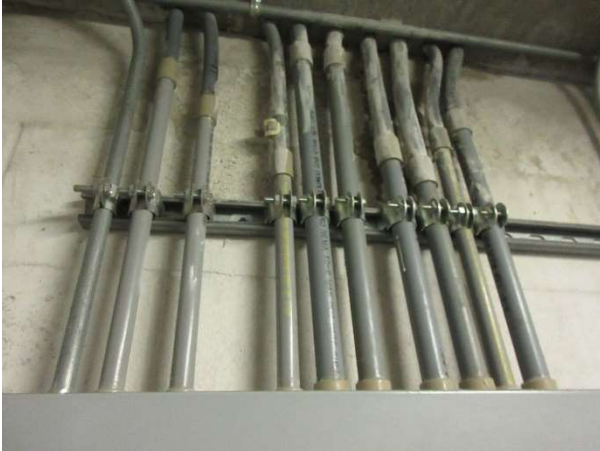
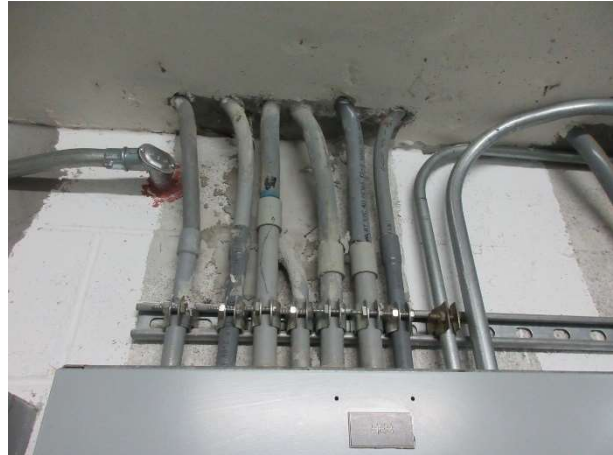
BELOW GRADE IN ALL CASES. SEE (9) ABOVE.

FOR THE APARTMENTS

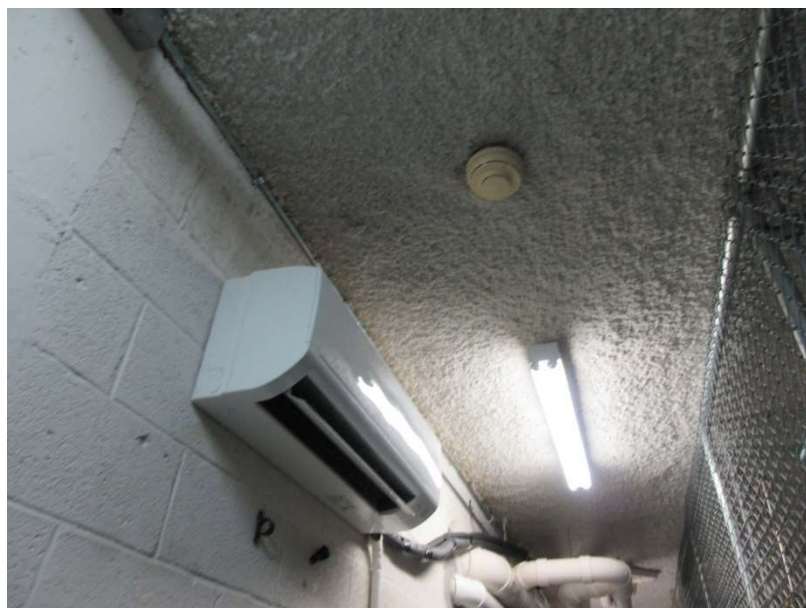
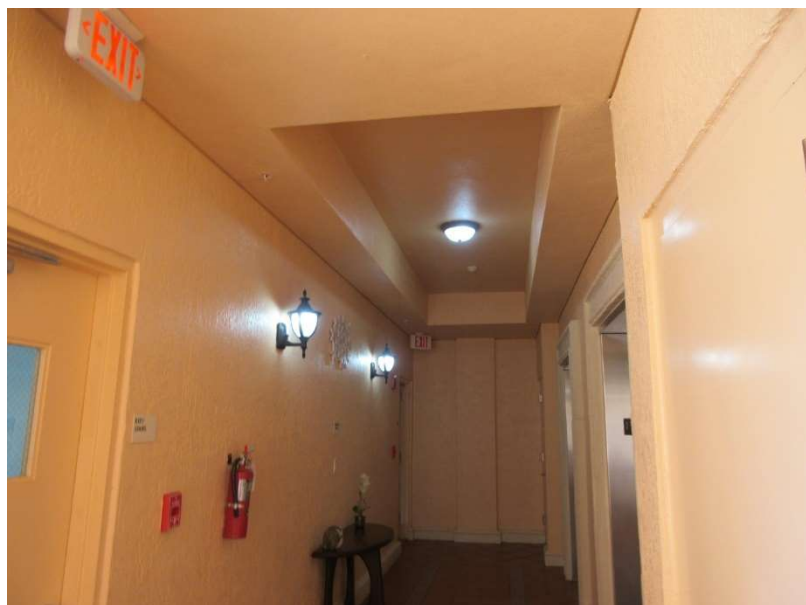
## 21. EXISTING SMOKE DETECTORS

TYPICAL IN ALL ELEVATOR LOBBY AREAS, ALL FLOORS.

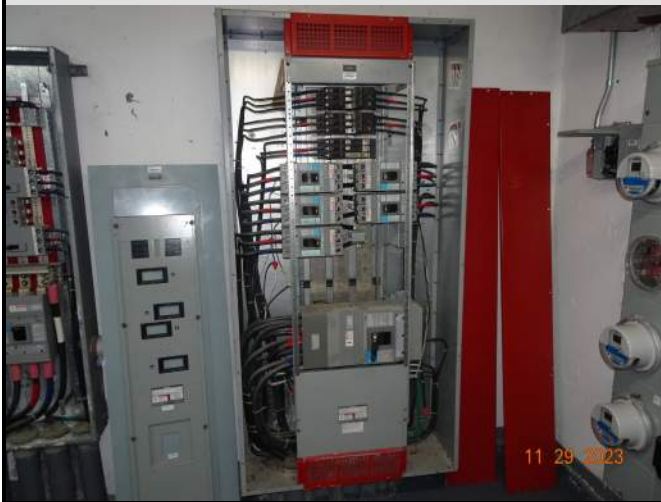
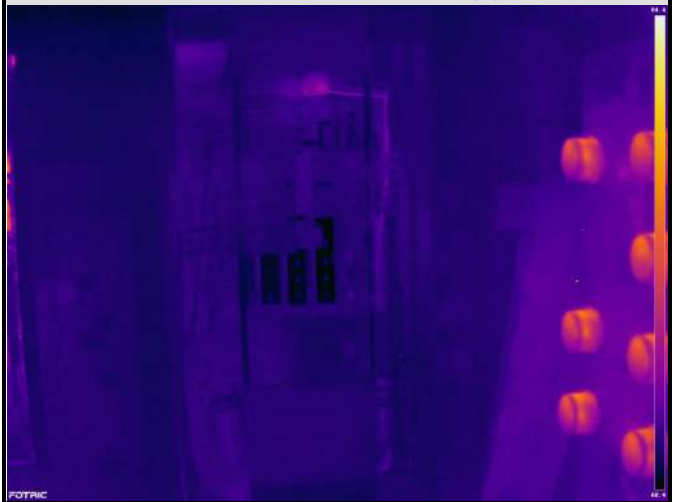
DSC00632.JPG

Ambient Temp: 72 °F

Measured Temp: 70 °F

Temp Threshold: 110 °F

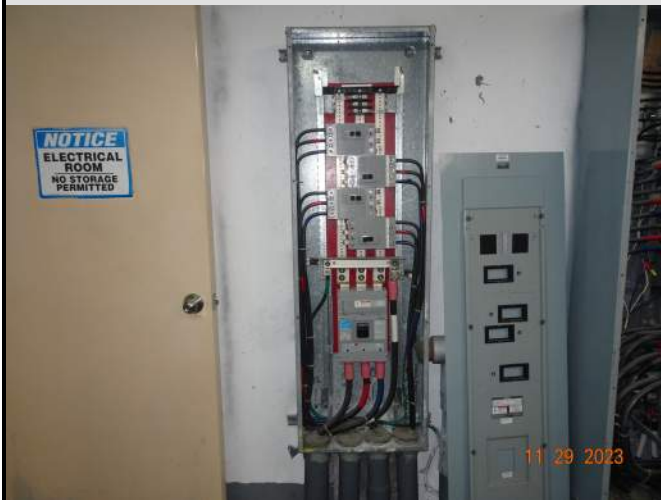
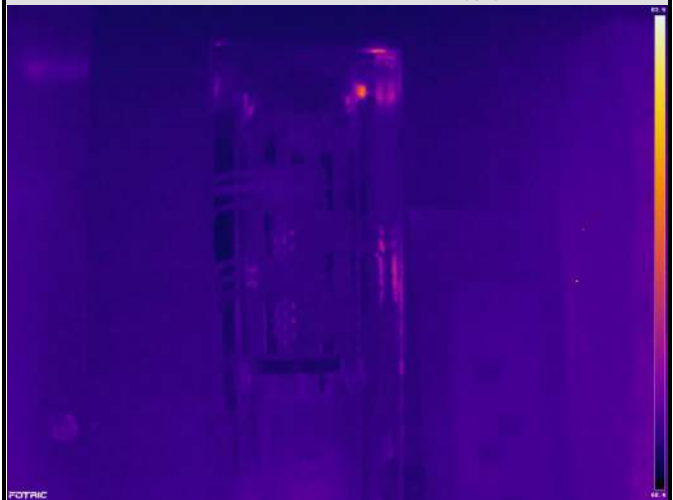
DSC00633.JPG

Ambient Temp: 72 °F

Measured Temp: 71 °F

Temp Threshold: 110 °F

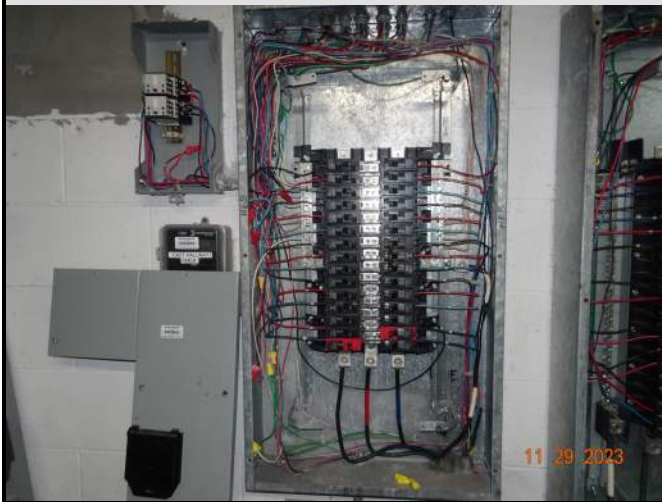
DSC00634.JPG

Ambient Temp: 72 °F

Measured Temp: 100 °F

Temp Threshold: 110 °F

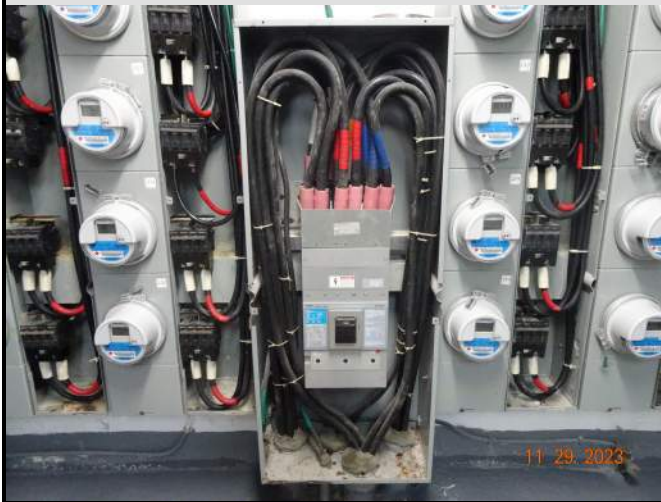
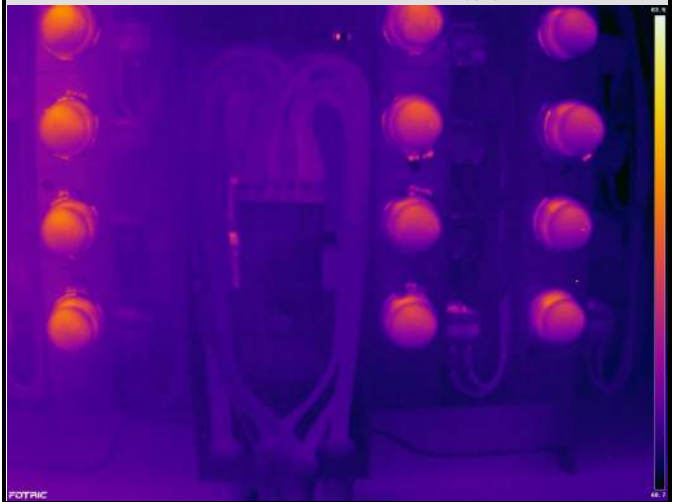
DSC00640.JPG

Ambient Temp: 72 °F

Measured Temp: 72 °F

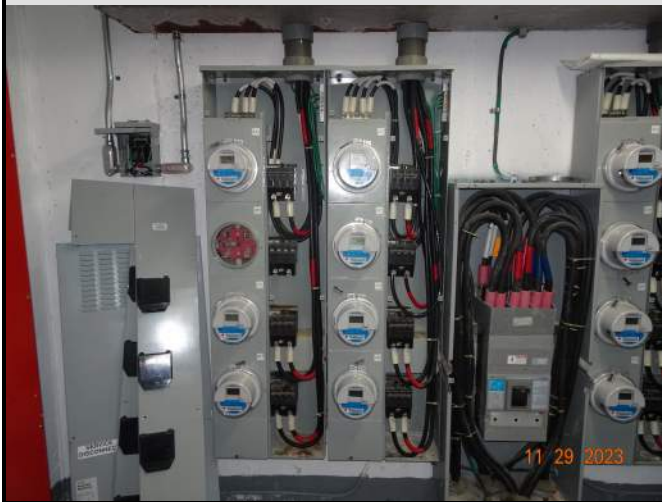
DSC00641.JPG

Ambient Temp: 72 °F

Measured Temp: 78 °F

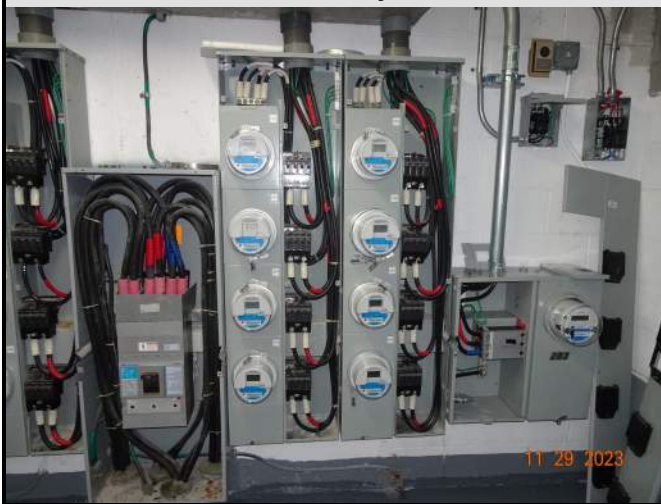
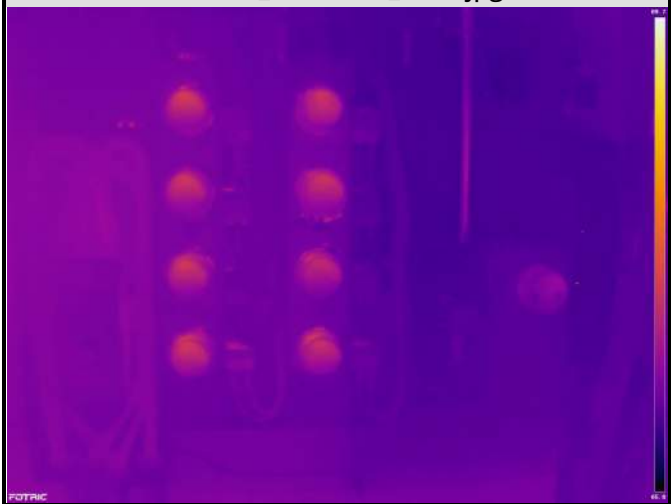
DSC00642.JPG

Ambient Temp: 72 °F

Measured Temp: 78 °F

Temp Threshold: 110 °F

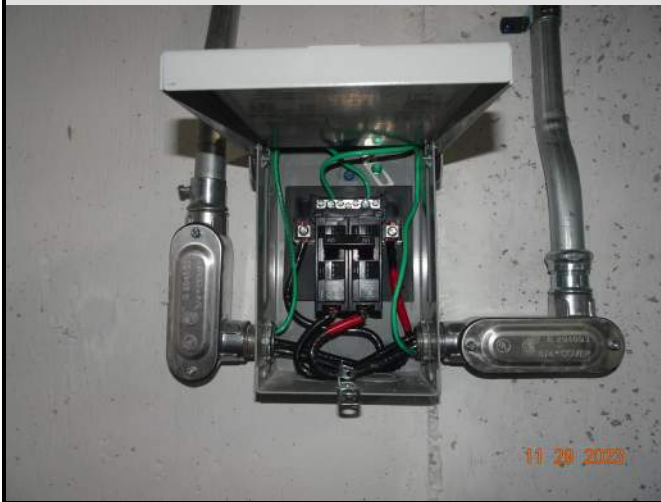
DSC00644.JPG

Ambient Temp: 72 °F

Measured Temp: 72 °F

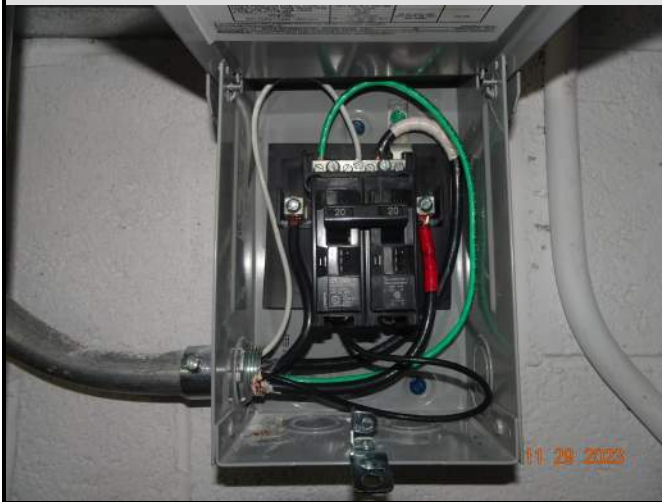
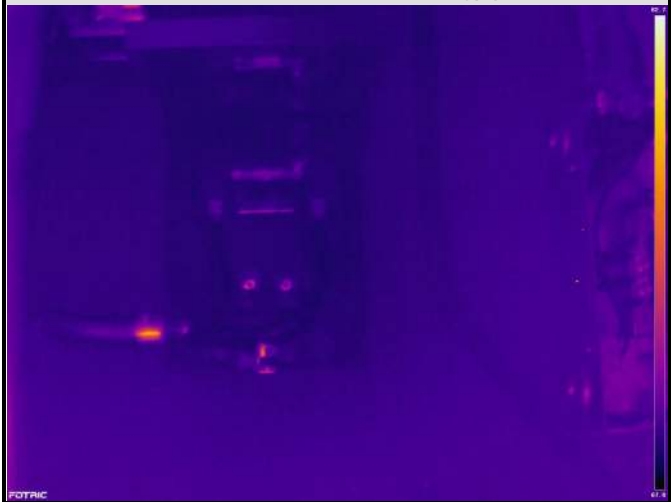
DSC00645.JPG

Ambient Temp: 72 °F

Measured Temp: 72 °F

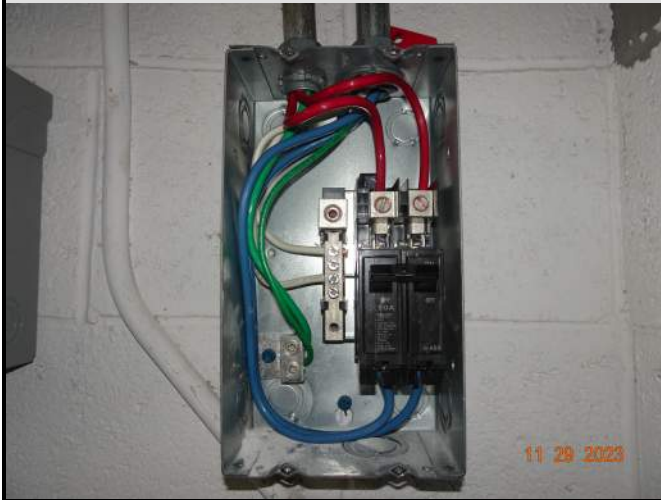
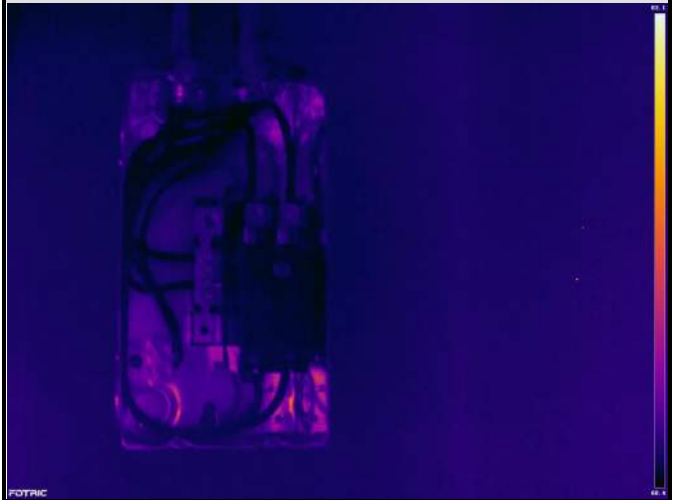
DSC00646.JPG

Ambient Temp: 72 °F

Measured Temp: 72 °F

Temp Threshold: 110 °F

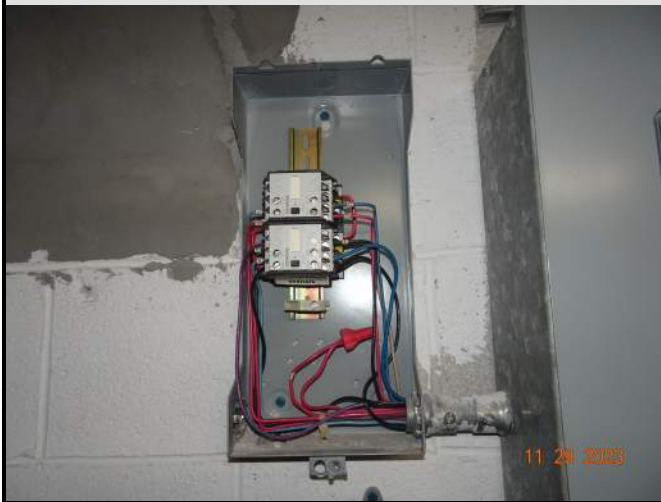
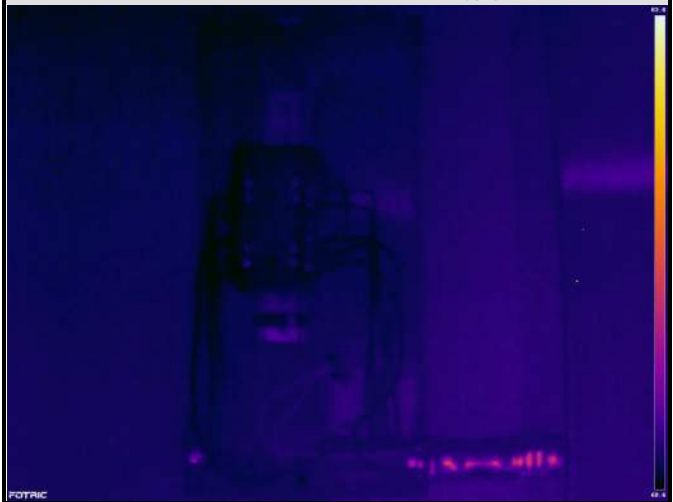
DSC00647.JPG

Ambient Temp: 72 °F

Measured Temp: 72 °F

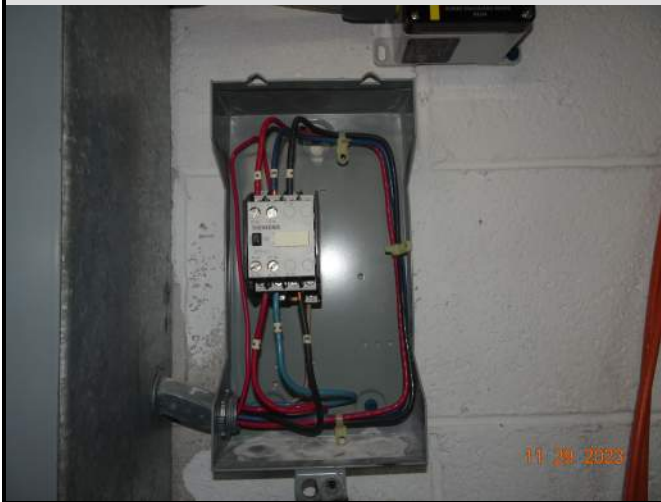
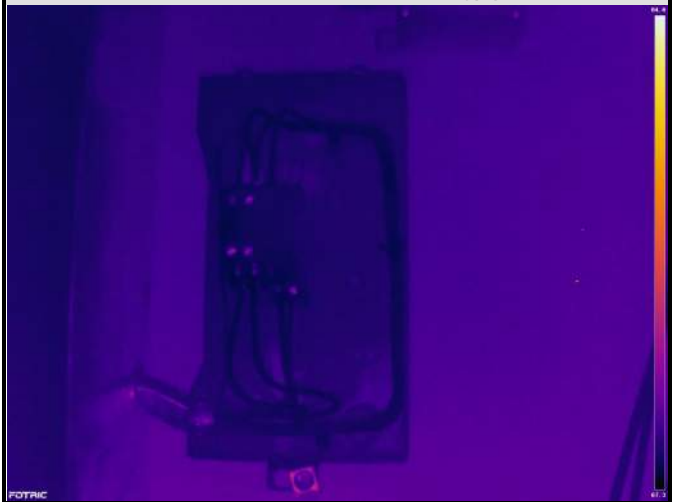
DSC00648.JPG

Ambient Temp: 72 °F

Measured Temp: 71 °F

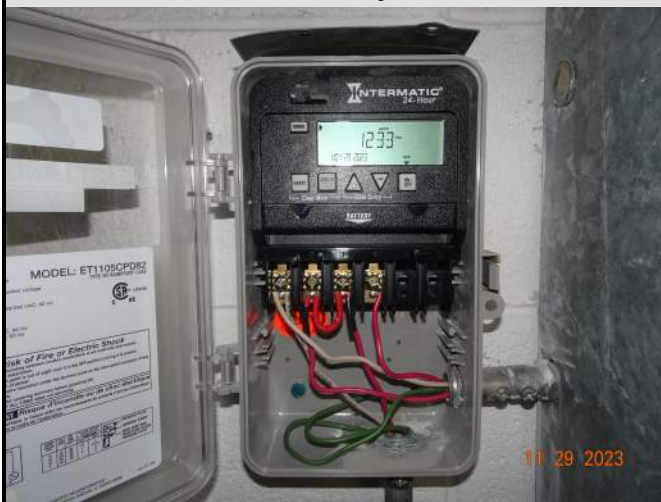
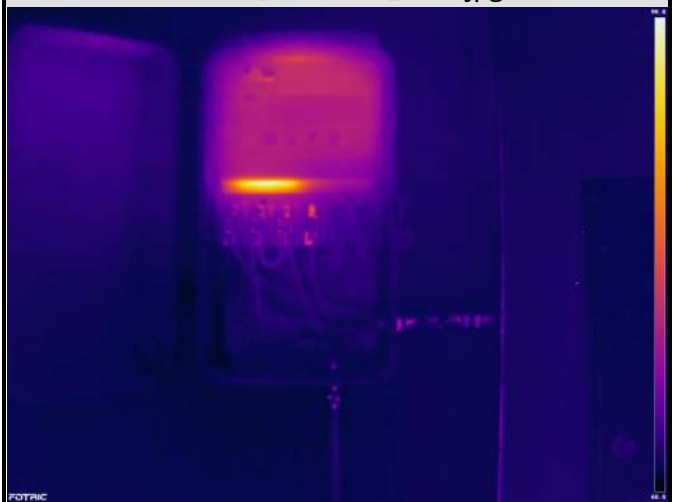
DSC00649.JPG

Ambient Temp: 72 °F

Measured Temp: 72 °F

Temp Threshold: 110 °F

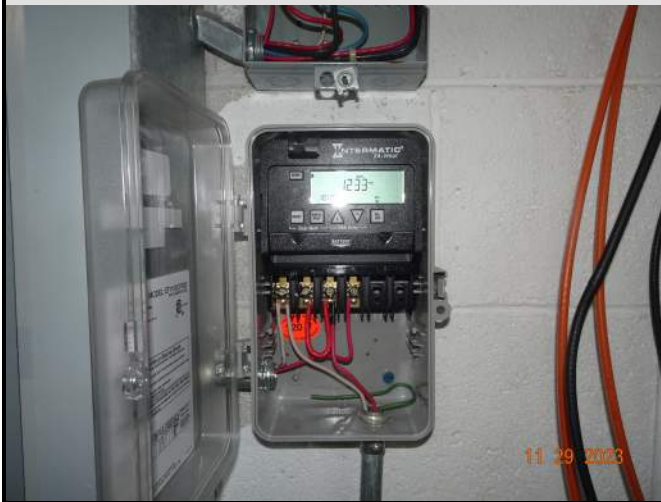
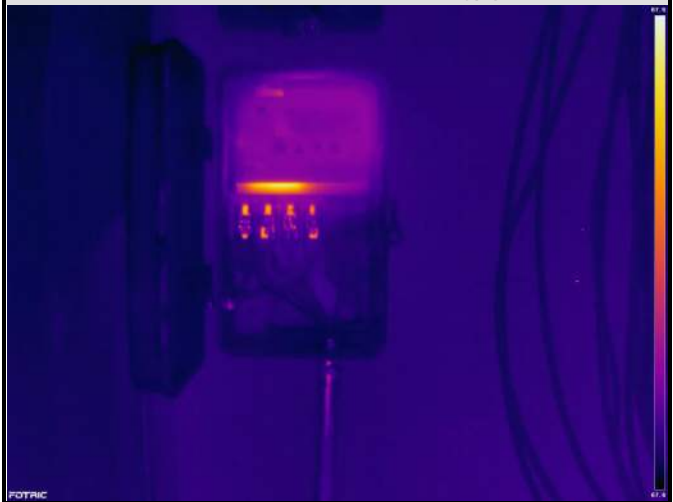
DSC00650.JPG

Ambient Temp: 72 °F

Measured Temp: 72 °F

Temp Threshold: 110 °F

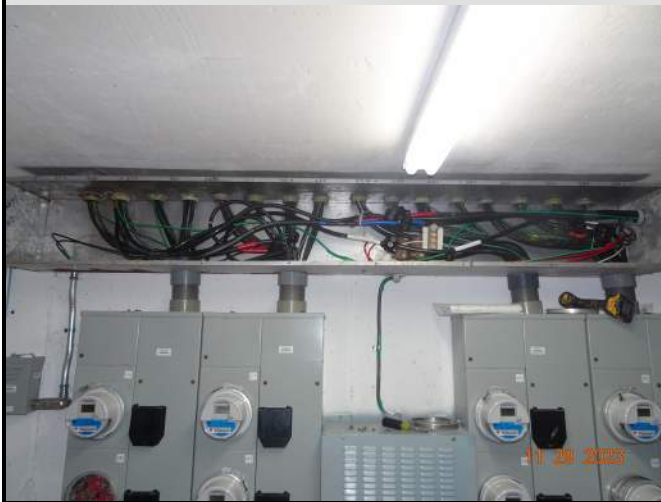
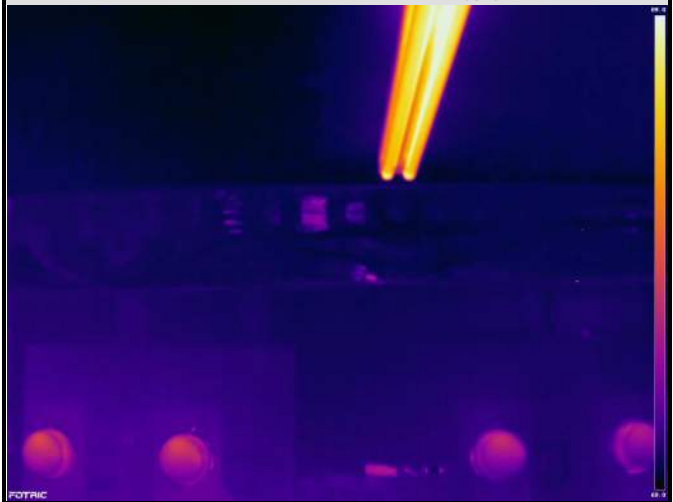
DSC00651.JPG

Ambient Temp: 72 °F

Measured Temp: 72 °F

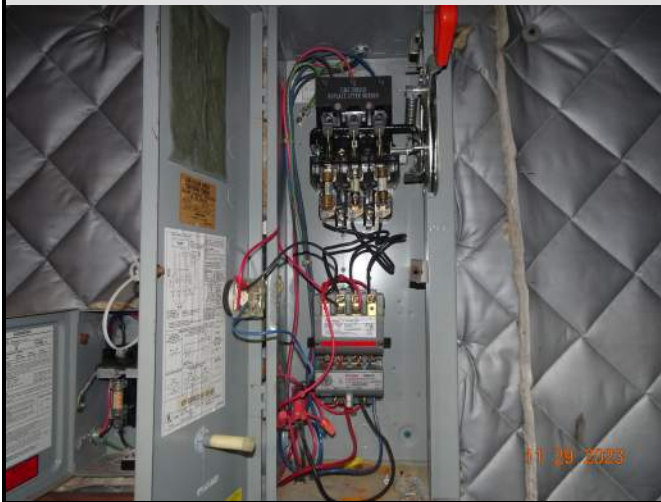
DSC00652.JPG

Ambient Temp: 72 °F

Measured Temp: 73 °F

Temp Threshold: 110 °F

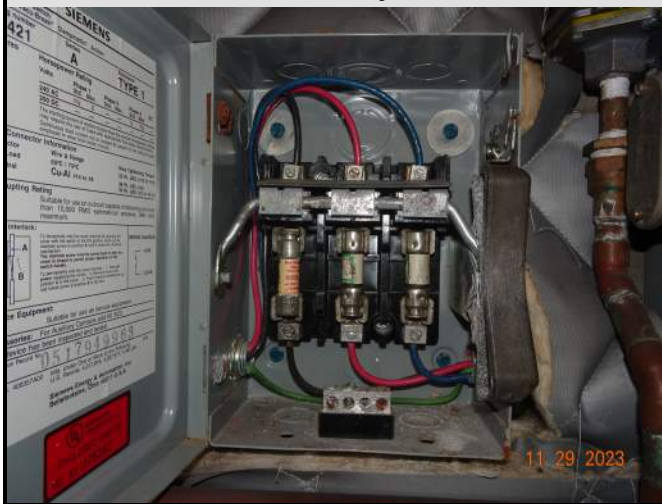
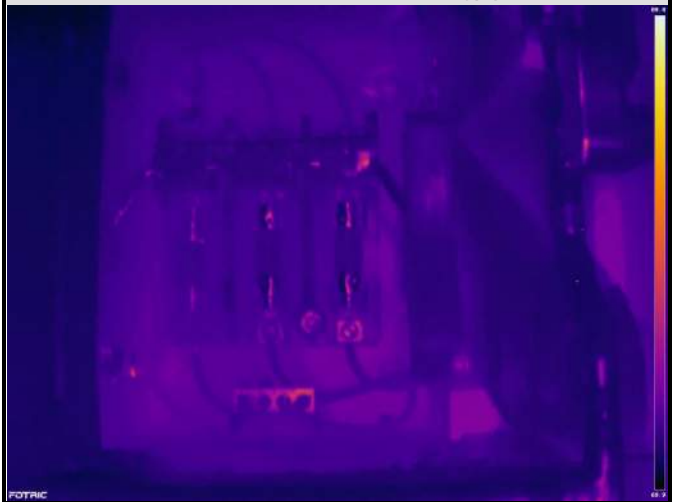
DSC00653.JPG

Ambient Temp: 72 °F

Measured Temp: 73 °F

Temp Threshold: 110 °F

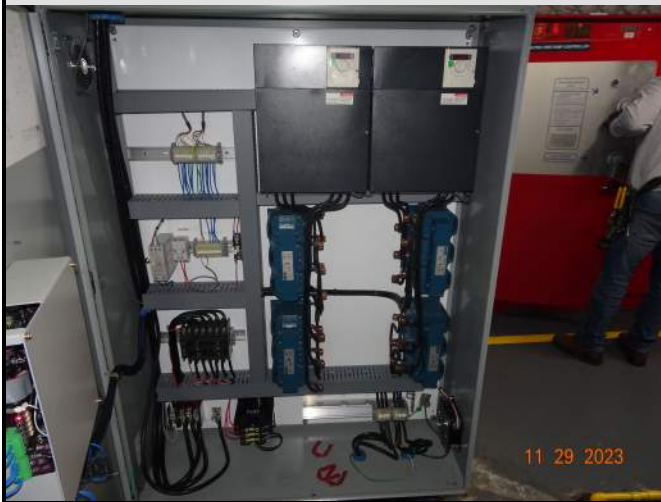
DSC00654.JPG

Ambient Temp: 72 °F

Measured Temp: 81 °F

Temp Threshold: 110 °F

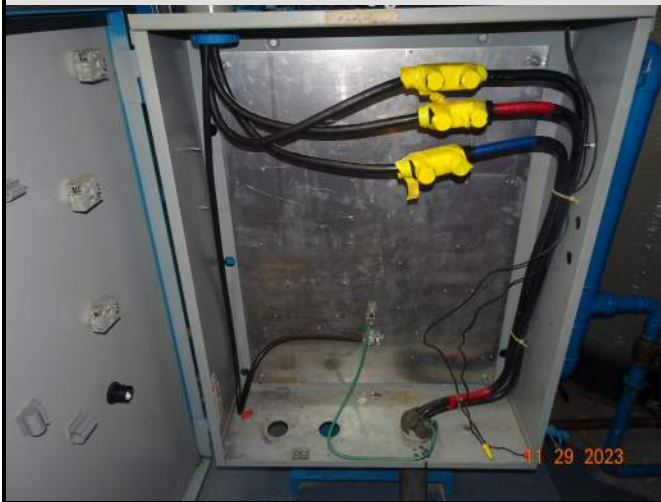
DSC00655.JPG

Ambient Temp: 72 °F

Measured Temp: 72 °F

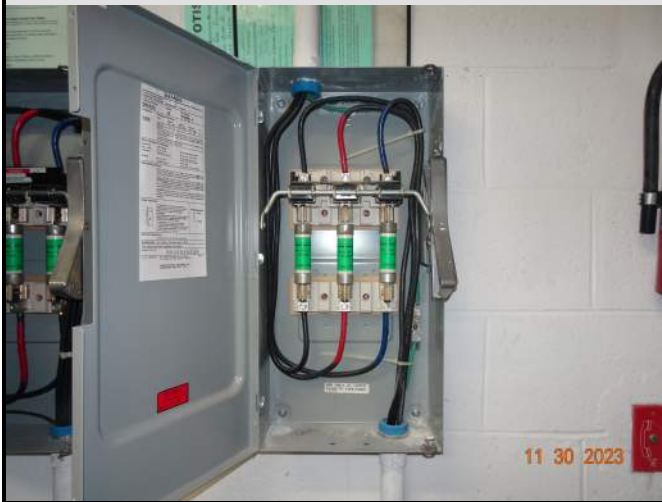
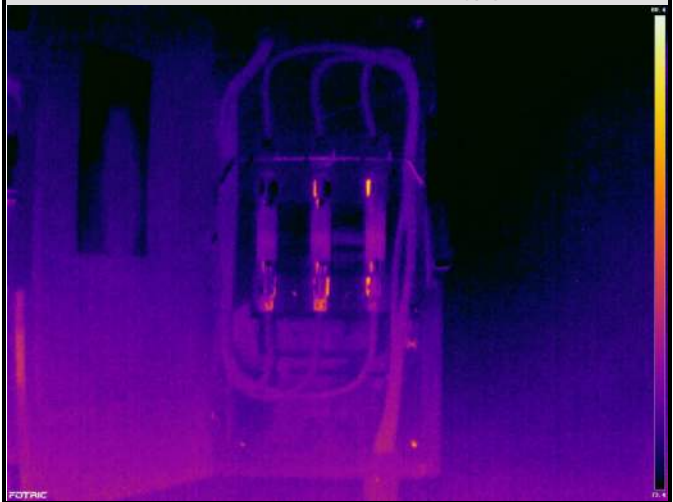
DSC00002.JPG

Ambient Temp: 72 °F

Measured Temp: 74 °F

Temp Threshold: 110 °F

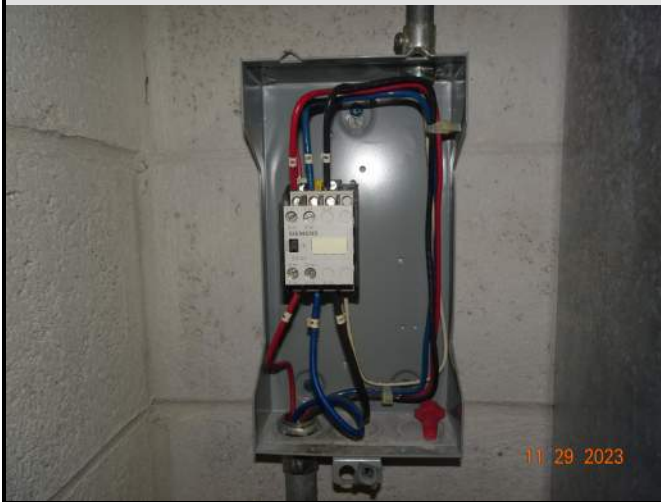
DSC00620.JPG

Ambient Temp: 78 °F

Measured Temp: 83 °F

Temp Threshold: 110 °F

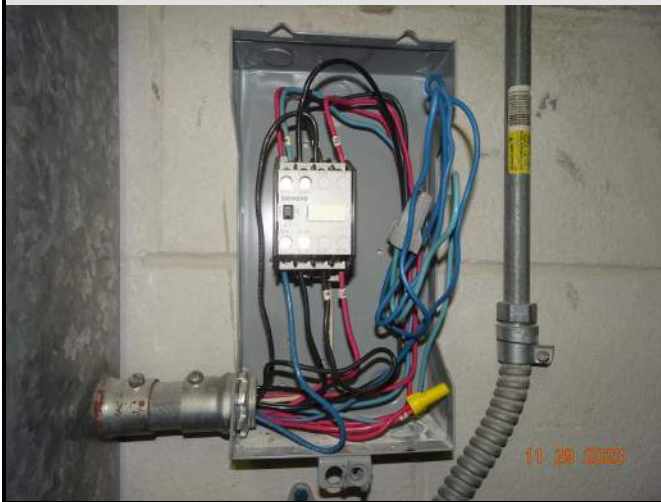
DSC00621.JPG

Ambient Temp: 78 °F

Measured Temp: 76 °F

Temp Threshold: 110 °F

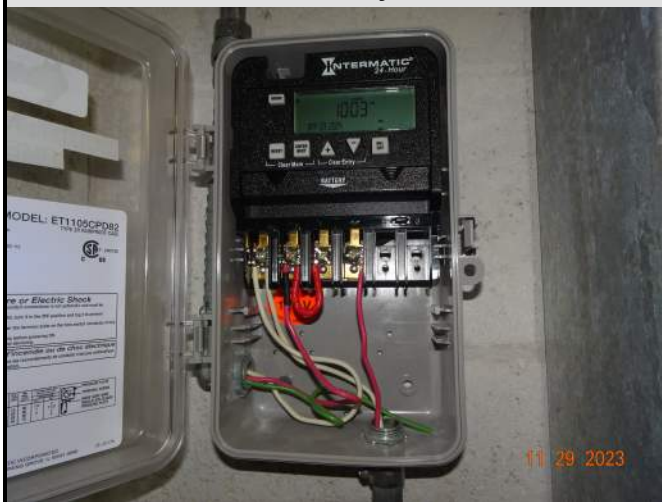
DSC00622.JPG

Ambient Temp: 78 °F

Measured Temp: 81 °F

Temp Threshold: 110 °F

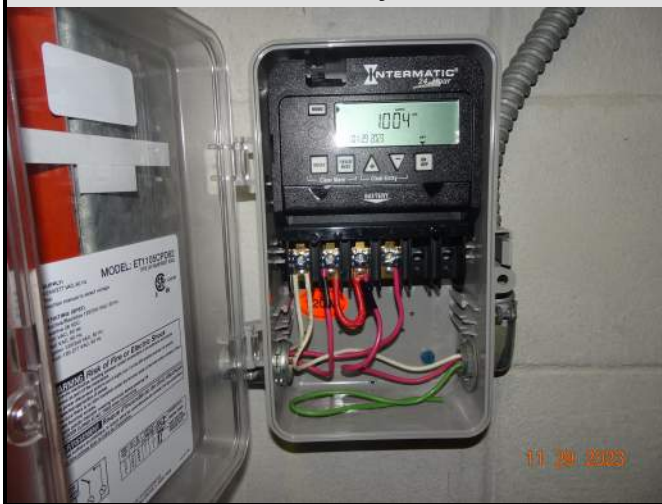
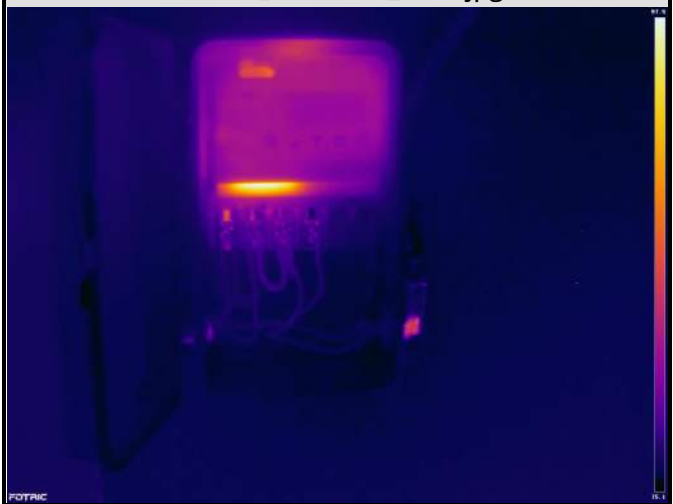
DSC00623.JPG

Ambient Temp: 78 °F

Measured Temp: 79 °F

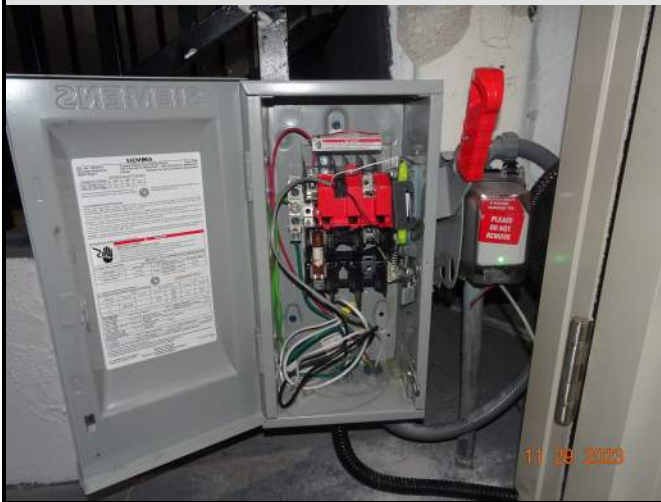
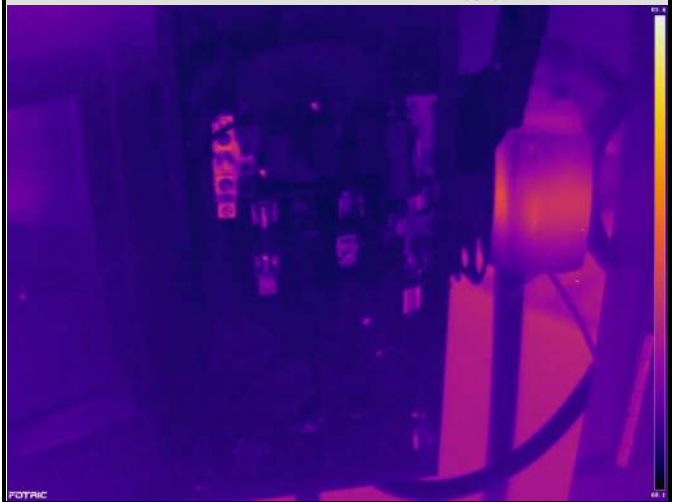
DSC00624.JPG

Ambient Temp: 68 °F

Measured Temp: 70 °F

Temp Threshold: 110 °F

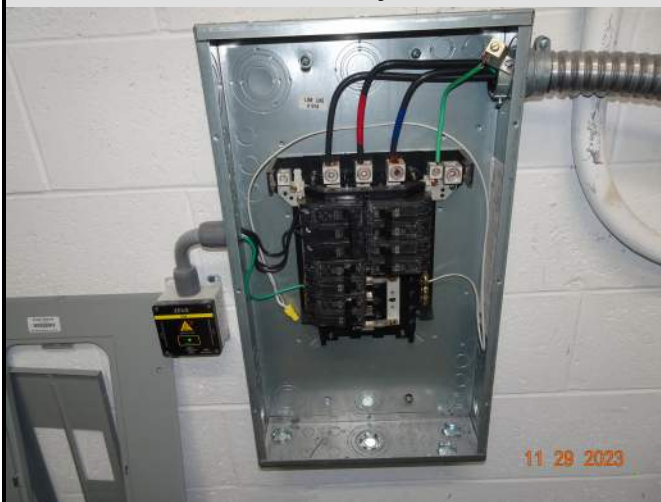
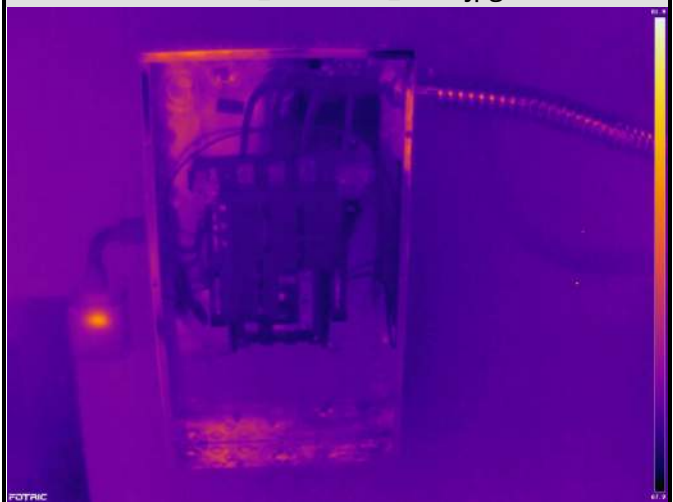
DSC00625.JPG

Ambient Temp: 70 °F

Measured Temp: 70 °F

Temp Threshold: 110 °F

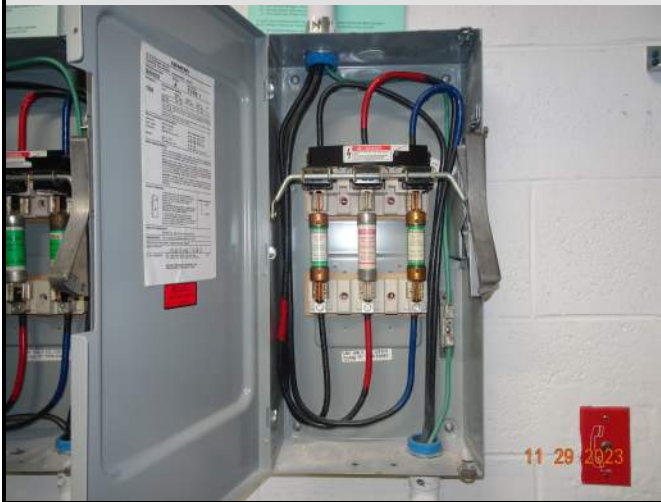
DSC00626.JPG

Ambient Temp: 70 °F

Measured Temp: 70 °F

Temp Threshold: 110 °F

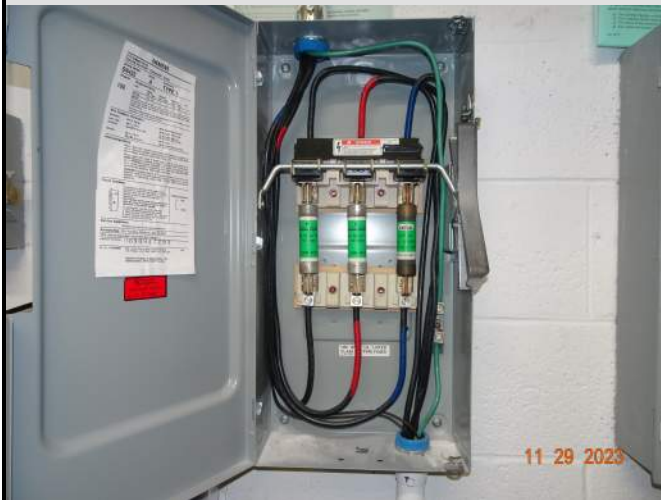
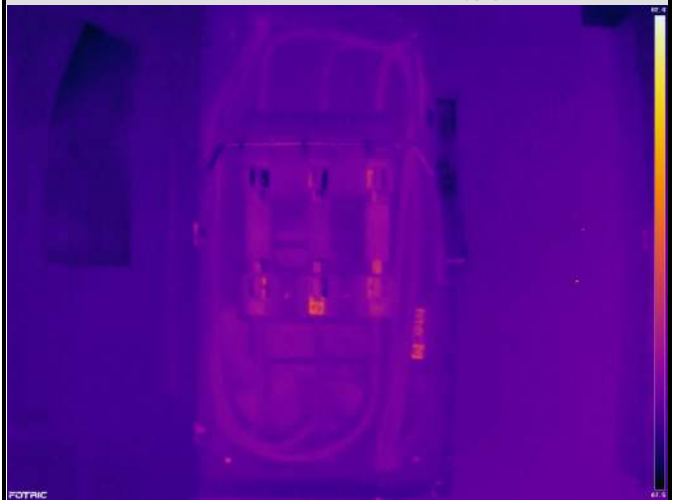
DSC00627.JPG

Ambient Temp: 70 °F

Measured Temp: 71 °F

Temp Threshold: 110 °F

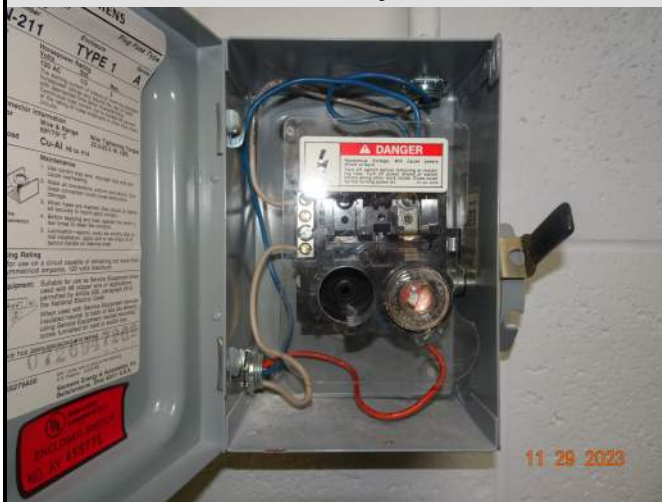
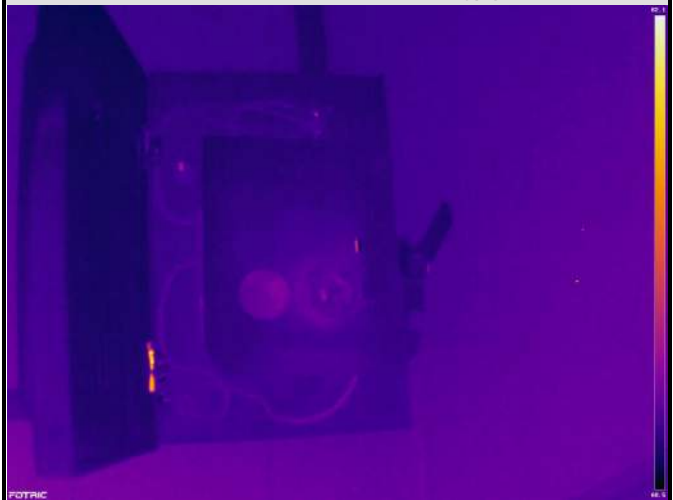
DSC00628.JPG

Ambient Temp: 70 °F

Measured Temp: 71 °F

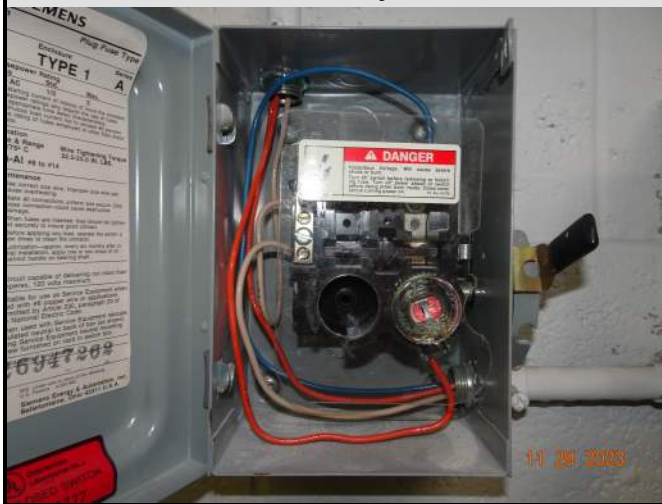
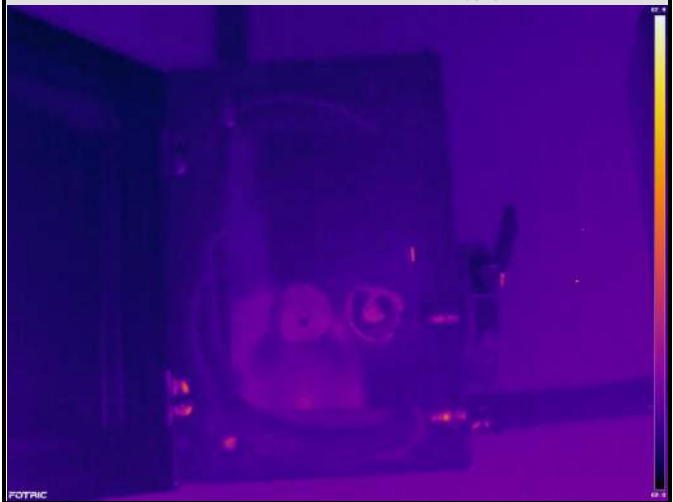
DSC00629.JPG

Ambient Temp: 70 °F

Measured Temp: 71 °F

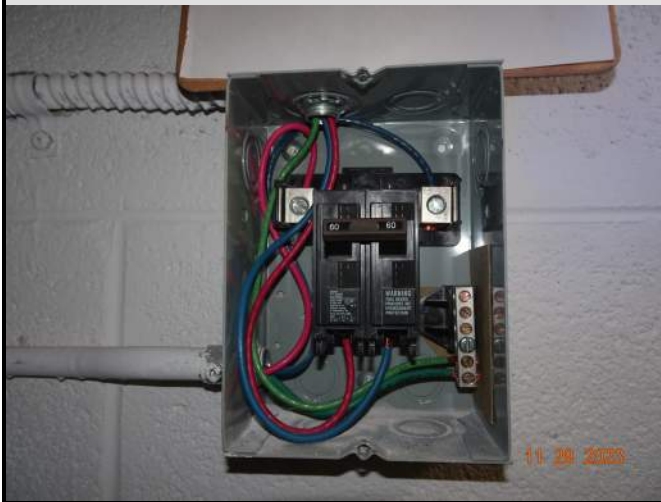
DSC00631.JPG

Ambient Temp: 70 °F

Measured Temp: 69 °F

Temp Threshold: 110 °F

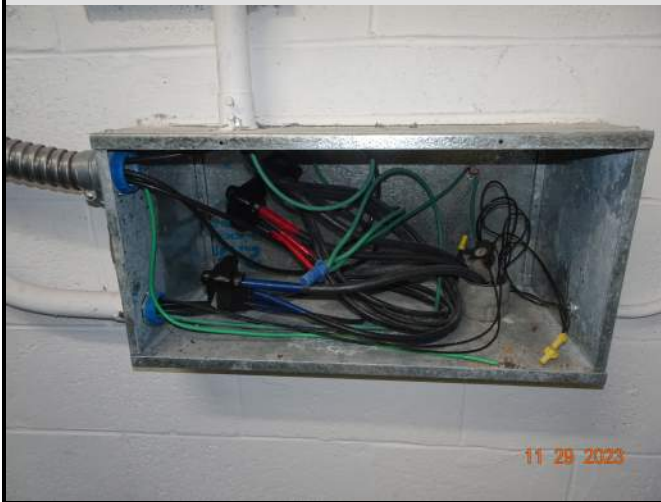
DSC00630.JPG

Ambient Temp: 70 °F

Measured Temp: 70 °F

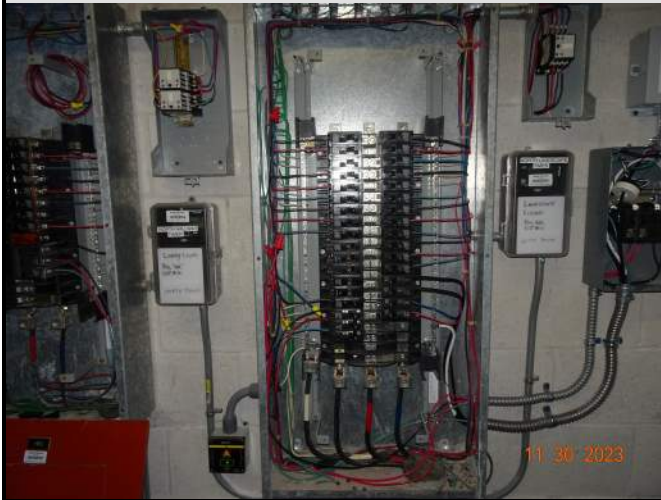
DSC00042.JPG

Ambient Temp: 74 °F

Measured Temp: 75 °F

Temp Threshold: 110 °F

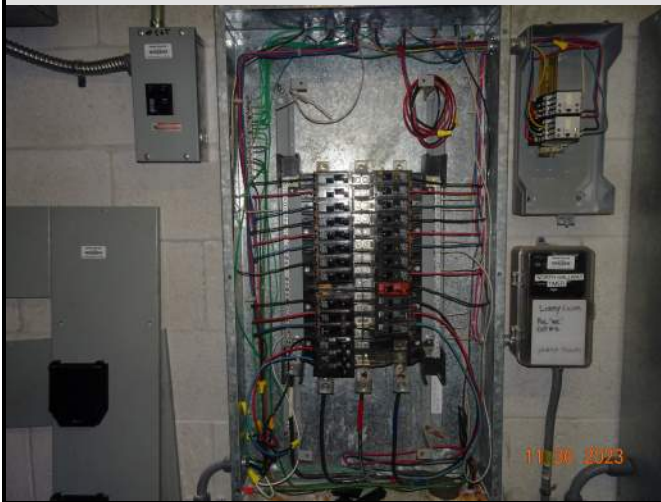
DSC00043.JPG

Ambient Temp: 74 °F

Measured Temp: 76 °F

Temp Threshold: 110 °F

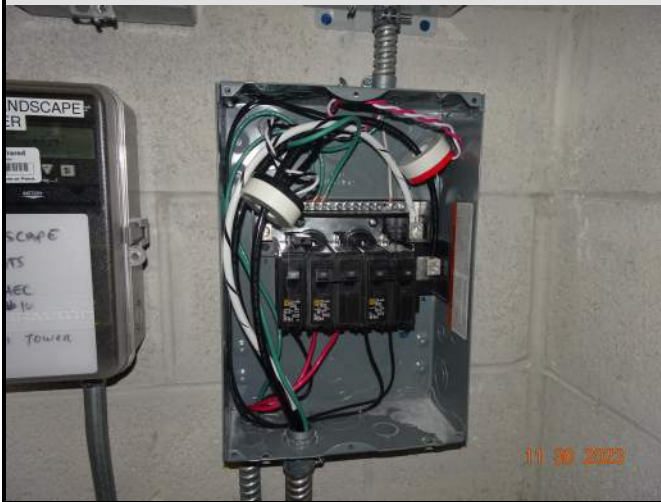
DSC00044.JPG

Ambient Temp: 74 °F

Measured Temp: 79 °F

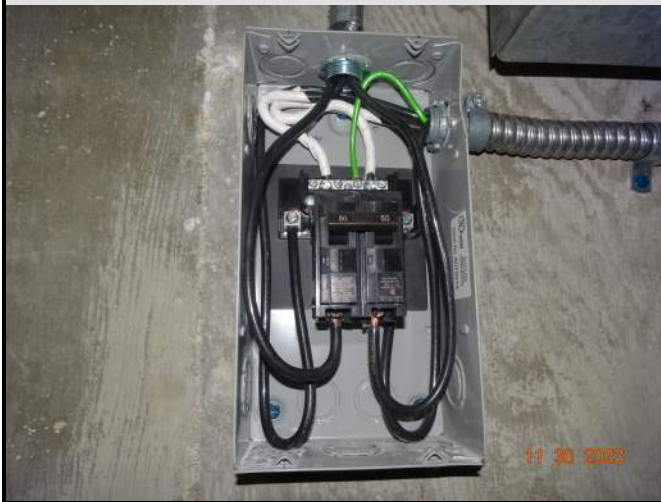
DSC00052.JPG

Ambient Temp: 74 °F

Measured Temp: 75 °F

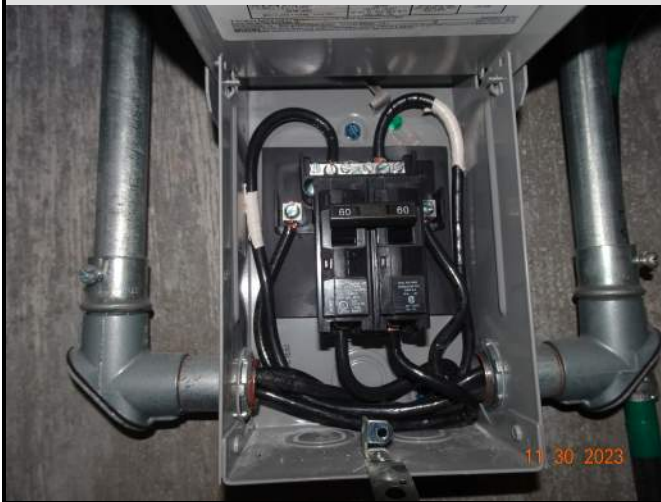
DSC00053.JPG

Ambient Temp: 74 °F

Measured Temp: 75 °F

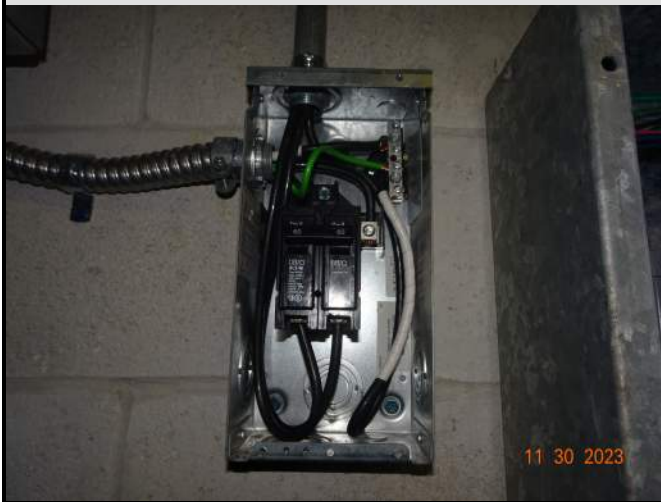
DSC00054.JPG

Ambient Temp: 74 °F

Measured Temp: 75 °F

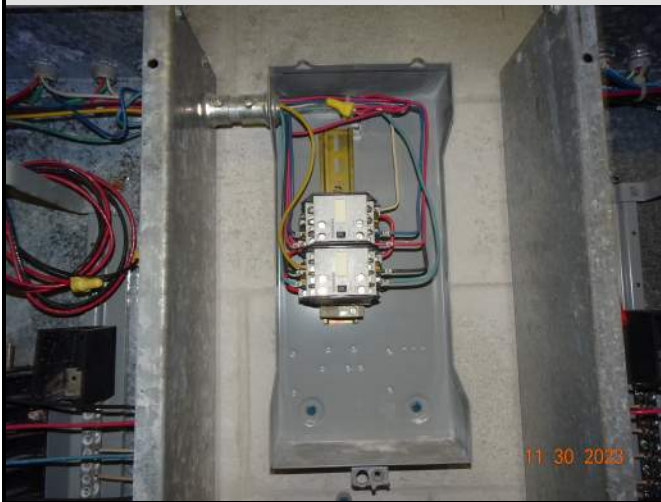
DSC00045.JPG

Ambient Temp: 74 °F

Measured Temp: 75 °F

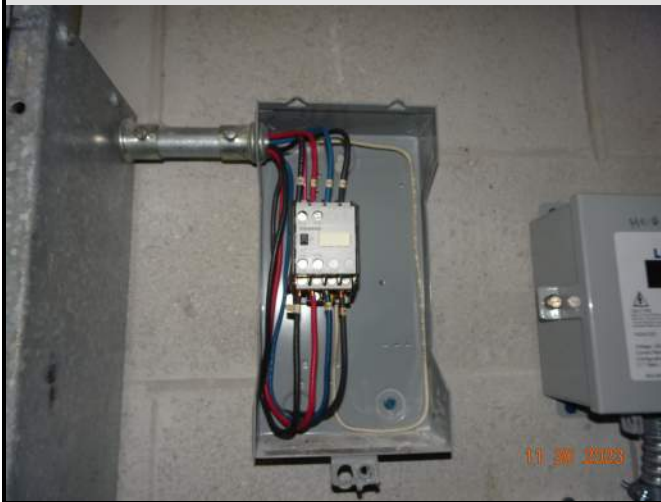
DSC00046.JPG

Ambient Temp: 74 °F

Measured Temp: 76 °F

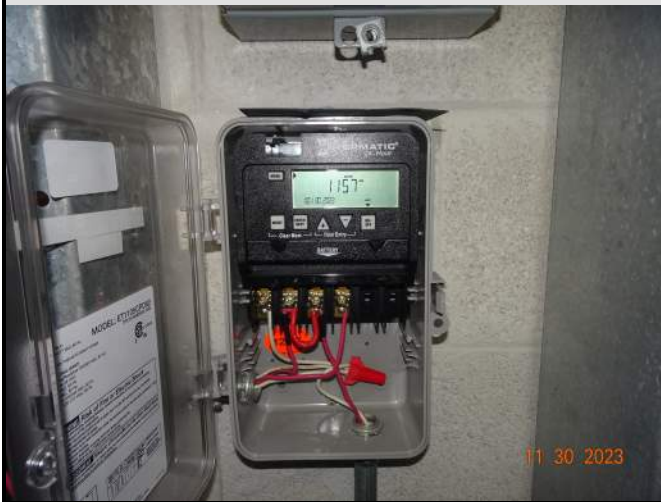
DSC00047.JPG

Ambient Temp: 74 °F

Measured Temp: 78 °F

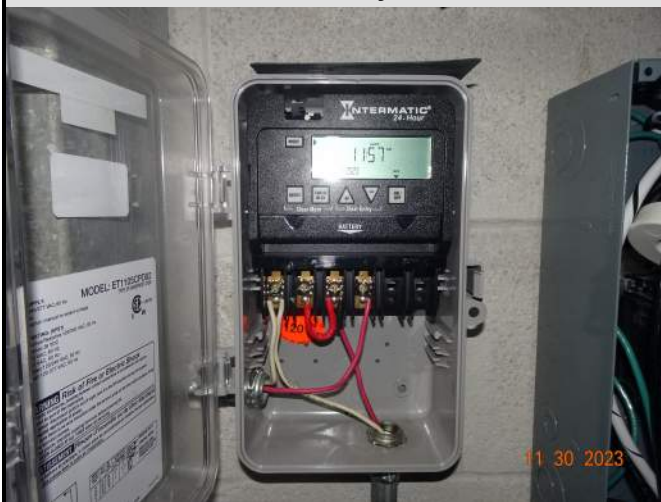
DSC00048.JPG

Ambient Temp: 74 °F

Measured Temp: 78 °F

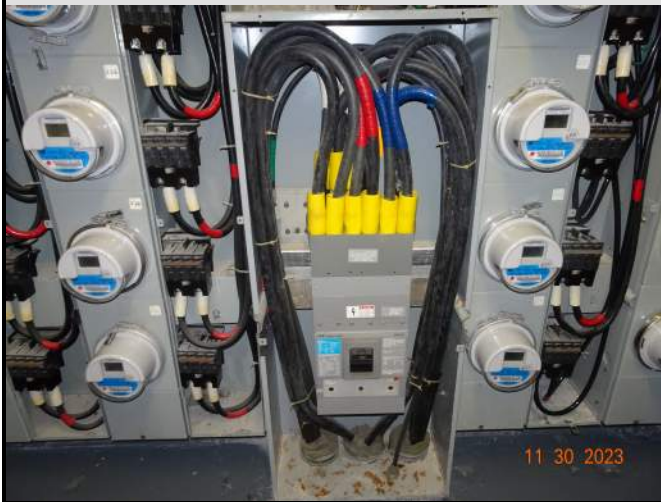
DSC00049.JPG

Ambient Temp: 74 °F

Measured Temp: 75 °F

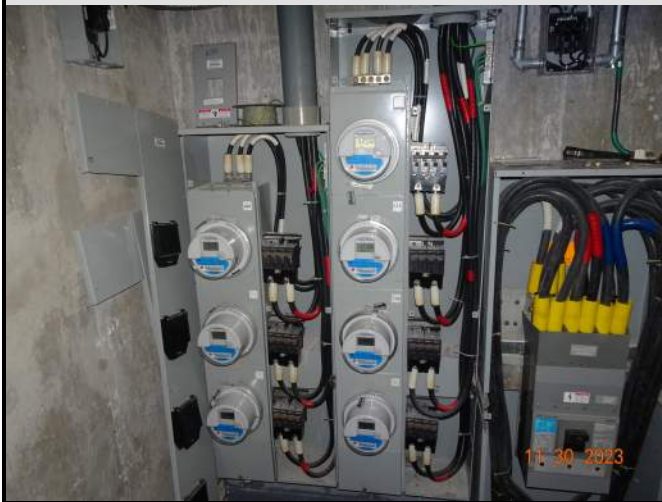
DSC00050.JPG

Ambient Temp: 74 °F

Measured Temp: 76 °F
