# PROPERTY APPRAISER OF MIAMI-DADE COUNTY

| PROPERTY INFORMATION | |
|---|---|
| Property Address | 13637 DEERING BAY DR<br>CORAL GABLES, FL 33158-0000 |

**NOTICE OF UNSAFE STRUCTURE VIOLATION FOR FAILURE TO RECERTIFY  
AND NOTICE OF HEARING**

☒ Initial Inspection Report ☐ Amended Inspection Report after completion of repairs

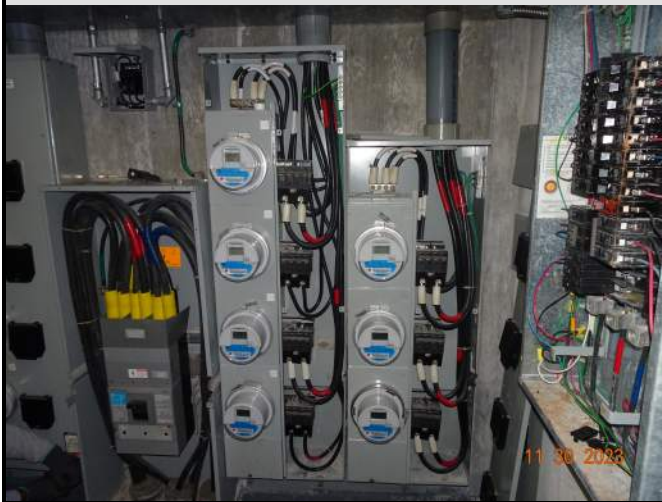
DSC00051.JPG

Ambient Temp: 74 °F

Measured Temp: 75 °F

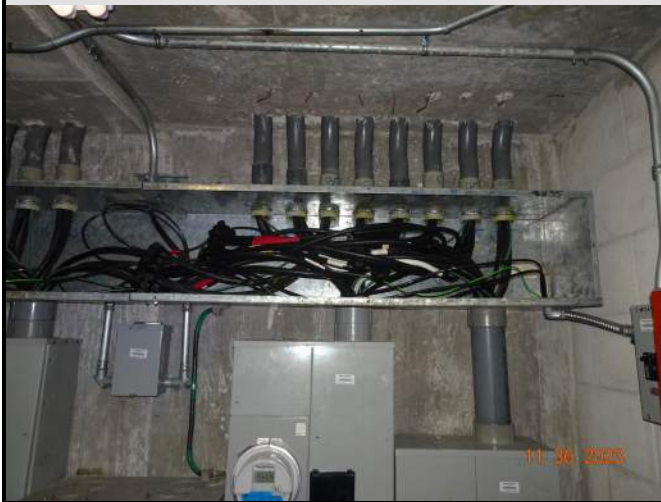
DSC00055.JPG

Ambient Temp: 74 °F

Measured Temp: 75 °F

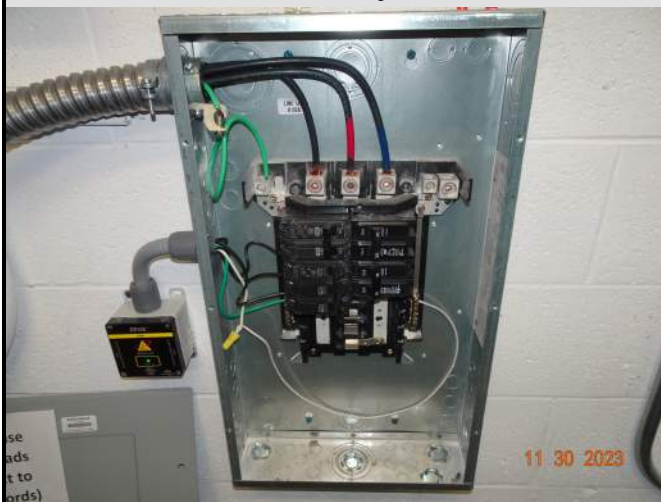
DSC00056.JPG

Ambient Temp: 72 °F

Measured Temp: 73 °F

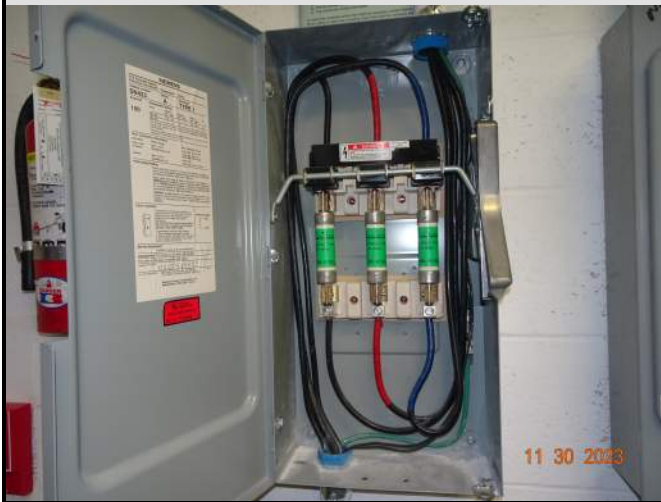
DSC00057.JPG

Ambient Temp: 72 °F

Measured Temp: 74 °F

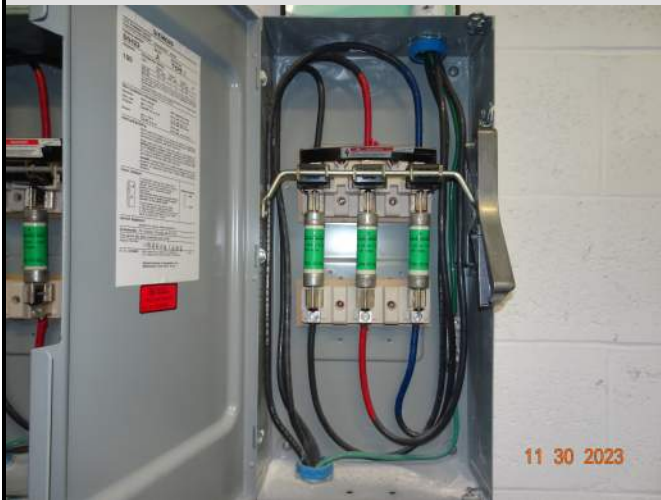
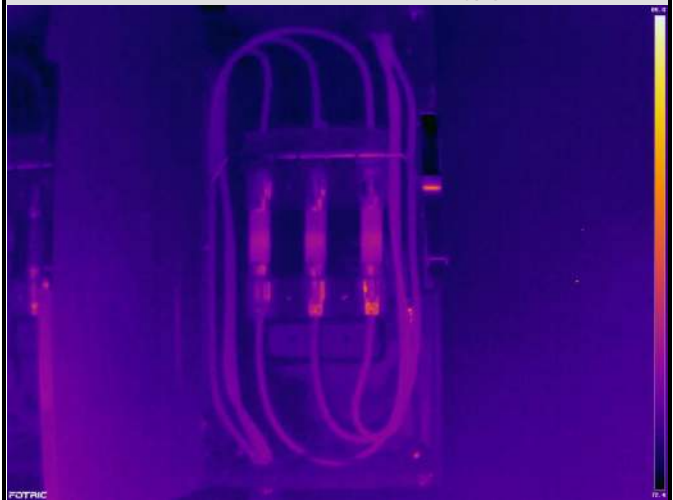
DSC00058.JPG

Ambient Temp: 72 °F

Measured Temp: 76 °F

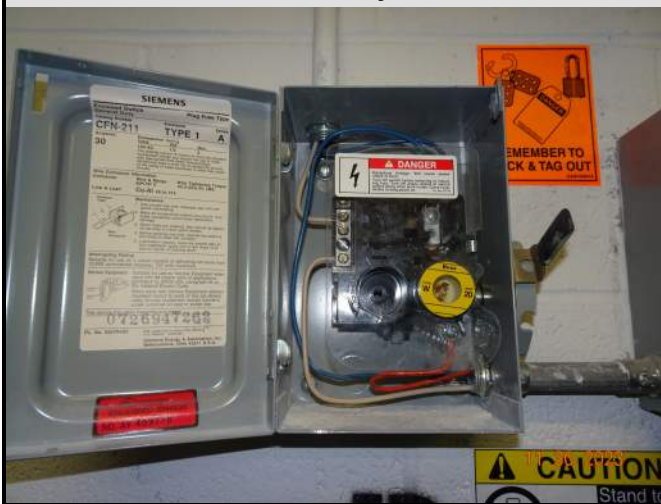
DSC00059.JPG

Ambient Temp: 72 °F

Measured Temp: 74 °F

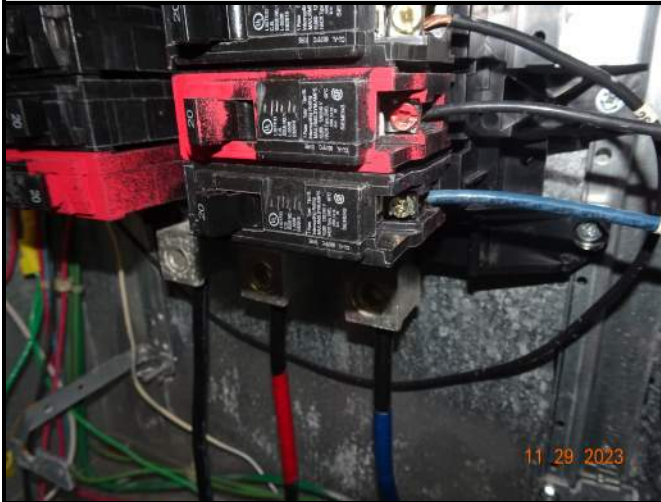
Section 1/2

Loose or deteriorated connection(s)

Clean all contact surfaces and torque connection to manufacturer specification. Replace breaker if needed

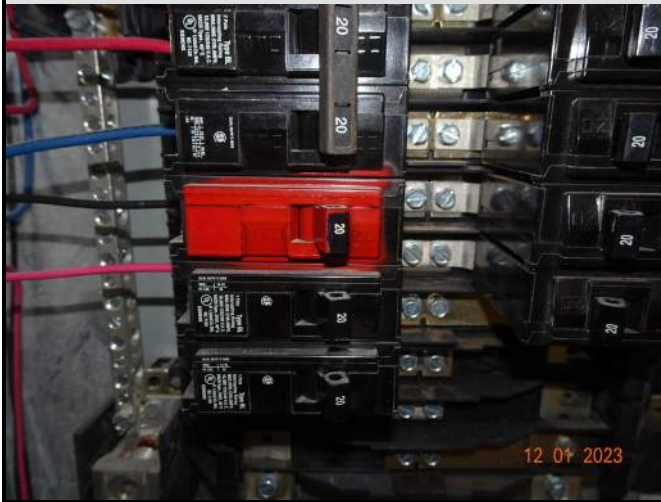
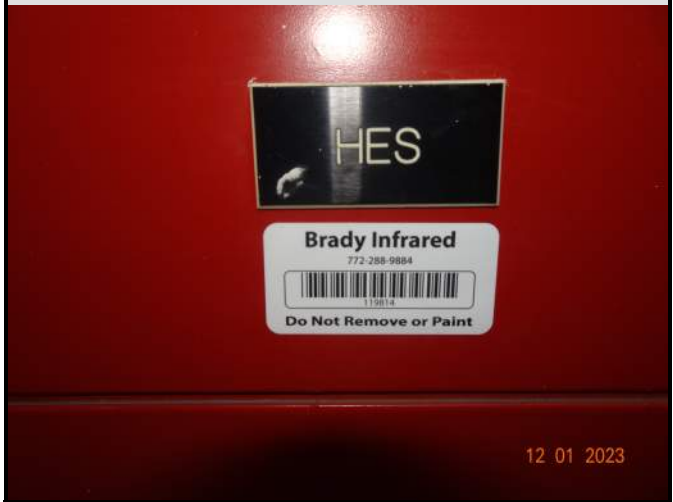
Improper installation

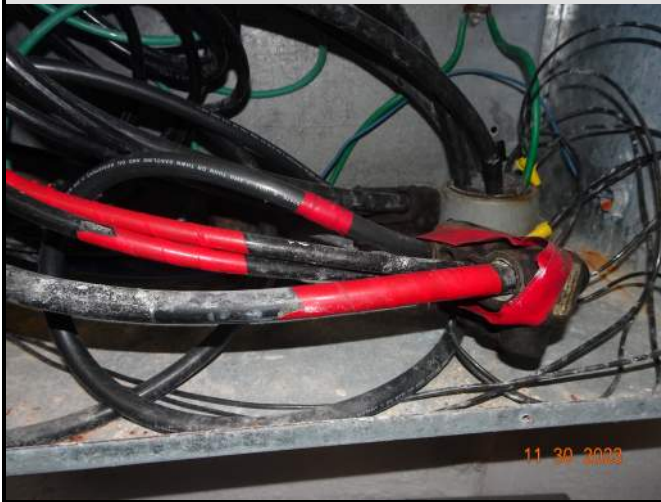
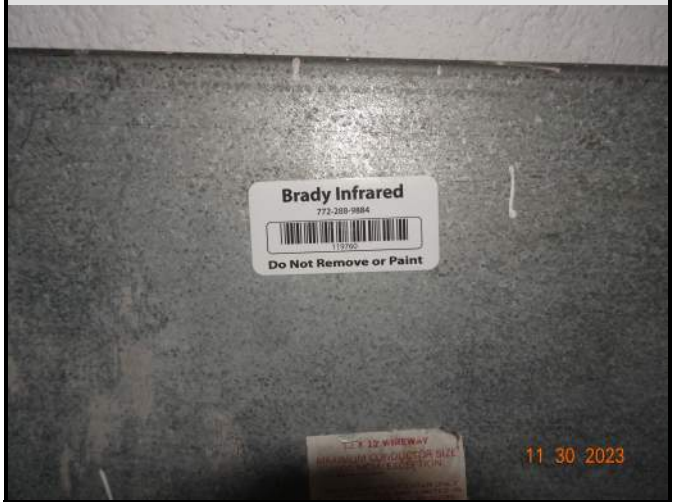
Corrosion

Worn components

Replace of corroded parts

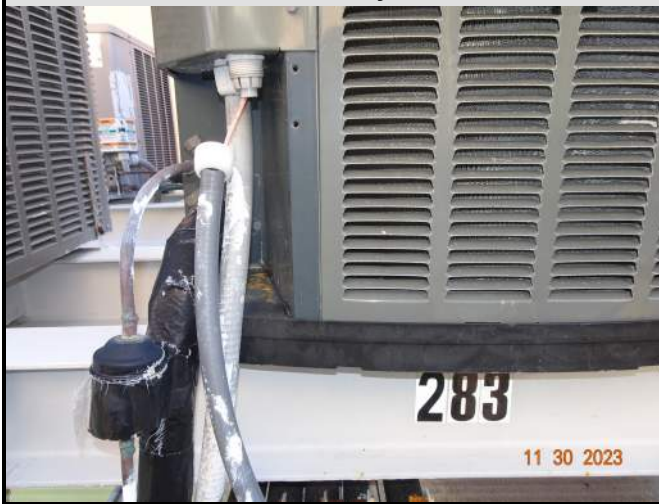
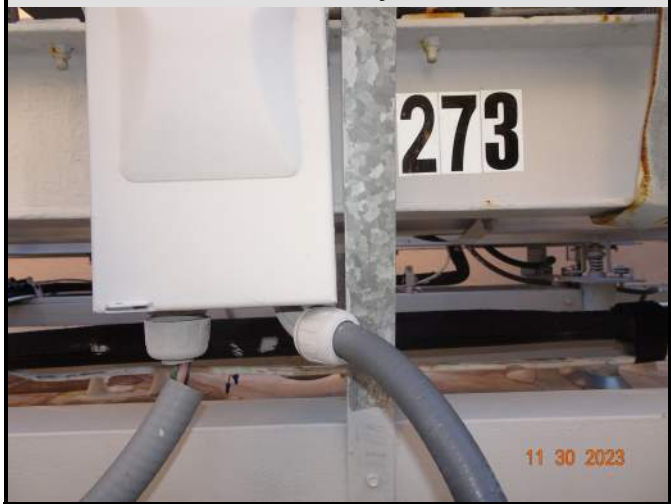
Improper installation

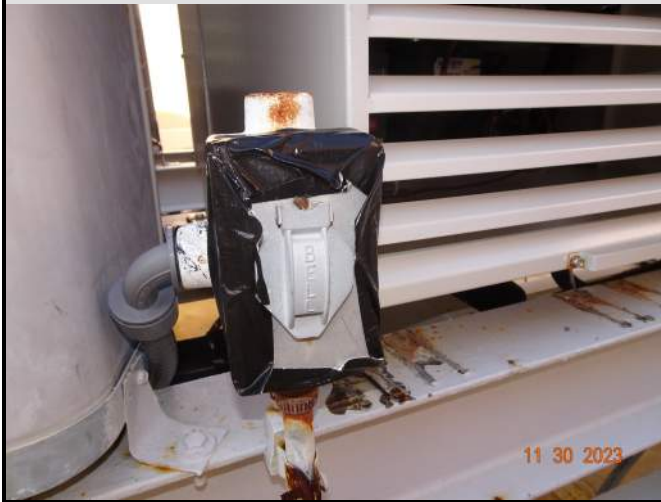
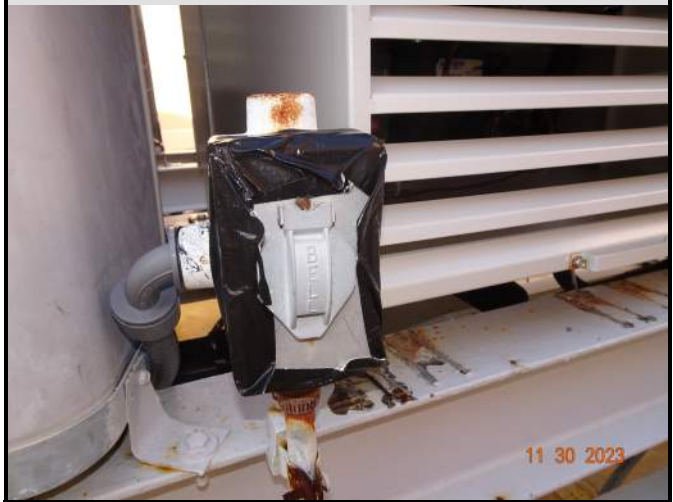
Improper installation

Shall be replaced with listed materials

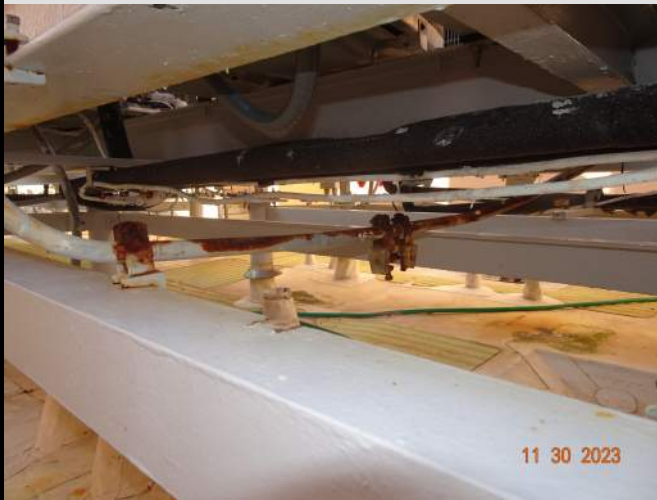
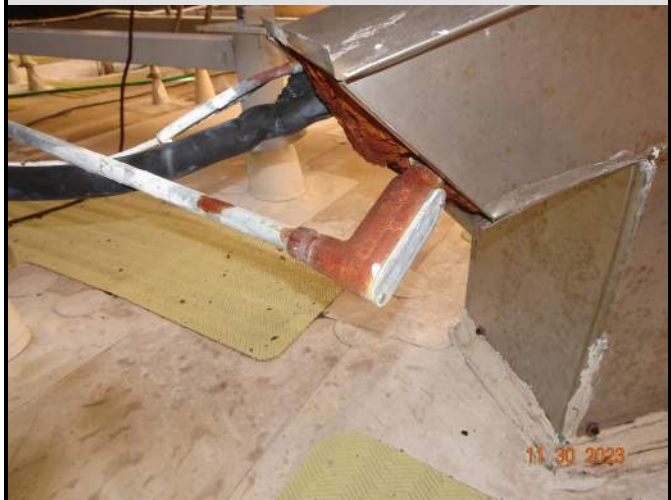
Corrosion

Improper installation

Replace of corroded parts

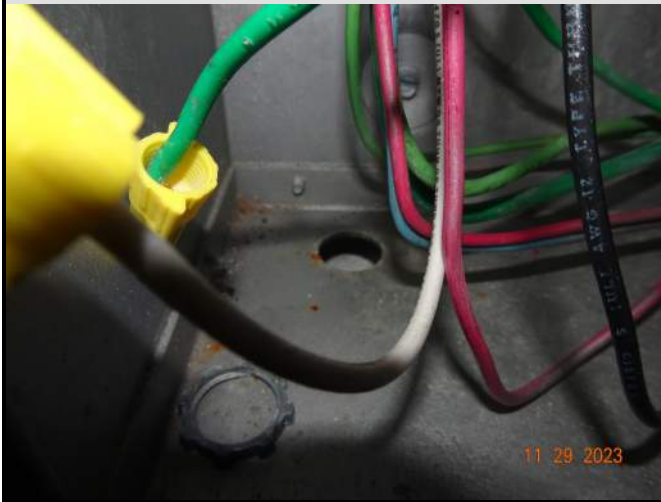
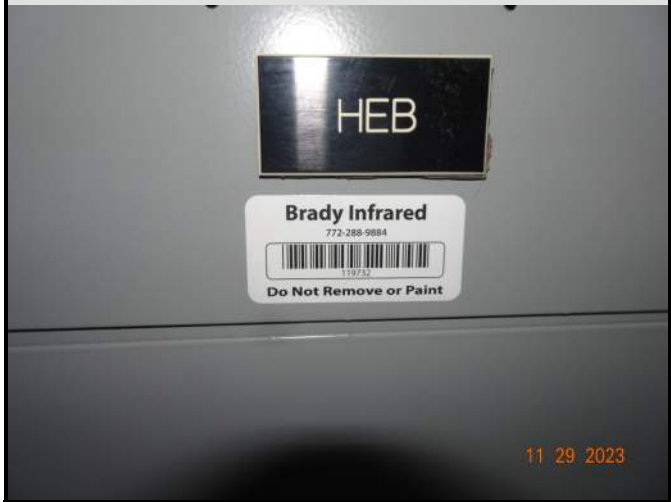
Missing KO seal

Improper installation

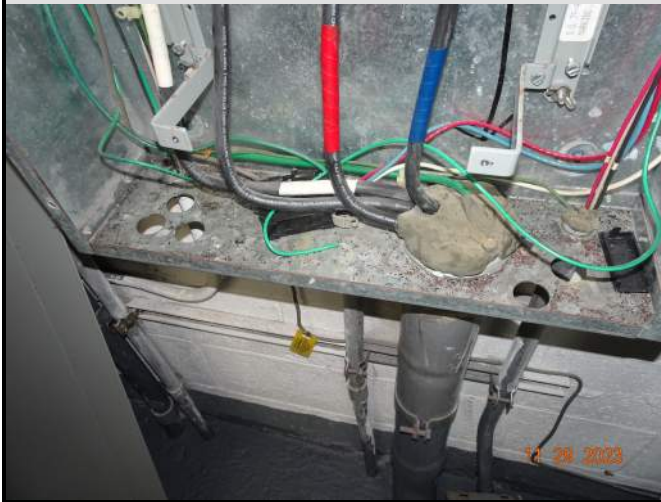
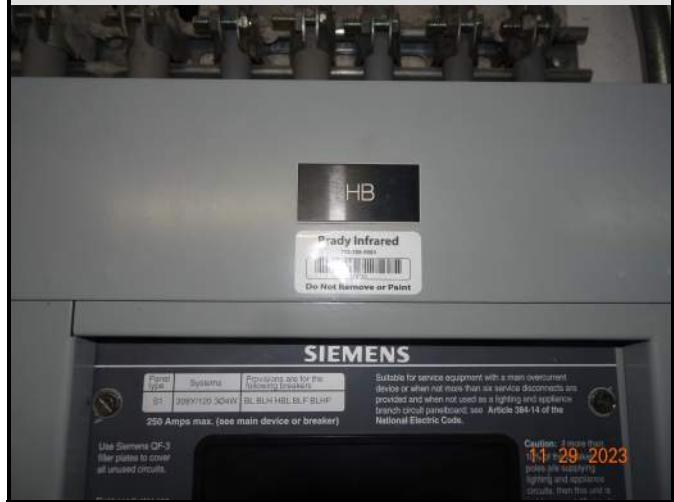
Missing KO seals (4)

Improper installation

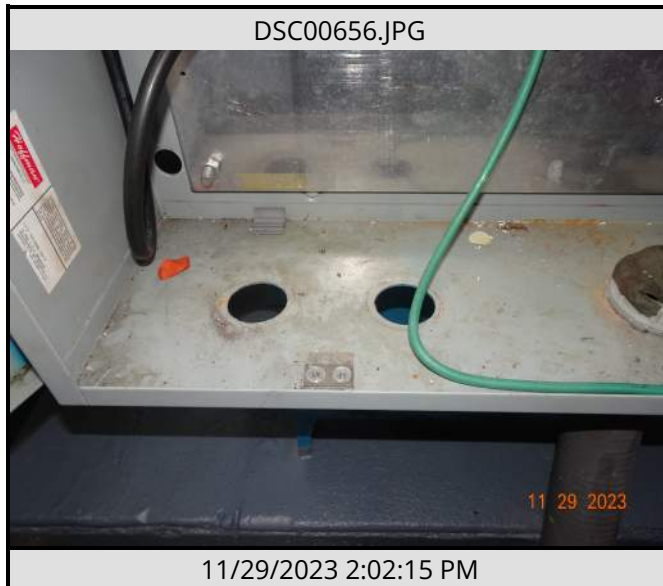
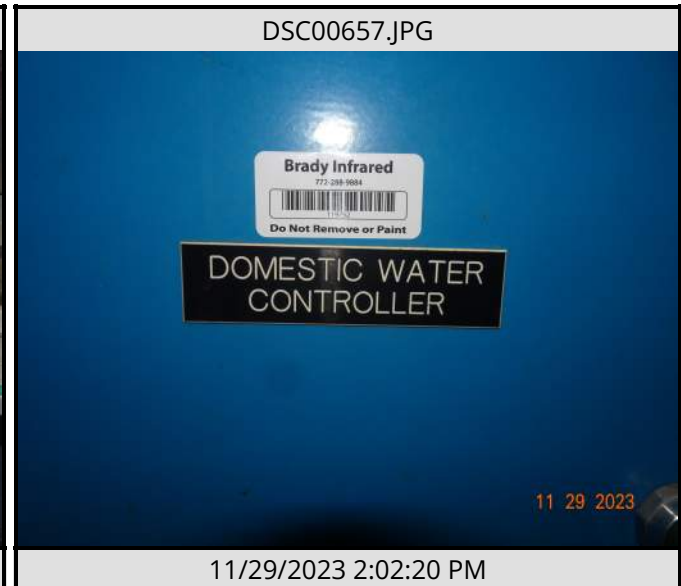
Missing KO seals (2)

Improper installation

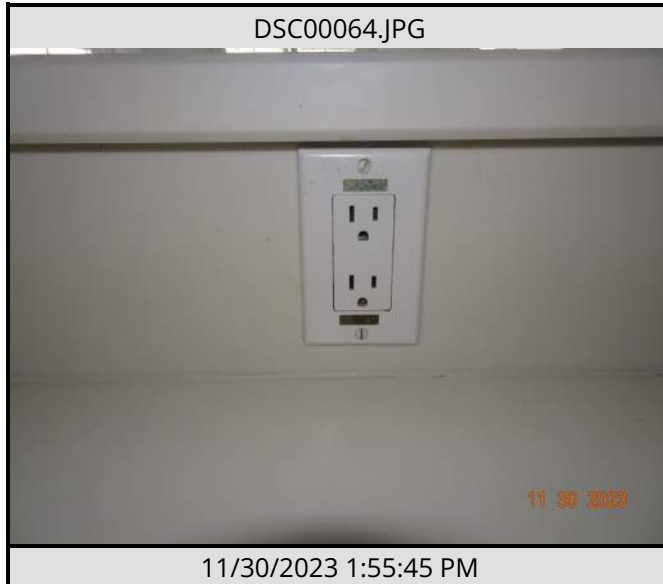
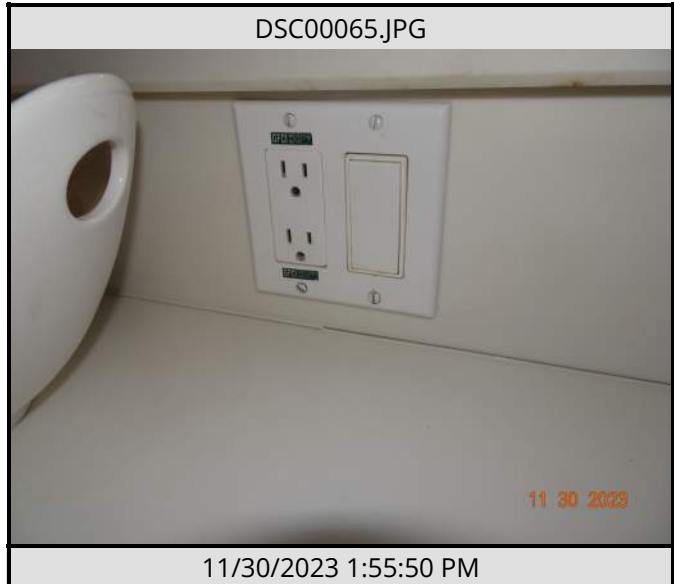
Improper installation

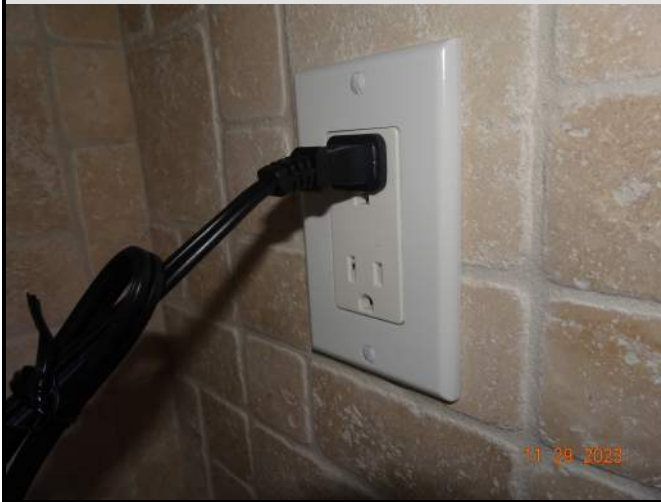
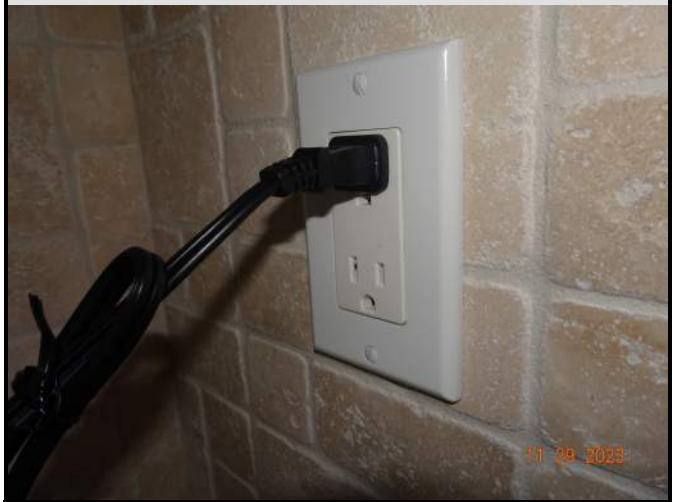
DSC00610.JPG

Improper installation

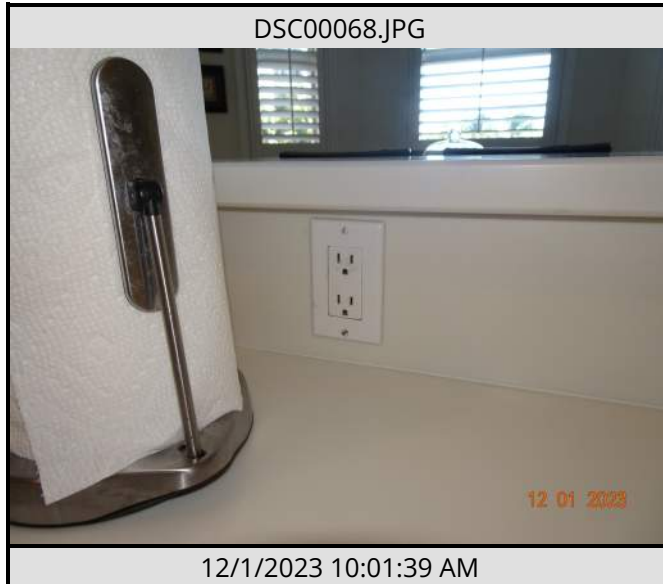
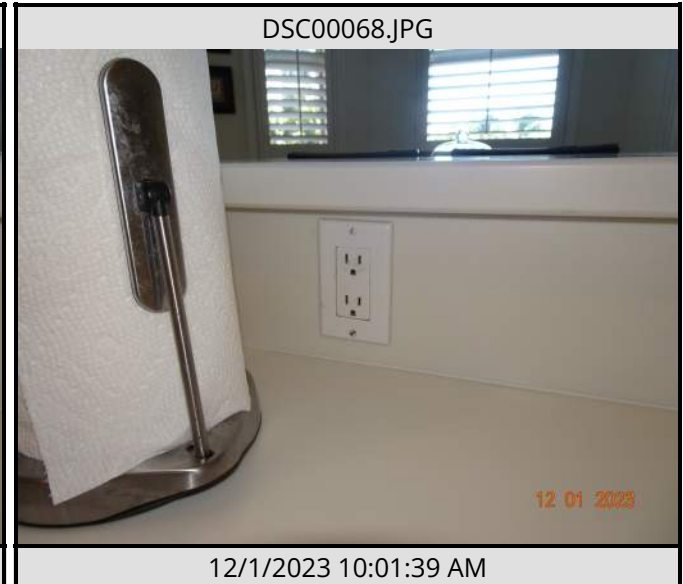
Improper installation

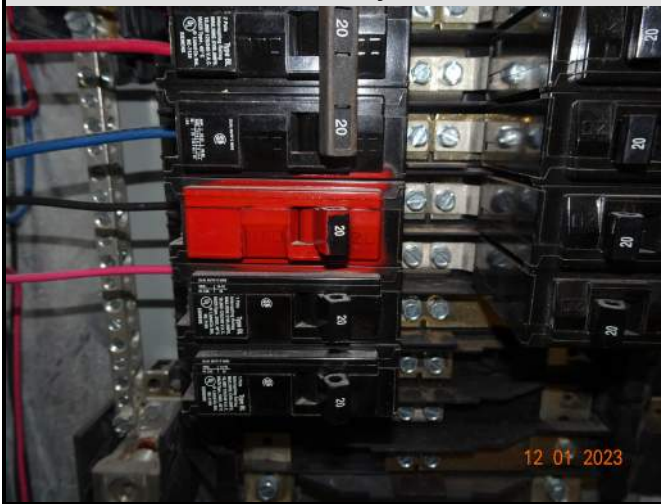
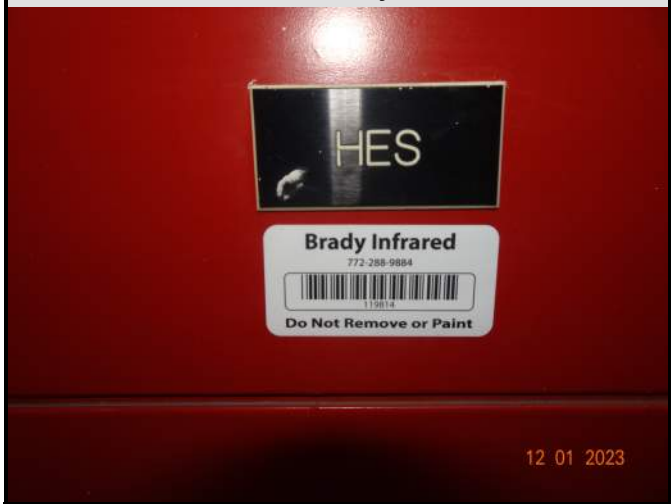
DSC00076.JPG

Improper installation

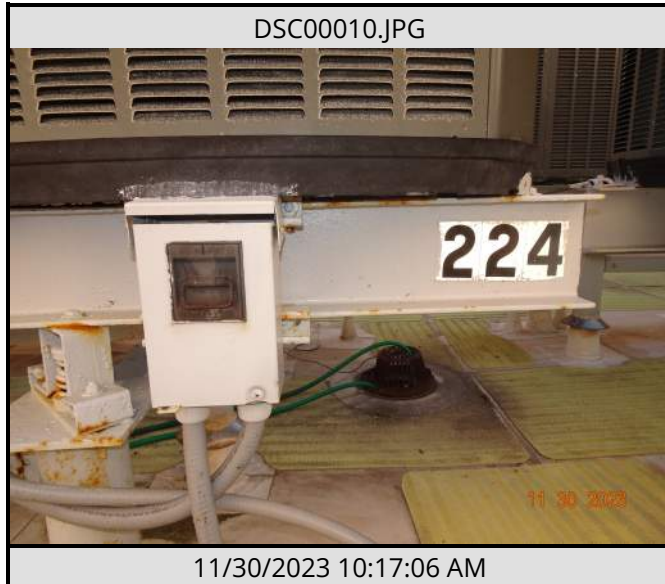
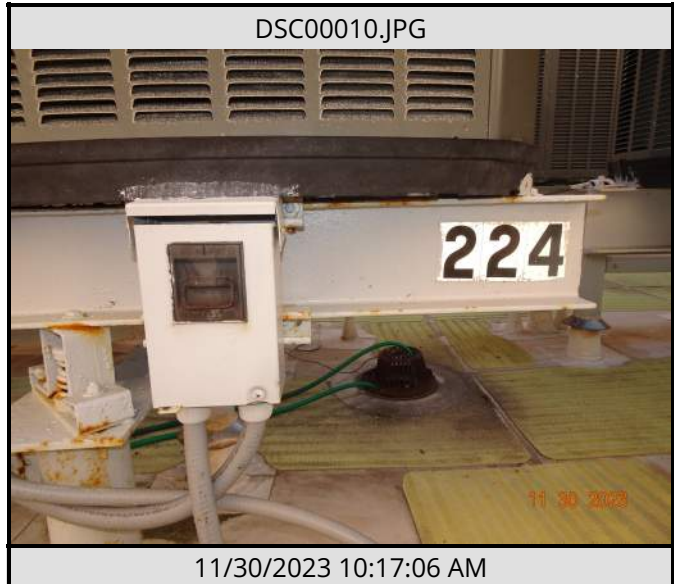
Missing panel cover

Improper installation

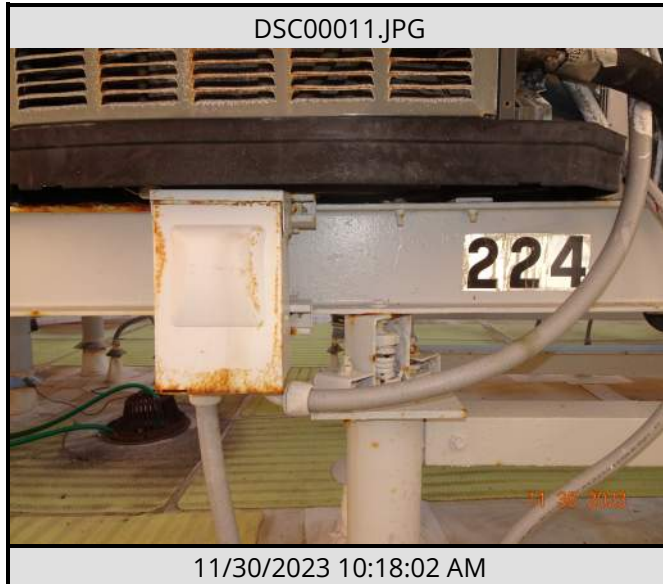
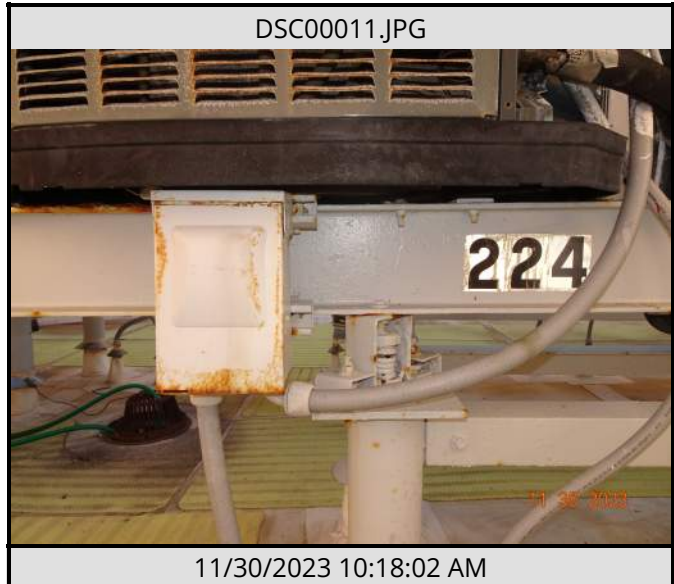
Corrosion

Worn components

Replace of corroded parts

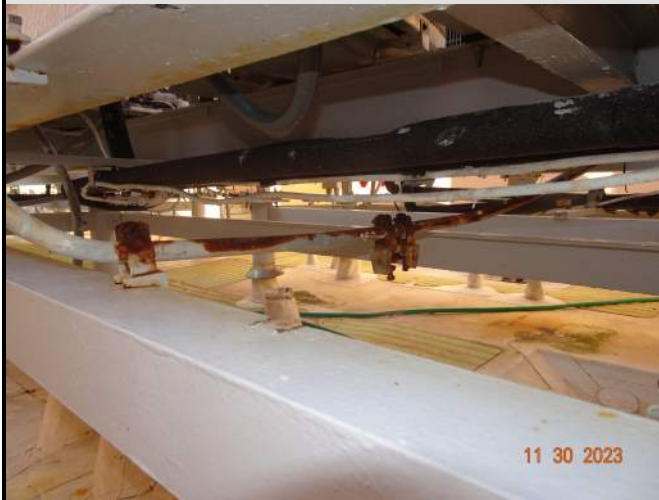
DSC00017.JPG

Corrosion

Improper installation

Replace of corroded parts

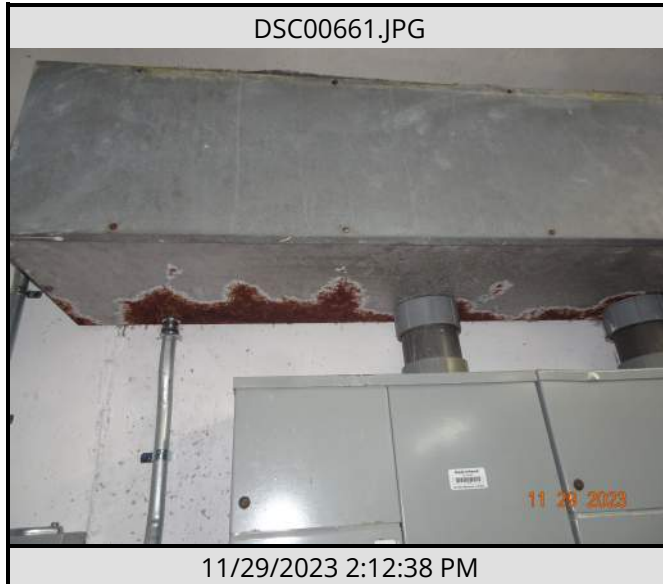
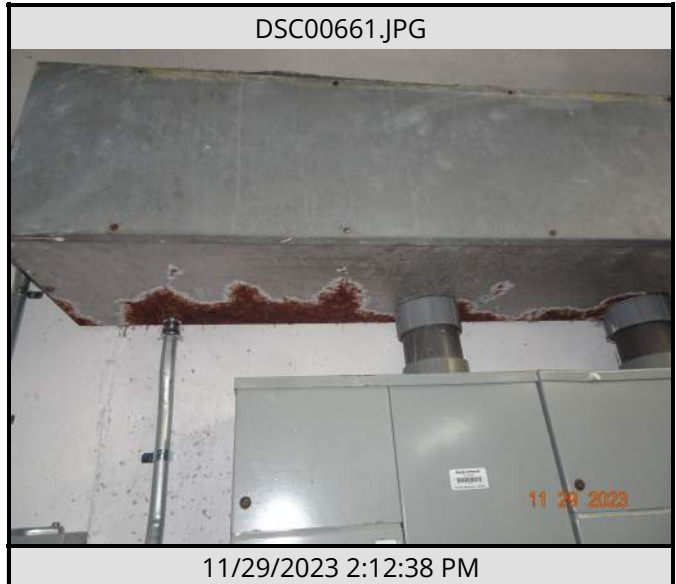
Corrosion

Improper installation

Replace of corroded parts

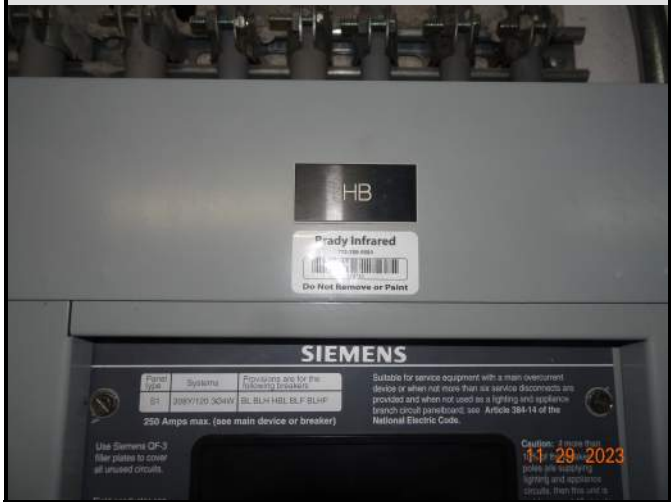
DSC00643.JPG

Missing KO seals (4)

Improper installation

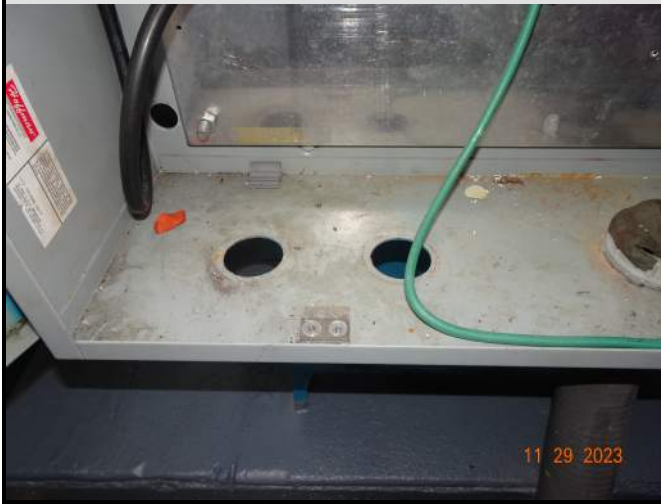
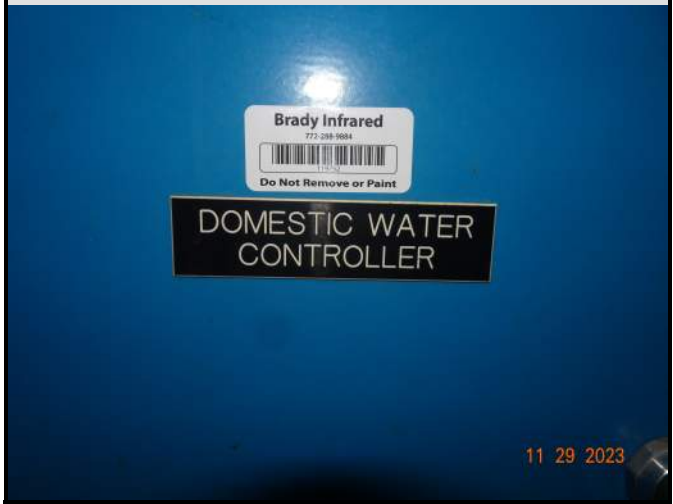
Missing KO seals (2)

Improper installation

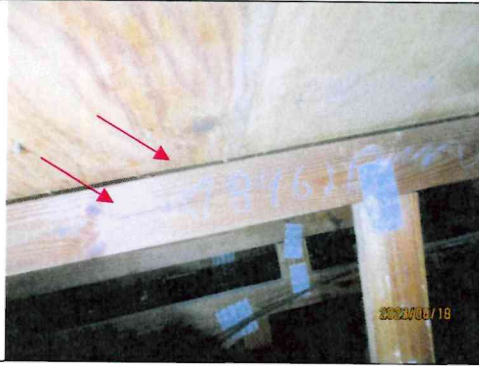
3. Damaged top chord is visible inside in the west tower attic. Refer to photograph #5.
4. A gap is observed between the truss top chord and the plywood sheathing at the overhead roof in the west tower attic. Refer to photograph #6.

| <p><i>Photo-5: Damaged top chord inside west tower attic.</i></p> | <p><i>Photo-6: Gap in between truss top chord and the plywood sheathing inside west tower attic.</i></p> |

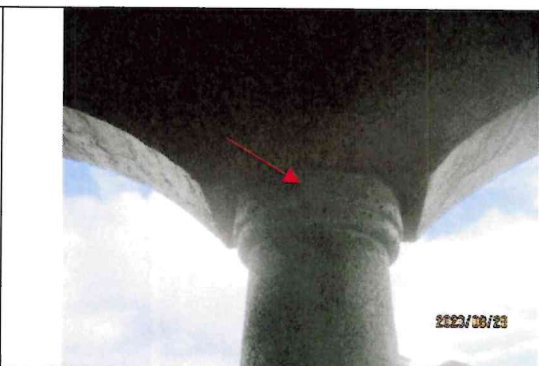
1. Cracks are visible in the columns on the balconies of Unit 293, Unit 285 and Unit 294. Refer to photographs #11, #12, and #13.
2. A crack was observed in the tile adjacent to the shutter on the balcony of Unit 243 and Unit 258. Refer to photographs #14 and #15.

| <p><i>Photo-11: Crack in the column at balcony of Unit 293.</i></p> | <p><i>Photo-12: Crack in the column at balcony of Unit 285.</i></p> |

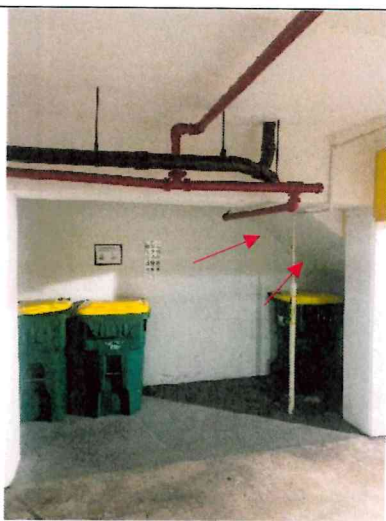
1. Water intrusion was observed in the expansion joint at the ground-level parking garage. Refer to photograph #29.
2. Water intrusion was observed in between the wall and the staircase joint at the ground-level parking garage. Refer to photograph #29.1.

| <p><i>Photo-29: Water intrusion in the expansion joint at the ground level parking garage.</i></p> | <p><i>Photo-29.1: Water intrusion in between the wall and the staircase joint at the ground level parking garage.</i></p> |

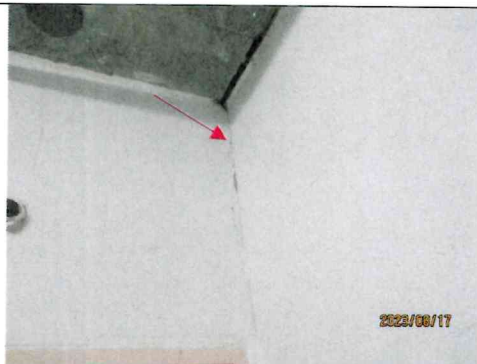
1. Cracks were observed in the C.M.U. wall inside the trash room at the north, south, and east towers. Refer to photographs #46, #47, and #48.
2. A crack was observed in the floor slab of the electrical room located at the west tower. Refer to photograph #49.
3. A crack was observed in the column of the electrical room located at the west tower. Refer to photograph #50.
4. Exposed, corroded nails are observed in the ceiling slab of the electrical room located at the north tower. Refer to photograph #51.

| <p><i>Photo-46: Crack in the C.M.U. wall inside trash room of north tower.</i></p> | <p><i>Photo-47: Crack in the C.M.U. wall inside trash room of south tower.</i></p> |
