1414 Galiano St

**NOTICE OF UNSAFE STRUCTURE VIOLATION FOR FAILURE TO RECERTIFY  
AND NOTICE OF HEARING**

1414 Galiano Street, Coral Gables, Florida 33134

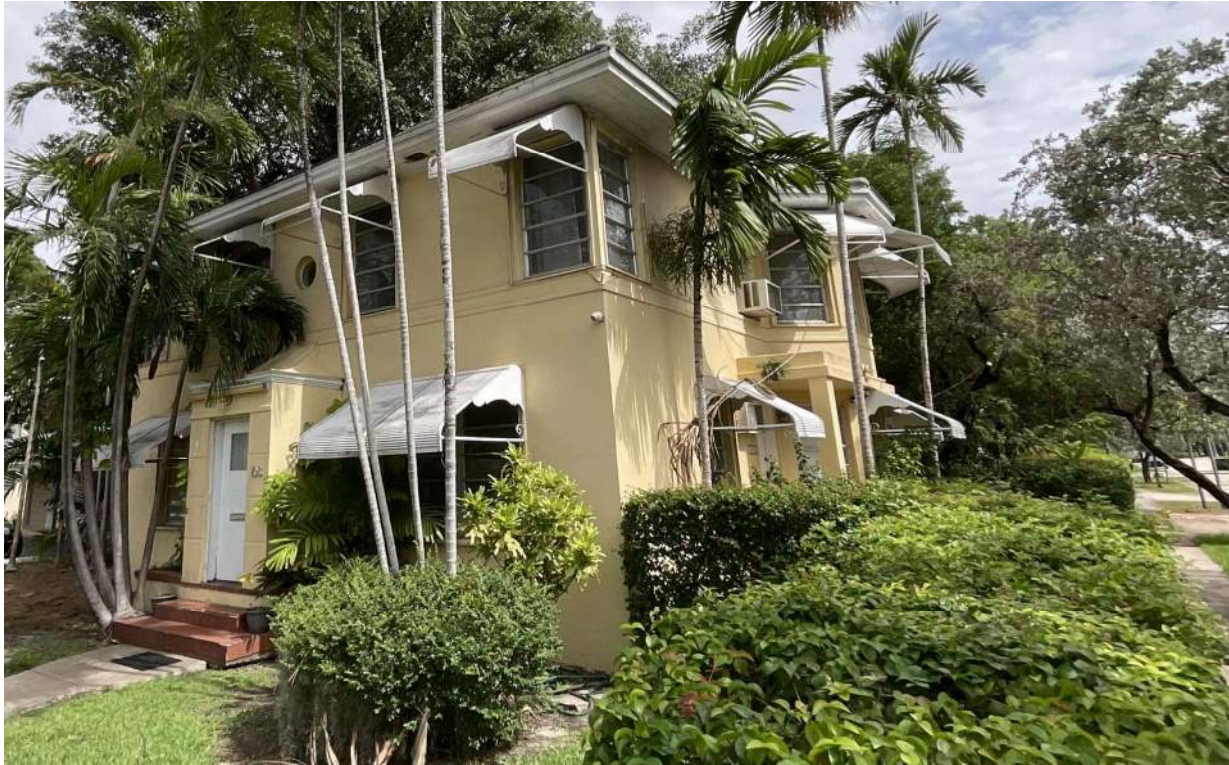
Picture No. 1: Building No.1 front-side elevation

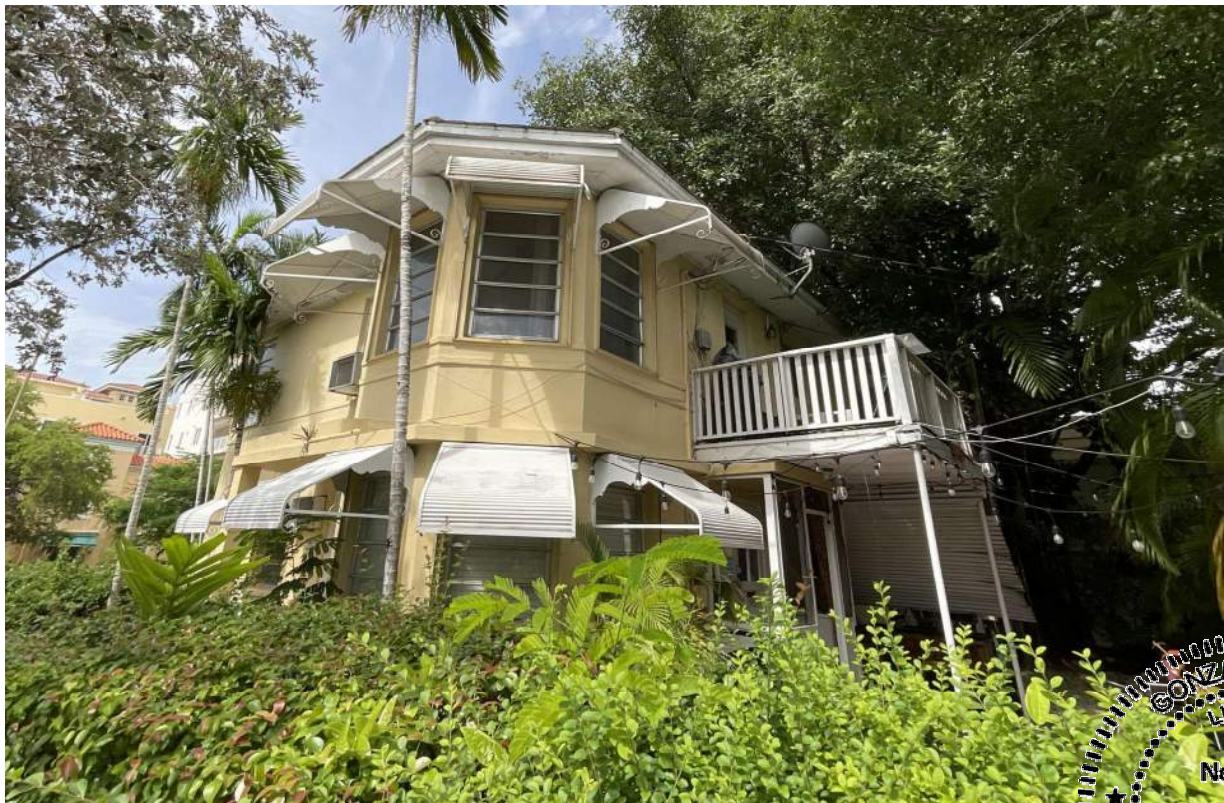
Picture No. 2: Building No.1 front-side elevation

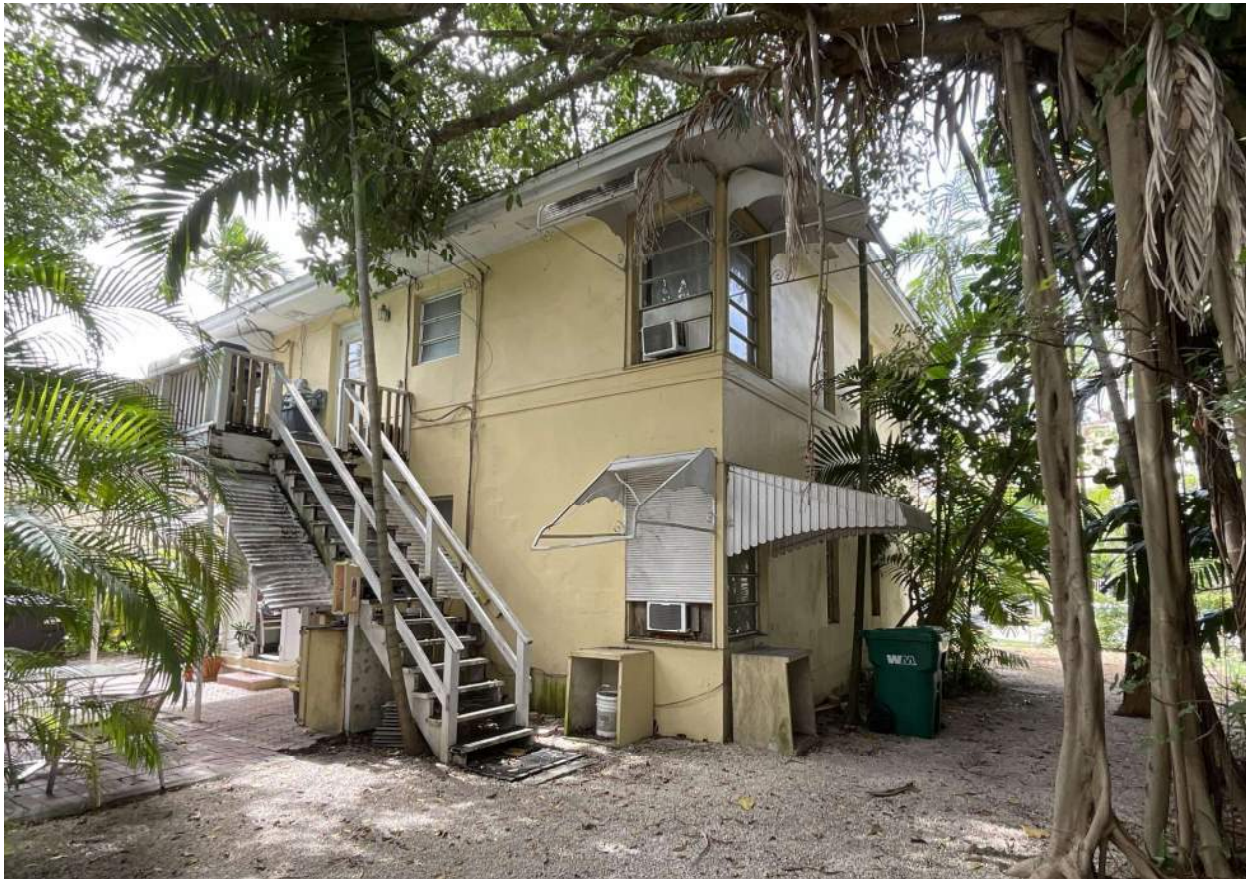
Picture No. 3: Building No.1 Rear-side elevation

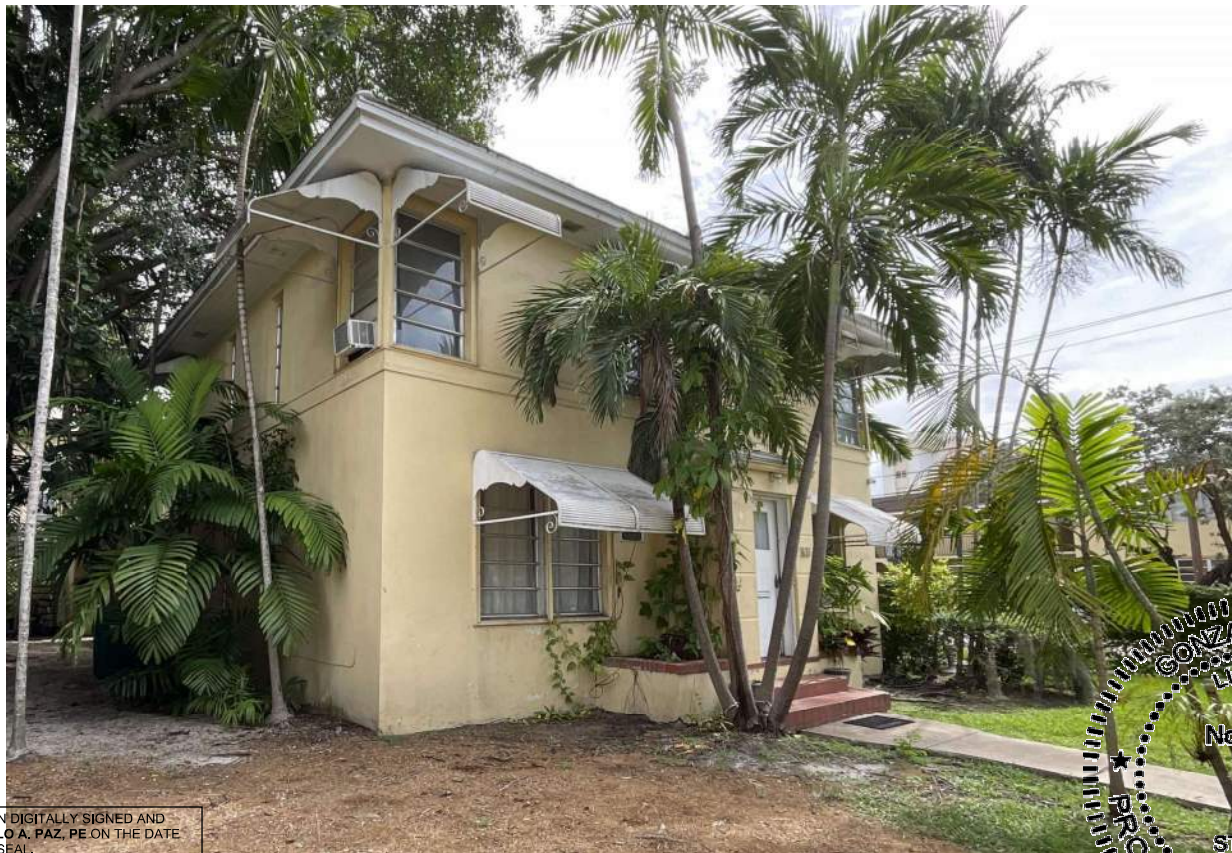
Picture No. 4: Building No.1 Rear-side elevation

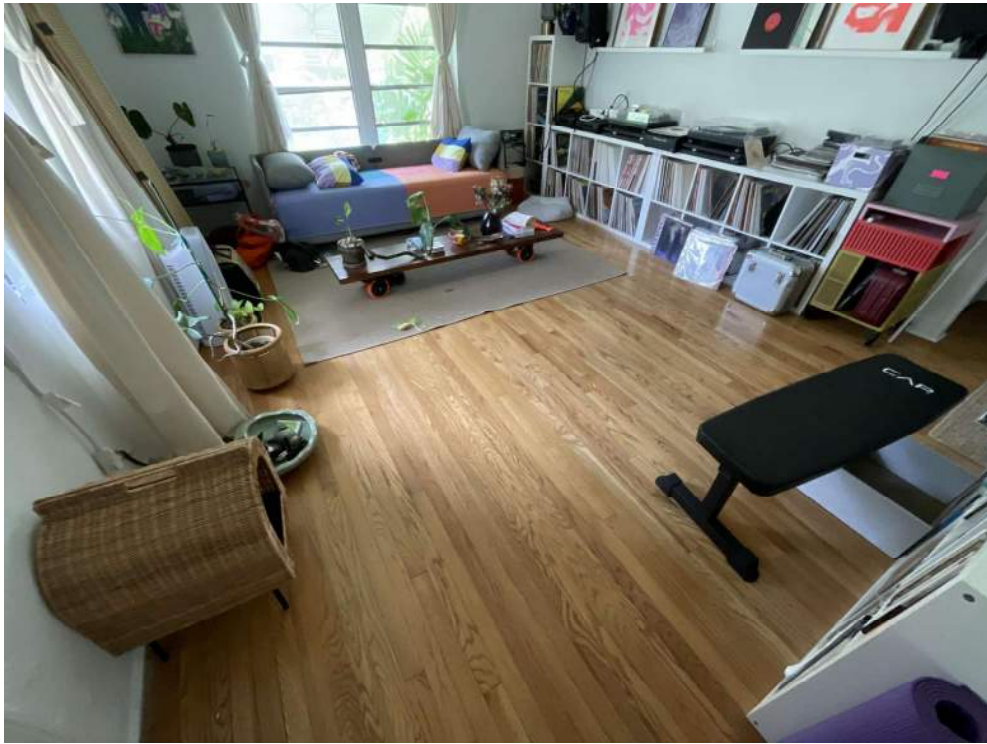
Picture No. 5: Building No.1 Ground floor framing of wood planks sheathing over wood rafters bearing on main wood beams supported on isolate concrete piers (at interior spans) and/or concrete masonry stem walls (at shell perimeter). In fair condition.

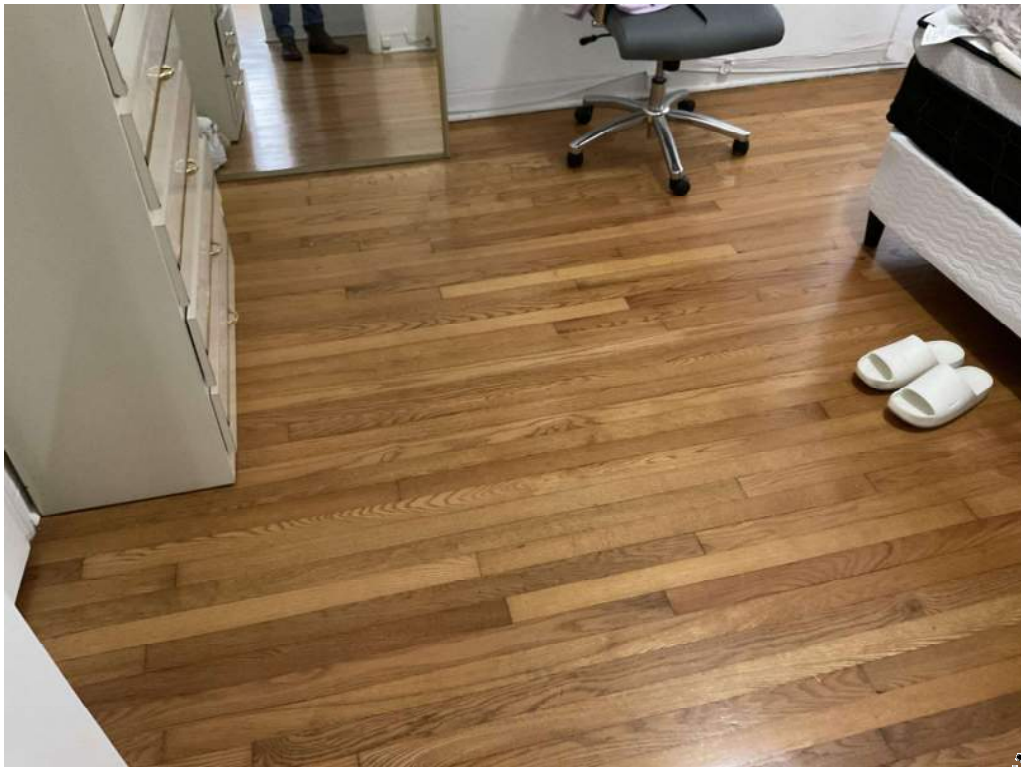
Picture No. 6: Building No.1 Second floor framing of wood planks sheathing over wood rafters bearing on concrete masonry perimeter walls. In fair condition.

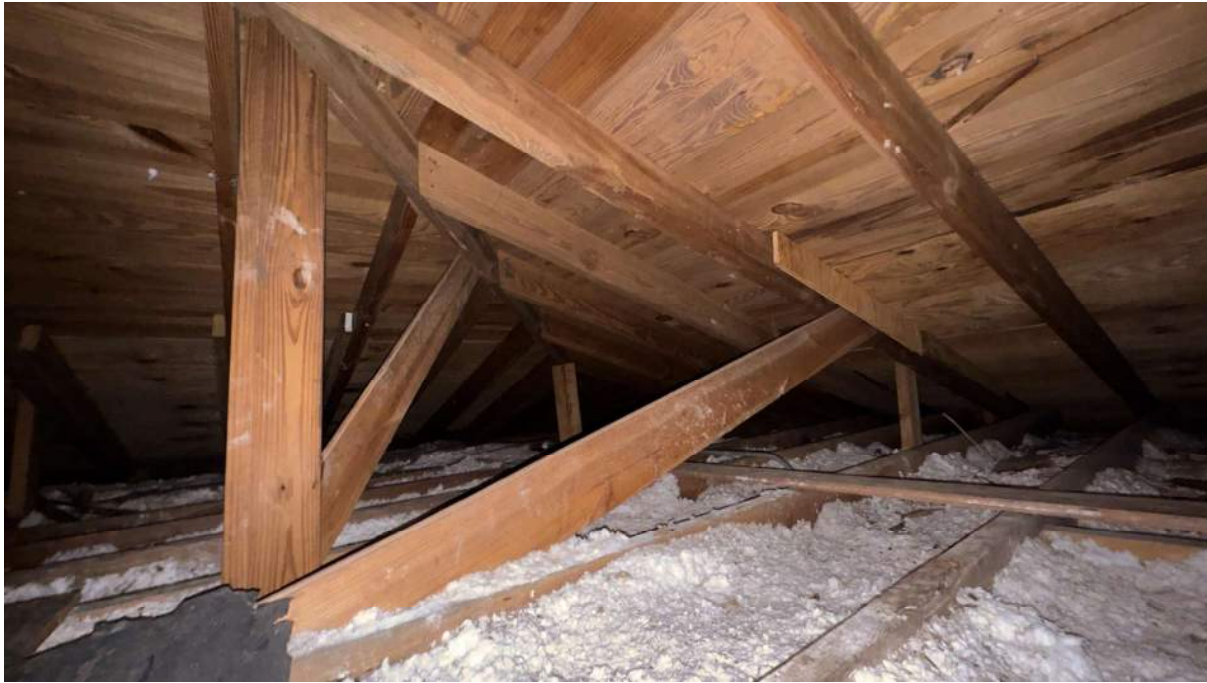
Picture No. 7: Building No.1 Roof framing of wood planks sheathing over wood trusses bearing on concrete masonry perimeter walls. In fair condition.

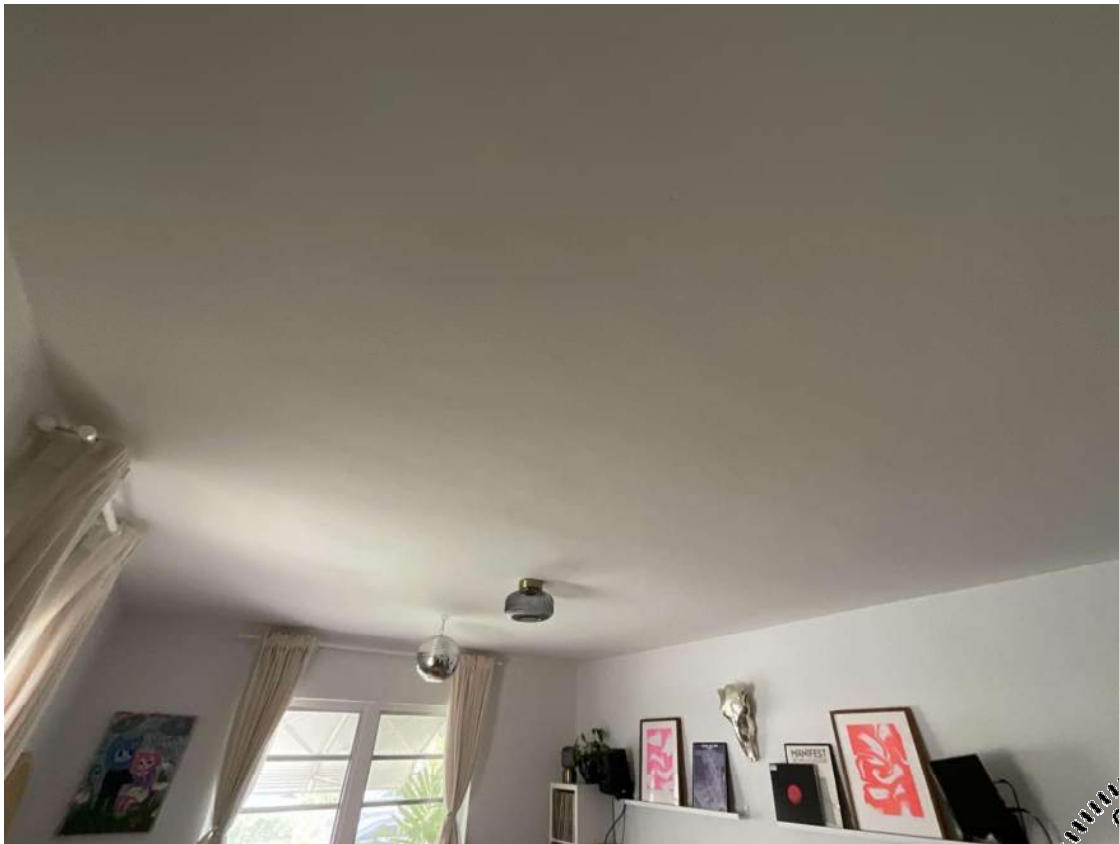
Picture No. 8: Building No.1 Second floor framing of wood planks sheathing over wood rafters bearing on concrete masonry perimeter walls. In fair condition.

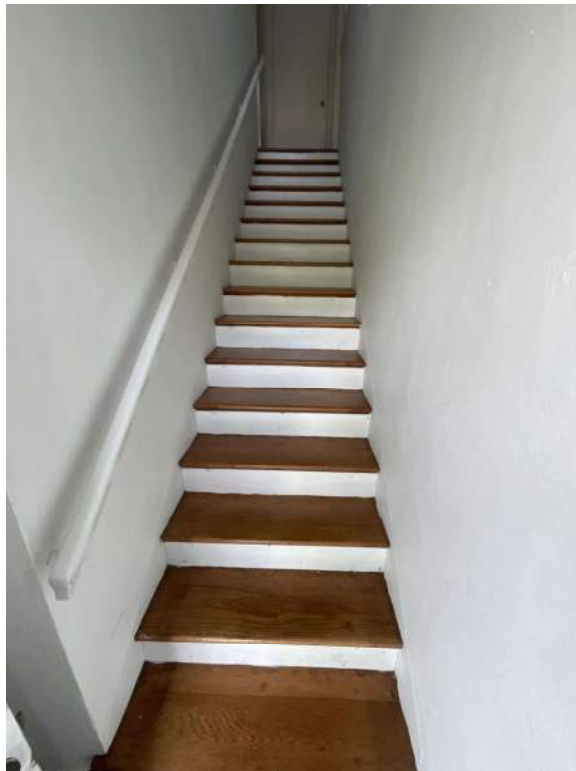
Picture No. 9: Building No.1 Interior stair framing of wood elements. In good condition.

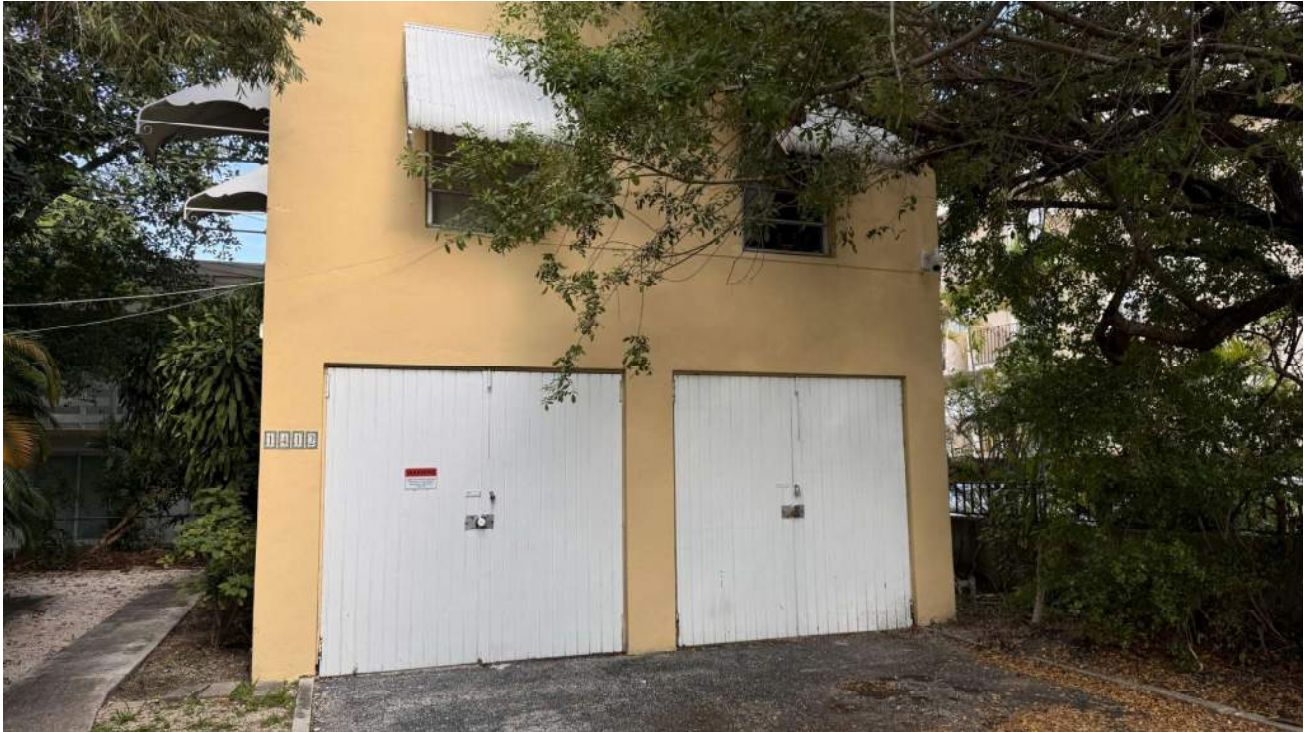
Picture No. 15: Building No.2 front-side elevation

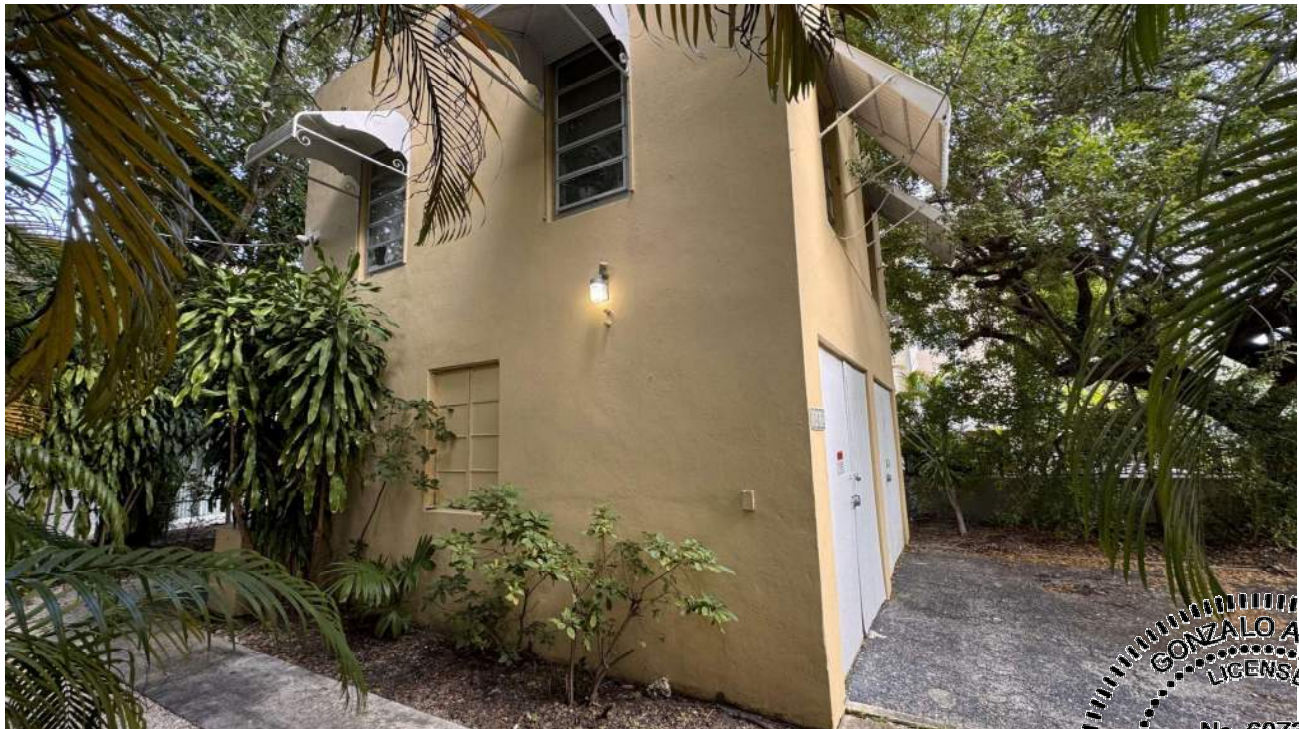
Picture No. 16: Building No.2 front-side elevation

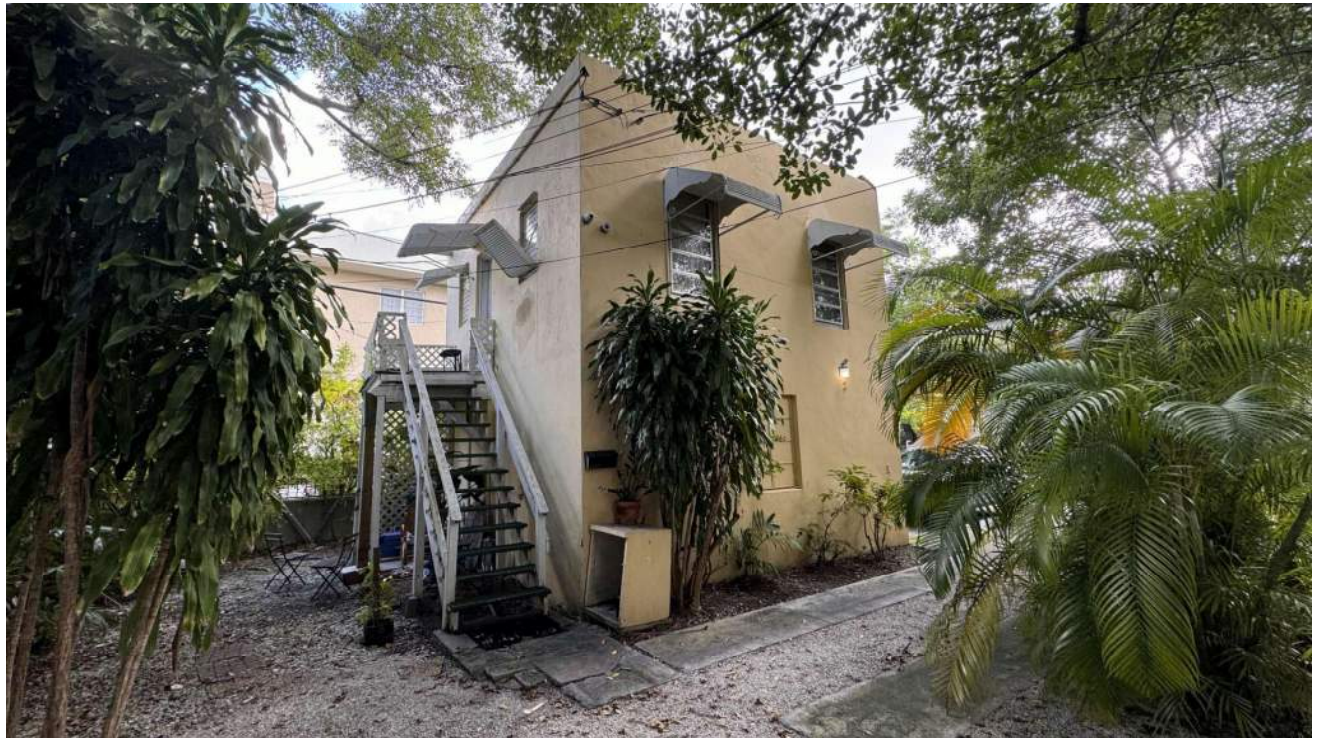
Picture No. 17: Building No.2 Rear-side elevation

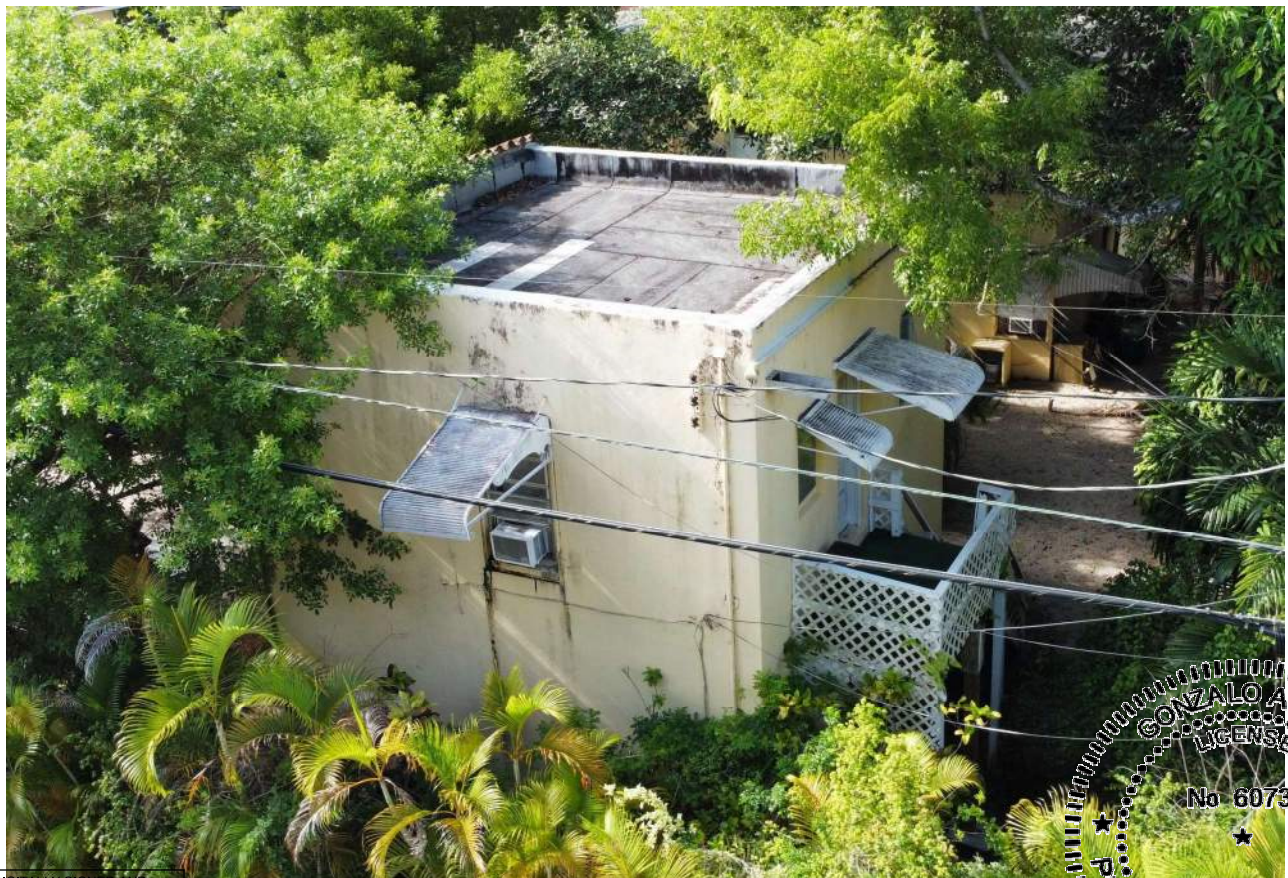
Picture No. 18: Building No.2 Rear-side elevation

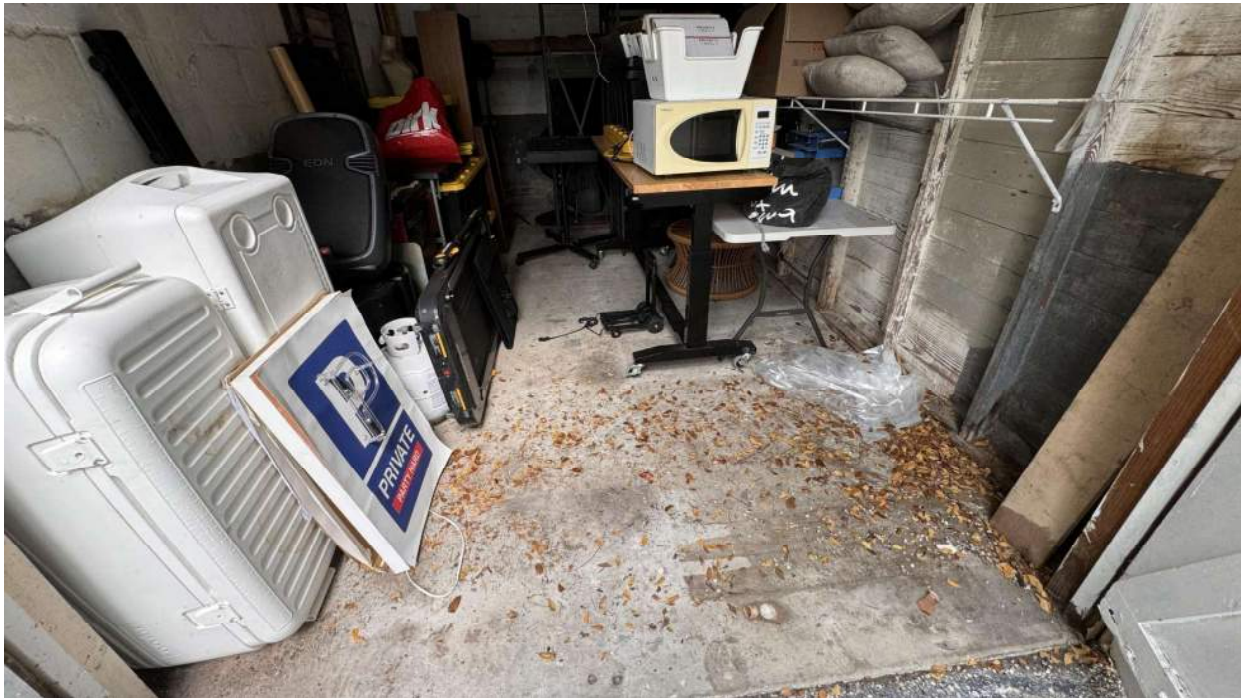
Picture No. 19: Building No.2 Ground floor Slab on grade. In fair condition.

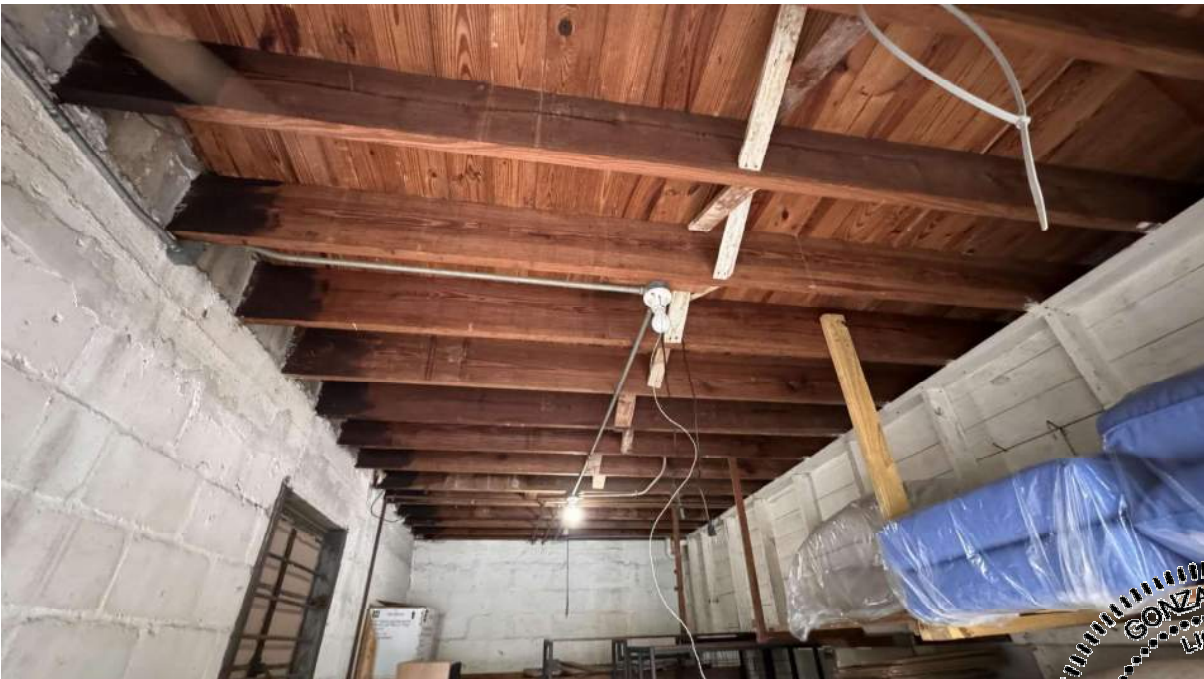
Picture No. 22: Building No.2 Second floor framing of wood planks sheathing over wood rafters bearing on concrete masonry perimeter walls. **In fair condition.**

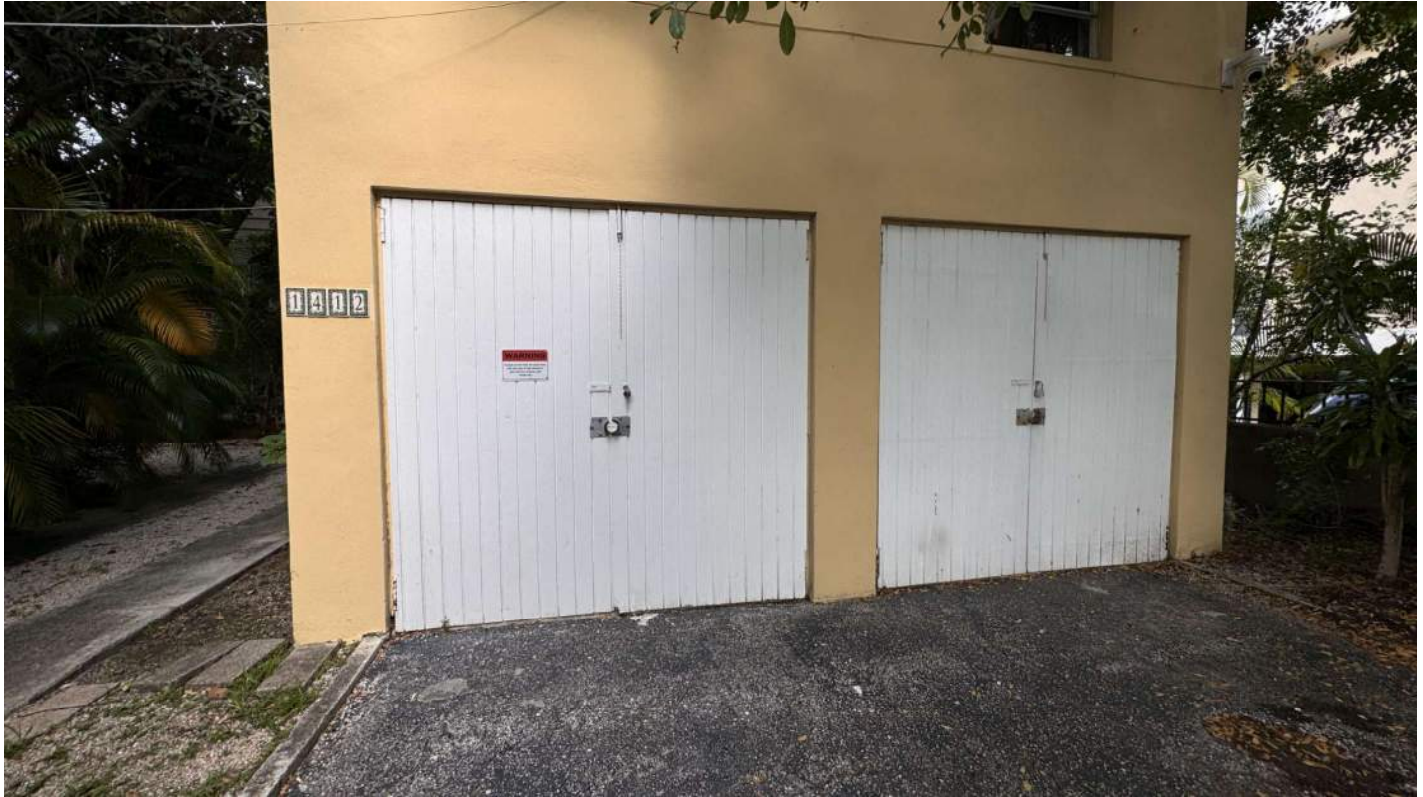
Picture No. 27: Building No.2 Wood Garage doors. In good condition.
