1414 Galiano St

**NOTICE OF UNSAFE STRUCTURE VIOLATION FOR FAILURE TO RECERTIFY
AND NOTICE OF HEARING**

Based on the visual inspection of exposed structural members, **the building is safe for its continued use and occupancy, however repairs will be needed to comply with the 40-year recertification.**

Building Being Certified
Building No.2

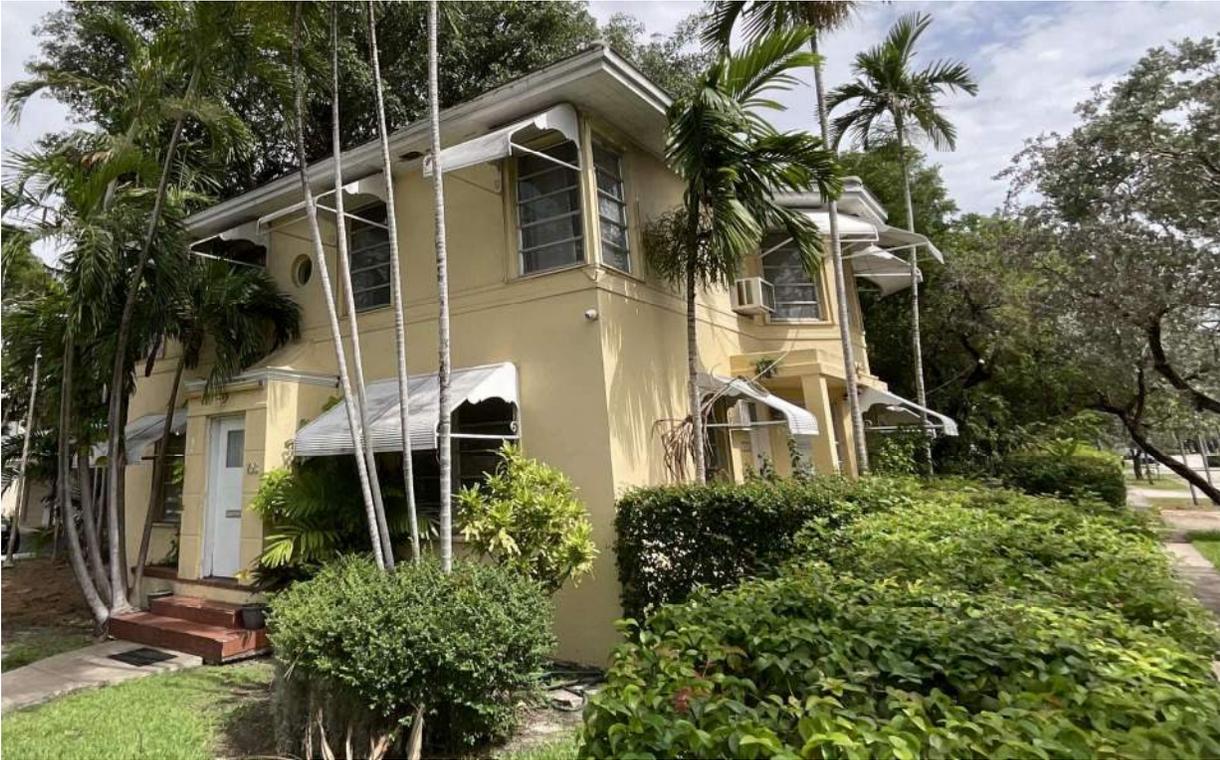
Picture No. 1: Building No.1 front-side elevation

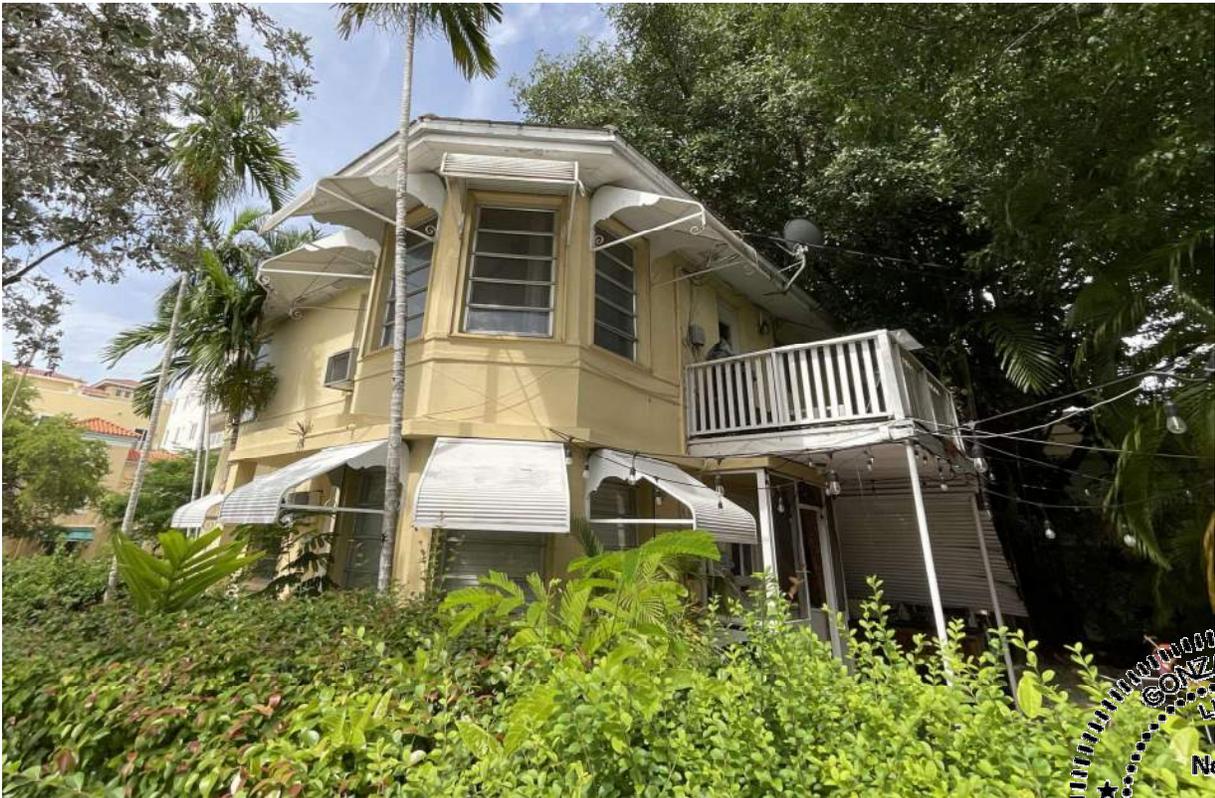
Picture No. 2: Building No.1 front-side elevation

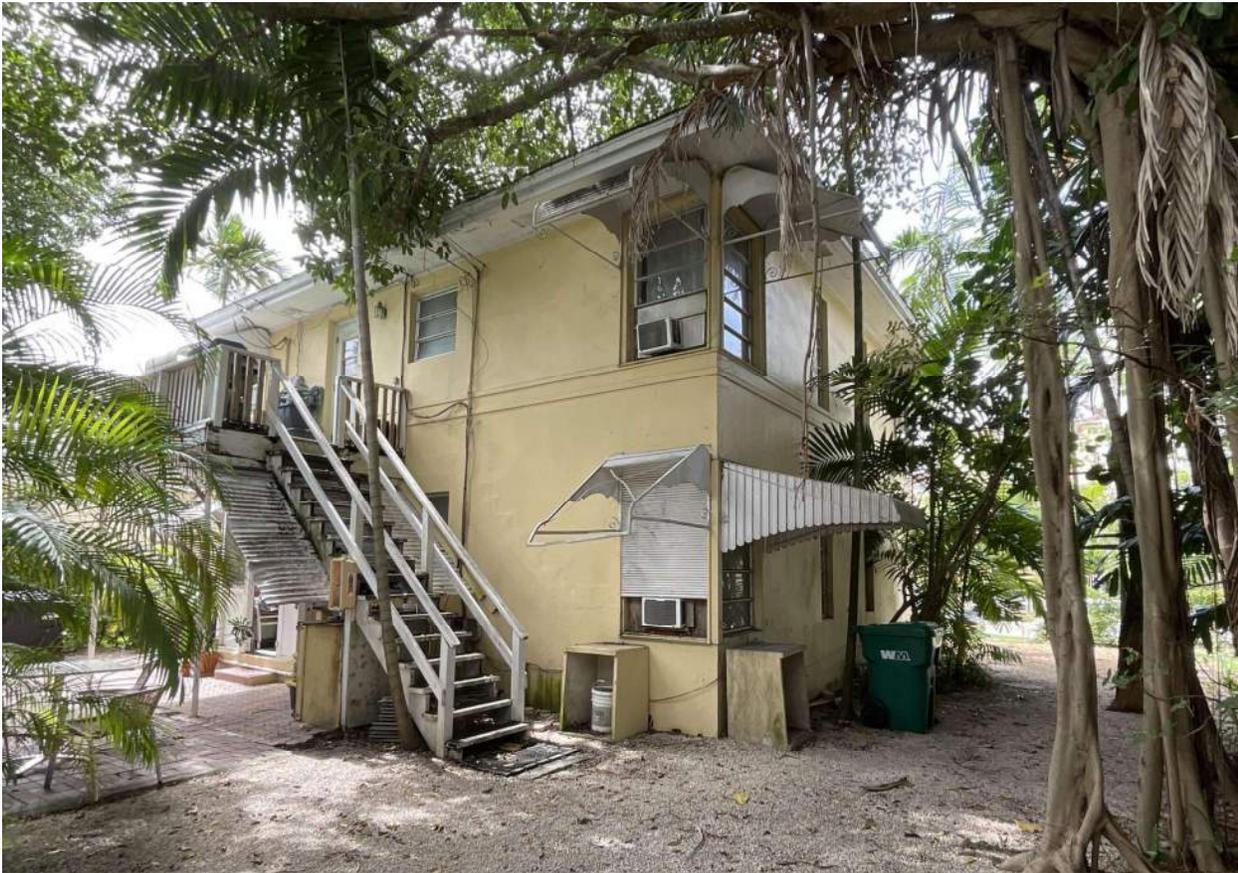
Picture No. 3: Building No.1 Rear-side elevation

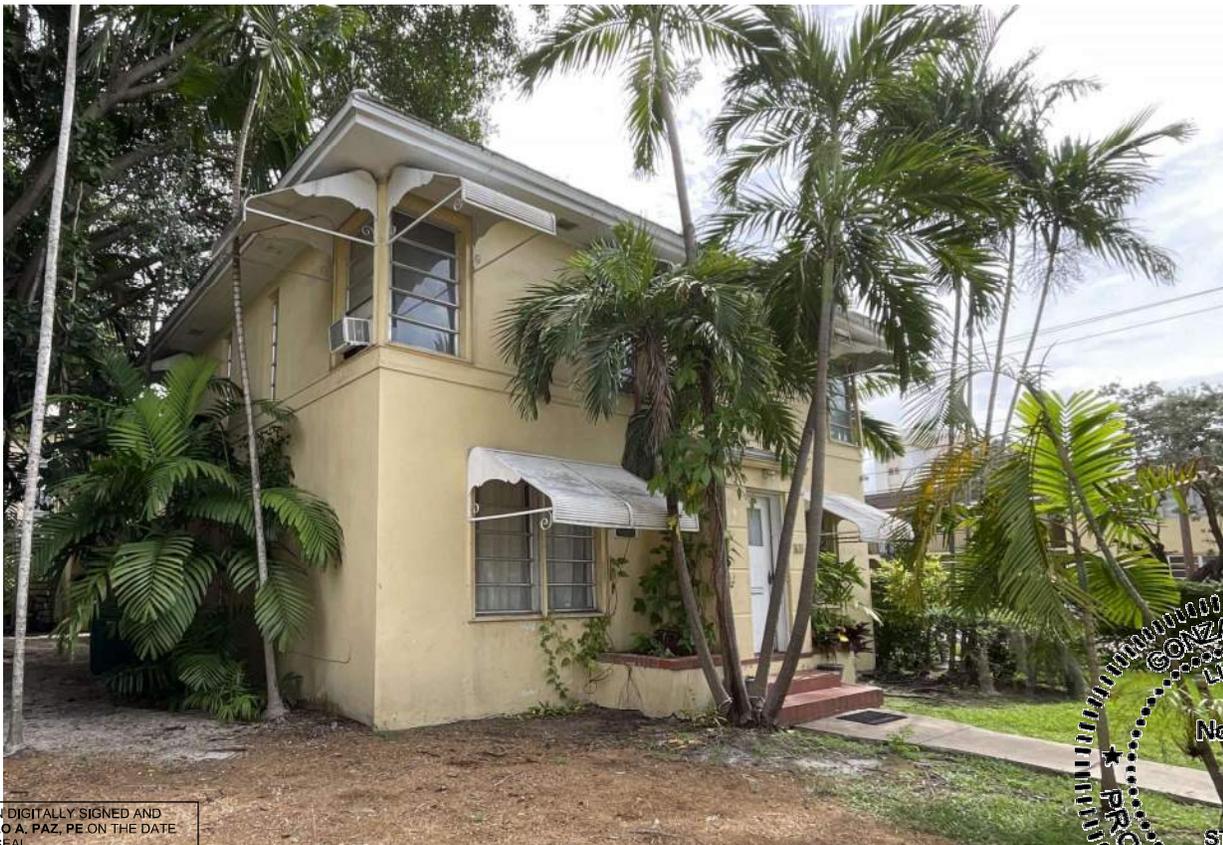
Picture No. 4: Building No.1 Rear-side elevation

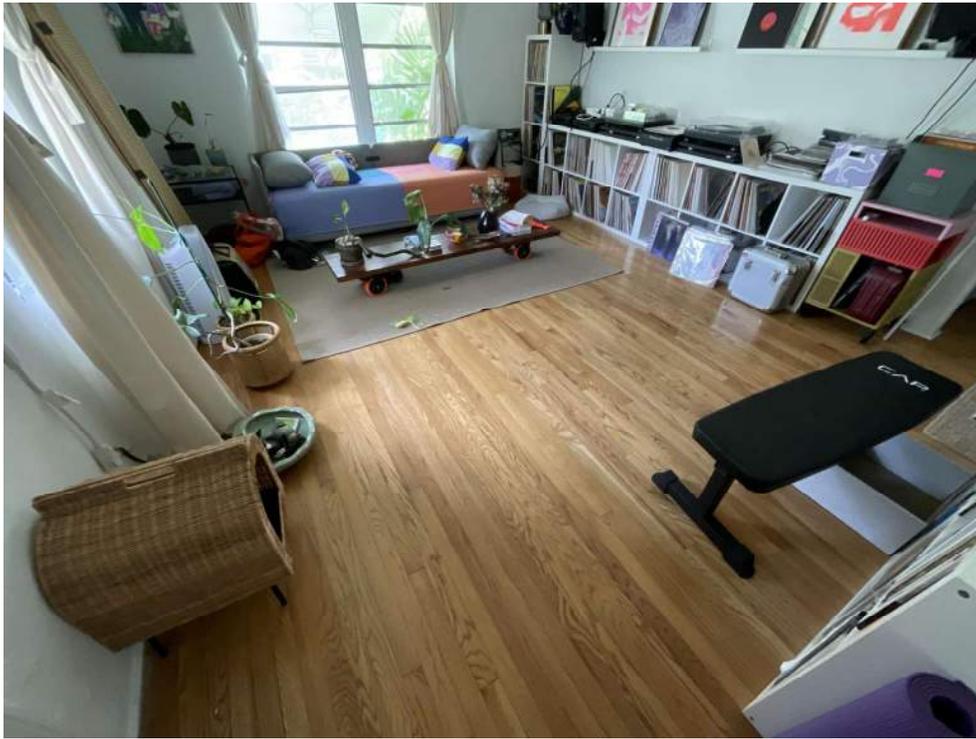
Picture No. 5: Building No.1 Ground floor framing of wood planks sheathing over wood rafters bearing on main wood beams supported on isolate concrete piers (at interior spans) and/or concrete masonry stem walls (at shell perimeter). In fair condition.

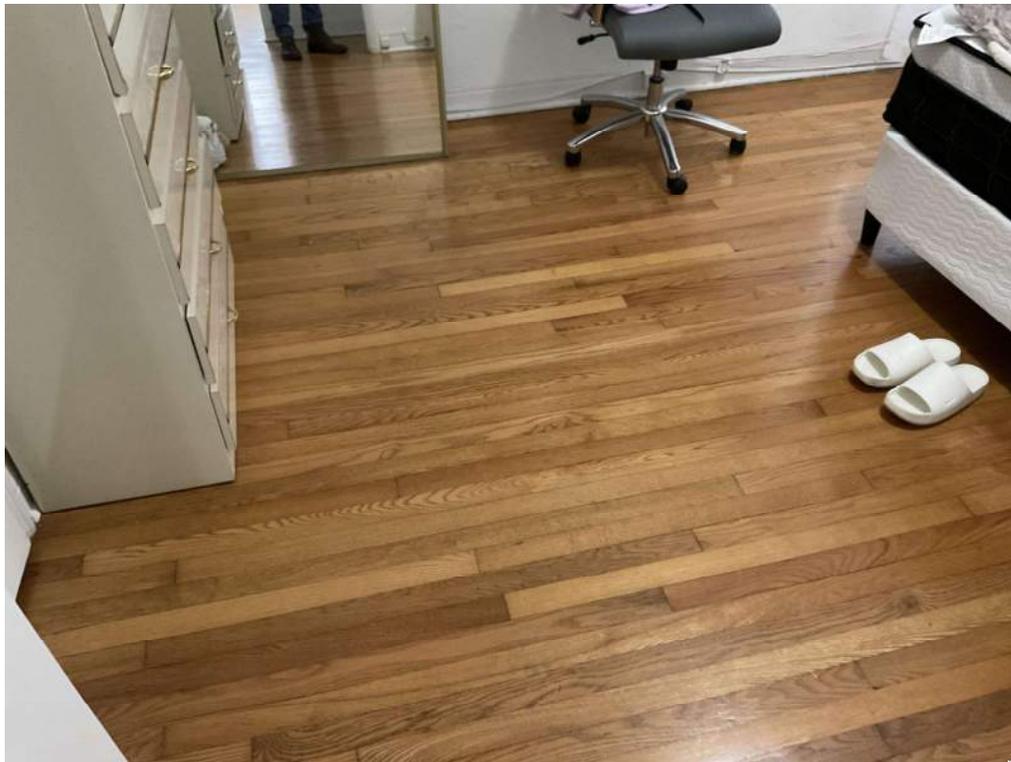
Picture No. 6: Building No.1 Second floor framing of wood planks sheathing over wood rafters bearing on concrete masonry perimeter walls. In fair condition.

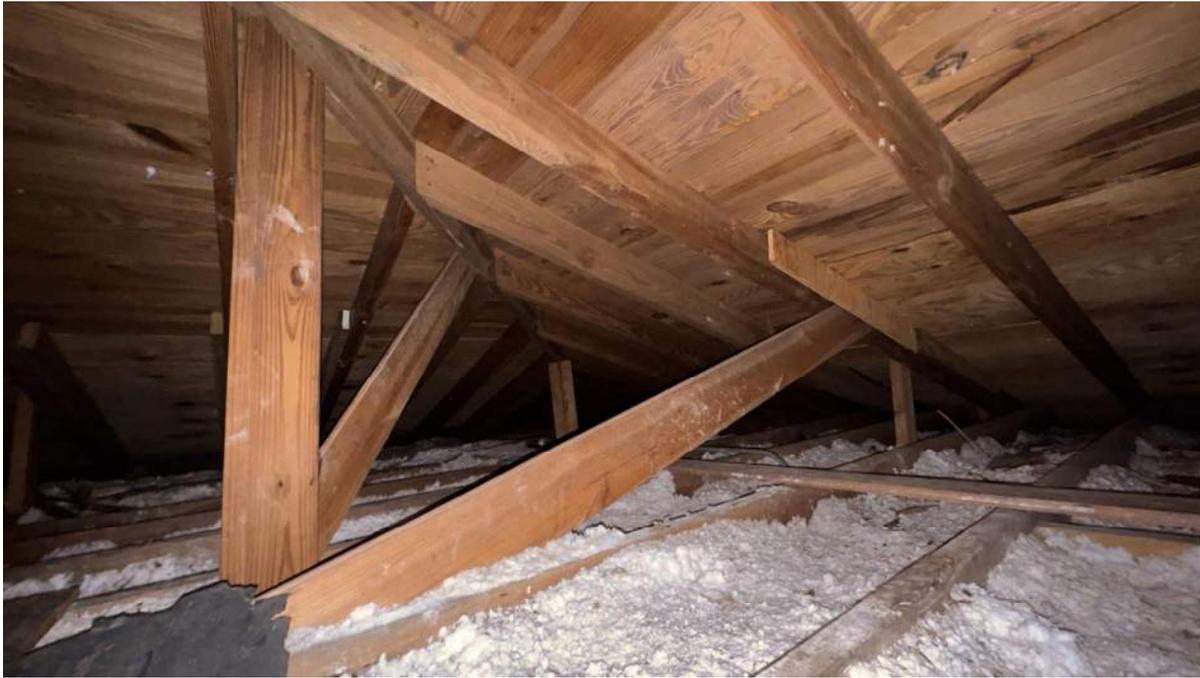
Picture No. 7: Building No.1 Roof framing of wood planks sheathing over wood trusses bearing on concrete masonry perimeter walls. In fair condition.

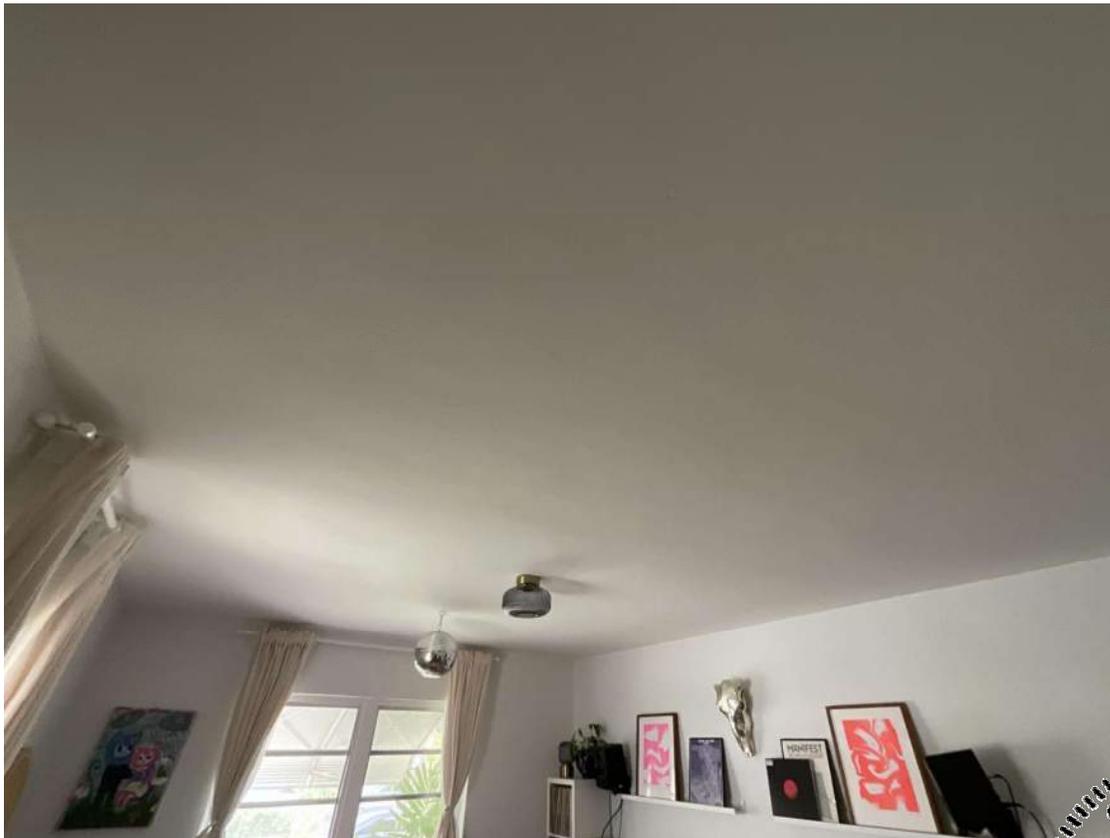
Picture No. 8: Building No.1 Second floor framing of wood planks sheathing over wood rafters bearing on concrete masonry perimeter walls. In fair condition.

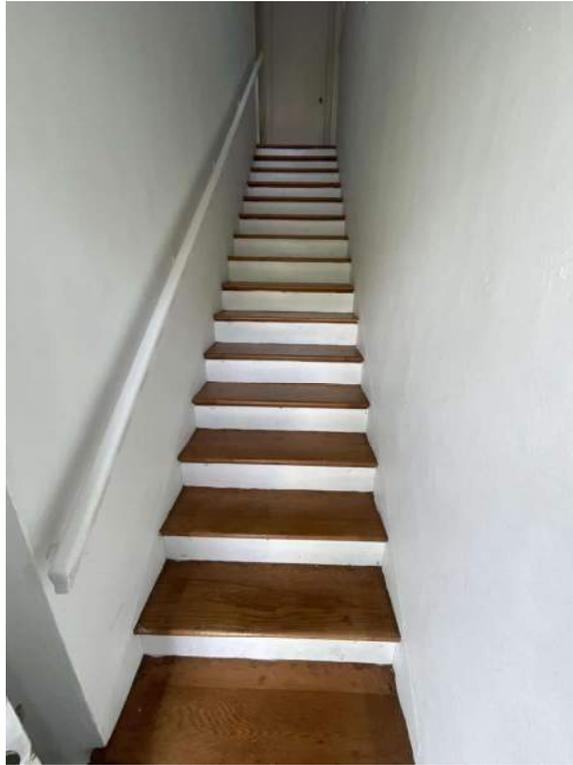
Picture No. 9: Building No.1 Interior stair framing of wood elements. In good condition.

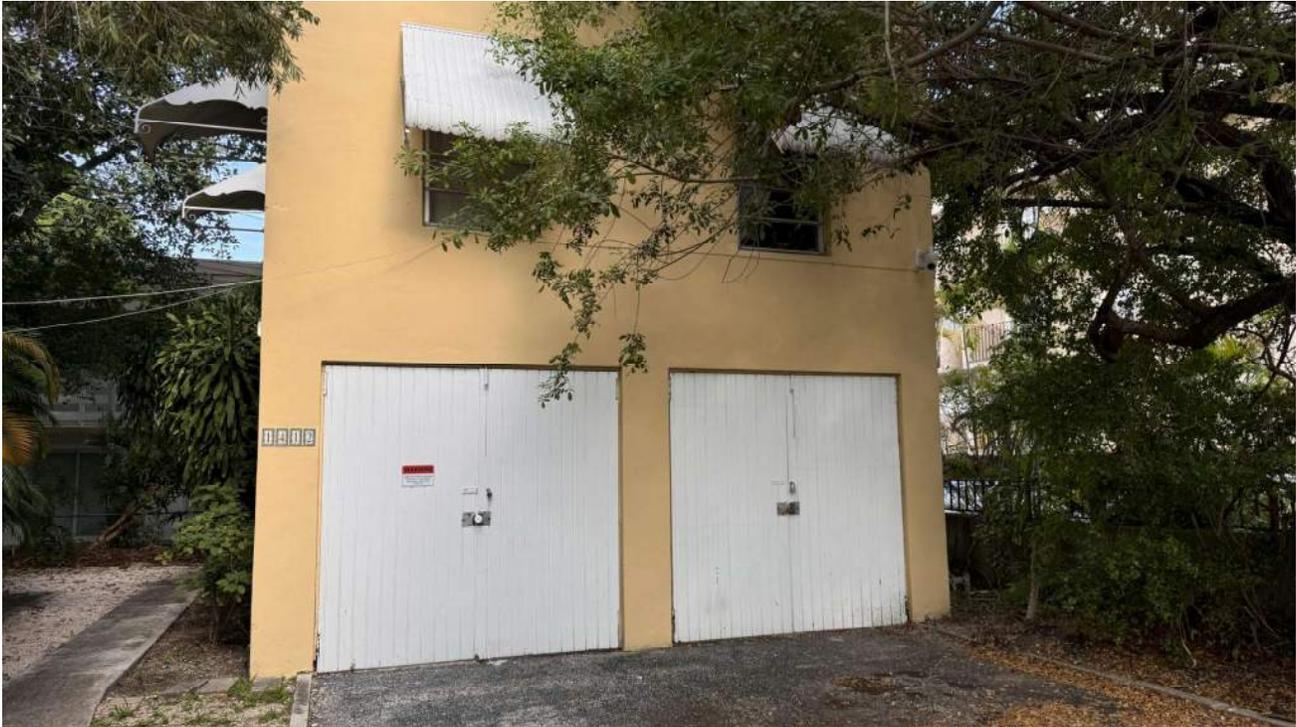
Picture No. 15: Building No.2 front-side elevation

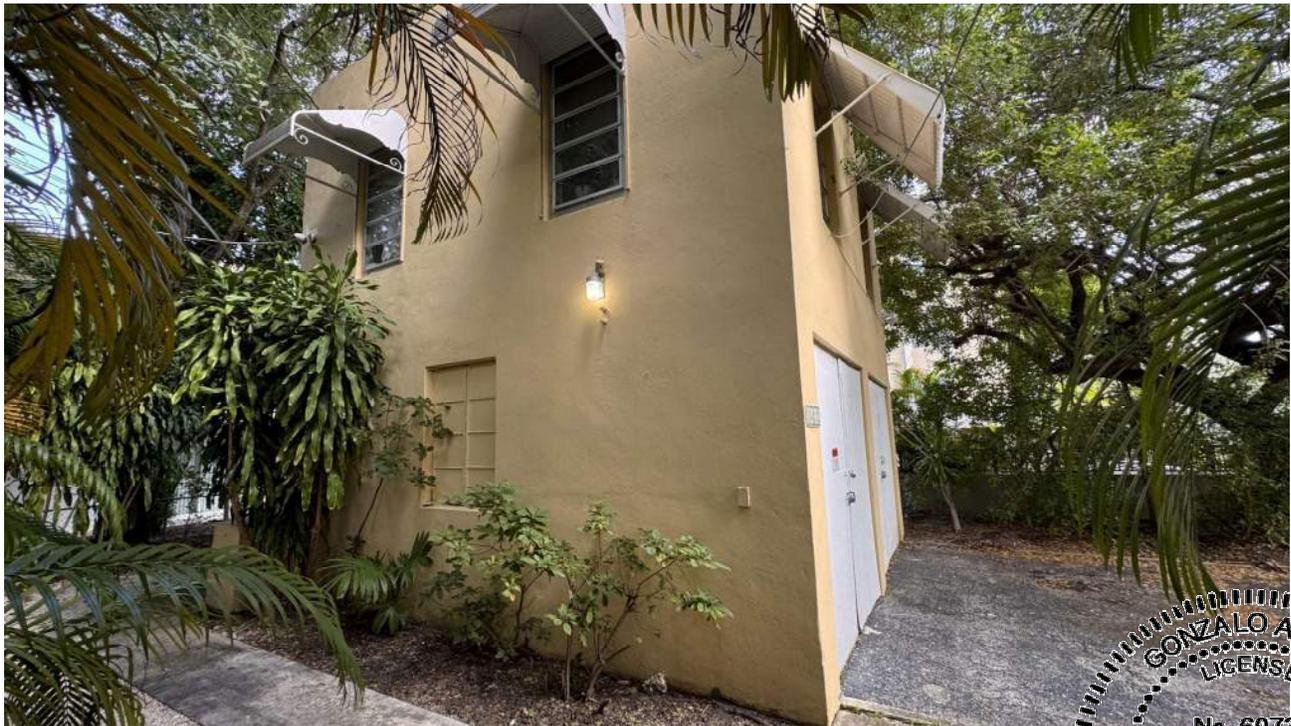
Picture No. 16: Building No.2 front-side elevation

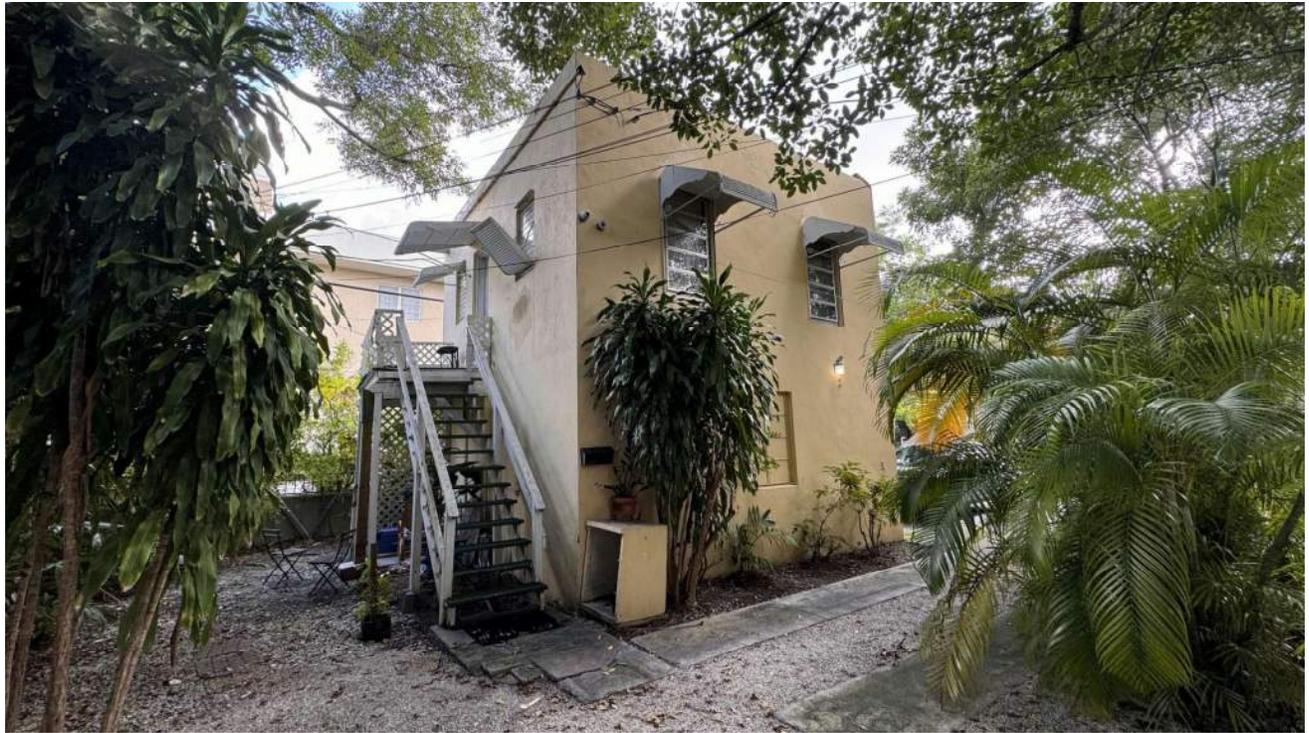
Picture No. 17: Building No.2 Rear-side elevation

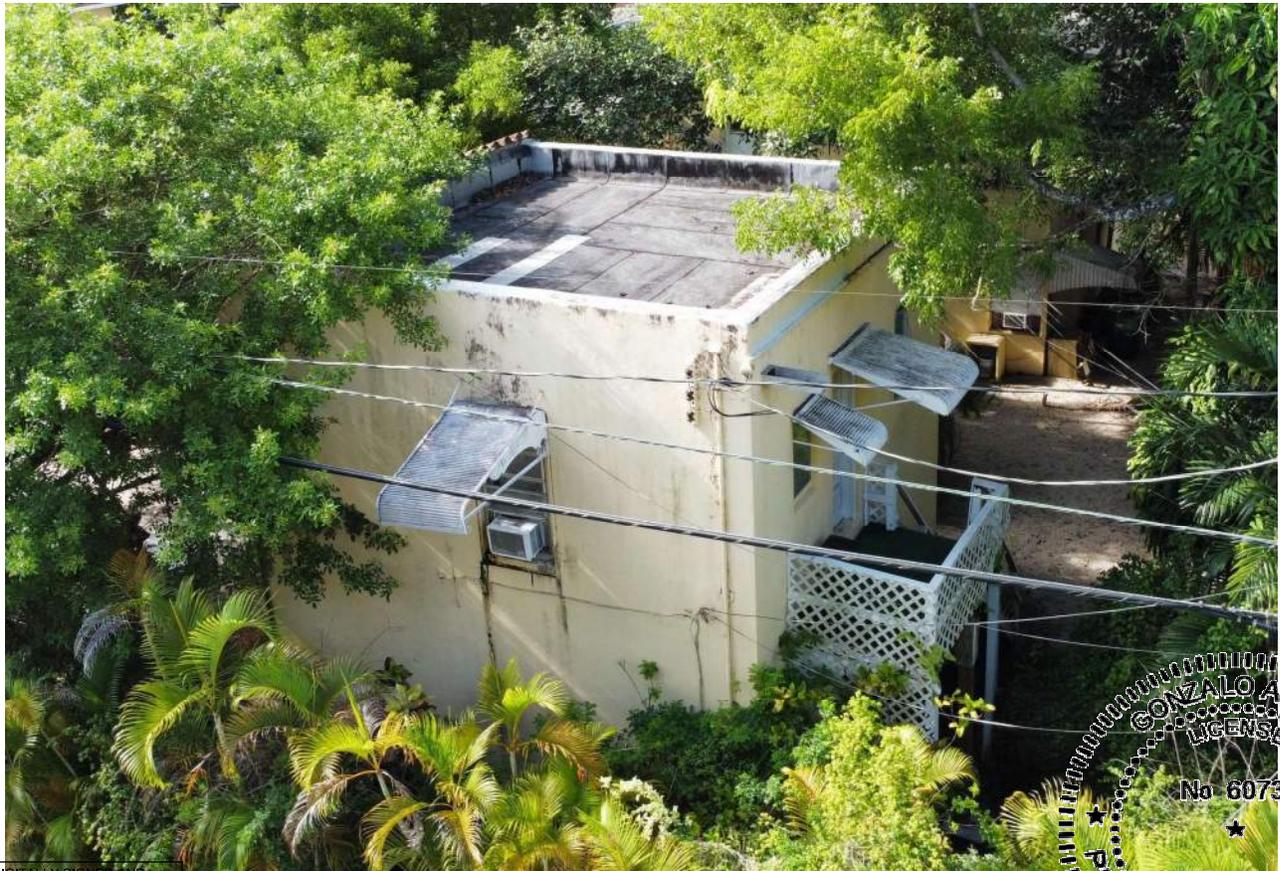
Picture No. 18: Building No.2 Rear-side elevation

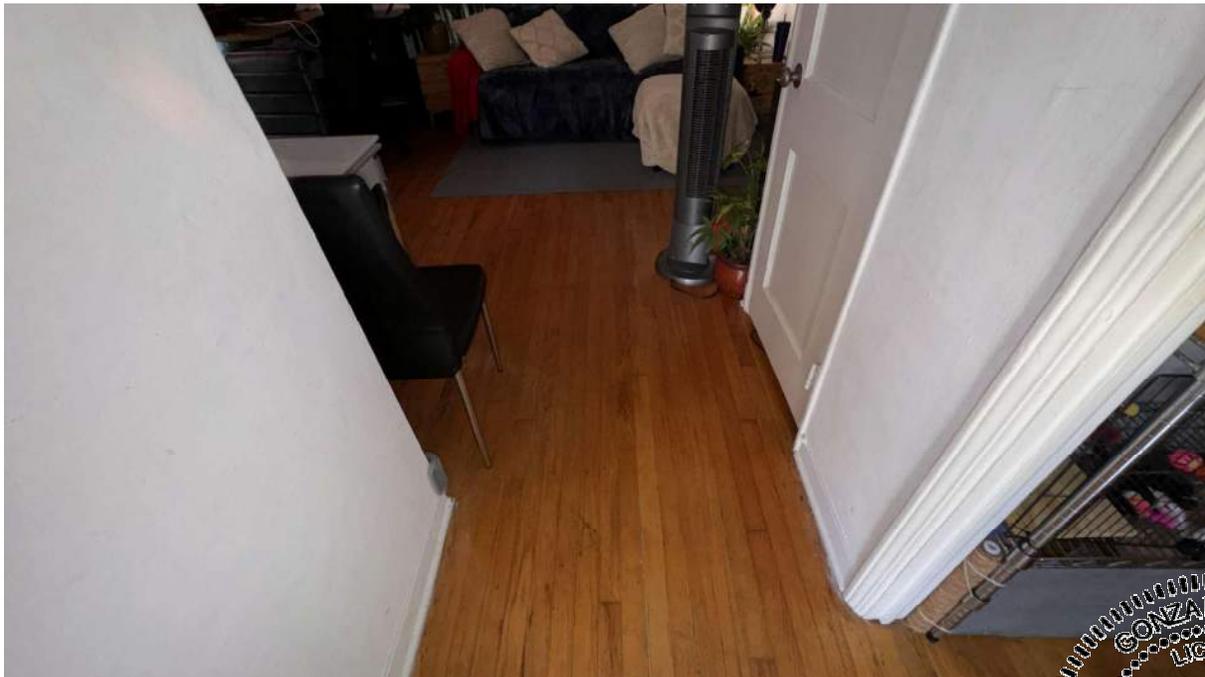
Picture No. 20: Building No.2 Second floor framing of wood planks sheathing over wood joists bearing on concrete masonry perimeter walls. In fair condition.

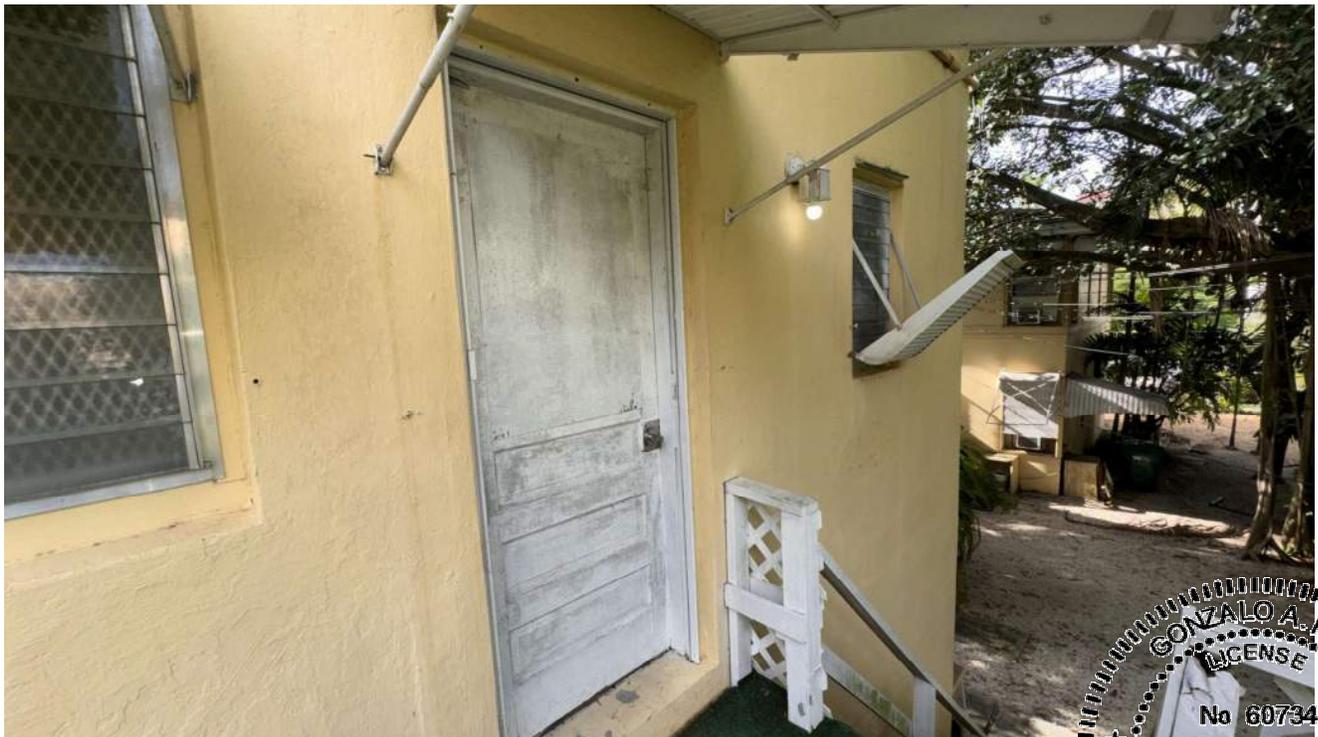
Picture No. 26: Building No.2 Entry Wood doors. See addendum for deficiencies & repairs.

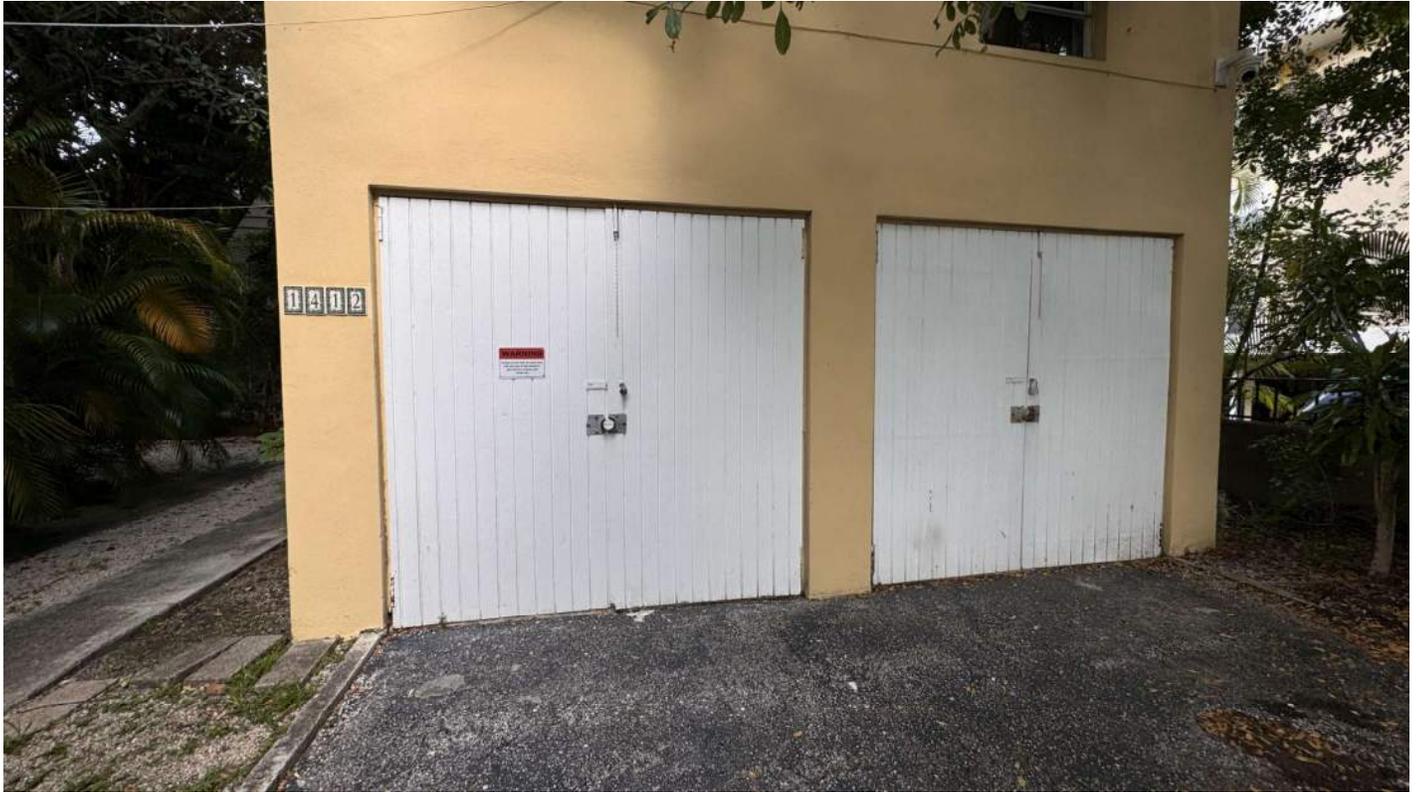
Picture No. 27: Building No.2 Wood Garage doors. In good condition.
