PROPERTY INSPECTION OR ASSESSMENT OF DAMAGES

ADDRESS: 229 Ridgewood Rd. Coral Gables, Fl.
CLIENT: Phil Padron
ID No: 2016417
DATE: 6/9/2016

PROPERTY INSPECTION –229 Ridgewood Rd Coral Gables, FL
ATTACHMENT - PHOTOGRAPHS
DATE: 06-09-2016

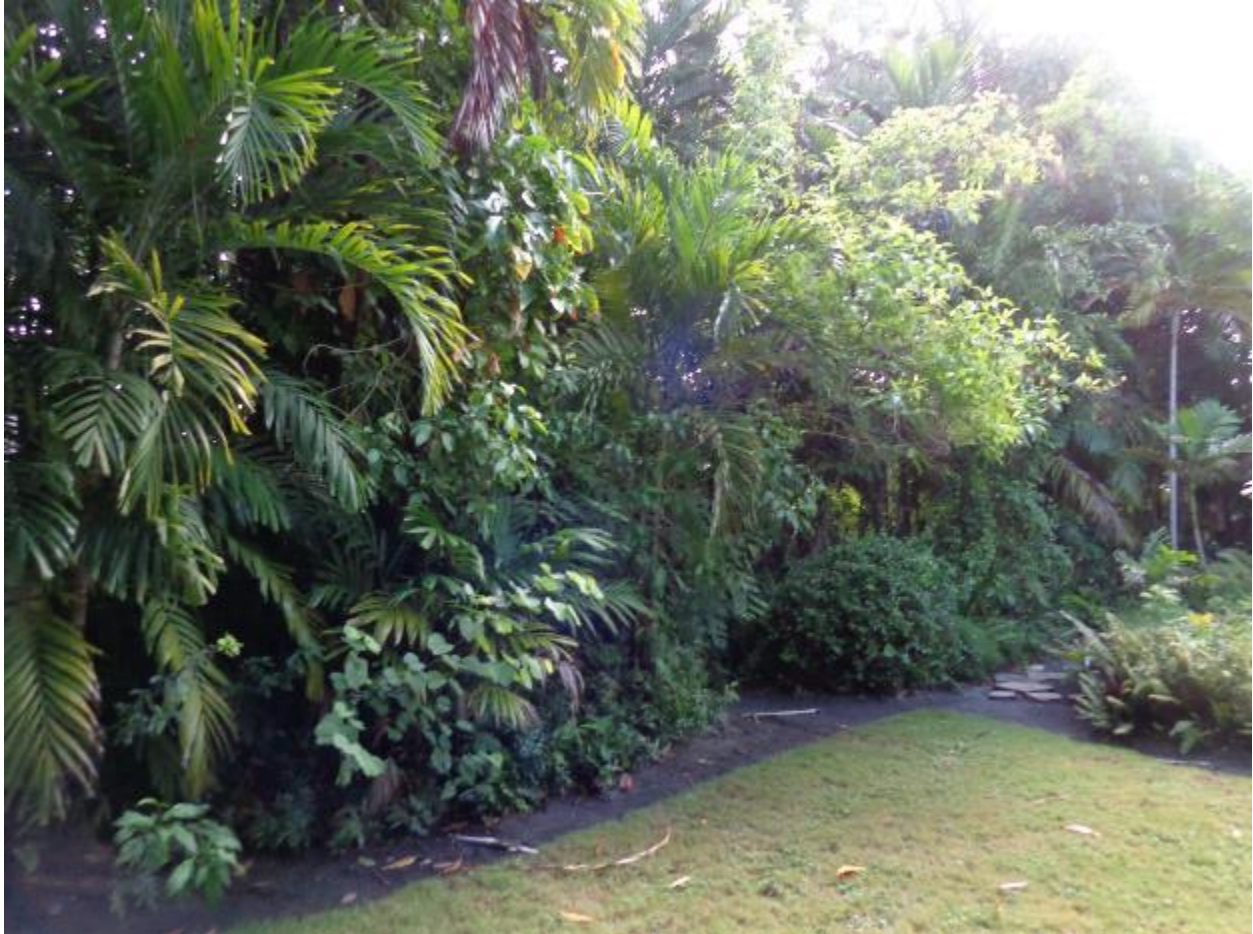
Allowances must be made for the removal of overgrown vegetation.

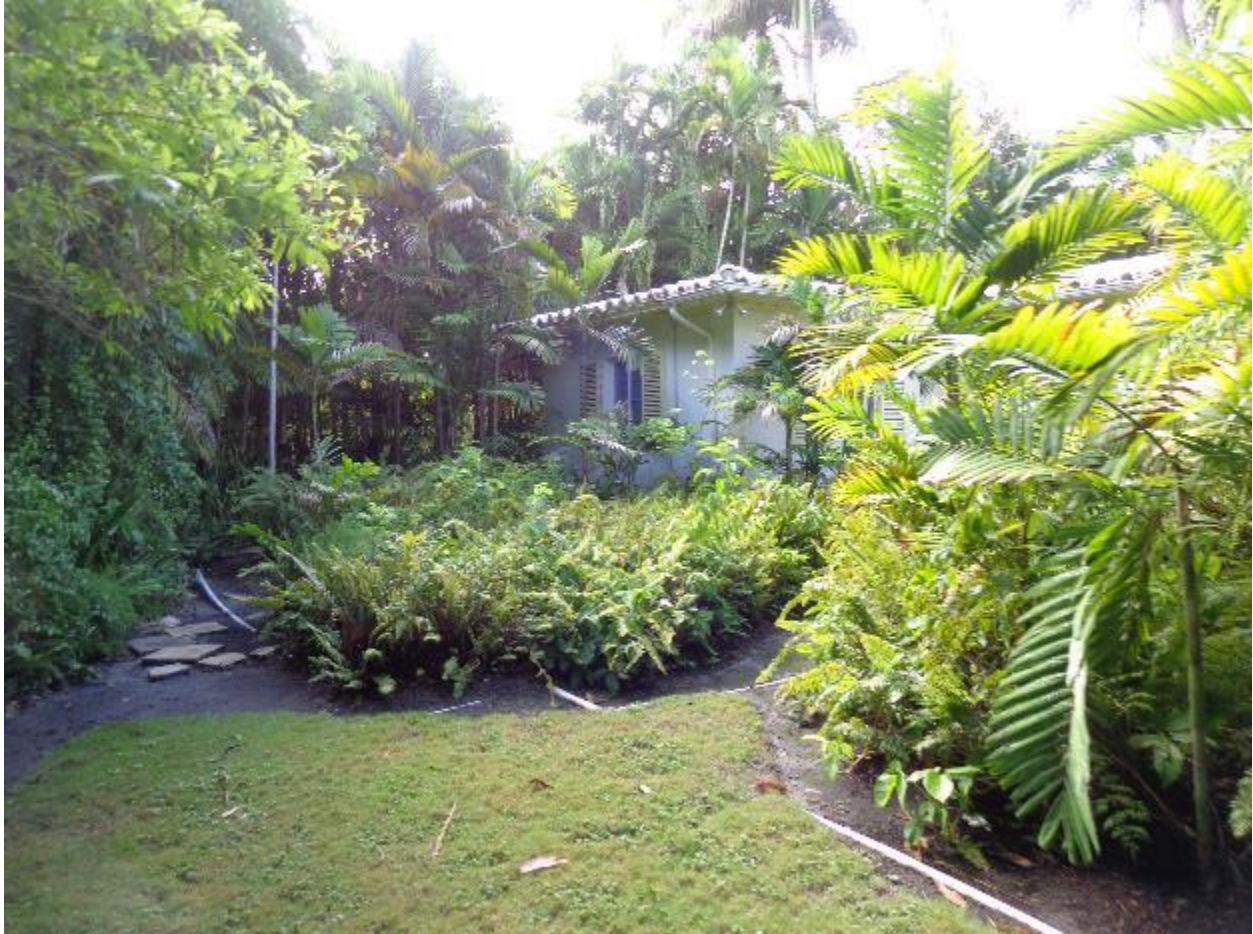
Allowances must be made for the removal of overgrown vegetation.

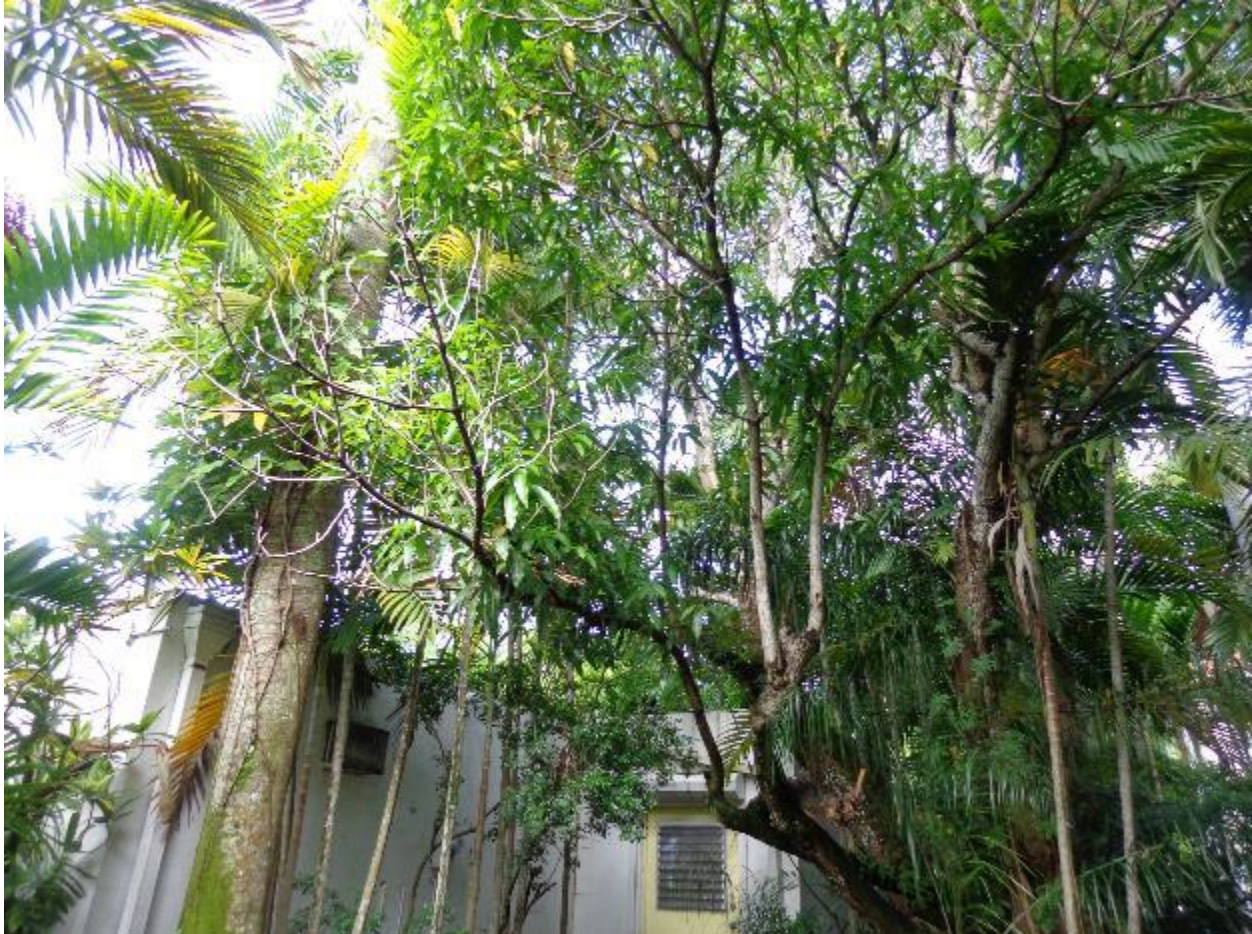
Allowances must be made for the removal of overgrown vegetation.

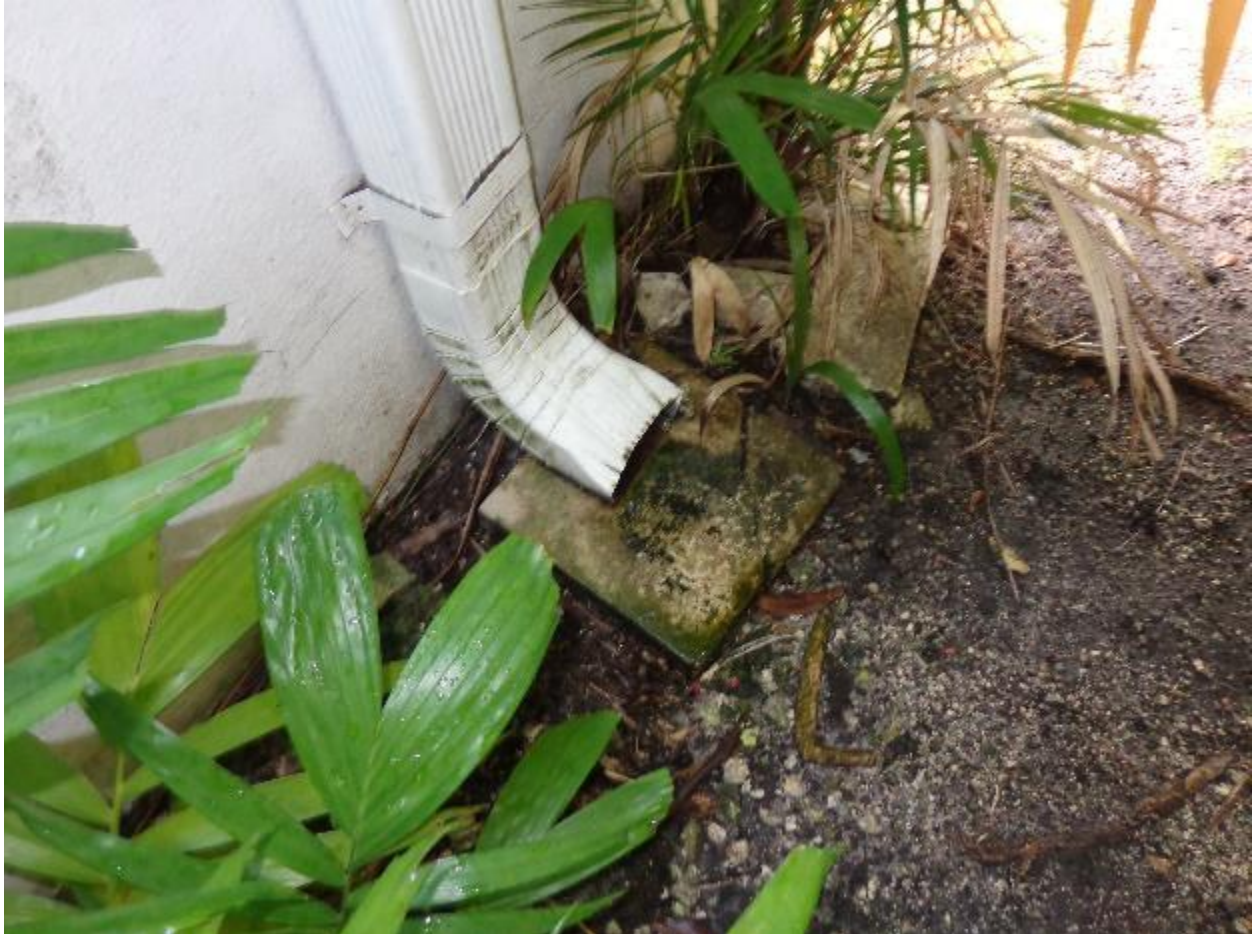
Gutters requires extensions to be installed. Water is not draining properly away from the house.

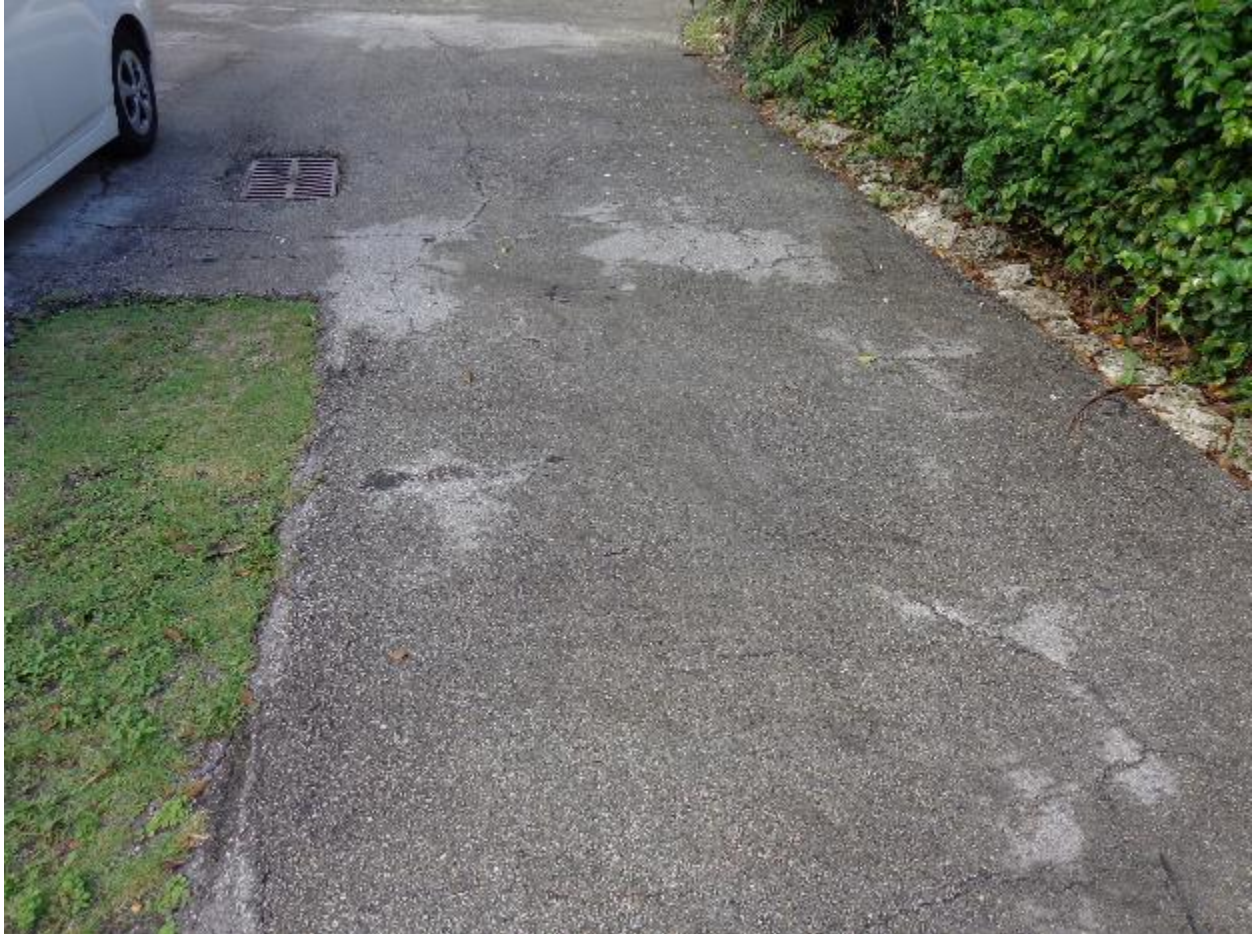
Asphalt recoating required on parking spaces/ driveway.

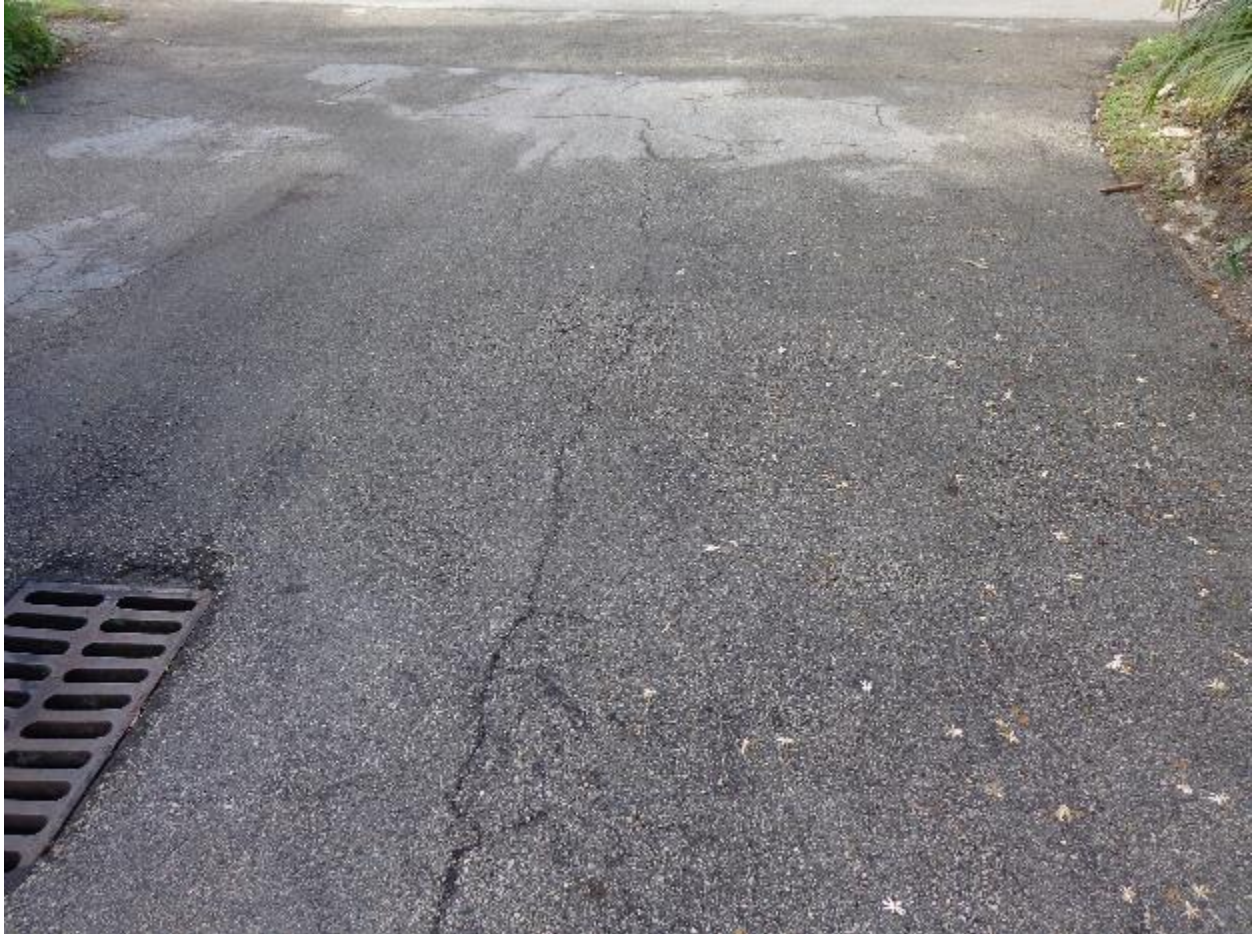
Asphalt recoating required on parking spaces/ driveway.

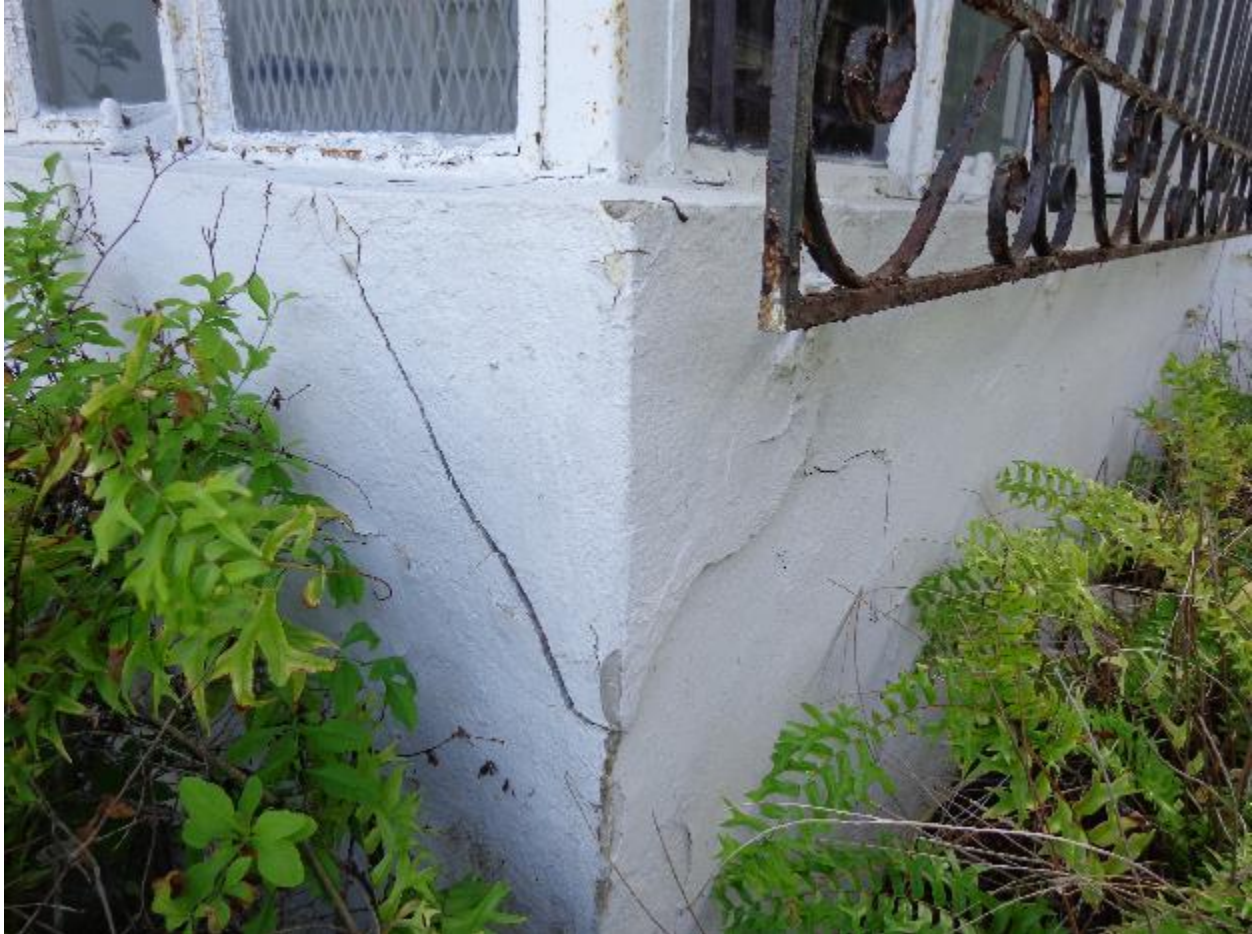
Stucco repairs required.

Structural repairs related to floor joists are required.

Wood structural joists not properly reinforced. Replacement or proper reinforcement of joists required.

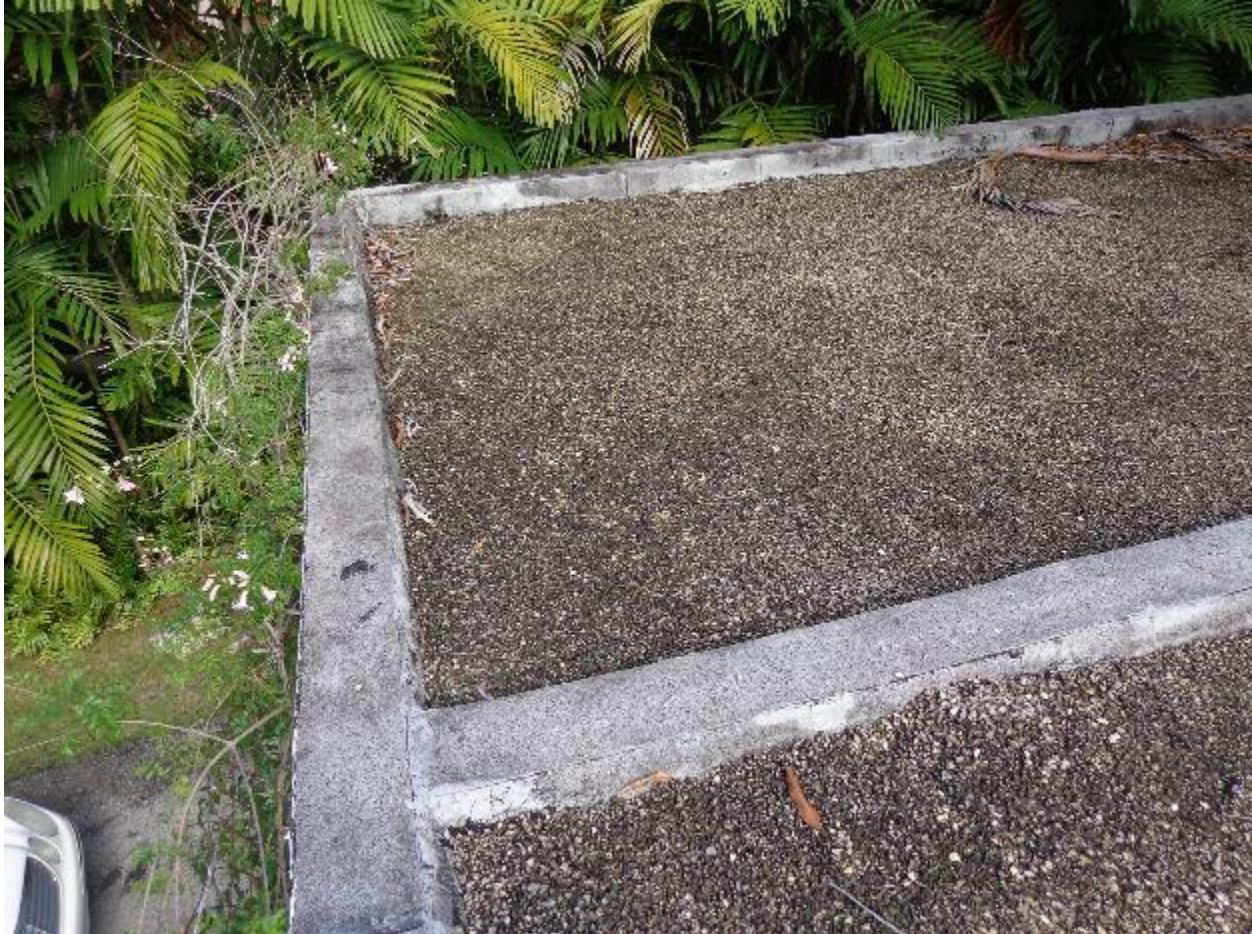
Minimum roofing repairs required, related to possible active leaks and water marks noted inside habitable space.

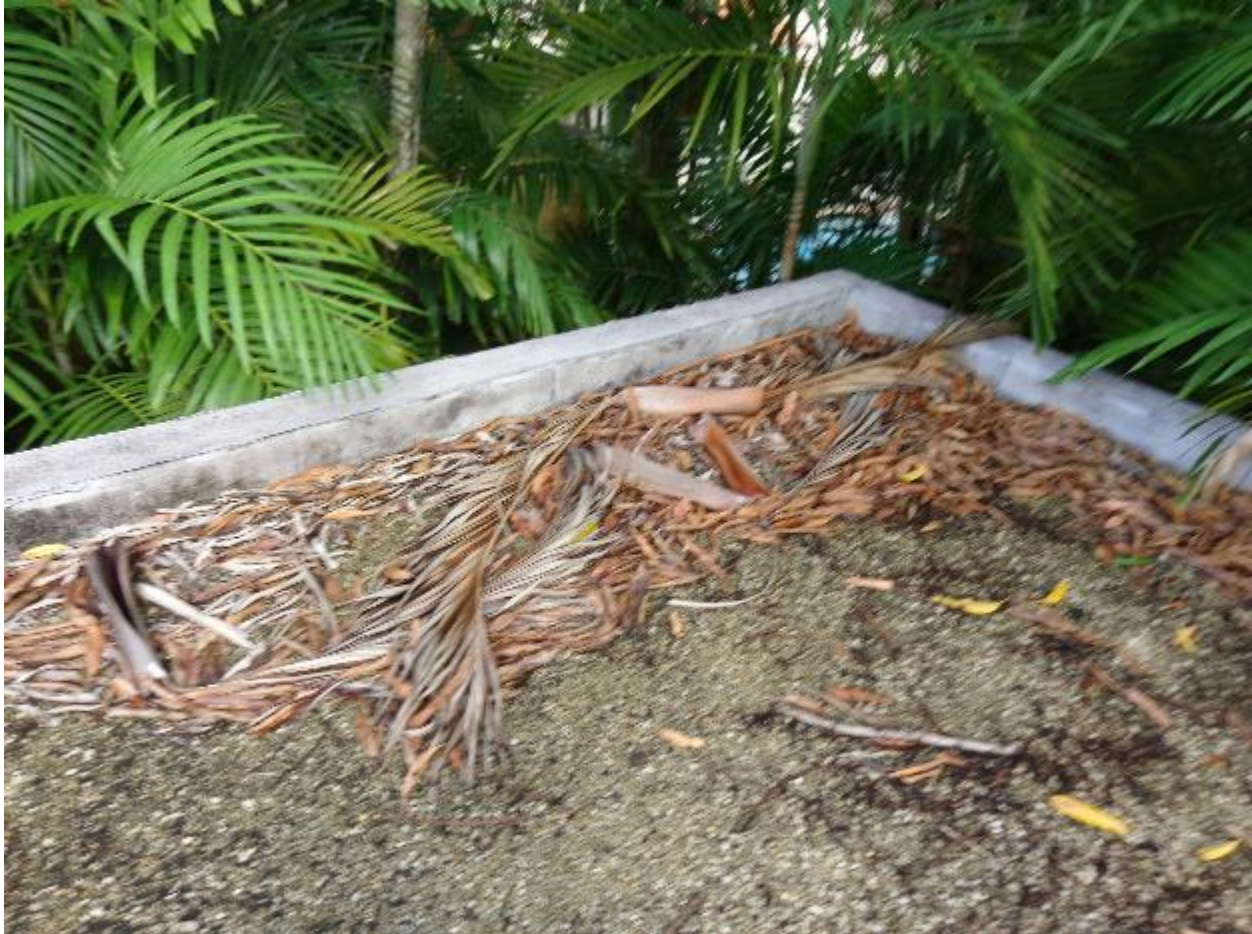
Allowances must be made for the removal of overgrown vegetation.

Minimum roofing repairs required, related to possible active leaks and water marks noted inside habitable space.

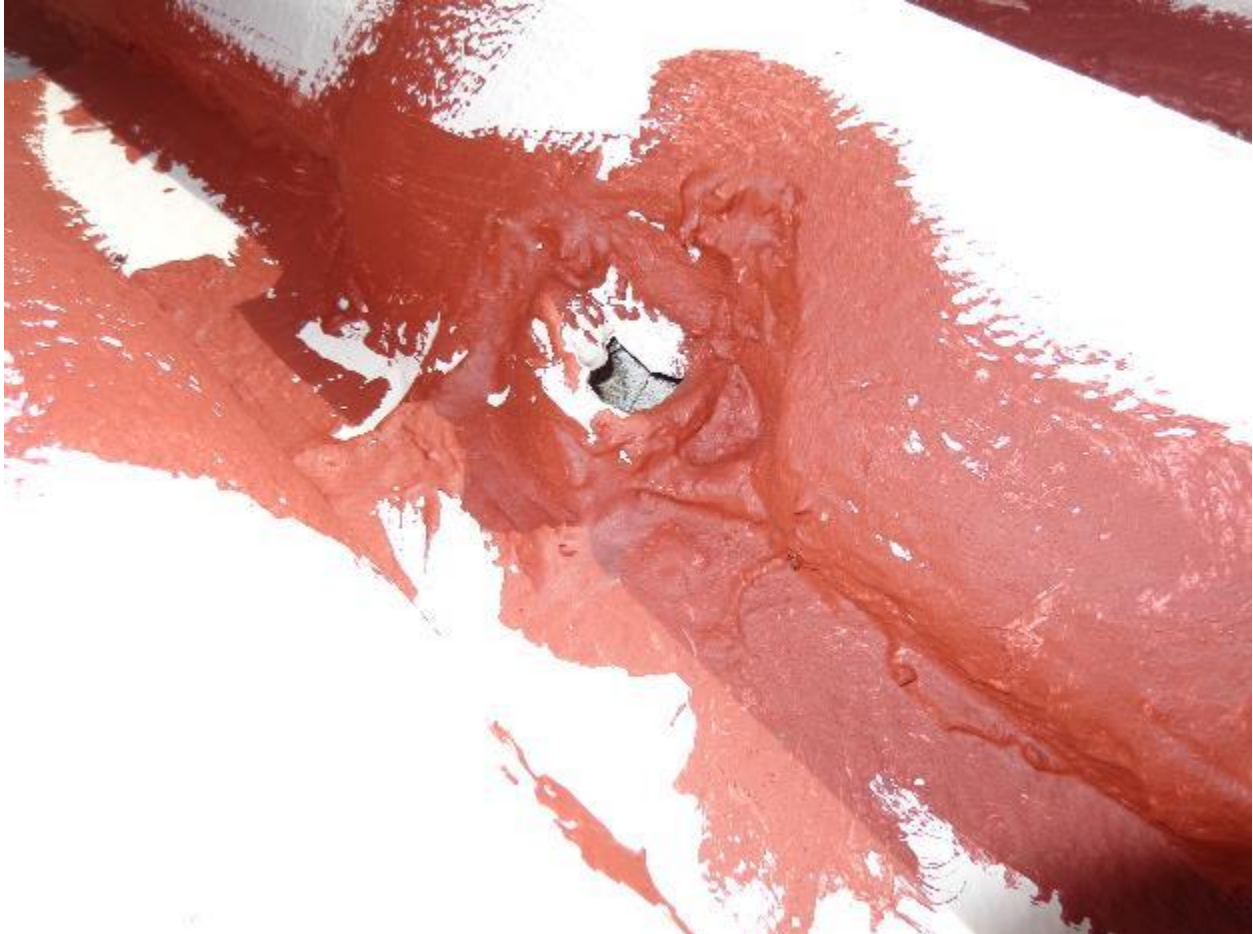
(2nd bathroom near garage) Vent pipe should be a minimum of 3 inches above roofline.

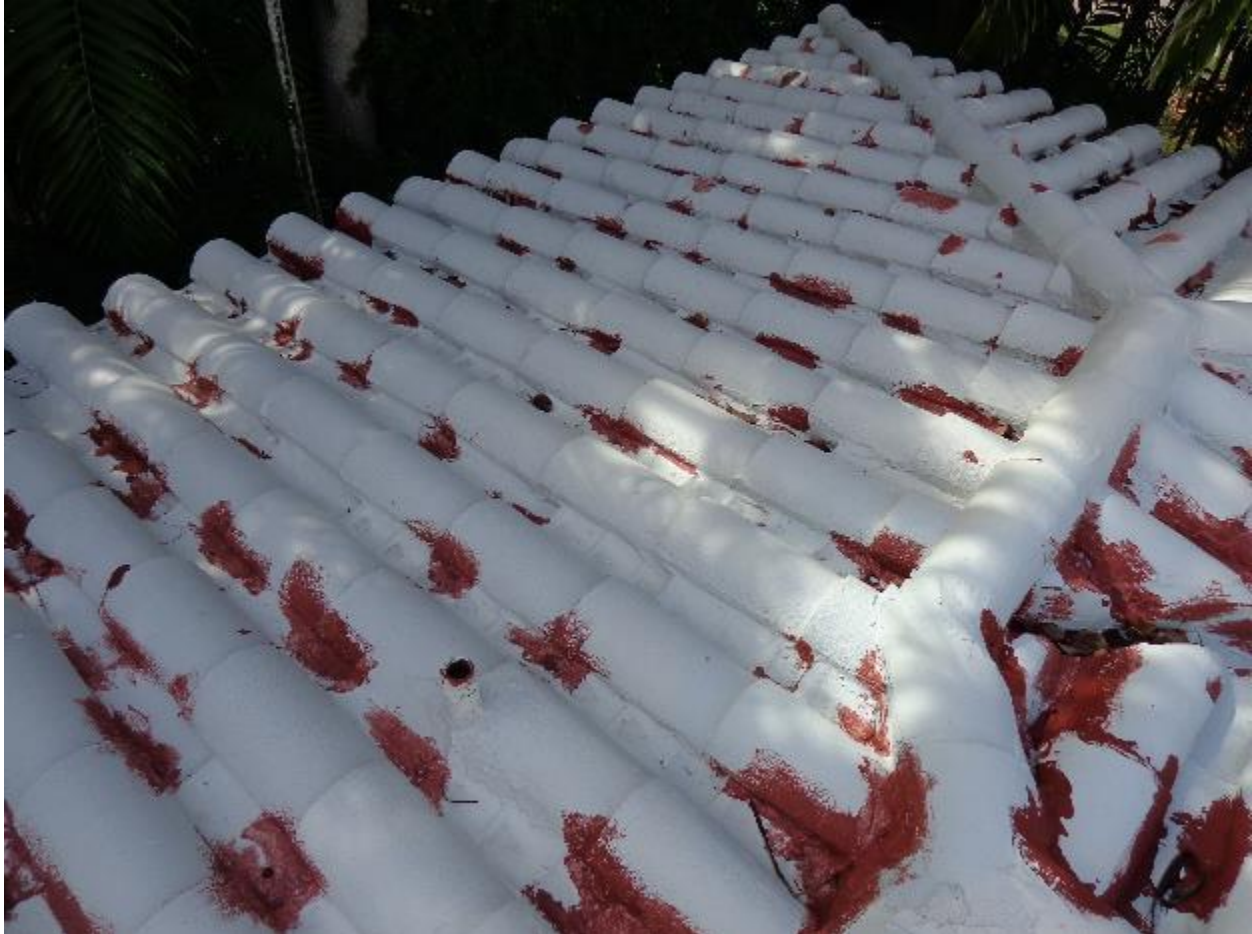
(Roof age unknown)

Roof was noted to be in general good condition and was properly sealed at time of inspection. No active leaks were noted inside home from the main roof.

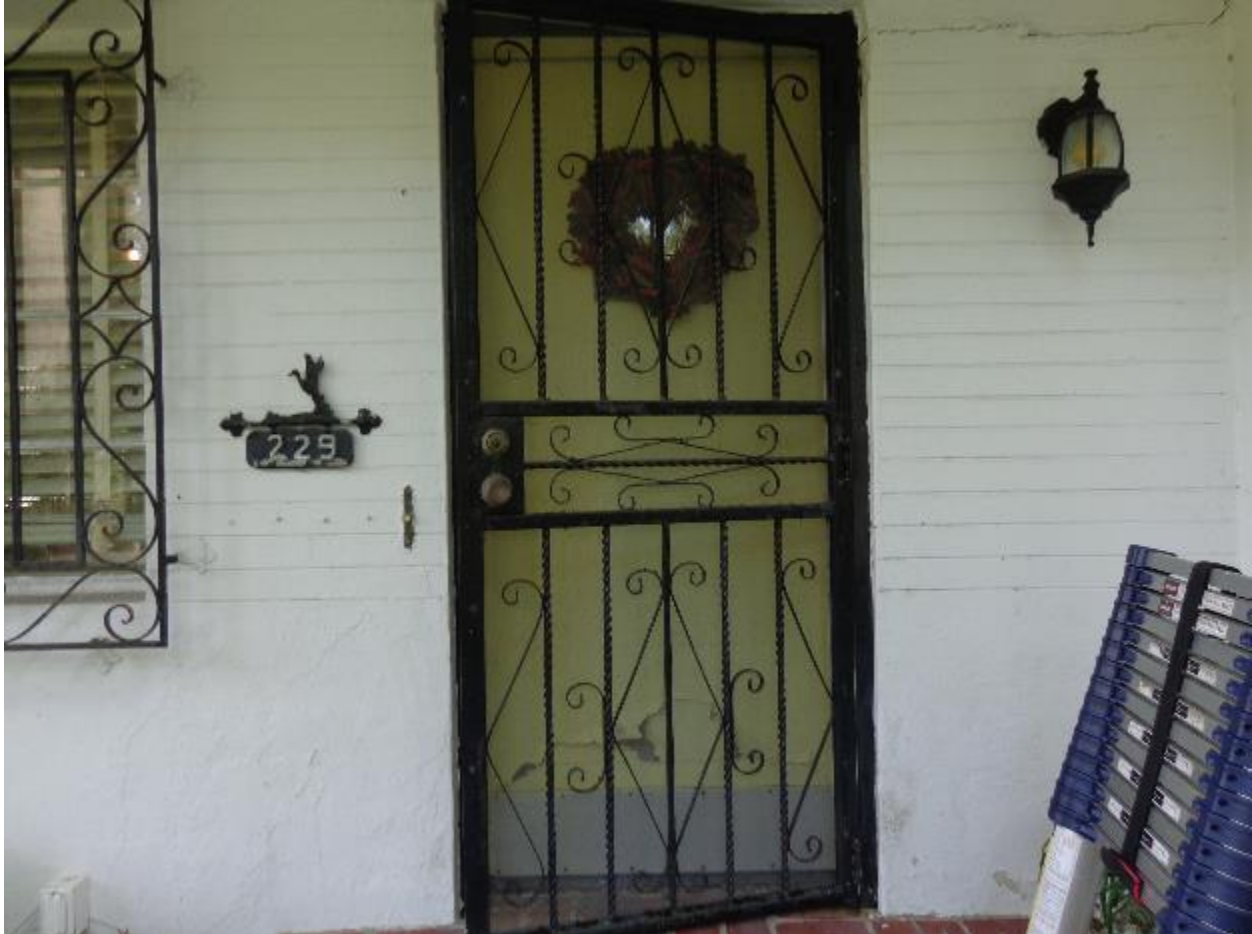
Exterior door(s) require replacement. Currently beyond possibilities of repair.

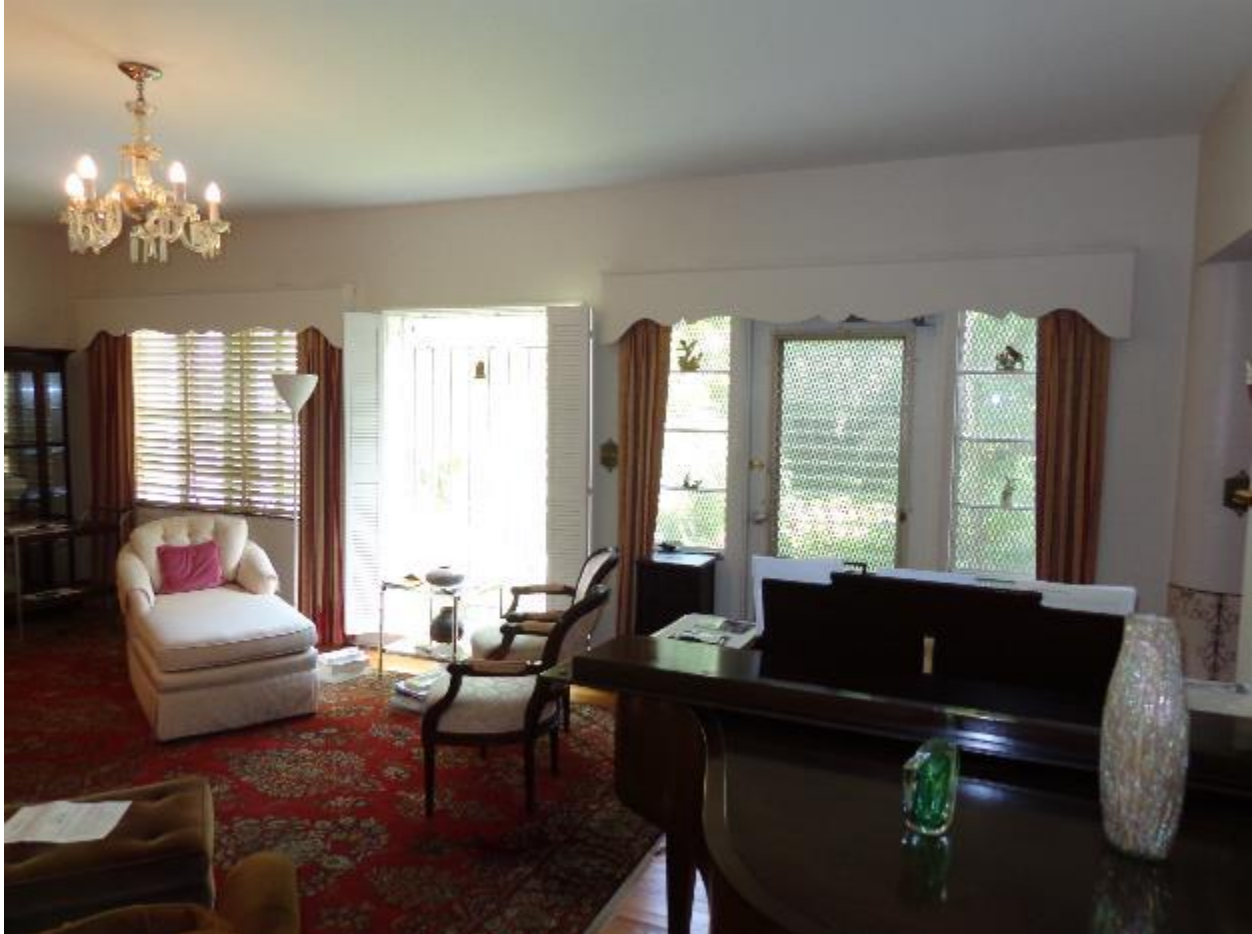
A complete rehabilitation of the interior is recommended. Plumbing, electrical and Ac systems require replacement or repairs.

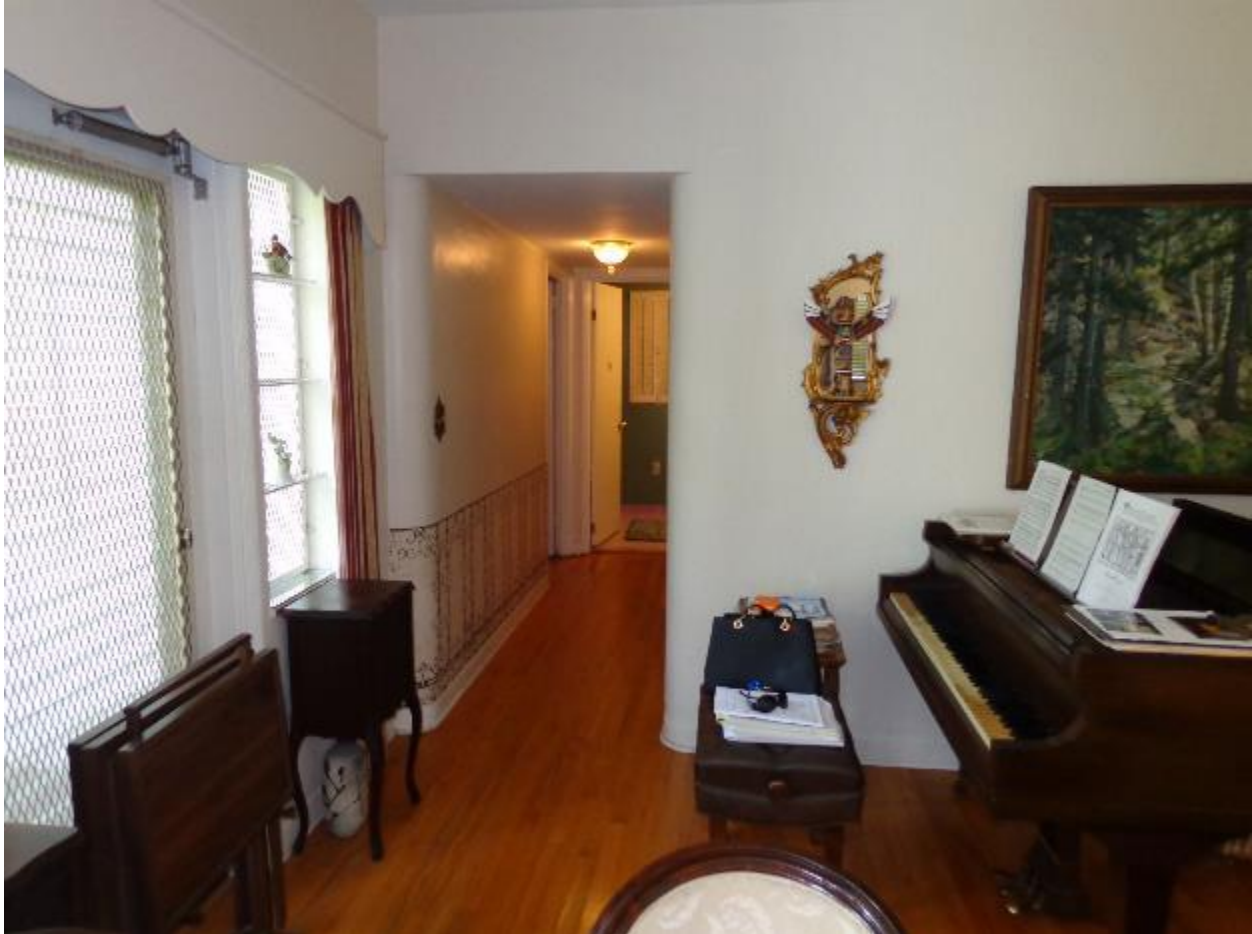
A complete rehabilitation of the interior is recommended. Plumbing, electrical and Ac systems require replacement or repairs.

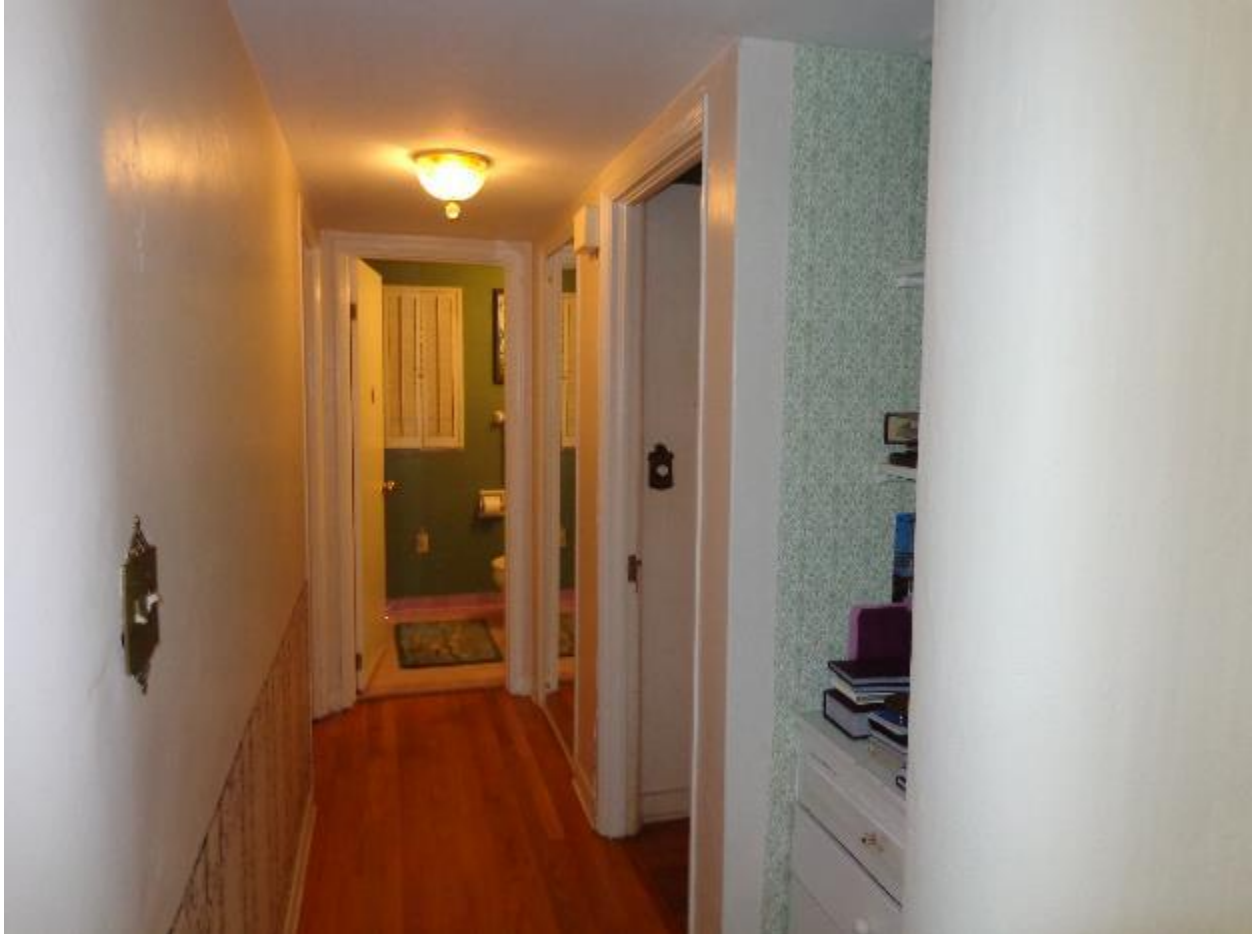
A complete rehabilitation of the interior is recommended. Plumbing, electrical and Ac systems require replacement or repairs.

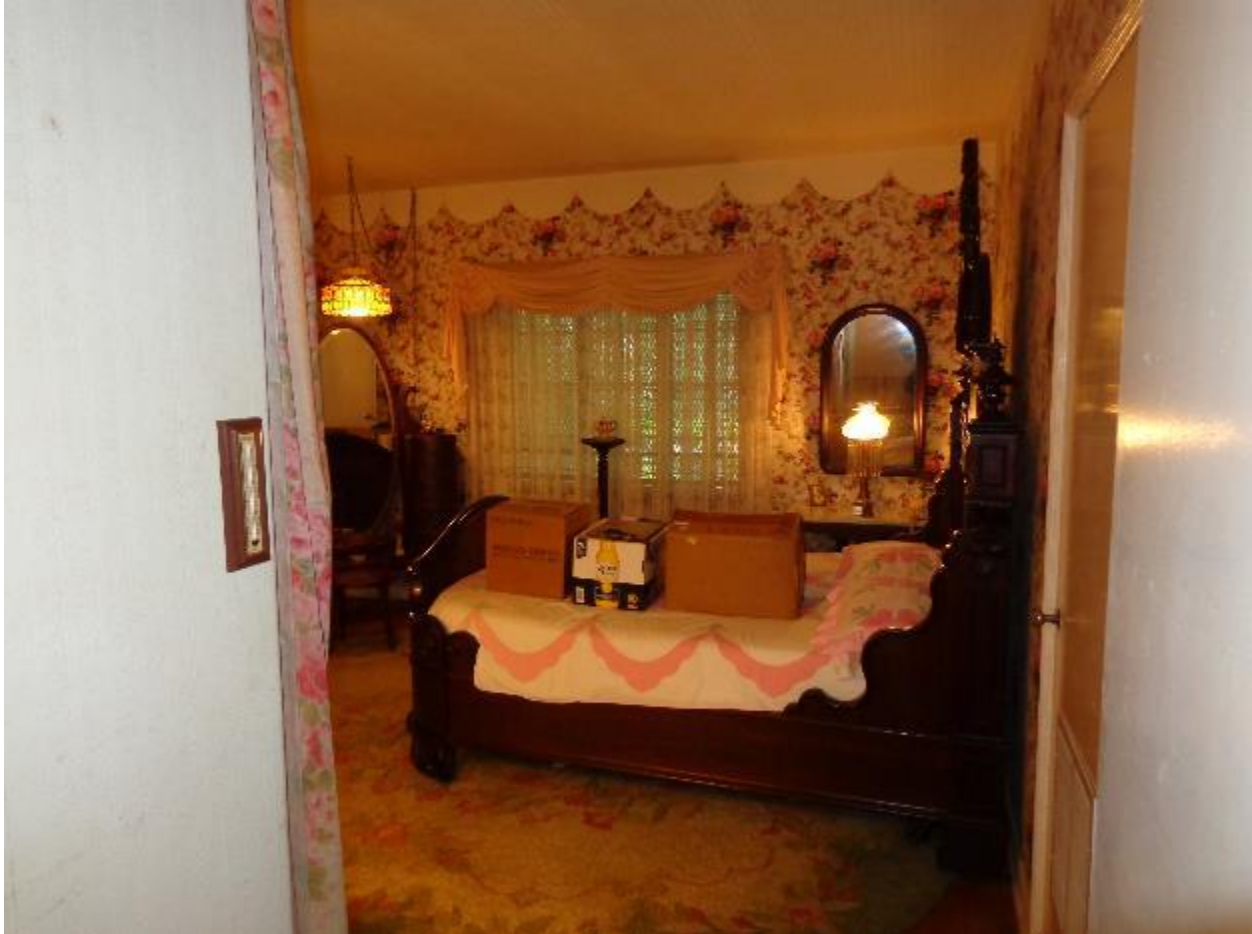
A complete rehabilitation of the interior is recommended. Plumbing, electrical and Ac systems require replacement or repairs.

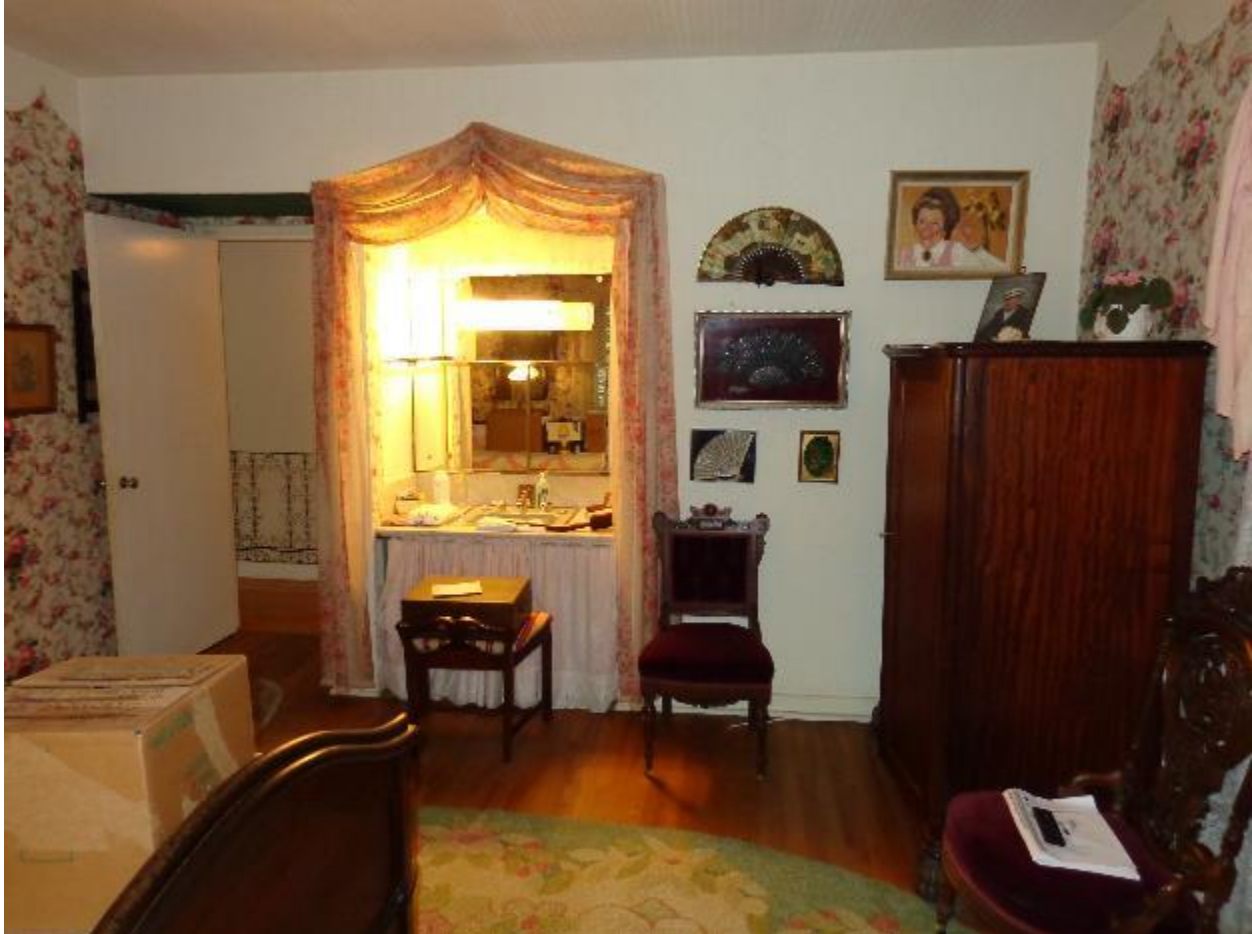
A complete rehabilitation of the interior is recommended. Plumbing, electrical and Ac systems require replacement or repairs.

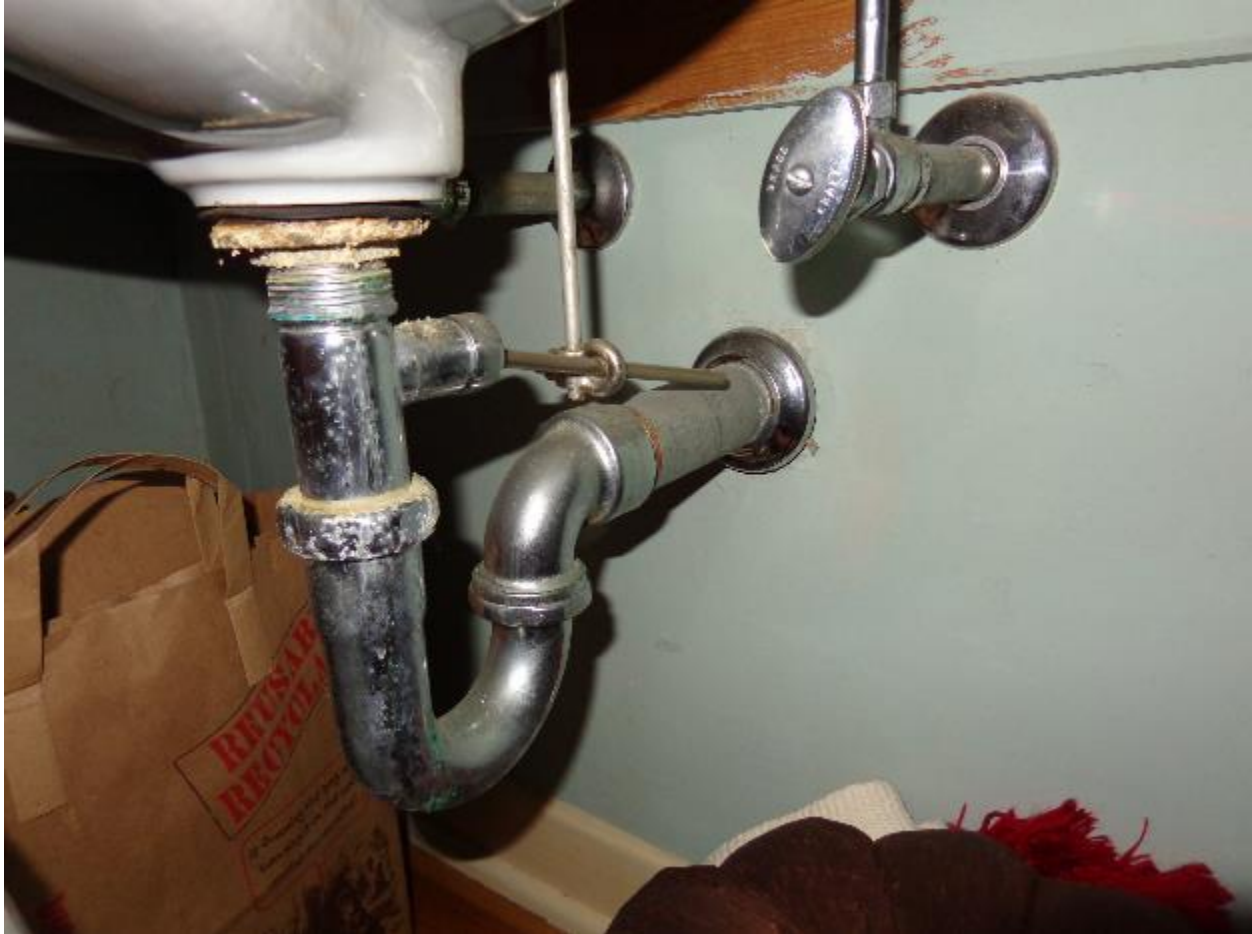
Deteriorated cast iron pipes will require a full upgrade replace with PVC.

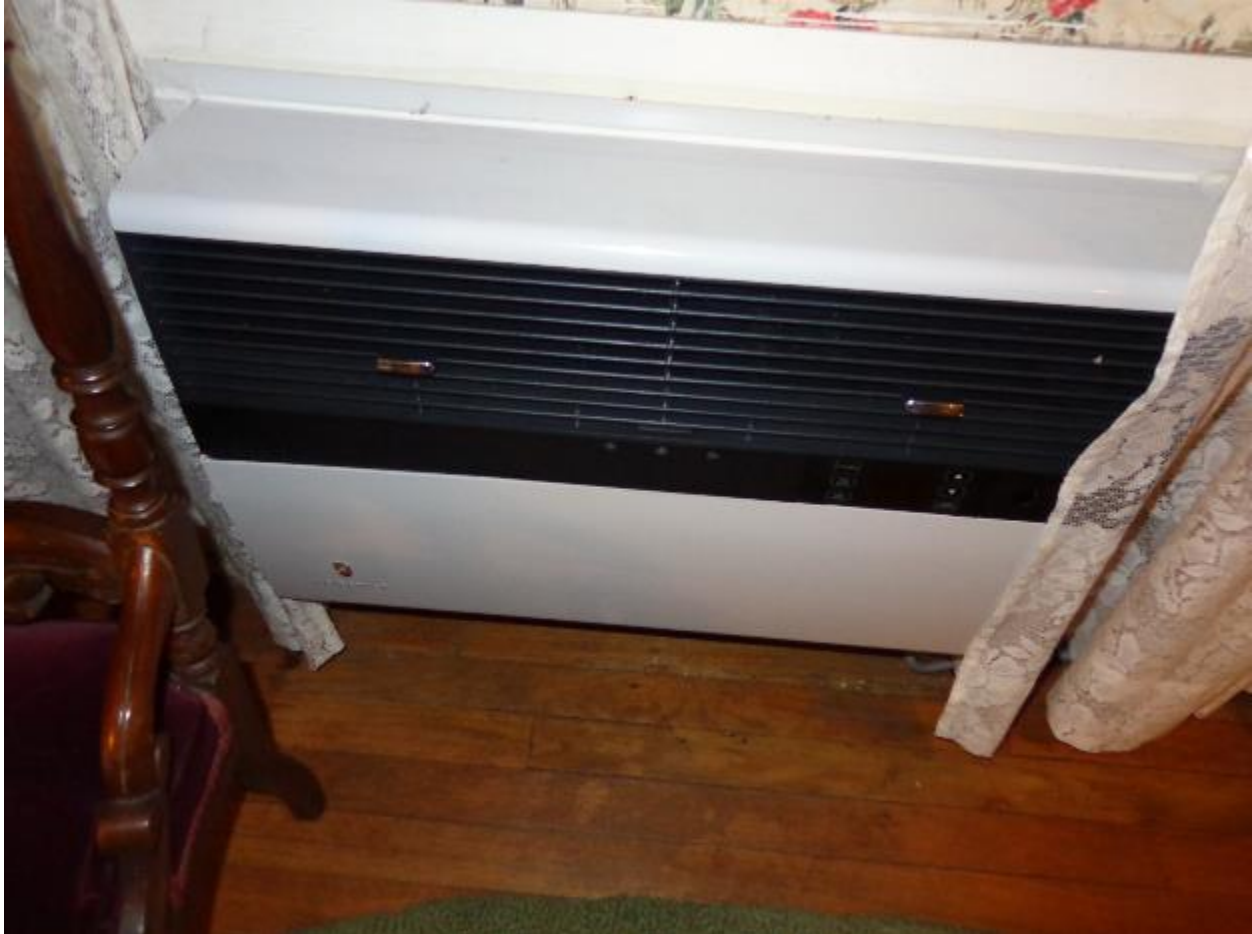
Allowances must be made for the installation of a new central AC system and removal of all window and walls units.
