PROPERTY INSPECTION OR ASSESSMENT OF DAMAGES

ADDRESS: 229 Ridgewood Rd. Coral Gables, Fl.
CLIENT: Phil Padron
ID No: 2016417
DATE: 6/9/2016

PROPERTY INSPECTION –229 Ridgewood Rd Coral Gables, FL
ATTACHMENT - PHOTOGRAPHS
DATE: 06-09-2016

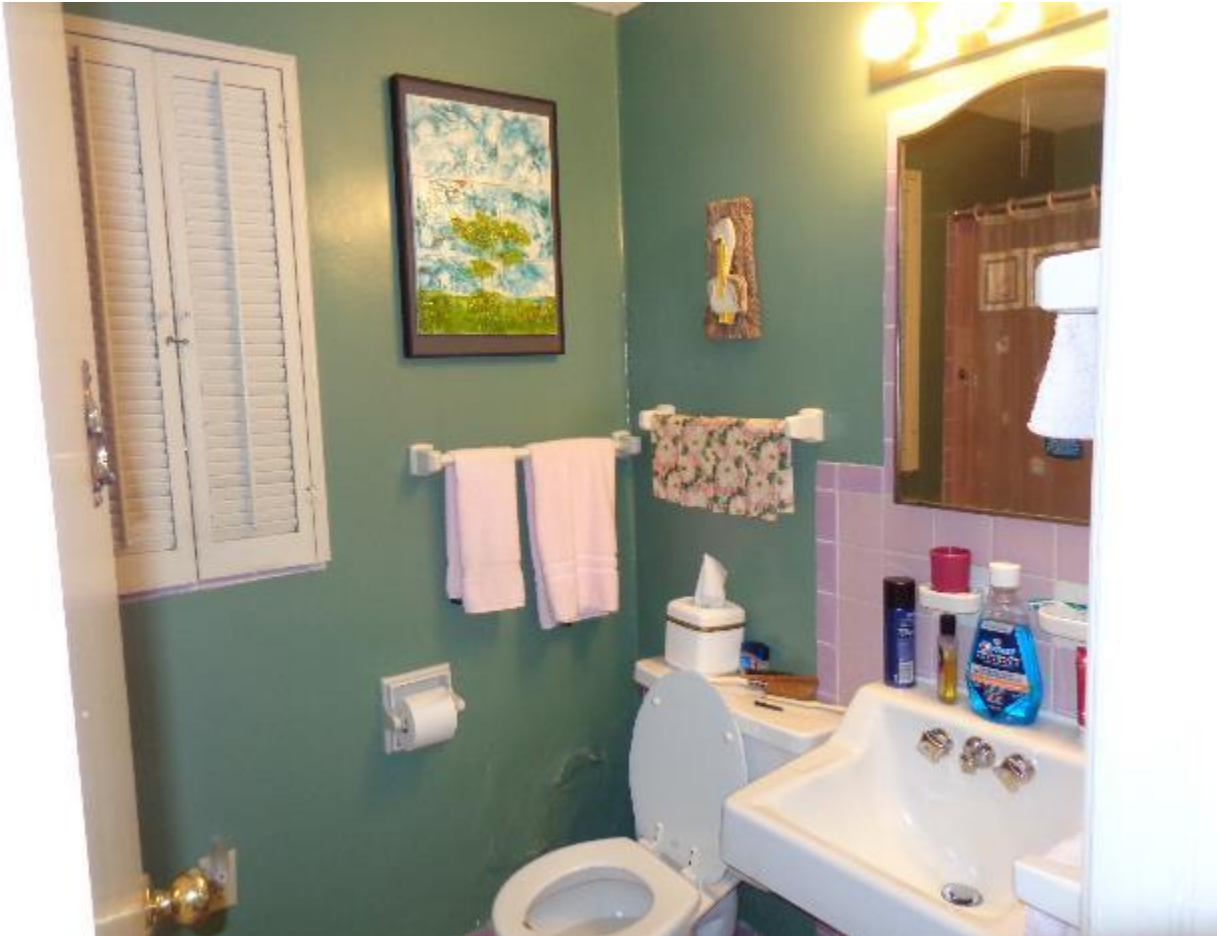
Allowances must be made for the complete upgrade of finishes in bathroom(s).

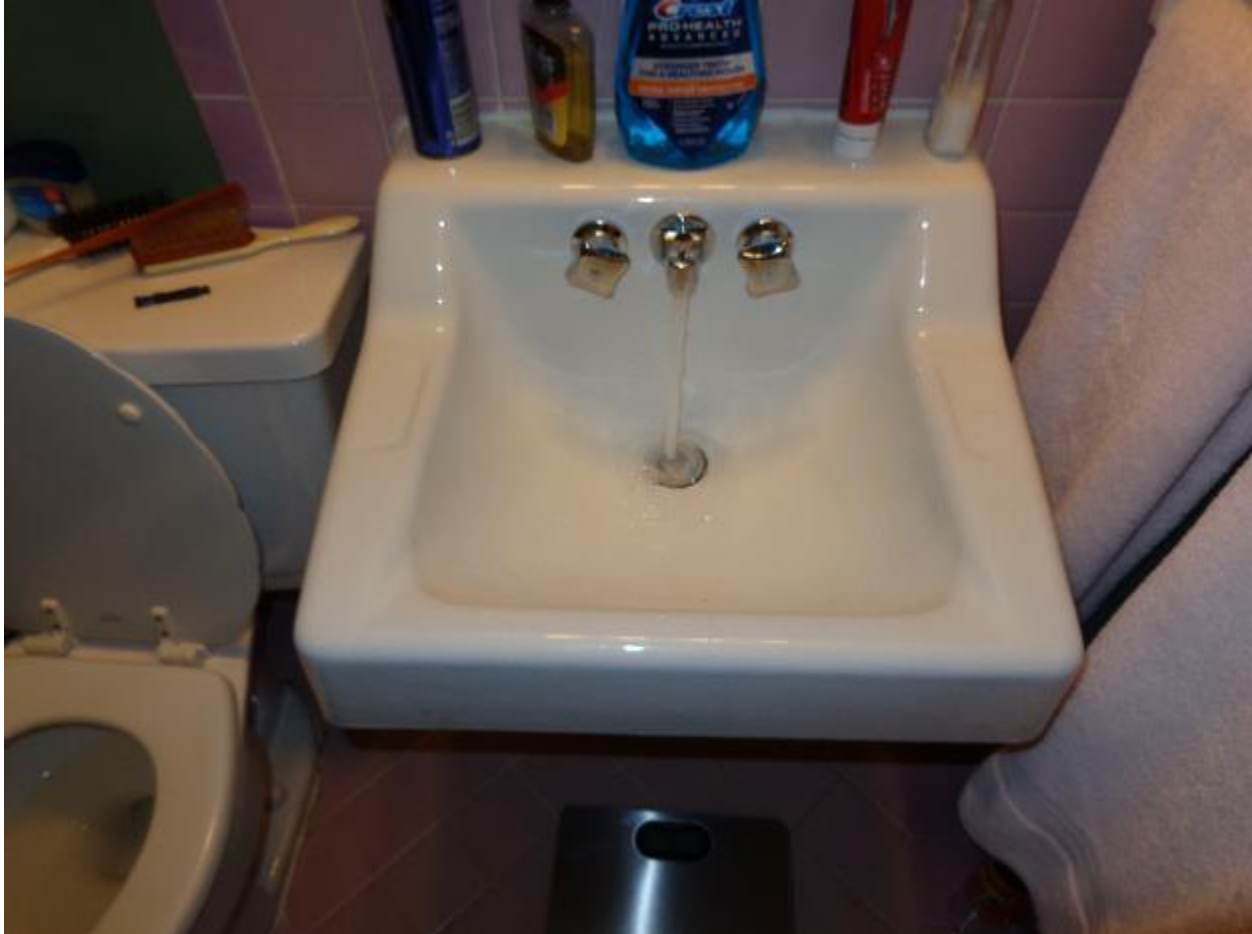
Deteriorated cast iron pipes will require a full upgrade replace with PVC.

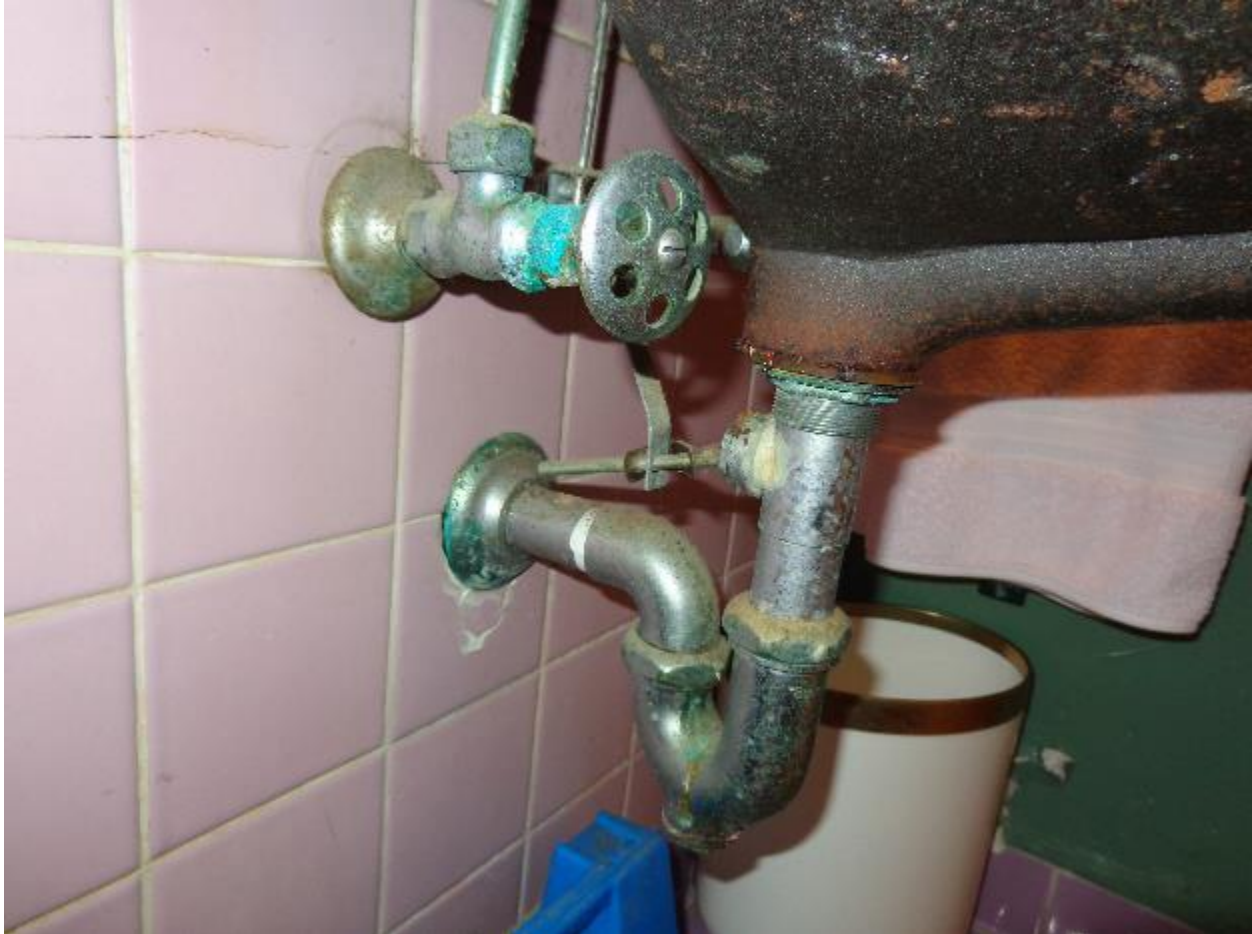
Deteriorated cast iron pipes will require a full upgrade replace with PVC.

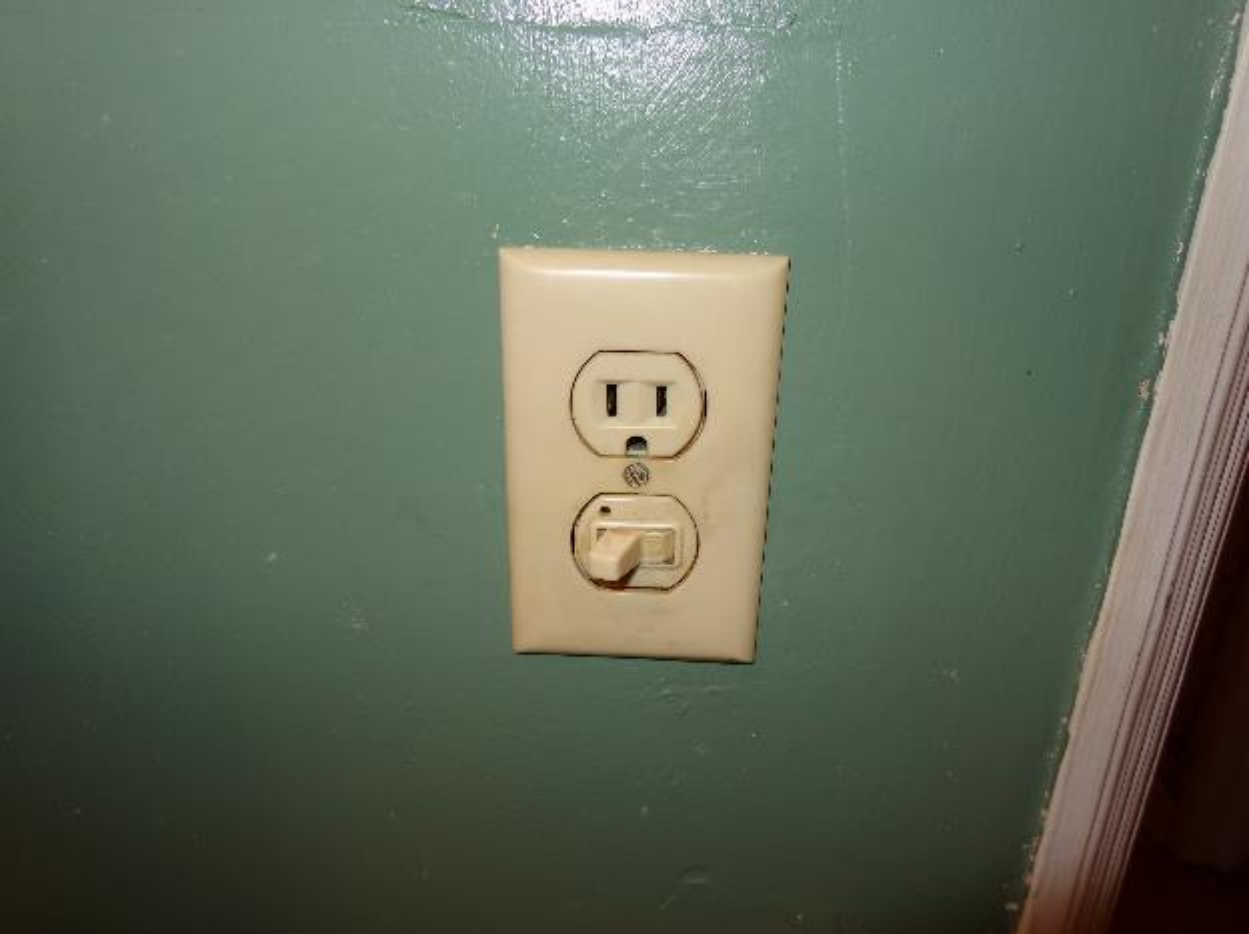
GFCI receptacles installation is required at wet areas such as bathrooms and kitchens.

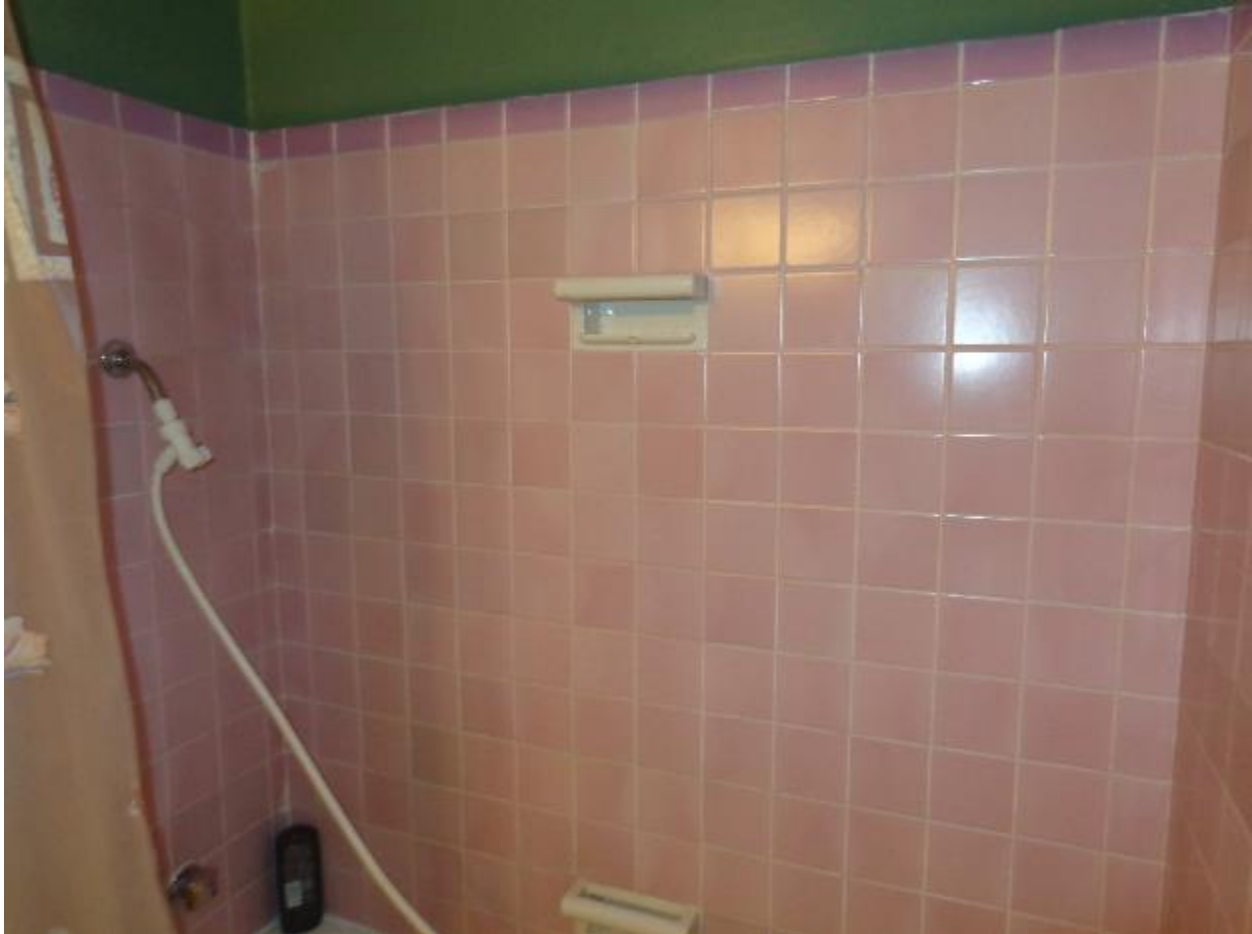
Allowances must be made for the complete upgrade of finishes in bathroom(s).

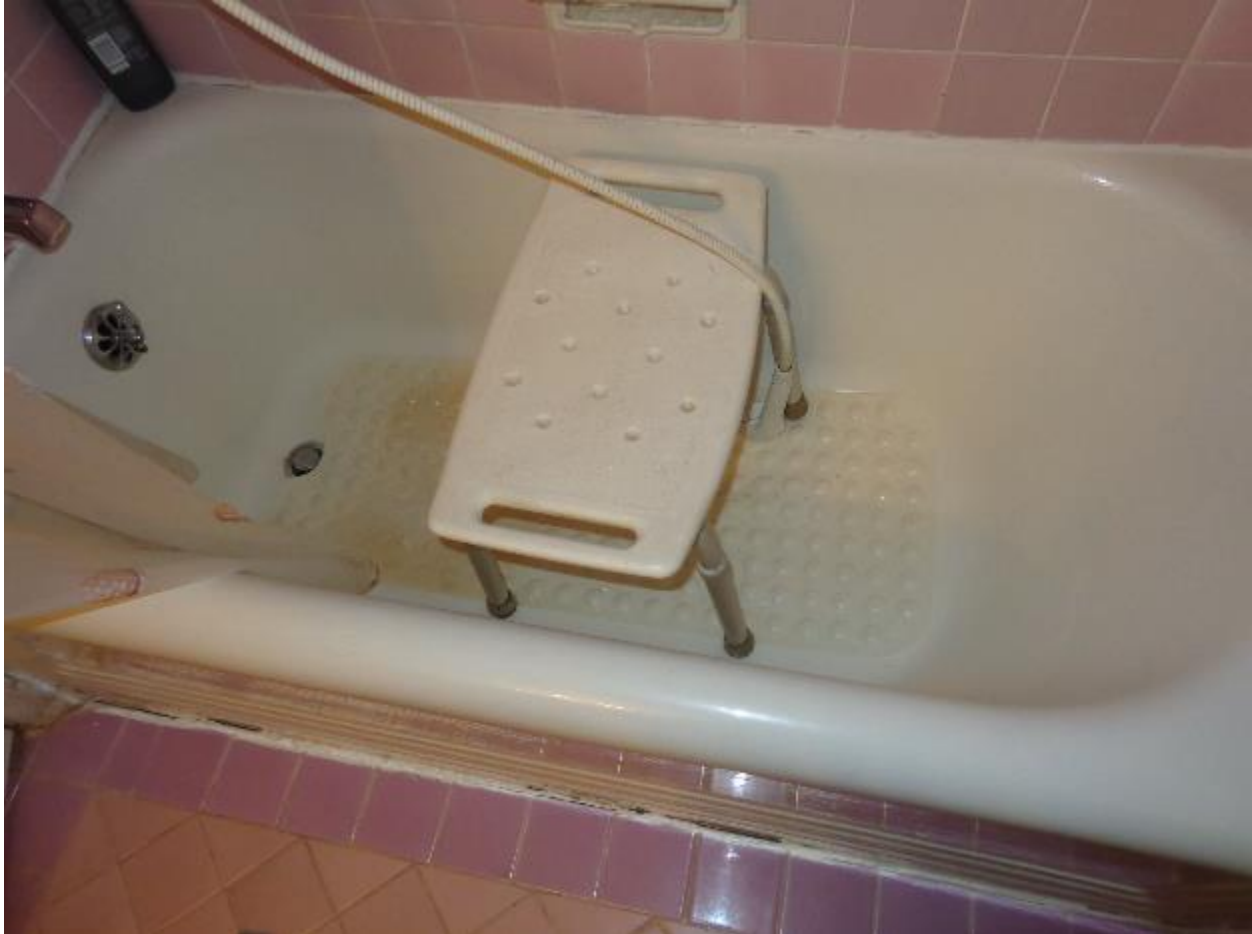
Allowances must be made for the complete upgrade of finishes in bathroom(s).

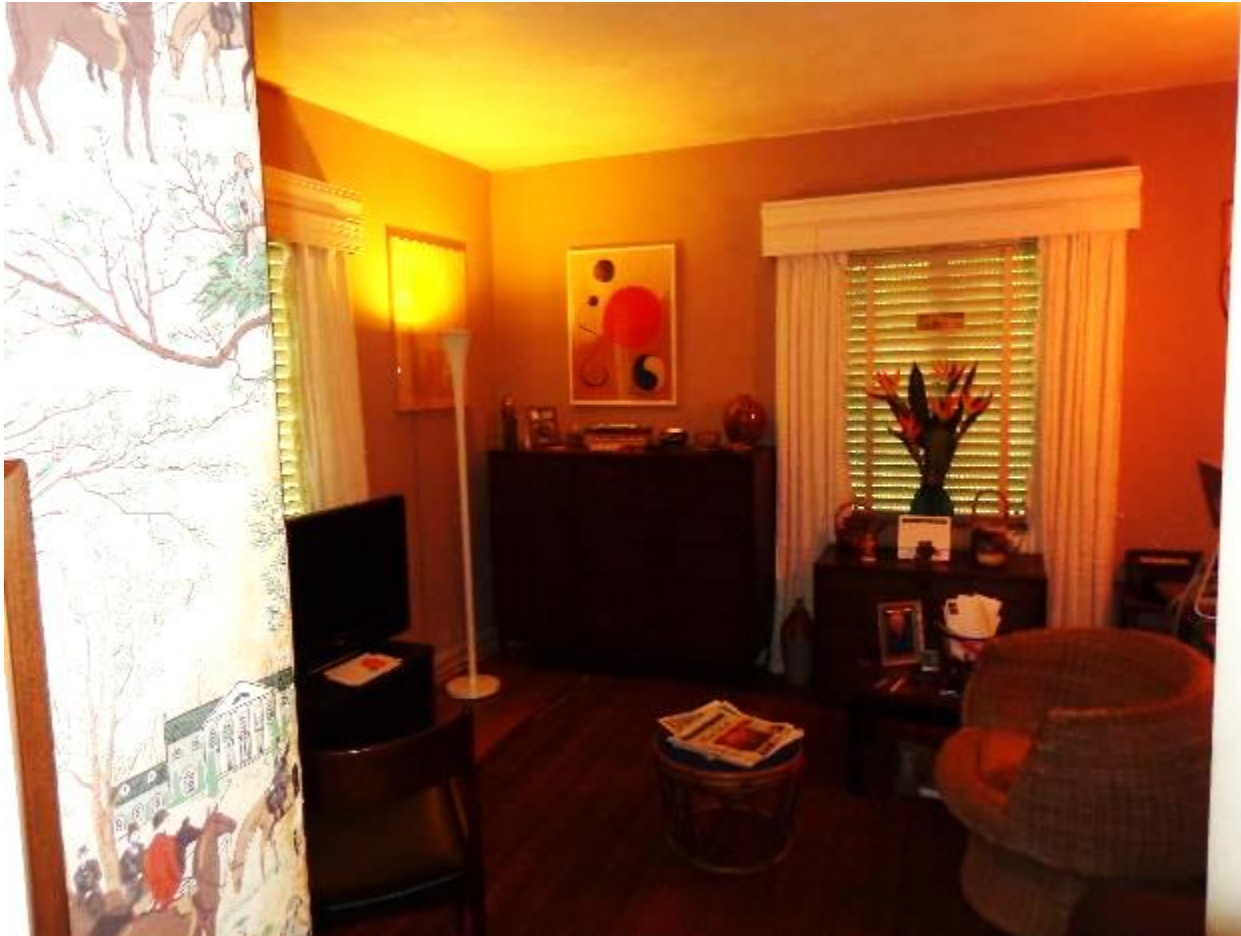
A complete rehabilitation of the interior is recommended. Plumbing, electrical and Ac systems require replacement or repairs.

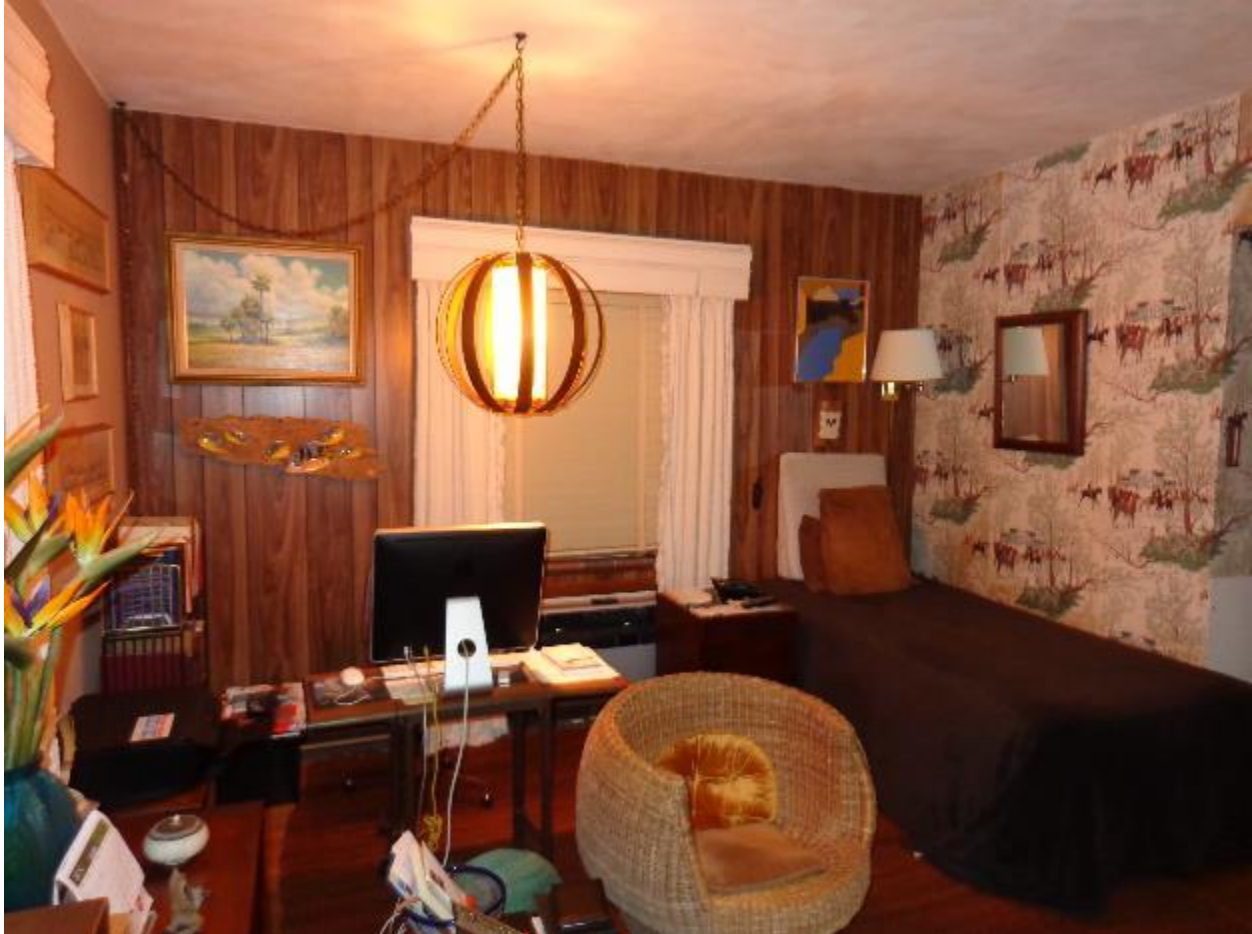
A complete rehabilitation of the interior is recommended. Plumbing, electrical and Ac systems require replacement or repairs.

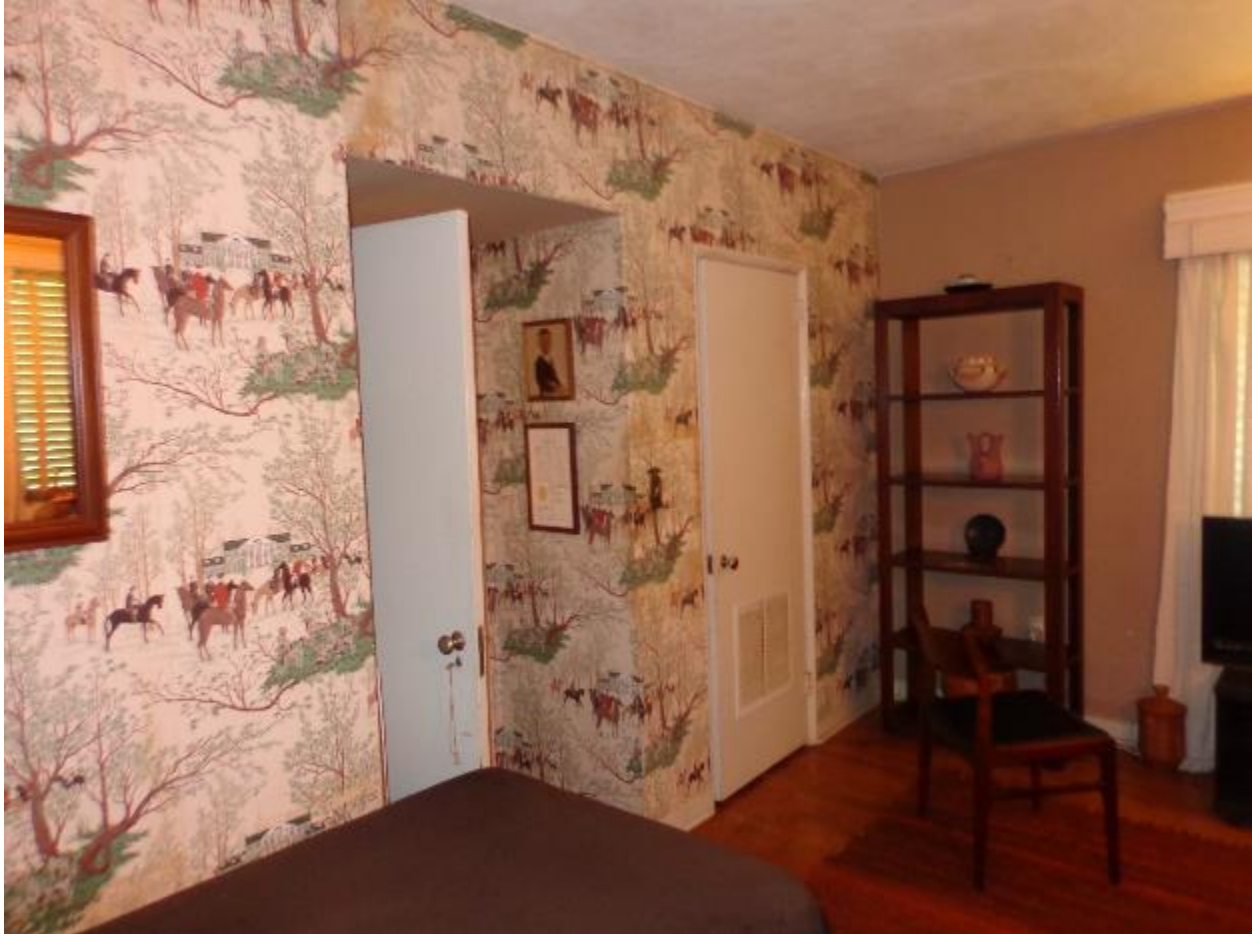
A complete rehabilitation of the interior is recommended. Plumbing, electrical and Ac systems require replacement or repairs.

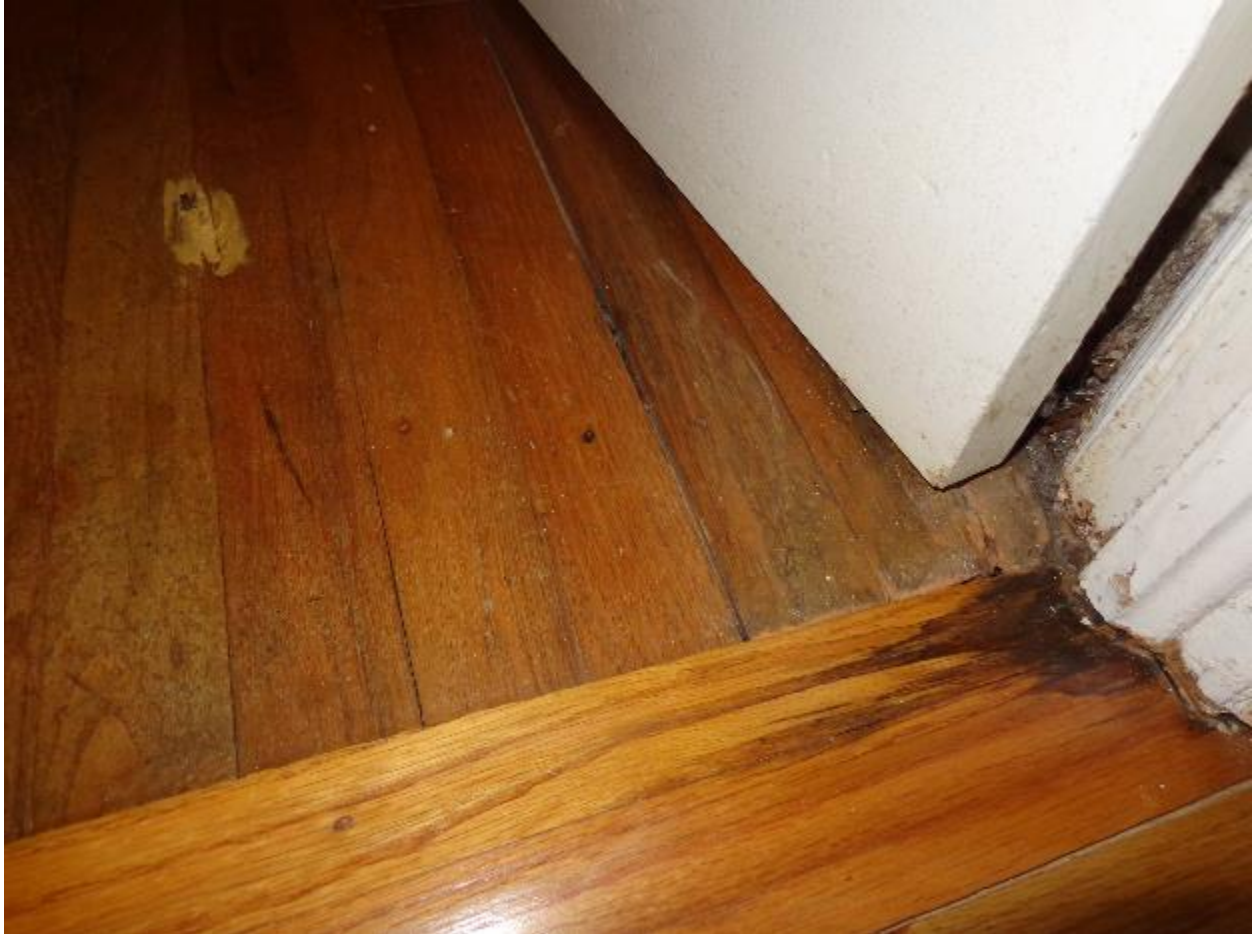
Previous water damage noted.

Water damage at the floor joists and wood deck. Structural repairs related to floor joists are required.

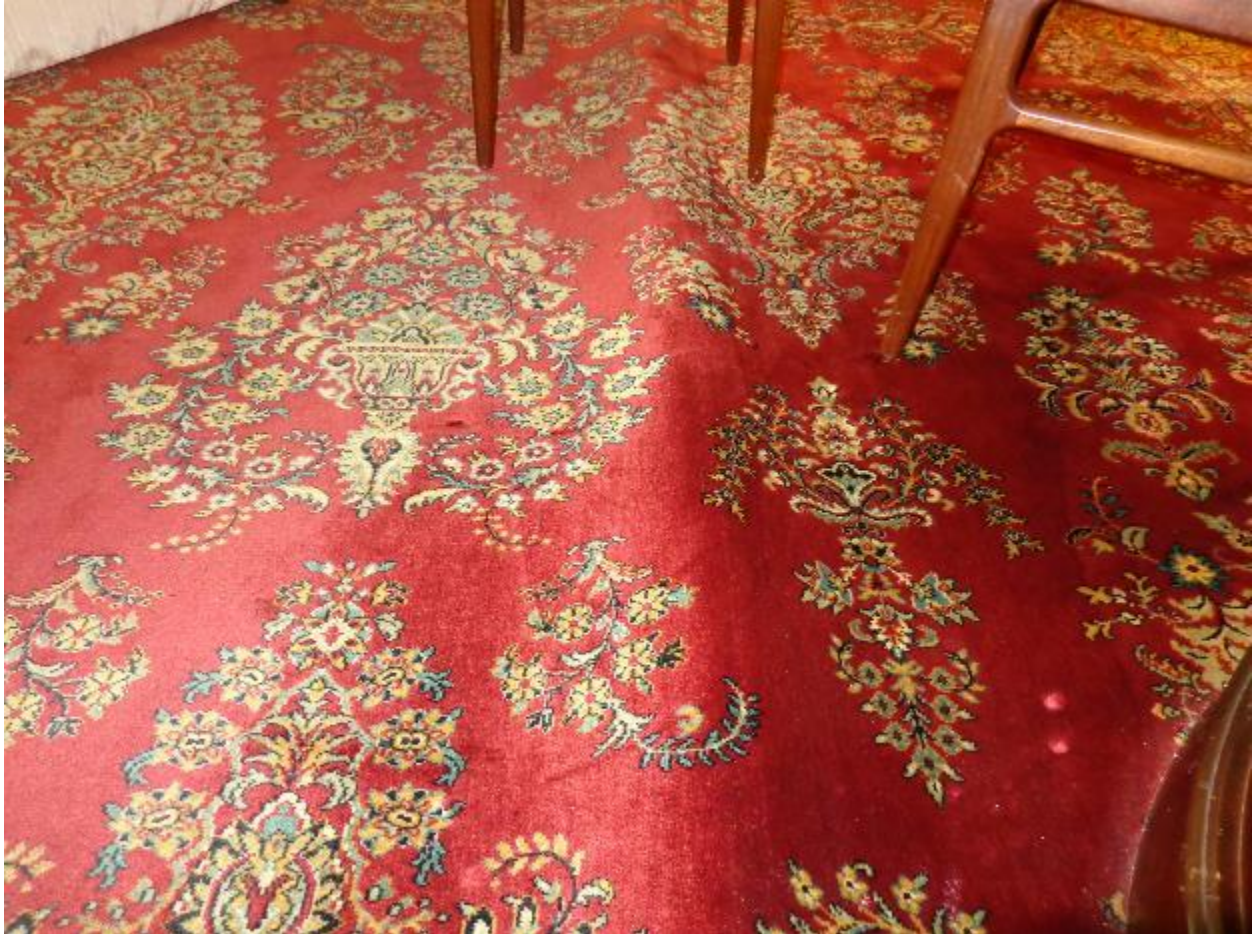
Previous water damage noted.

Water damage at the floor joists and wood deck. Structural repairs related to floor joists are required.

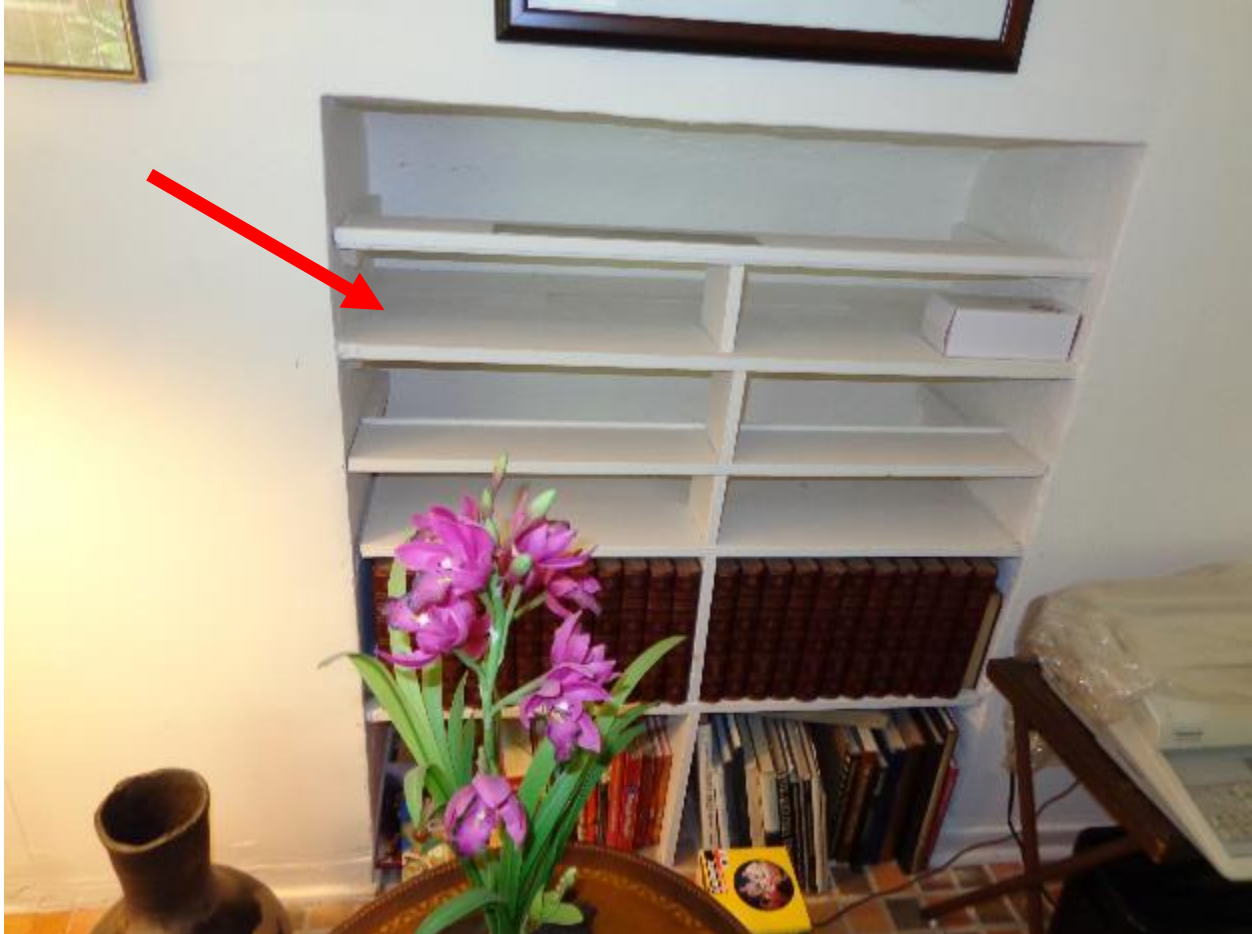
Old Chimney.

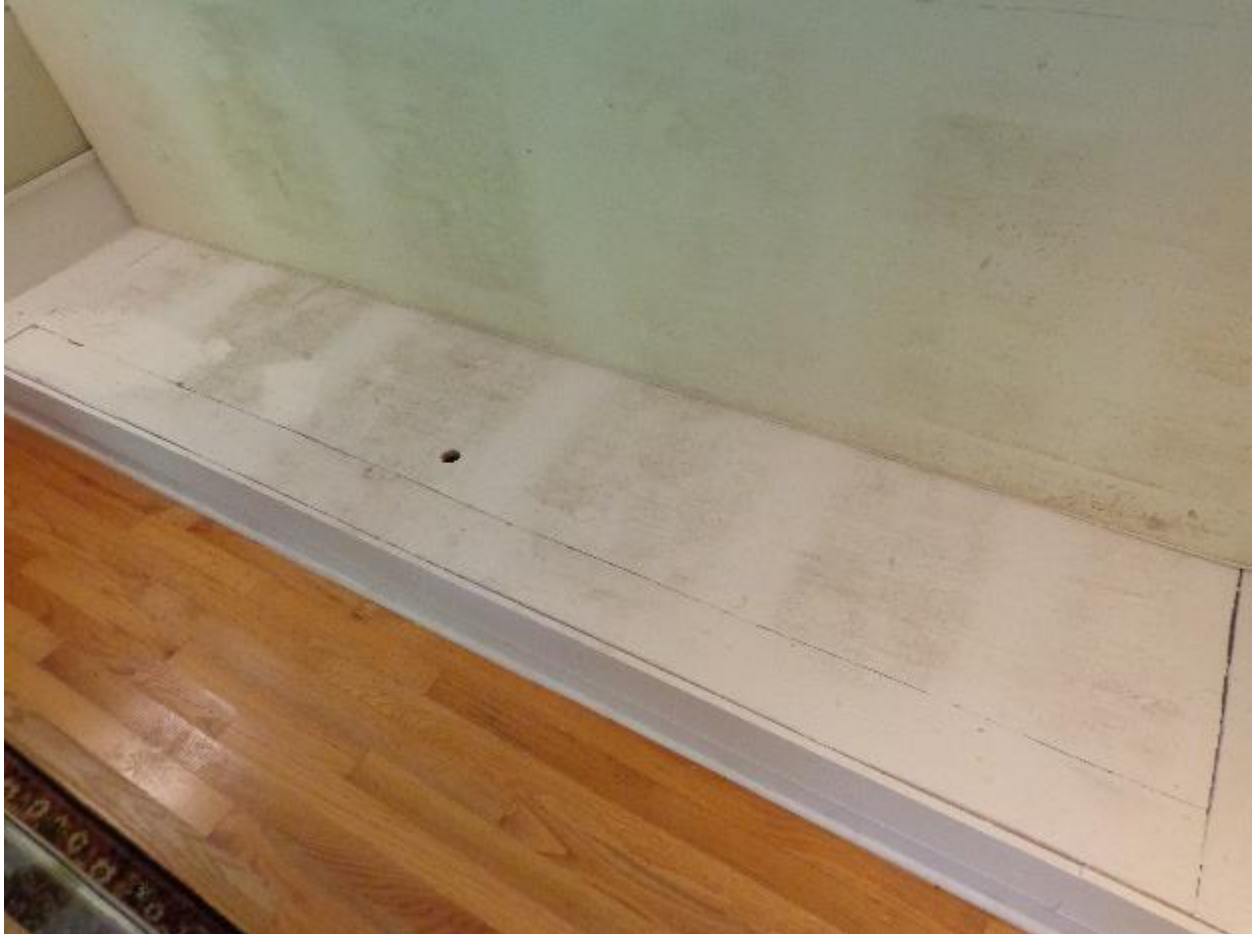
Mold growth caused by water damage is visible. Do not attempt to remove damaged surfaces related to Mold growth or with signs of mold growth on your own. Hire only licensed and Insured Mold remediation services.

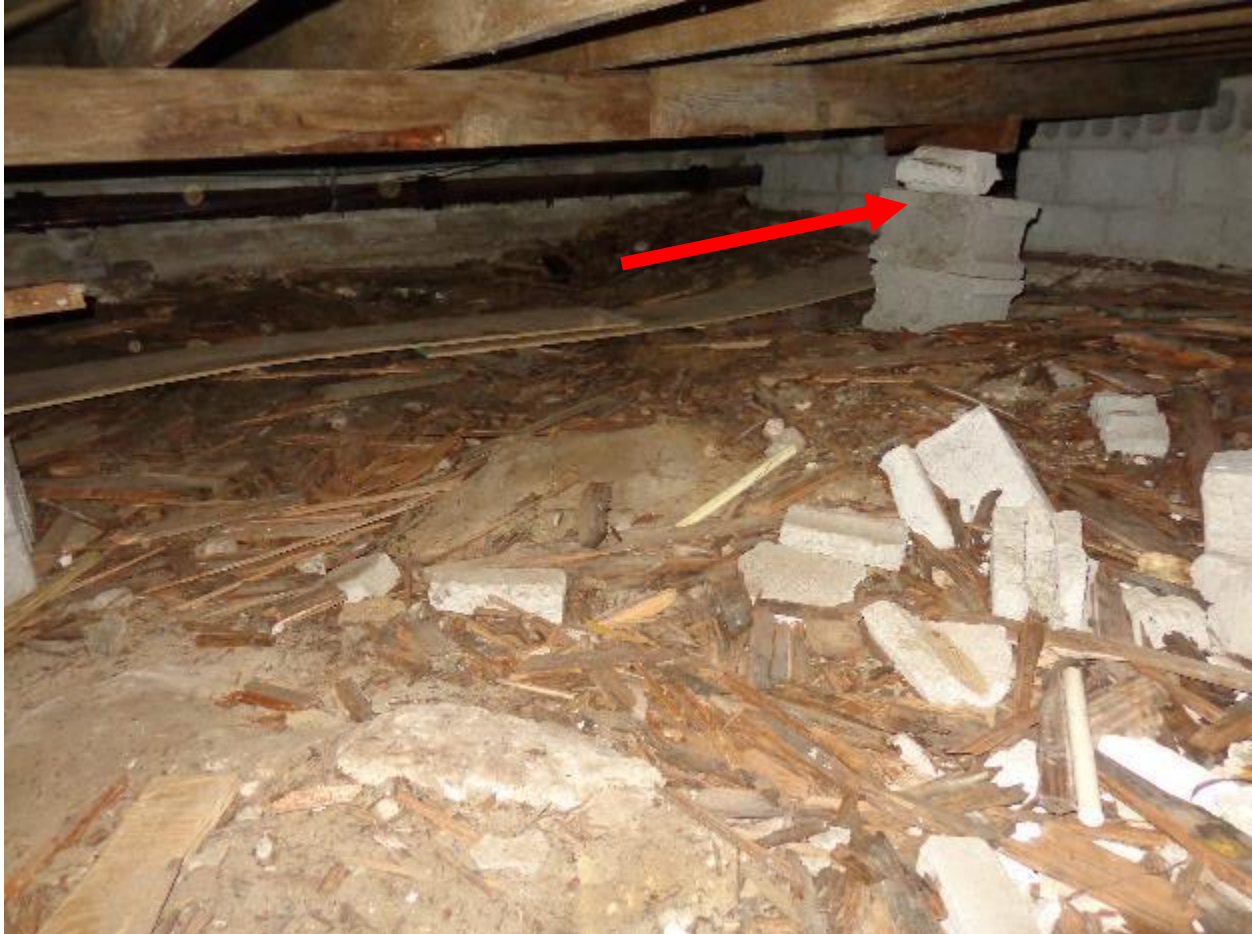
Wood structural joists not properly reinforced. Replacement or proper reinforcement of joists required.

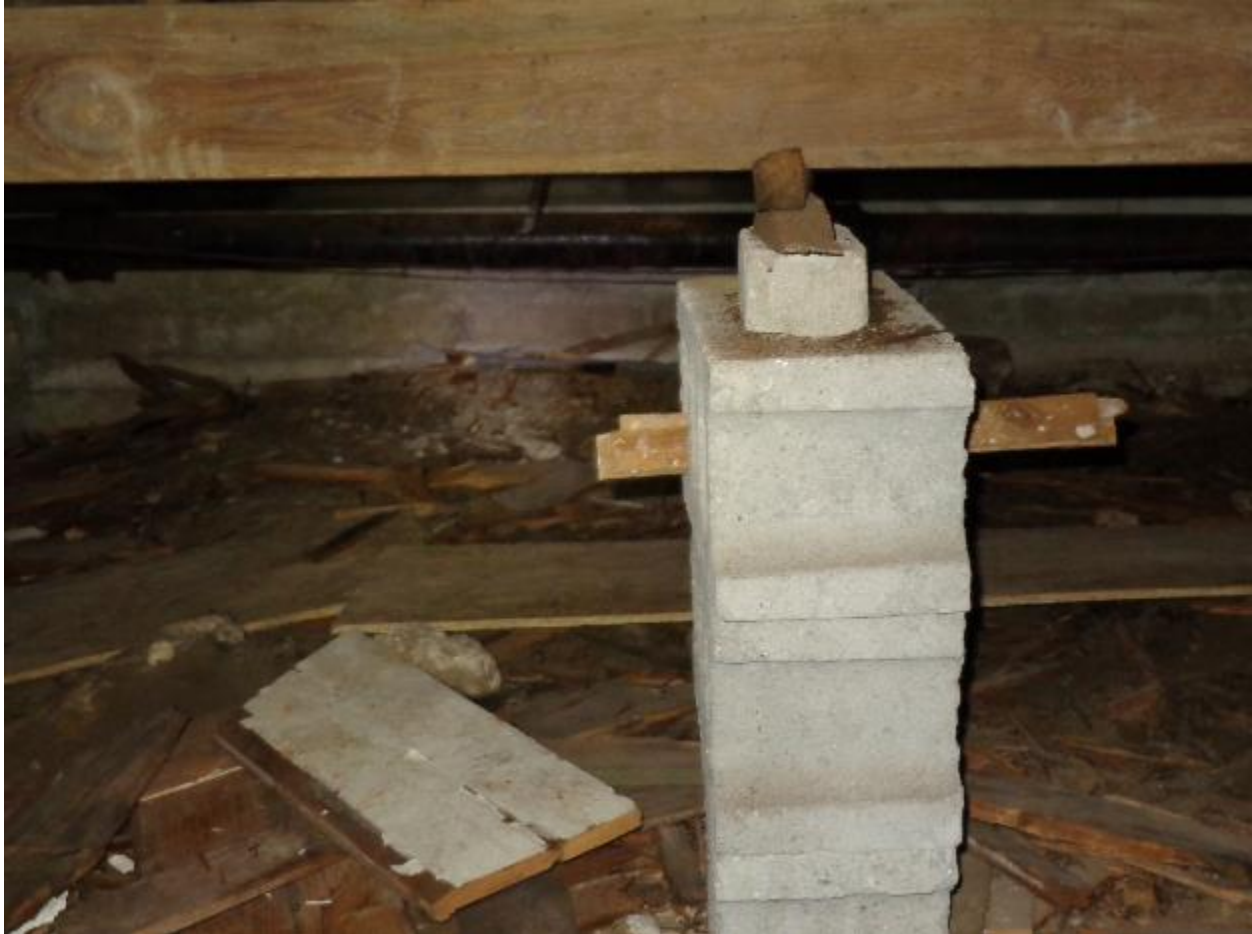
Wood structural joists not properly reinforced. Replacement or proper reinforcement of joists required.

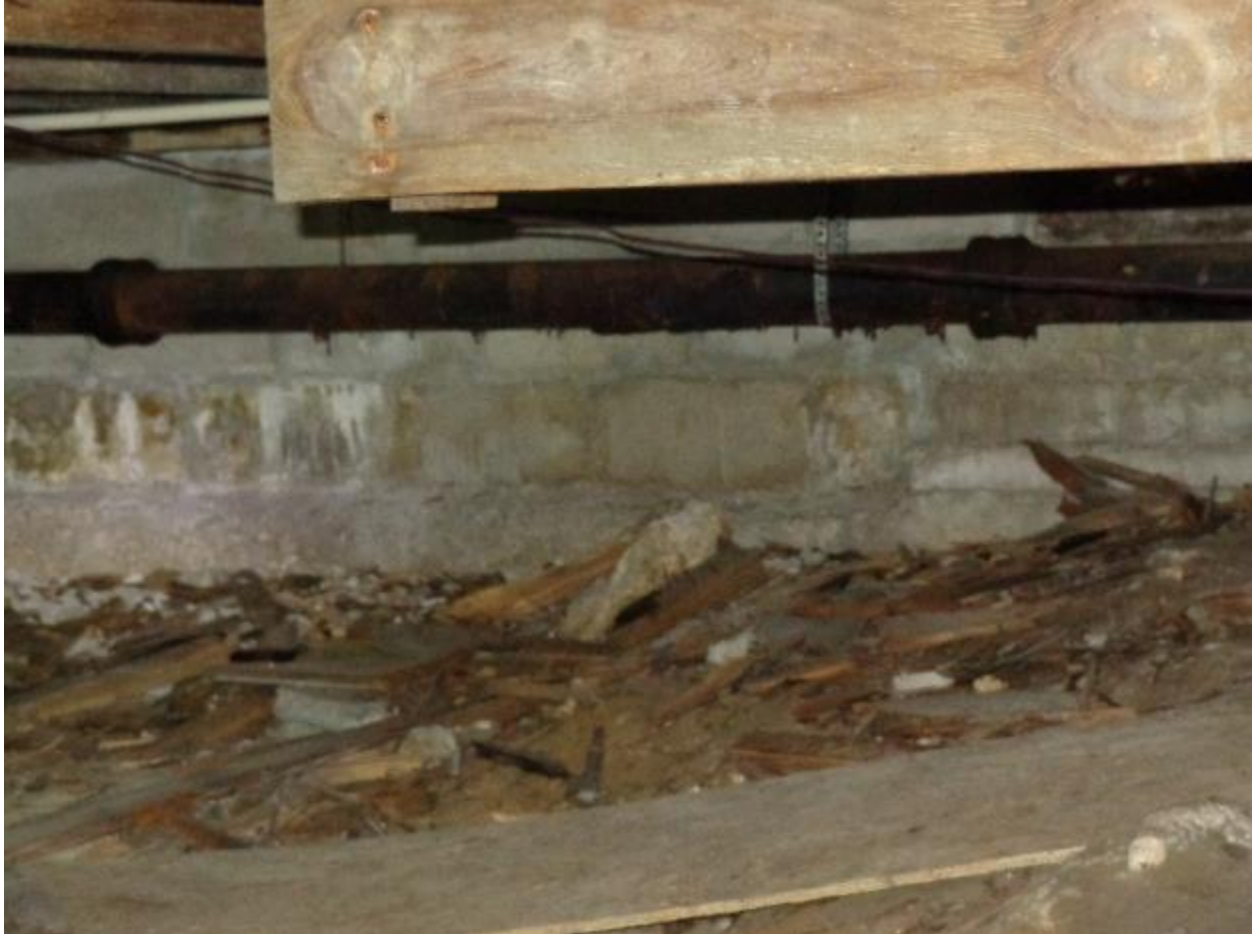
Deteriorated cast iron pipes will require a full upgrade replace with PVC.

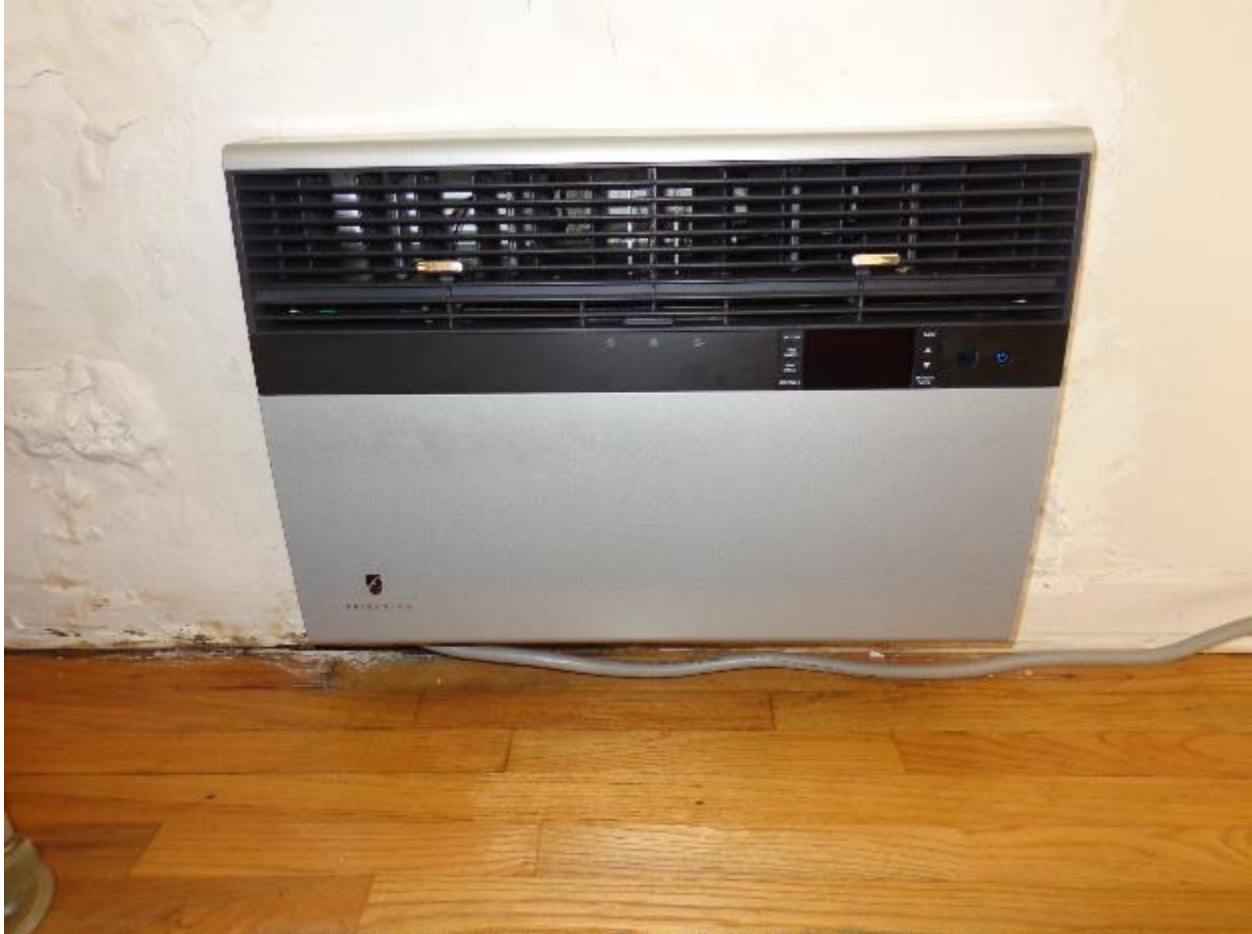
Allowances must be made for the installation of a new central AC system and removal of all window and walls units.

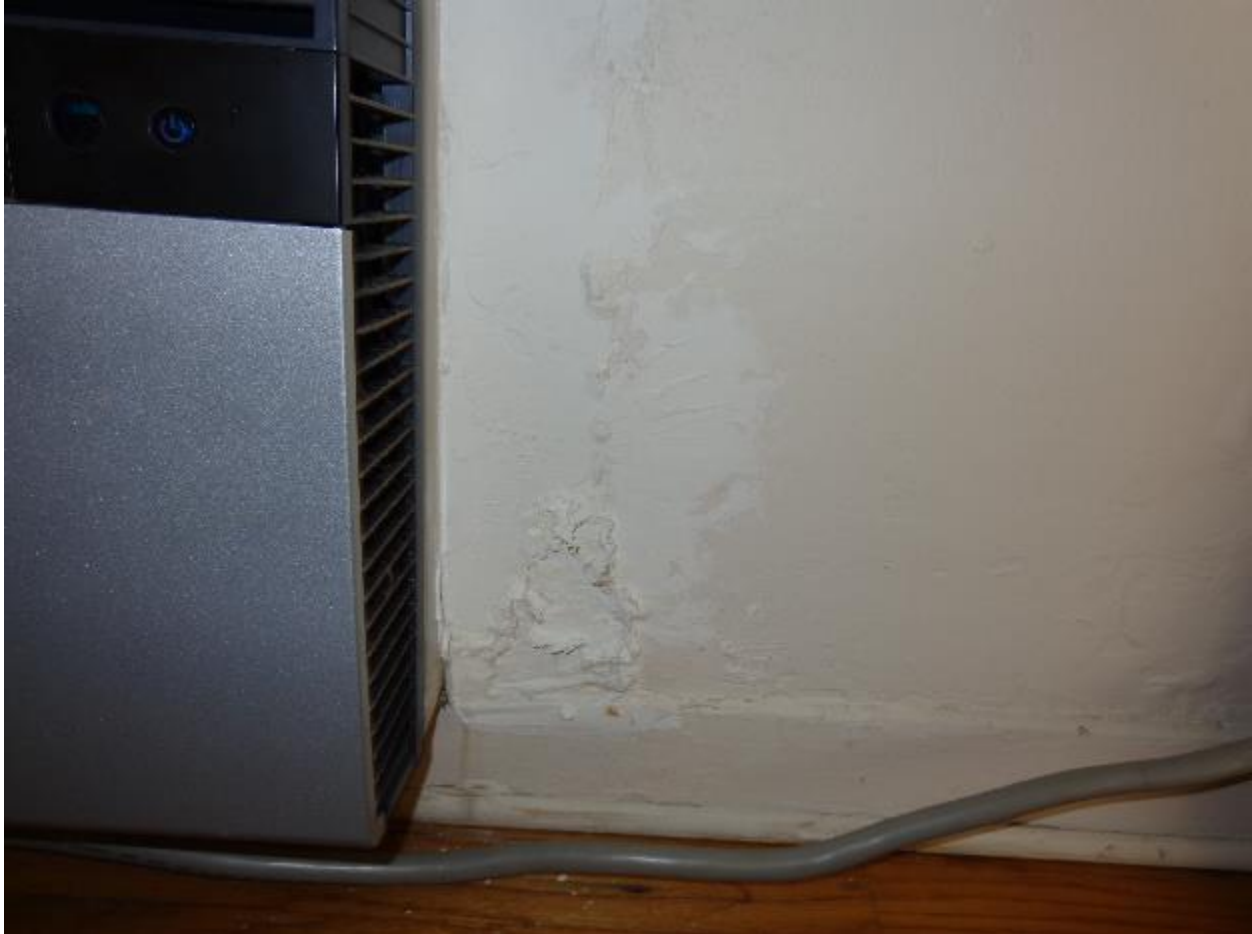
Mold growth caused by water damage is visible. Do not attempt to remove damaged surfaces related to Mold growth or with signs of mold growth on your own. Hire only licensed and Insured Mold remediation services.

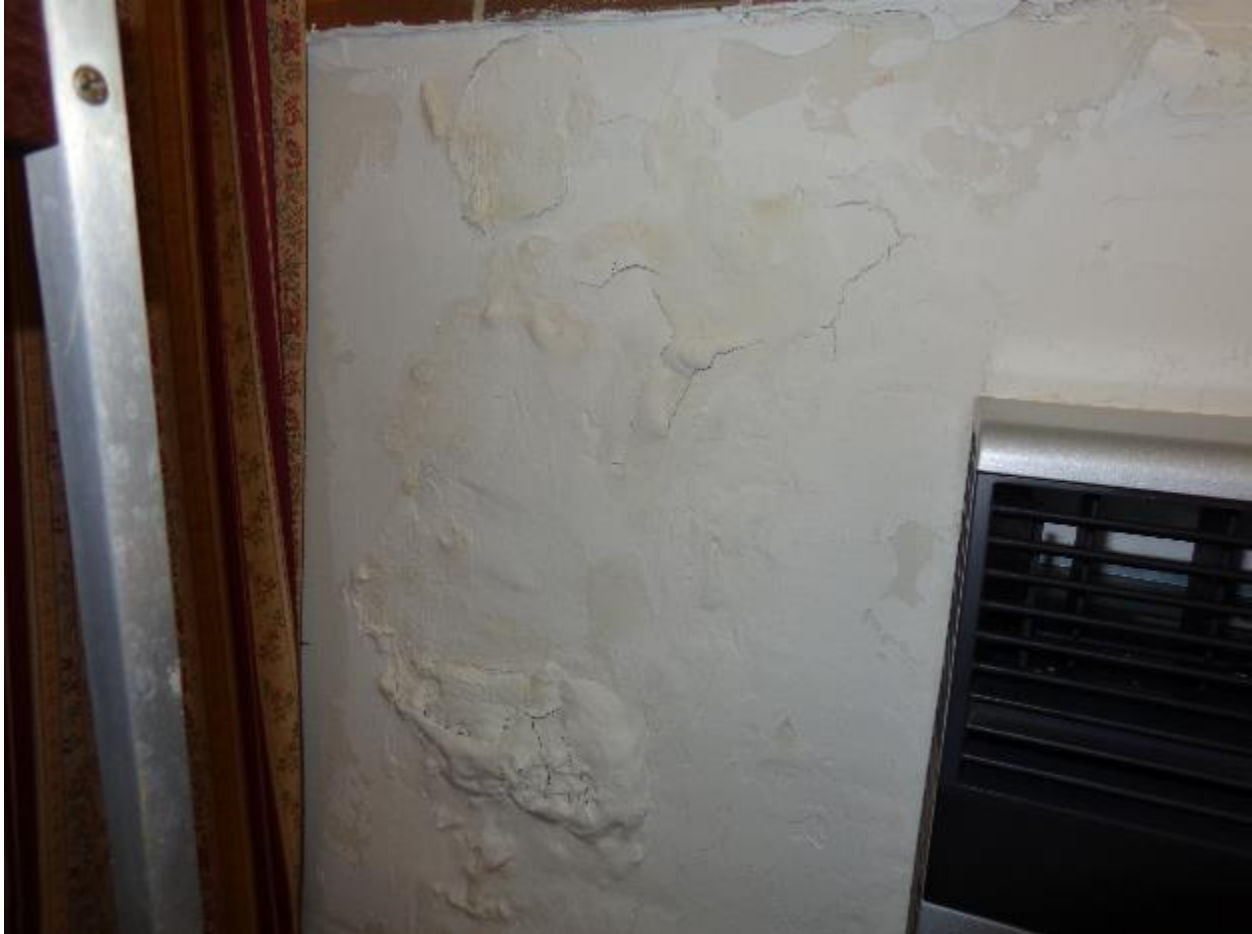
Mold growth caused by water damage is visible. Do not attempt to remove damaged surfaces related to Mold growth or with signs of mold growth on your own. Hire only licensed and Insured Mold remediation services.
