PROPERTY INSPECTION OR ASSESSMENT OF DAMAGES

ADDRESS: 229 Ridgewood Rd. Coral Gables, Fl.
CLIENT: Phil Padron
ID No: 2016417
DATE: 6/9/2016

PROPERTY INSPECTION –229 Ridgewood Rd Coral Gables, FL
ATTACHMENT - PHOTOGRAPHS
DATE: 06-09-2016

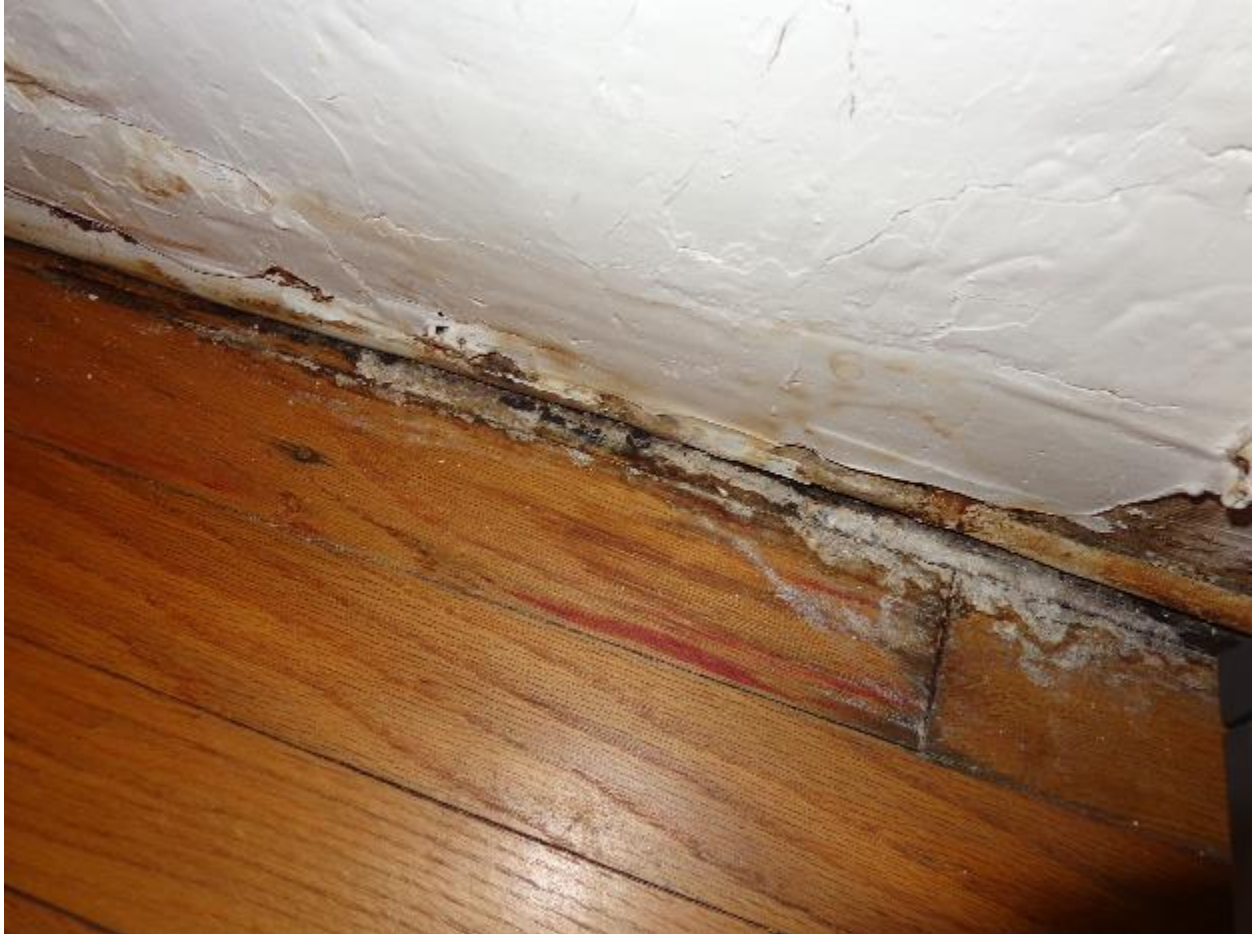
Mold growth caused by water damage is visible. Do not attempt to remove damaged surfaces related to Mold growth or with signs of mold growth on your own. Hire only licensed and Insured Mold remediation services.

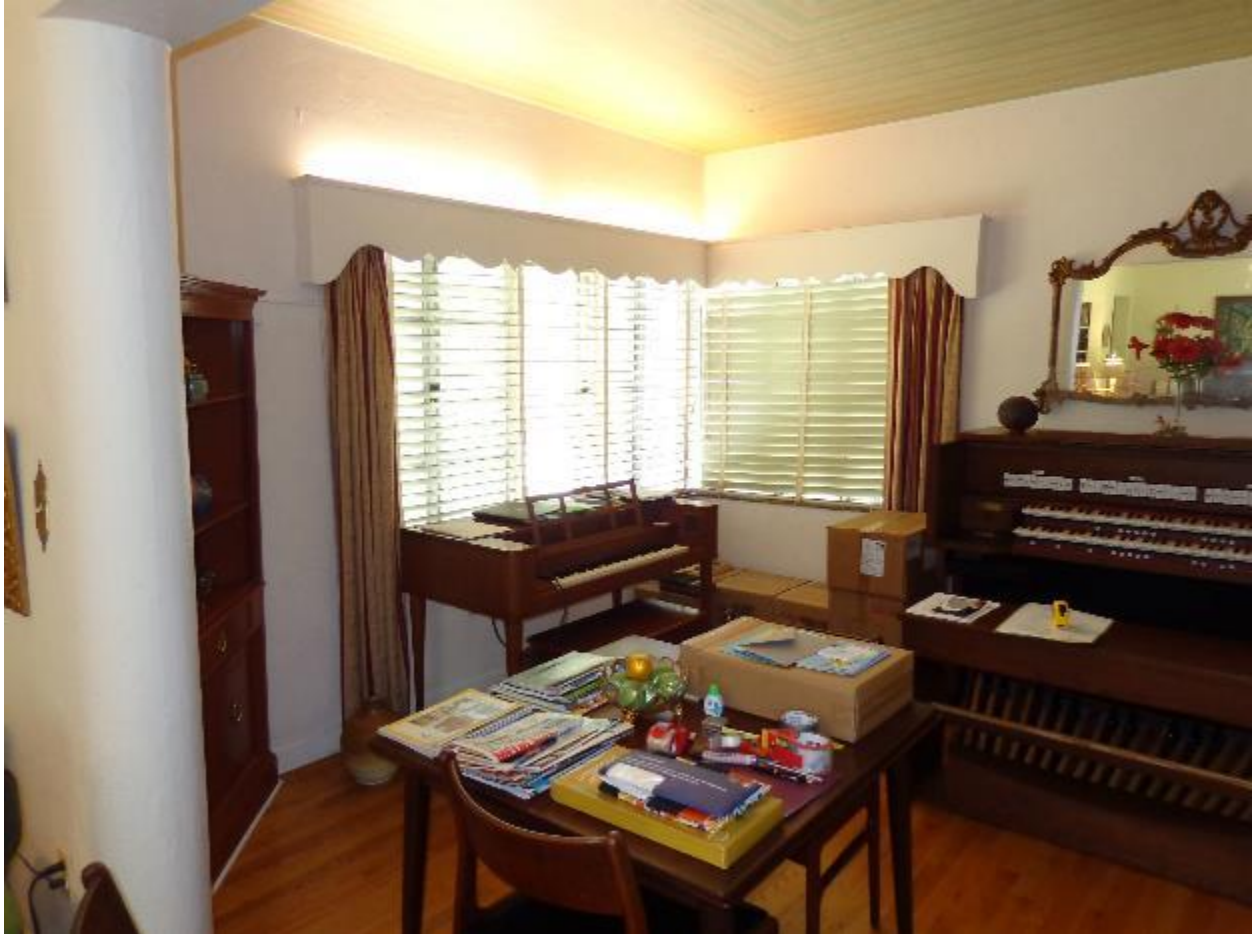
A complete rehabilitation of the interior is recommended. Plumbing, electrical and Ac systems require replacement or repairs.

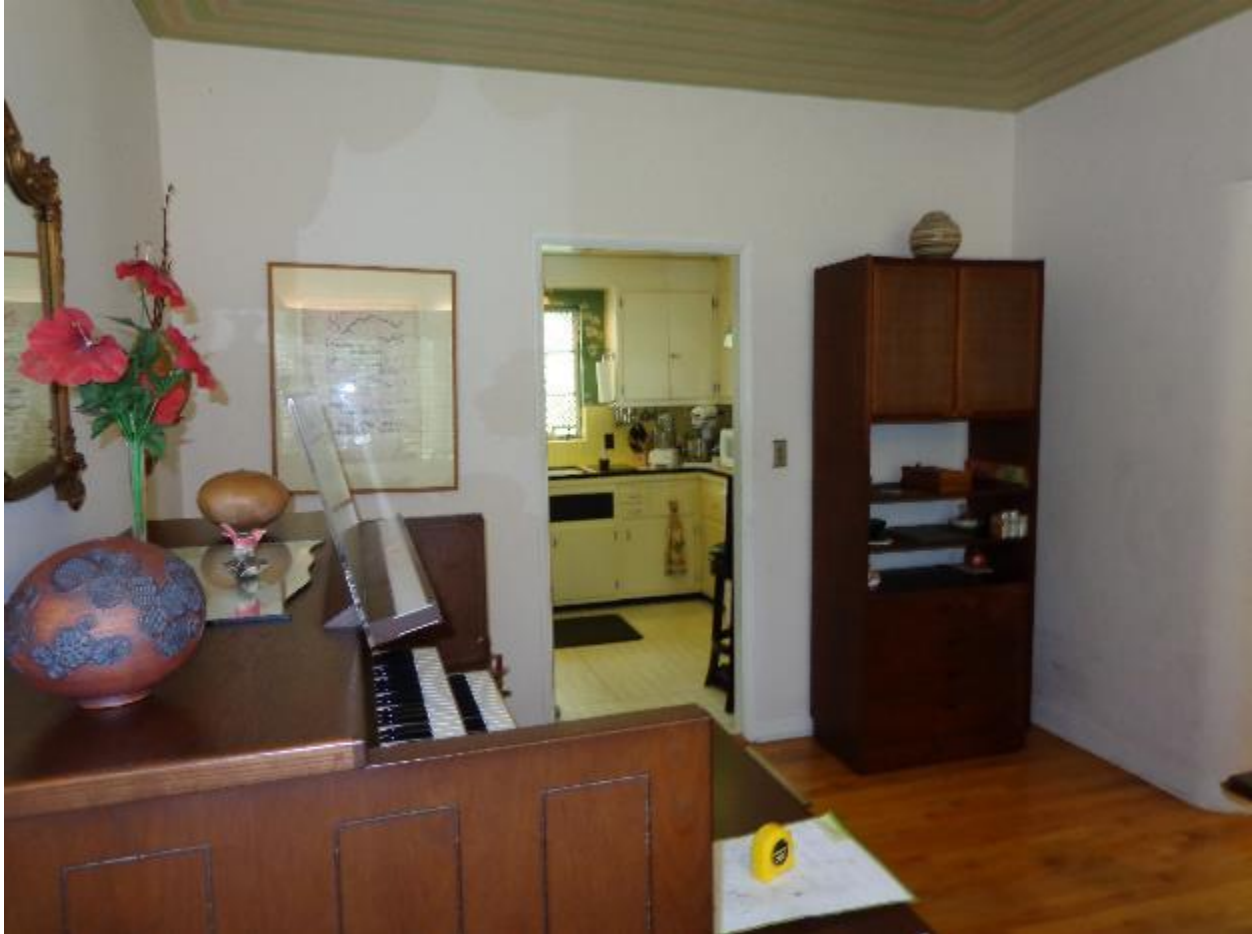
A complete rehabilitation of the interior is recommended. Plumbing, electrical and Ac systems require replacement or repairs.

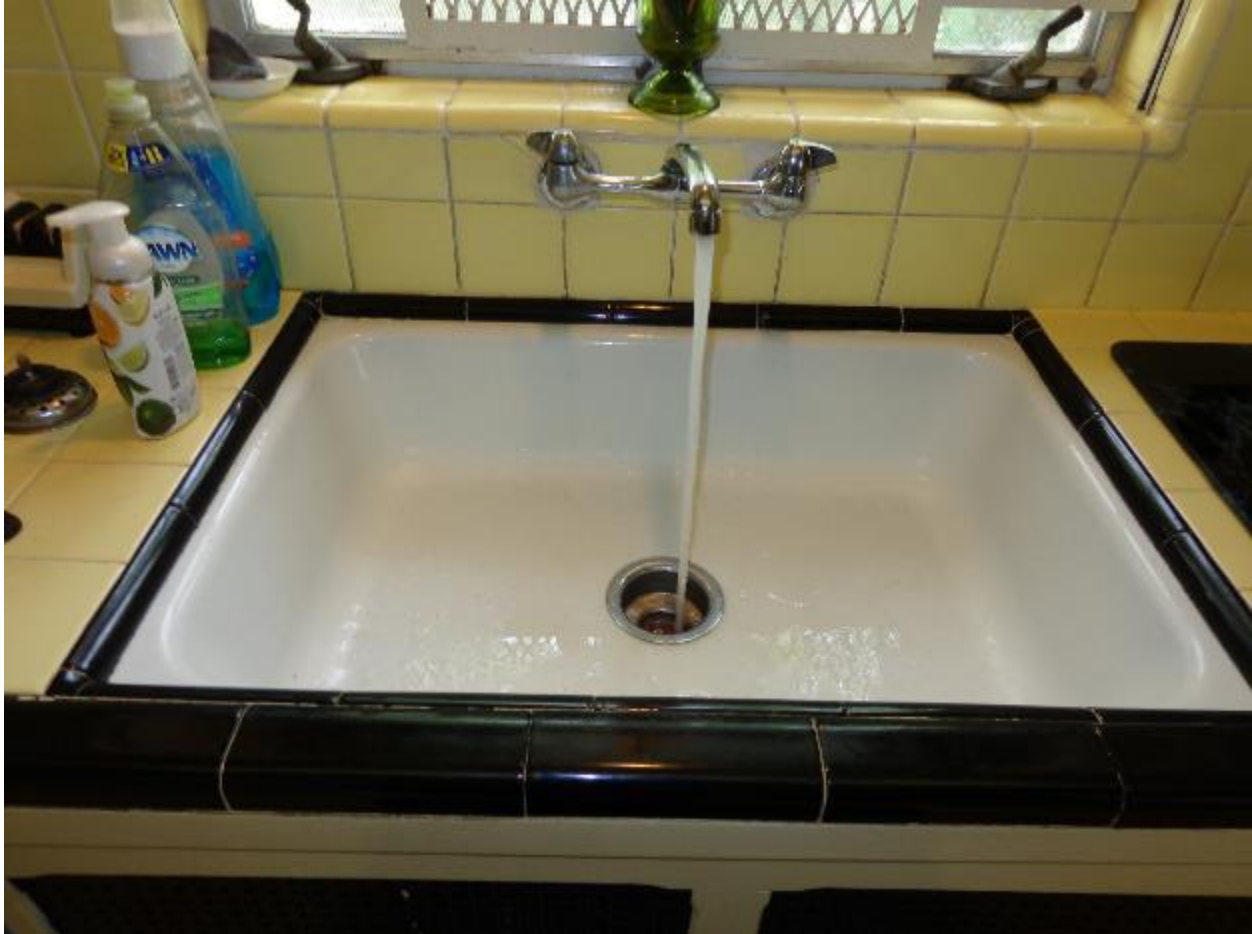
Deteriorated cast iron pipes will require a full upgrade replace with PVC.

Allowances must be made for the complete upgrade of finishes in kitchen area including cabinetry, countertops, backsplash and new appliances.

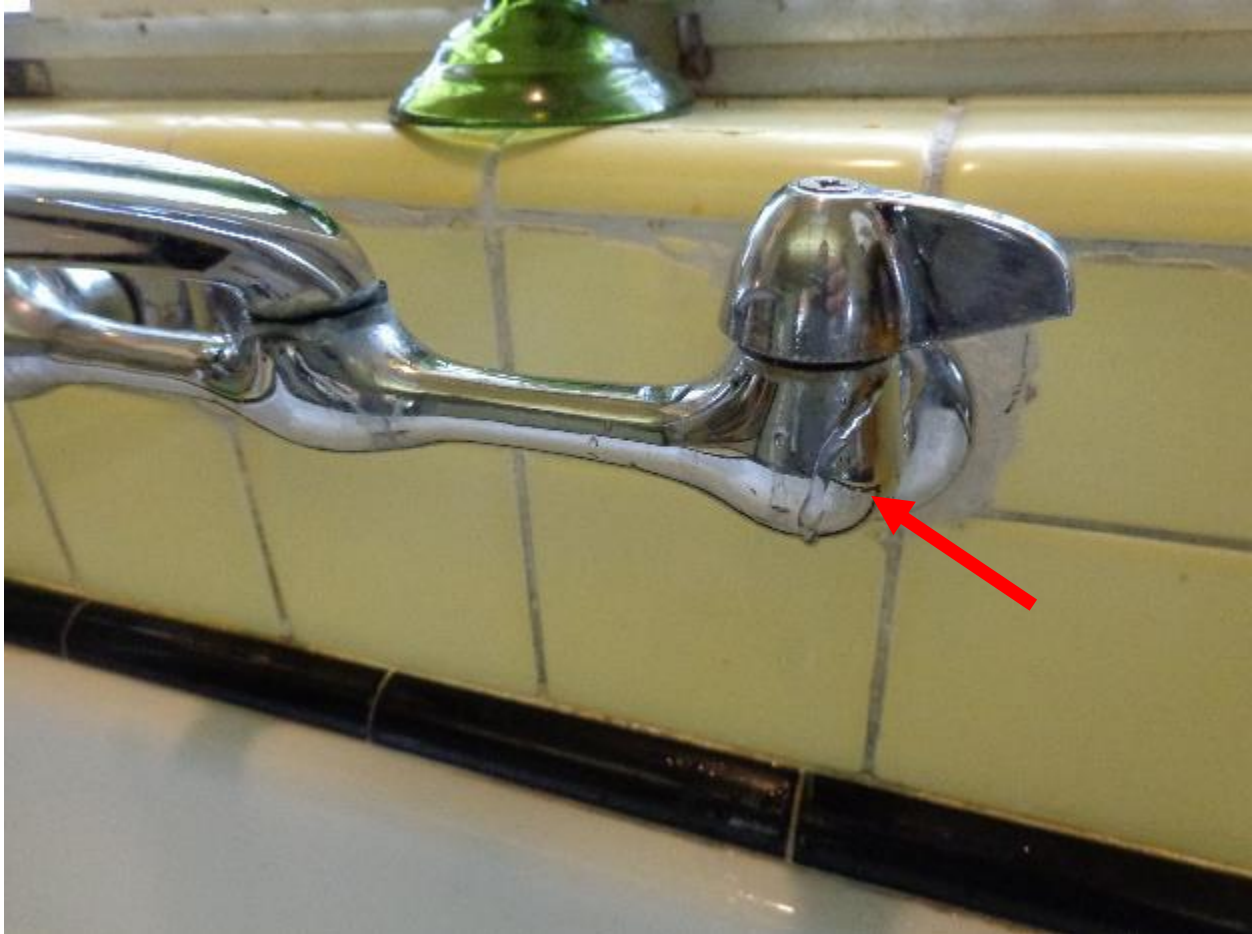
Active leak when open.

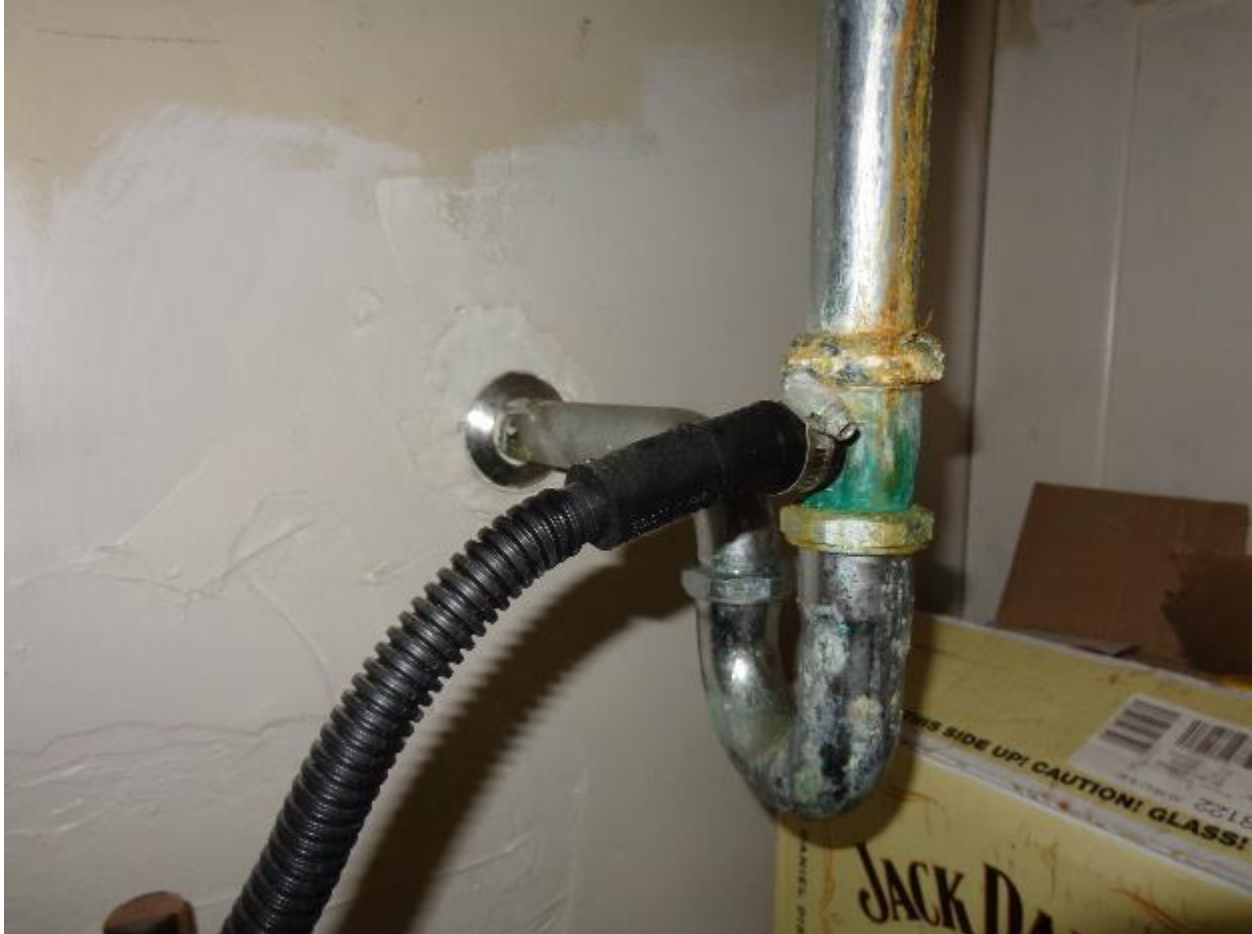
Deteriorated cast iron pipes will require a full upgrade replace with PVC.

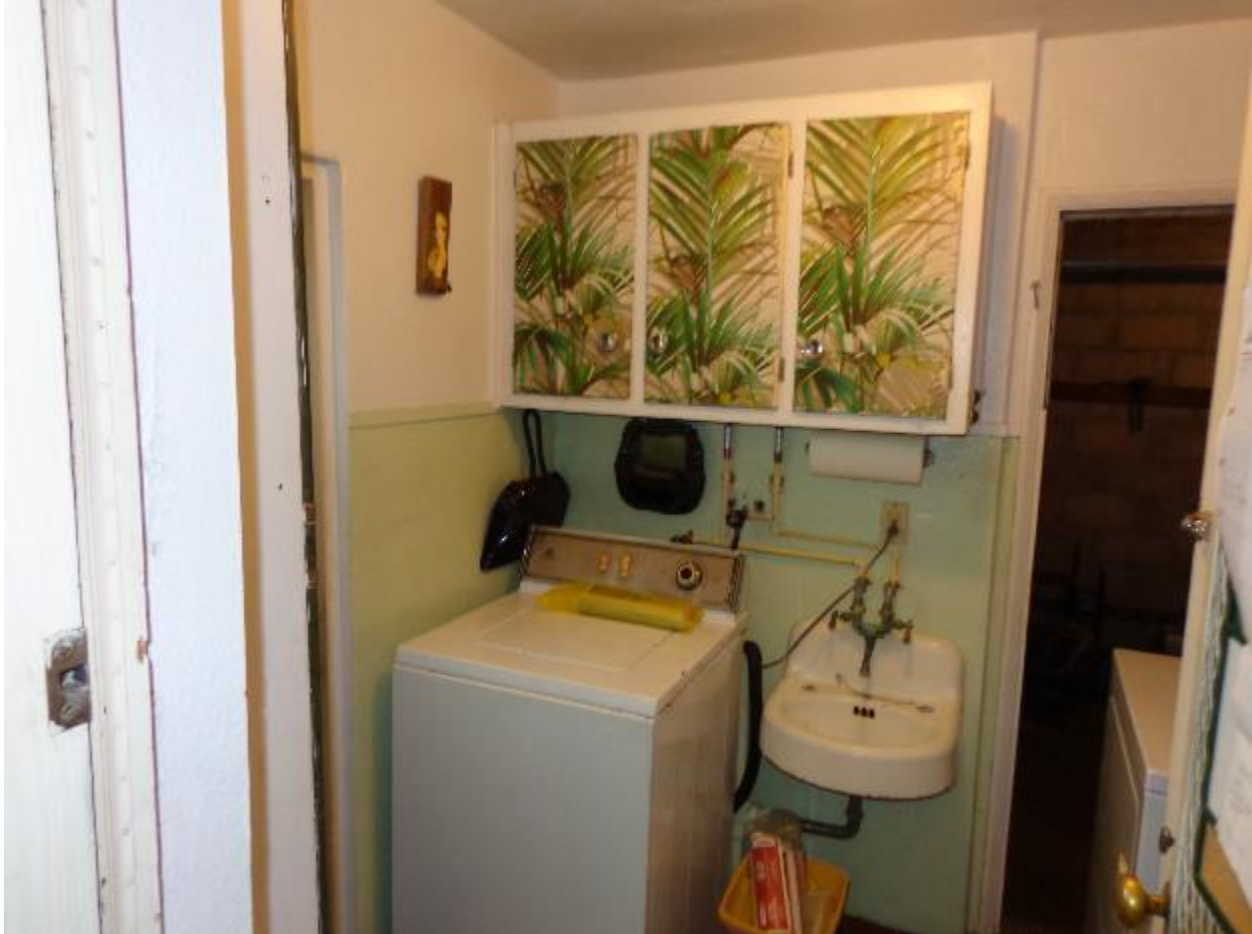
A complete rehabilitation of the interior is recommended. Plumbing, electrical and Ac systems require replacement or repairs.

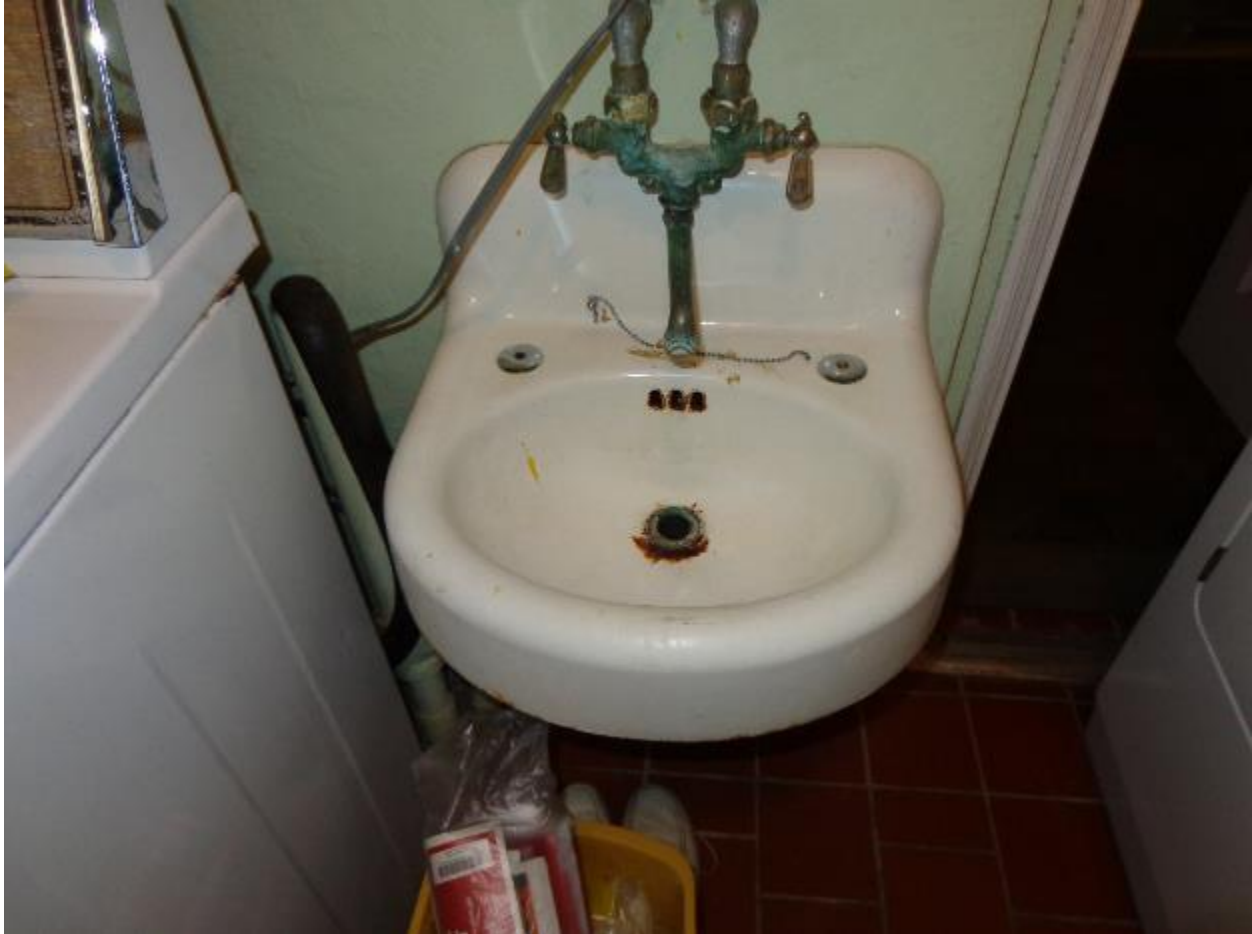
Deteriorated cast iron pipes will require a full upgrade replace with PVC.

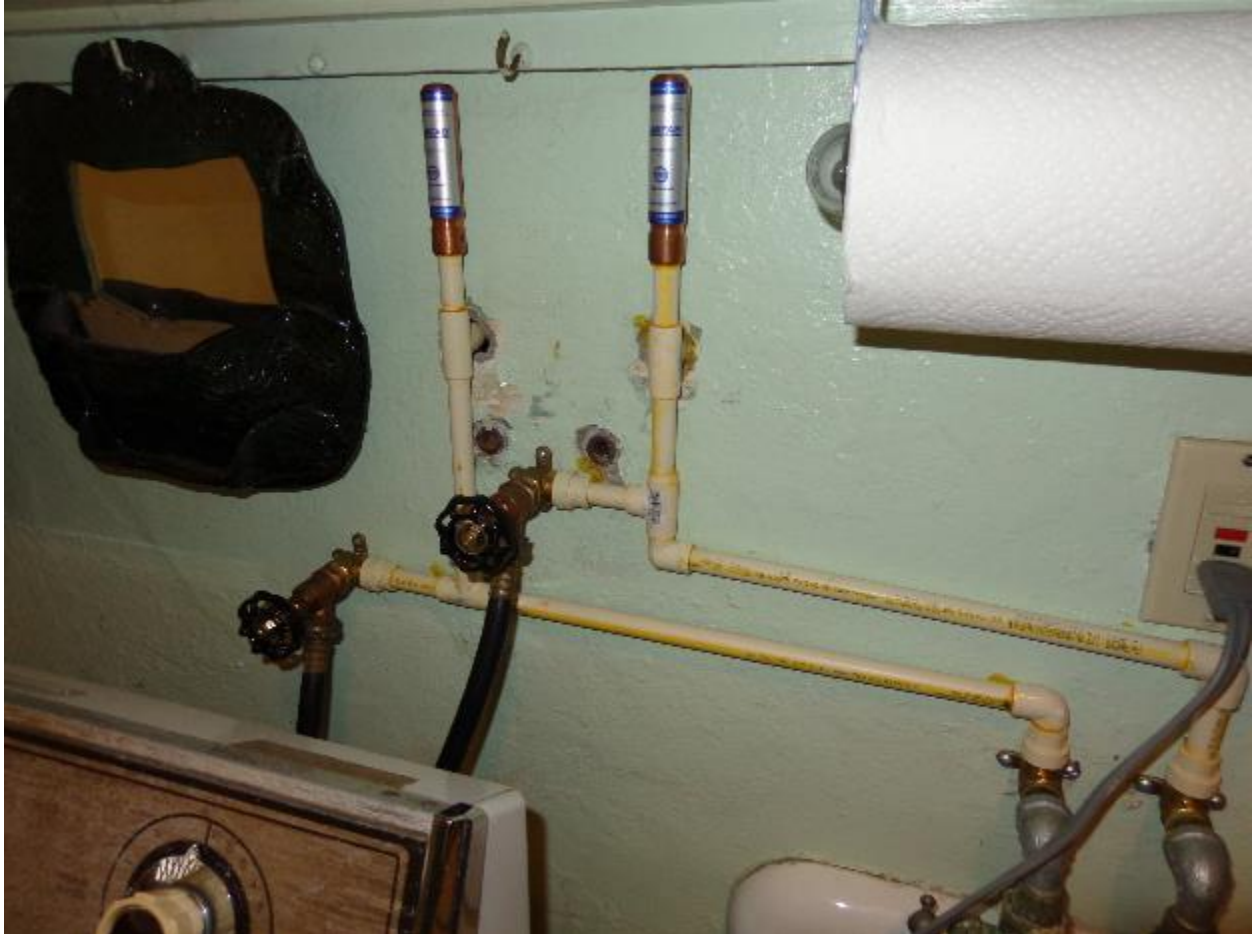
Home was noted to have had a full update of galvanized water lines, to CPVC lines.

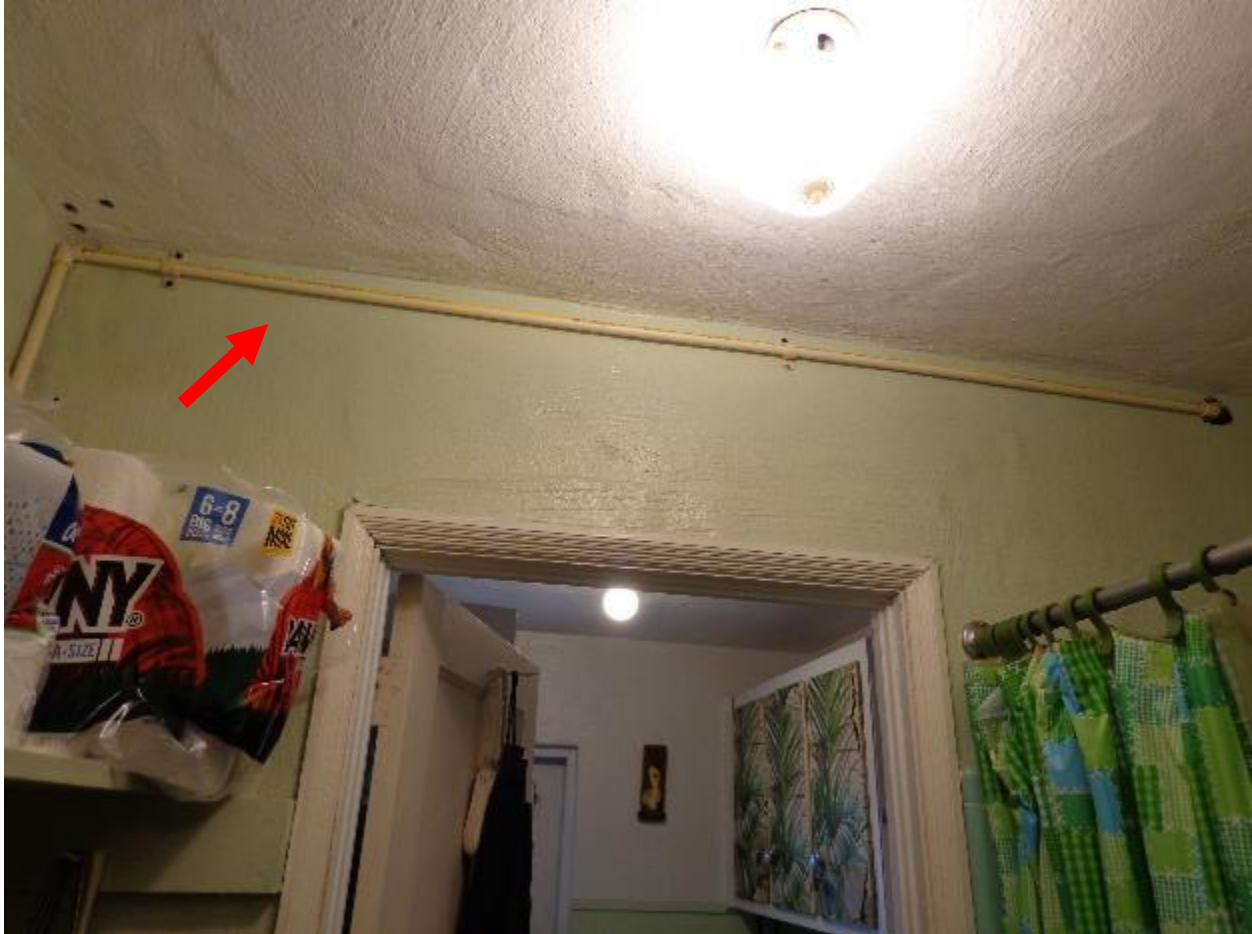
Home was noted to have had a full update of galvanized water lines, to CPVC lines.

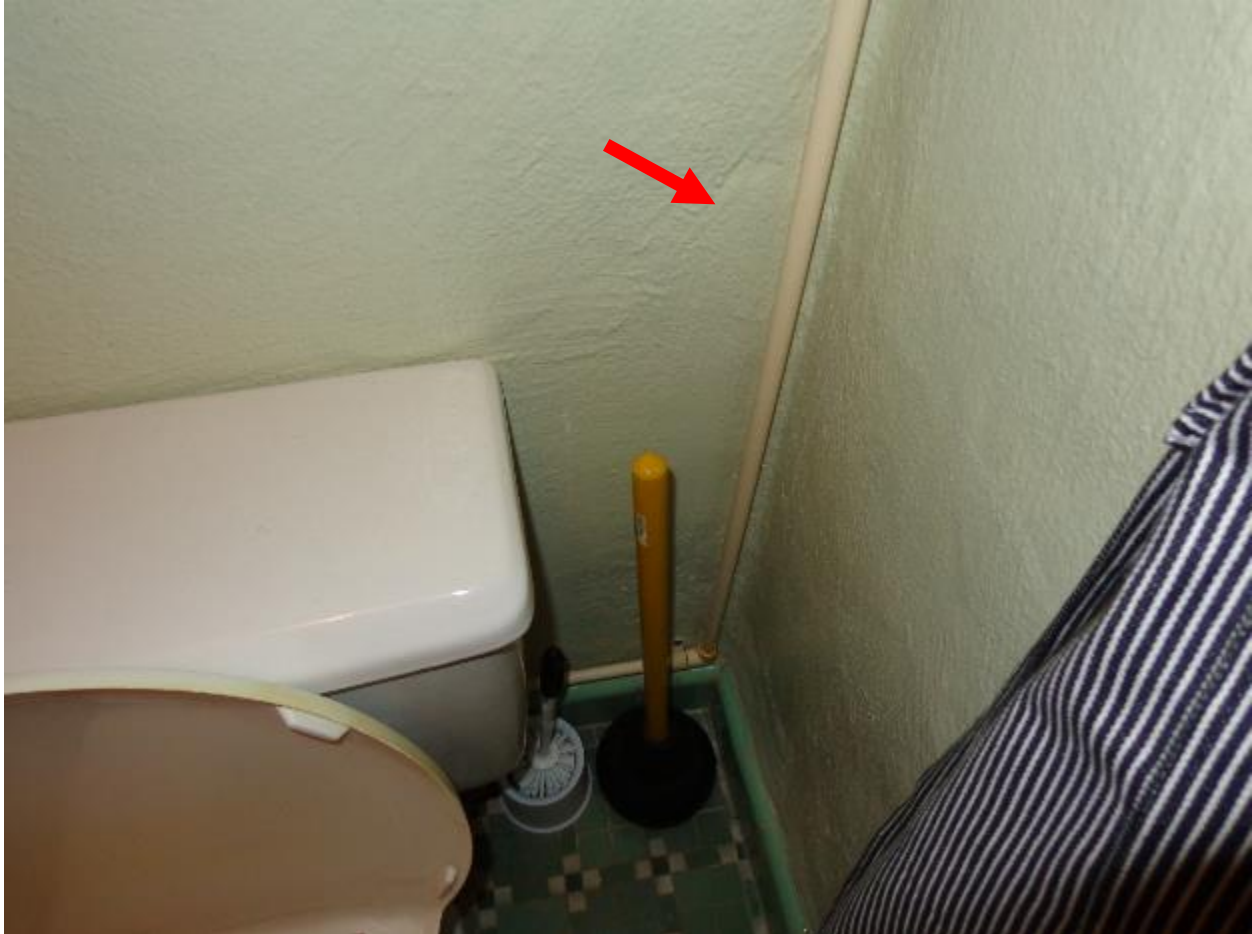
Home was noted to have had a full update of galvanized water lines, to CPVC lines.

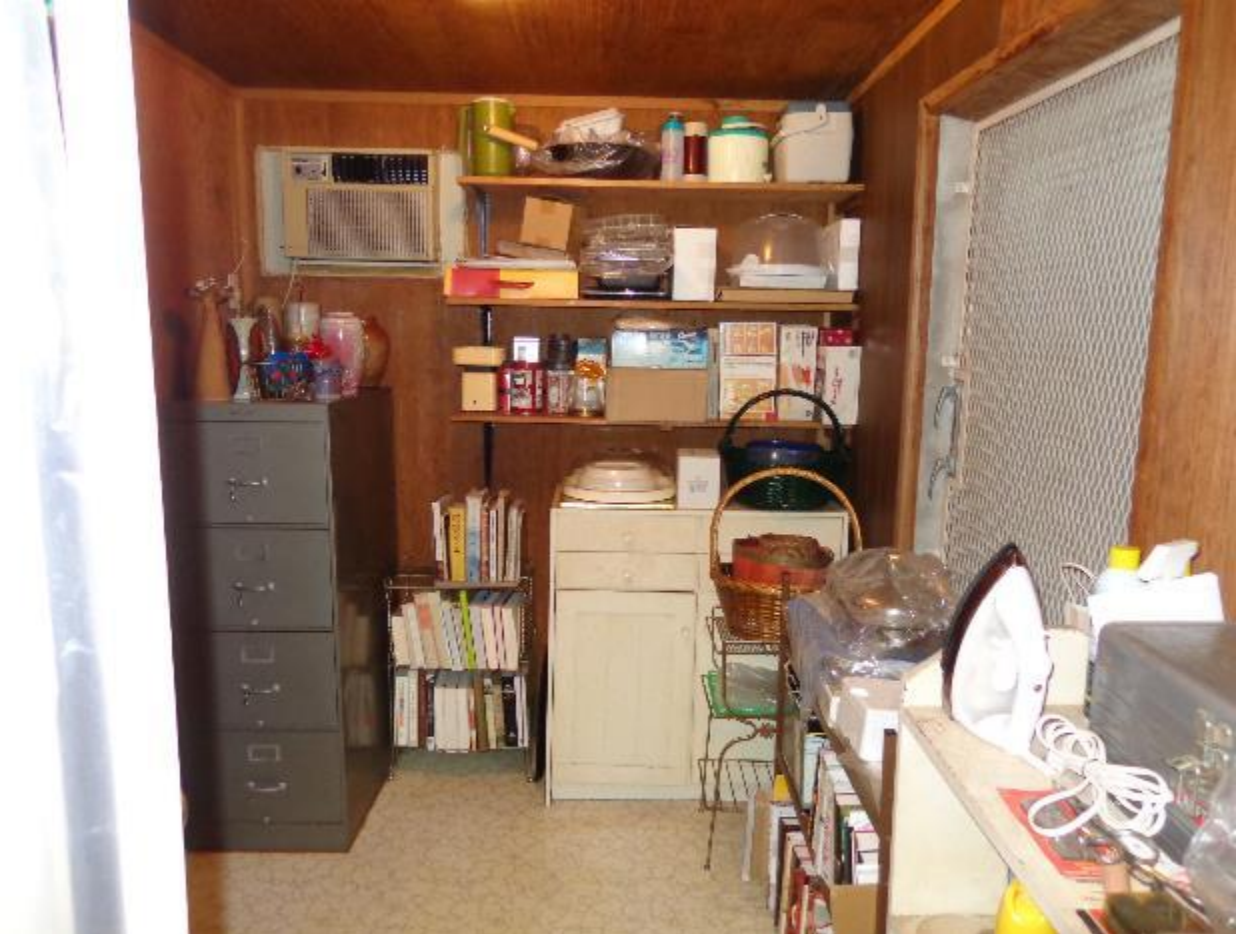
A complete rehabilitation of the interior is recommended. Plumbing, electrical and Ac systems require replacement or repairs.

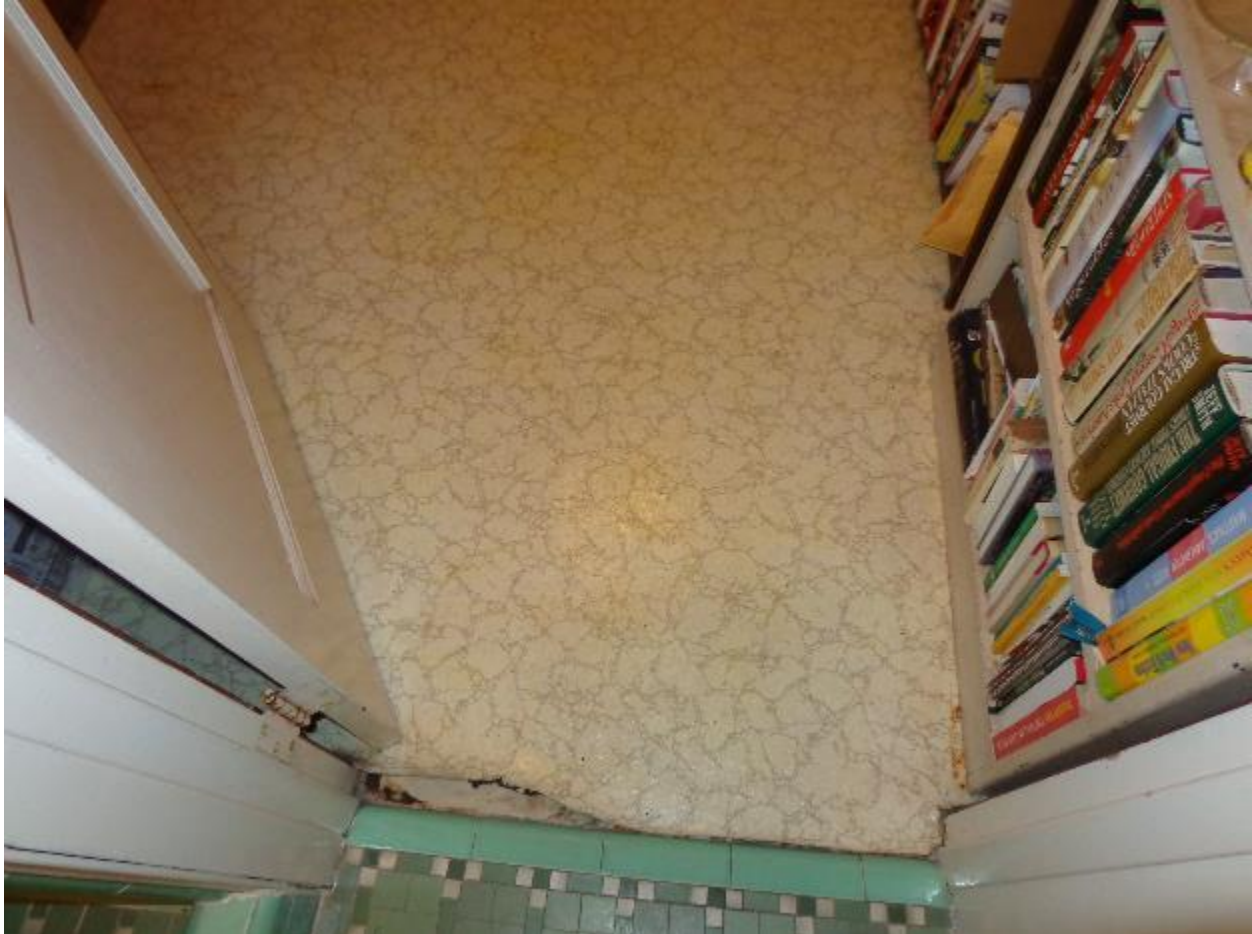
A complete rehabilitation of the interior is recommended. Plumbing, electrical and Ac systems require replacement or repairs.

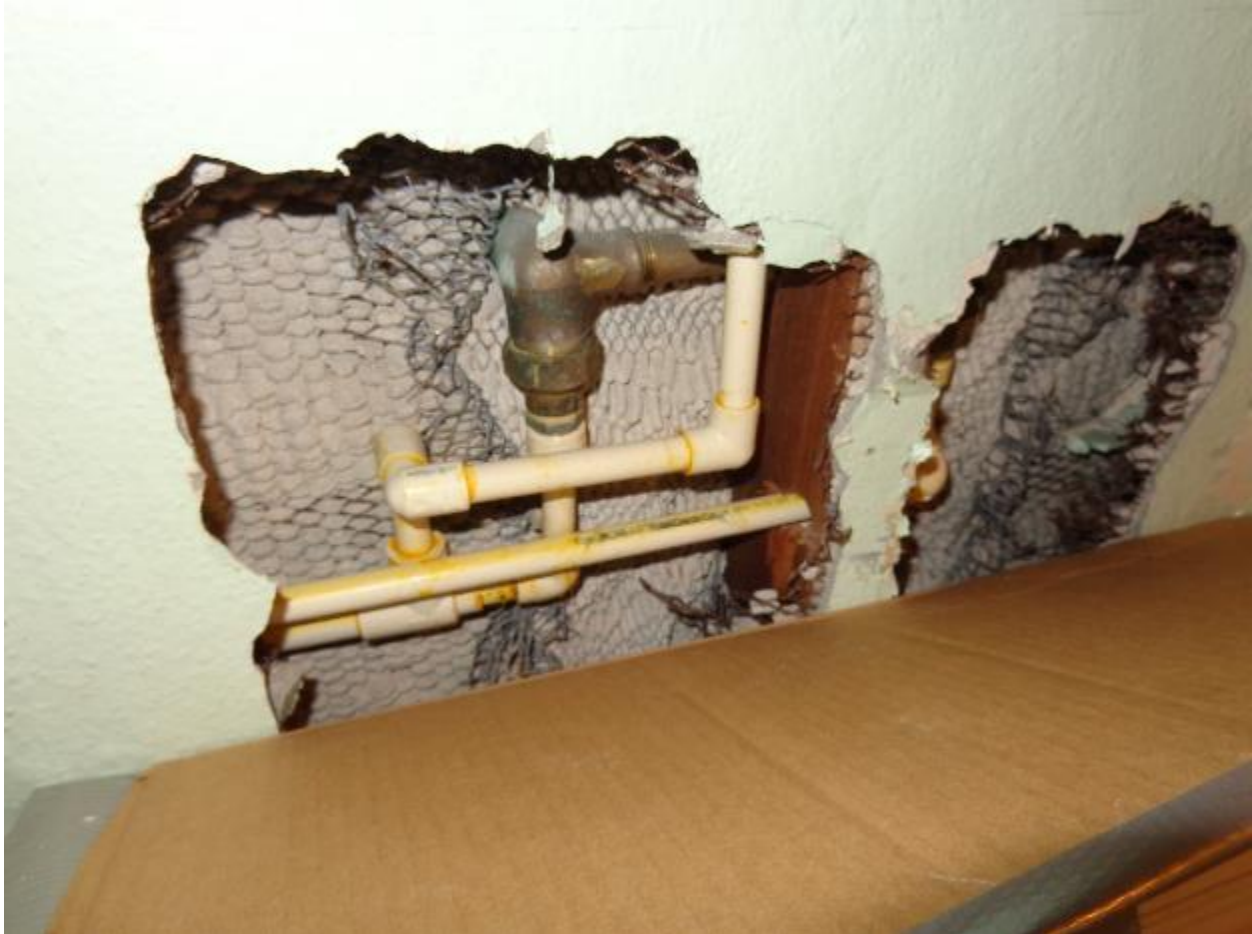
Home was noted to have had a full update of galvanized water lines, to CPVC lines.

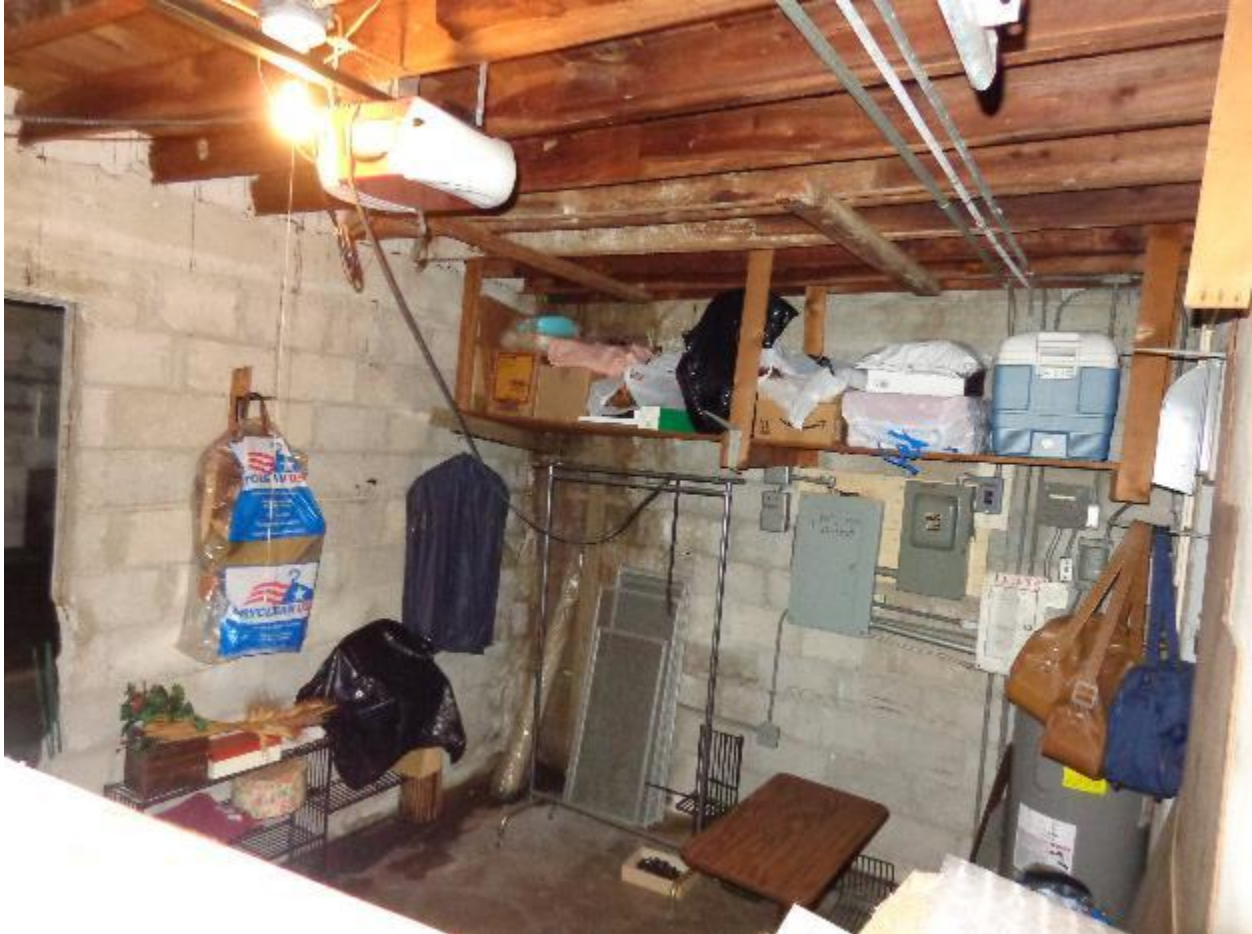
Signs of water infiltration due to roof failure noticed at the habitable space ceiling; allowances must be made for roofing and ceiling repair.

Minimum roofing repairs required, related to active leaks and water marks noted inside habitable space.

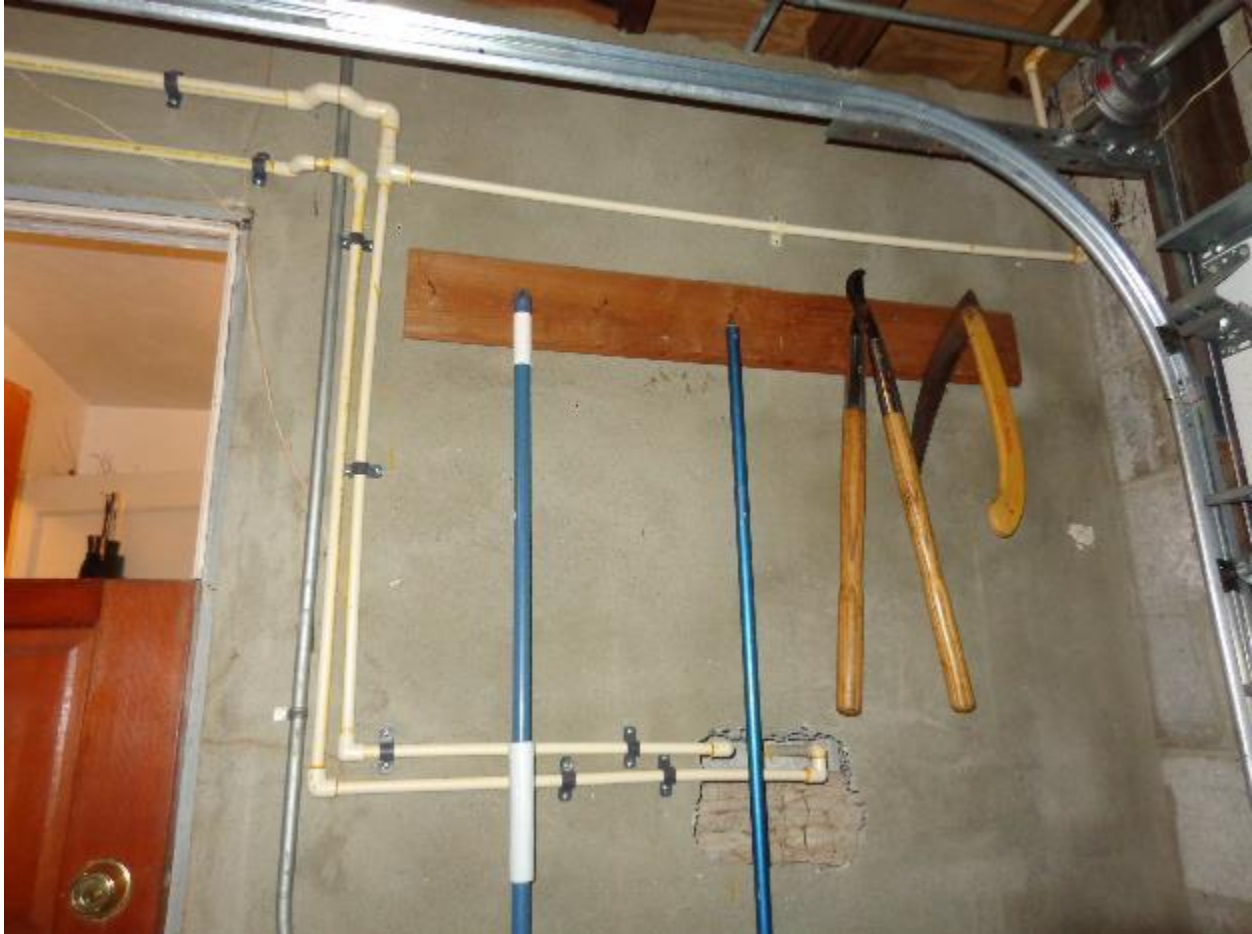
Home was noted to have had a full update of galvanized water lines, to CPVC lines.

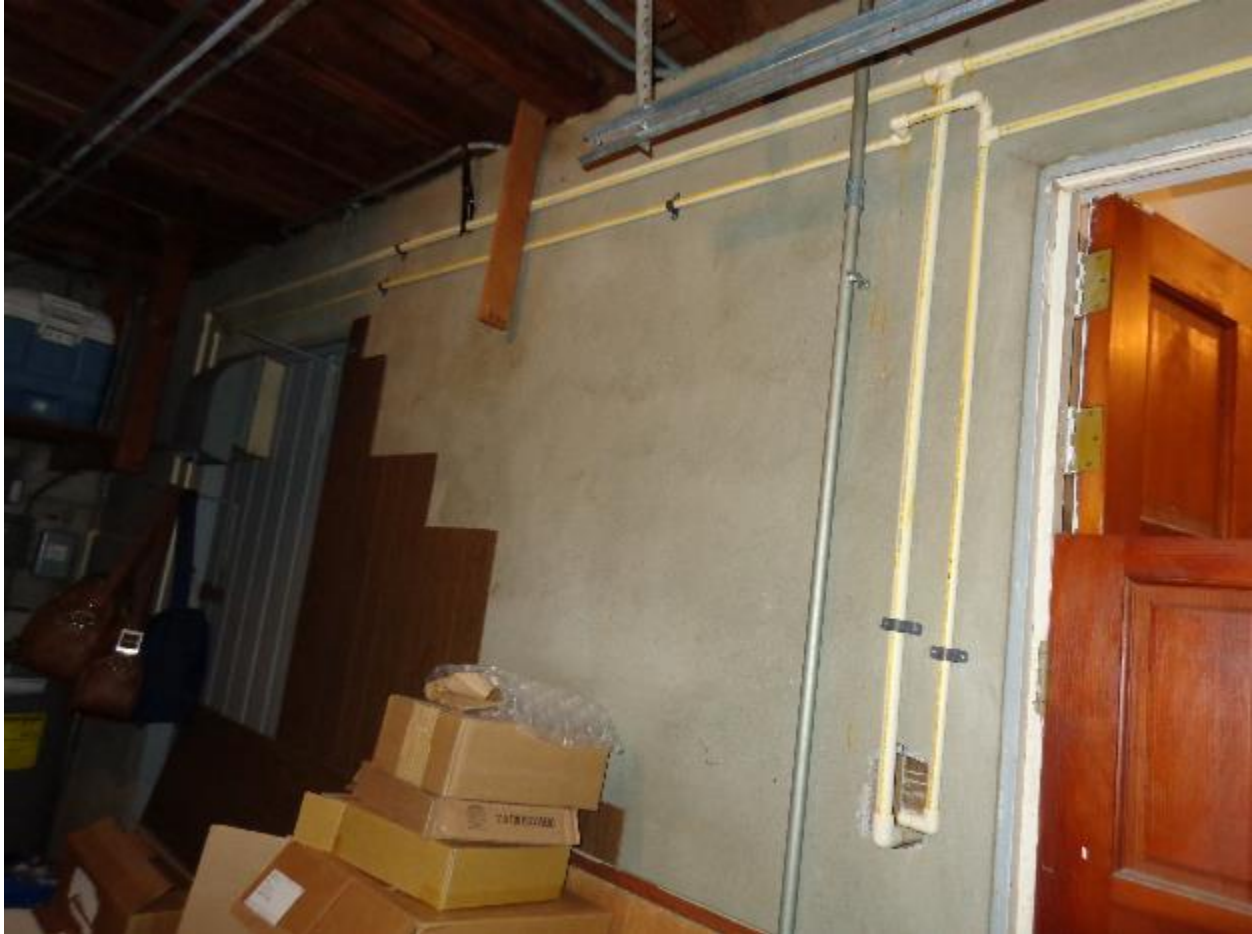
Home was noted to have had a full update of galvanized water lines, to CPVC lines.

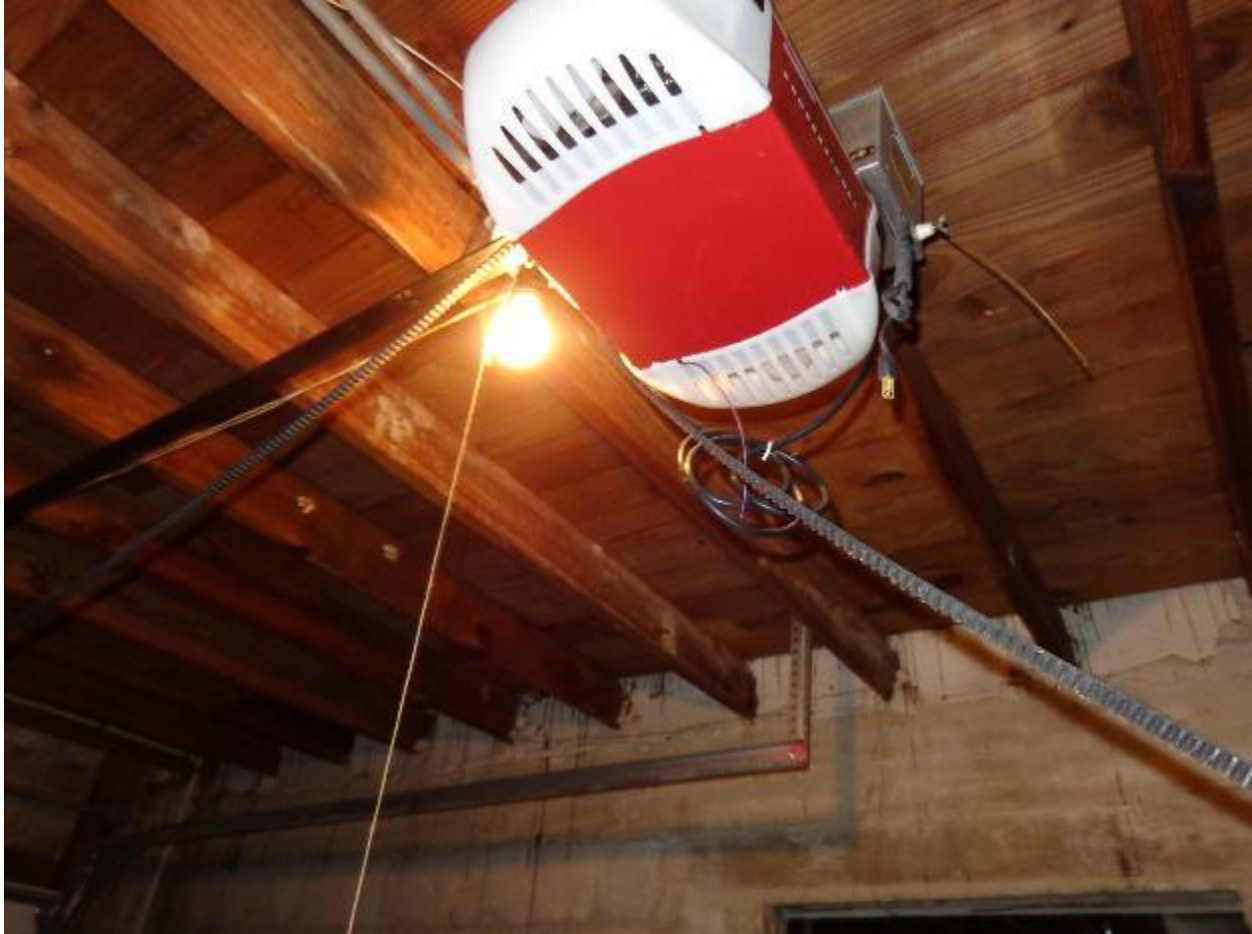
Garage door motors on door garage doors require repairs.

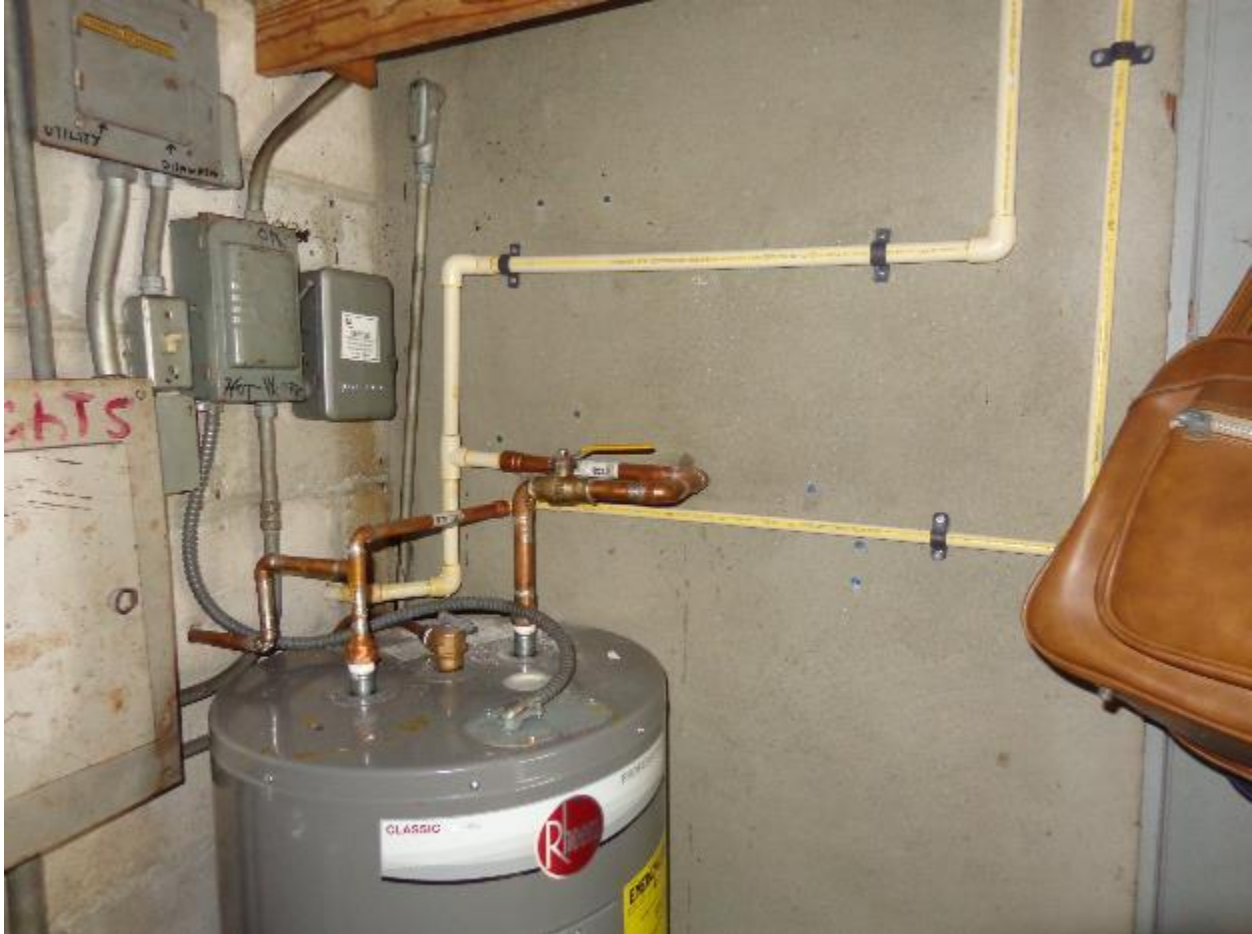
Home was noted to have had a full update of galvanized water lines, to CPVC lines.
