PROPERTY INSPECTION OR ASSESSMENT OF DAMAGES

ADDRESS: 229 Ridgewood Rd. Coral Gables, Fl.
CLIENT: Phil Padron
ID No: 2016417
DATE: 6/9/2016

PROPERTY INSPECTION –229 Ridgewood Rd Coral Gables, FL
ATTACHMENT - PHOTOGRAPHS
DATE: 06-09-2016

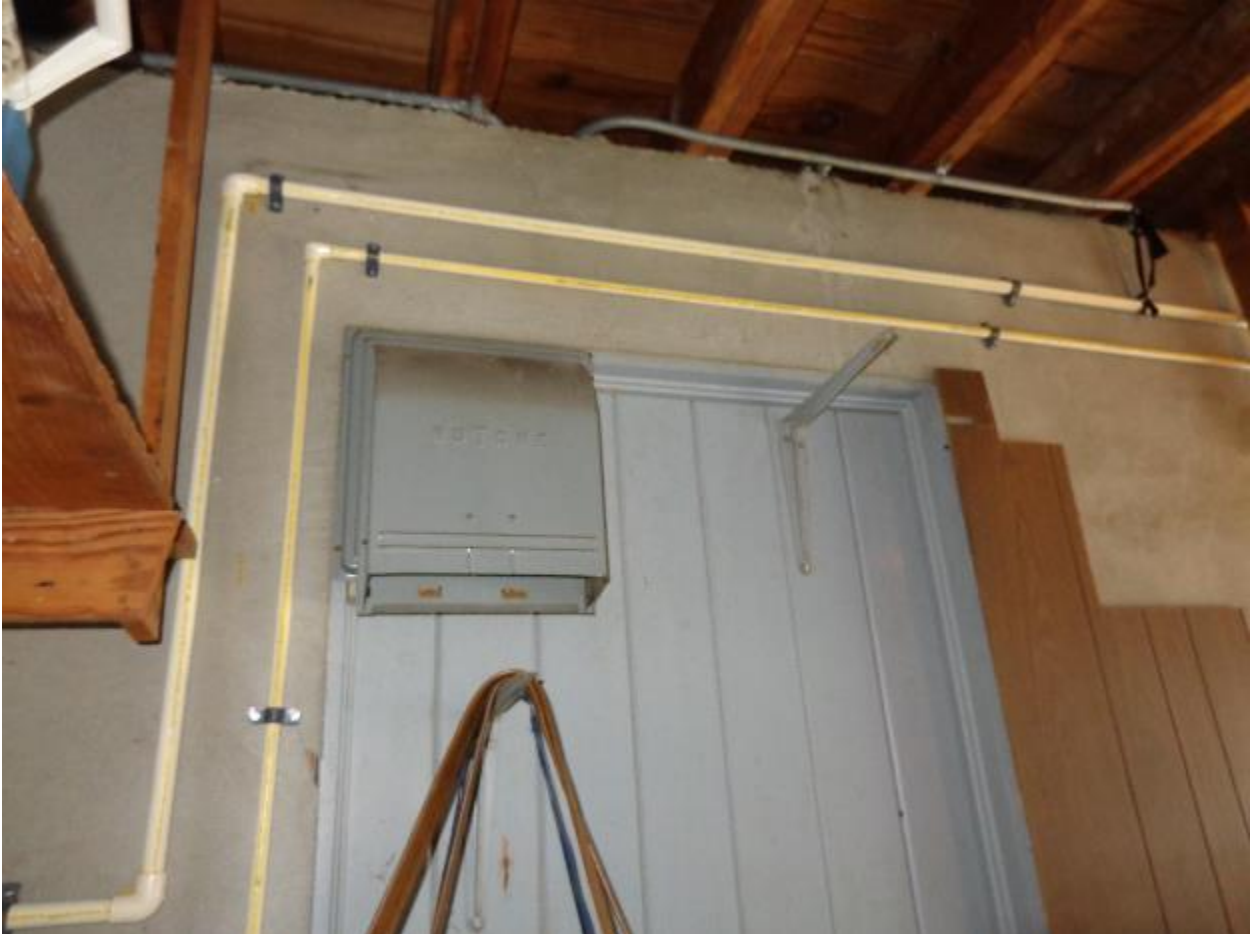
Home was noted to have had a full update of galvanized water lines, to CPVC lines.

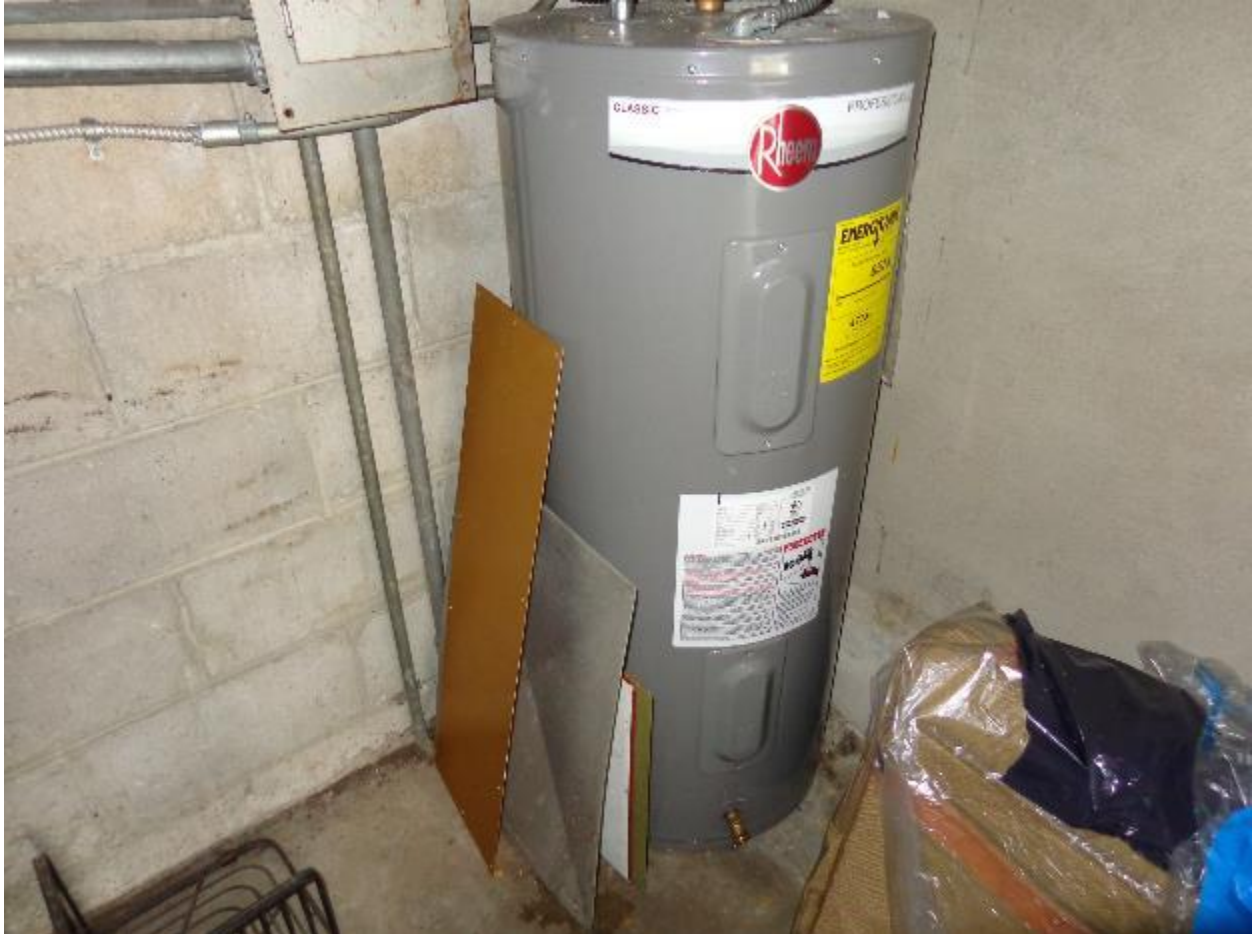
Water heater in good working condition at time of inspection.

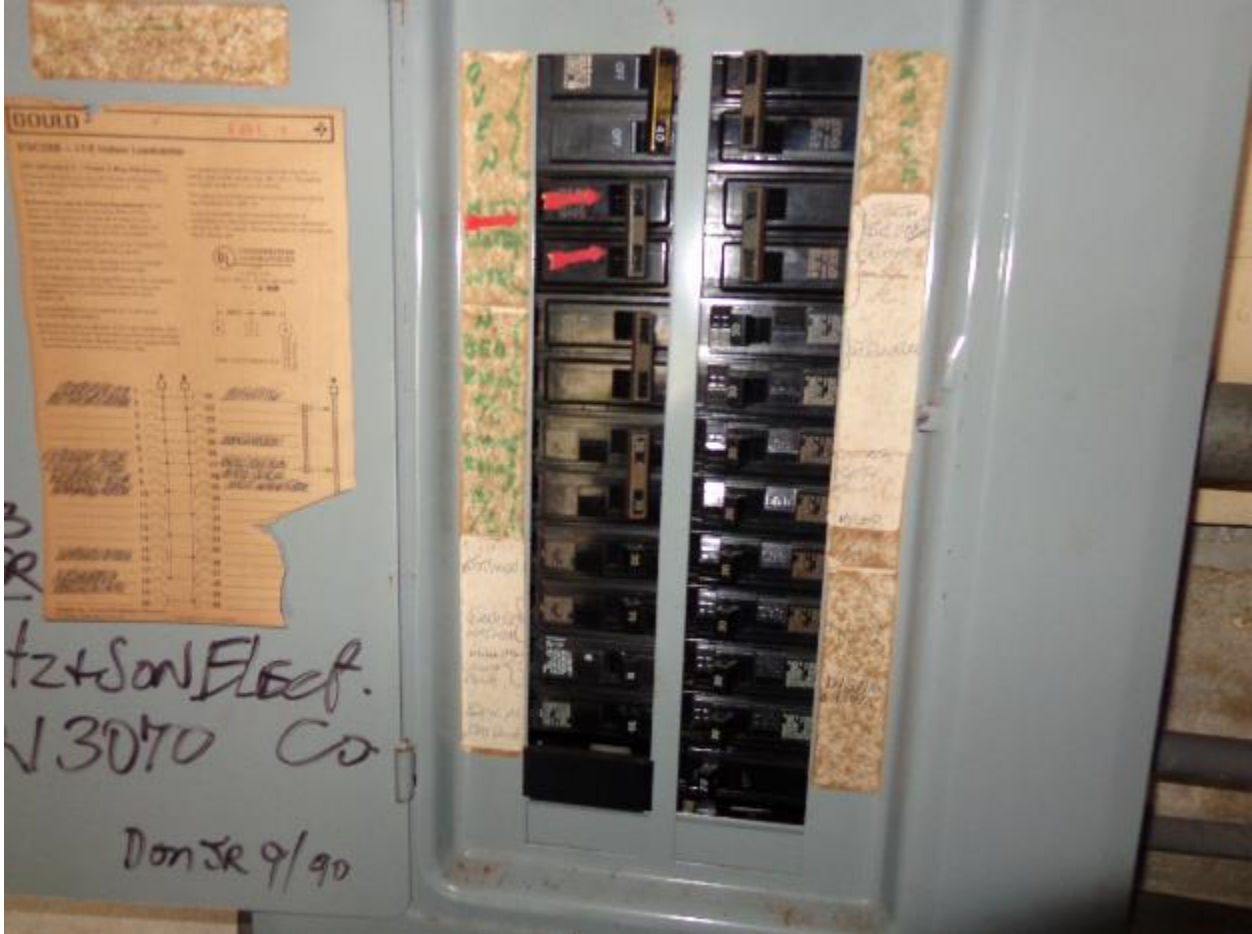
Electrical breaker panel in good condition at the time of inspection.

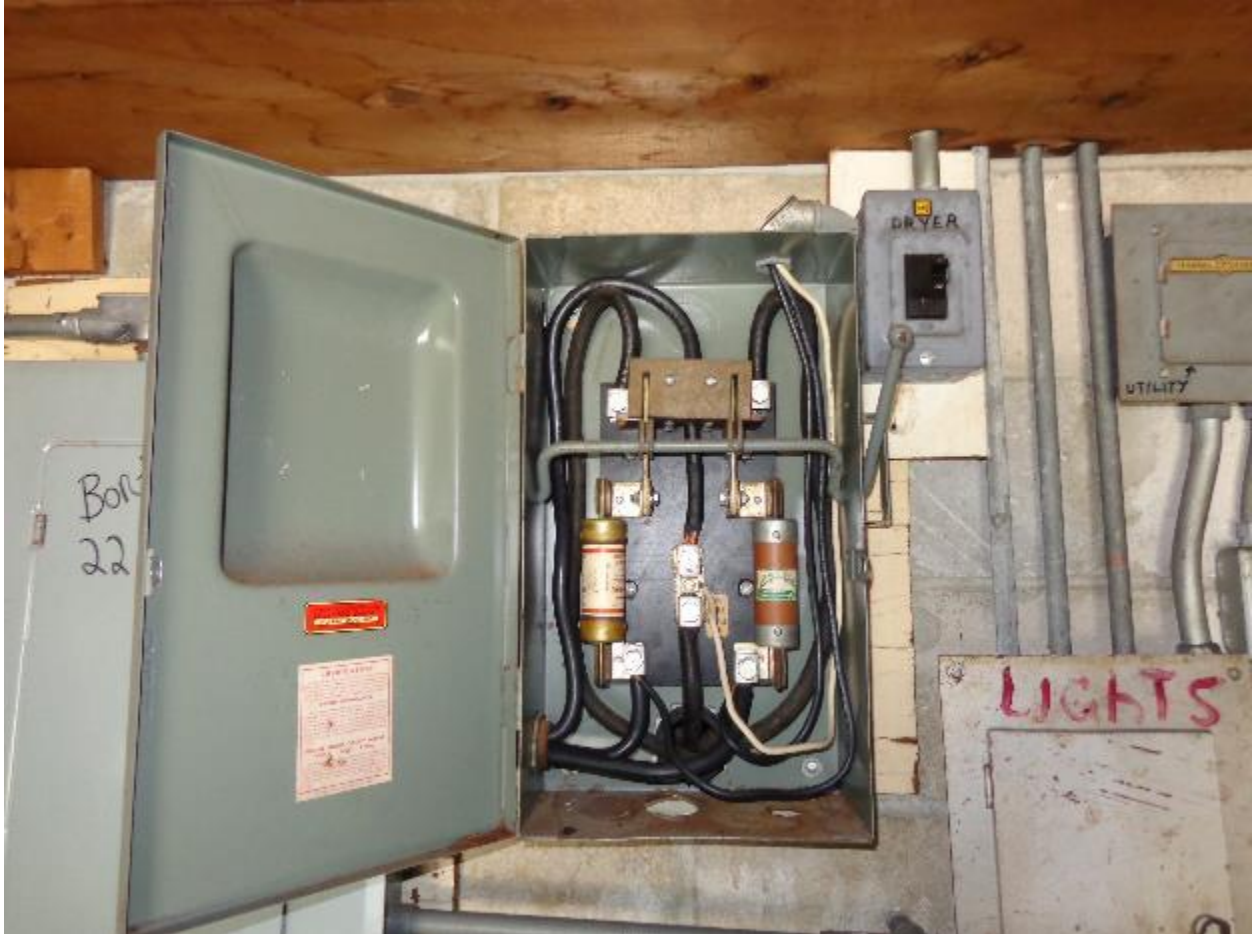
Double taps noted during inspection in main disconnect panel.

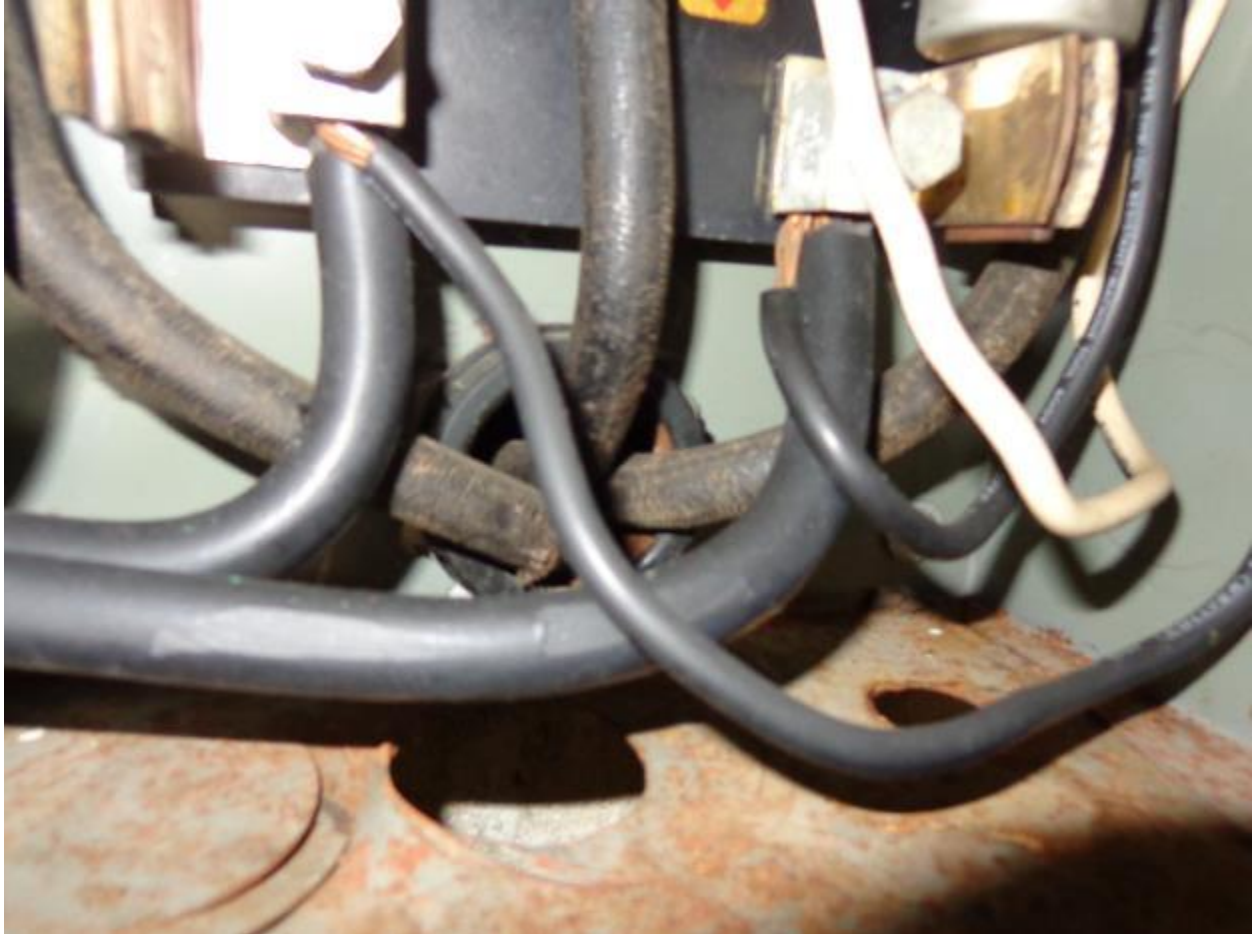
Double taps noted during inspection in main disconnect panel.

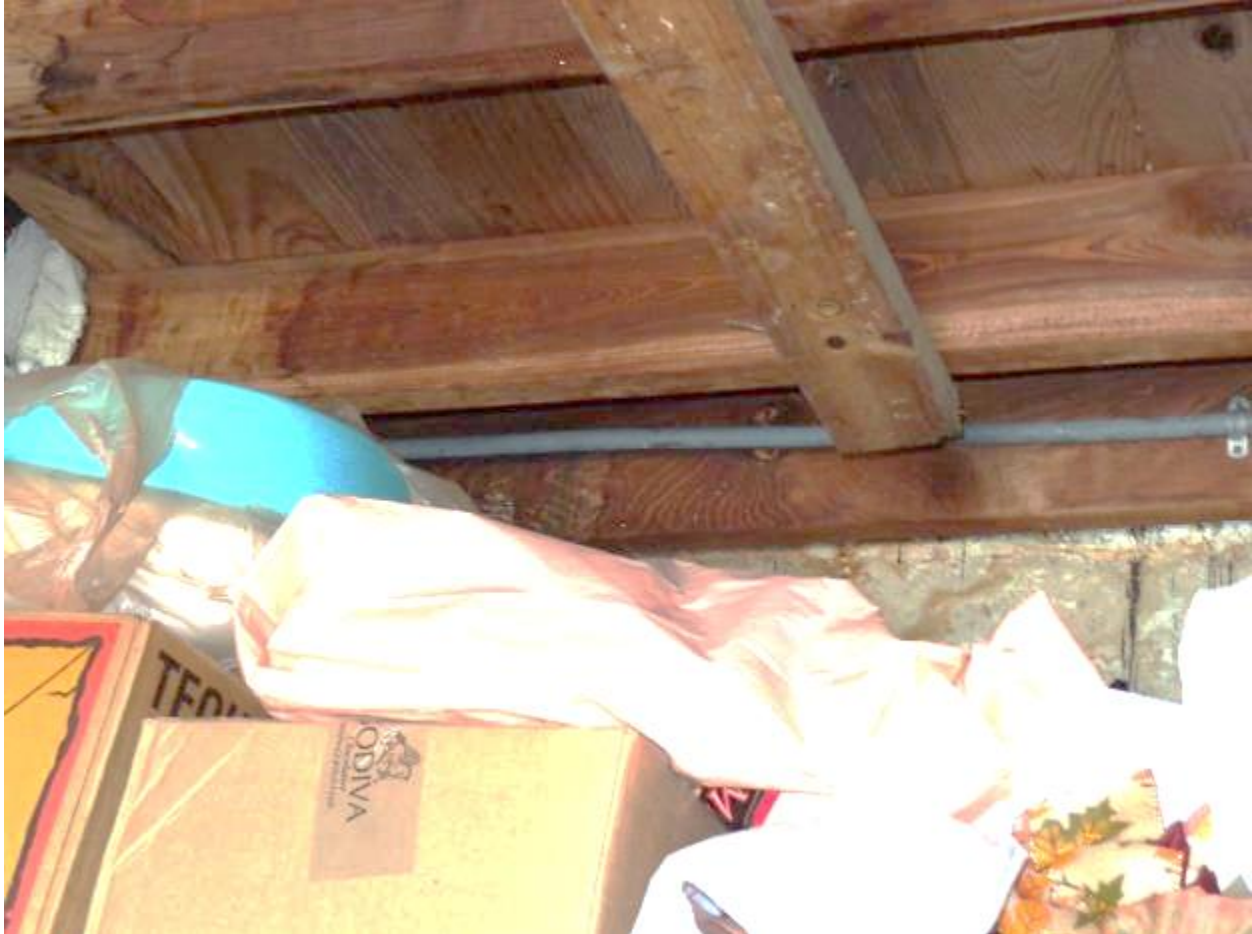
Signs of water infiltration due to roof failure noticed at the habitable space ceiling; allowances must be made for roofing and ceiling repair.

Minimum roofing repairs required, related to active leaks and water marks noted inside habitable space.

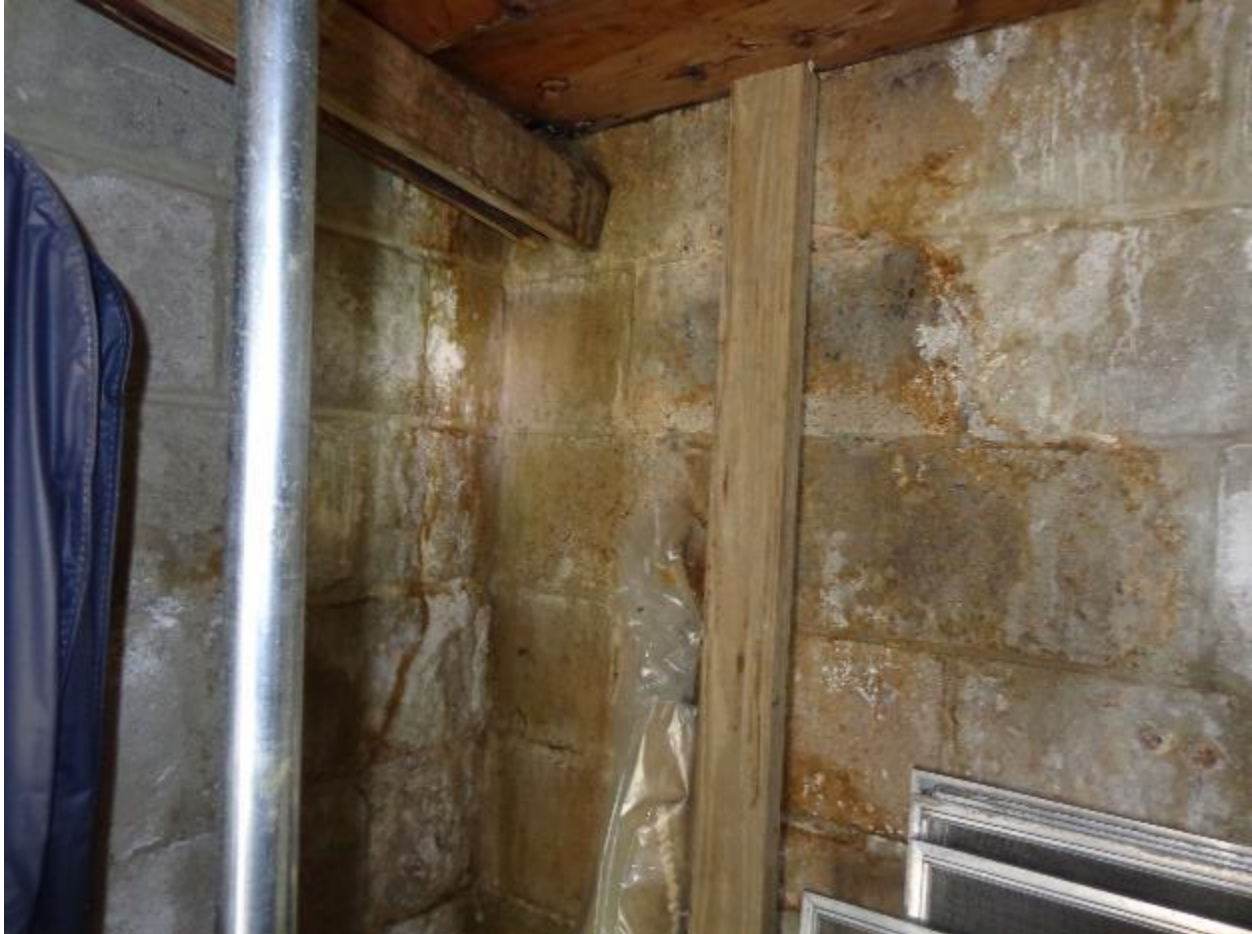
Signs of water infiltration due to roof failure noticed at the habitable space ceiling; allowances must be made for roofing and ceiling repair.

Minimum roofing repairs required, related to active leaks and water marks noted inside habitable space.

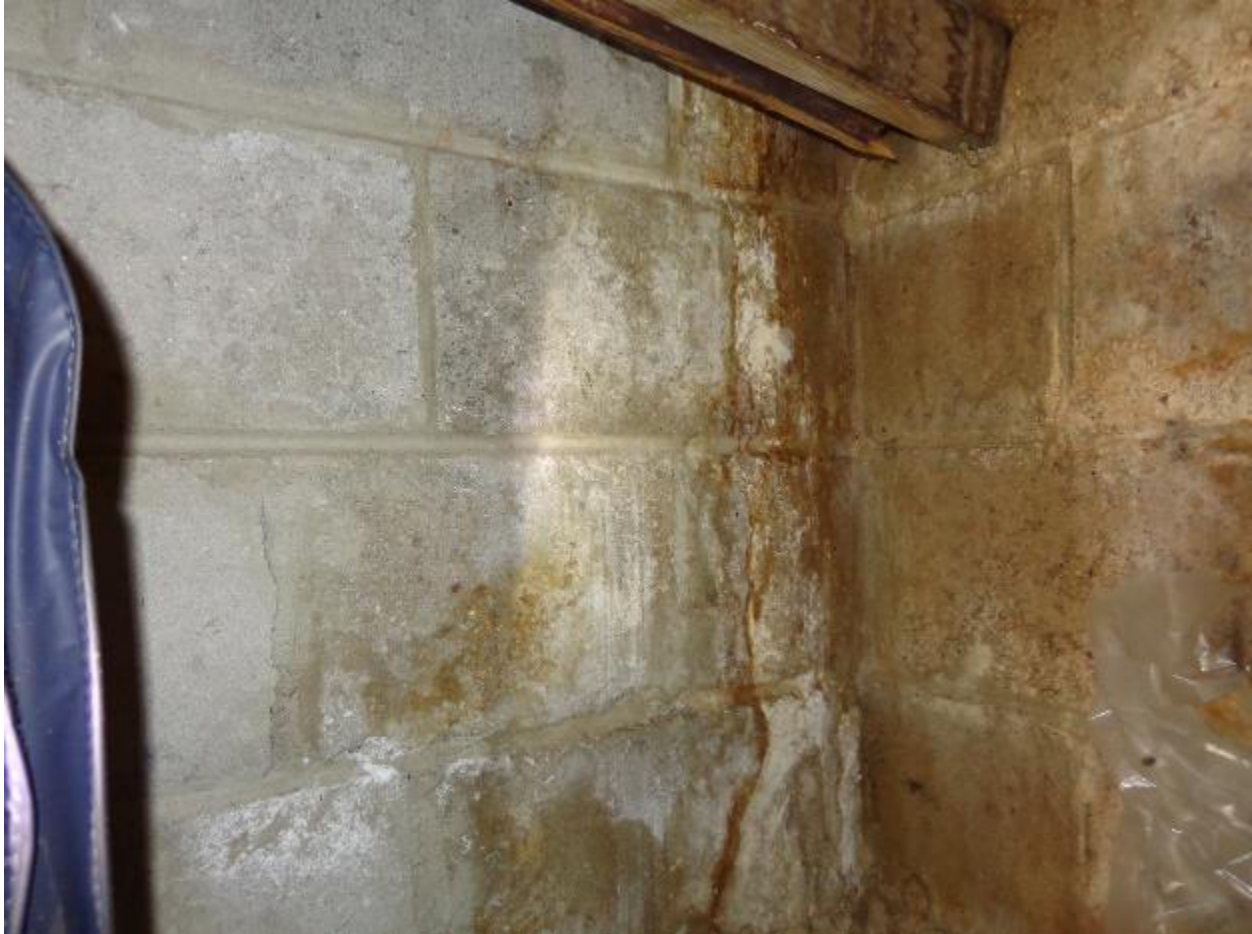
Signs of water infiltration due to roof failure noticed at the habitable space ceiling; allowances must be made for roofing and ceiling repair.

Minimum roofing repairs required, related to active leaks and water marks noted inside habitable space.

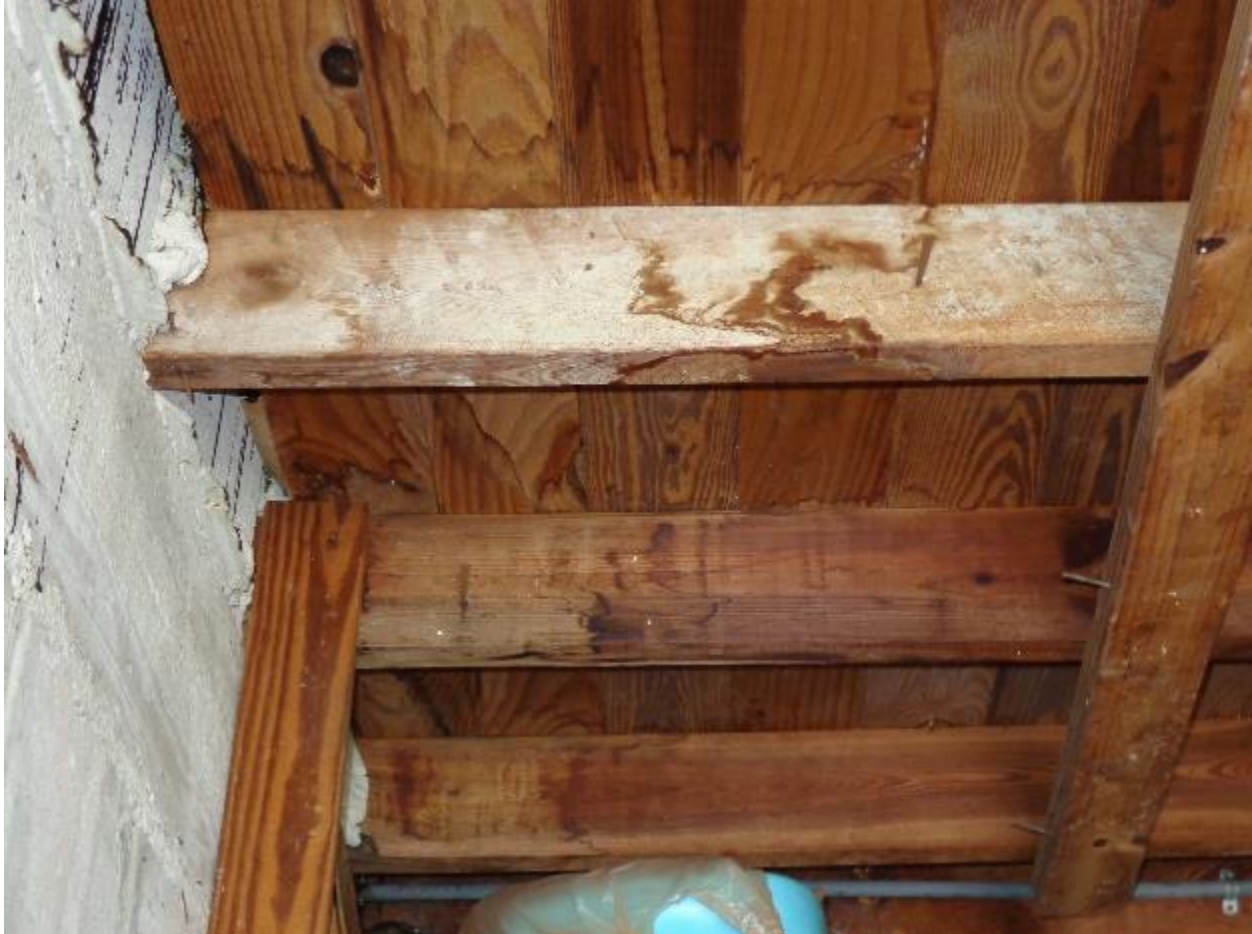
Signs of water infiltration due to roof failure noticed at the habitable space ceiling; allowances must be made for roofing and ceiling repair.

Minimum roofing repairs required, related to active leaks and water marks noted inside habitable space.

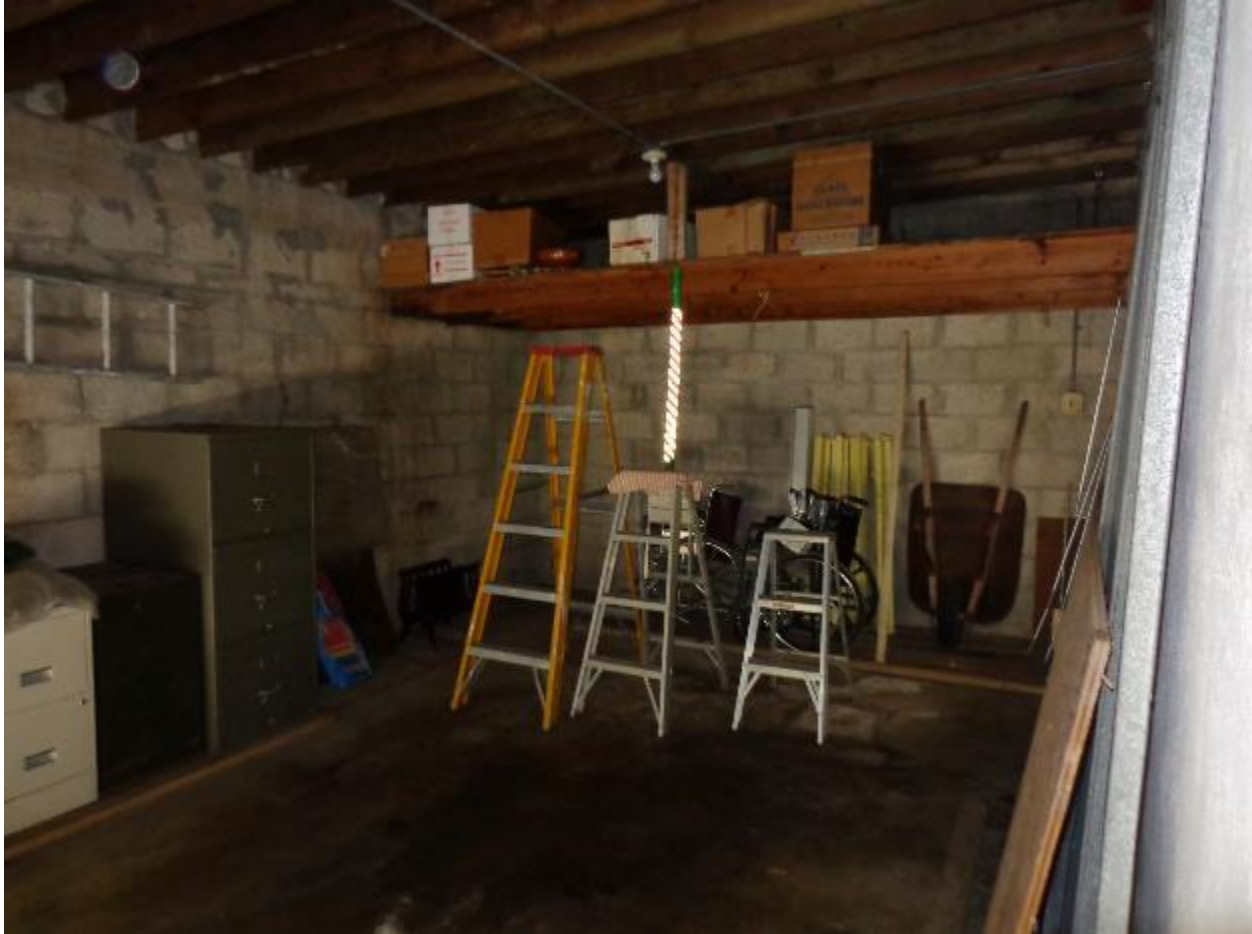
Signs of water infiltration due to roof failure noticed at the habitable space ceiling; allowances must be made for roofing and ceiling repair.

Minimum roofing repairs required, related to active leaks and water marks noted inside habitable space.

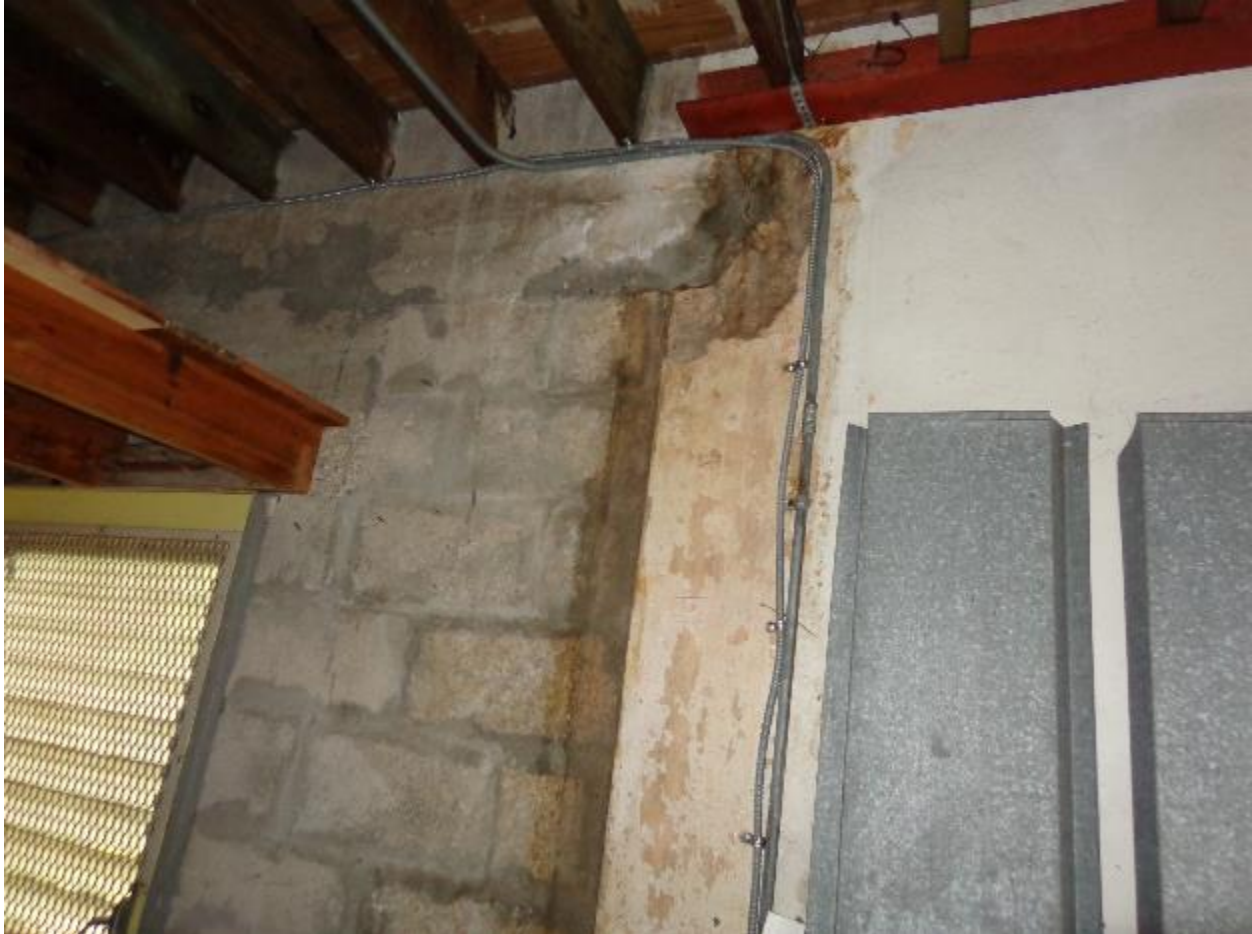
Signs of water infiltration due to roof failure noticed at the habitable space ceiling; allowances must be made for roofing and ceiling repair.

Minimum roofing repairs required, related to active leaks and water marks noted inside habitable space.

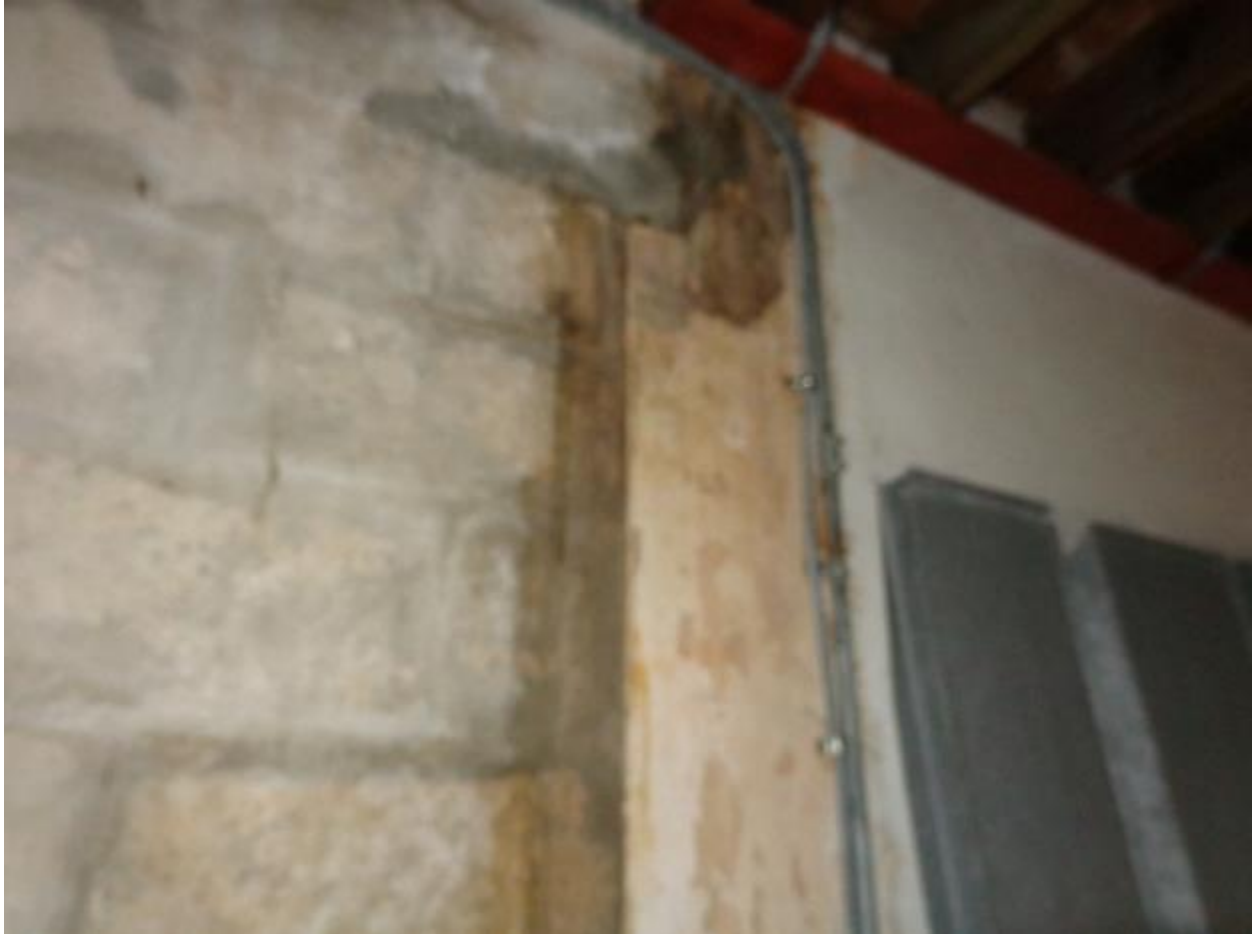
Signs of water infiltration due to roof failure noticed at the habitable space ceiling; allowances must be made for roofing and ceiling repair.

Minimum roofing repairs required, related to active leaks and water marks noted inside habitable space.

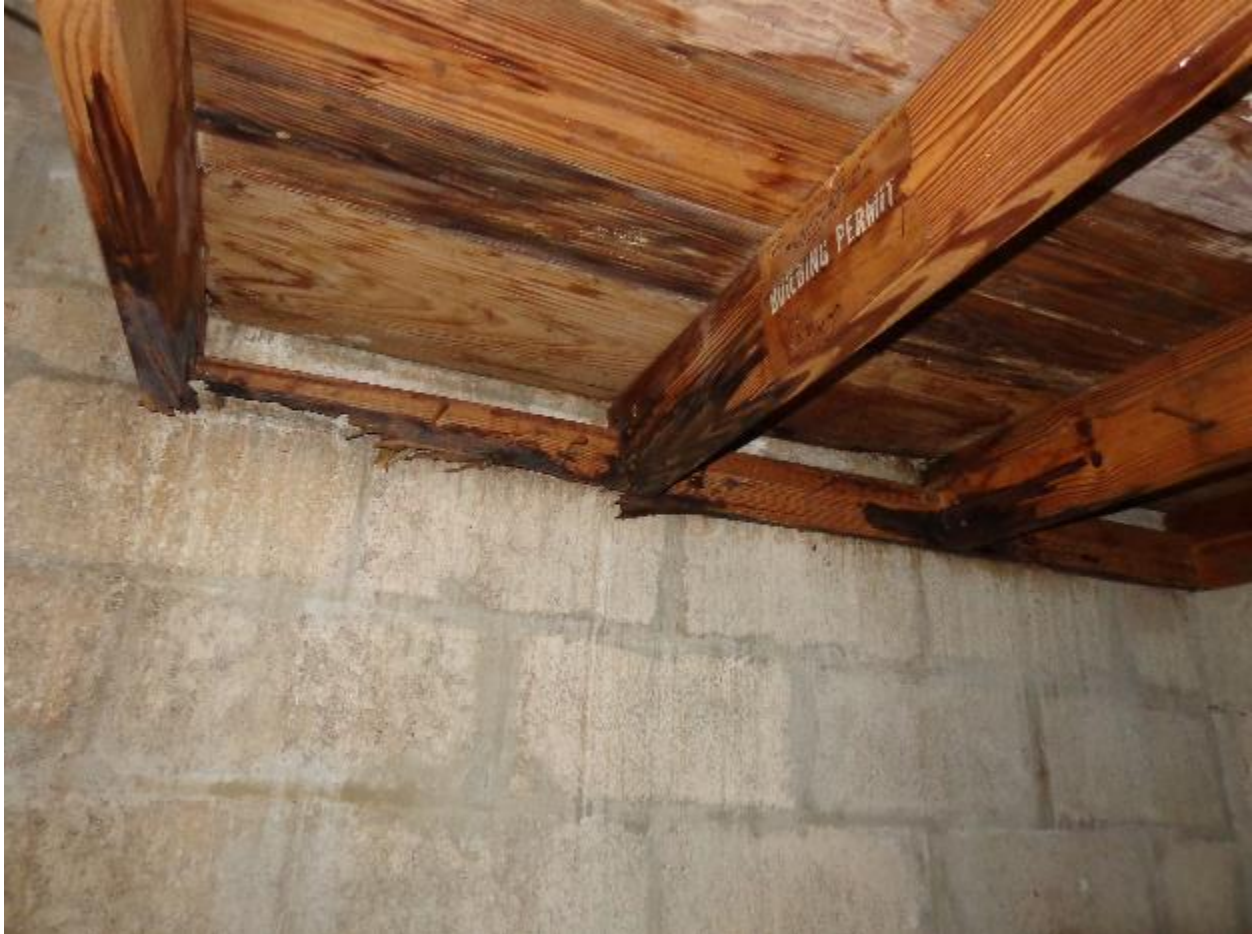
Signs of water infiltration due to roof failure noticed at the habitable space ceiling; allowances must be made for roofing and ceiling repair.

Minimum roofing repairs required, related to active leaks and water marks noted inside habitable space.

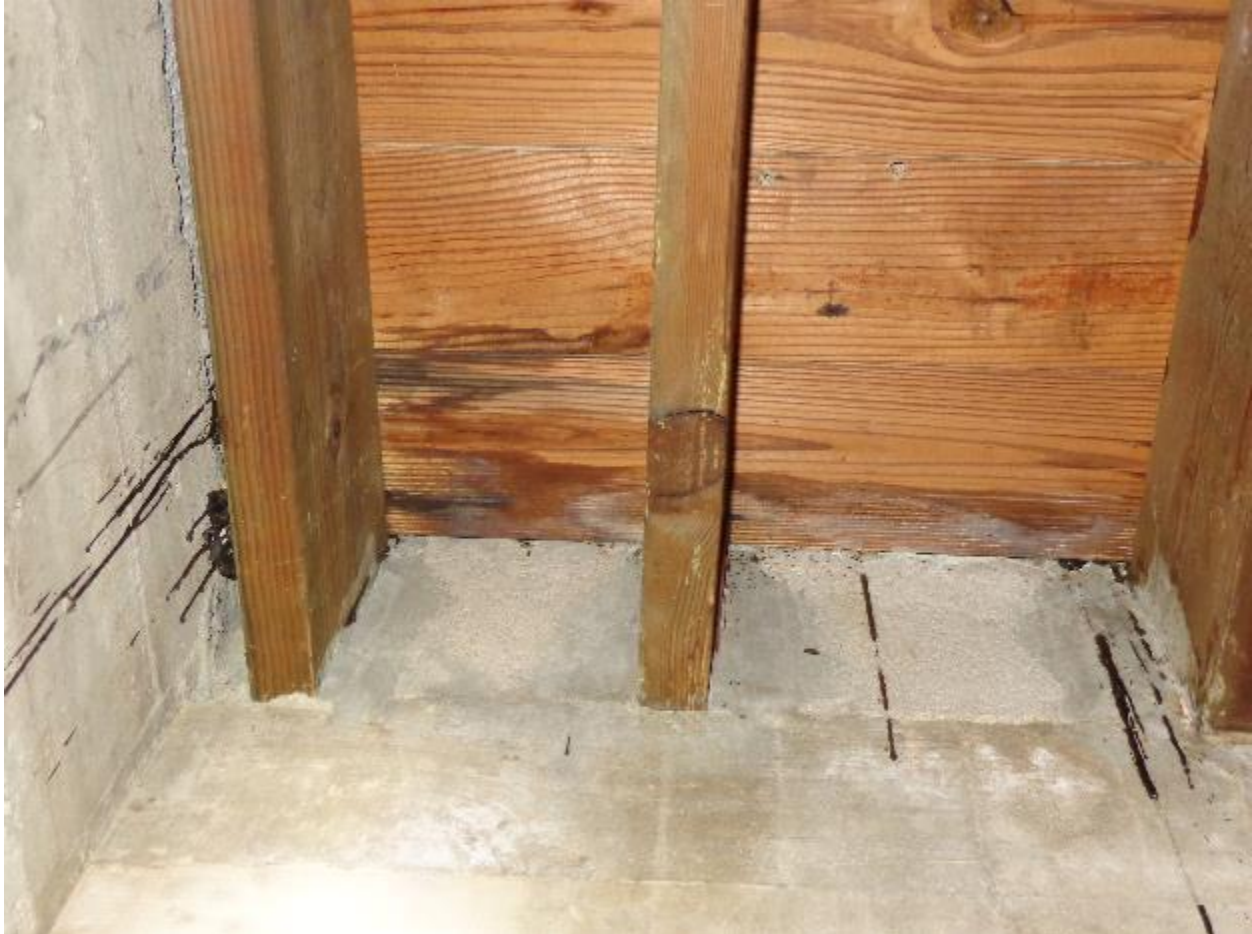
Signs of water infiltration due to roof failure noticed at the habitable space ceiling; allowances must be made for roofing and ceiling repair.

Minimum roofing repairs required, related to active leaks and water marks noted inside habitable space.
