SHORT LEGAL DESCRIPTION	
THE BILTMORE REGENT CONDO	
CORAL GABLES BILTMORE SEC	
LOTS 24 THRU 32 BLK 1 PB 20-28	
F/A/U 03-4117-008-0200

**NOTICE OF UNSAFE STRUCTURE VIOLATION FOR FAILURE TO RECERTIFY
AND NOTICE OF HEARING**

The Falcon Group (Falcon) conducted a 30-Year **Electrical** Recertification of the referenced building in accordance with the requirements of section 8-11(f) of Miami Dade County and City of Coral Gables “General Considerations & Guidelines” for the building safety inspections. In summary, in accordance with the above regulations and guidelines, the recertification is not approved since repairs are required to meet current standards of safety.

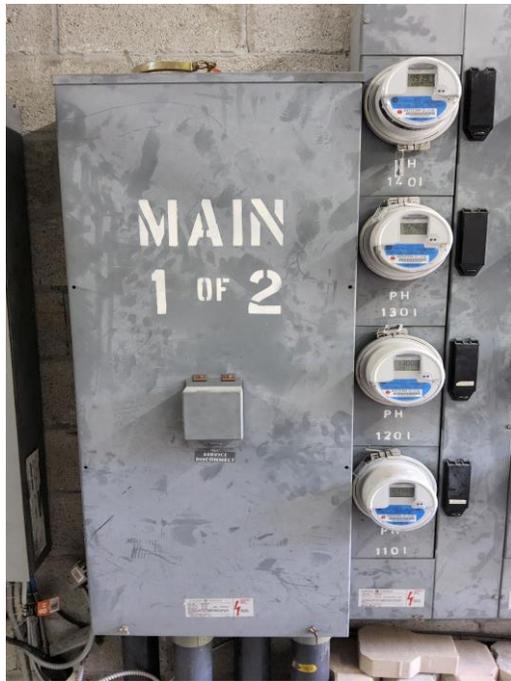
Photo # 1. Item 3.1. Meter Electrical Room. Disconnect Switch. Main 1 of 2.

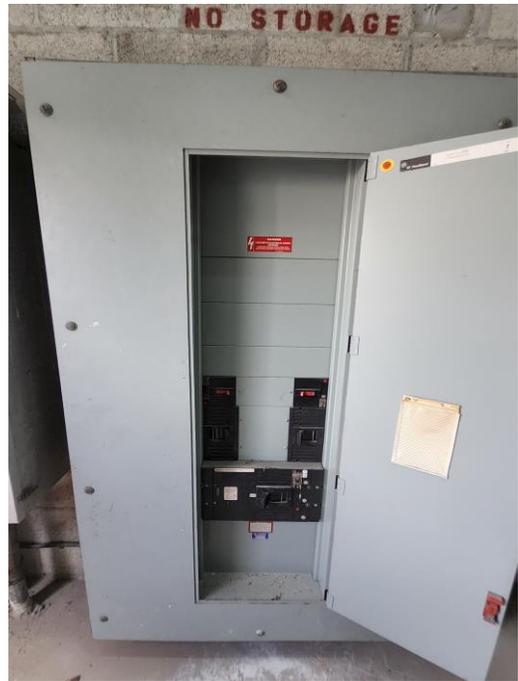
Photo # 2. Item 3.2. Meter Electrical Room. Panelboard. Main 2 of 2. Missing proper circuit identification.

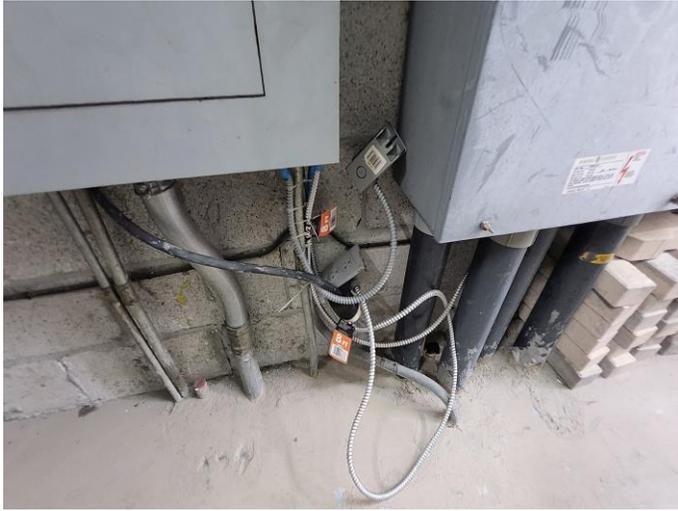
Photo # 5. Item 5.1.a. Meter Electrical Room. All temporary wiring and receptacles must be removed.

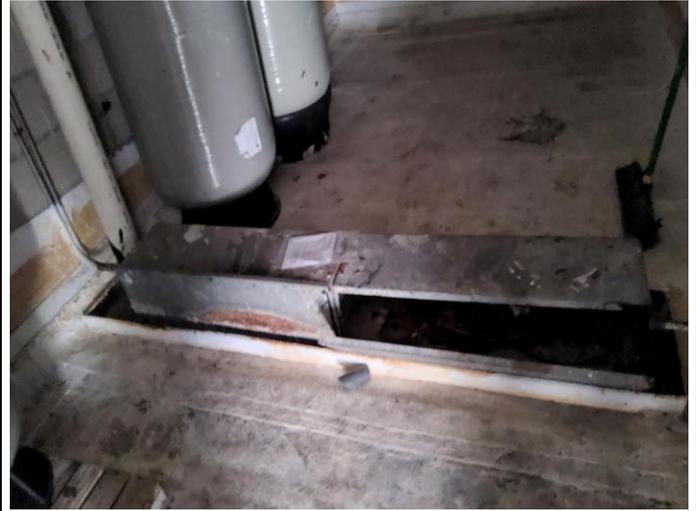
Photo # 6. Item 6.1. Roof. Water domestic pump. Gutter is open, missing screws.

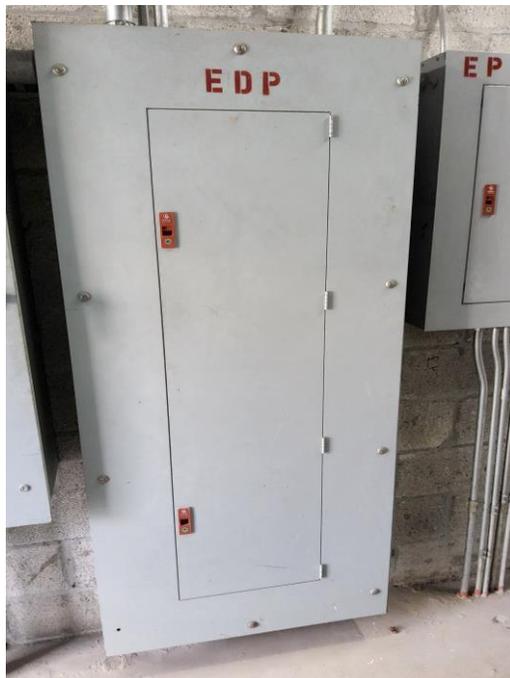
Photo # 7. Item 7.1. Meter Electrical Room. Panelboard EDP. Missing screws.

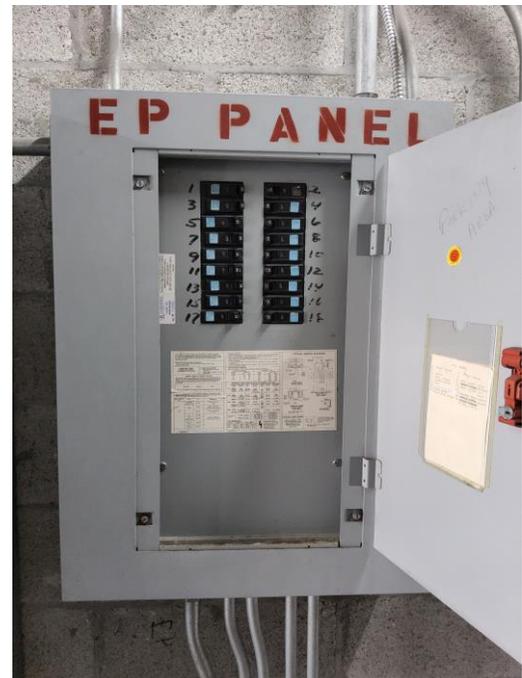
Photo # 8. Item 7.2. Meter Electrical Room. Panelboard EP. Missing proper circuit identification.

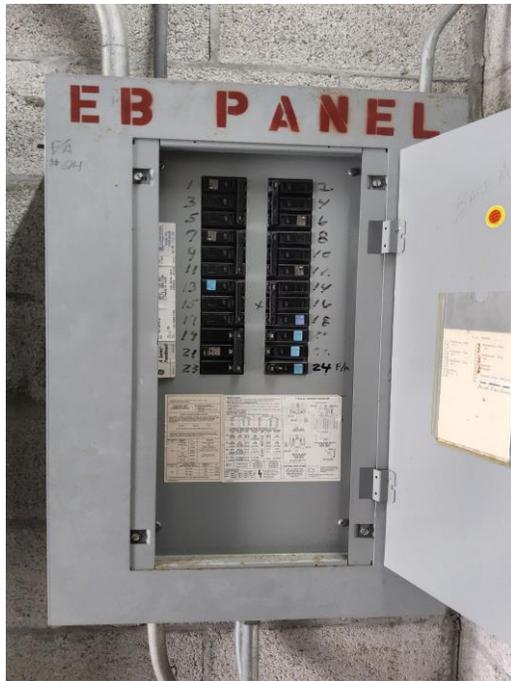
Photo # 9. Item 7.3. Meter Electrical Room. Panelboard EB.

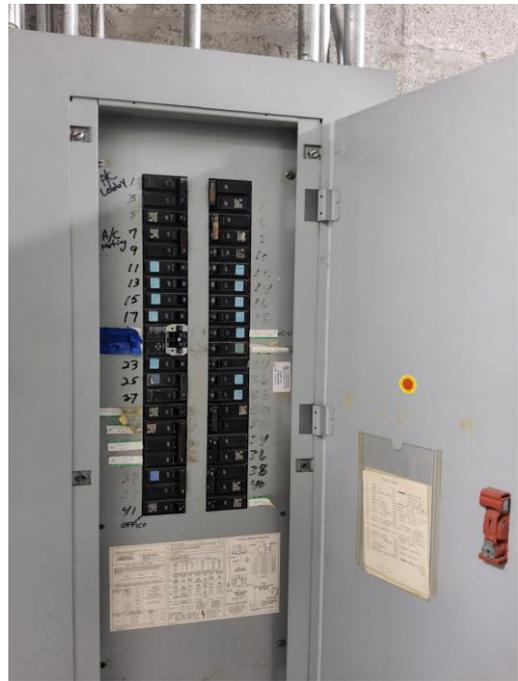
Photo # 10. Item 7.4.a. Meter Electrical Room. Panelboard HOUSE. Missing proper circuit identification.

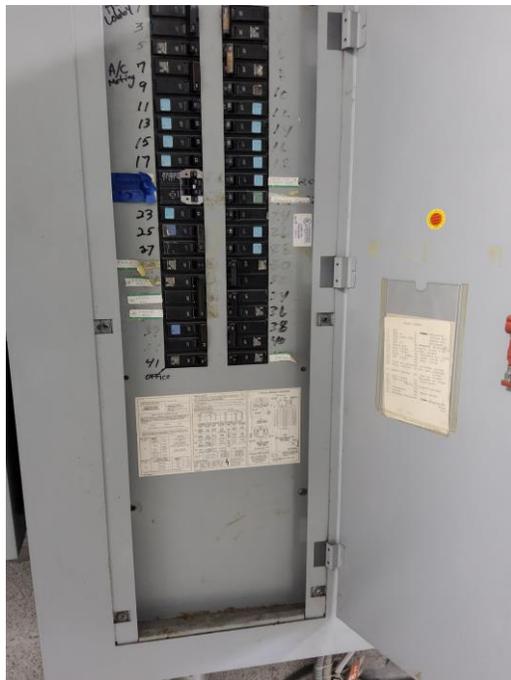
Photo # 11. Item 7.4.b. Meter Electrical Room. Panelboard HOUSE. Missing screws.

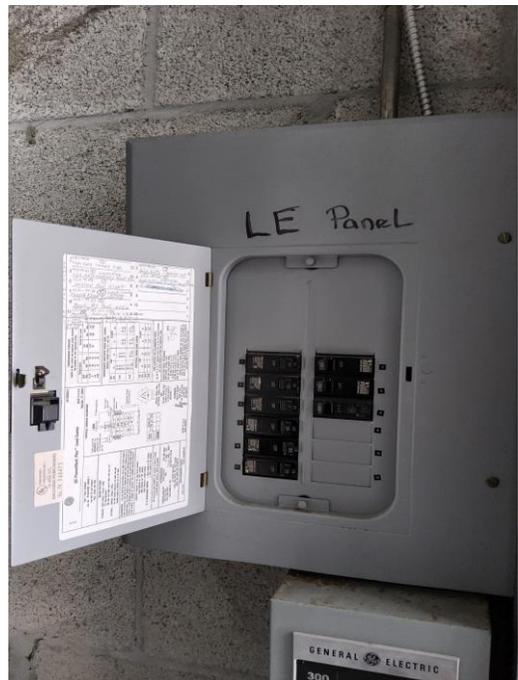
Photo # 12. Item 7.5. Meter Electrical Room. Panelboard LE. Missing proper circuit identification.

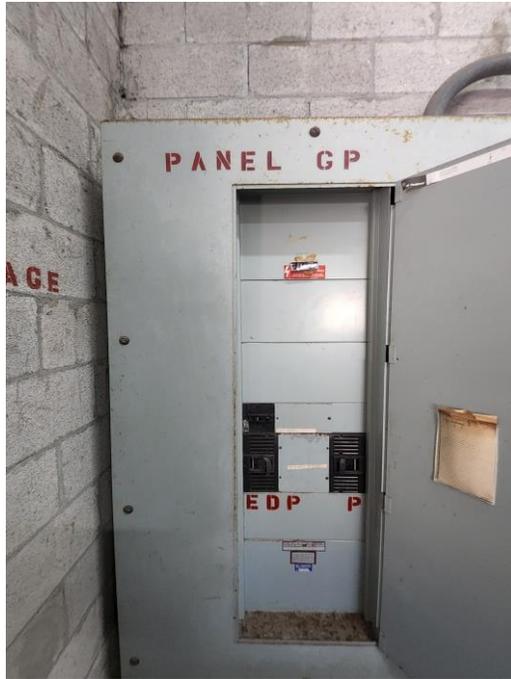
Photo # 13. Item 7.6. Meter Generator - Fire Pump Room. Panelboard GP. Missing proper circuit identification.

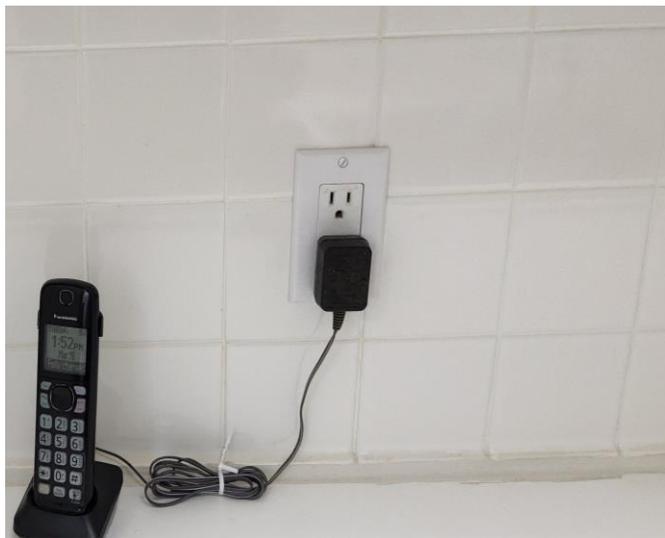
Photo # 15. Item 16.a. Conference Area. Kitchennete. Missing GFCI protection for receptacle - Test Fail.

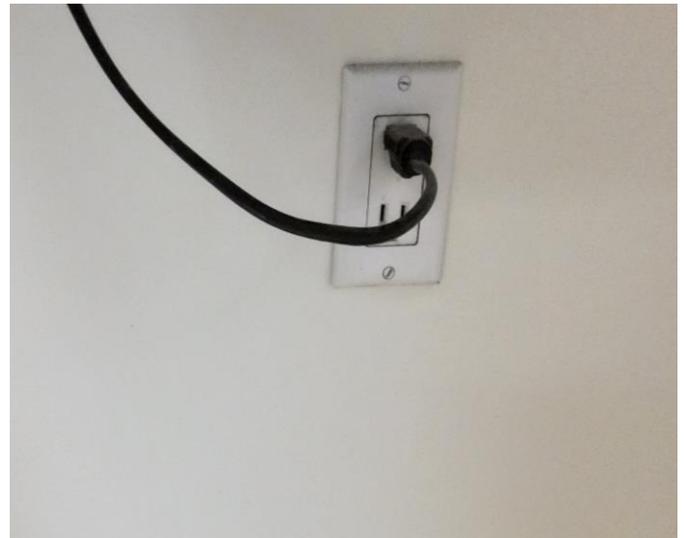
Photo # 16. Item 16.b. Drinking fountain. Missing GFCI protection for receptacles.

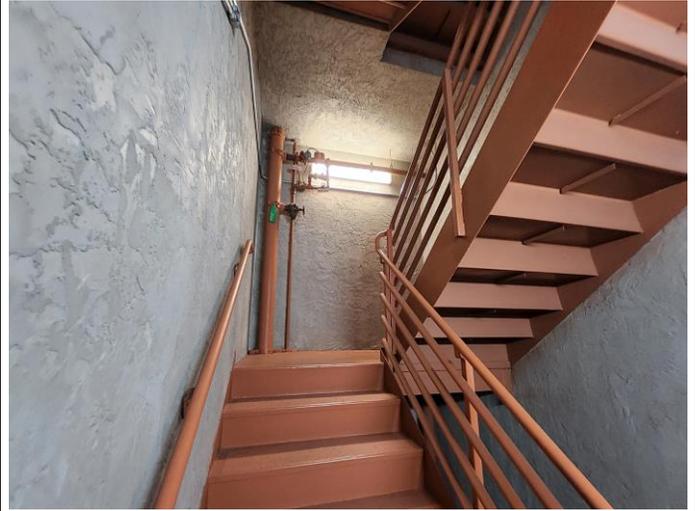
Photo # 18. Item 19.a. Level 2. West Stair Illumination

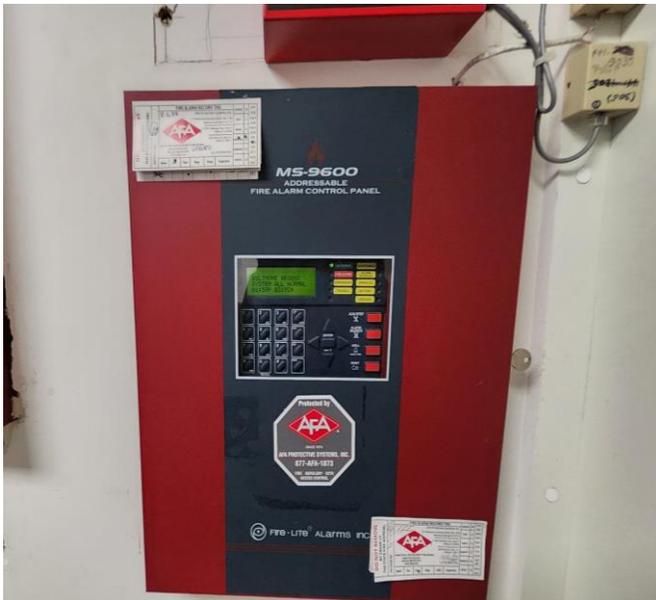
Photo # 19. Item 20.1. Level G. Fire Alarm Central Panel.

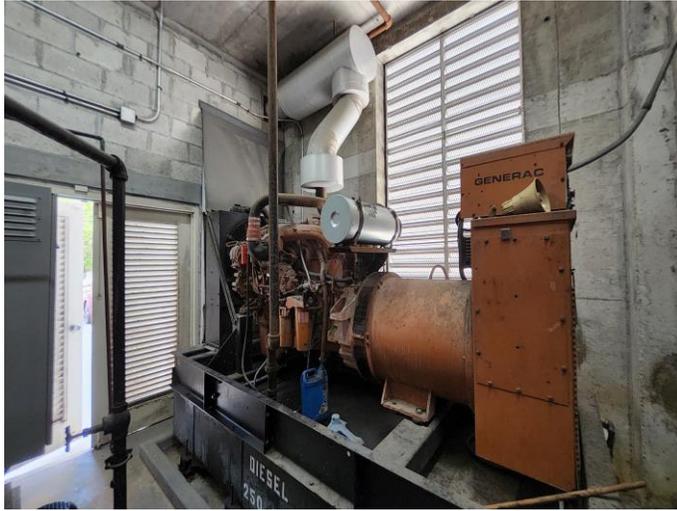
Emergency Generator. See Annex "A", photo #21.

Photo # 21. Item 23.1. Level G. Emergency Generator.

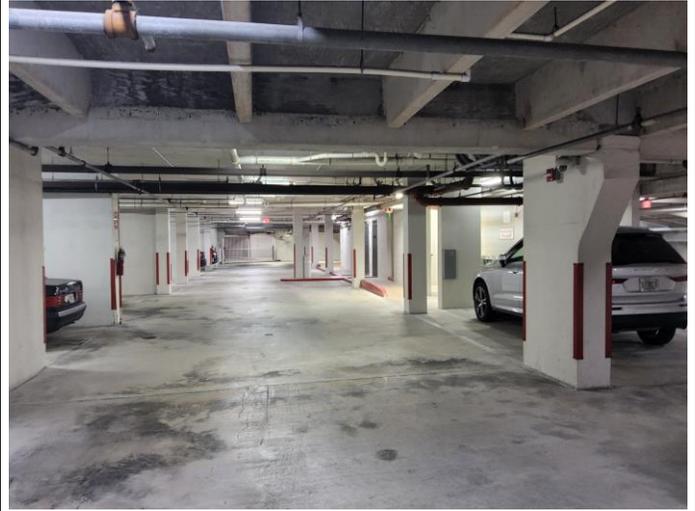
Photo # 22. Item 25.1. Basement Level - Cover parking, Fc = 13.38.

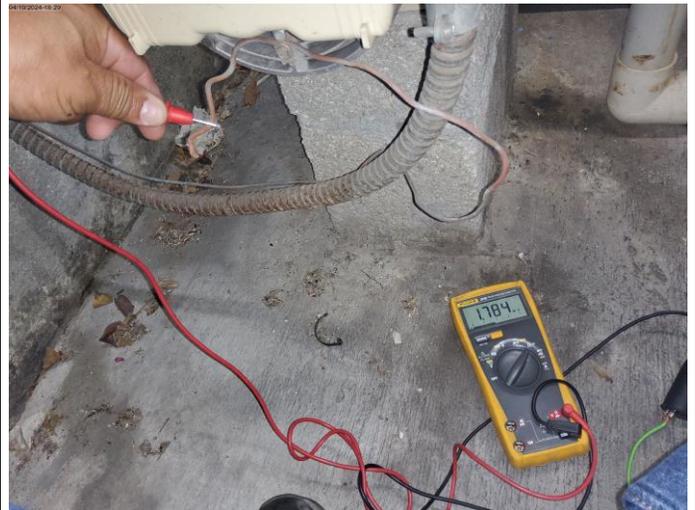
Photo # 24. Item 26.a. Pool equipotential bonding: Failed test between pumps and metal parts.

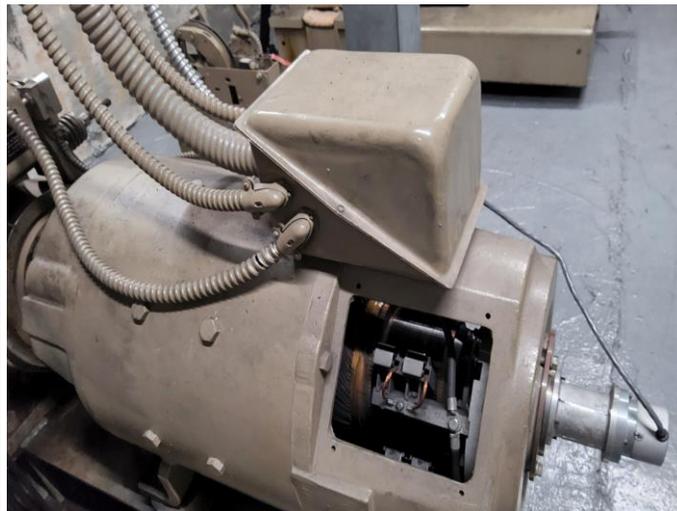
Photo # 26. Item 27.a. Roof. Elevator room. Missing motor cover protection.

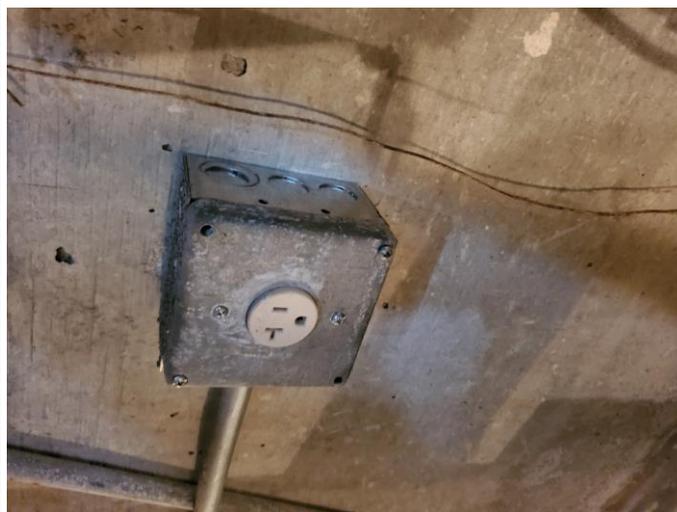
Explanation: Missing GFCI protection for receptacle below grade of elevator. See Annex "A", photo #28.

Photo # 28. Item 27.c. Level Bassement. Elevator. Missing GFCI protection for receptacle.

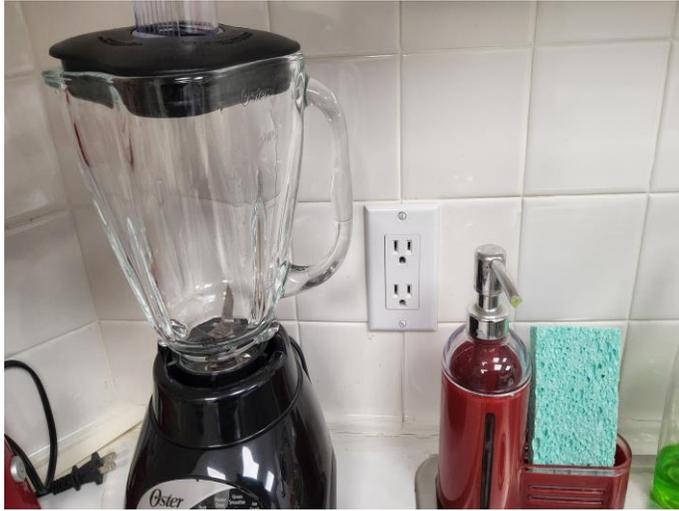
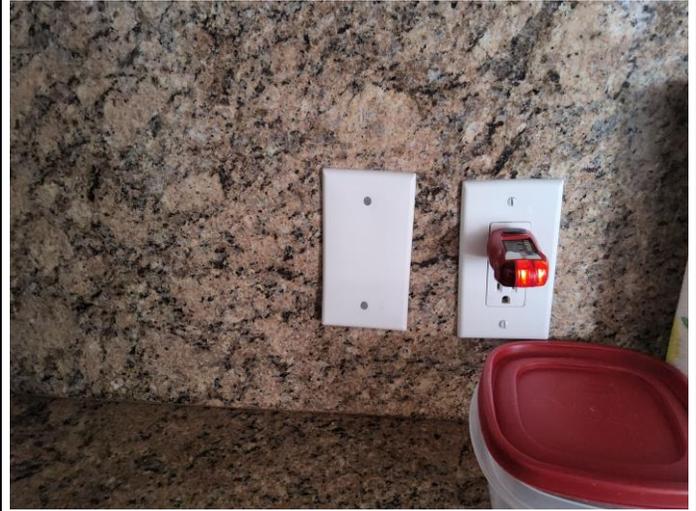
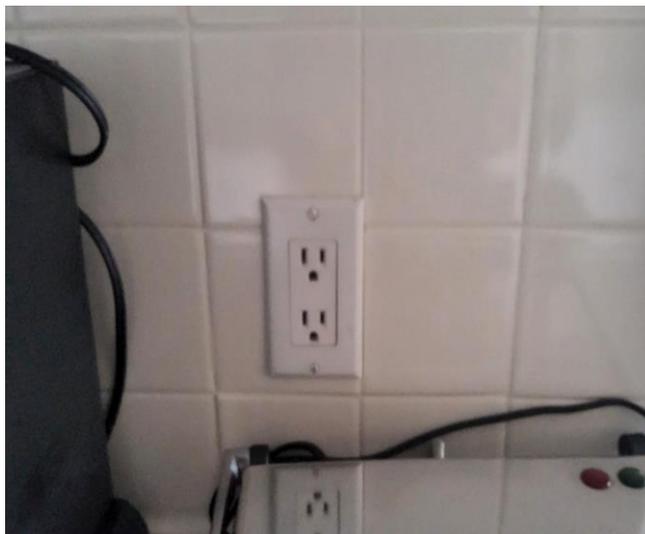
Photo # 29. Item 28.1. Missing GFCI protection for receptacles in the kitchen.

Photo # 30. Item 28.1. Missing GFCI protection for receptacles in the kitchen.

Photo # 31. Item 28.1. Missing GFCI protection for receptacles in the kitchen.

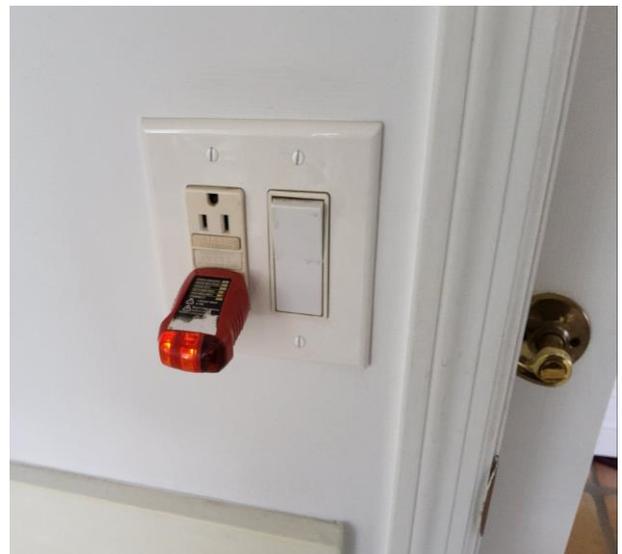
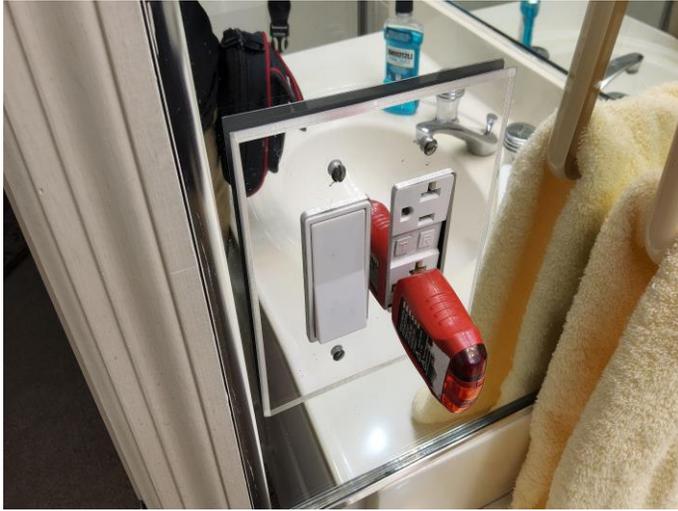
Photo # 32. Item 28.2. Missing GFCI protection for receptacles in the bathroom- test fail.

Photo # 33. Item 28.2 Missing GFCI protection for receptacles in the bathroom- test fail.

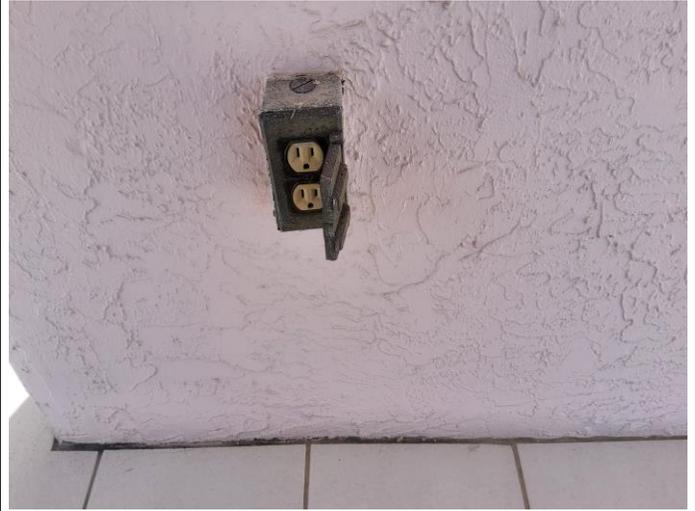
Photo # 34. Item 28.3. Missing GFCI protection for receptacles in the balcony.

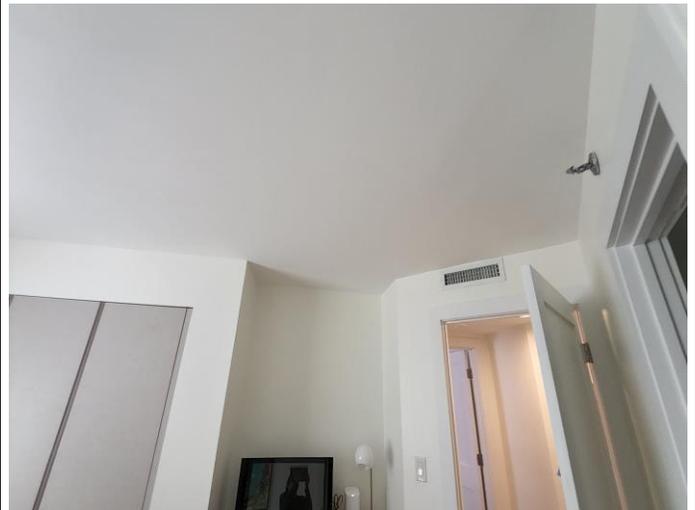
Photo # 36. Item 28.5. Missing smoke alarm inside the sleeping rooms.

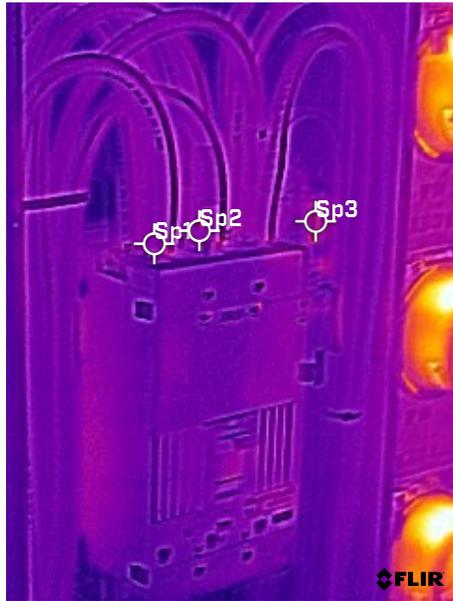
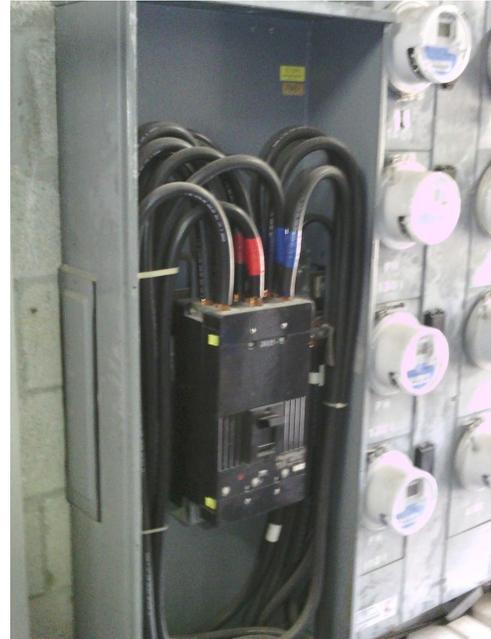
THE BILTMORE REGENT CONDO	
Date	04/10/2024
Location	Electric meter room
Equipment	Main 1 of 2
Component	Circuit breaker
File name	FLIR1353.jpg
Condition	NORMAL

Sp1	26.2 °C
Sp2	26.2 °C
Sp3	26.6 °C

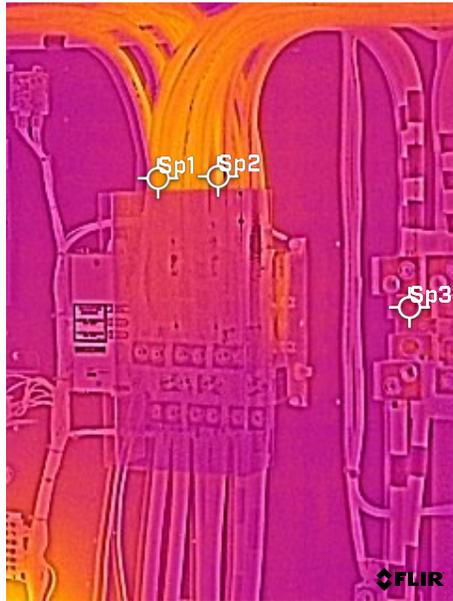
THE BILTMORE REGENT CONDO	
Date	04/10/2024
Location	Electric meter room
Equipment	ATS
Component	ATS
File name	FLIR1357.jpg
Condition	NORMAL

Sp1	27.3 °C
Sp2	27.6 °C
Sp3	26.4 °C

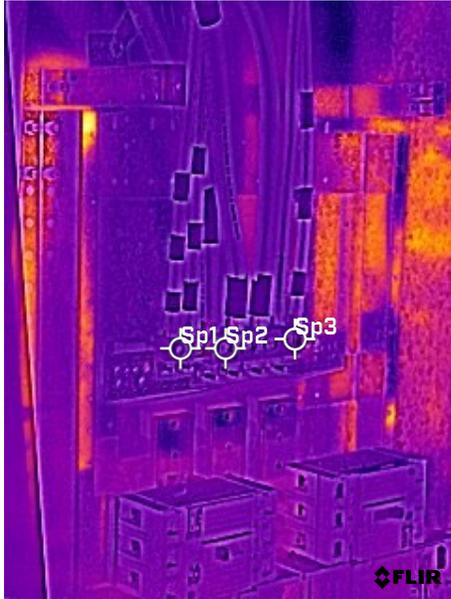
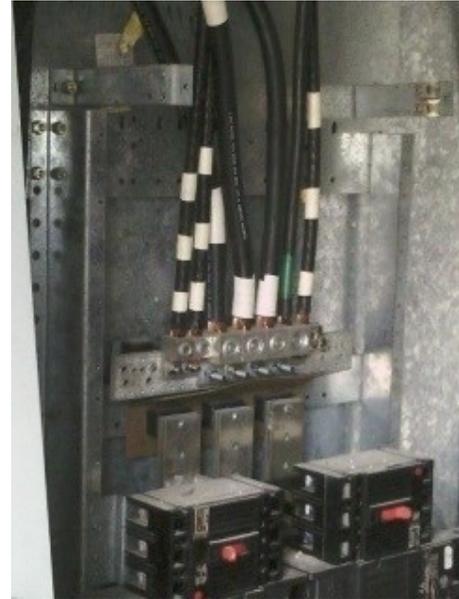
THE BILTMORE REGENT CONDO	
Date	04/10/2024
Location	Electric meter room
Equipment	Main 2 of 2
Component	Panelboard-Neutral bar
File name	FLIR1371.jpg
Condition	NORMAL

Sp1	26.4 °C
Sp2	26.5 °C
Sp3	26.7 °C

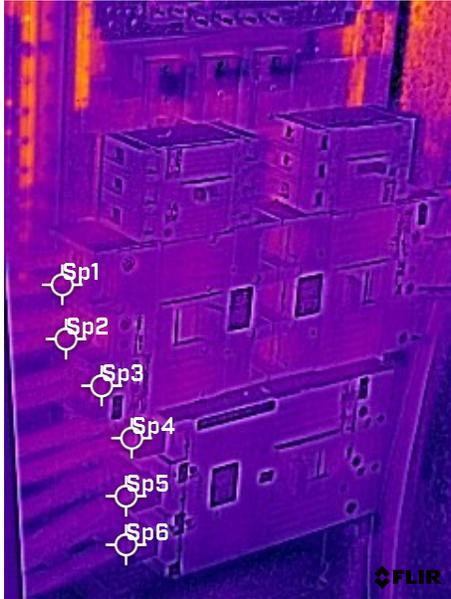
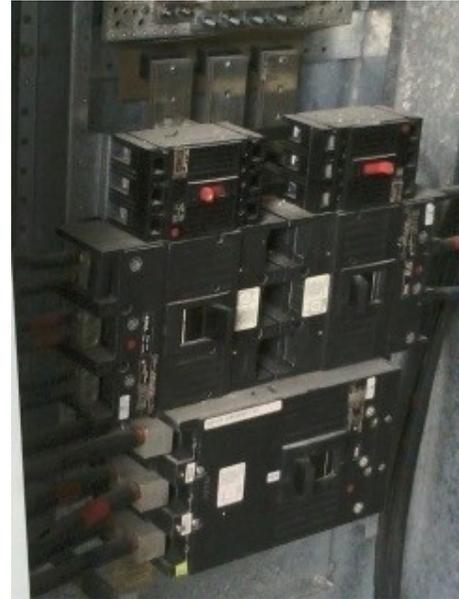
THE BILTMORE REGENT CONDO	
Date	04/10/2024
Location	Electric meter room
Equipment	Main 2 of 2
Component	Panelboard
File name	FLIR1373.jpg
Condition	NORMAL

Sp1	26.9 °C
Sp2	26.9 °C
Sp3	26.9 °C
Sp4	26.9 °C
Sp5	26.7 °C
Sp6	26.4 °C

None.

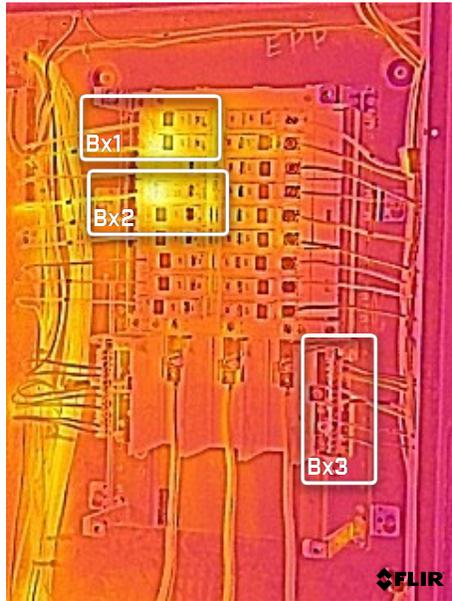
THE BILTMORE REGENT CONDO	
Date	10/14/2025
Location	Electric meter room
Equipment	EP
Component	Panelboard
File name	FLIR5211.jpg
Condition	NORMAL

Bx1	
Max	30.3 °C
Bx2	
Max	30.4 °C
Bx3	
Max	28.1 °C

None.

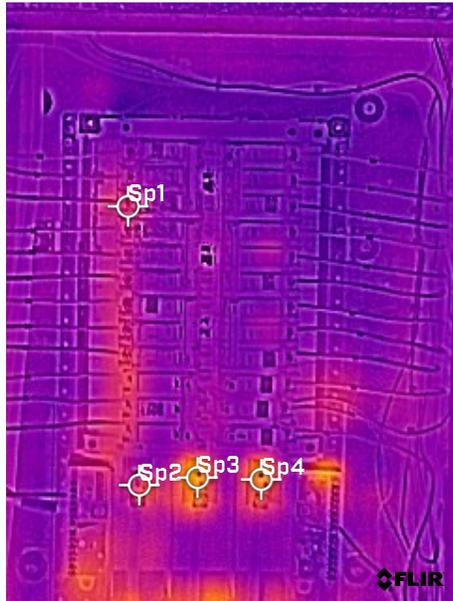
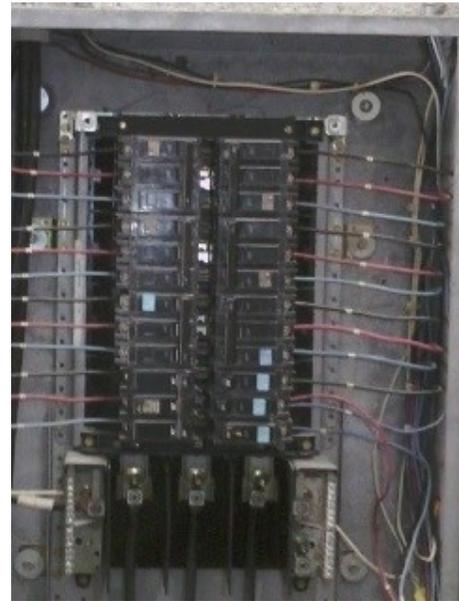
THE BILTMORE REGENT CONDO	
Date	04/10/2024
Location	Electric meter room
Equipment	EB
Component	Panelboard
File name	FLIR1475.jpg
Condition	NORMAL

Sp1	26.5 °C
Sp2	26.6 °C
Sp3	27.4 °C
Sp4	27.2 °C

None.

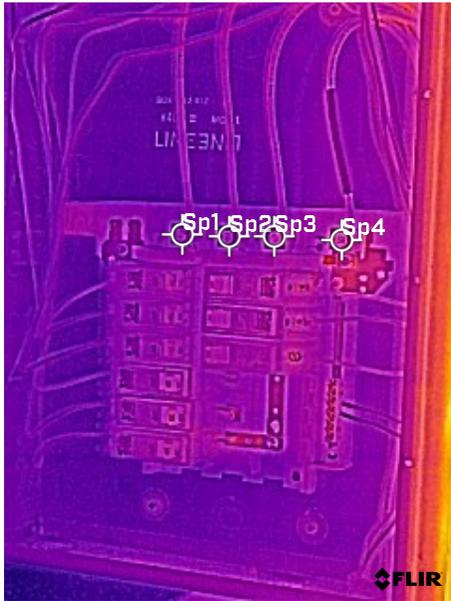
THE BILTMORE REGENT CONDO	
Date	04/10/2024
Location	Electric meter room
Equipment	LE
Component	Panelboard
File name	FLIR1491.jpgg
Condition	NORMAL

Sp1	25.4 °C
Sp2	25.4 °C
Sp3	25.6 °C
Sp4	25.9 °C

None.

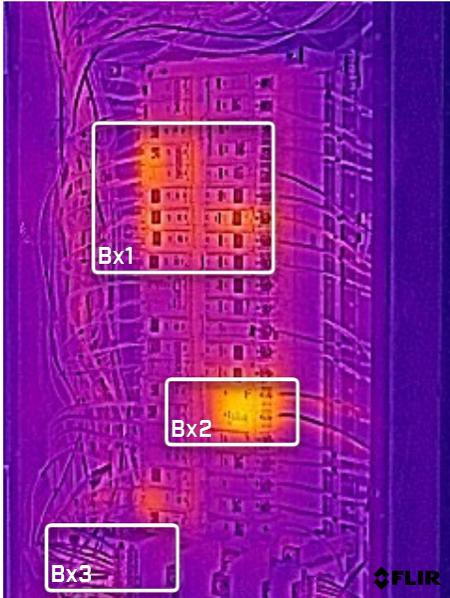
THE BILTMORE REGENT CONDO	
Date	10/14/2025
Location	Electric meter room
Equipment	House
Component	Panelboard
File name	FLIR5189.jpg
Condition	NORMAL

Bx1	
Max	32.2 °C
Bx2	
Max	33.9 °C
Bx3	
Max	29.7 °C

None.

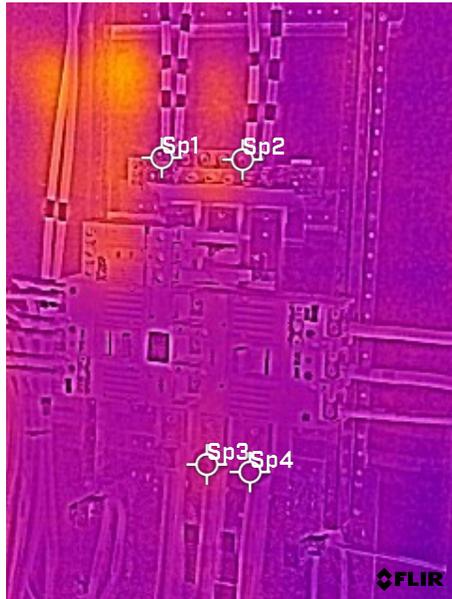
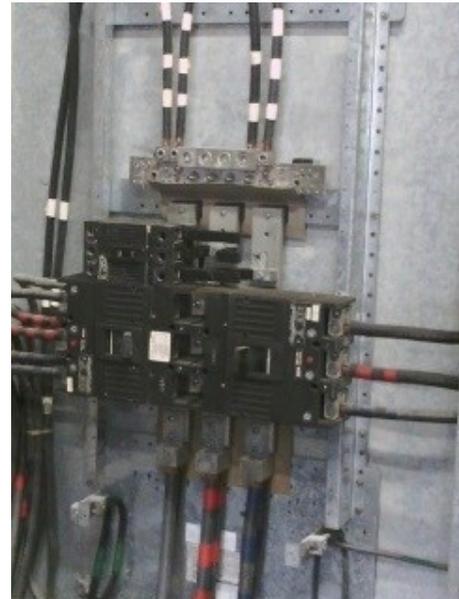
THE BILTMORE REGENT CONDO	
Date	04/10/2024
Location	Generator & Fire Pump Room
Equipment	GP
Component	Panelboard
File name	FLIR1525.jpgg
Condition	NORMAL

Sp1	26.3 °C
Sp2	26.4 °C
Sp3	26.4 °C
Sp4	26.2 °C

None.

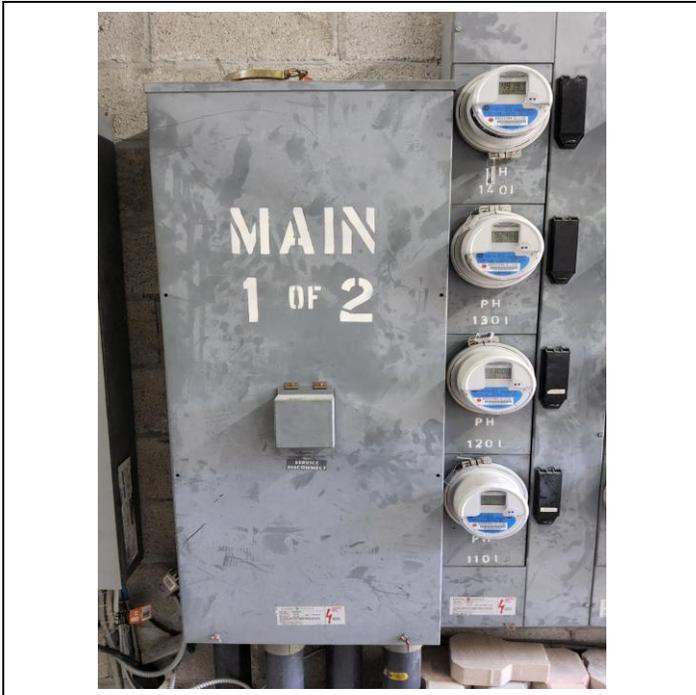
Photo # 3. Item 3. Electrical Service.

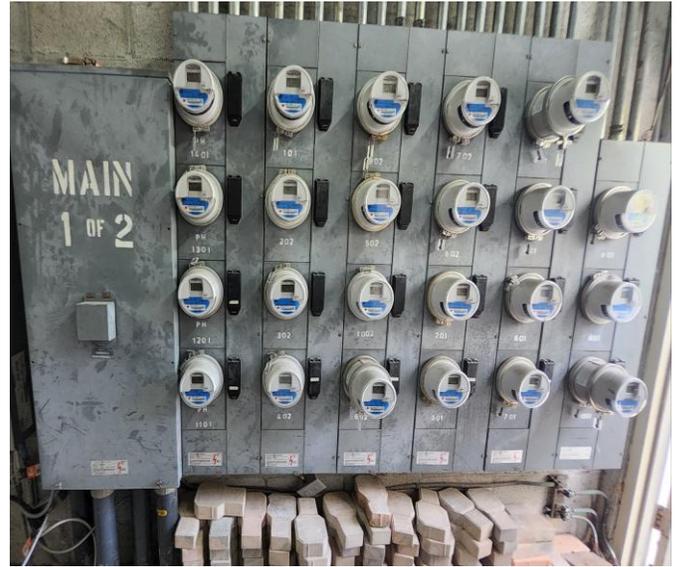
Photo # 4. Item 4. Metering Equipment.

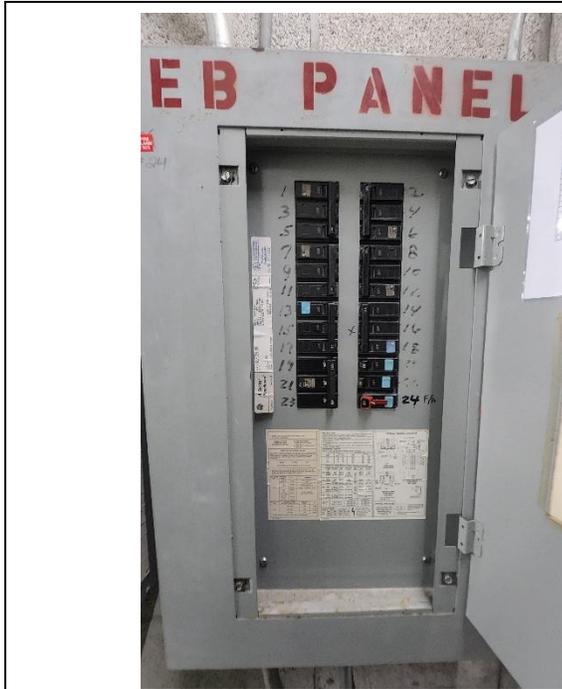
Photo # 7. Item 7. Electrical Panels. Panelboard EB.

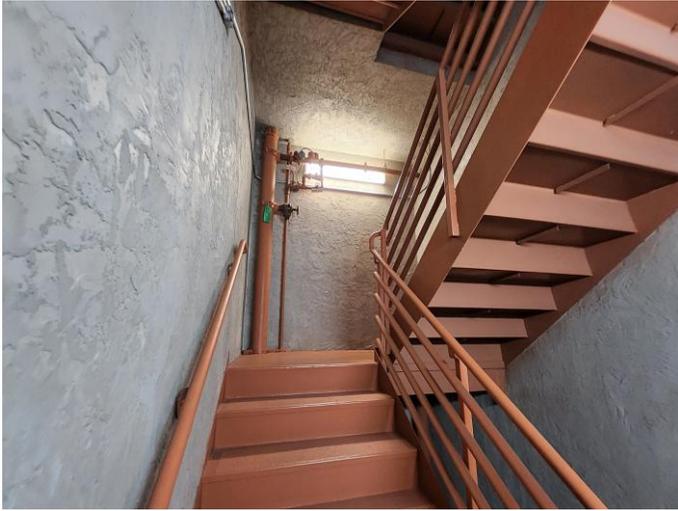
Photo # 19. Item 19. Building Egress Illumination.

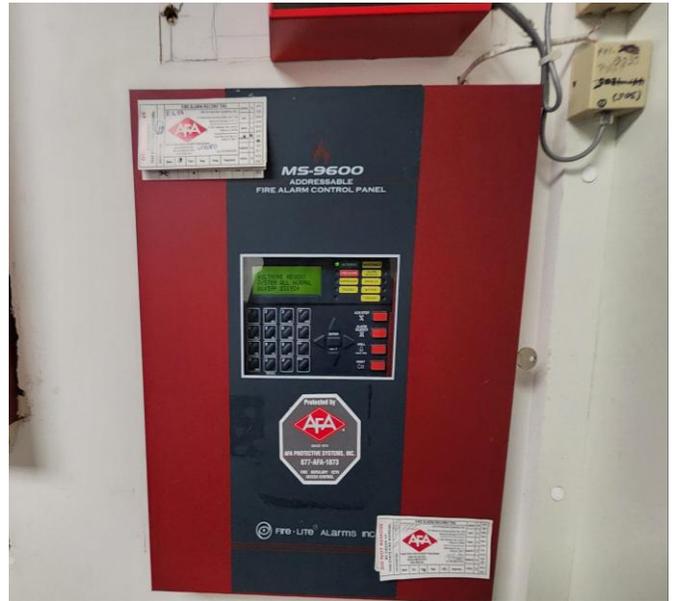
Photo # 20. Item 20. Fire Alarm System.

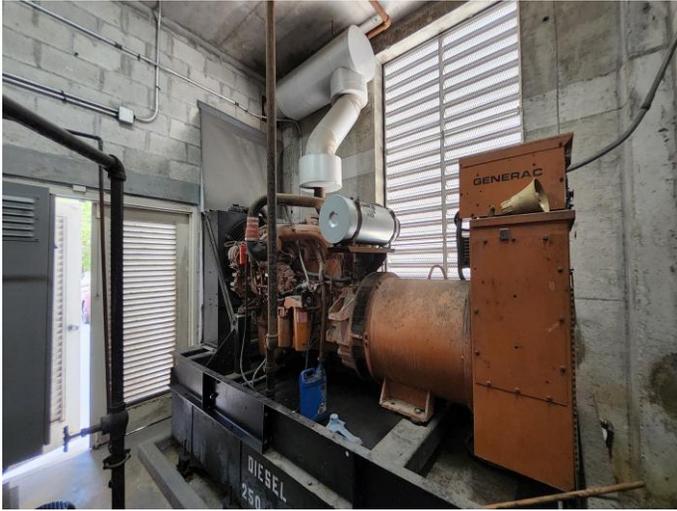
Photo # 23. Item 23. Emergency Generator.

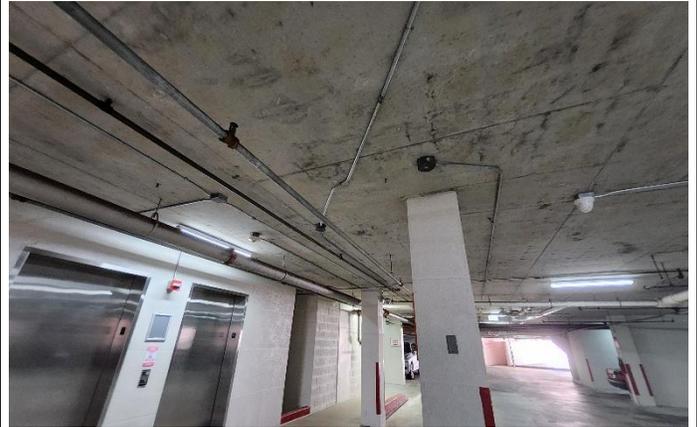
Photo # 24. Item 24. Wiring in open or undercover parking garage areas.

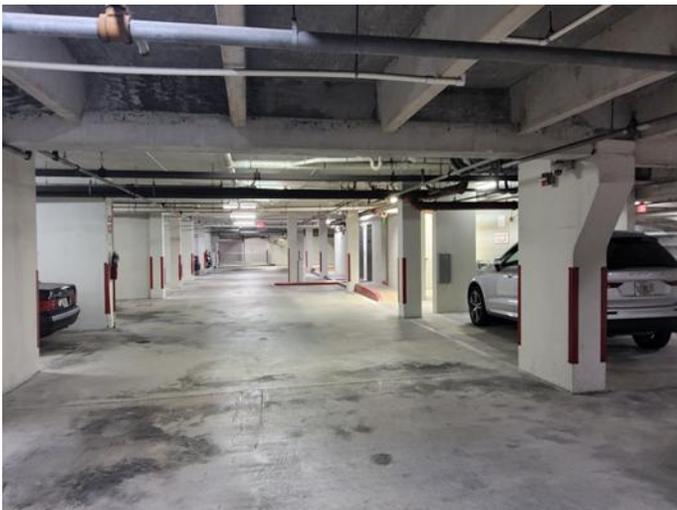
Photo # 25. Item 25. Open parking garage areas.

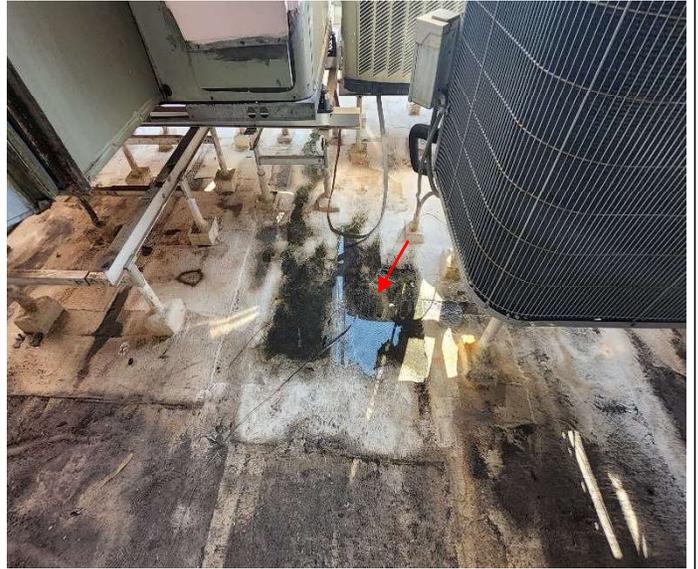
Photo # 18. **Water ponding at the lower flat roof.**

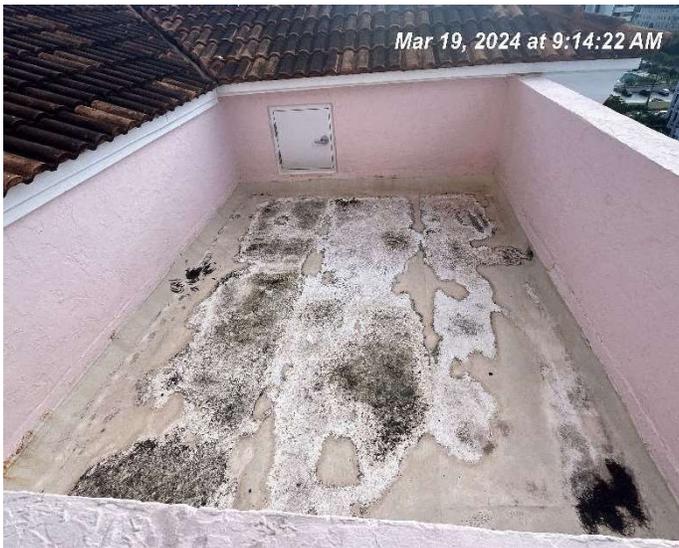
Photo # 19. **Water ponding stains at the PH floor flat roof.**

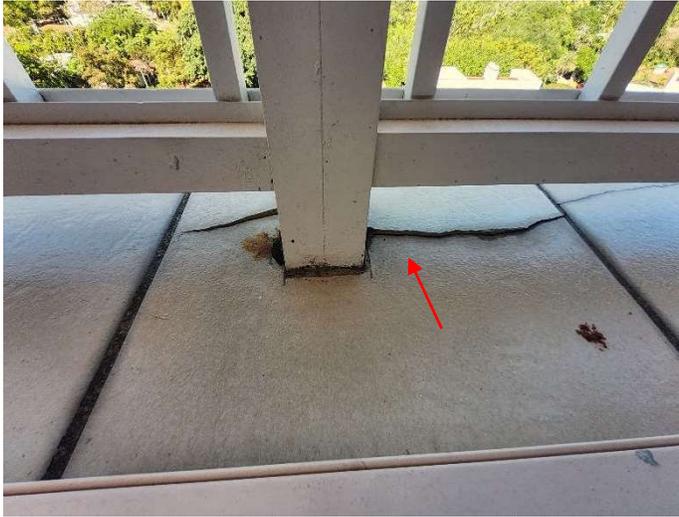
Photo # 33. Cracked tile around the railing post.

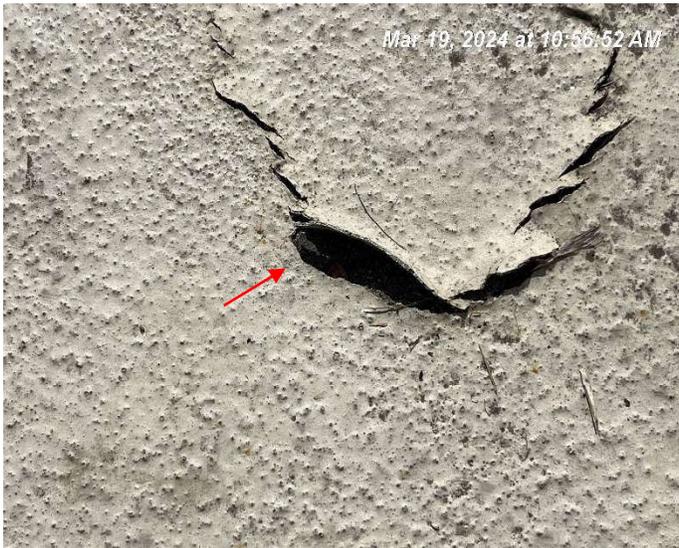
Photo # 47. Delaminated waterproofing coating at the parking deck.

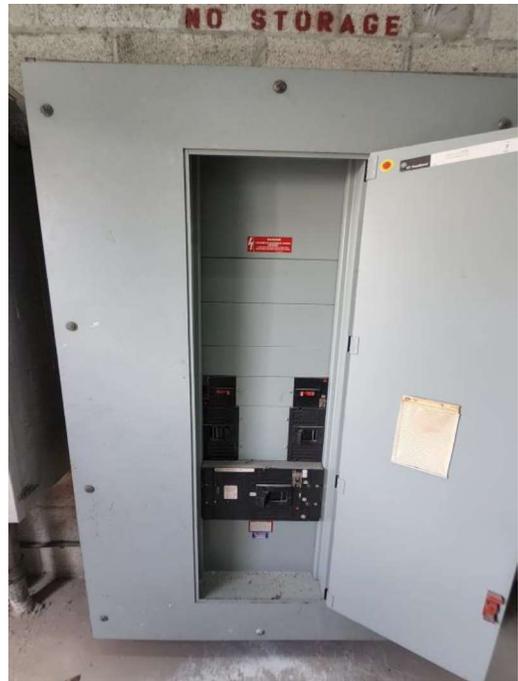
2. MAIN SERVICE- 2 of 2									
Size:	Voltage	208	Amperage	800	Type:	Fuses	800	Breakers	
Phase:	Three-phase	<input checked="" type="radio"/>	Single-phase	<input type="radio"/>					
Condition:	Good	<input type="radio"/>	Fair	<input type="radio"/>	Needs repair	<input checked="" type="radio"/>			
Comments:	Location: Electrical ROOM								
Repairs are required as follows:									
a. Missing proper circuit identification.									
See Annex "A", photo #2.

Photo # 2. Item 3.2. Meter Electrical Room. Panelboard. Main 2 of 2. Missing proper circuit identification.

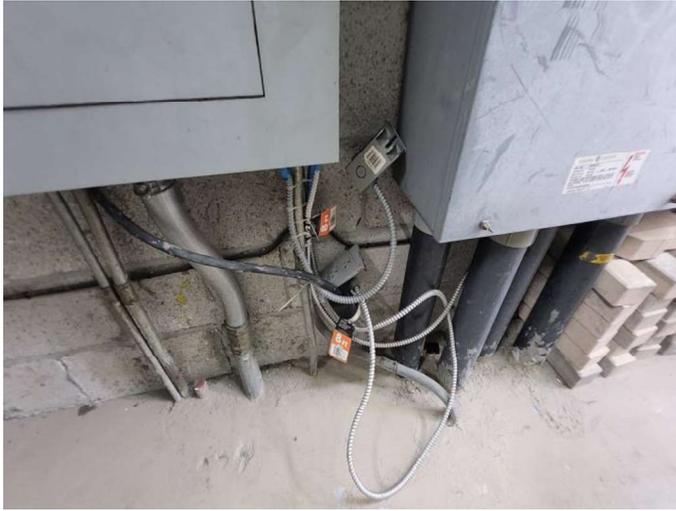
Photo # 5. Item 5.1.a. Meter Electrical Room. All temporary wiring and receptacles must be removed.

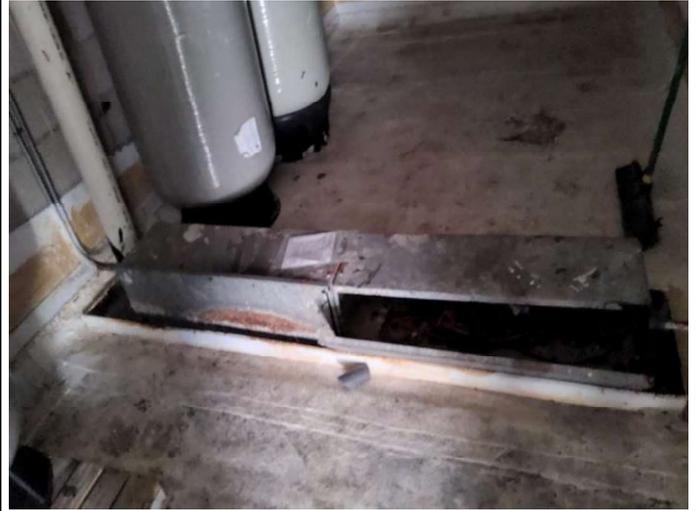
Photo # 6. Item 6.1. Roof. Water domestic pump. Gutter is open, missing screws.

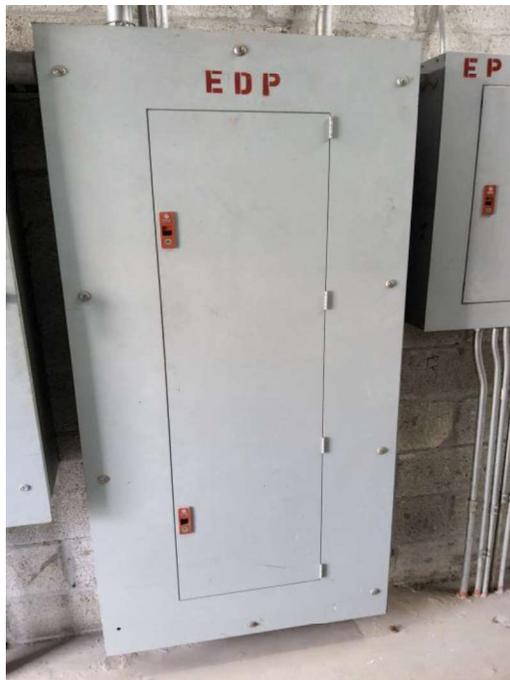
Photo # 7. Item 7.1. Meter Electrical Room. Panelboard EDP. Missing screws.

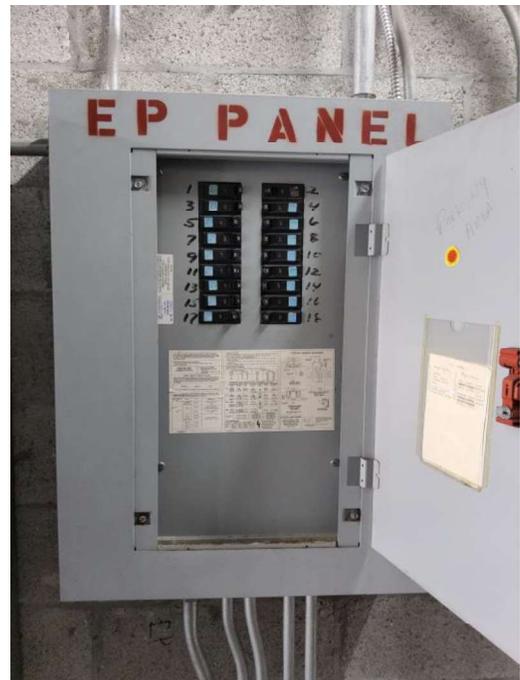
2. Panel #:	EP	Location:	Meter Electrical Room		
		Good	<input type="radio"/>	Needs repair	<input checked="" type="radio"/>
Comments:	Size: No rating	Volt: 208/120	Phases: 3	Type: MLO	
Repairs are required as follows: Missing proper circuit identification. See Annex "A", photo #8.

Photo # 8. Item 7.2. Meter Electrical Room. Panelboard EP. Missing proper circuit identification.

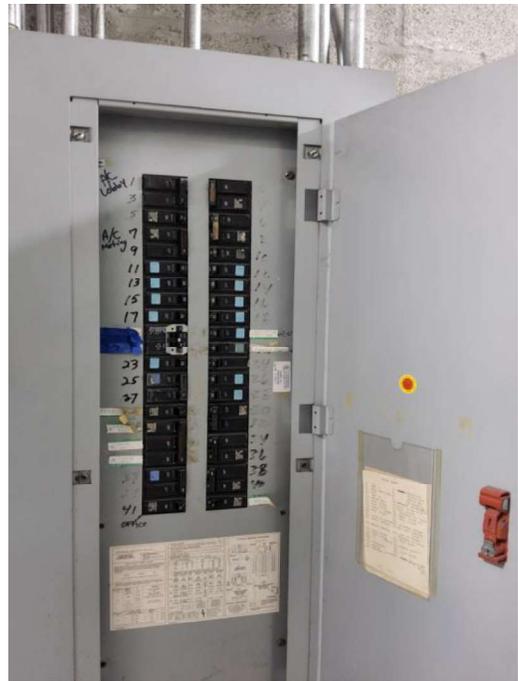
4. Panel #:	HOUSE	Location:	Meter Electrical Room		
		Good	<input type="radio"/>	Needs repair	<input checked="" type="radio"/>
Comments:	Size: No rating	Volt: 208/120	Phases: 3	Type: MLO	
Repairs are required as follows: a. Missing proper circuit identification. See Annex "A", photo #10. b. Missing screws. See Annex "A", photo #11.

Photo # 10. Item 7.4.a. Meter Electrical Room. Panelboard HOUSE. Missing proper circuit identification.

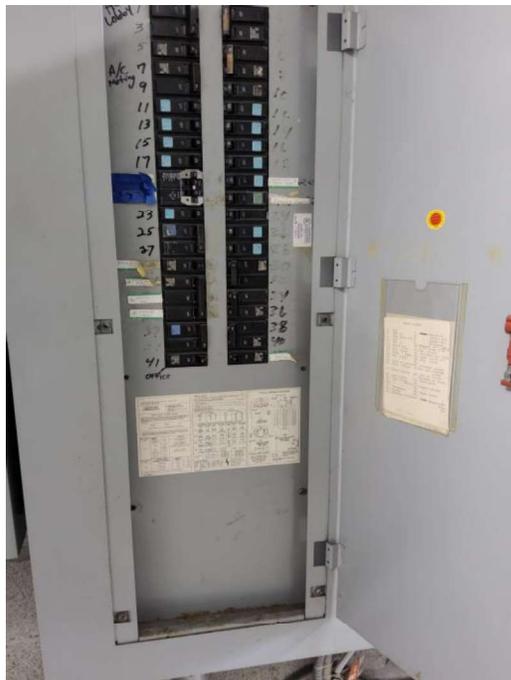
Photo # 11. Item 7.4.b. Meter Electrical Room. Panelboard HOUSE. Missing screws.

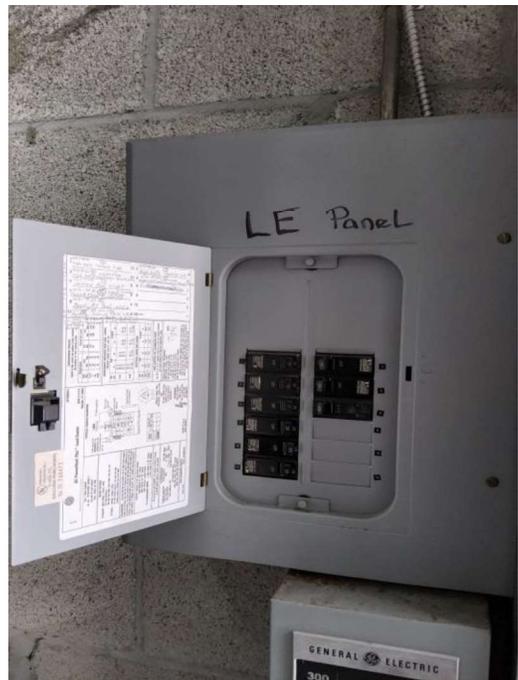
5. Panel #: LE	Location: Meter Electrical Room			
	Good <input type="radio"/>	Needs repair <input checked="" type="radio"/>		
Comments:	Size: No rating	Volt: 480/277	Phases: 3	Type: MLO
Repairs are required as follows: Missing proper circuit identification. See Annex "A", photo #12.

Photo # 12. Item 7.5. Meter Electrical Room. Panelboard LE. Missing proper circuit identification.
