SHORT LEGAL DESCRIPTION	
THE BILTMORE REGENT CONDO	
CORAL GABLES BILTMORE SEC	
LOTS 24 THRU 32 BLK 1 PB 20-28	
F/A/U 03-4117-008-0200

**NOTICE OF UNSAFE STRUCTURE VIOLATION FOR FAILURE TO RECERTIFY
AND NOTICE OF HEARING**

The Falcon Group (Falcon) conducted a 30-Year **Electrical** Recertification of the referenced building in accordance with the requirements of section 8-11(f) of Miami Dade County and City of Coral Gables “General Considerations & Guidelines” for the building safety inspections. In summary, in accordance with the above regulations and guidelines, the recertification is not approved since repairs are required to meet current standards of safety.

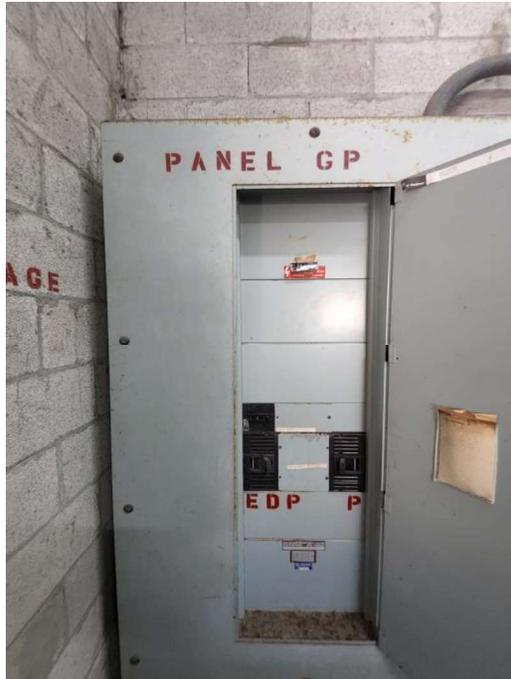
6. Panel #: GP	Location: Generator - Fire Pump Room			
	Good <input type="radio"/>	Needs repair <input checked="" type="radio"/>		
Comments:	Size: 800 AMPS	Volt: 208/120	Phases: 3	Type: MLO
Repairs are required as follows: Missing proper circuit identification. See Annex "A", photo #13.

Photo # 13. Item 7.6. Meter Generator - Fire Pump Room. Panelboard GP. Missing proper circuit identification.

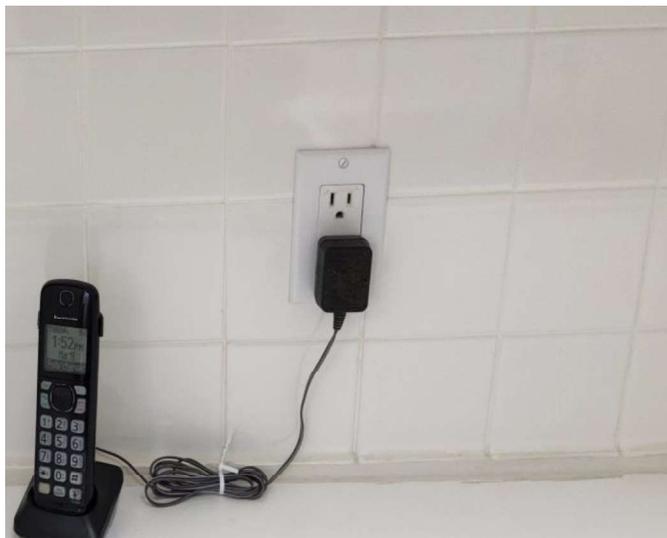
- a. Conference area. Kitchennete. Missing GFCI protection for receptacles above countertop. See Annex "A", photo #15.
- b. Drinking fountain. Missing GFCI protection for receptacles. See Annex "A", photo #16.
- c. Maintenance office. Missing 1-gang cover for receptacles. See Annex "A", photo #17.

Photo # 15. Item 16.a. Conference Area. Kitchennete. Missing GFCI protection for receptacle - Test Fail.

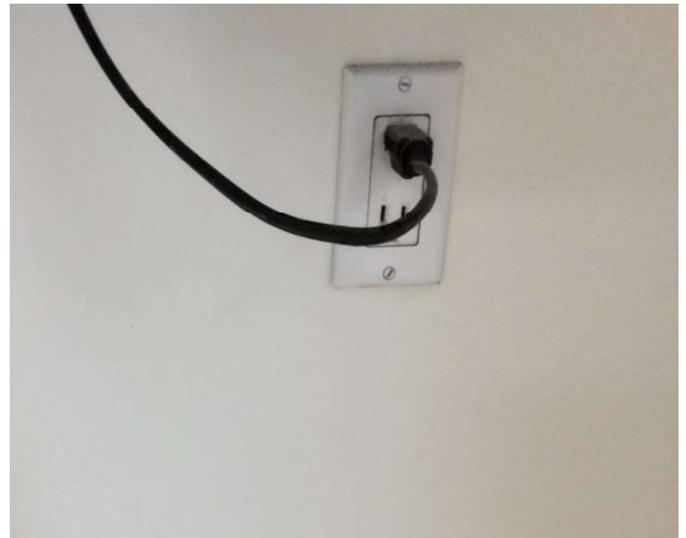
Photo # 16. Item 16.b. Drinking fountain. Missing GFCI protection for receptacles.

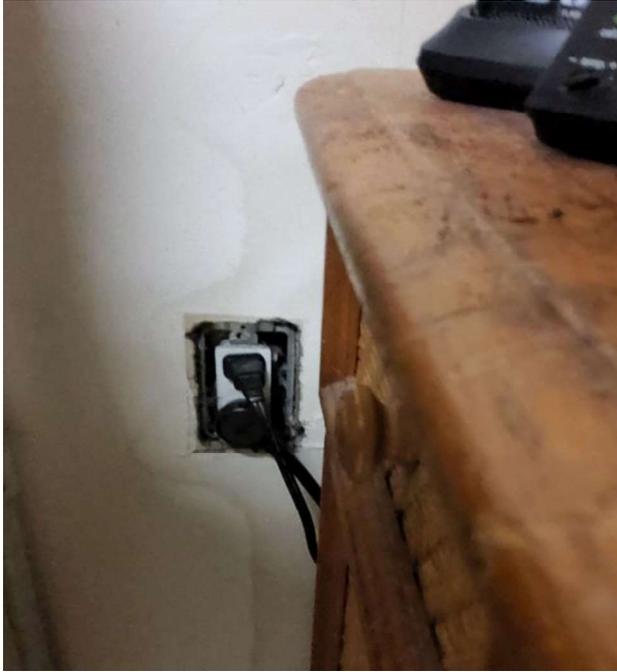
Photo # 17. Item 16.c. Maintenance office. Missing cover for receptacles.

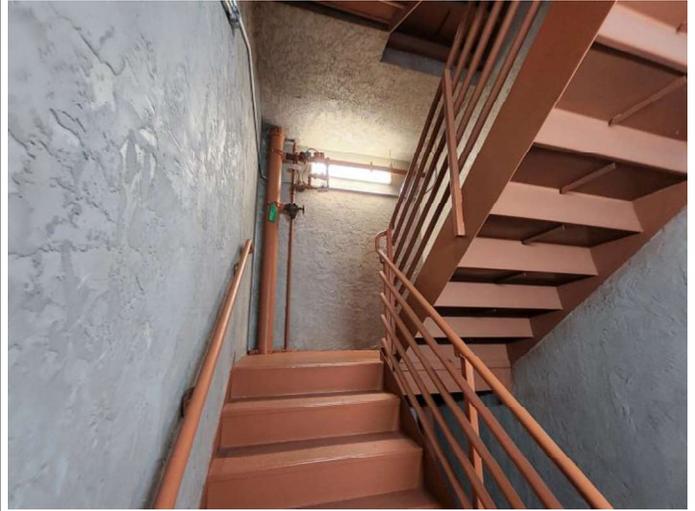
Photo # 18. Item 19.a. Level 2. West Stair Illumination

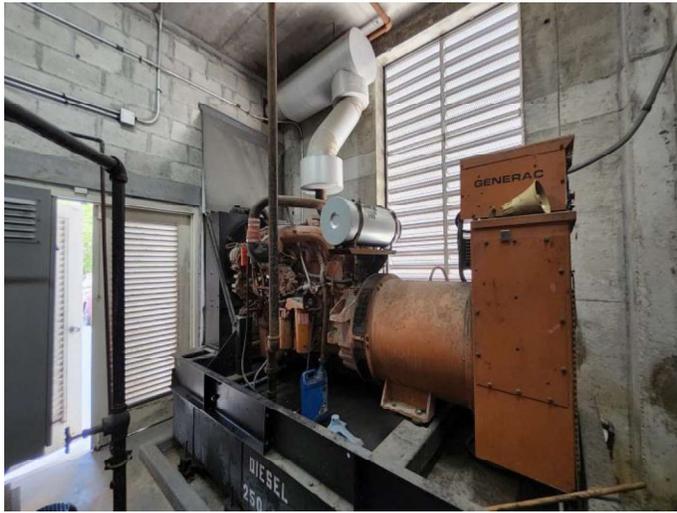
Emergency Generator. See Annex "A", photo #21.

Photo # 21. Item 23.1. Level G. Emergency Generator.

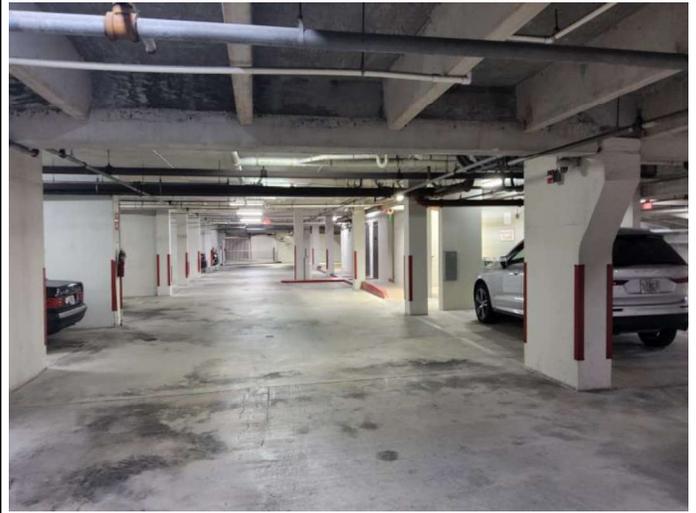
Photo # 22. Item 25.1. Basement Level - Cover parking, Fc = 13.38.

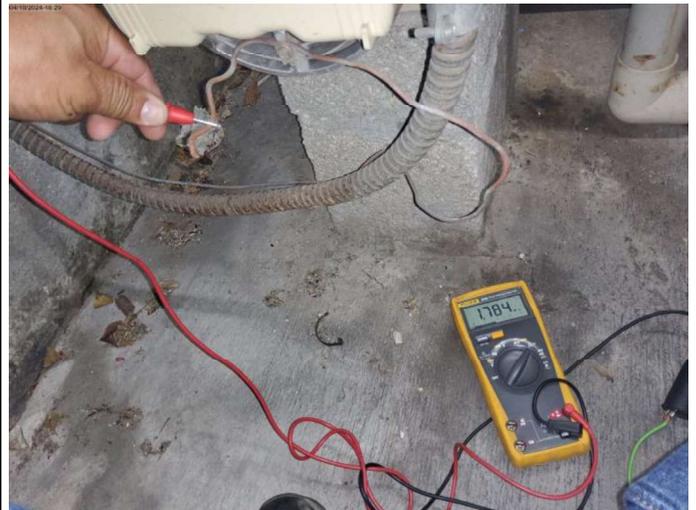
Photo # 24. Item 26.a. Pool equipotential bonding: Failed test between pumps and metal parts.

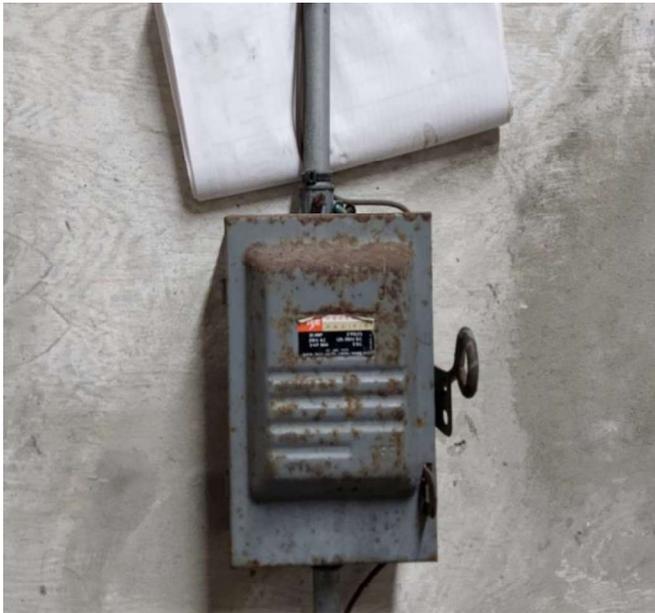
Photo # 25. Item 26.b. Pool pump. Disconnect switch is unsafely rusted.

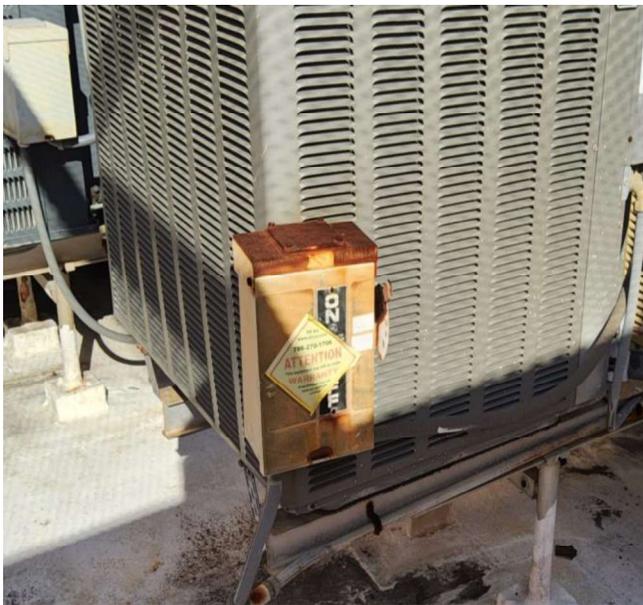
Photo # 27. Item 27.b. Roof. Disconnect Switch is unsafely rusted.

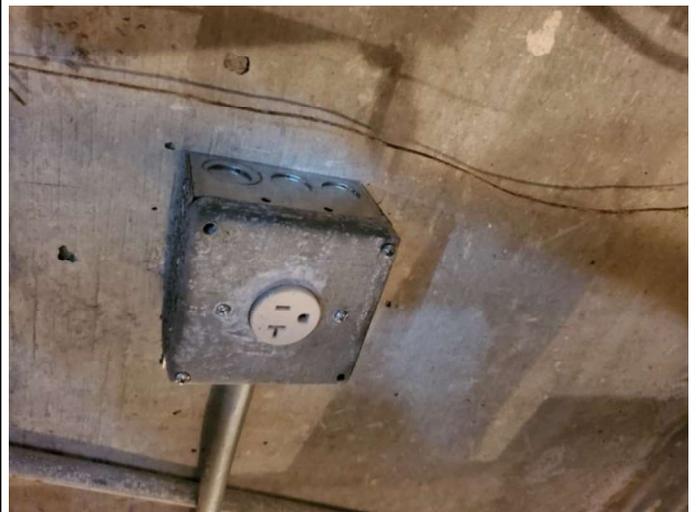
Explanation: Missing GFCI protection for receptacle below grade of elevator. See Annex "A", photo #28.

Photo # 28. Item 27.c. Level Bassement. Elevator. Missing GFCI protection for receptacle.

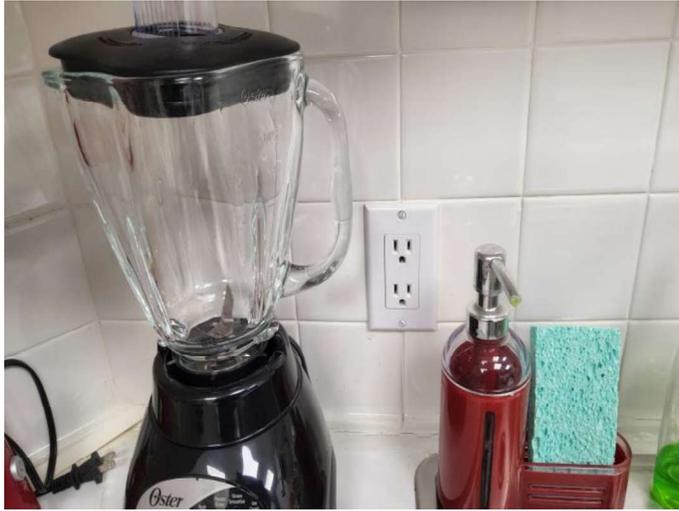
Photo # 29. Item 28.1. Missing GFCI protection for receptacles in the kitchen.

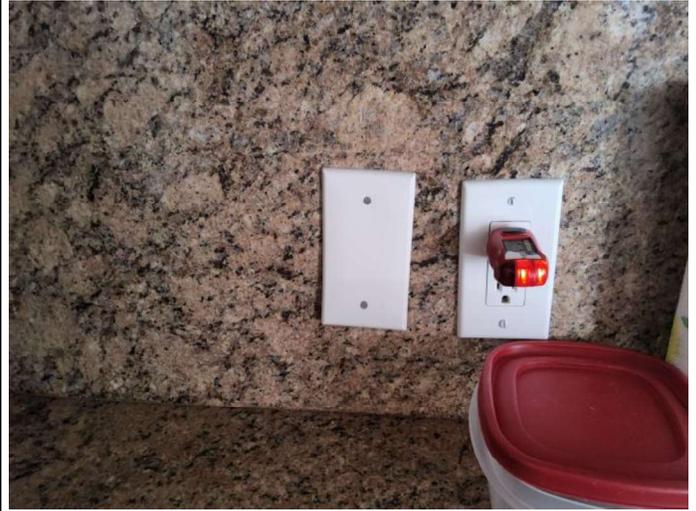
Photo # 30. Item 28.1. Missing GFCI protection for receptacles in the kitchen.

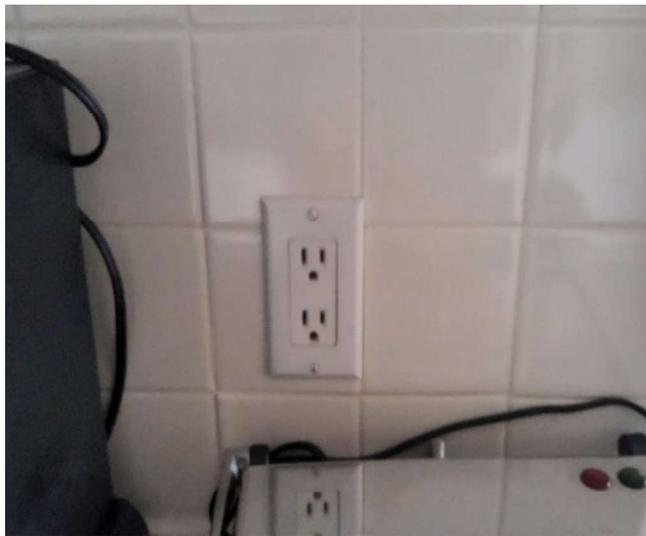
Photo # 31. Item 28.1. Missing GFCI protection for receptacles in the kitchen.

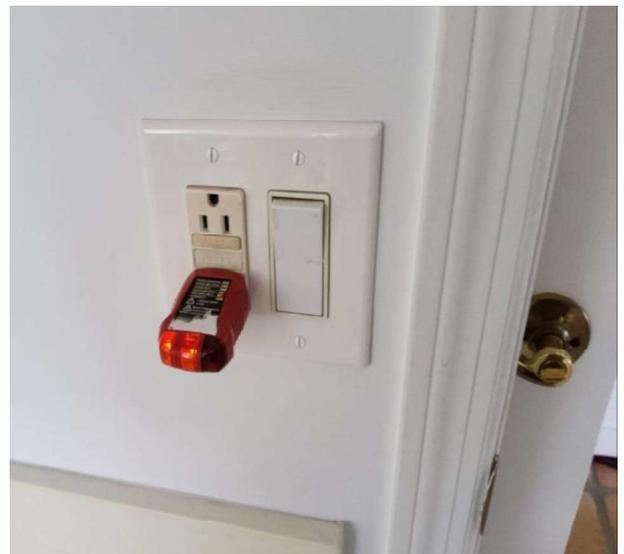
Photo # 32. Item 28.2. Missing GFCI protection for receptacles in the bathroom- test fail.

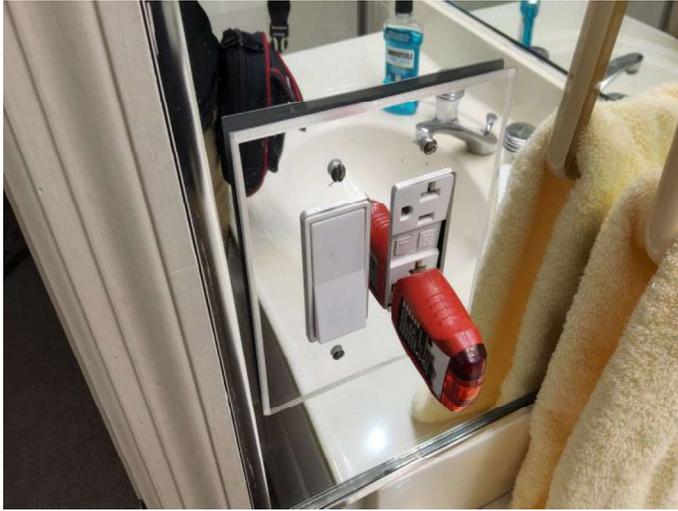
Photo # 33. Item 28.2 Missing GFCI protection for receptacles in the bathroom- test fail.

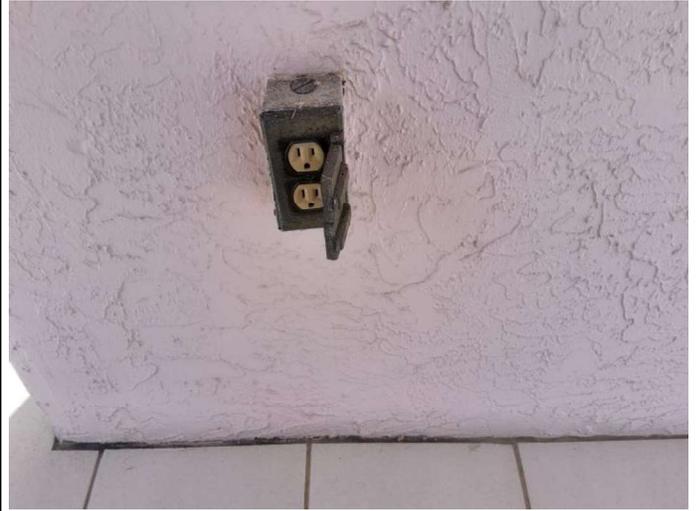
Photo # 34. Item 28.3. Missing GFCI protection for receptacles in the balcony.

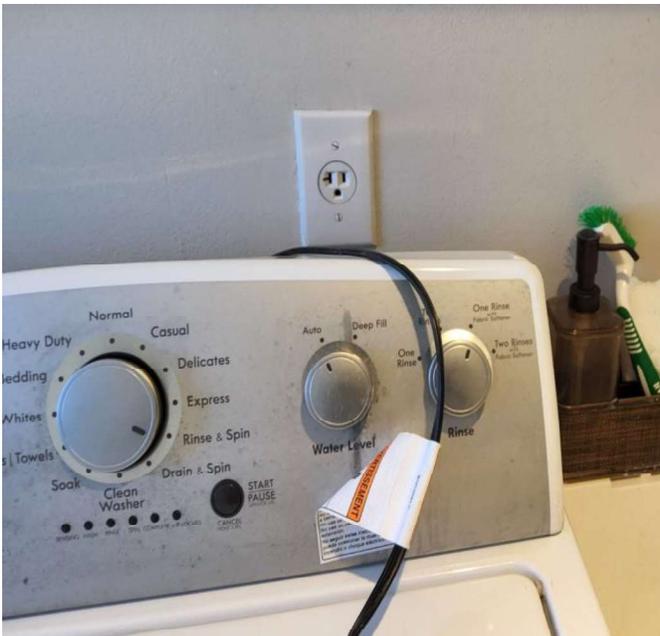
Photo # 35. Item 28.4. Missing GFCI protection for receptacles in the laundry.

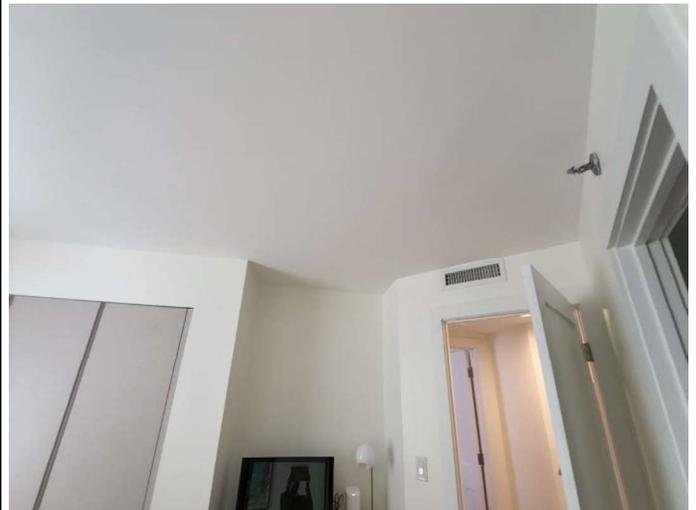
Photo # 36. Item 28.5. Missing smoke alarm inside the sleeping rooms.

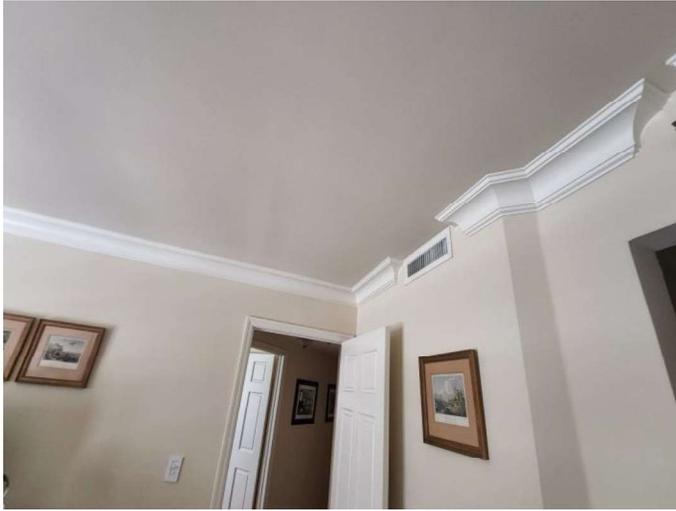
Photo # 37. Item 28.3. Missing smoke alarm inside the sleeping rooms.

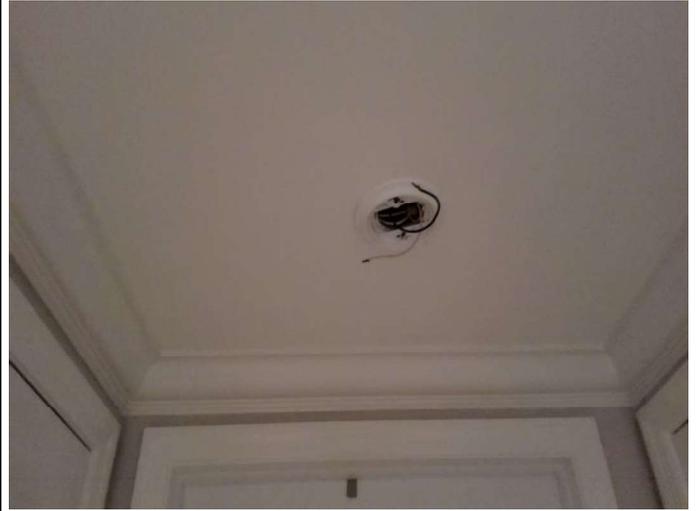
Photo # 38. Item 28.6. Missing smoke alarm outside the sleeping rooms.

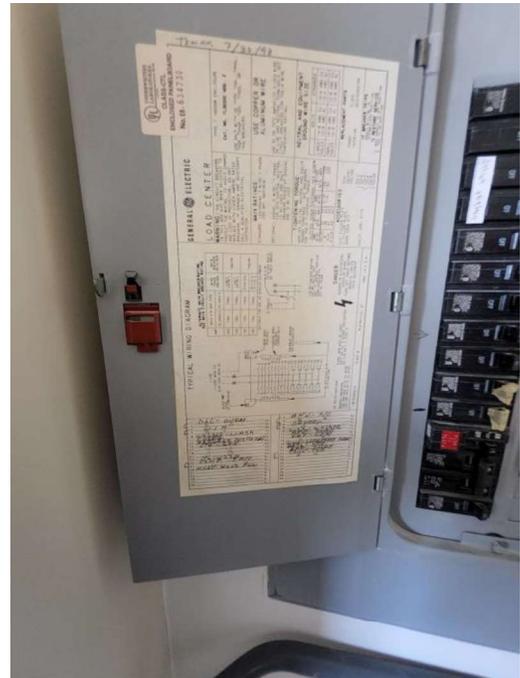
Photo # 40. Item 28.7. Electrical panel missing or incomplete proper circuit directory.

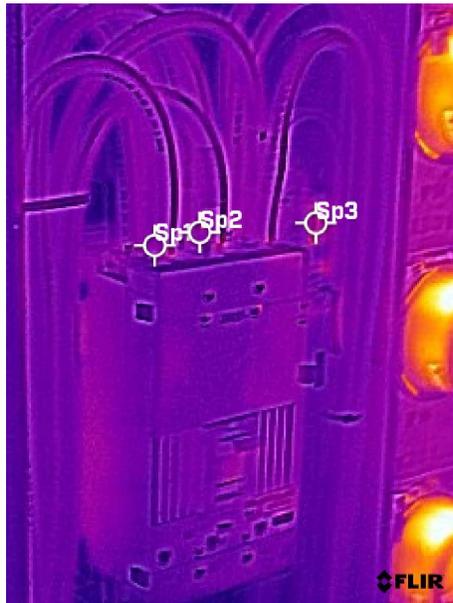
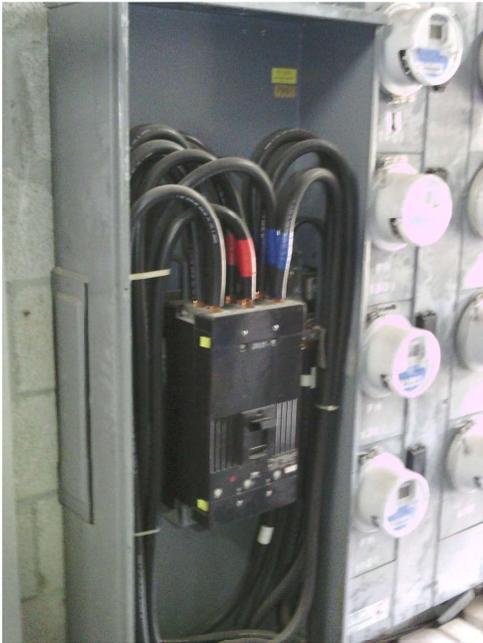
THE BILTMORE REGENT CONDO	
Date	04/10/2024
Location	Electric meter room
Equipment	Main 1 of 2
Component	Circuit breaker
File name	FLIR1353.jpg
Condition	NORMAL

Sp1	26.2 °C
Sp2	26.2 °C
Sp3	26.6 °C

None.

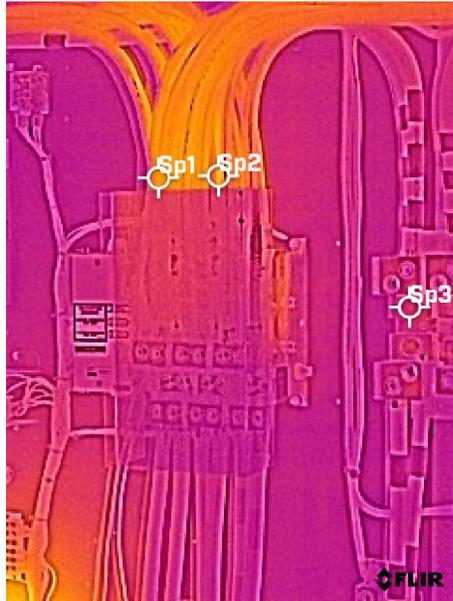
THE BILTMORE REGENT CONDO	
Date	04/10/2024
Location	Electric meter room
Equipment	ATS
Component	ATS
File name	FLIR1357.jpg
Condition	NORMAL

Sp1	27.3 °C
Sp2	27.6 °C
Sp3	26.4 °C

None.

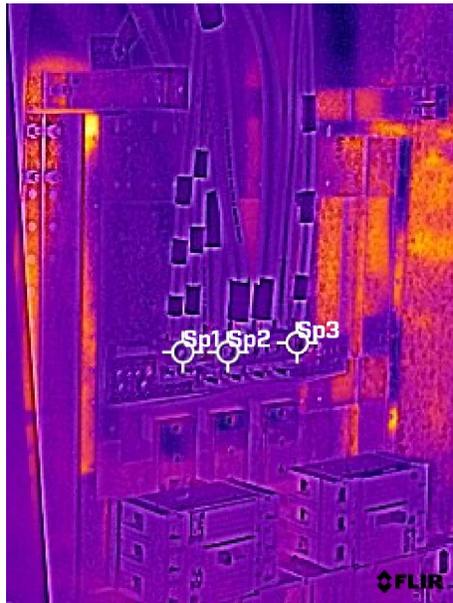
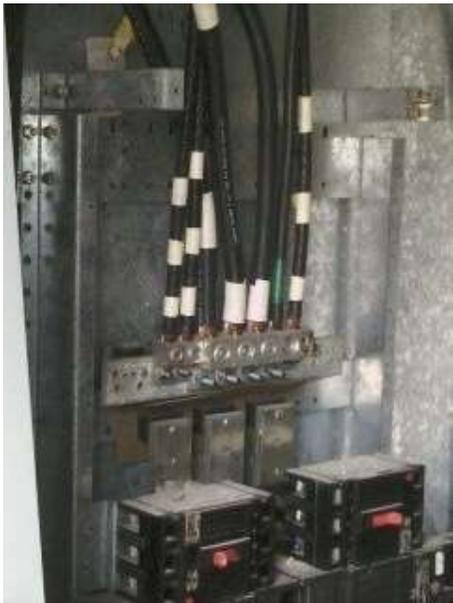
THE BILTMORE REGENT CONDO	
Date	04/10/2024
Location	Electric meter room
Equipment	Main 2 of 2
Component	Panelboard-Neutral bar
File name	FLIR1371.jpg
Condition	NORMAL

Sp1	26.4 °C
Sp2	26.5 °C
Sp3	26.7 °C

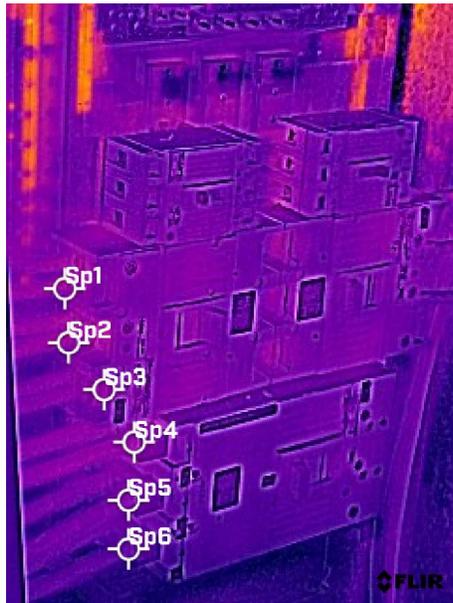
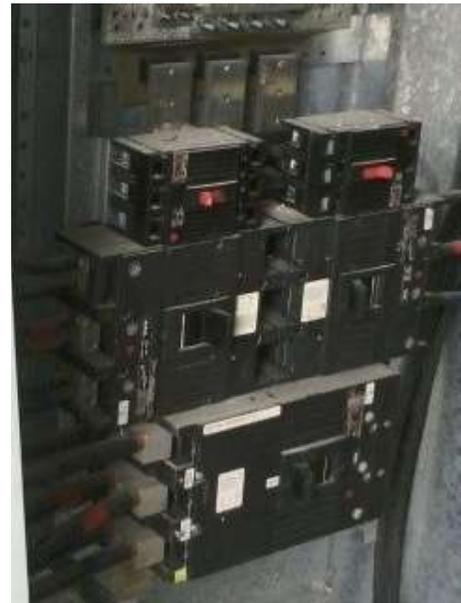
Date	04/10/2024
Location	Electric meter room
Equipment	Main 2 of 2
Component	Panelboard
File name	FLIR1373.jpg
Condition	NORMAL

Sp1	26.9 °C
Sp2	26.9 °C
Sp3	26.9 °C
Sp4	26.9 °C
Sp5	26.7 °C
Sp6	26.4 °C

None.

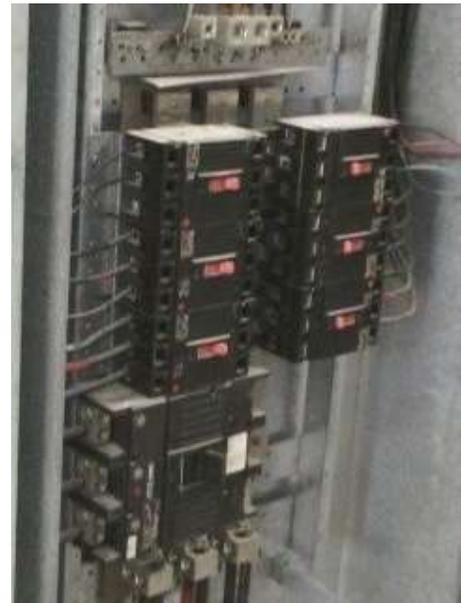
THE BILTMORE REGENT CONDO	
Date	04/10/2024
Location	Electric meter room
Equipment	EDP
Component	Panelboard
File name	FLIR1395.jpg
Condition	NORMAL

Sp1	27.7 °C
Sp2	27.4 °C
Sp3	27.6 °C
Sp4	27.9 °C
Sp5	27.0 °C
Sp6	26.9 °C

None.

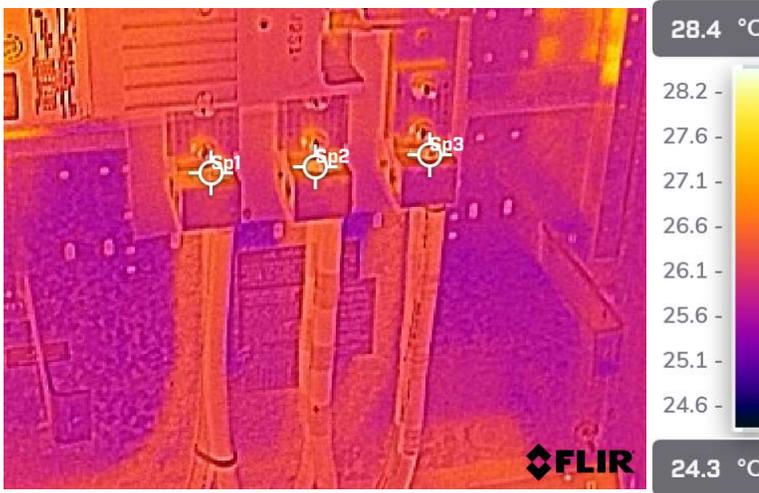
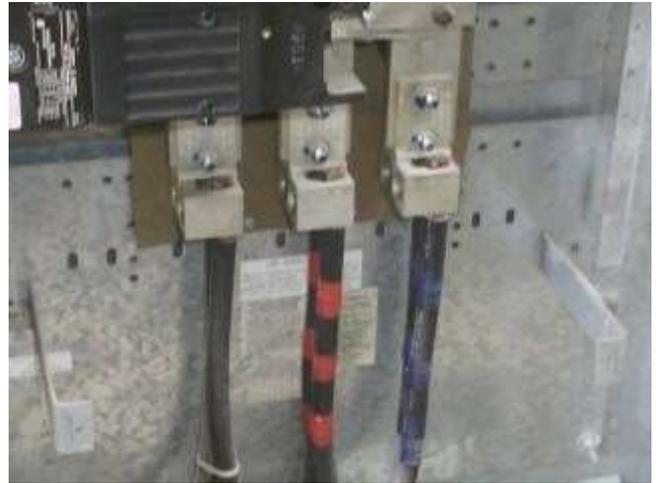
THE BILTMORE REGENT CONDO	
Date	04/10/2024
Location	Electric meter room
Equipment	EDP
Component	Panelboard-busbar
File name	FLIR1409.jpg
Condition	NORMAL

Sp1	26.6 °C
Sp2	26.7 °C
Sp3	26.5 °C

None.

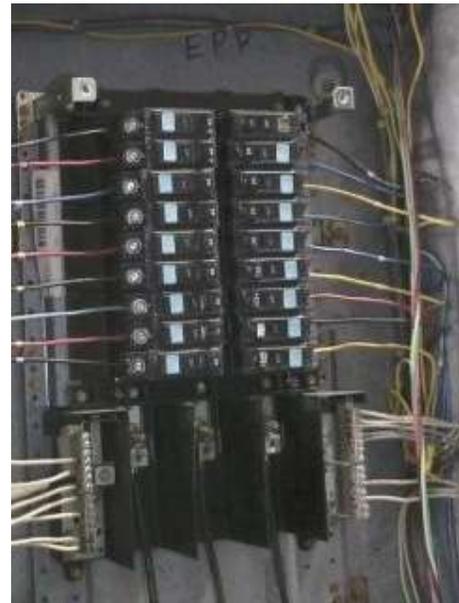
THE BILTMORE REGENT CONDO	
Date	04/10/2024
Location	Electric meter room
Equipment	EP
Component	Panelboard
File name	FLIR1461.jpg
Condition	DEFICIENCY

Sp1	29.9 °C
Sp2	29.6 °C
Sp3	35.4 °C

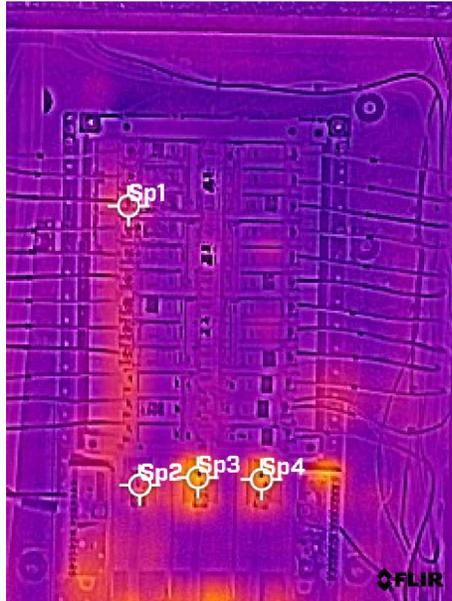
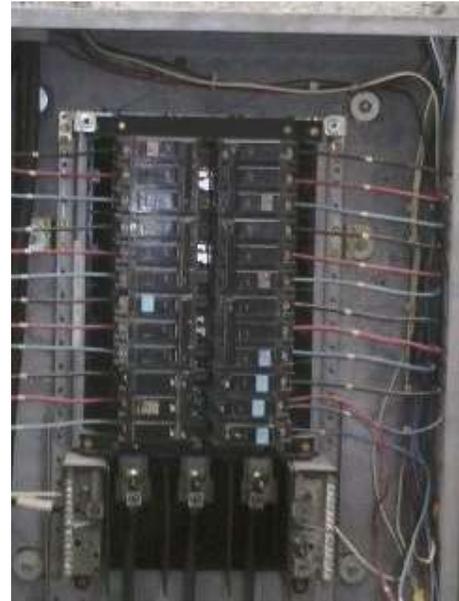
THE BILTMORE REGENT CONDO	
Date	04/10/2024
Location	Electric meter room
Equipment	EB
Component	Panelboard
File name	FLIR1475.jpg
Condition	NORMAL

Temp. Measurements

Sp1	26.5 °C
Sp2	26.6 °C
Sp3	27.4 °C
Sp4	27.2 °C

None.

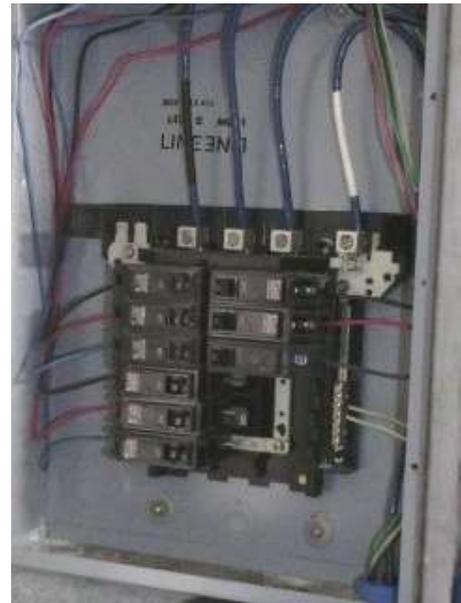
THE BILTMORE REGENT CONDO	
Date	04/10/2024
Location	Electric meter room
Equipment	LE
Component	Panelboard
File name	FLIR1491.jpg
Condition	NORMAL

Temp. Measurements

Sp1	25.4 °C
Sp2	25.4 °C
Sp3	25.6 °C
Sp4	25.9 °C

None.

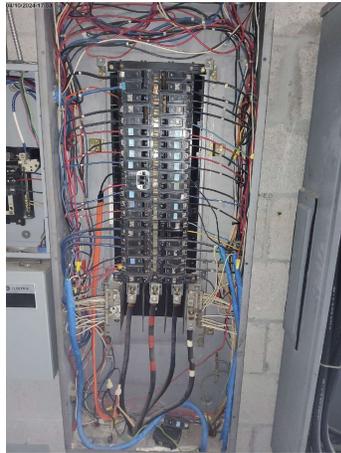
THE BILTMORE REGENT CONDO	
Date	04/10/2024
Location	Electric meter room
Equipment	House Panelboard
Component	Circuit breaker #30-32
File name	FLIR1519.jpg
Condition	POSSIBLE DEFICIENCY

Sp1	38.9 °C
Sp2	31.4 °C
Sp3	38.9 °C
Sp4	31.5 °C

2.- Possible deficiency in circuit breakers #30-32.

2.- Remove conductors. Inspect conductors and circuit breaker.
-Clean the parts, and install conductors (apply torque according to manufacturer specifications).

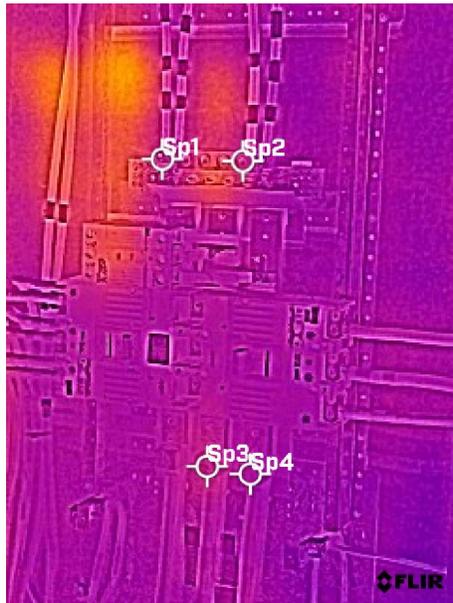
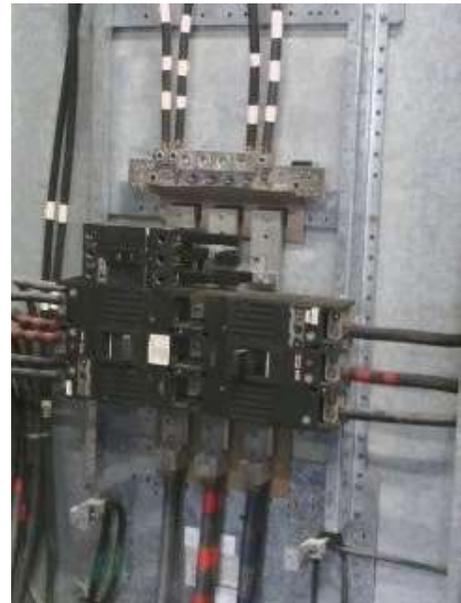
THE BILTMORE REGENT CONDO	
Date	04/10/2024
Location	Generator & Fire Pump Room
Equipment	GP
Component	Panelboard
File name	FLIR1525.jpg
Condition	NORMAL

Sp1	26.3 °C
Sp2	26.4 °C
Sp3	26.4 °C
Sp4	26.2 °C

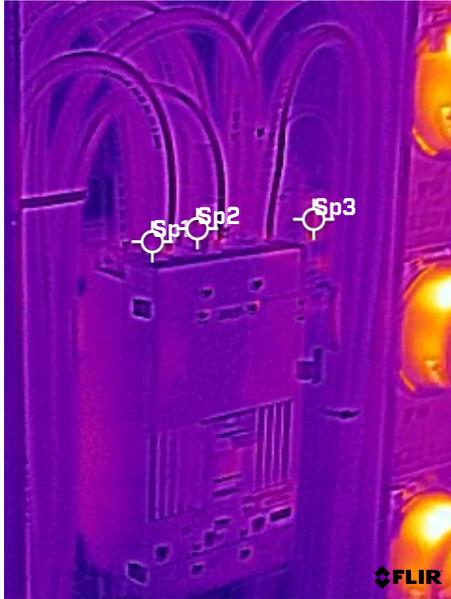
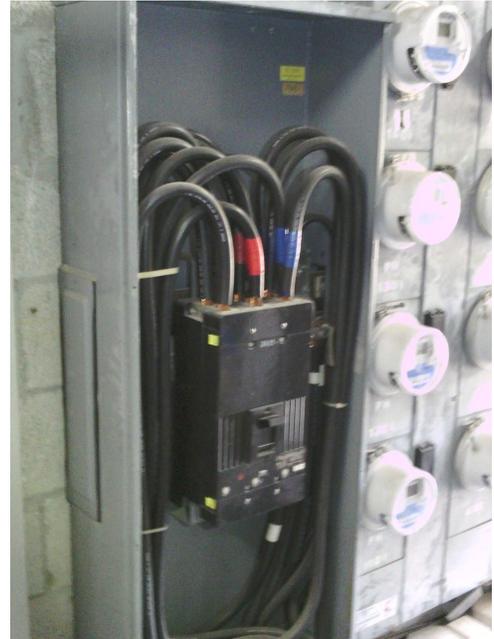
THE BILTMORE REGENT CONDO	
Date	04/10/2024
Location	Electric meter room
Equipment	Main 1 of 2
Component	Circuit breaker
File name	FLIR1353.jpg
Condition	NORMAL

Sp1	26.2 °C
Sp2	26.2 °C
Sp3	26.6 °C

None.

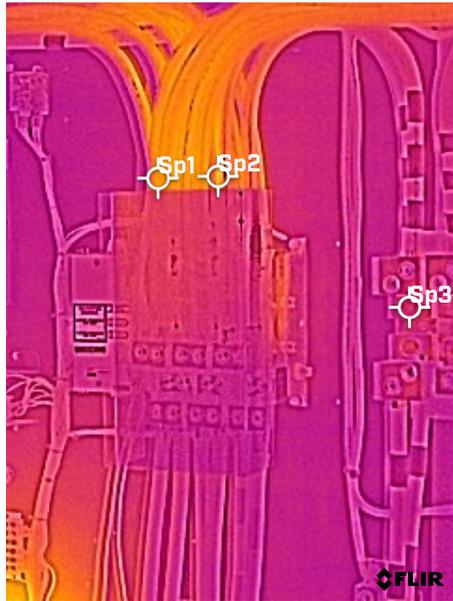
THE BILTMORE REGENT CONDO	
Date	04/10/2024
Location	Electric meter room
Equipment	ATS
Component	ATS
File name	FLIR1357.jpg
Condition	NORMAL

Sp1	27.3 °C
Sp2	27.6 °C
Sp3	26.4 °C

None.

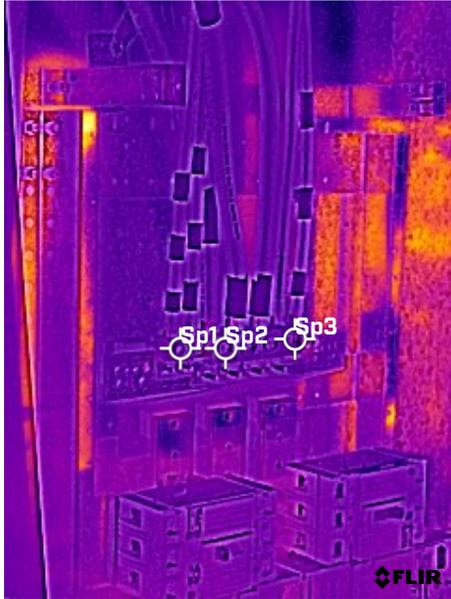
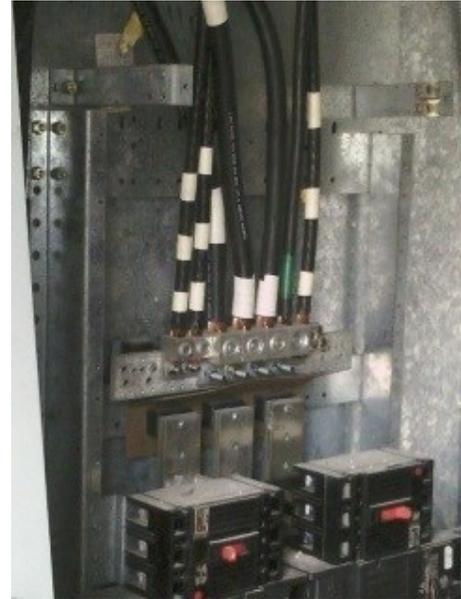
THE BILTMORE REGENT CONDO	
Date	04/10/2024
Location	Electric meter room
Equipment	Main 2 of 2
Component	Panelboard-Neutral bar
File name	FLIR1371.jpg
Condition	NORMAL

Sp1	26.4 °C
Sp2	26.5 °C
Sp3	26.7 °C

None.

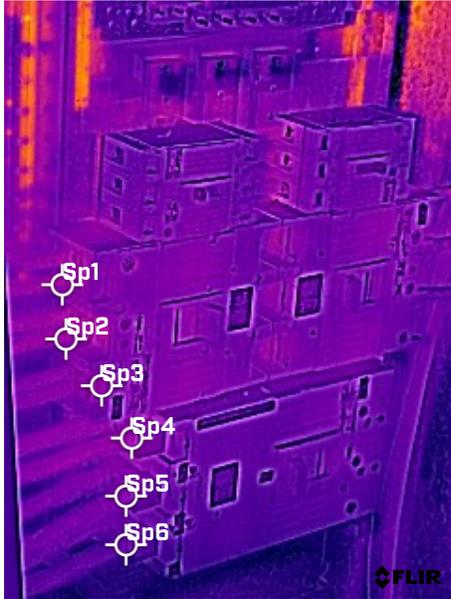
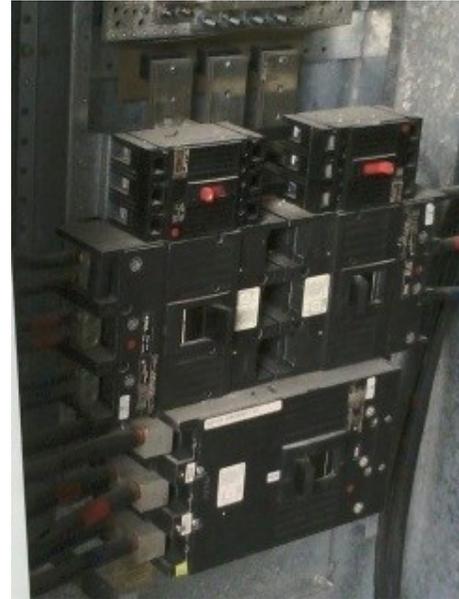
THE BILTMORE REGENT CONDO	
Date	04/10/2024
Location	Electric meter room
Equipment	Main 2 of 2
Component	Panelboard
File name	FLIR1373.jpg
Condition	NORMAL

Sp1	26.9 °C
Sp2	26.9 °C
Sp3	26.9 °C
Sp4	26.9 °C
Sp5	26.7 °C
Sp6	26.4 °C

None.

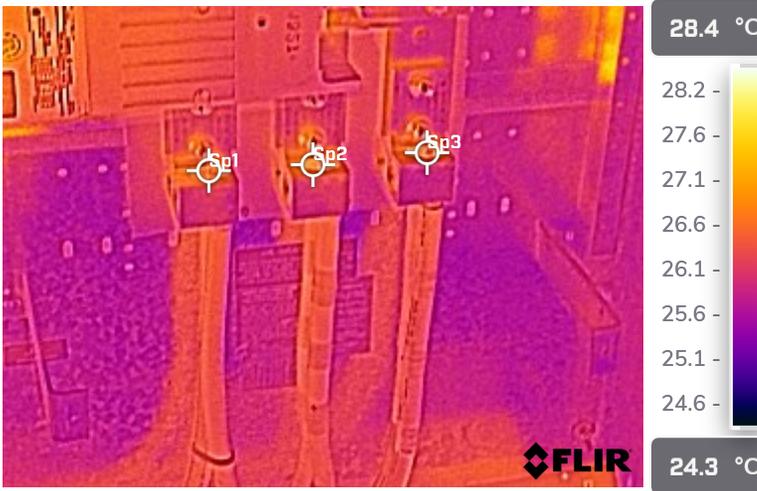
THE BILTMORE REGENT CONDO	
Date	04/10/2024
Location	Electric meter room
Equipment	EDP
Component	Panelboard-busbar
File name	FLIR1409.jpg
Condition	NORMAL

Sp1	26.6 °C
Sp2	26.7 °C
Sp3	26.5 °C

None.

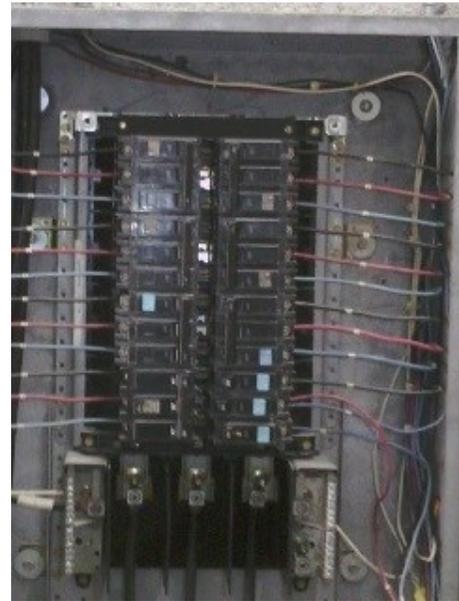
THE BILTMORE REGENT CONDO	
Date	04/10/2024
Location	Electric meter room
Equipment	EB
Component	Panelboard
File name	FLIR1475.jpg
Condition	NORMAL

Sp1	26.5 °C
Sp2	26.6 °C
Sp3	27.4 °C
Sp4	27.2 °C

None.

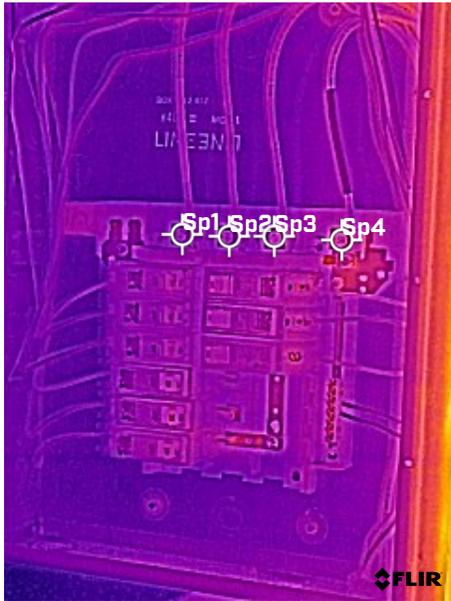
THE BILTMORE REGENT CONDO	
Date	04/10/2024
Location	Electric meter room
Equipment	LE
Component	Panelboard
File name	FLIR1491.jpg
Condition	NORMAL

Sp1	25.4 °C
Sp2	25.4 °C
Sp3	25.6 °C
Sp4	25.9 °C

None.

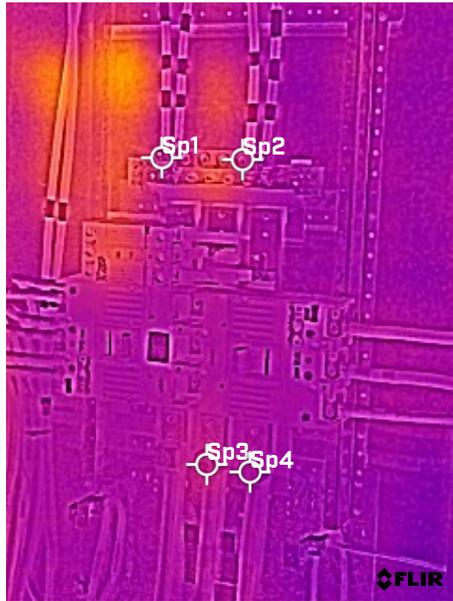
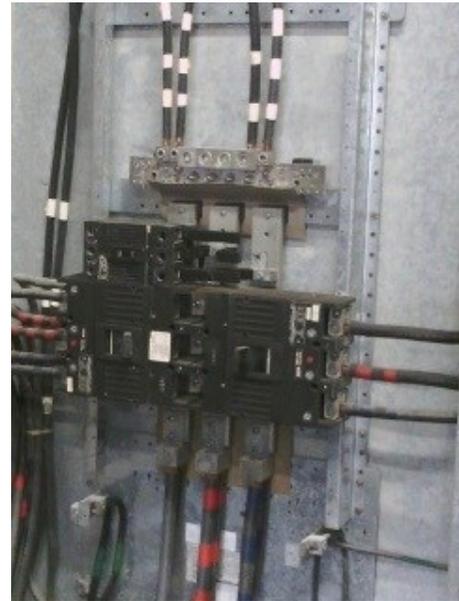
THE BILTMORE REGENT CONDO	
Date	04/10/2024
Location	Generator & Fire Pump Room
Equipment	GP
Component	Panelboard
File name	FLIR1525.jpg
Condition	NORMAL

Sp1	26.3 °C
Sp2	26.4 °C
Sp3	26.4 °C
Sp4	26.2 °C

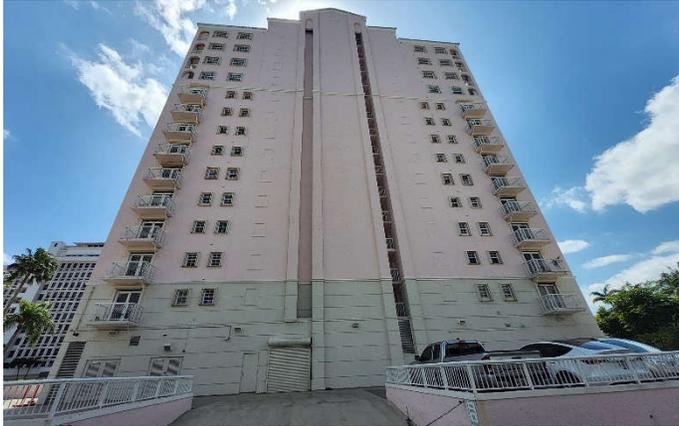
Photo # 1. North building elevation.

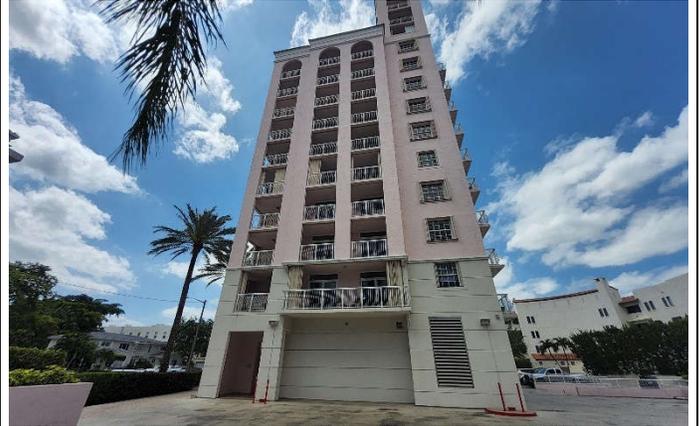
Photo # 2. East building elevation.

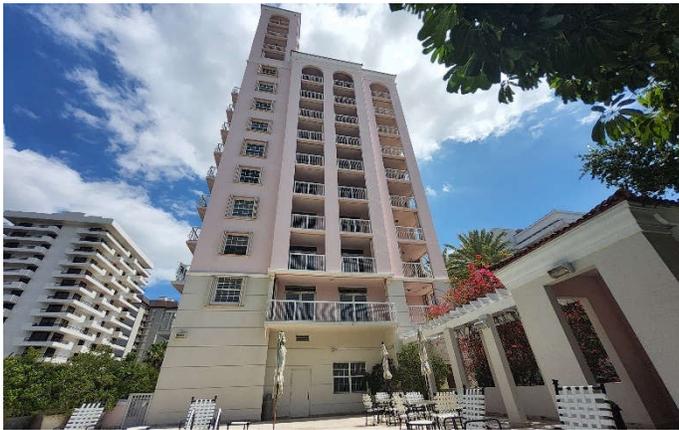
Photo # 3. West building elevation.

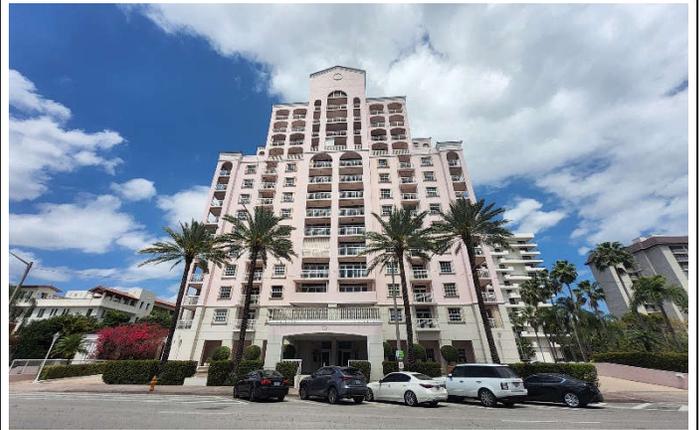
Photo # 4. South building elevation.

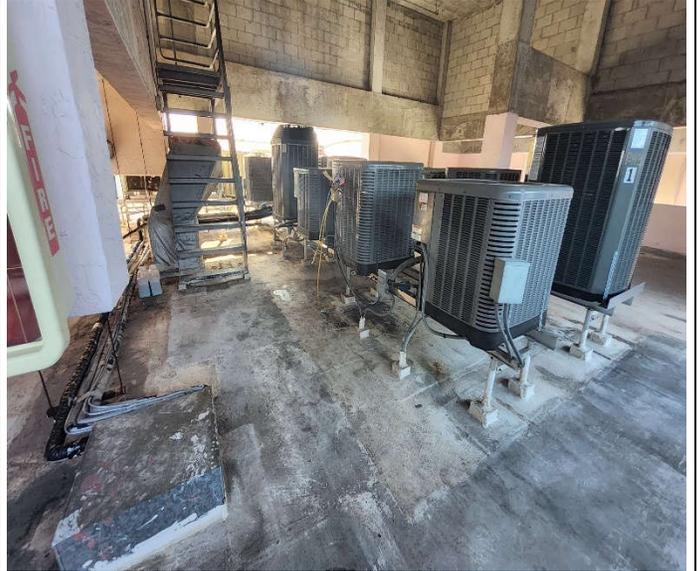
Photo # 6. Lower roof with TPO membrane roofing system.

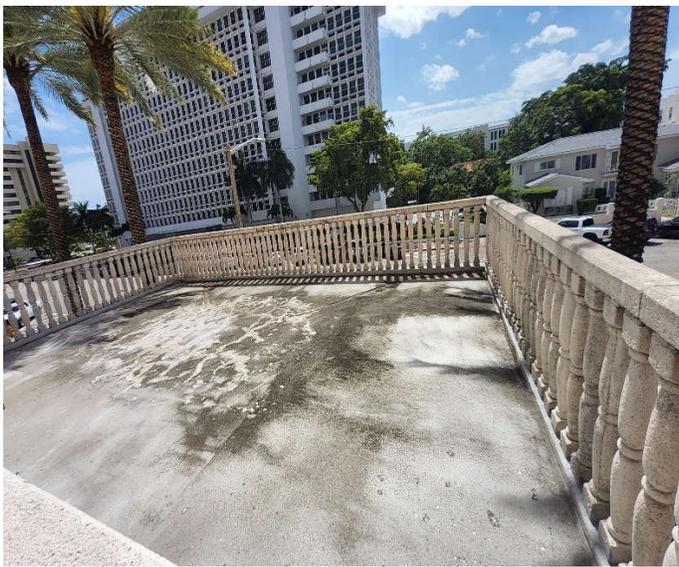
Photo # 7. Porte-cochere roof with bitumen membrane roofing system.

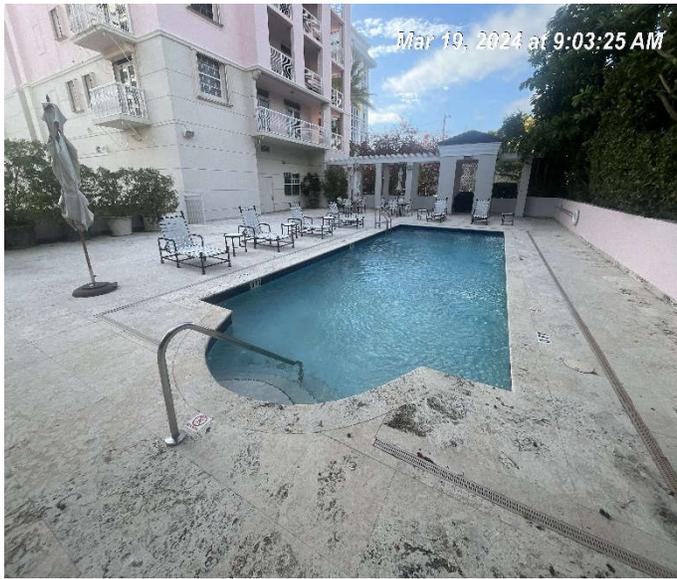
Photo # 9. Pool and pool deck.

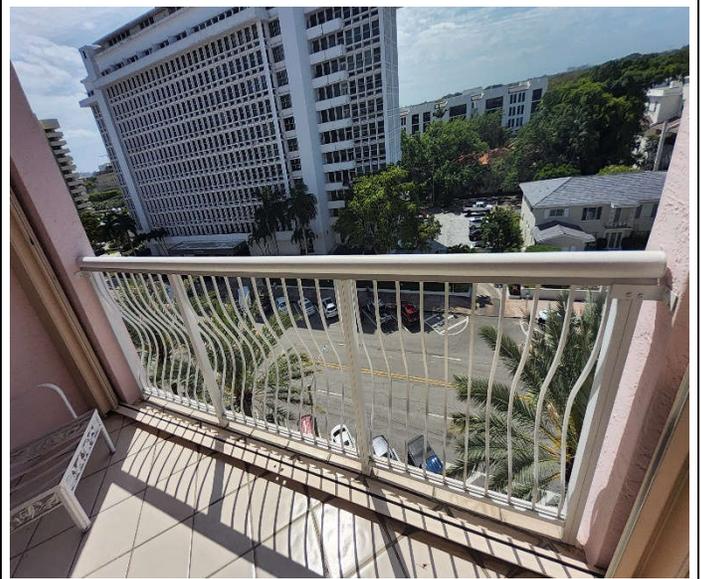
Photo # 10. Balcony railing.

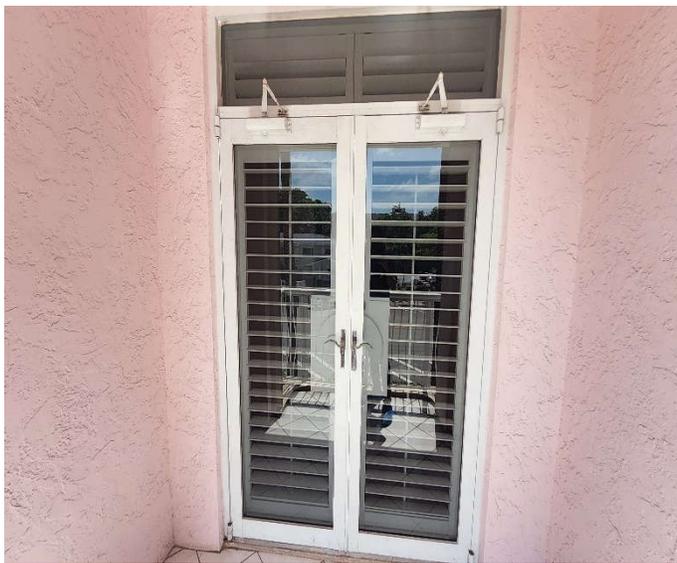
Photo # 11. Balcony double outswing glass door.

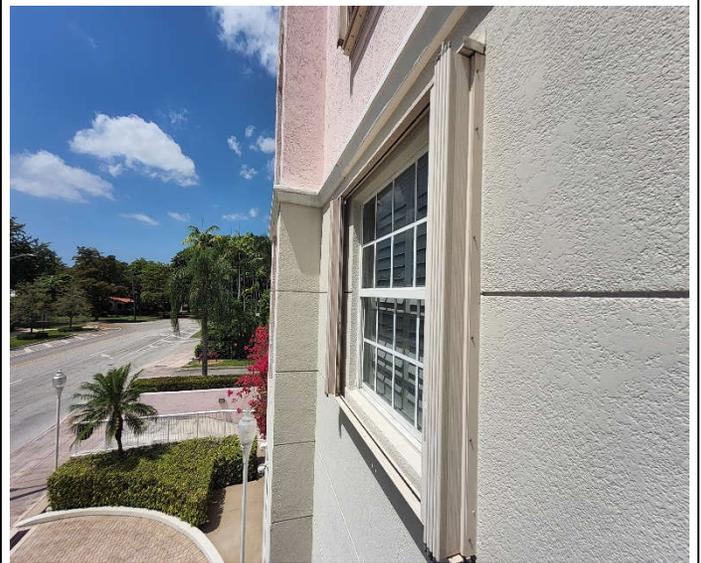
Photo # 12. Typical window.

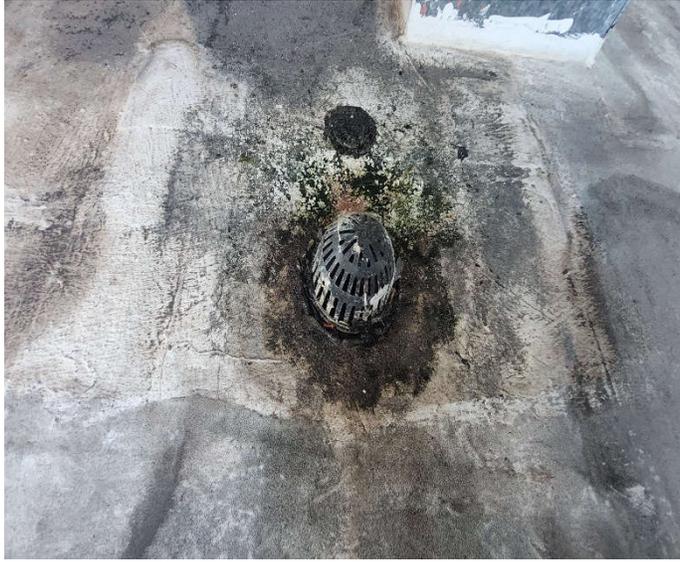
Photo # 13. Primary drain at the lower roof.

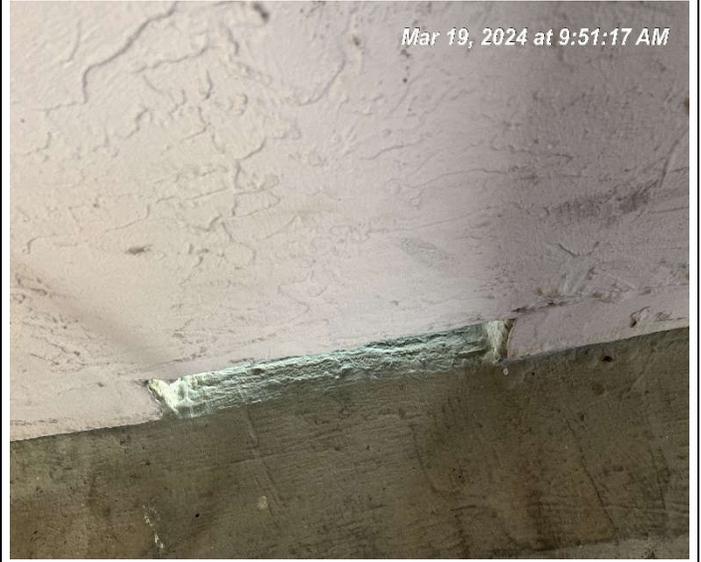
Photo # 14. Primary scupper at the lower roof.

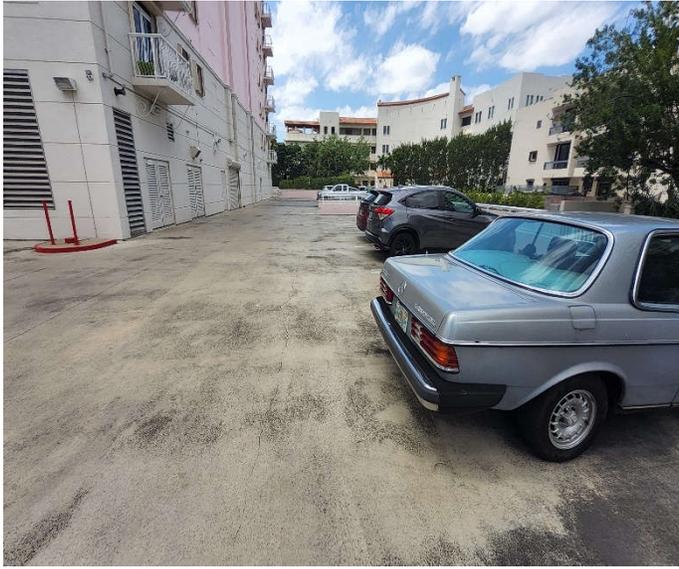
Photo # 17. **Garage deck.**
