SHORT LEGAL DESCRIPTION	
THE BILTMORE REGENT CONDO	
CORAL GABLES BILTMORE SEC	
LOTS 24 THRU 32 BLK 1 PB 20-28	
F/A/U 03-4117-008-0200

**NOTICE OF UNSAFE STRUCTURE VIOLATION FOR FAILURE TO RECERTIFY
AND NOTICE OF HEARING**

The Falcon Group (Falcon) conducted a 30-Year **Electrical** Recertification of the referenced building in accordance with the requirements of section 8-11(f) of Miami Dade County and City of Coral Gables “General Considerations & Guidelines” for the building safety inspections. In summary, in accordance with the above regulations and guidelines, the recertification is not approved since repairs are required to meet current standards of safety.

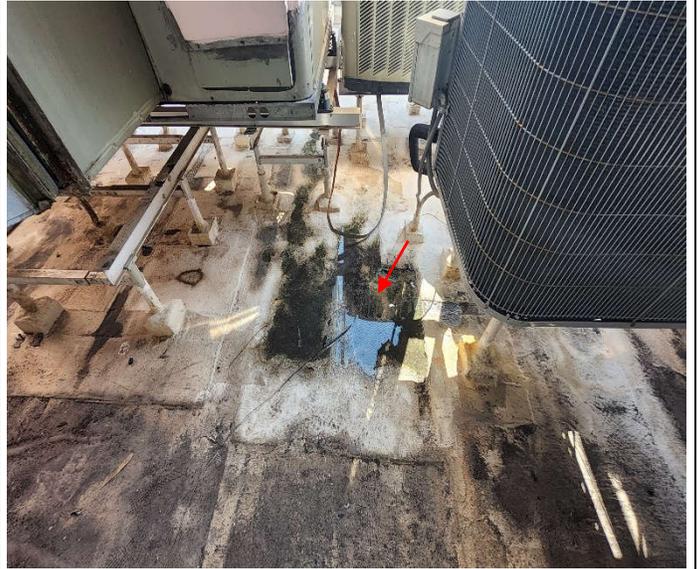
Photo # 18. **Water ponding at the lower flat roof.**

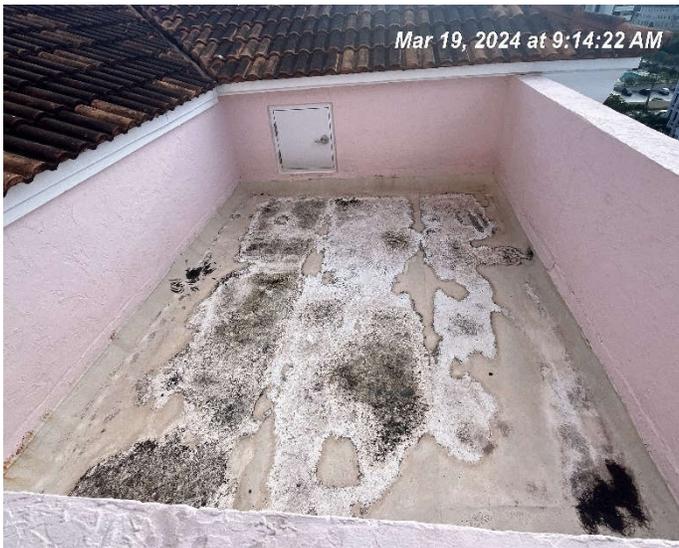
Photo # 19. **Water ponding stains at the PH floor flat roof.**

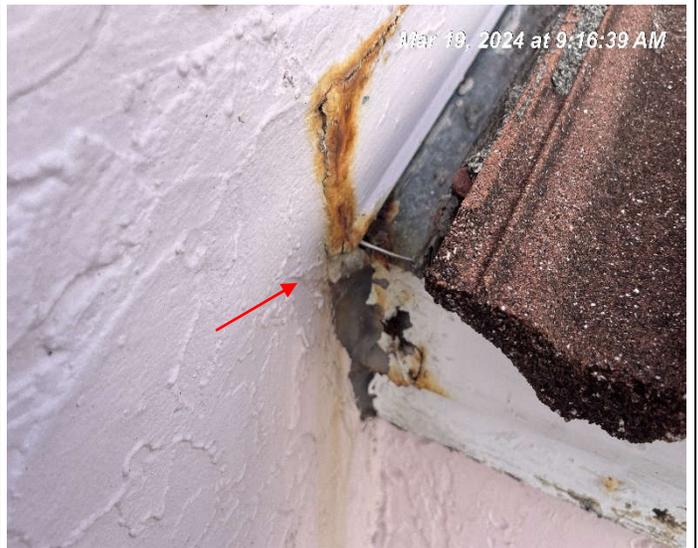
Photo # 20. **Corrosion stains at the roof flashing.**

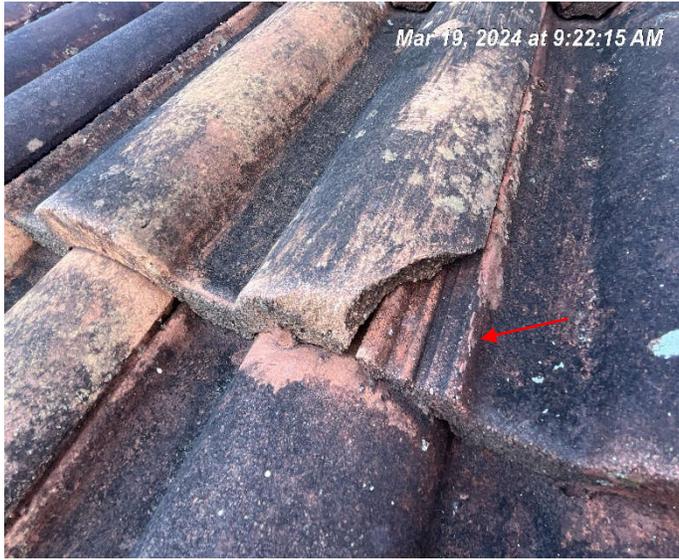
Photo # 21. Chipped clay barrel tile at the PH floor roof.

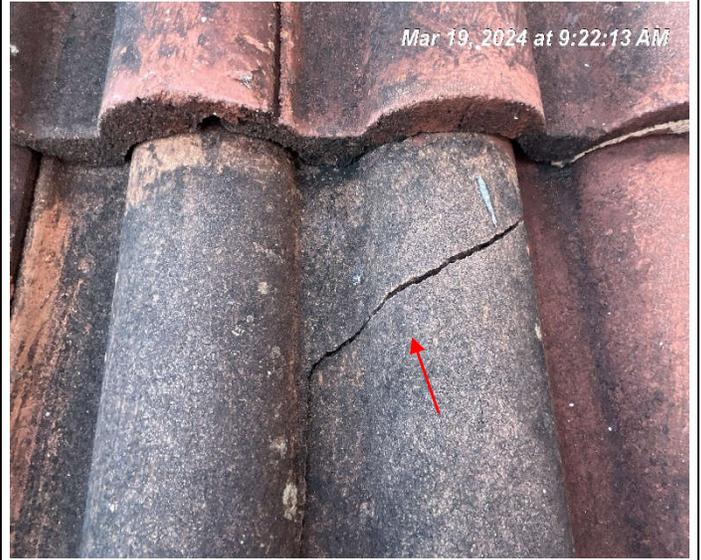
Photo # 22. Cracked clay barrel tile at the PH floor roof.

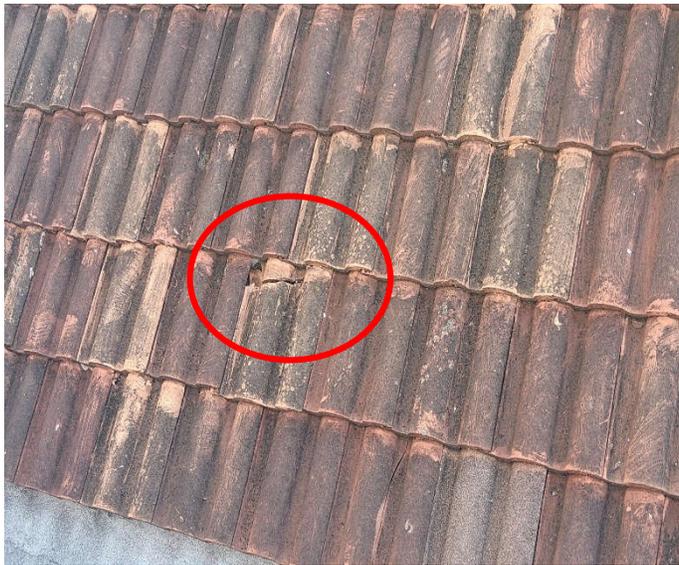
Photo # 23. Cracked clay barrel tile at the PH floor roof.

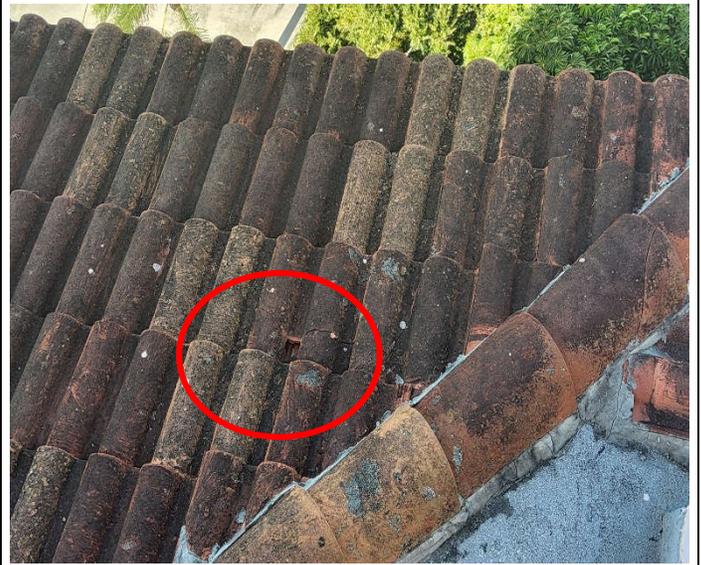
Photo # 24. Cracked clay barrel tile at the PH floor roof.

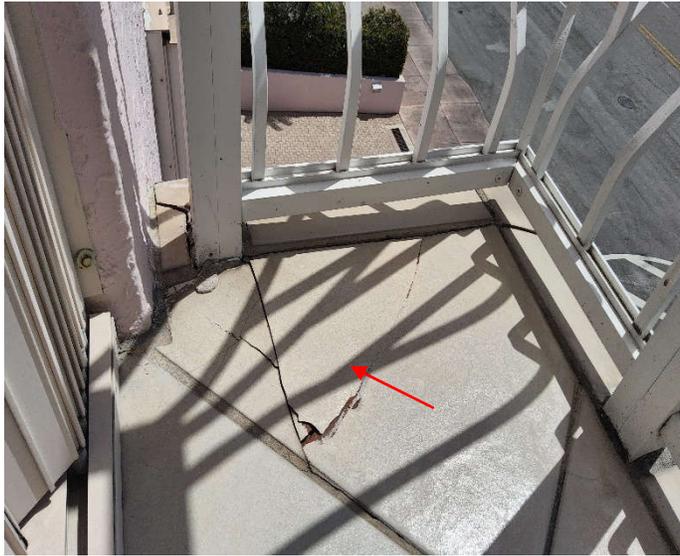
Photo # 25. Cracked tiles at the balcony around the railing post.

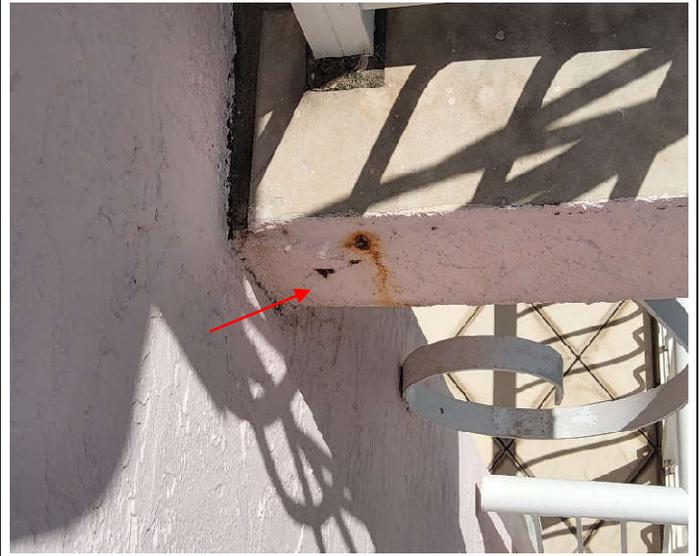
Photo # 26. Rust spot at the balcony slab edge.

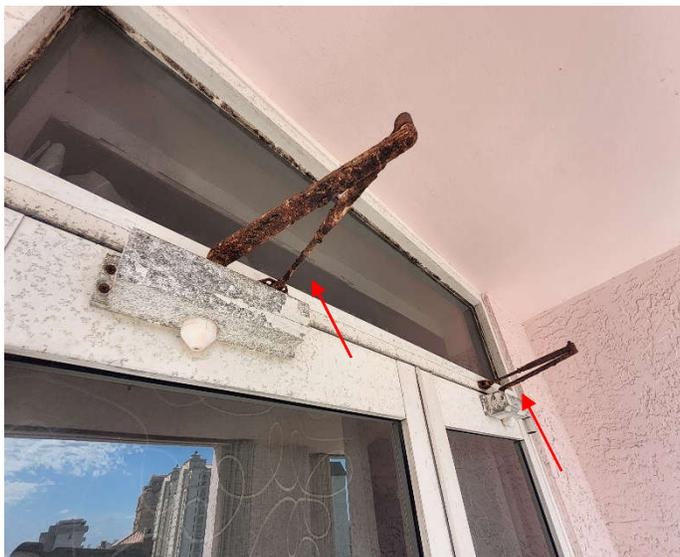
Photo # 27. Corroded door closer at the balcony throughout.

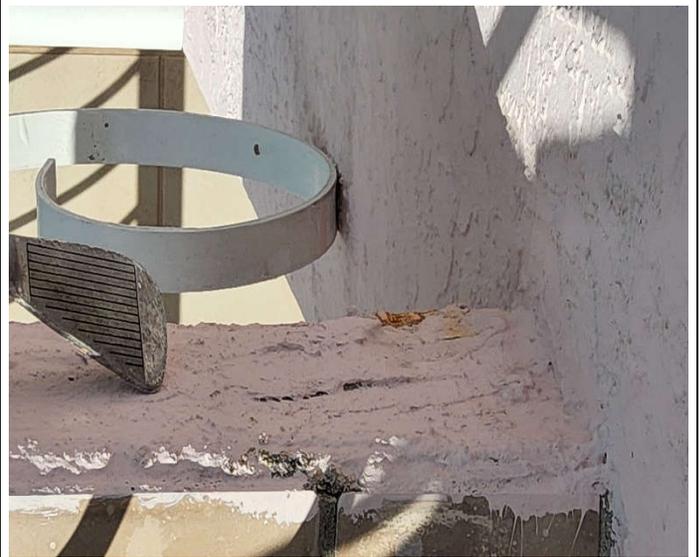
Photo # 28. Stucco delamination and rust spot at the balcony slab edge.

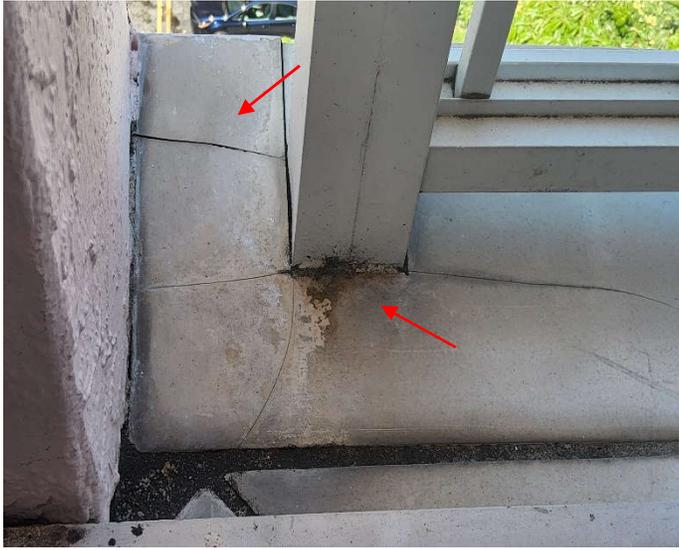
Photo # 29. Cracked tile at the balcony and missing sealant/grout at the railing post throughout.

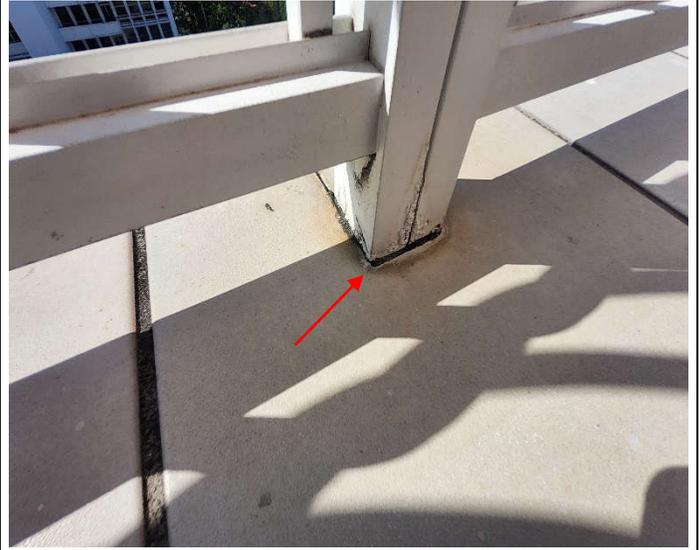
Photo # 30. Pitting corrosion at the balcony railing post throughout.

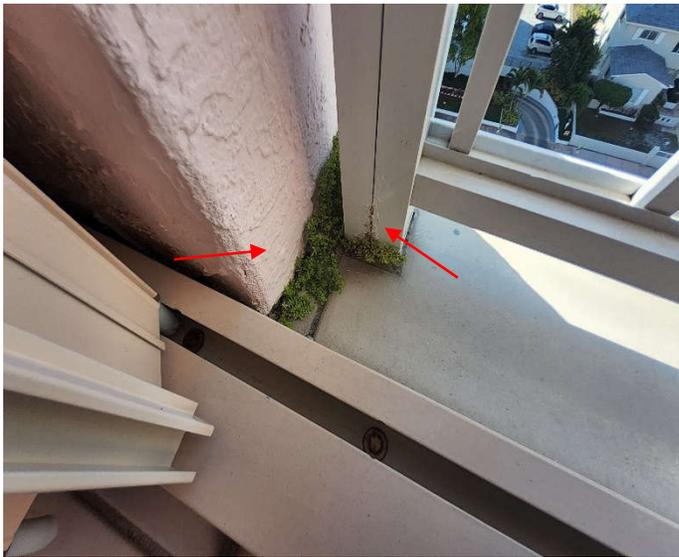
Photo # 31. Biological growth and pitting corrosion at the balcony railing post.

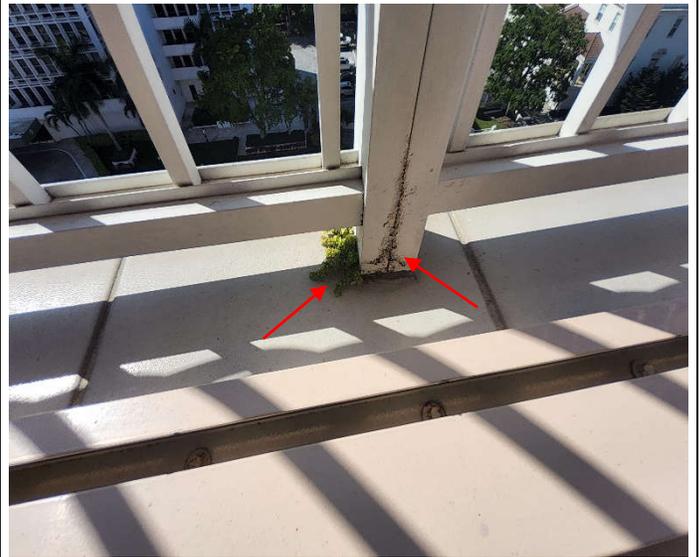
Photo # 32. Biological growth and pitting corrosion at the balcony railing post.

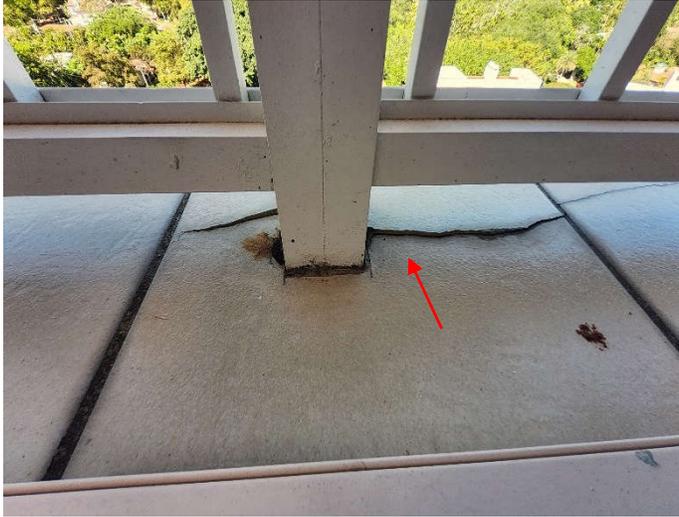
Photo # 33. Cracked tile around the railing post.

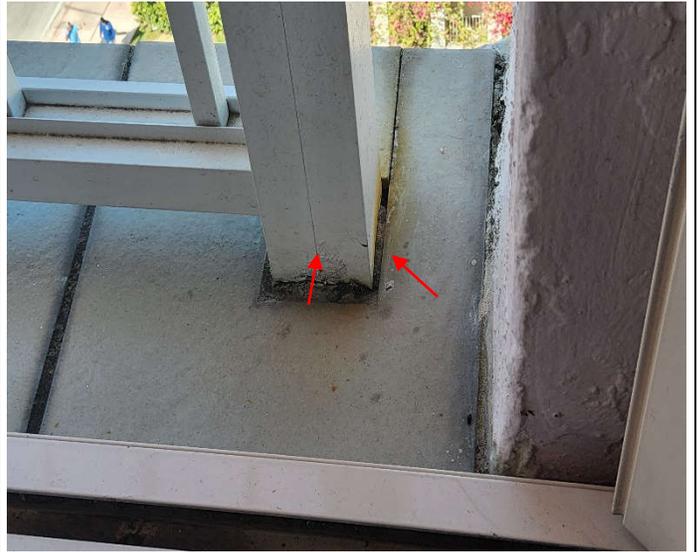
Photo # 34. Missing sealant/grout and pitting corrosion at the balcony railing post.

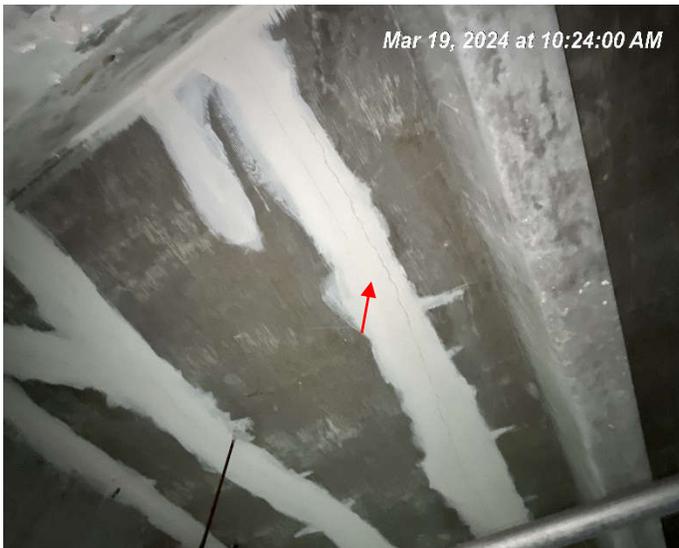
Photo # 35. Concrete crack at the ceiling slab of the basement garage.

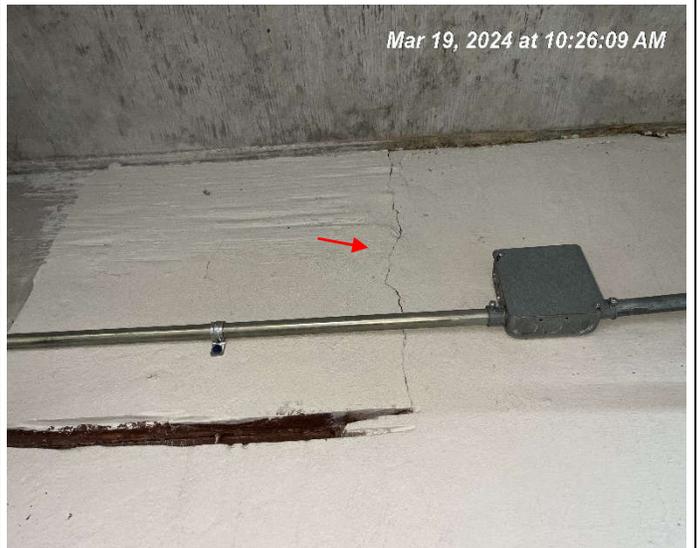
Photo # 36. Concrete crack at the wall of the basement garage.

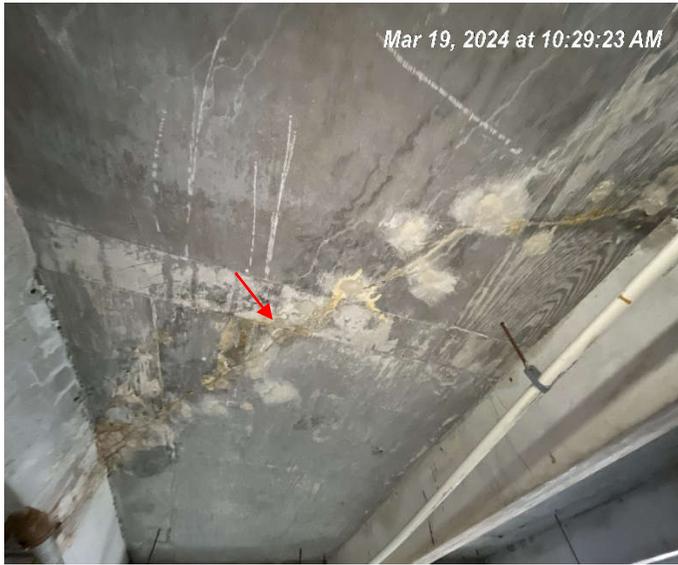
Photo # 37. Concrete crack with water stains and efflorescence at the ceiling slab of the basement garage.

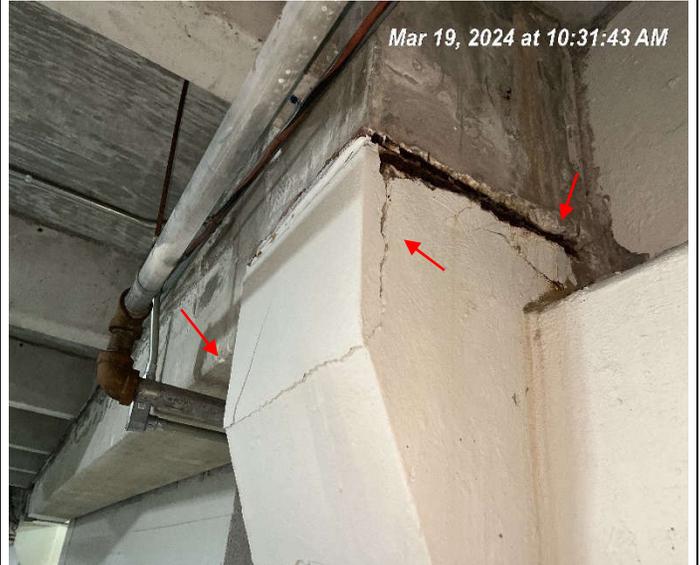
Photo # 38. Cracked and delaminated concrete at the column of the basement garage.

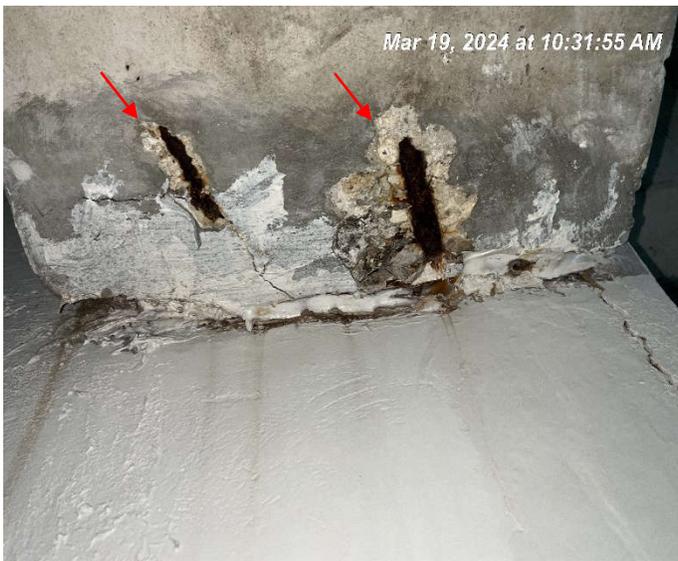
Photo # 39. Spalled concrete with exposed corroded rebar at the beam of the parking garage.

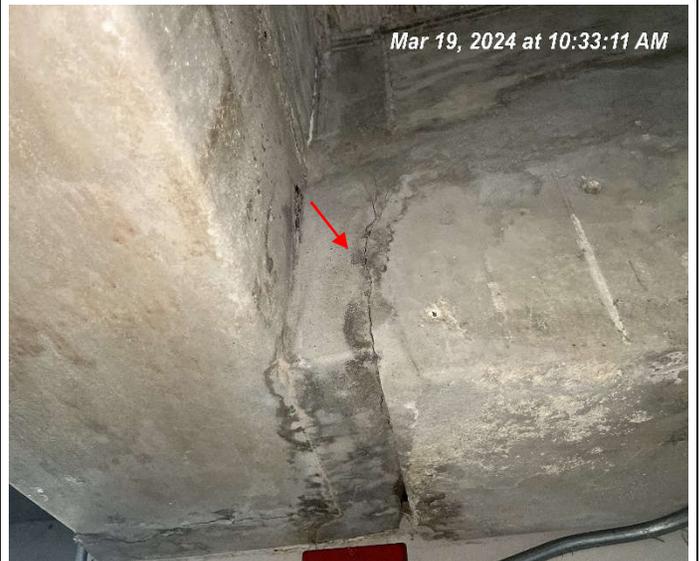
Photo # 40. Concrete crack at the beam of the basement garage.

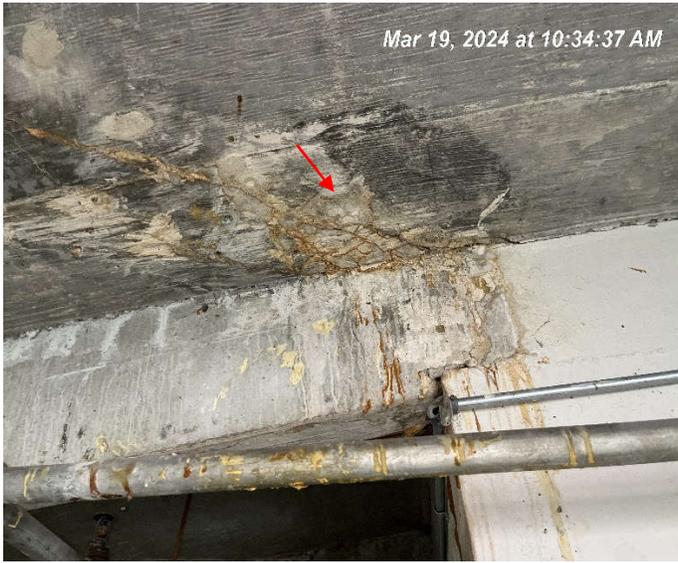
Photo # 41. Concrete crack with water stains and efflorescence at the ceiling slab of the basement garage.

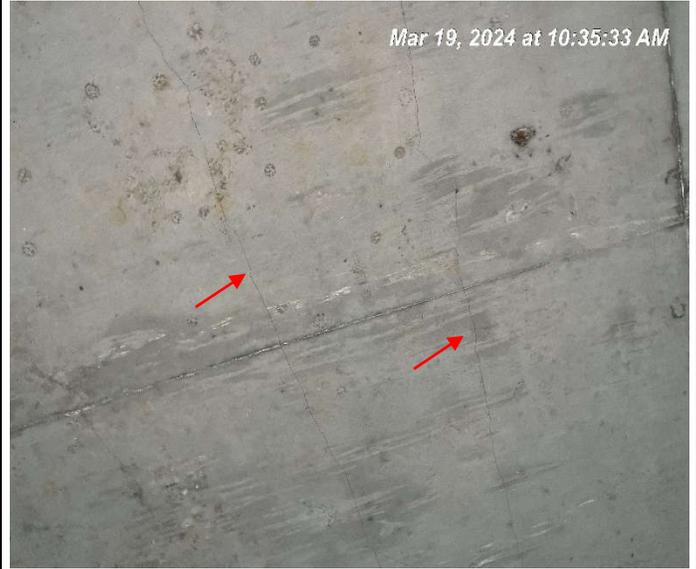
Photo # 42. Concrete cracks at the ceiling slab of the basement garage.

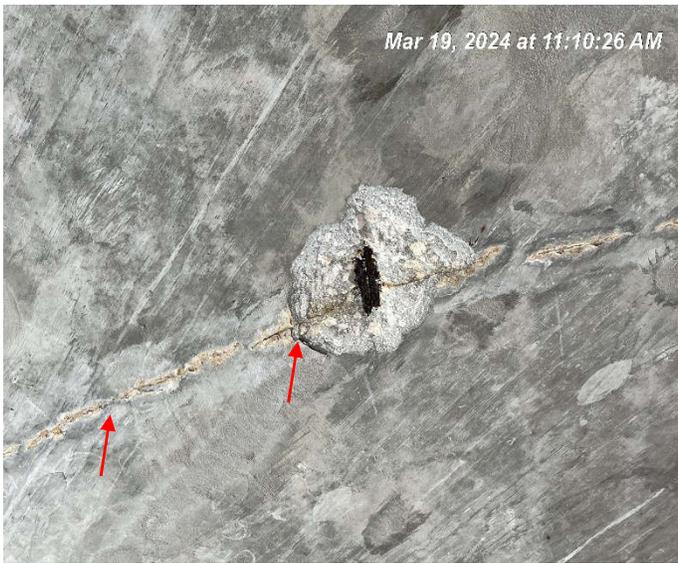
Photo # 43. Cracked and spalled concrete with exposed corroded rebar at the ramp ceiling slab (East Side)

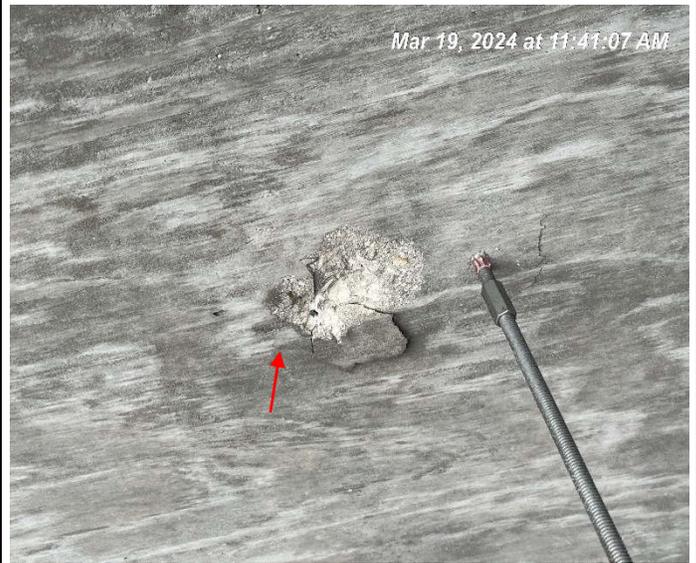
Photo # 44. Cracked and spalled concrete at the ramp ceiling slab (West Side)

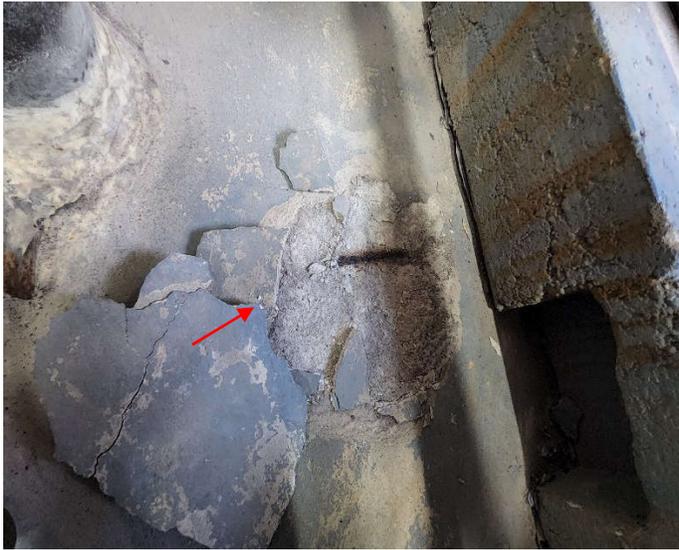
Photo # 45. Cracked and spalled concrete with exposed corroded rebar at the Generator & Fire Pump Room.

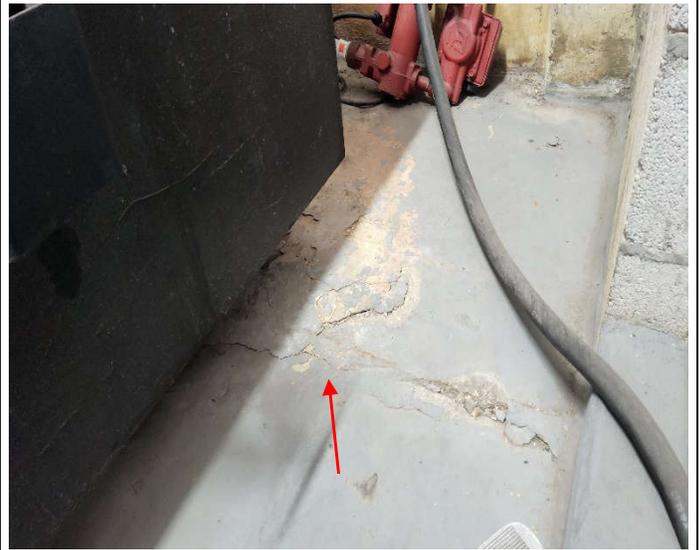
Photo # 46. Cracked and spalled concrete at the Generator & Fire Pump Room.

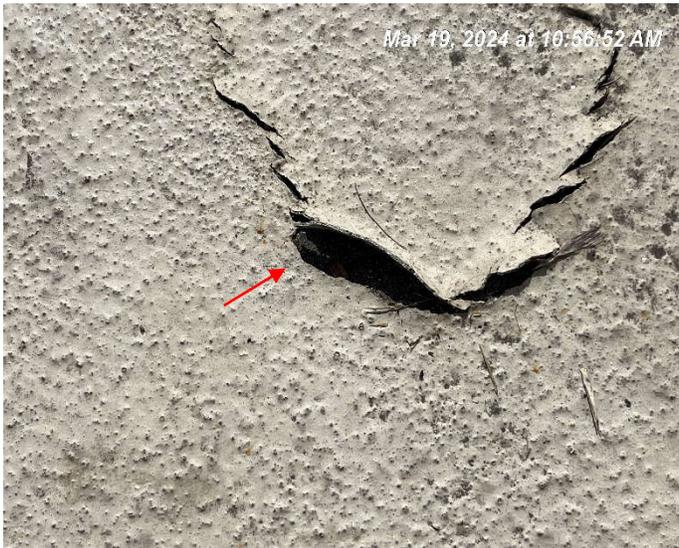
Photo # 47. Delaminated waterproofing coating at the parking deck.

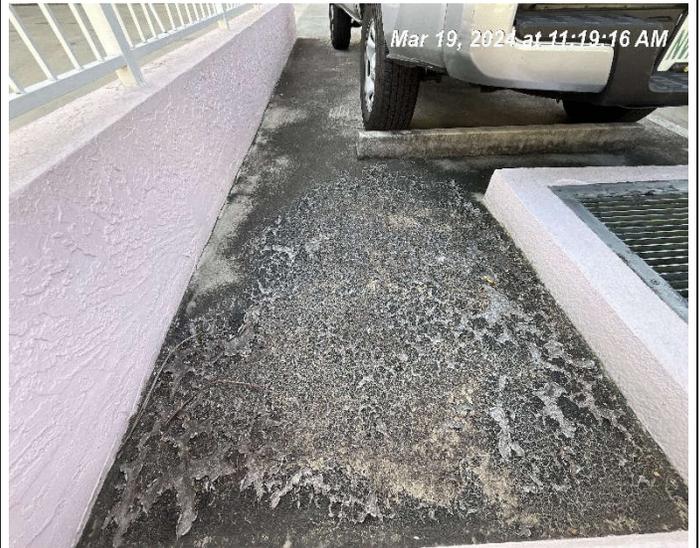
Photo # 48. Deteriorated waterproofing coating at the parking deck.
