**CORAL GABLES PUBLIC ART
CONDITION ASSESSMENT
MIAMI, FLORIDA**

Prepared for:
Catherine Cathers
Arts & Culture Specialist

Prepared by:
Kelly Caldwell
Senior Conservator & Director of Conservation
kcaldwell@evergreene.com

Submission Date: March 19, 2021

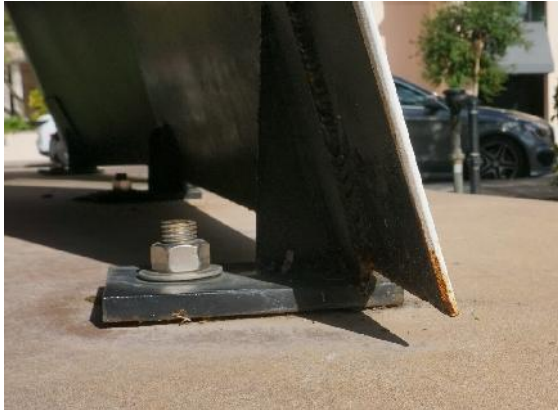
Figure 3. Corrosion on edge (photo by EverGreene, February 2021).

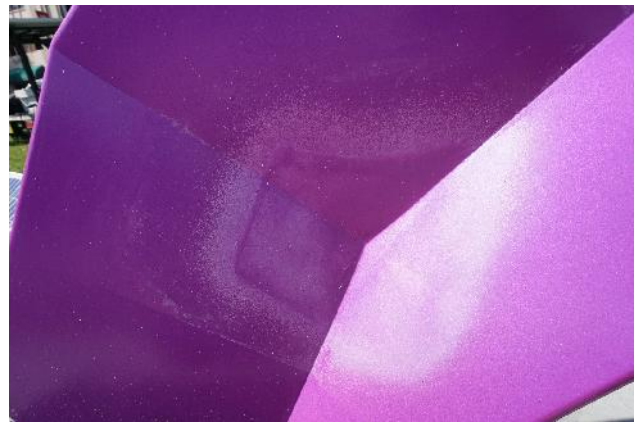
Figure 4. Discoloration/clouding of coating on bottom of sculpture (photo by EverGreene, February 2021).

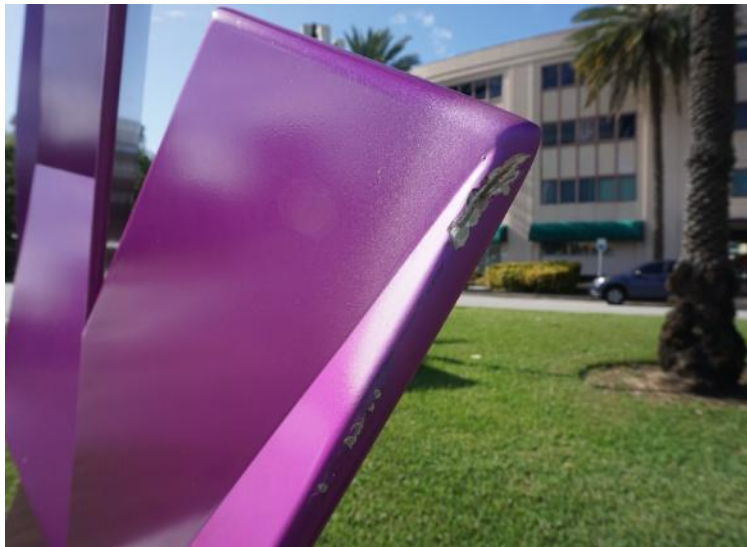
Figure 5. Gouge and coating loss on the top edge of the bottom prism (photo by EverGreene, February 2021).

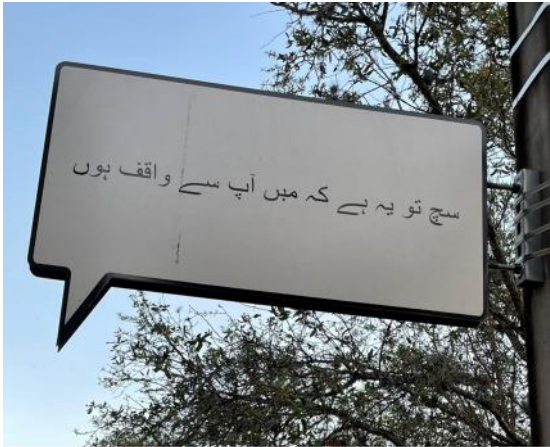
Figure 2. M: The Truth is I Know You, soiling (photo by EverGreene, February 2021).

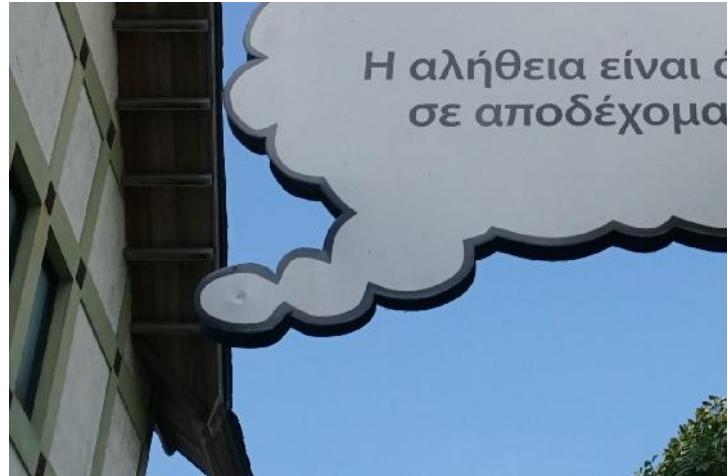
Figure 5. F: The Truth is I Accept You, indent on point (photo by EverGreene, February 2021).

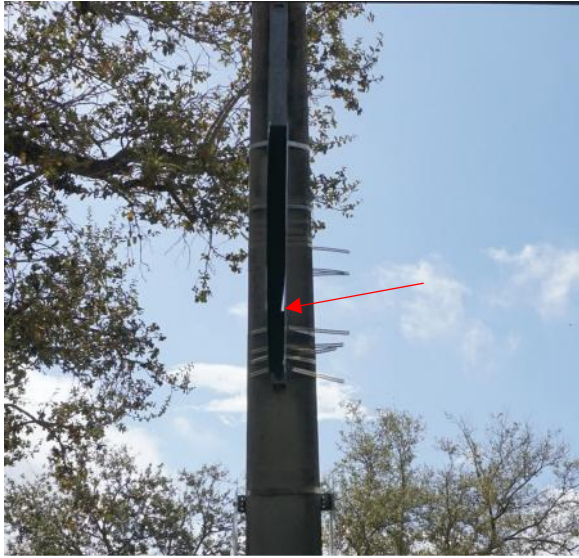
Figure 6. R: The Truth is I Follow You, deformed point (photo by EverGreene, February 2021).

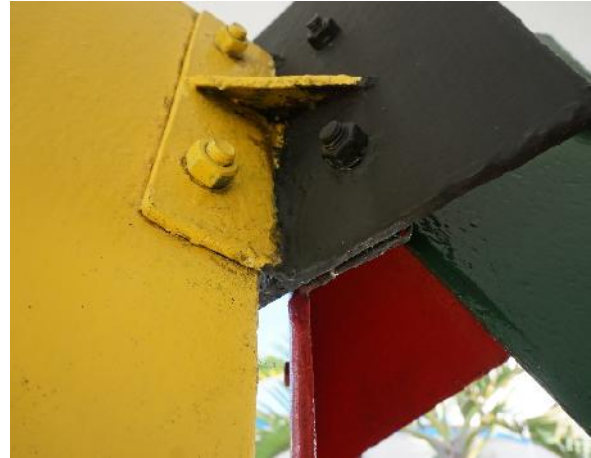
Figure 2. Intersection of the four pieces, soiling accumulation under the yellow angle (photo by EverGreene, February 2021).

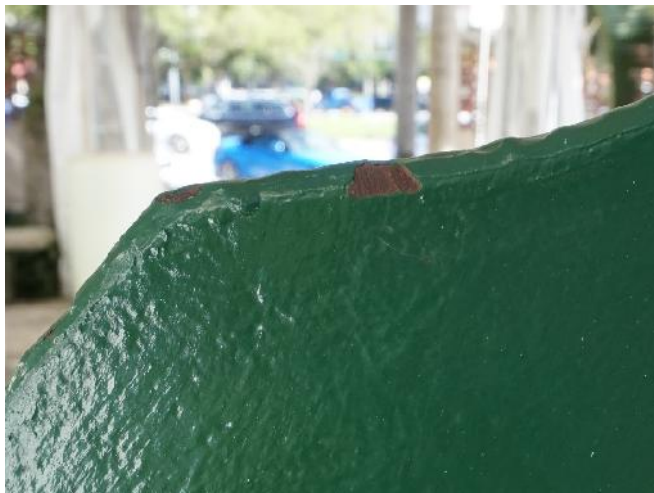
Figure 7. Small chip in metal and paint (photo by EverGreene, February 2021).

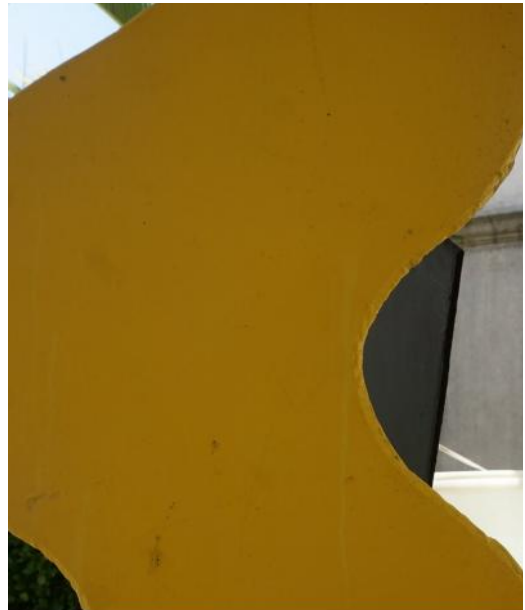
Figure 8. Soiling on yellow piece, typical both sides (photo by EverGreene, February 2021).

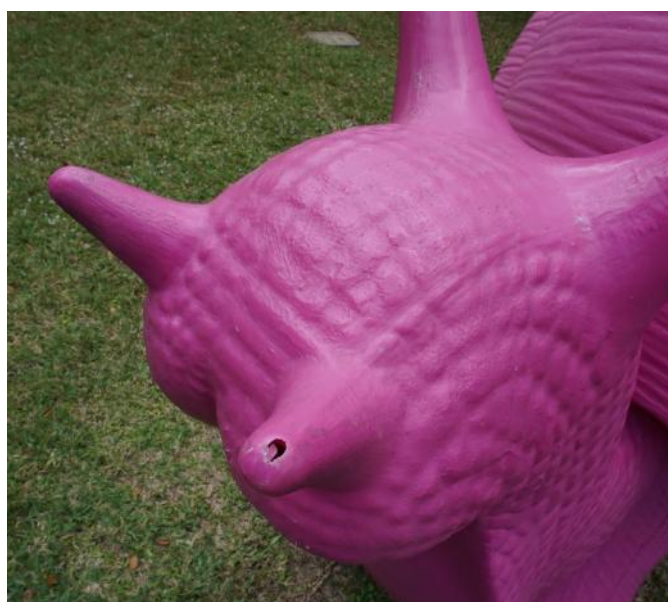
Figure 2. Hole is proper left eye (photo by EverGreene, February 2021).

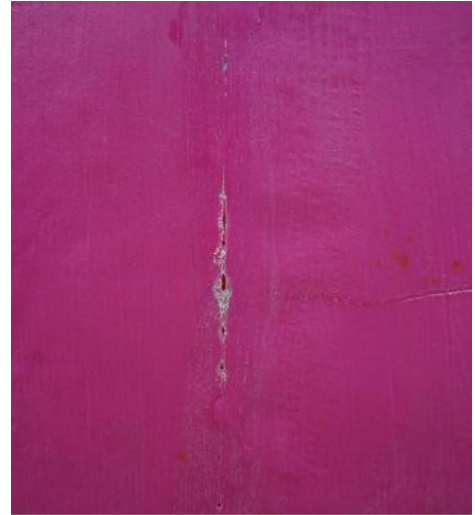
Figure 4. Opening at seam due to deterioration (photo by EverGreene, February 2021).

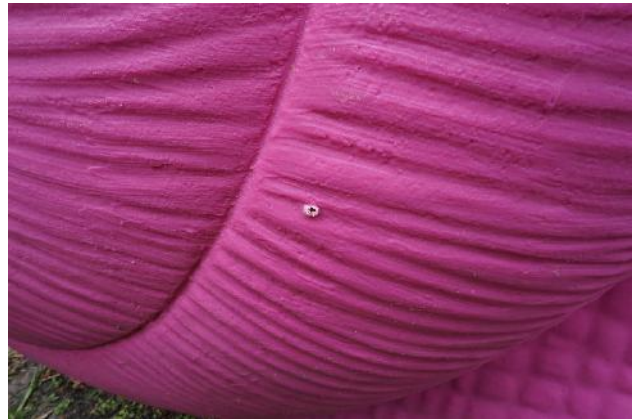
Figure 6. Exit hole in shell on proper right (photo by EverGreene, February 2021).

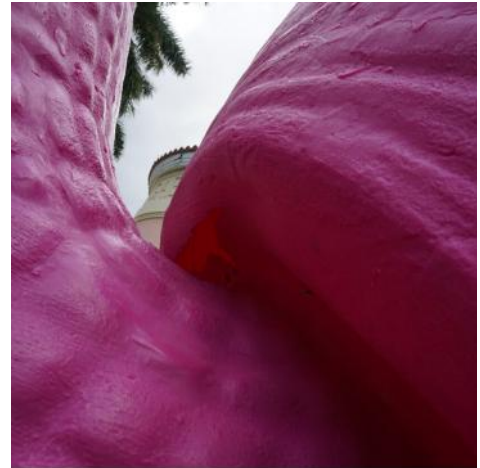
Figure 8. Large break on underside of the shell (photo by EverGreene, February 2021).

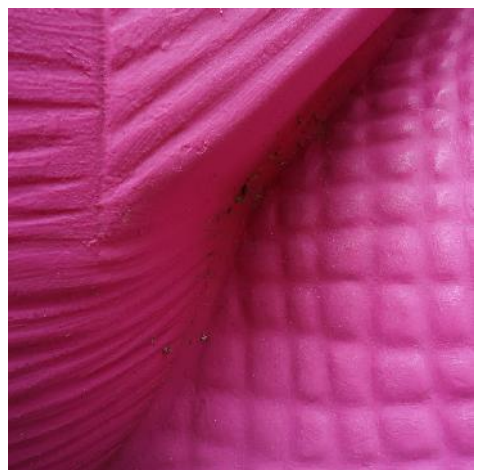
Figure 10. Soiling and debris collecting on underside of shell (photo by EverGreene, February 2021).

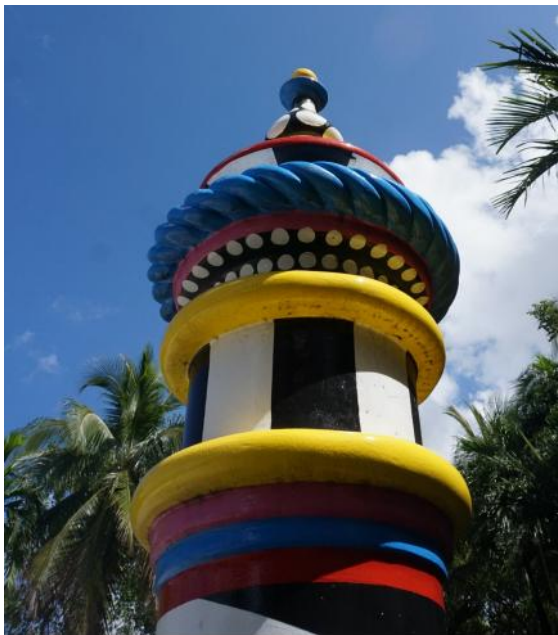
Figure 1: Capital of the *Pop Venice* shaft showing soiling on the underside surfaces (photo by EverGreene, February 2021).

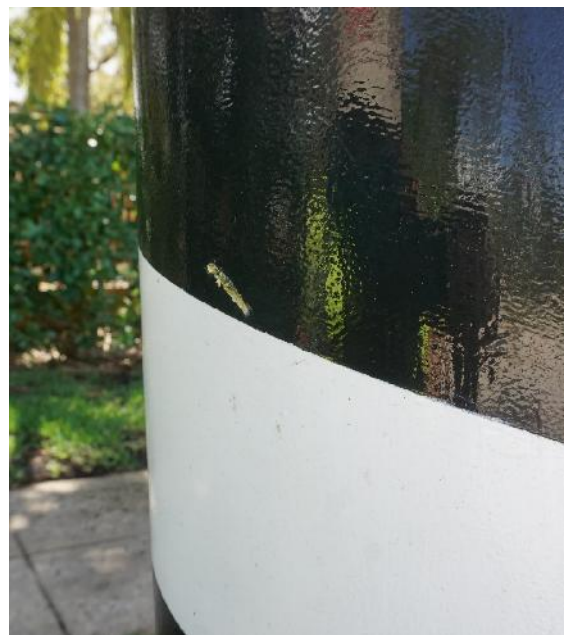
Figure 2: Gouge on the shaft of *Pop Venice* (photo by EverGreene, February 2021).

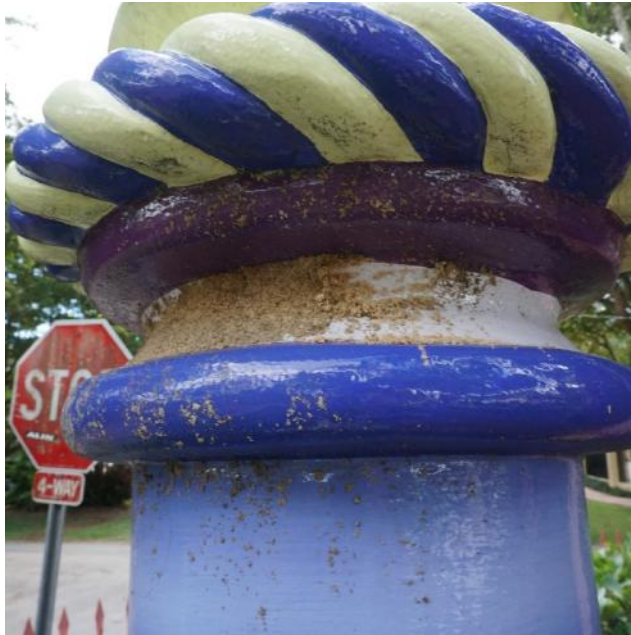
Figure 3. Soiling build-up on capital of *Passionflower*, possibly from insect activity (photo by EverGreene, February 2021).

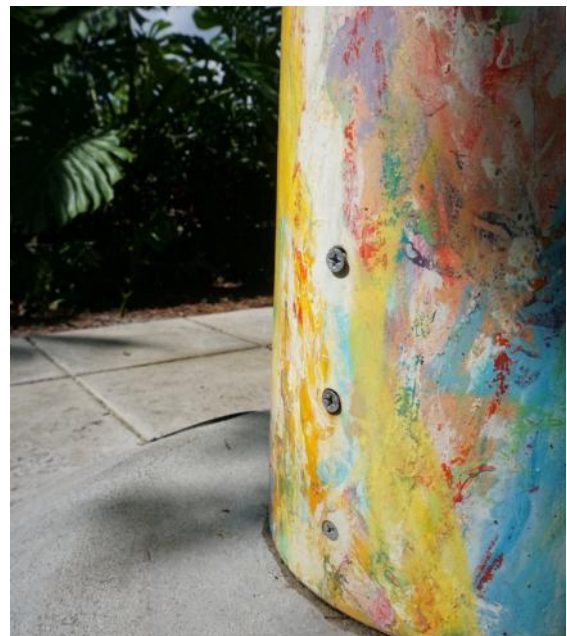
Figure 2. Two proud screws on base of the shaft (photo by EverGreene, February 2021).

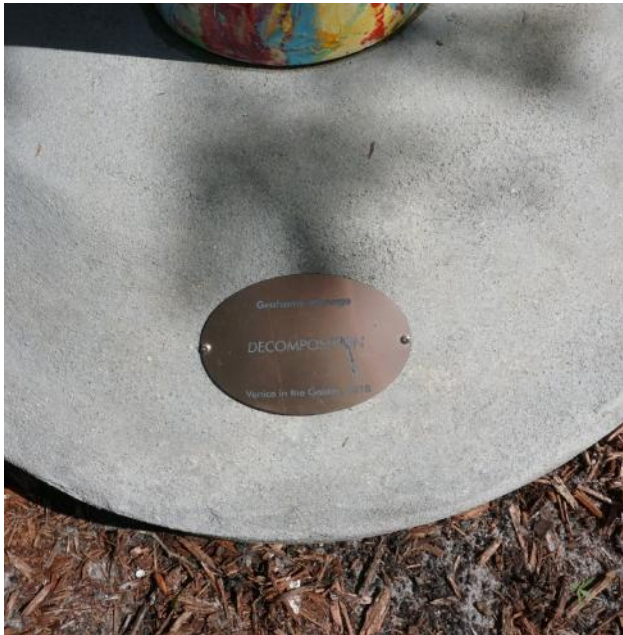
Figure 3. Plaque with abrasion (photo by EverGreene, February 2021).

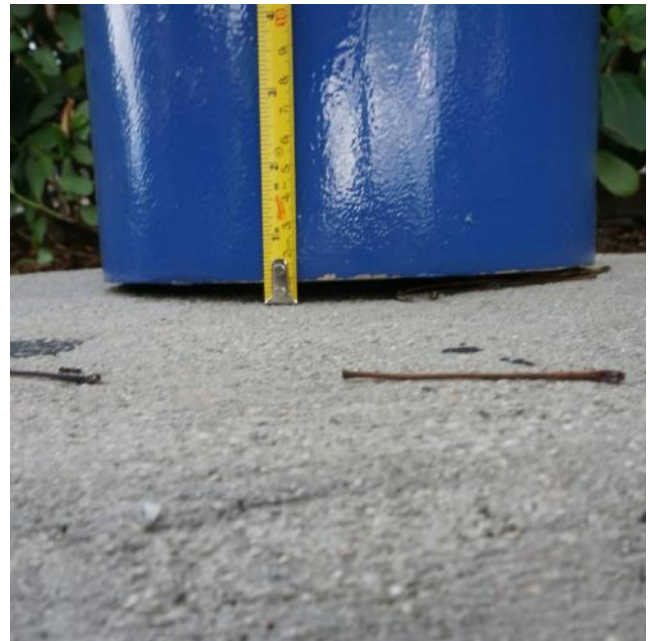
Figure 2. 3/8" gap at the base of the shaft (photo by EverGreene, February 2021).

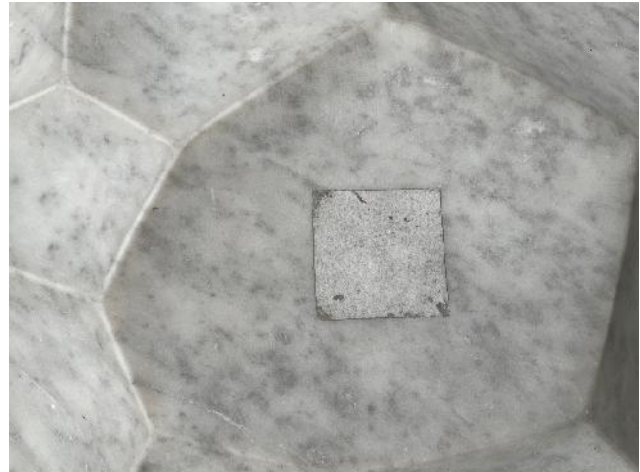
Figure 4. Remnant adhesive and paper from sticker on the large stone (photo by EverGreene, February 2021).

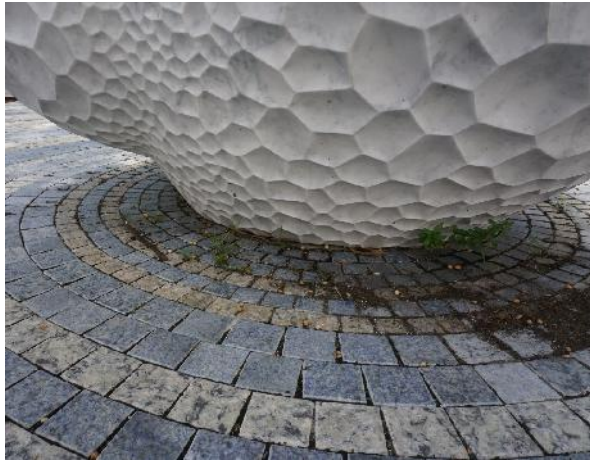
Figure 7. Plant growth in paver joints (photo by EverGreene, February 2021).

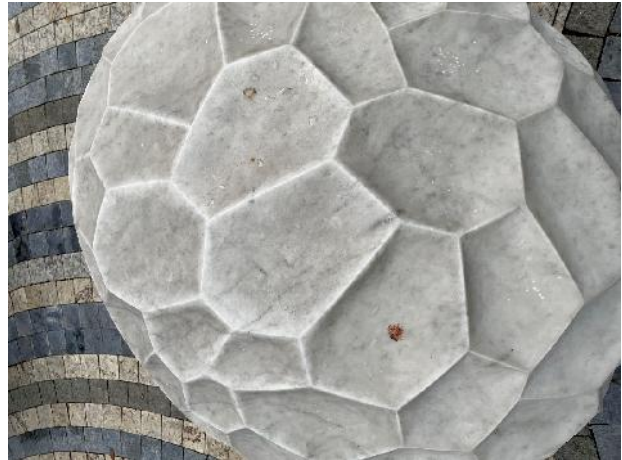
Figure 8. General soiling and guano, typical (photo by EverGreene, February 2021).

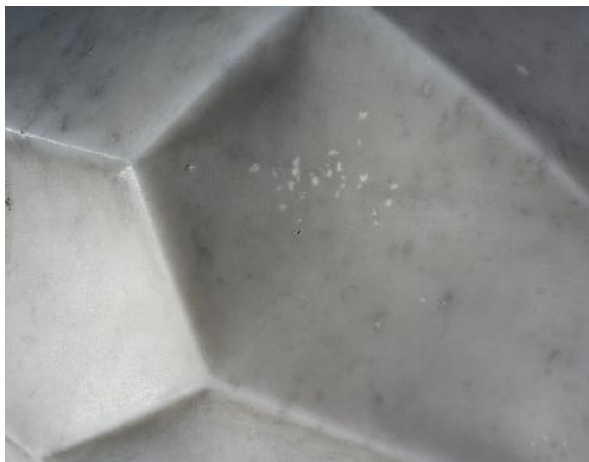
Figure 9. Abrasions on small stone, typical (photo by EverGreene, February 2021).

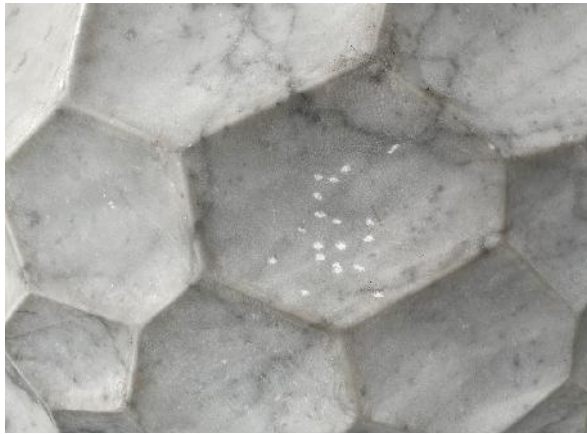
Figure 1. Abrasions (photo by EverGreene, February 2021).

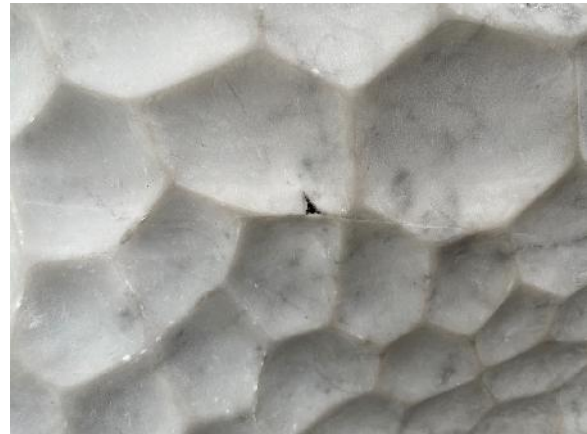
Figure 2. Loss in stone (photo by EverGreene, February 2021).

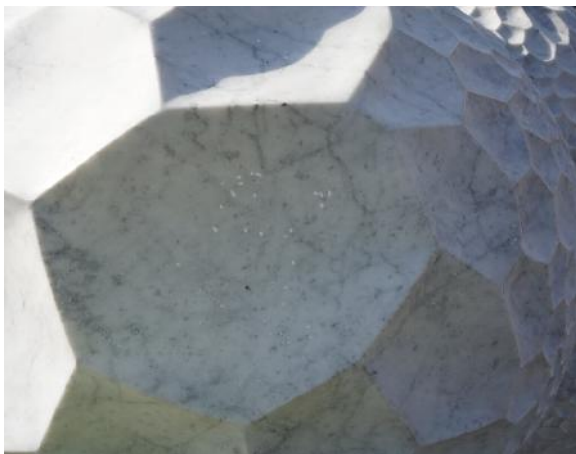
Figure 3. More abrasions (photo by EverGreene, February 2021).

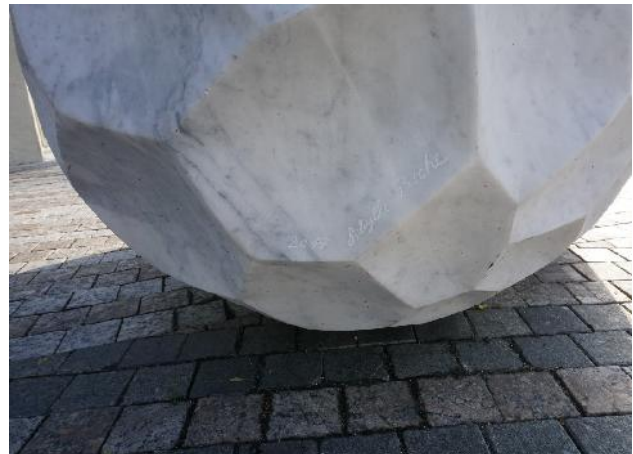
Figure 4. Artist's signature (photo by EverGreene, February 2021).

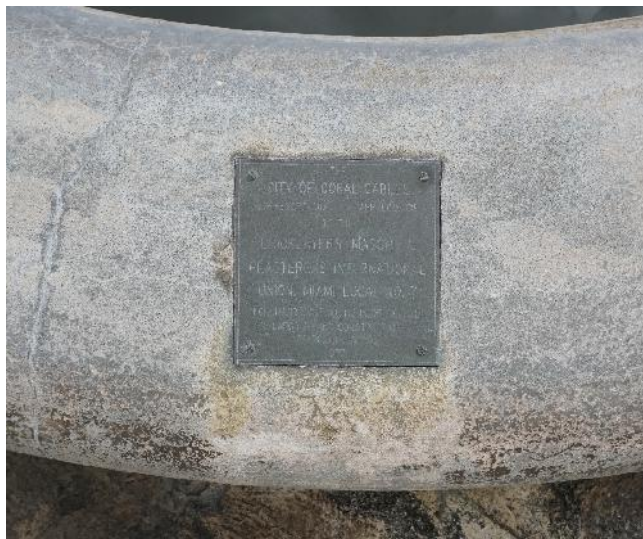
Figure 2. Bronze plaque on west side on concrete basin (photo by EverGreene, February 2021).

Wax bronze plaques (2)	Apply paste wax and buff metal elements per manufacturers application recommendations	Wax Buffing brush	Annual
Replace light bulbs/ Fix lighting failures	Inspect lighting system to determine cause of lighting failure		One-time inspection Annual condition check
Chemically treat water	Retain plumbing and water treatment specialist to recommend and treat water		Determined by chemical method chosen

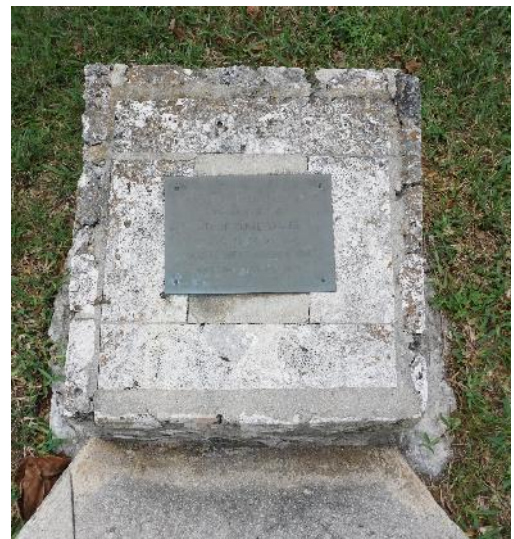
Figure 3. Bronze plaque on oolite base south of the fountain (photo by EverGreene, February 2021).

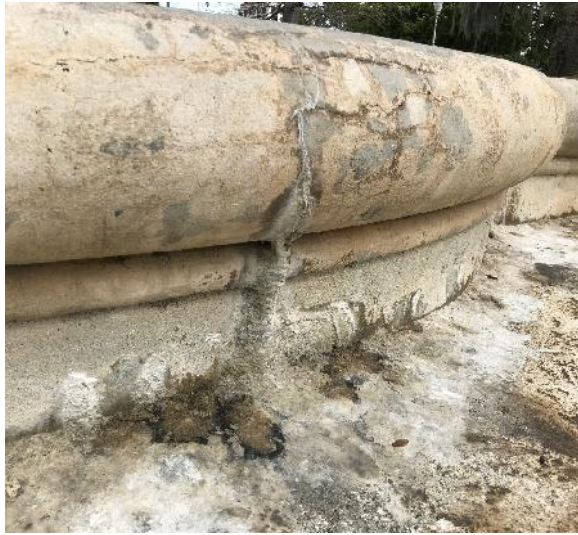
The main basin is cast concrete. The Italian marble fountain sits at the center of the concrete basin. The concrete is in poor condition. It has pervasive network cracks. There are large losses and large cracks/fractures. The large fractures have built up inches of mineral accretions. This occurs on all sides of the fountain.

Figure 4. Detail of the typical mineral accretions on the outside of the concrete basin (photo by EverGreene, February 2021).

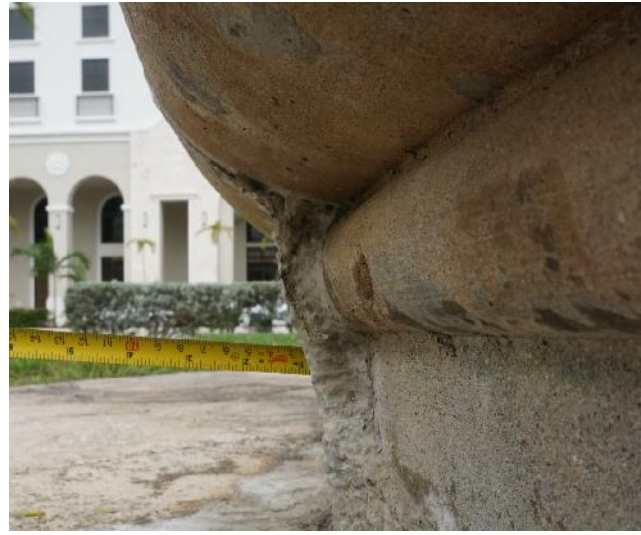
Figure 5. Detail of mineral accretions that have built-up to about 1" (photo by EverGreene, February 2021).

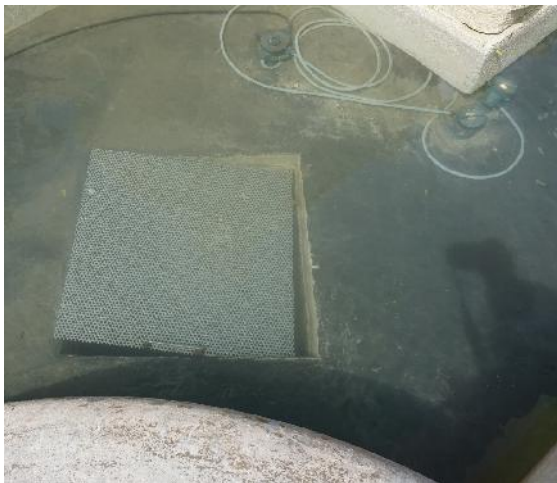
Figure 6. Displaced door (photo by EverGreene, February 2021).

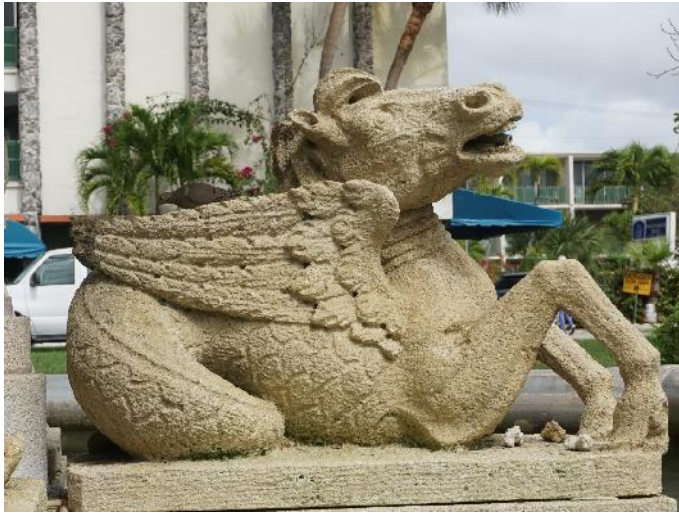
Figure 8. South side of east pegasus, much of the carved detail remains (photo by EverGreene, February 2021).

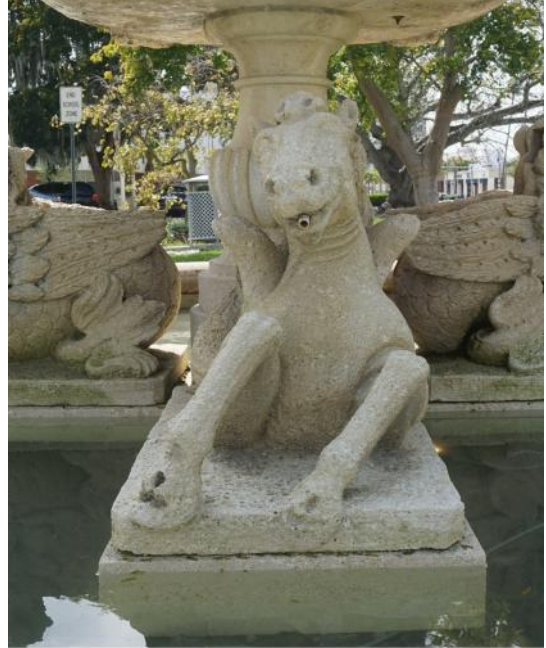
Figure 9. Front of north pegasus, biological growth can be seen on east and west pegasi (photo by EverGreene, February 2021).

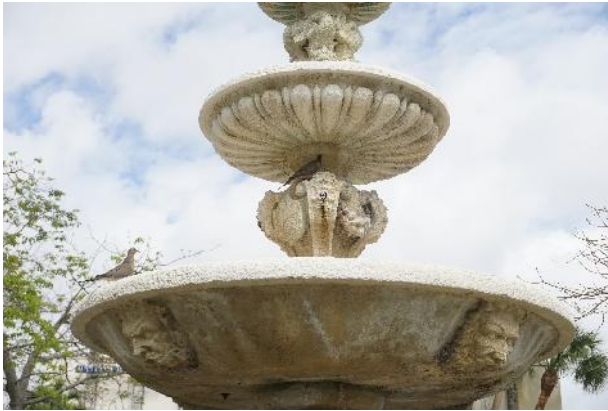
Figure 12. Undersides of lower marble and middle basin; soiling, discoloring, and mineral accretion (photo by EverGreene, February 2021).

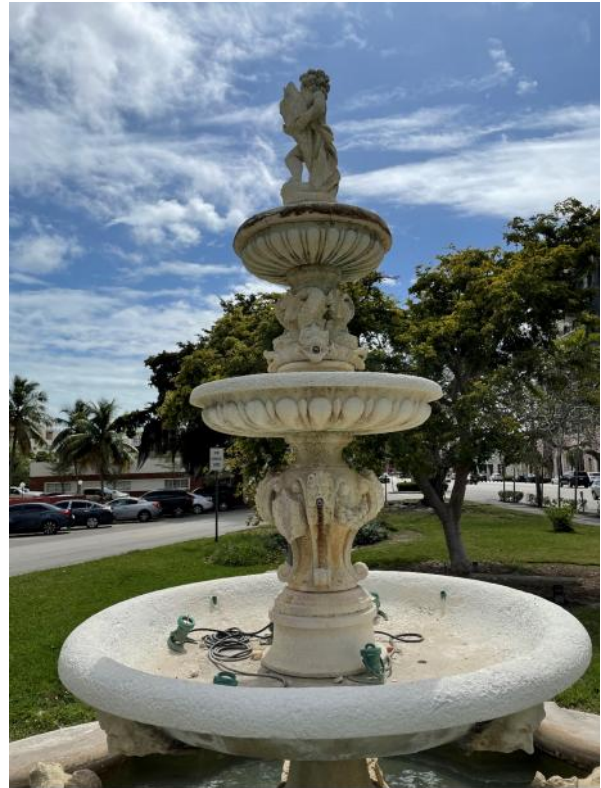
Figure 13. Lighting hardware in lower basin, no water has collected in the lower basin (photo by EverGreene, February 2021).

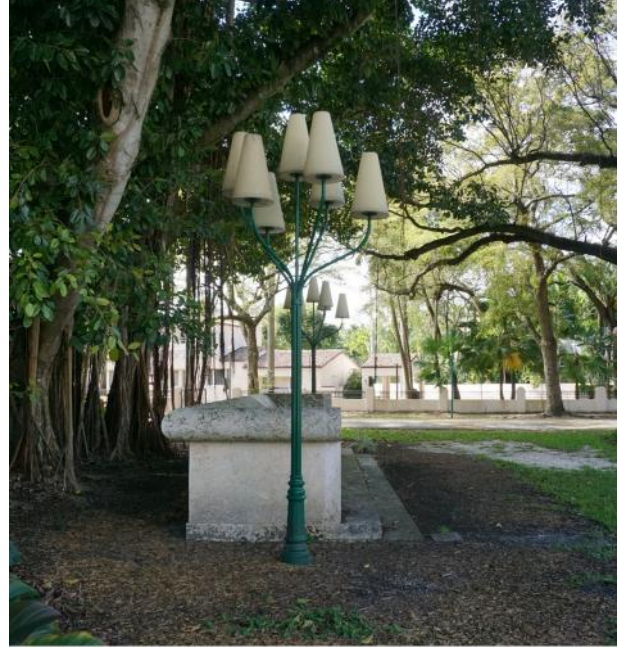
Figure 2. Southeast lamp and southeast side of bench (photo by EverGreene, February 2021).

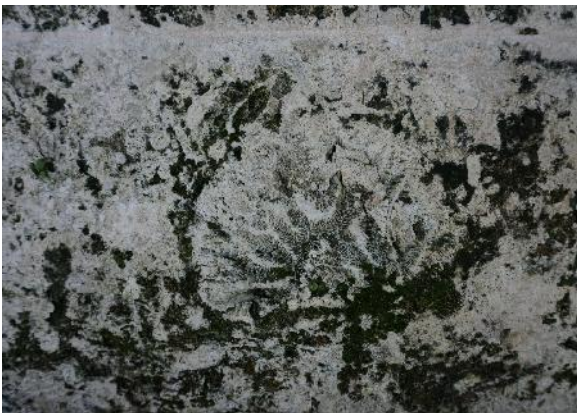
The bench and lamps are in good condition. Biological growth and soiling are on all surface except for the back and sides of the bench which are protected. The natural depressions and pores in the oolite allow for moisture and soiling to collect which creates an environment for biological growth to thrive.

Figure 3. Detail of oolite stone, biological growth (photo by EverGreene, February 2021).

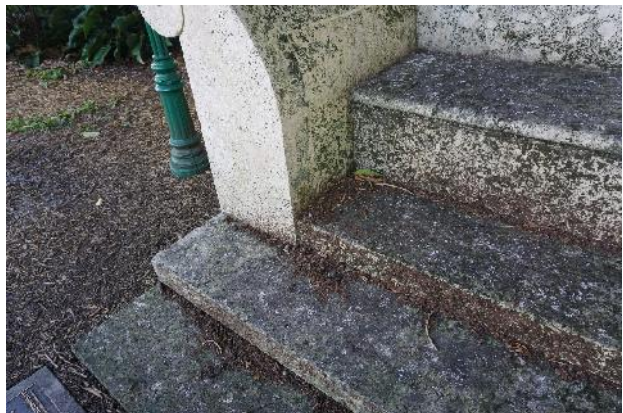
Figure 4. Accumulation of soiling and debris (photo by EverGreene, February 2021).

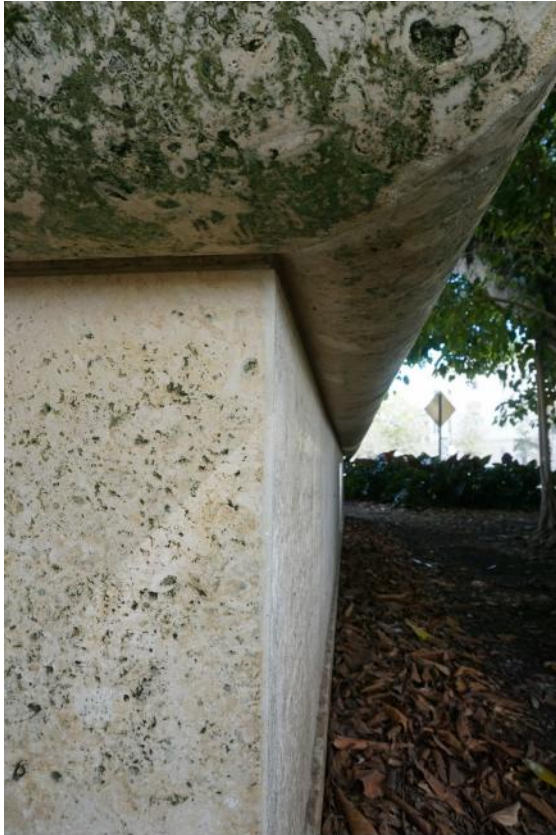
Figure 5. Protected oolite surfaces have minimal biological growth and soiling (photo by EverGreene, February 2021).

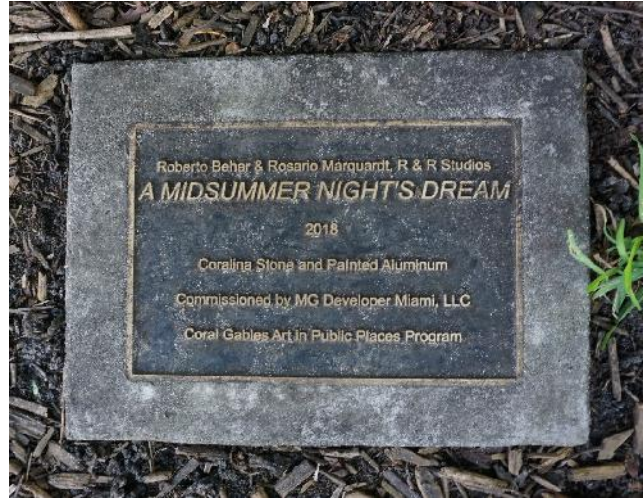
Figure 6. Plaque on ground, southeast corner (photo by EverGreene, February 2021).

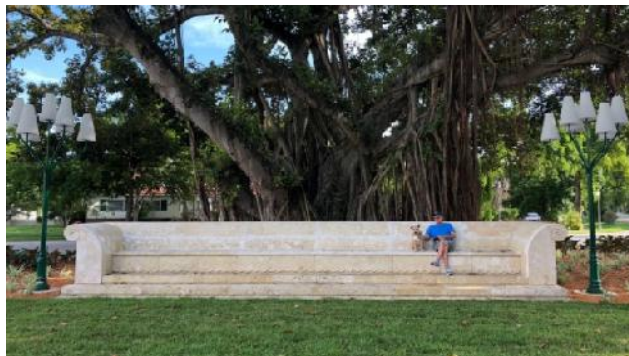
Figure 7. Artwork prior to accumulation of soiling and biological growth (photo courtesy of Coral Gables website, <https://www.coralgables.com/ArtinPublicPlaces>).

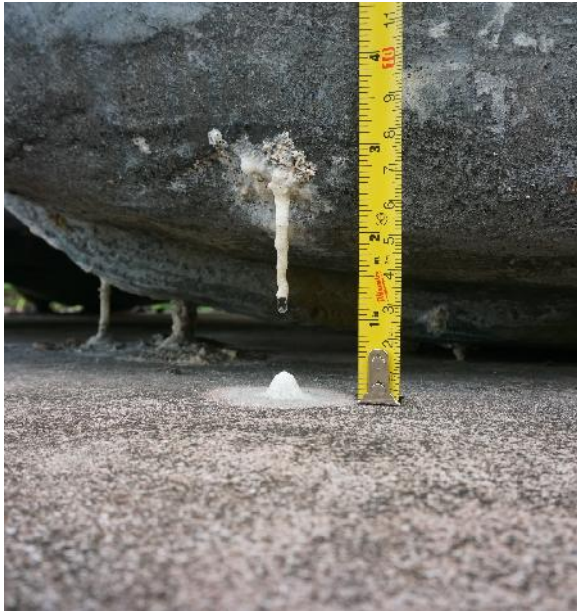
Figure 4. More mineral accretions, actively dripping at the time of the assessment (photo by EverGreene, February 2021).

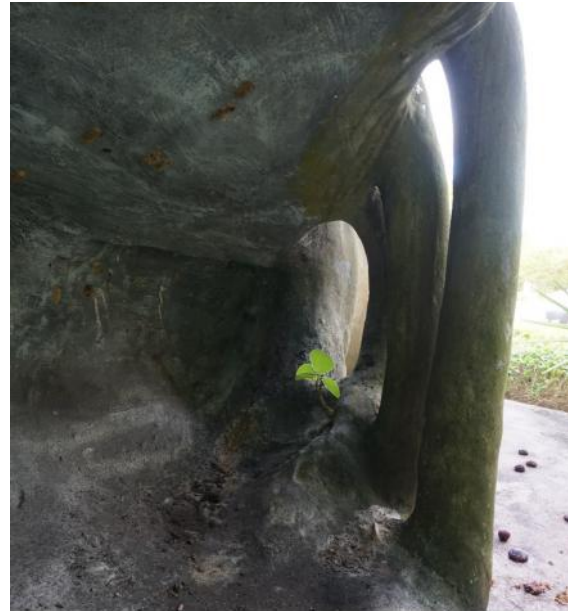
Figure 5. Plant growth and cocoons in the north shoe, banyan fruit deposited on sculpture and platform (photo by EverGreene, February 2021).

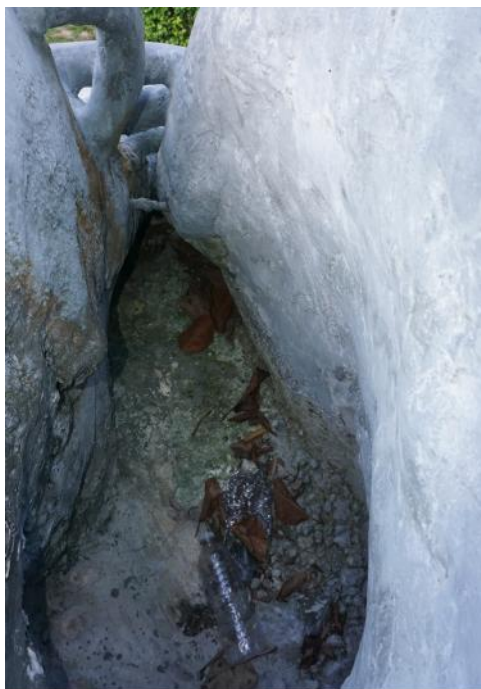
Figure 6. View of inside of south shoe, accumulation of soiling and debris (photo by EverGreene, February 2021).

Bakers' scaffold / ladder	
Conditions Check	Visual inspection from ground.	Camera	Annual
Clear weep holes	Clean out debris accumulated in weep hole is both shoe pieces.	Scrub brush Vacuum	Annual
Site Maintenance	Keep surrounding area maintained and soiling/debris away from base of sculpture. Remove debris that collect inside the upright shoe.	Bench	Weekly/bi-weekly
Wax metal plaques	Apply paste wax and buff metal plaques per manufacturers application recommendations.	Wax Buffing brush	Annual

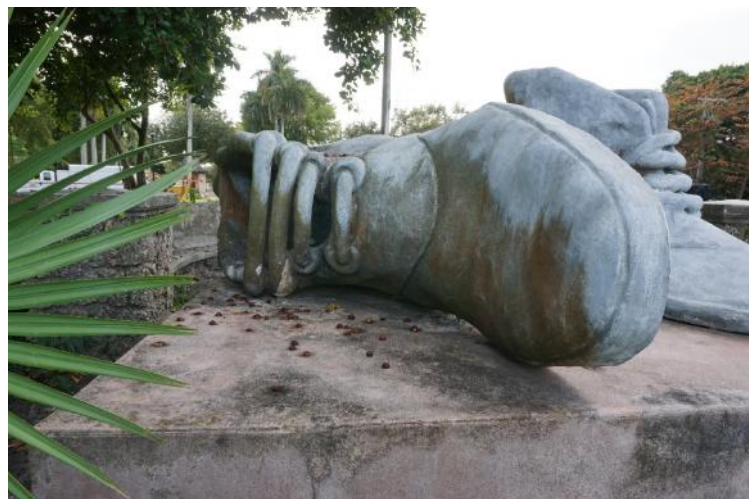
Figure 7. View of north shoe, biological growth and debris (photo by EverGreene, February 2021).

Remove biological growth	Clean masonry with biological solution per manufacturers application instructions.	Scrub brush Filtered water Biological cleaner for masonry Low pressure washer Bench / ladder
Remove ferrous staining	Apply ferrous stain remover per manufacturers application recommendations.	Ferrous stain remover
Restore metal plaques	Mechanically remove corrosion on plaques. Patinate as needed to achieve a statuary brown color. Hot and cold wax and buff per manufacturers application recommendations.	Bronze bristle brushes Abrasives Patinas Hot and cold wax
Remove mineral accretions	Use micro-abrasive methods to remove mineral accretions.	Abrasive media
Fill cracks and losses	Fill cracks with masonry crack filler color matched to stone.	Masonry crack filler, color matched to exiting concrete
Coating application	Remove failed/unstable paint. Apply paint to areas of paint loss. Apply per manufacturers application recommendations.	Exterior grade paint compatible with outdoor concrete, color matched to existing. Multiple colors should be matched and applied to match the existing mottling.

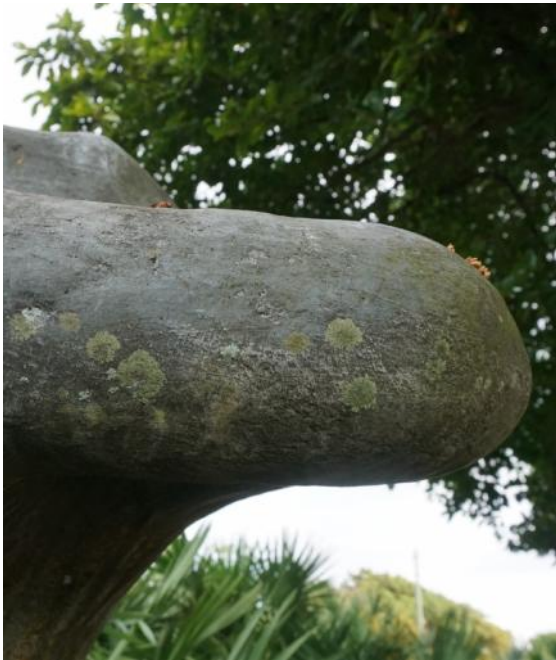
Figure 8. Lichen (photo by EverGreene, February 2021).

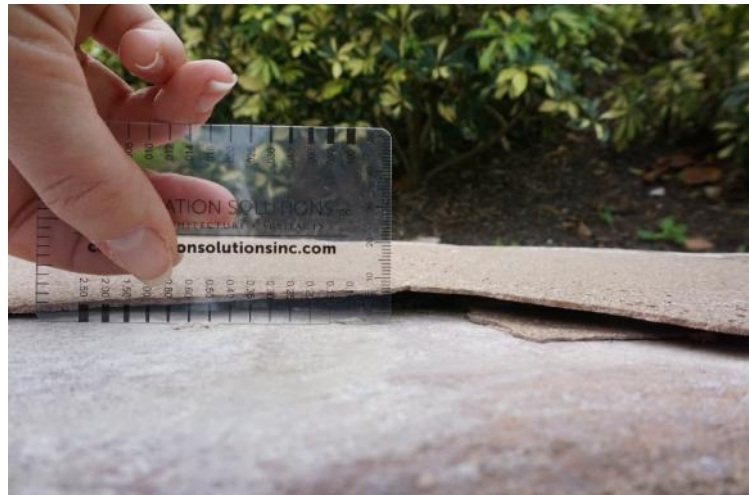
The platform is in poor condition. There are large losses on all surfaces. Delamination and network cracking are pervasive. There are previous repairs on the surfaces of the base which indicate that this delamination deterioration is not a new condition. The concrete plaque has been repaired, likely at the time of the sculpture repair work in 2012.

Figure 11. Delamination on platform, 1/2 cm gap (photo by EverGreene, February 2021).

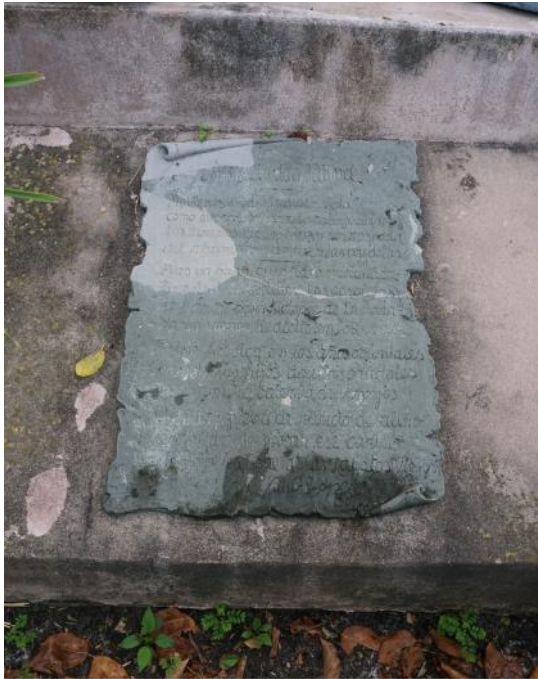
Figure 12. Concrete plaque (photo by EverGreene, February 2021).

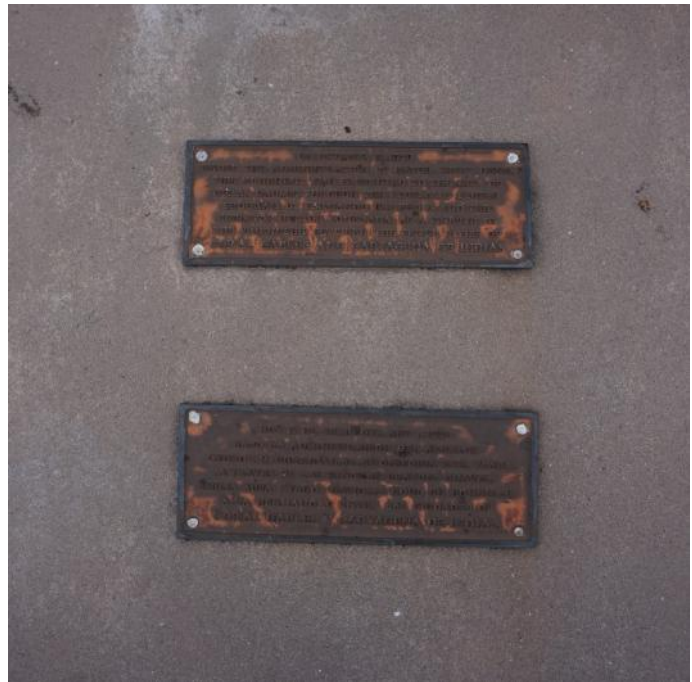
Figure 13. Bronze plaques (photo by EverGreene, February 2021).

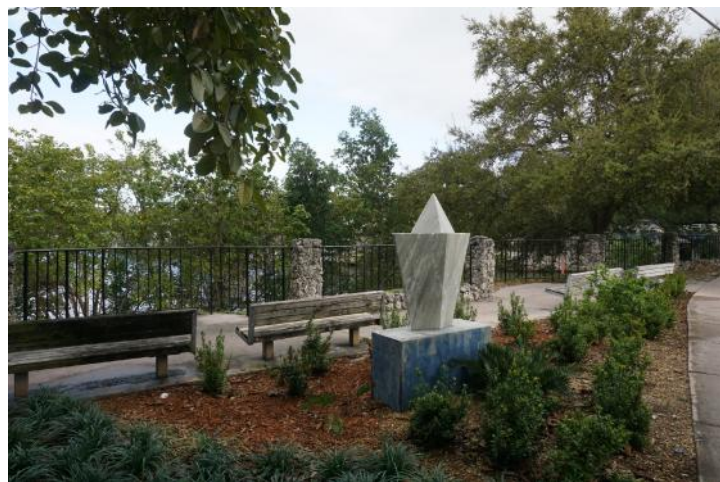
Figure 2. View of artwork from the south west (photo by EverGreene, February 2021).

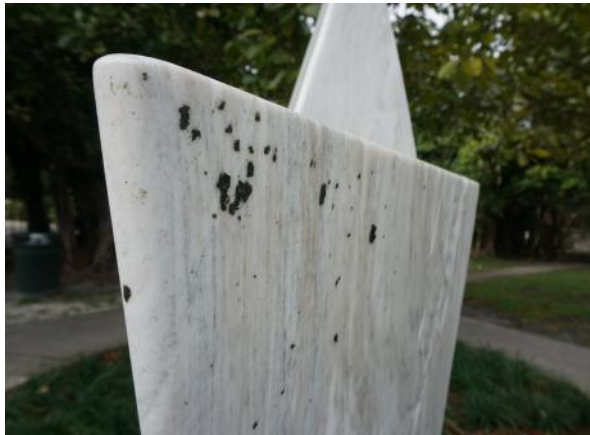
Figure 5. Biological growth on north east face of sculpture (photo by EverGreene, February 2021).

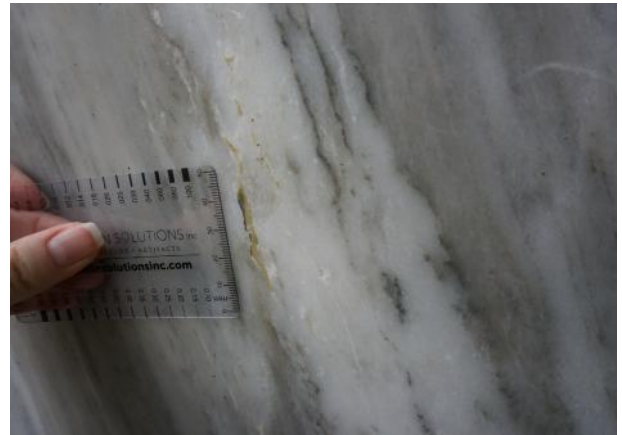
Figure 6. Discolored fills in marble on north west face of the sculpture (photo by EverGreene, February 2021).

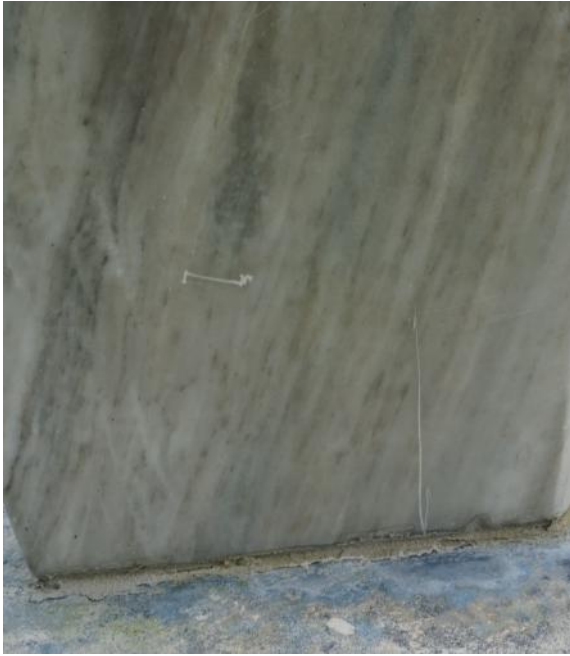
Figure 7. Biological growth on north east face of sculpture (photo by EverGreene, February 2021).

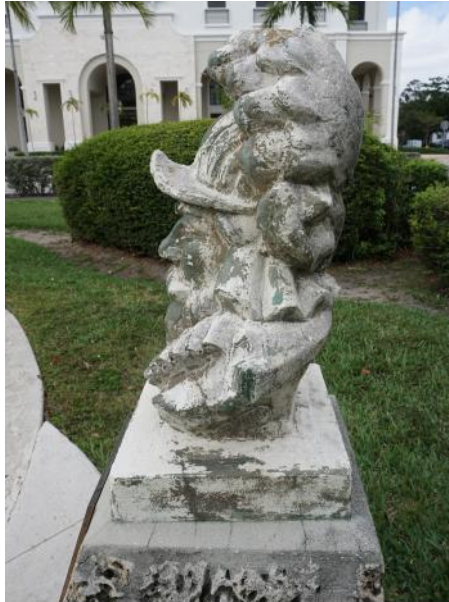
Figure 1. Bust of Juan Ponce de Leon, view of east side (photo by EverGreene, February 2021).

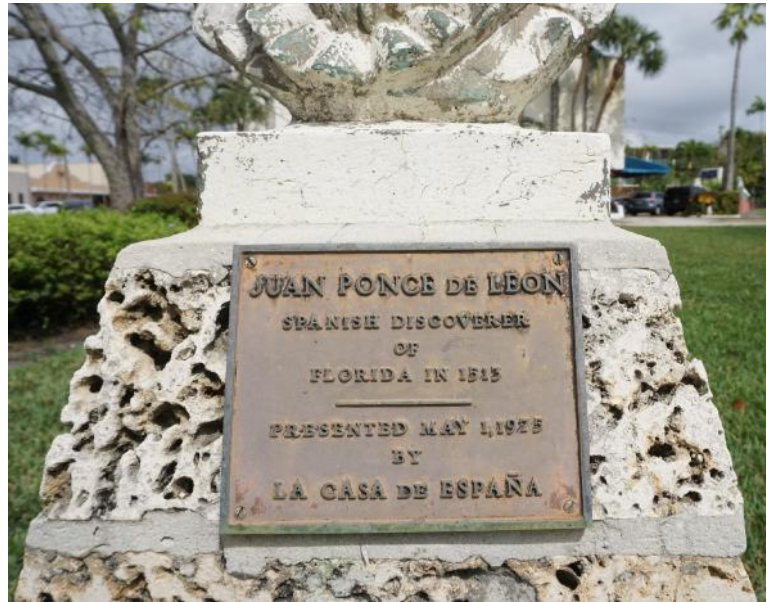
Figure 2. Bronze plaque (photo by EverGreene, February 2021).

Work Procedures	Means and Methods	Equipment	Frequency
General Cleaning	Detergent cleaning and low-pressure washing (500 psi) on the stone base and hose pressure on the bust.	Low pressure washer Heated, filtered water Scrub brush Detergent Bench / ladder	Annual
Conditions Check	Visual inspection from ground	Camera	Annual
Site Maintenance	Keep surrounding area maintained and soiling/debris away from base of sculpture. Keep grass cut. Remove plant growth from oolite indentations.		Weekly/bi-weekly
Wax plaque	Apply paste wax and buff metal elements per manufacturers application recommendations	Wax Buffing brush	Annual

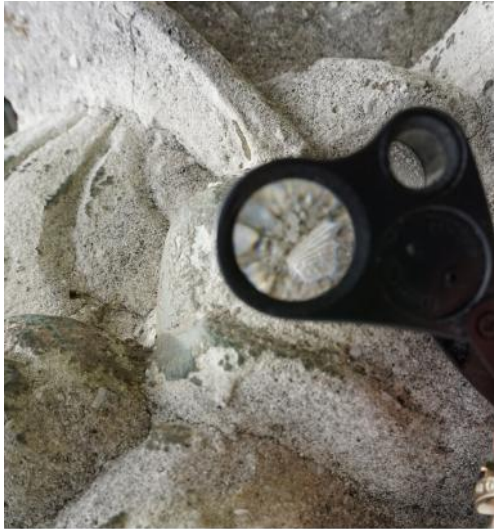
Figure 5. Shell inclusions (photo by EverGreene, February 2021).
